Project title
TRAFFIC IMPROVEMENT SCHEME IN TUEN MUN
– WIDENING AND ADDITION OF SLIP ROADS
AT LUNG FU ROAD/ TUEN MUN ROAD/
WONG CHU ROAD/ HOI WING ROAD

Drawing title
PHOTOMONTAGE VIEWPOINT 02

Drawing no.	FIGURE 9.8.2	Rev.	B
Drawn	Date	Checked	Approved
Scale	N.T.S.	Status	FOR INFORMATION

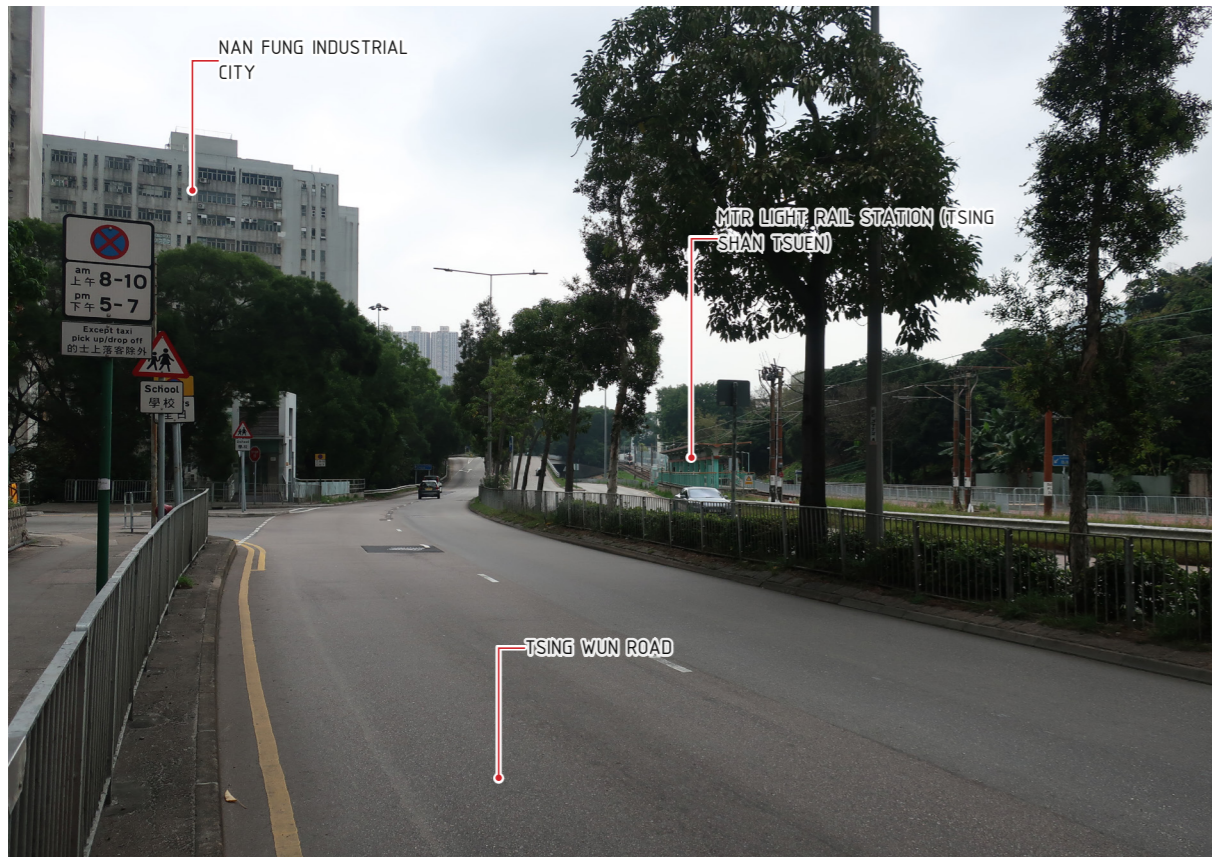
VP02 – BUS STOP (SKH ST PETER'S CHURCH) ON TSING WUN ROAD (SOUTHBOUND) - EXISTING SITE CONDITION

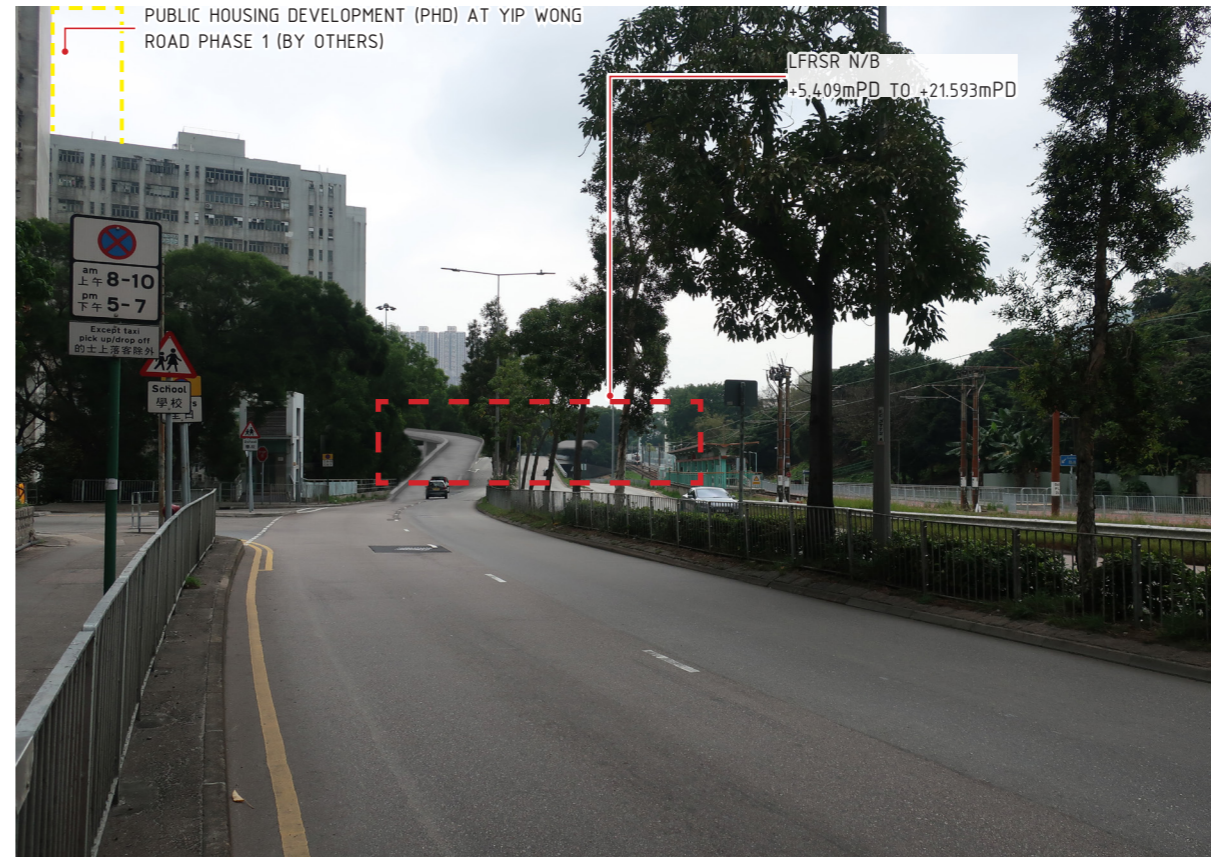
VP02 – BUS STOP (SKH ST PETER'S CHURCH) ON TSING WUN ROAD (SOUTHBOUND) - WITHOUT MITIGATION MEASURES

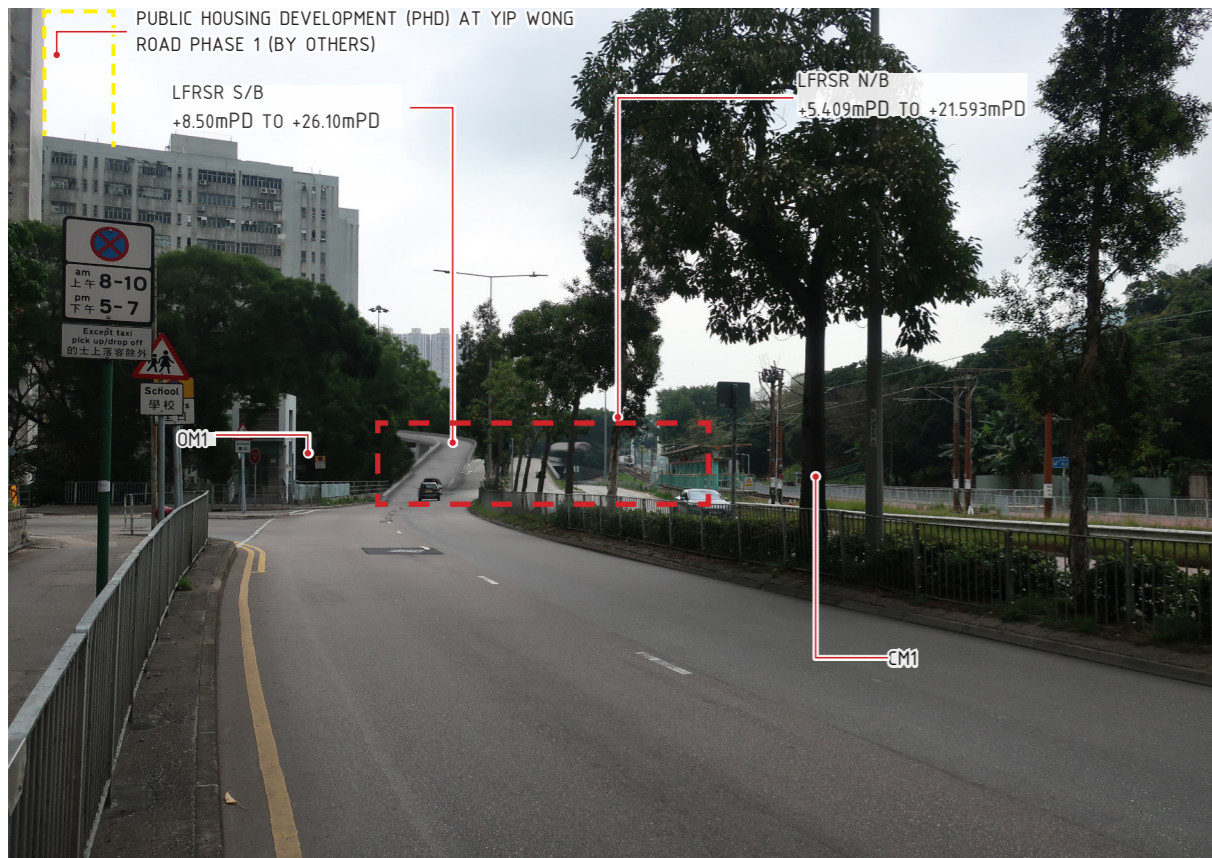
VP02 – BUS STOP (SKH ST PETER'S CHURCH) ON TSING WUN ROAD (SOUTHBOUND) - DAY 1 WITH MITIGATION MEASURES

CM1	Preservation of Existing Vegetation
CM2	Transplanting of Affected Trees
CM3	Control of Night-time Lighting Glare
CM4	Good Site Practice
CM5	Erection of Decorative Screen Hoarding

OM1	Compensatory Tree Planting
OM2	Roadside Planting
OM3	Aesthetically treatment Noise Barrier
OM4	Aesthetically pleasing design

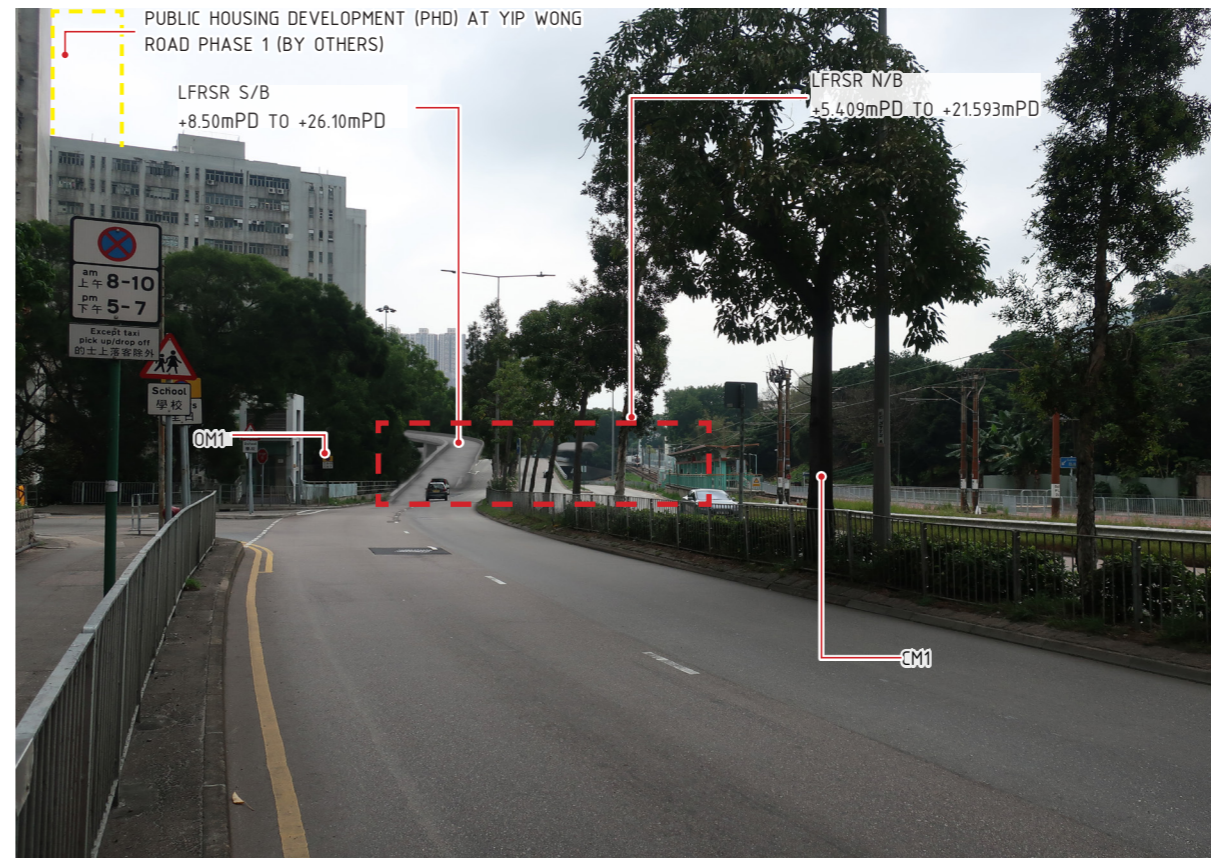
VP02 – BUS STOP (SKH ST PETER'S CHURCH) ON TSING WUN ROAD (SOUTHBOUND) - YEAR 10 WITH MITIGATION MEASURES
