View 1: From Fa Peng, Cheung Chau

Figure 11.7A Lamma Breakwater Island Landfill - Photomontages

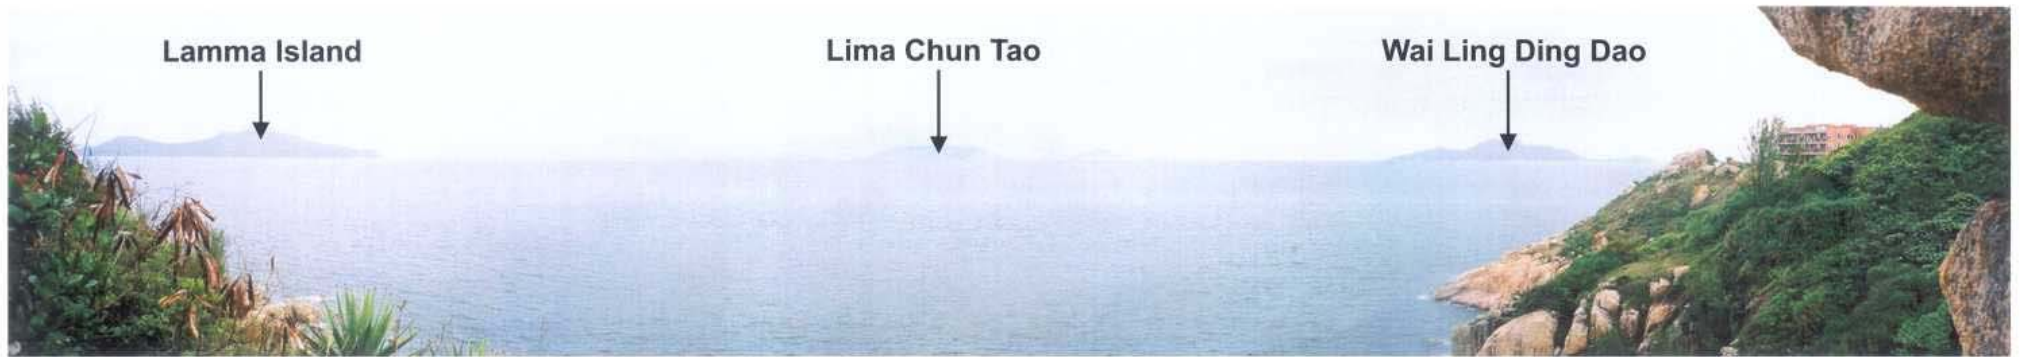
Lamma Island

Lima Chun Tao

Wai Ling Ding Dao

Existing

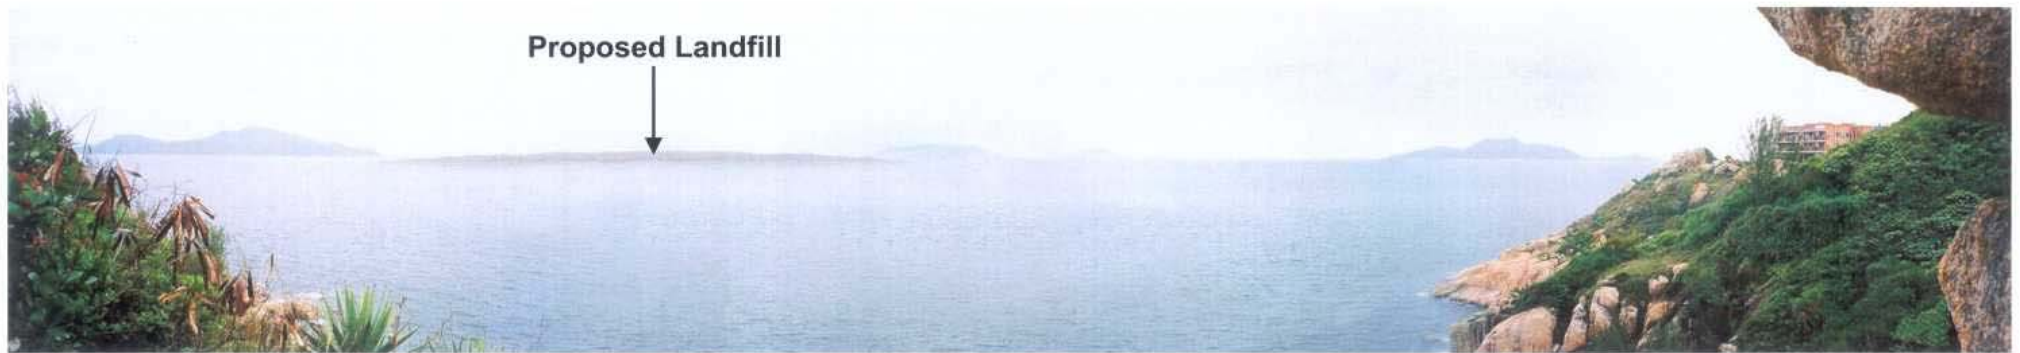
Proposed Landfill

Without Mitigation

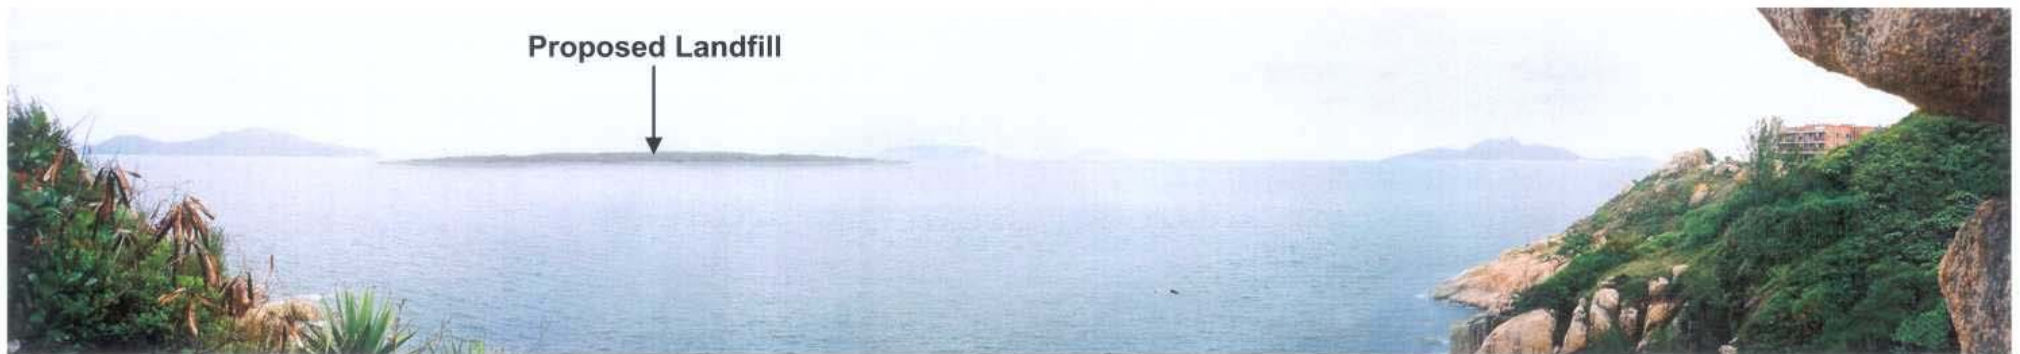
Proposed Landfill

Year 10 With Mitigation
