(ACE Paper 4/98)
for information

Contaminated Mud Disposal at East Sha Chau Interim Report VII

Fill Management Committee Secretariat
Geotechnical Engineering Office
Civil Engineering Department
January 1998

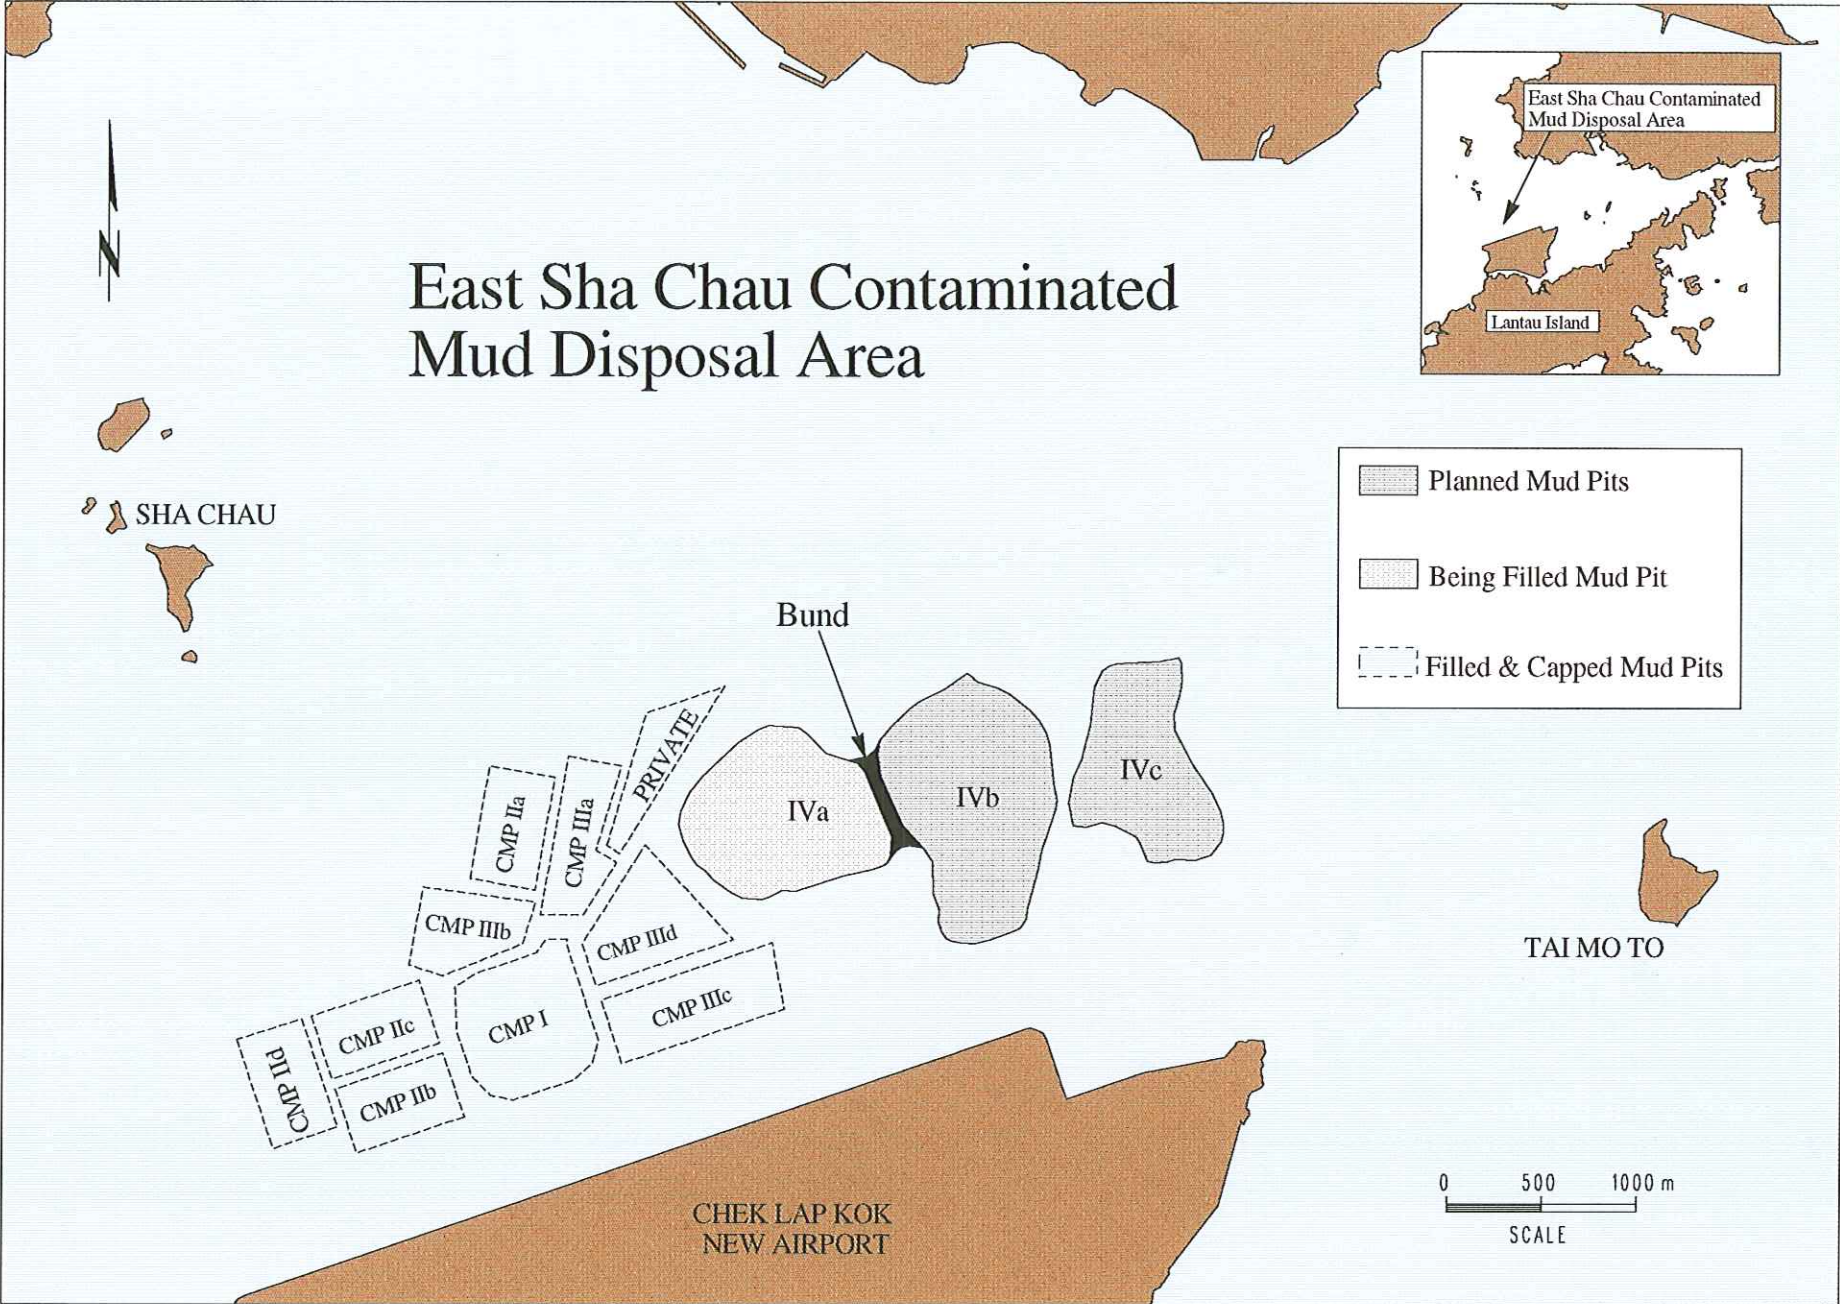
East Sha Chau Contaminated Mud Disposal Area

2. The last purpose-dredged seabed pit, CMP III d ceased receiving mud on 1 December 1997 when the first subpit of the empty marine sand borrow pit (CMP IV a) commenced operation. The attached drawing no. FMC/377K-1 shows the locations of mud pits at the East Sha Chau facility.

Drawing no. FMC/377K-1 "East Sha Chau Contaminated Mud Disposal Area".
