Pilot Green Transport Fund

Final Report

Trial of Single-deck Electric Bus for Coach Hiring Service
(Tai On Investment Limited)

**Final Report
(Trial Period: 1 September 2019 – 31 August 2021)**

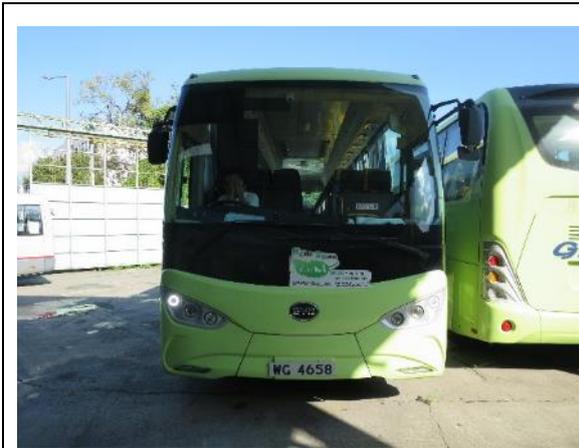
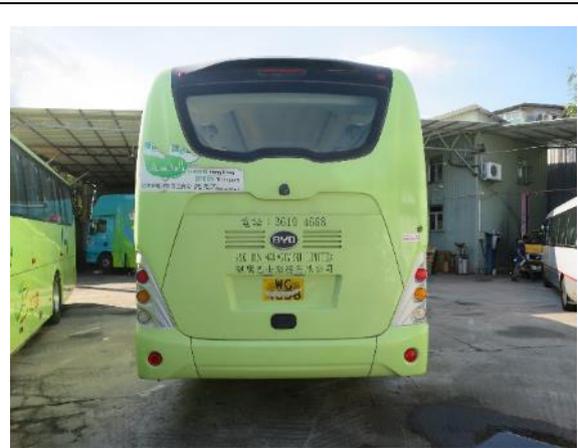
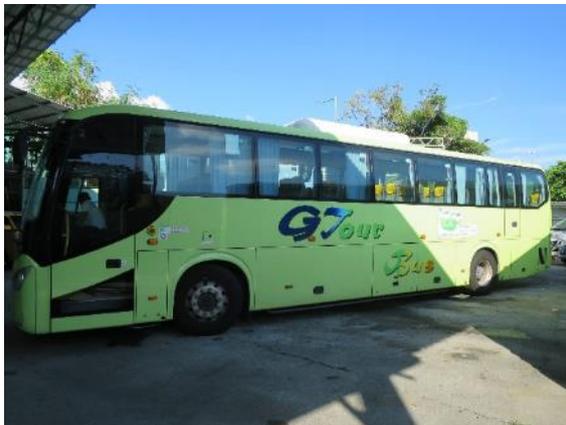
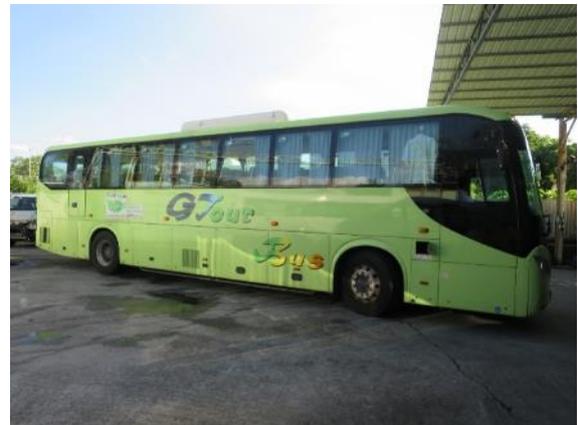
Front view of the EV

Rear view of the EV

Left side view of the EV

Right side view of the EV

Registration mark	WG4658
Make:	BYD
Model:	C9R
Class:	Public bus
Gross vehicle weight:	18,000 kg
Seating capacity:	driver + 65 passengers
Rated power:	300 kW
Travel range:	250 km (air conditioning off)
Maximum speed:	100 km/h
Battery material:	Lithium iron phosphate
Battery capacity:	324 kWh
Year of manufacture:	2018

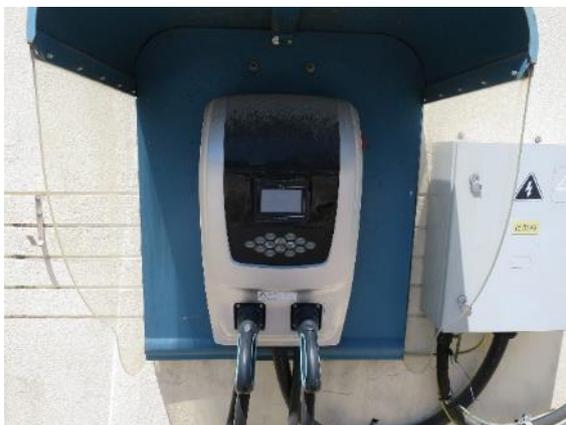
80 kW, 3-phase AC quick charging facility

Make:	BYD
Model:	EVA080KG/01
Power:	80 kW, 3-phase AC
Charging standard:	GB/T 20234.2
Weight:	30 kg
Year of manufacture:	2018

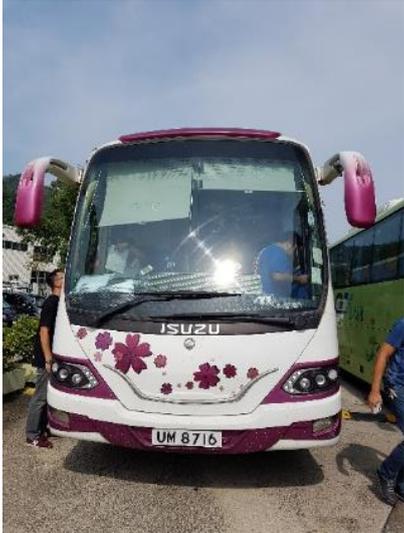
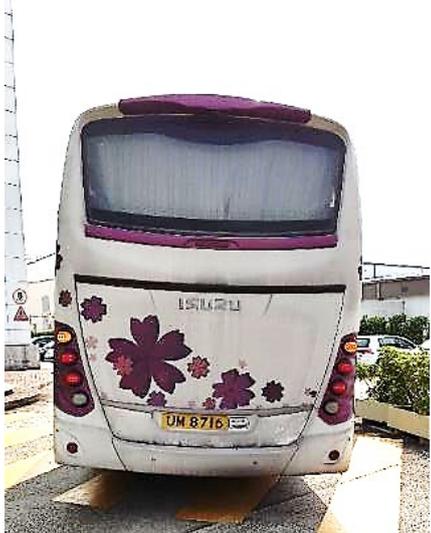
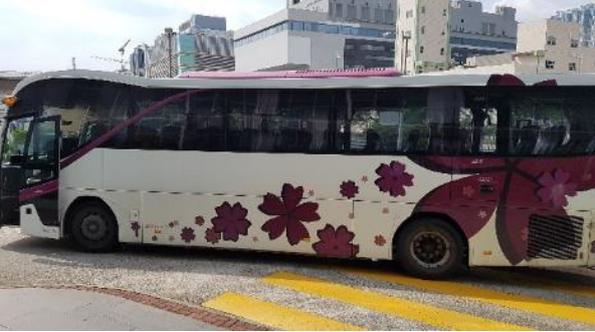
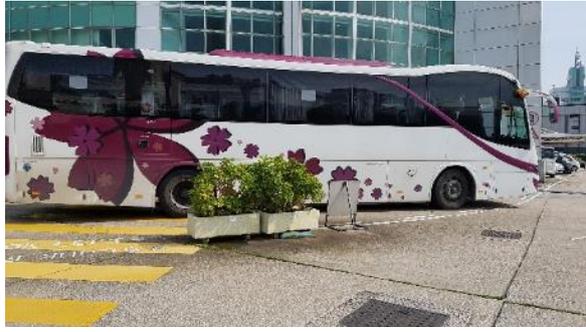
DV1: UM8716 (1 Sep 2019 to 10 Oct 2019)

A front-facing view of a white Isuzu bus with purple floral decorations. The license plate is UM 8716. The word 'ISUZU' is visible on the front grille.

A rear-facing view of the same white Isuzu bus with purple floral decorations. The license plate is UM 8716. The word 'ISUZU' is visible on the rear panel.
<p>Front view of DV1</p>	<p>Rear view of DV1</p>

A side view of the white Isuzu bus from the left side, showing purple floral decorations and a purple stripe along the roofline.

A side view of the white Isuzu bus from the right side, showing purple floral decorations and a purple stripe along the roofline.
<p>Left side view of DV1</p>	<p>Right side view of DV1</p>

1 Sep 2019 to 10 Oct 2019	30 Oct 2019 to 30 Oct 2020
Registration mark:	DV1: UM8716 ^[1]	DV2: SS5402 ^[2]
Make:	Isuzu	Scania
Model:	LT434PF-6S-V	K280IB4X2NB
Class:	Public bus	Public bus
Gross vehicle weight:	14,800 kg	16,000 kg
Seating capacity:	Driver + 66 passengers	Driver + 65 passengers
Cylinder capacity:	7,790 cc	9,290 cc
Year of manufacture:	2015	2013

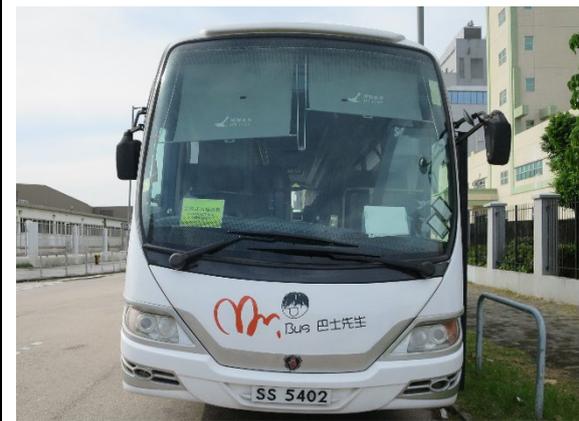
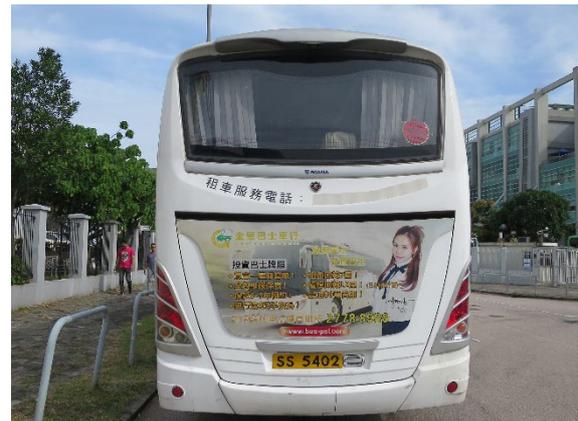
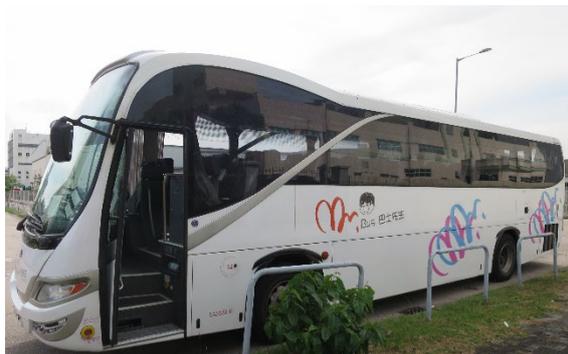
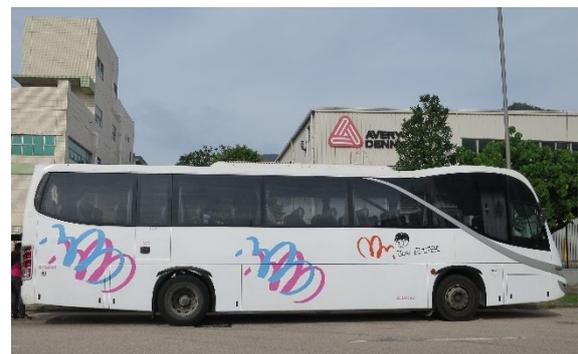
DV2: SS5402 (from 30 Oct 2019 to 31 Oct 2020)

Front view of DV2

Rear view of DV2

Left side view of DV2

Right side view of DV2
