**CEDD CONTRACT NO. CV/2012/05 –
BATHING BEACH AT LUNG MEI, TAI PO**

**POST-CONSTRUCTION MONITORING AND AUDIT
REPORT**

PREPARED FOR
WELCOME CONSTRUCTION CO., LTD.

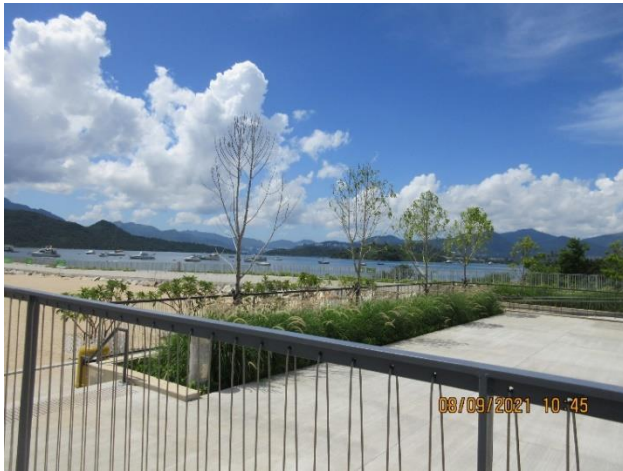
Photo I.

2.1	The physical protection (fencing) is in place?	✓			
2.2	Any poor health condition or dead tree observed?	✓			Two <i>Michelia x alba</i> are dead
2.3	Any poor practice of pruning observed?		✓

Dead *Michelia x alba*

1. Two nos. of new trees (*Michelia x alba*) are found dead, contractor is required to replace the concerned trees. (Photo I)
2. There is no planting with bare soil in the planters outside the male (Planter P14) and female (Planter P3b) changing rooms. (Photo J and Photo K).
3. The contractor is required to plant *Schefflera arboricola* instead of *Rhapis excelsa* as shown on the plan for the planter (Planter P7) close to the male changing room. (Photo L)
4. *Bauhinia glauca* is required to plant as shown on plan but it was not found within the site. The Contractor is required to follow the approved plan and complete all planting including the planting of *Bauhinia glauca* before the next audit checking.

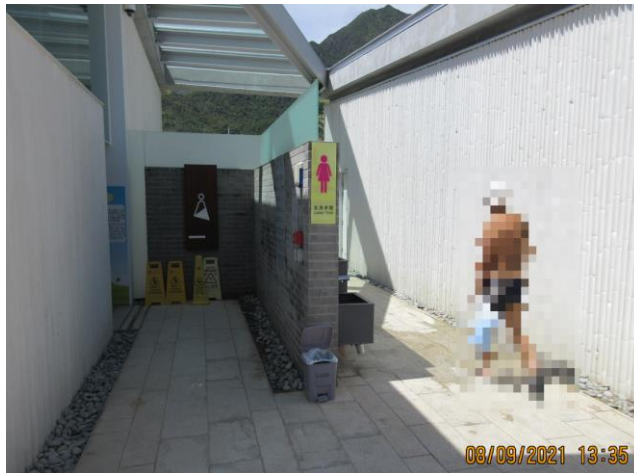
Photo K.

No plant in the planter outside the female (Planter P3b) changing room

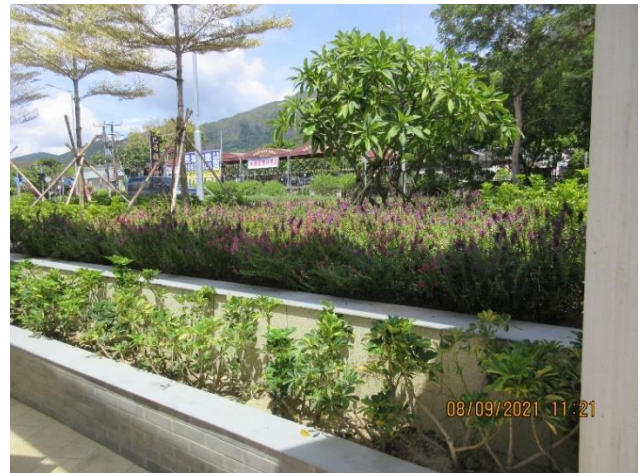
Photo L.

1.8	Are the planting including species, size and plants quality completed following the landscape plan?		✓		<ul style="list-style-type: none"> ● The plant near the male changing room (Planter P7) is <i>Schefflera arboricola</i> instead of <i>Rhapis excelsa</i> in the plan ● No <i>Bauhinia glauca</i> could be found
2	Protection of trees

The plant near the male changing room (Planter P7) is *Schefflera arboricola* instead of *Rhapis excelsa* shown in the plan

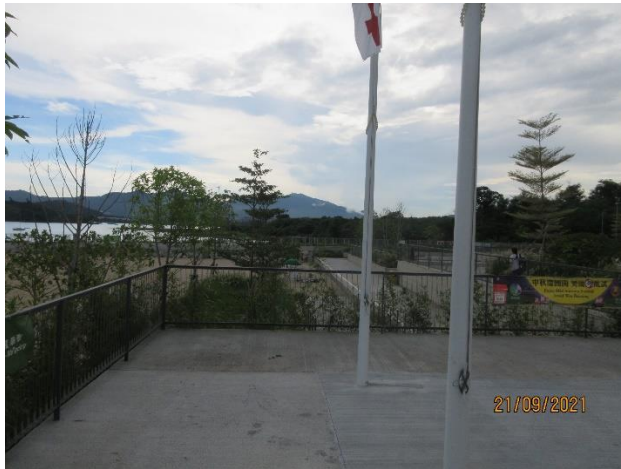
Photo I.

2.1	The physical protection (fencing) is in place?	✓			
2.2	Any poor health condition or dead tree observed?	✓			Two <i>Michelia x alba</i> are dead
2.3	Any poor practice of pruning observed?		✓

Dead *Michelia x alba*

1. Two nos. of new trees (*Michelia x alba*) are found dead, contractor is required to replace the concerned trees. (Photo I)
2. There is no planting with bare soil in the planters outside the male (Planter P14) and female (Planter P3b) changing rooms. (Photo J and Photo K).
3. The contractor is required to plant *Schefflera arboricola* instead of *Rhapis excelsa* as shown on the plan for the planter (Planter P7) close to the male changing room. (Photo L)
4. *Bauhinia glauca* is required to plant as shown on plan but it was not found within the site. The Contractor is required to follow the approved plan and complete all planting including the planting of *Bauhinia glauca* before the next audit checking.

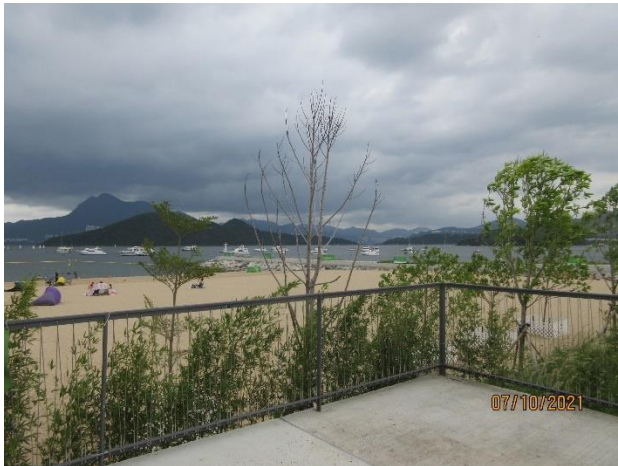
Photo I.

2.1	The physical protection (fencing) is in place?	✓			
2.2	Any poor health condition or dead tree observed?	✓			Two <i>Michelia x alba</i> are dead
2.3	Any poor practice of pruning observed?		✓

Dead *Michelia x alba*

1. Two nos. of new trees (*Michelia x alba*) are found dead, contractor is required to replace the concerned trees. (Photo I)
2. There is no planting with bare soil in the planters outside the male (Planter P14) and female (Planter P3b) changing rooms. (Photo J and Photo K).
3. The contractor is required to plant *Schefflera arboricola* instead of *Rhapis excelsa* as shown on the plan for the planter (Planter P7) close to the male changing room. (Photo L)
4. *Bauhinia glauca* is required to plant as shown on plan but it was not found within the site. The Contractor is required to follow the approved plan and complete all planting including the planting of *Bauhinia glauca* before the next audit checking.

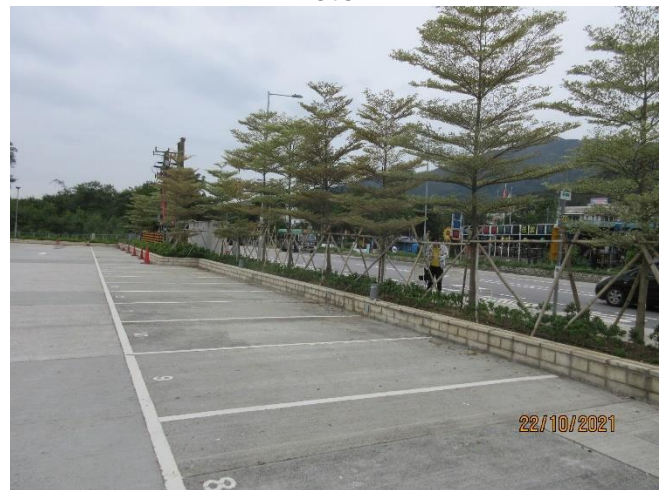
Photo D.

General view (4)

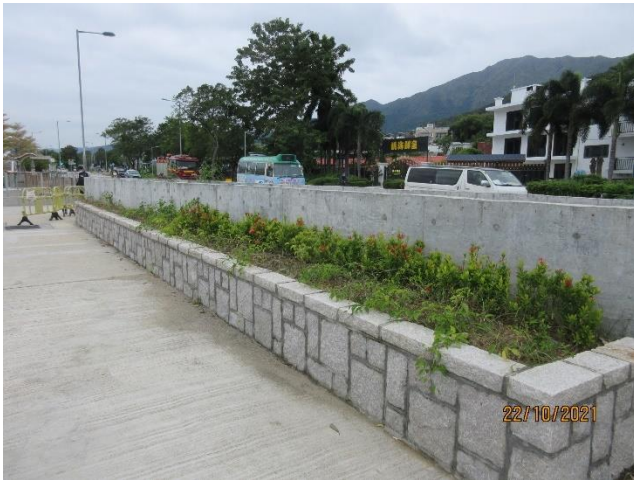
Photo F.

General view (5)

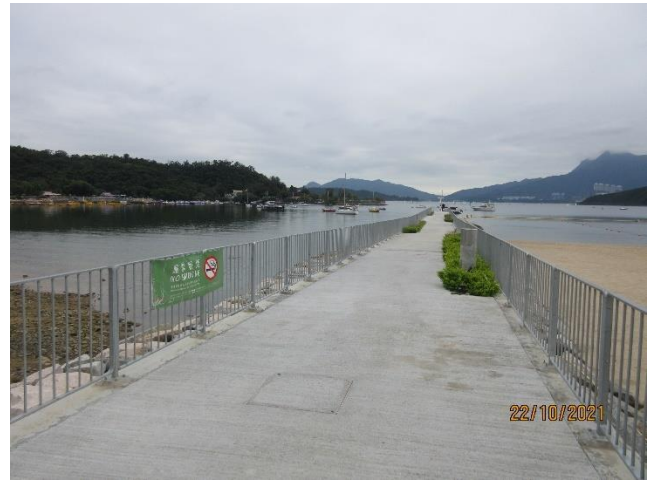
Photo G.

General view (6)

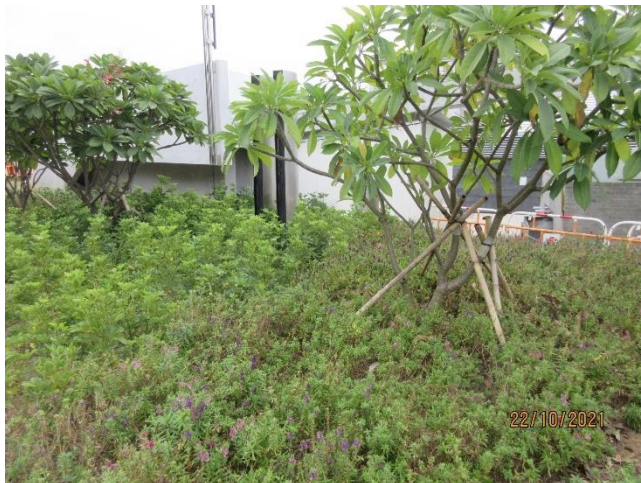
Photo H.

General view (7)

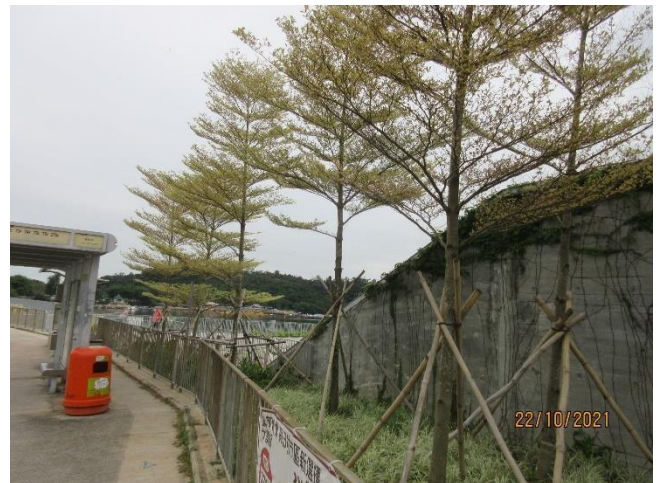
Photo I.

General view (8)

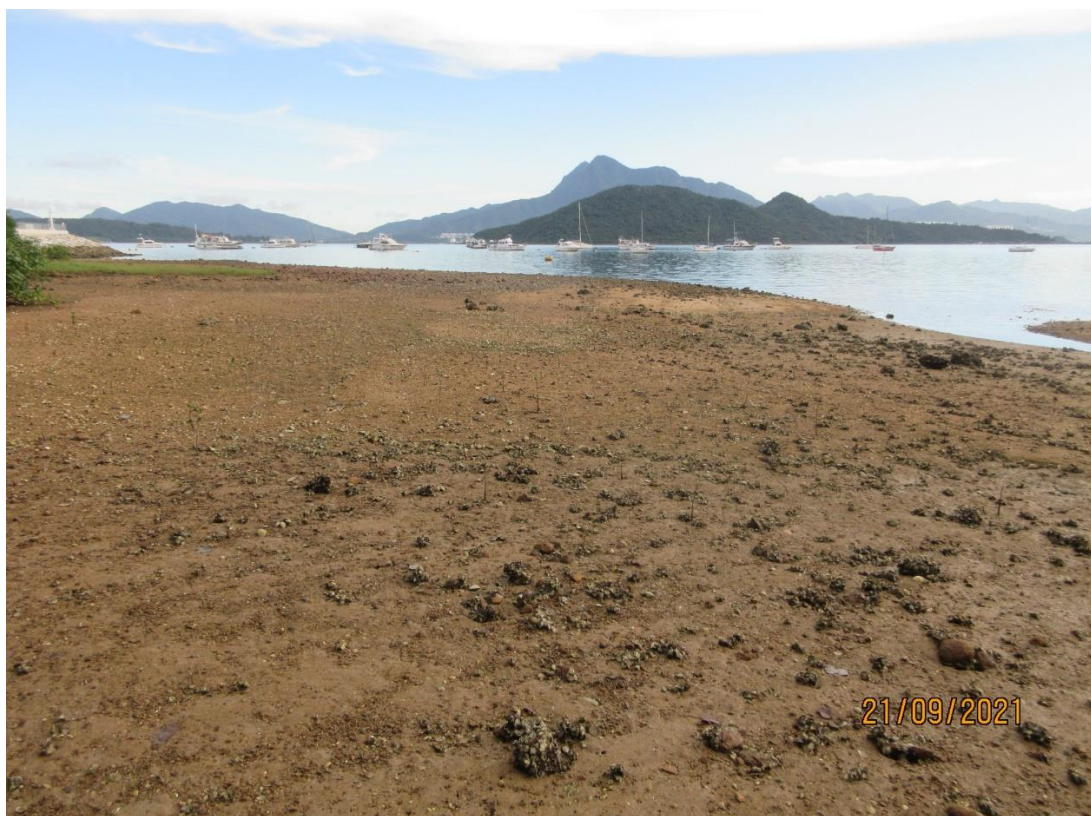
Photo 2.1 General view of the mangrove in location 1

For location 1, Nearly half of the seedlings were alive, however, only a few of the seedlings on the most landward side have leaves (Photo 3.1). Many of the seedlings were in poor condition (no leaves but still alive (Photo 3.2)) and approximate half of the seedlings were dead (Photo 3.3).

The contractor is recommended to replant the seedlings and review if the planting location should be moved to a more landward side to improve the survival rate.

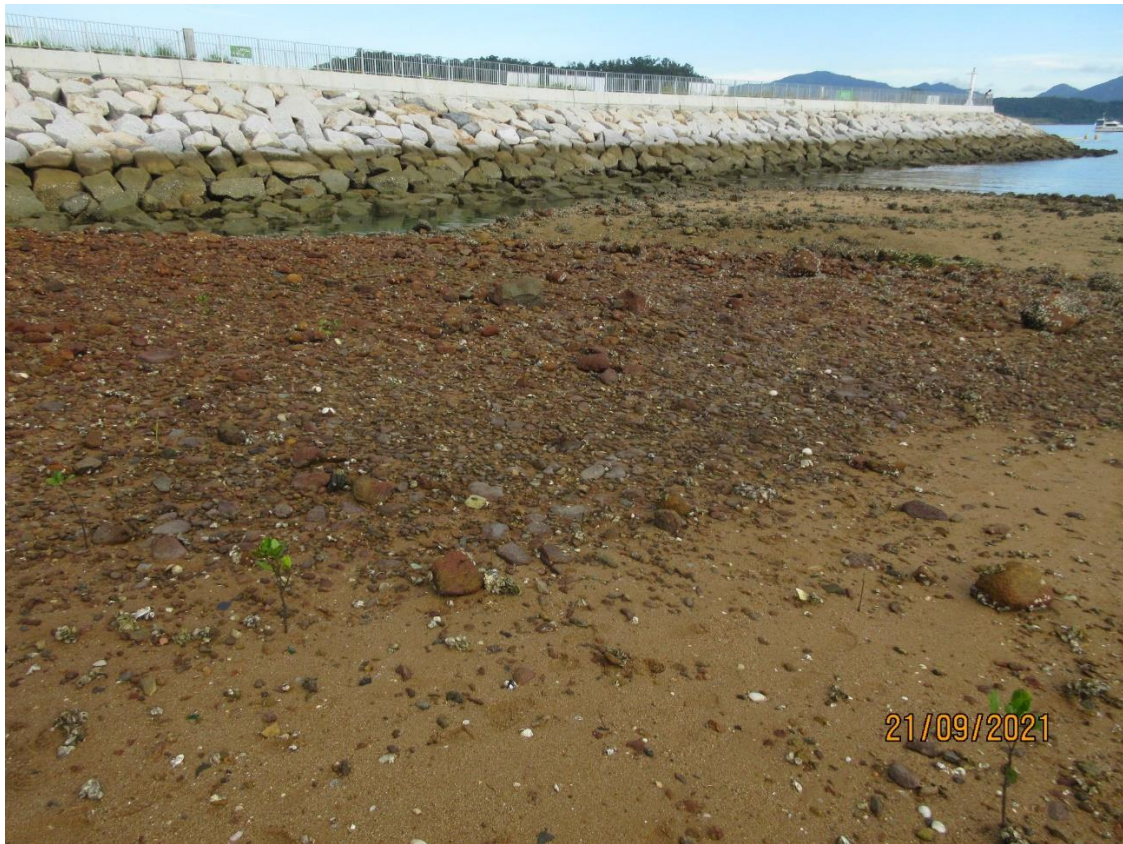
Photo 2.2 General view of the mangrove in location 2

For location 2, A large amount of the seedlings were dead (Photo 3.4), few of the seedlings on the most landward side have leaves (Photo 3.5) and several seedlings are in poor condition (no leaves but still alive)

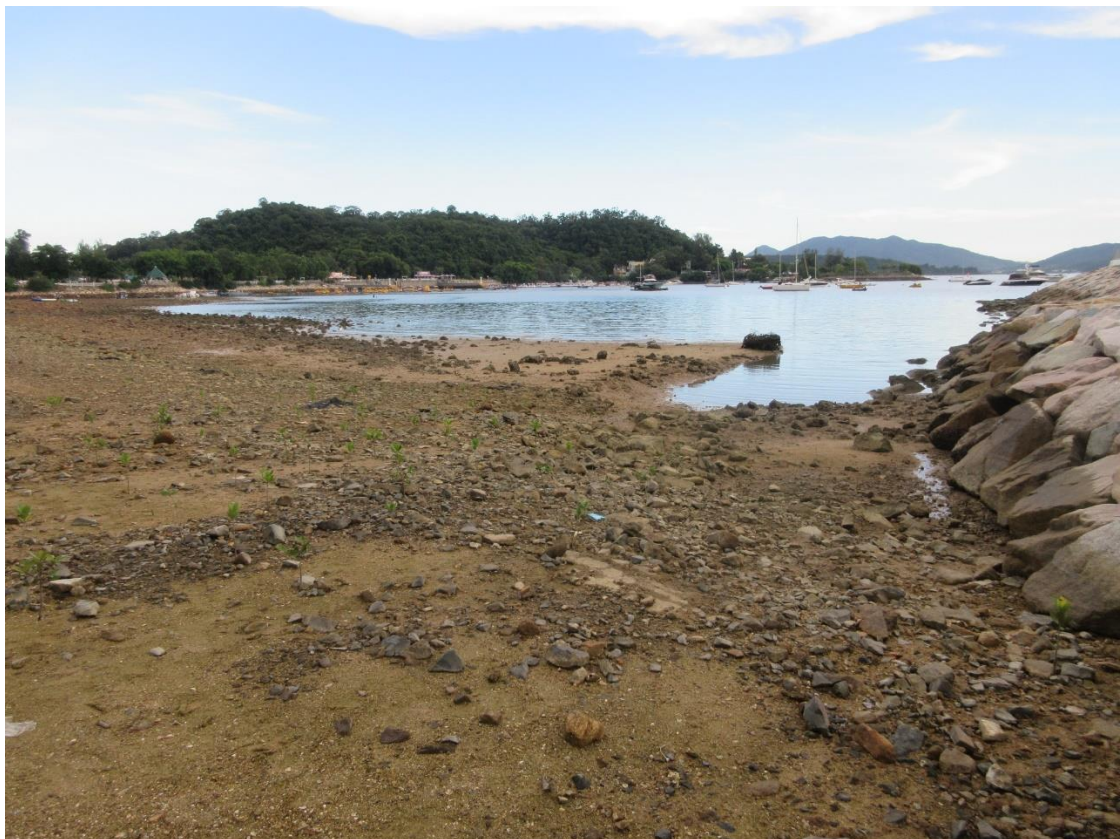
Photo 2.3 General view of the mangrove in location 3

For location 3, most of the seedlings have leaves and are in good condition (Photo 3.6). A small portion of the seedlings at the seaward side was in poor condition (no leaves but still alive) and dead (Photo 3.7).

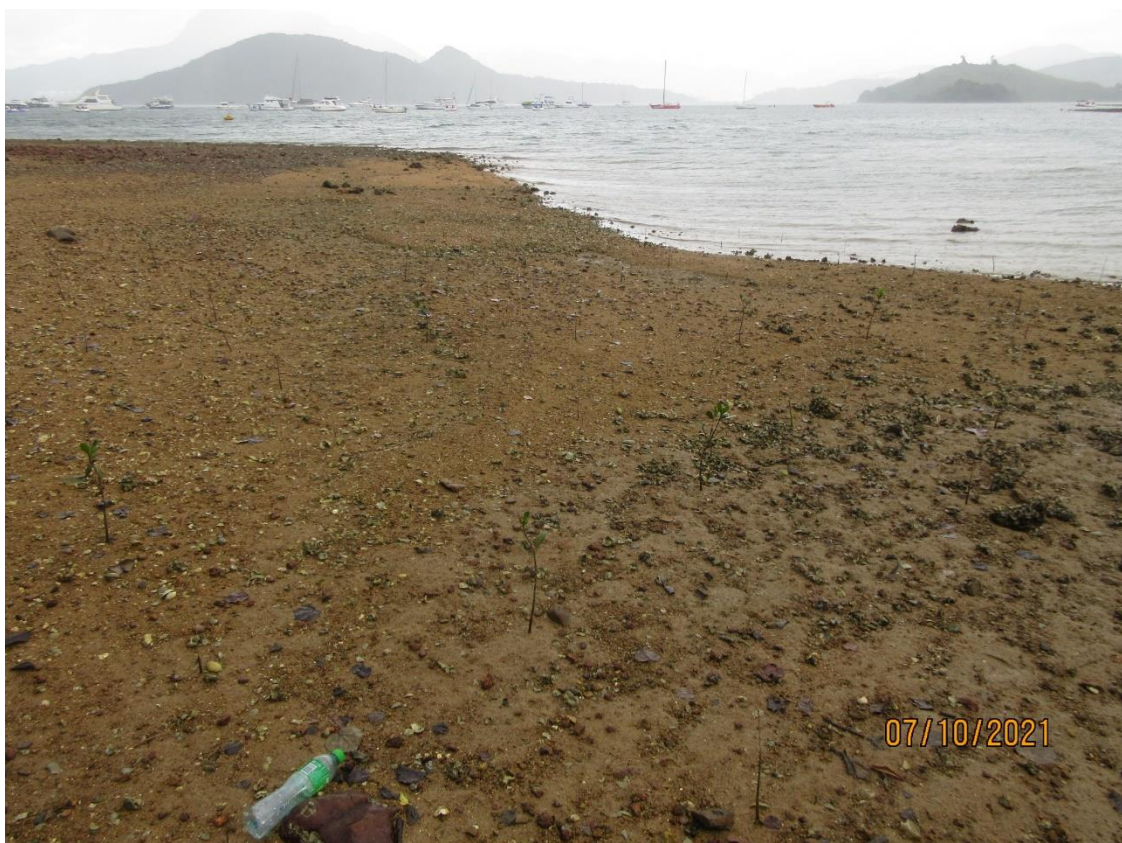
Photo 2.1 General view of the mangrove in location 1

For location 1, Nearly half of the seedlings were alive, however, only a few of the seedlings on the most landward side have leaves (Photo 3.1). Many of the seedlings were in poor condition (no leaves but still alive (Photo 3.2)) and approximate half of the seedlings were dead (Photo 3.3).

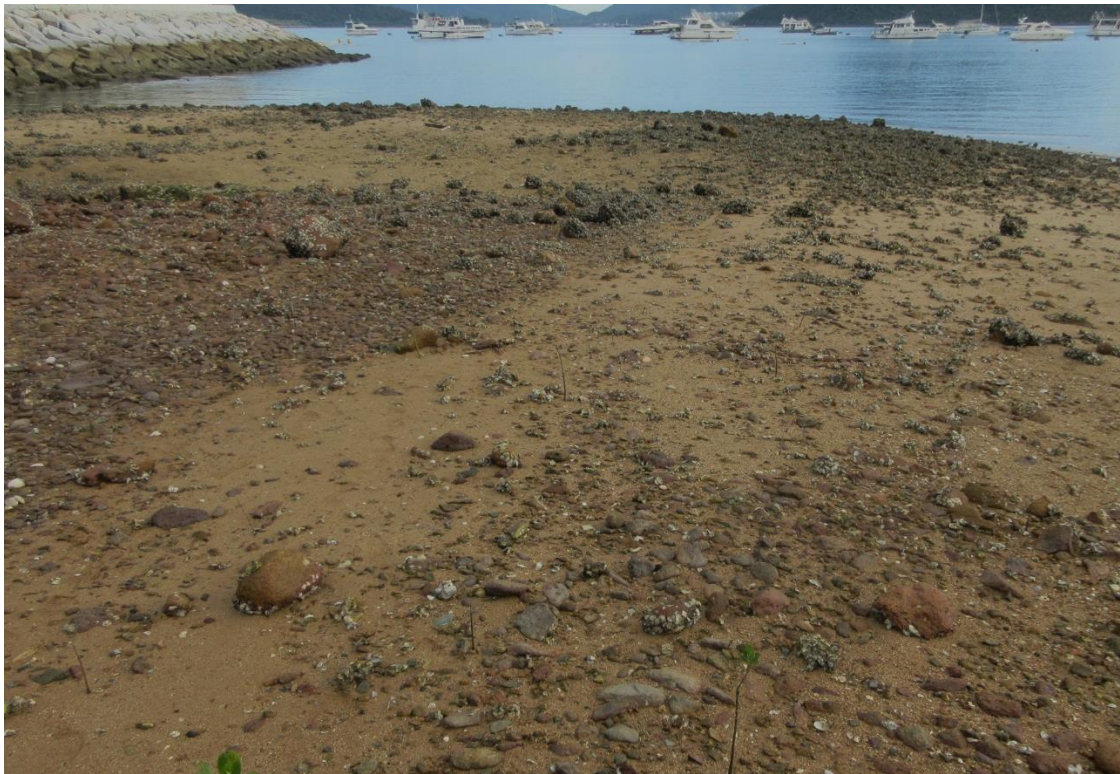
Photo 2.2 General view of the mangrove in location 2

For location 2, A large amount of the seedlings were dead (Photo 3.4), few of the seedlings on the most landward side have leaves (Photo 3.5) and several seedlings are in poor condition (no leaves but still alive)

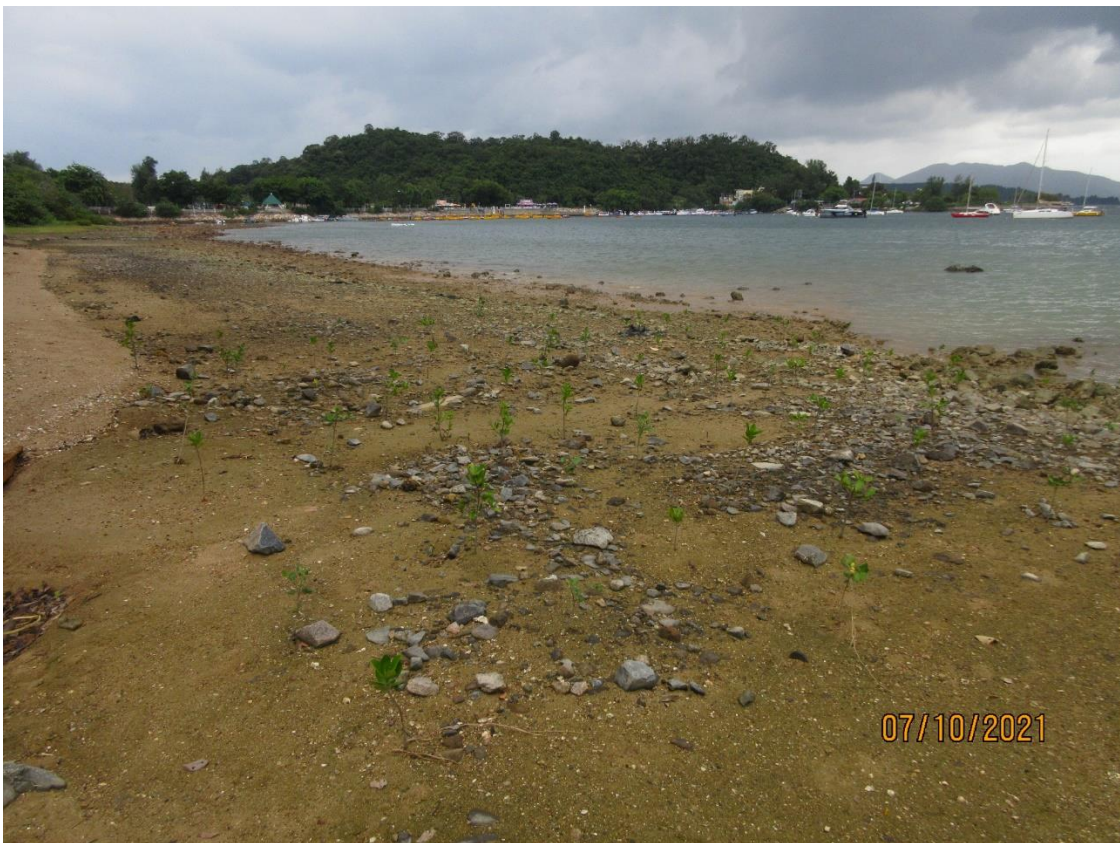
Photo 2.3 General view of the mangrove in location 3

For location 3, most of the seedlings have leaves and are in good condition (Photo 3.6). A small portion of the seedlings at the seaward side was in poor condition (no leaves but still alive) and dead (Photo 3.7).

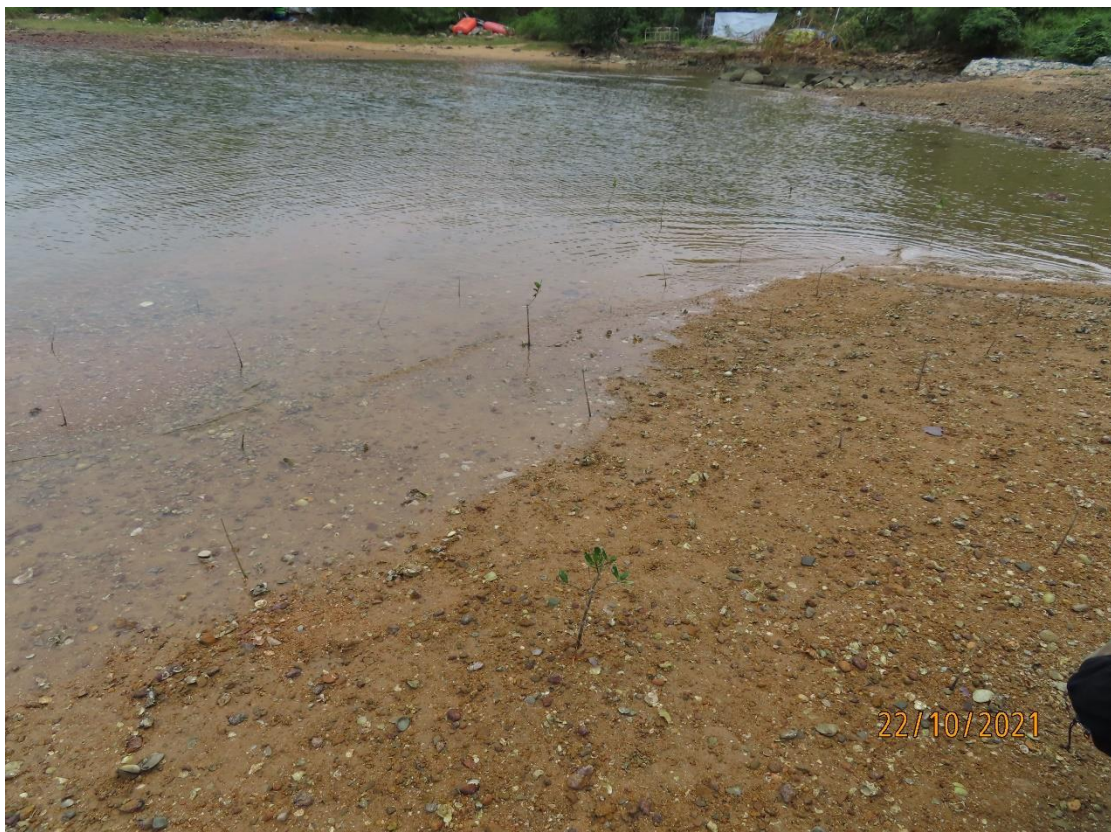
Photo 2.1 General view of the mangrove in location 1

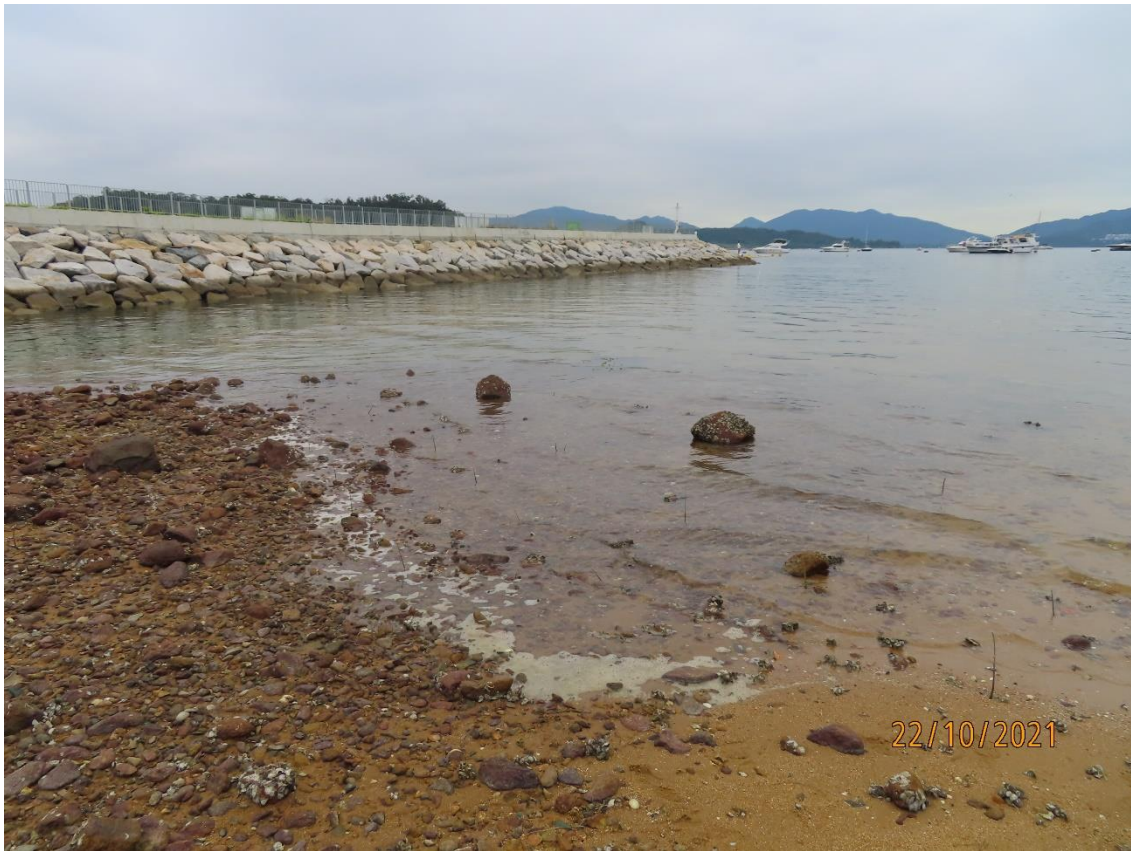
Photo 2.2 General view of the mangrove in location 2

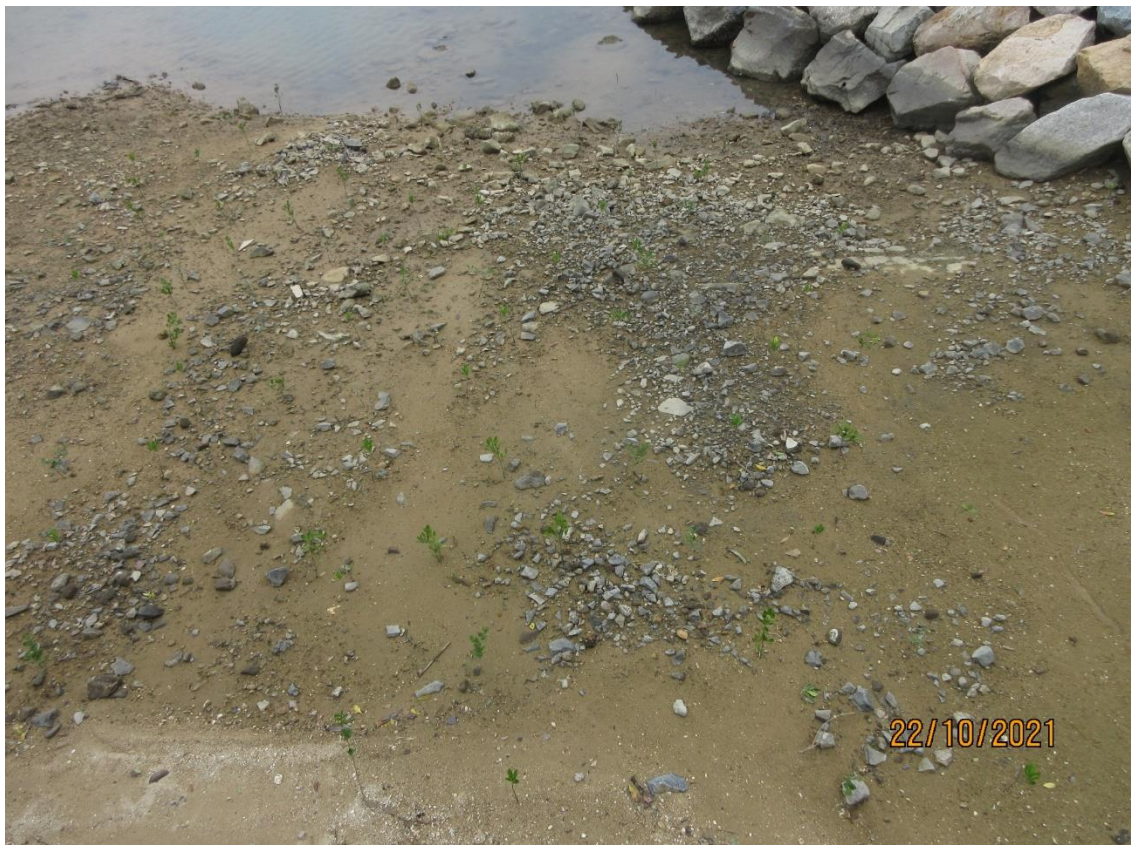
Photo 2.3 General view of the mangrove in location 3
