PROJECT No.: TCS/00874/16

**CEDD CONTRACT NO. CV/2012/05 –
BATHING BEACH AT LUNG MEI, TAI PO**

**POST-CONSTRUCTION MONITORING AND AUDIT
REPORT (JANUARY TO FEBRUARY 2022)**

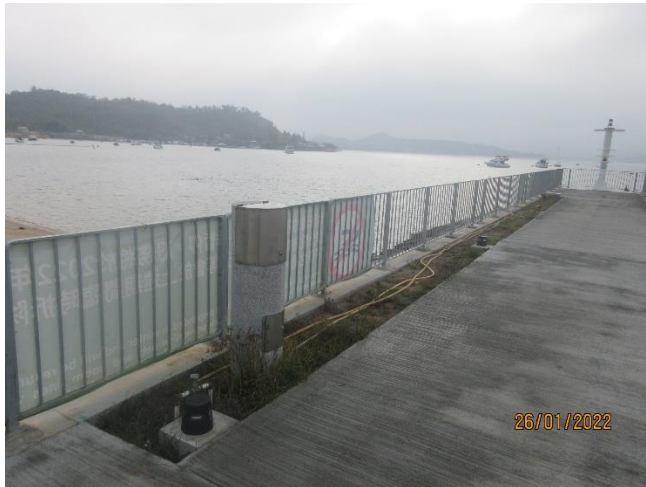
Photo I.

1. Some of the plants in the planters on the Western groyne were wilted and should be removed and replaced. (Photo I)
2. Some ties and stakes were detached at Western Box Culvert should be tightened up to standard. (Photo J and Photo K)
3. The planters at the Eastern box culvert were repaired and enlarged and the plants in the planters were removed. Replacement planting should be provided. (Photo L)
4. Some ties and stakes already girdled and affected the growth of the trees. (Photo M and Photo N)

Some of the plants in the planters on the Western groyne were wilted and removed

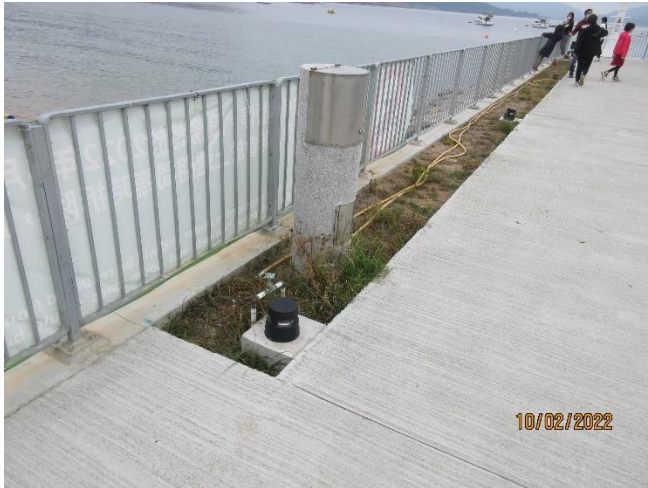
Photo I.

Some of the plants in the planters on the Western groyne were wilted and removed

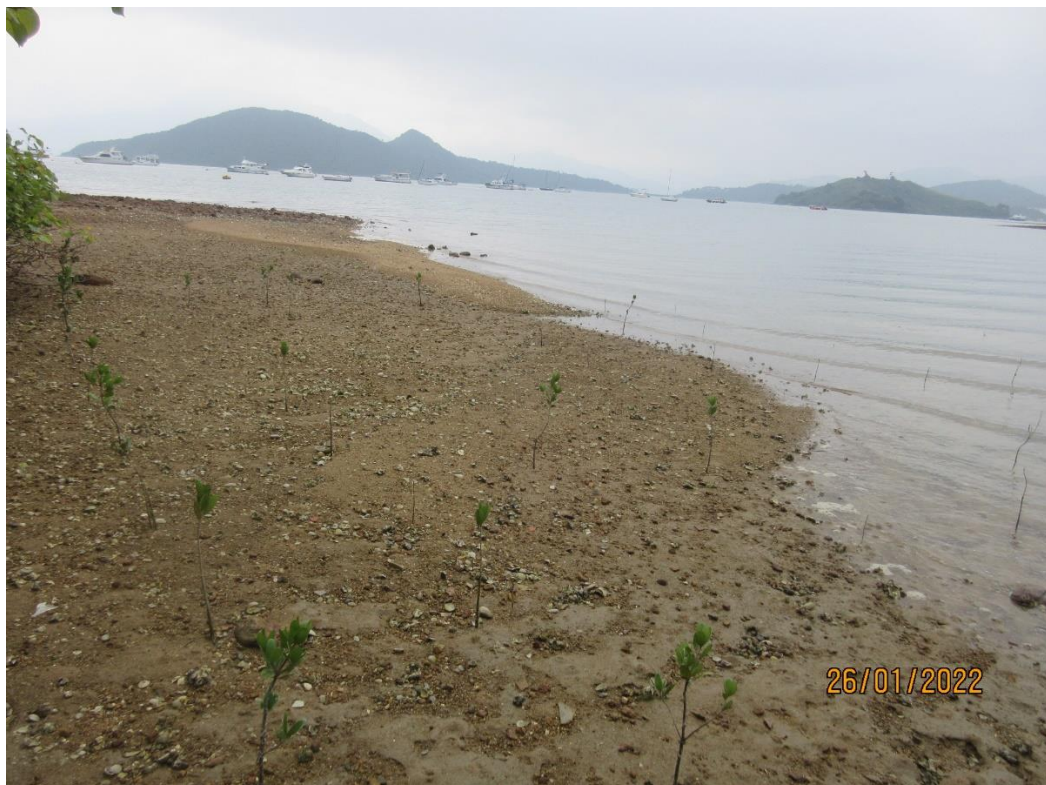
Photo 2.1 General view of the mangrove in location 1

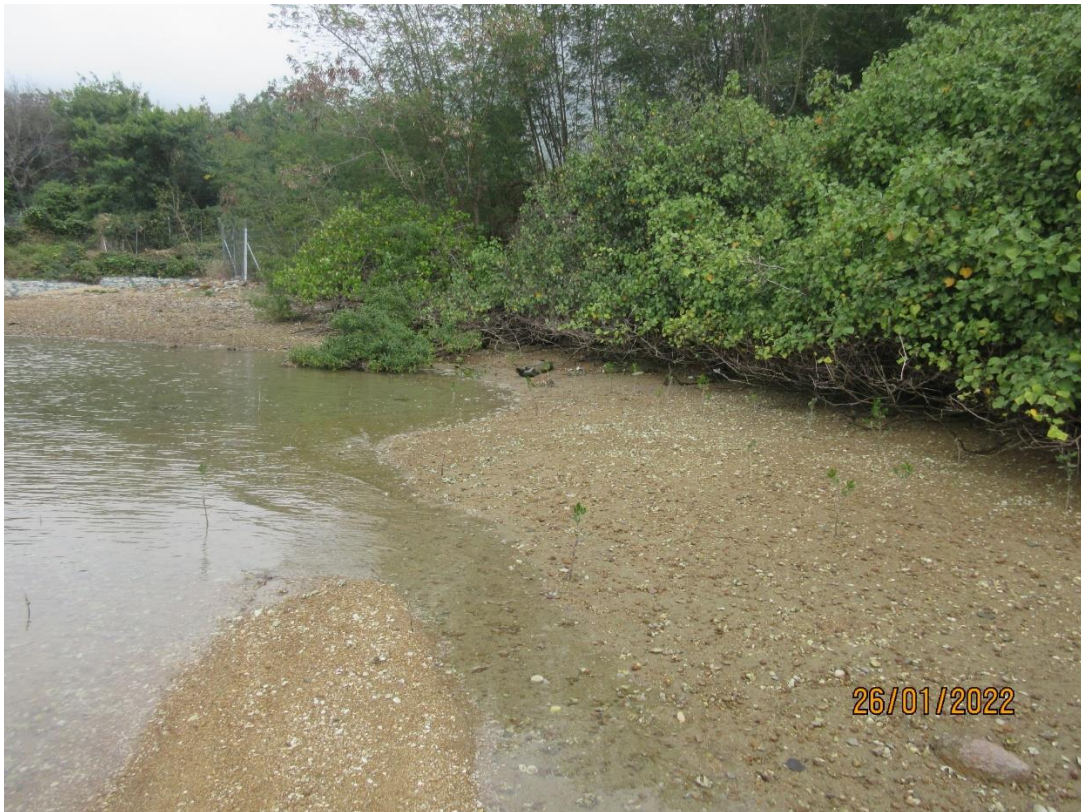
Photo 2.2 General view of the mangrove in location 2

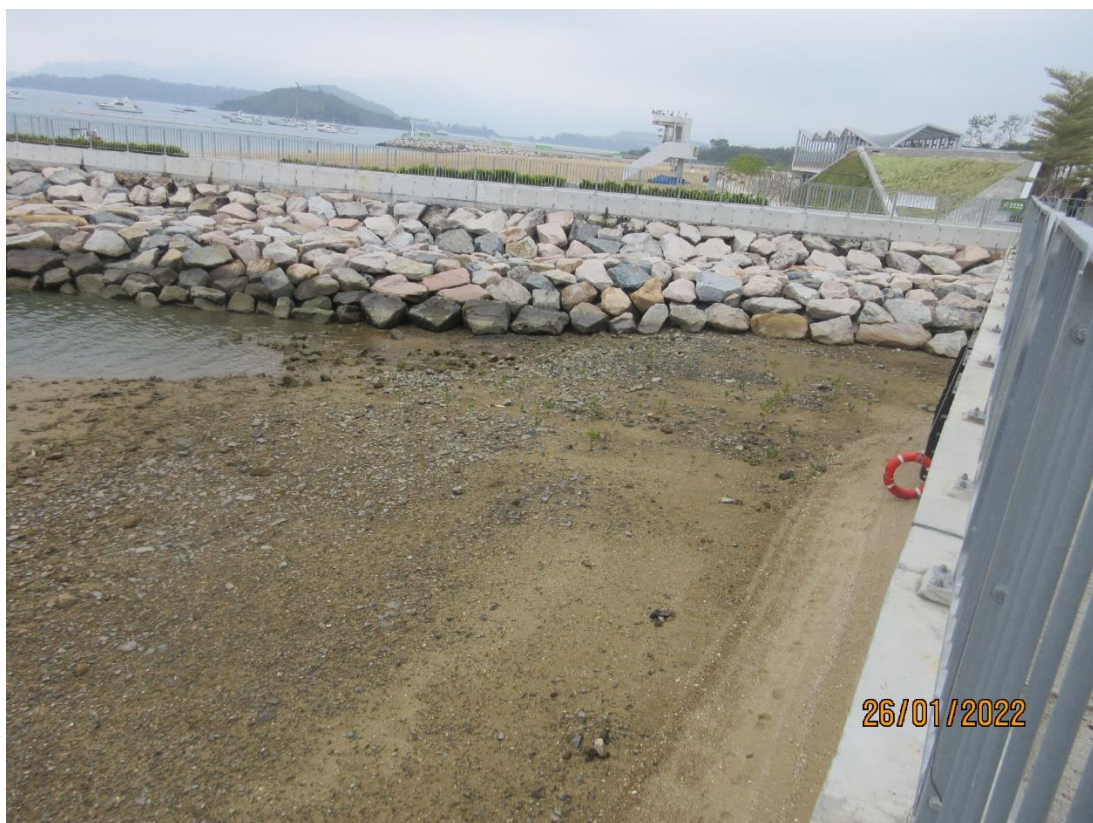
Photo 2.3 General view of the mangrove in location 3

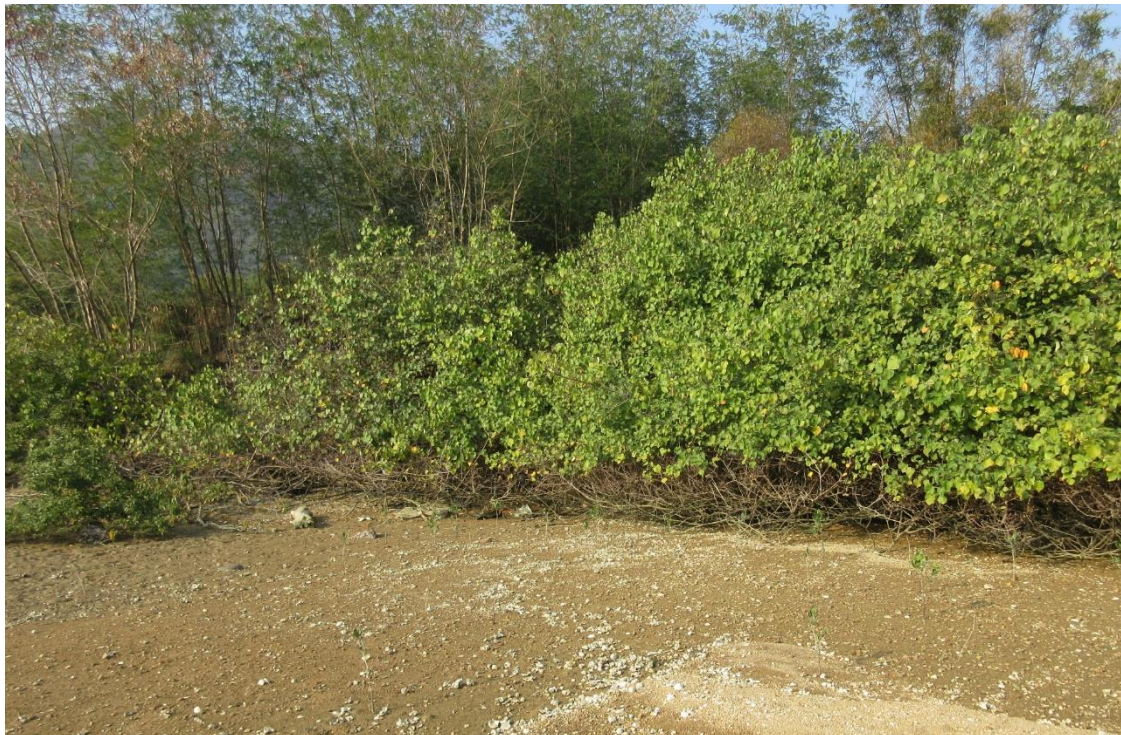
Photo 2.1 General view of the mangrove in location 1

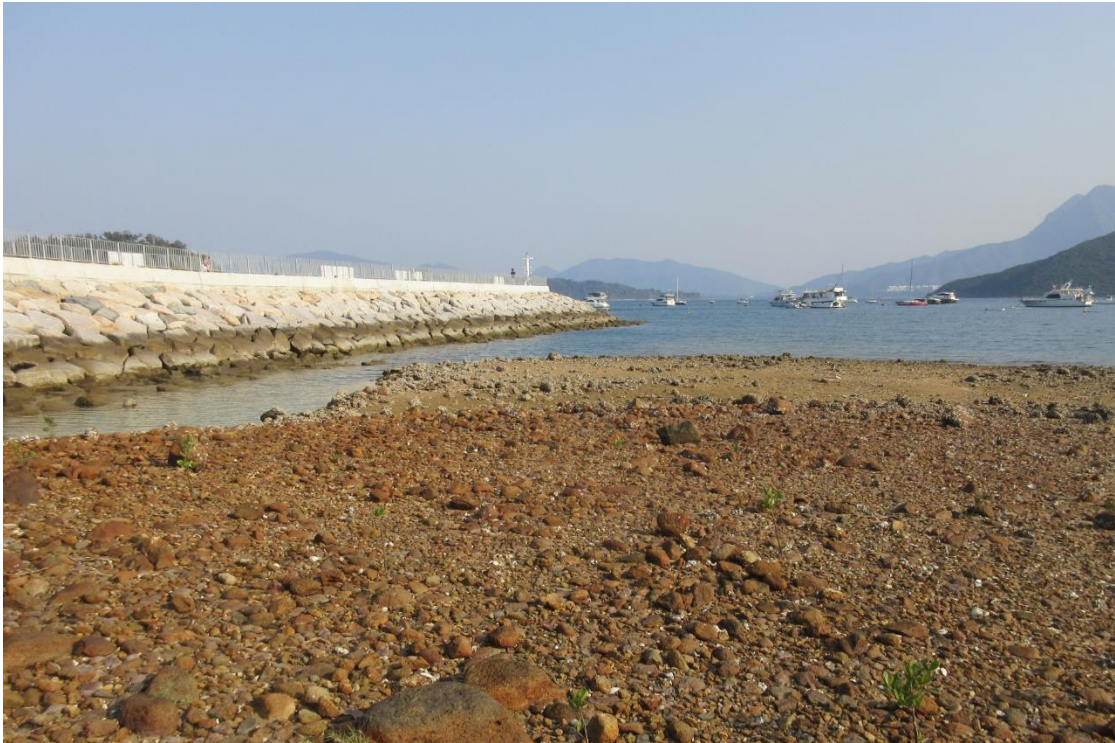
Photo 2.2 General view of the mangrove in location 2

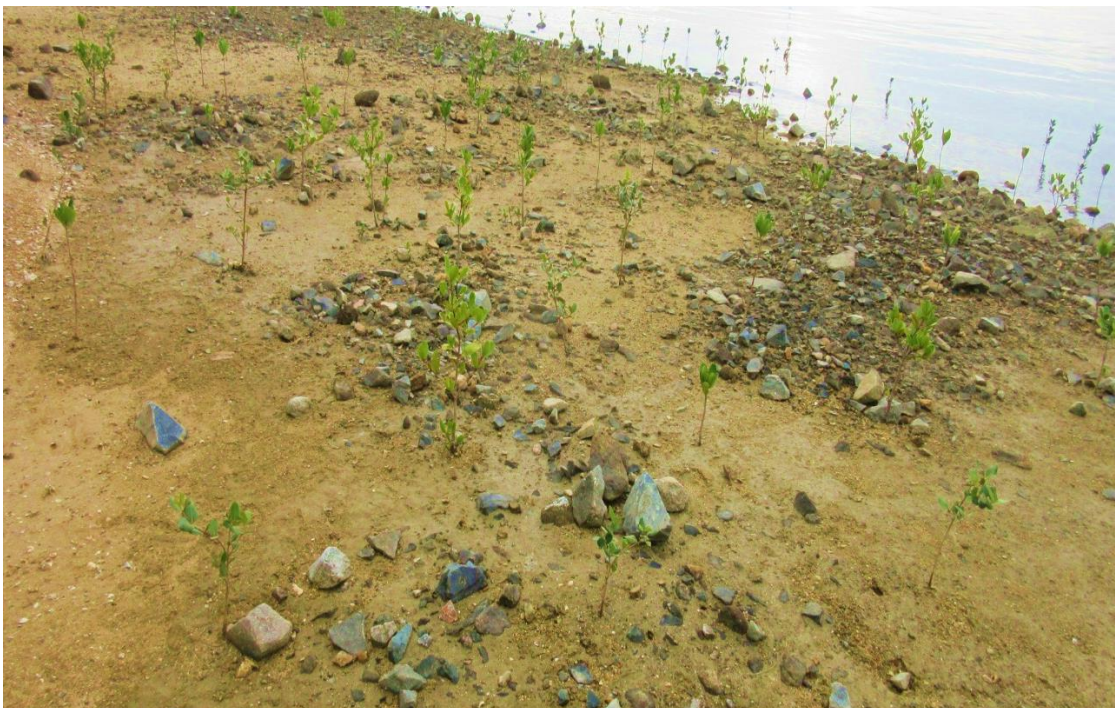
Photo 2.3 General view of the mangrove in location 3
