Contract No. CV/2013/08
Liantang / Heung Yuen Wai Boundary Control Point
Site Formation and Infrastructure Works – Contract 6

Environmental Permit No. EP-404/2011/C
Condition 2.16 – Photographic and Cartographic Survey Report

Contract No. CV/2013/08
Liantang/Heung Yuen Wai
Boundary Control Point Site
Formation and Infrastructure
Works – Contract 6
*Cartographic and Photographic
Survey Report*

December 2015

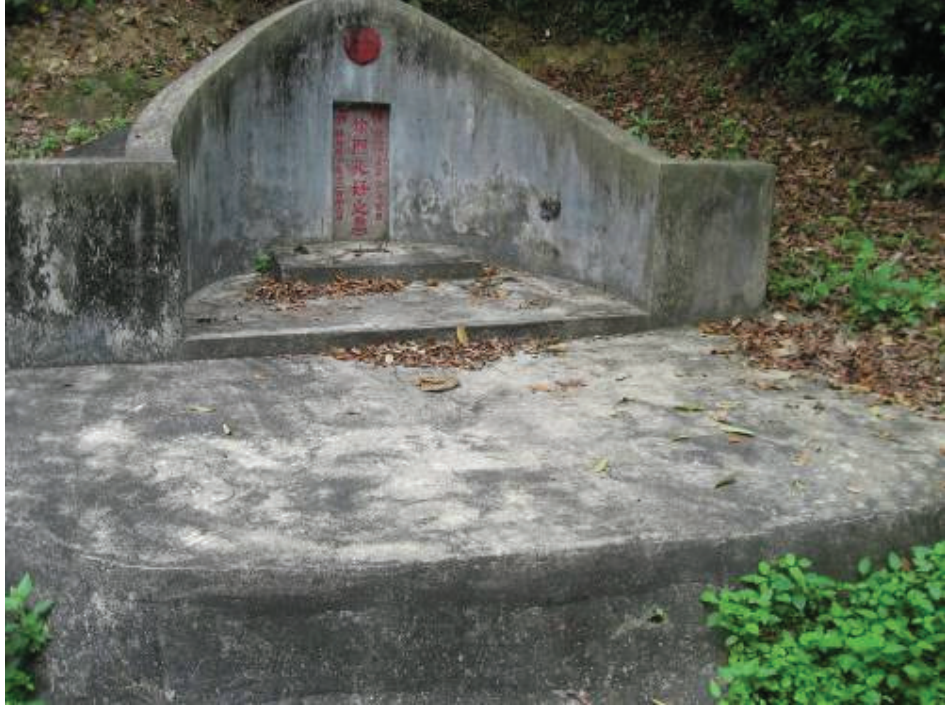
General Front View

| Existing Condition: Fair | |

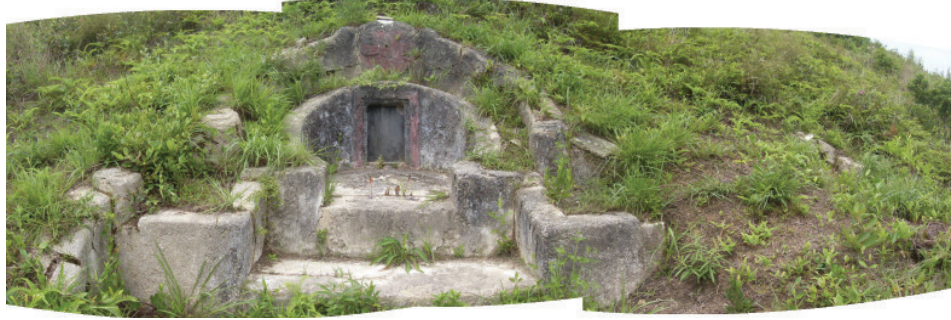
General Front View

| Existing Condition: Poor; Overgrown with weeds | |

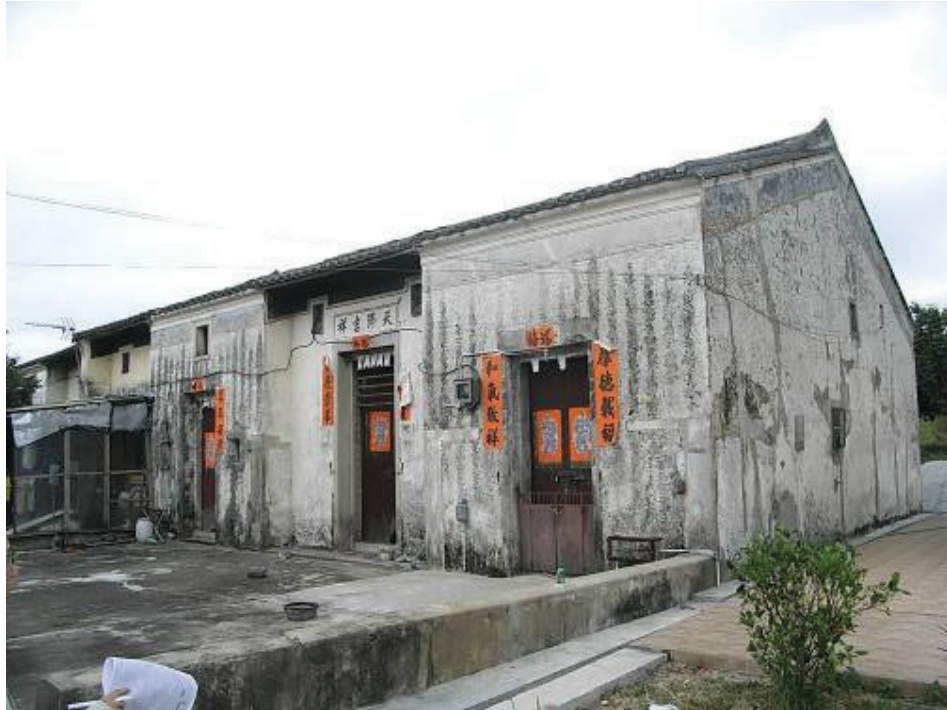
General Front View

| Existing Condition: Fair | |
| Notes on any Modifications: Superficially altered with modern utilities and some external repair works with modern materials; front yard extensively modified with additional temporary structures. | |

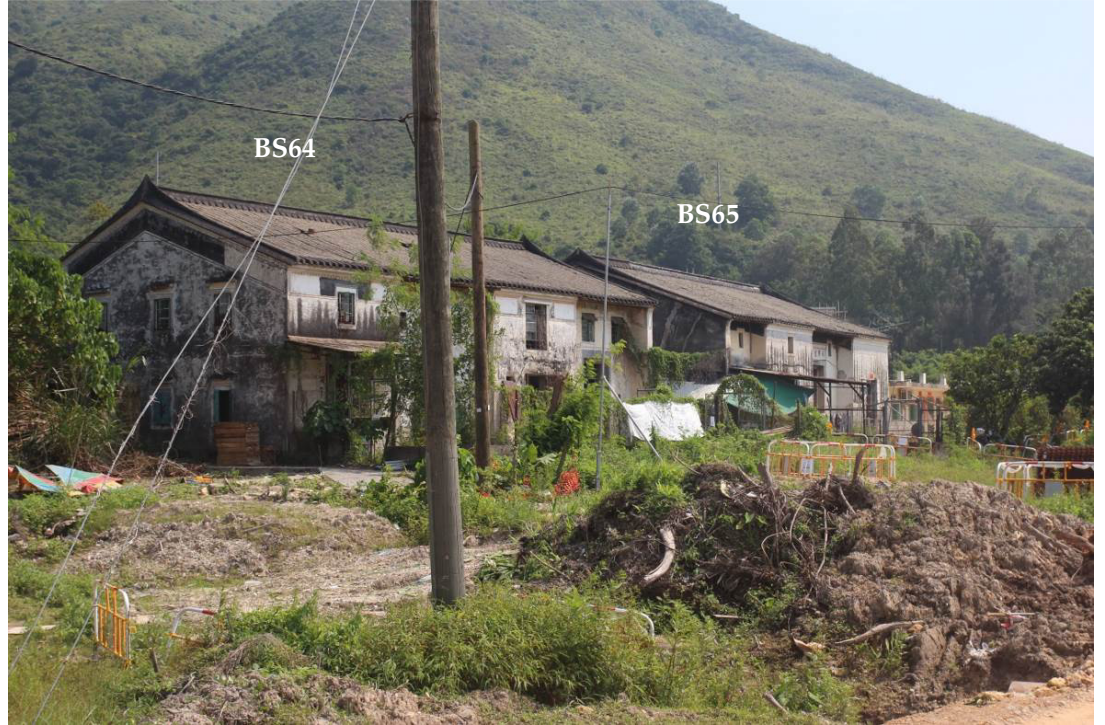
BS64-overall-P1

Oblique view of BS64 (view from northwest) BS64側視圖 (攝自西北方)

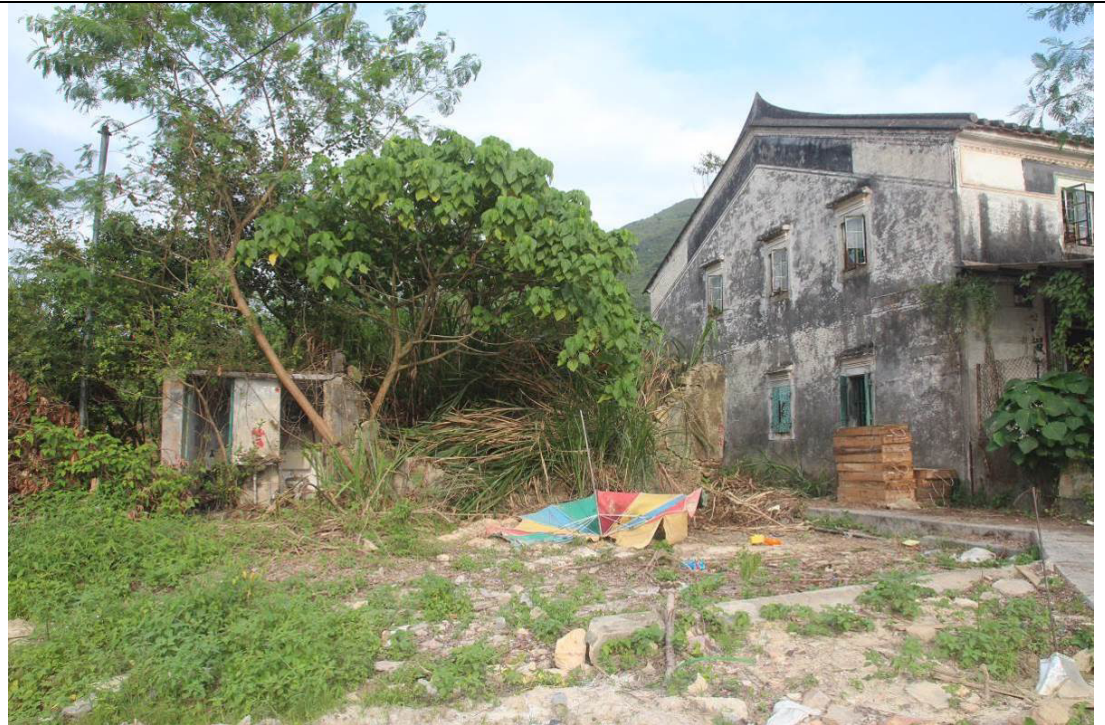
BS64-overall-P2

Ruins next to BS64-4 BS64-4旁的廢屋

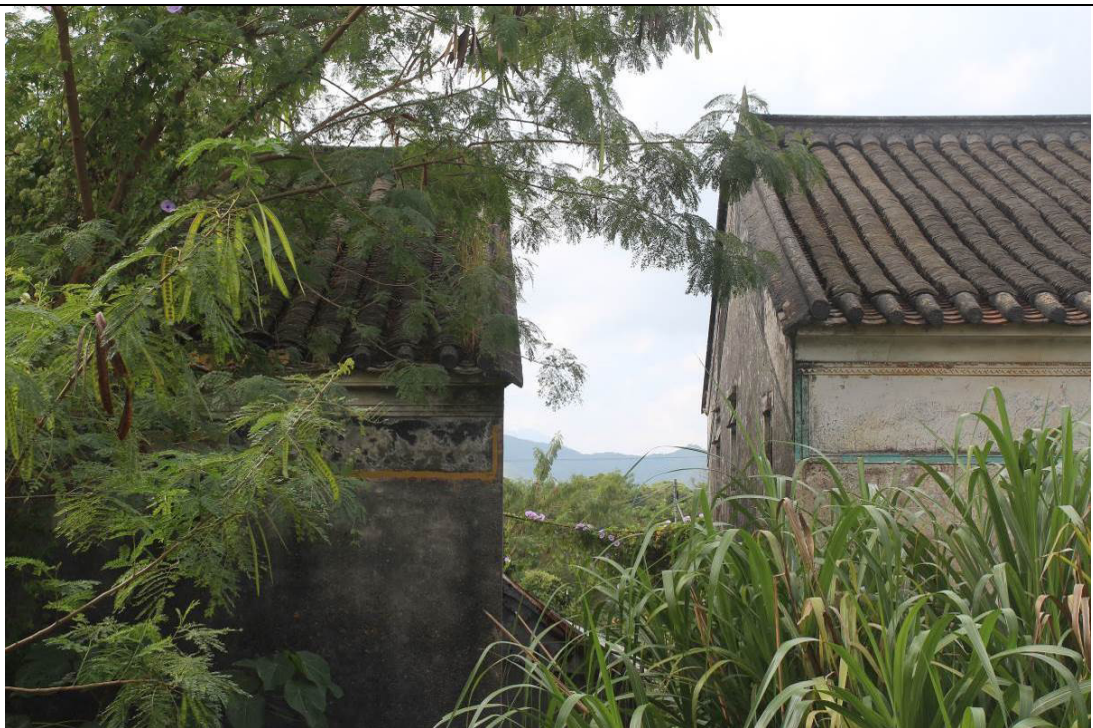
BS64-overall-P18

Height difference between BS64 and BS65 BS64及BS65的高差

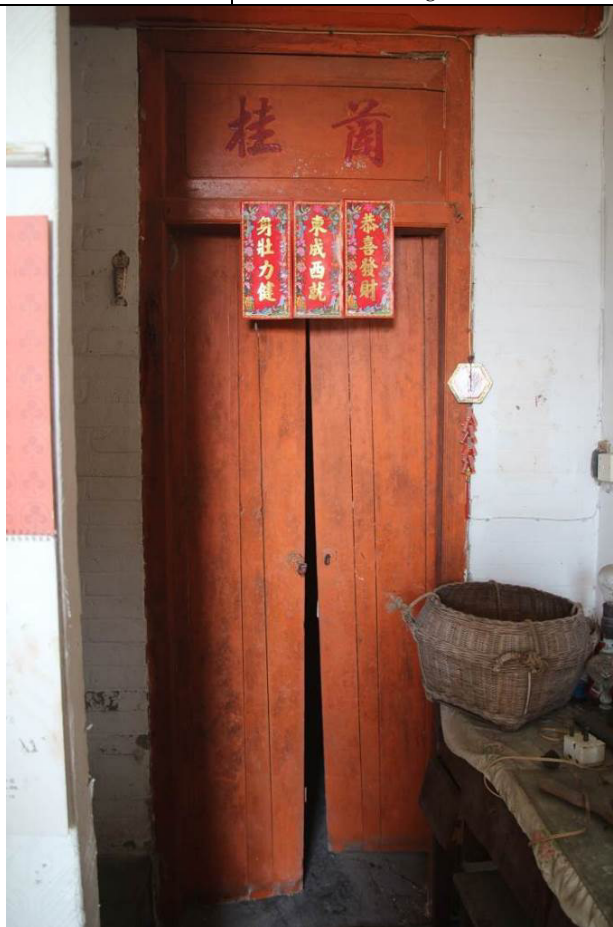
BS64-overall-P29

Room door on the ground floor carved with characters “蘭桂” in BS64-1. Similar door is found in BS64-3. BS64-1中刻有“蘭桂”二字的下層房門，相似的房門見於BS64-3.

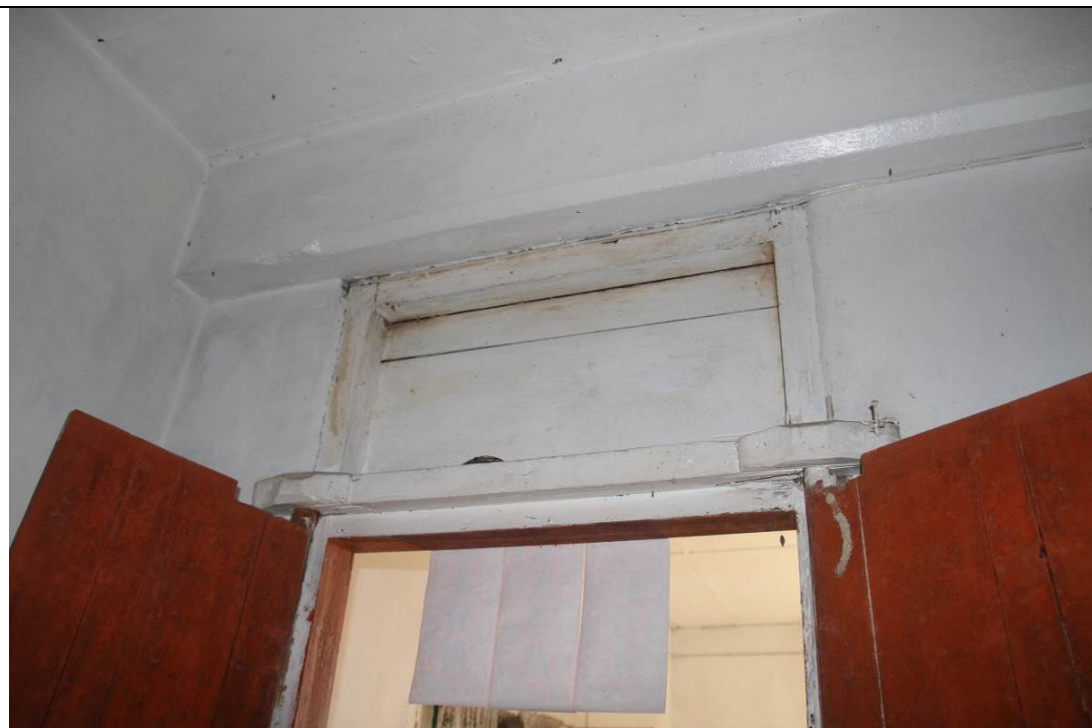
BS64-overall-P30

Back of door and decorated beam viewing inside the room of BS64-1 BS64-1房間中看房門及裝飾的樑

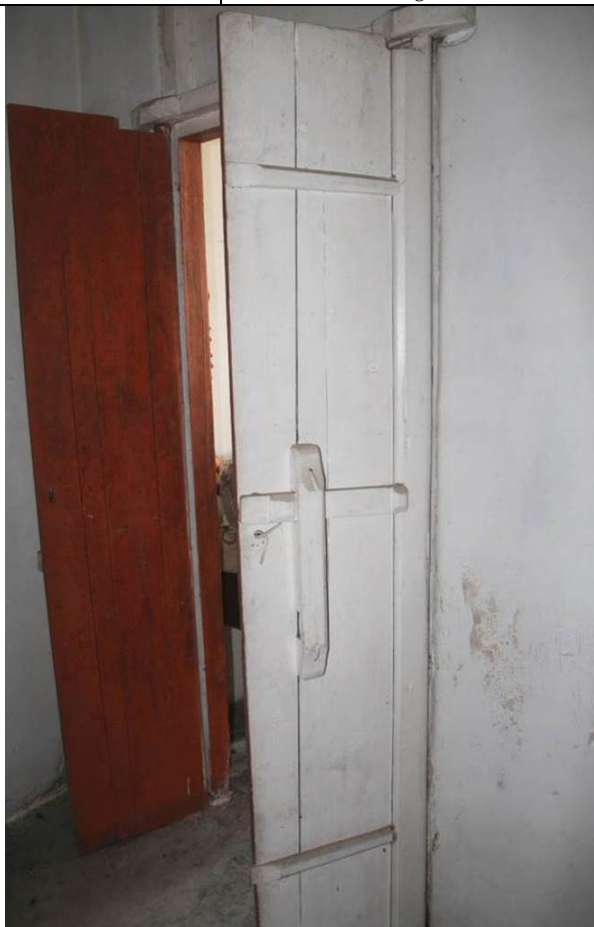
BS64-overall-P31

Back of door viewing inside the room of BS64-1 BS64-1房間中看房門

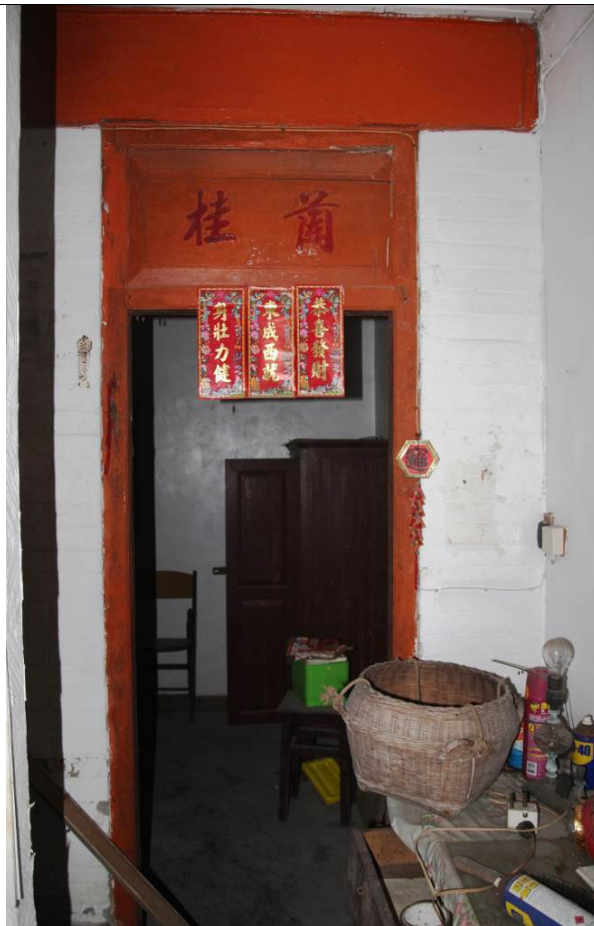
| Site Code | Photo No. | Content | Categories |
|---|---|---|---|
| | BS64-1-P15 | Doorway leading to a room, decorated with the characters “蘭桂”. A beam which is colored orange is observed on top of the wall. 進入房間的門，飾有“蘭桂”二字，亦可見牆上有橙色的橫樑。 | Interior (b) |

Doorway leading to a room, decorated with the characters "蘭桂". A beam which is colored orange is observed on top of the wall. 進入房間的門，飾有“蘭桂”二字，亦可見牆上有橙色的橫樑。

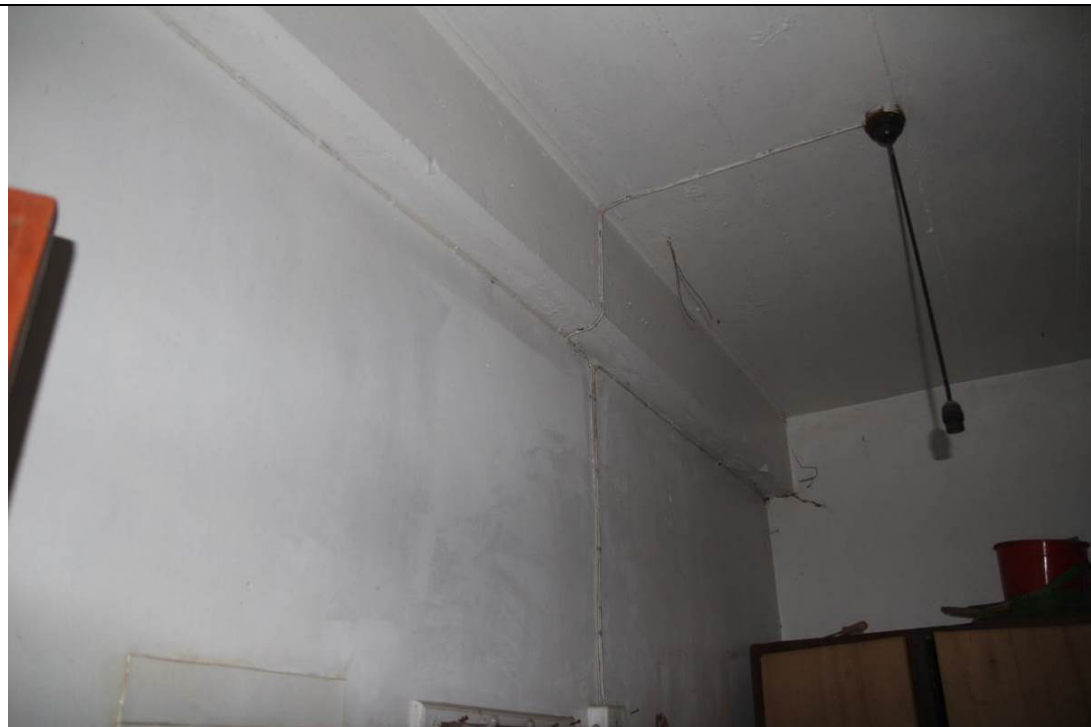
| Site Code | Photo No. | Content | Categories |
|---|---|---|---|
| | BS64-1-P16 | Beam on top of the wall, observed from the room 房間內看牆上的橫樑 | Interior (b) |

Beam on top of the wall, observed from the room 房間內看牆上的橫樑

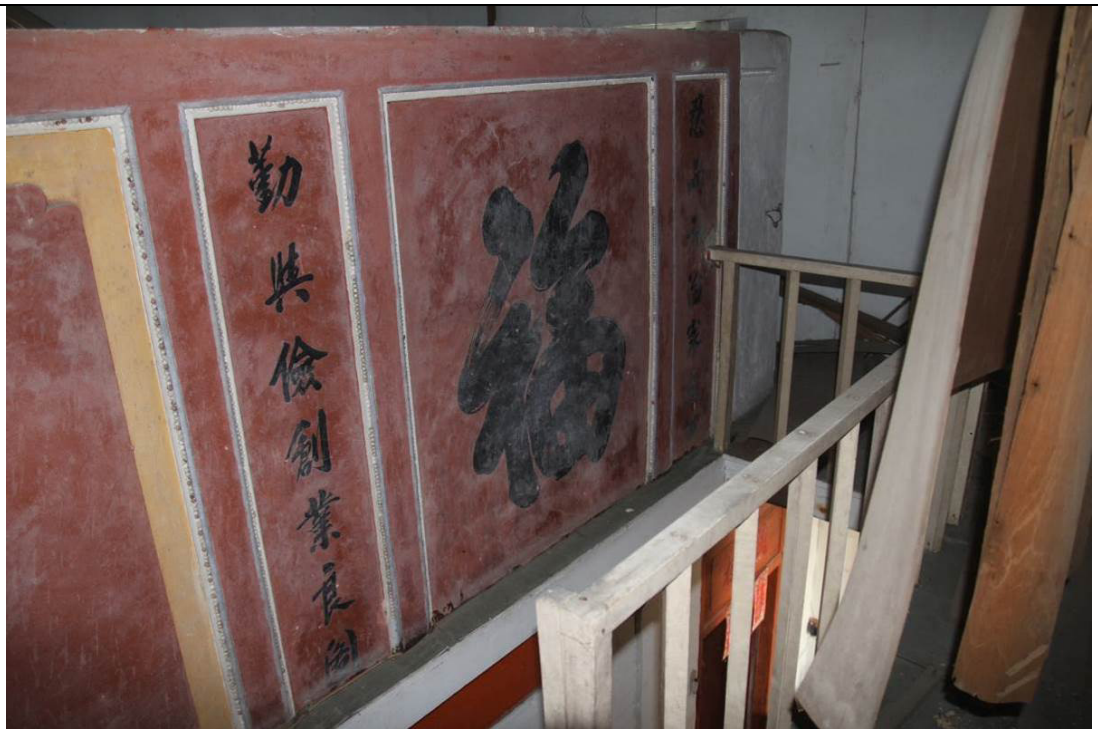
BS64-1-P22

Balustrade of the original cockloft is decorated with character "福" and Chinese couplet 原有的閣樓圍欄飾有「福」字及對聯「忍而和治家善策 勤與儉創業良圖」

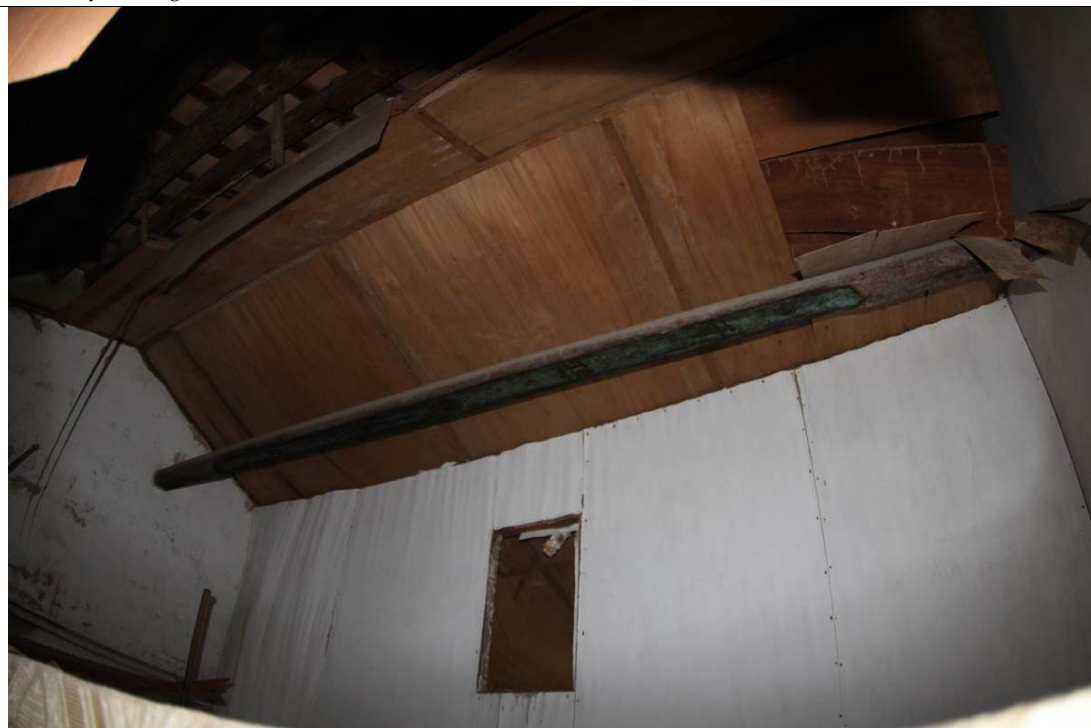
| Site Code | Photo No. | Content | Categories |
|---|---|---|---|
| | BS64-1-P29 | Tie-beam and roof observed from upper floor 上層看繫樑及屋頂 | Interior (b) |

Tie-beam and roof observed from upper floor 上層看繫樑及屋頂

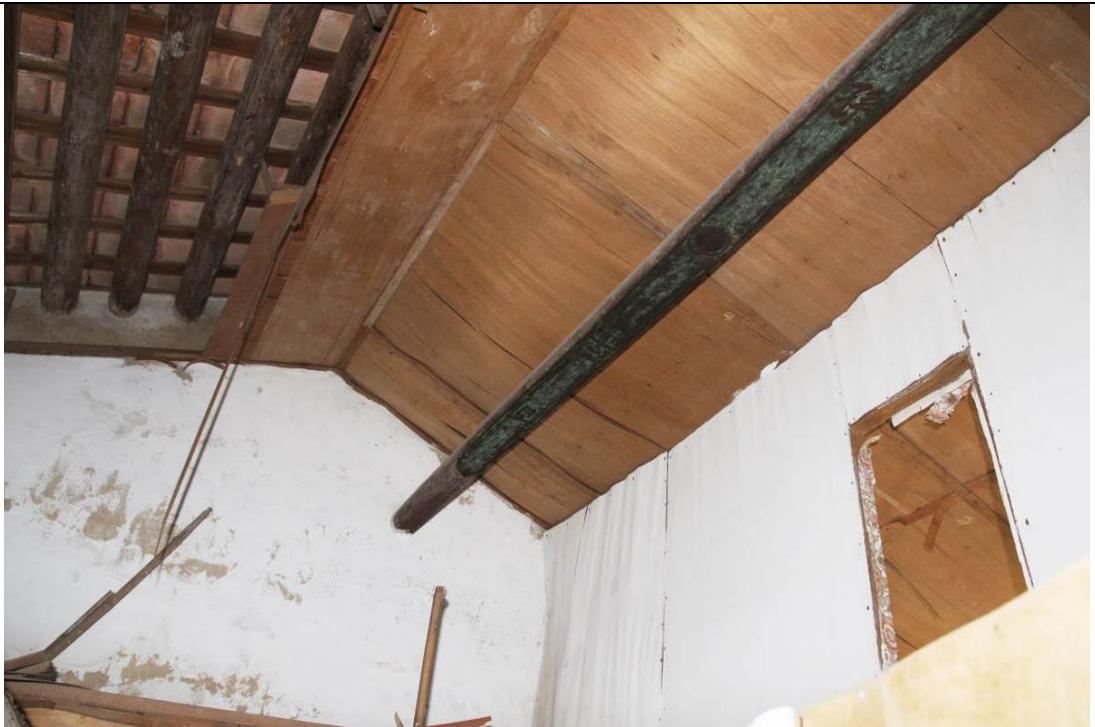
| Site Code | Photo No. | Content | Categories |
|---|---|---|---|
| | BS64-1-P30 | Tie-beam and roof observed from upper floor 上層看繫樑及屋頂 | Interior (b) |

Tie-beam and roof observed from upper floor 上層看繫樑及屋頂

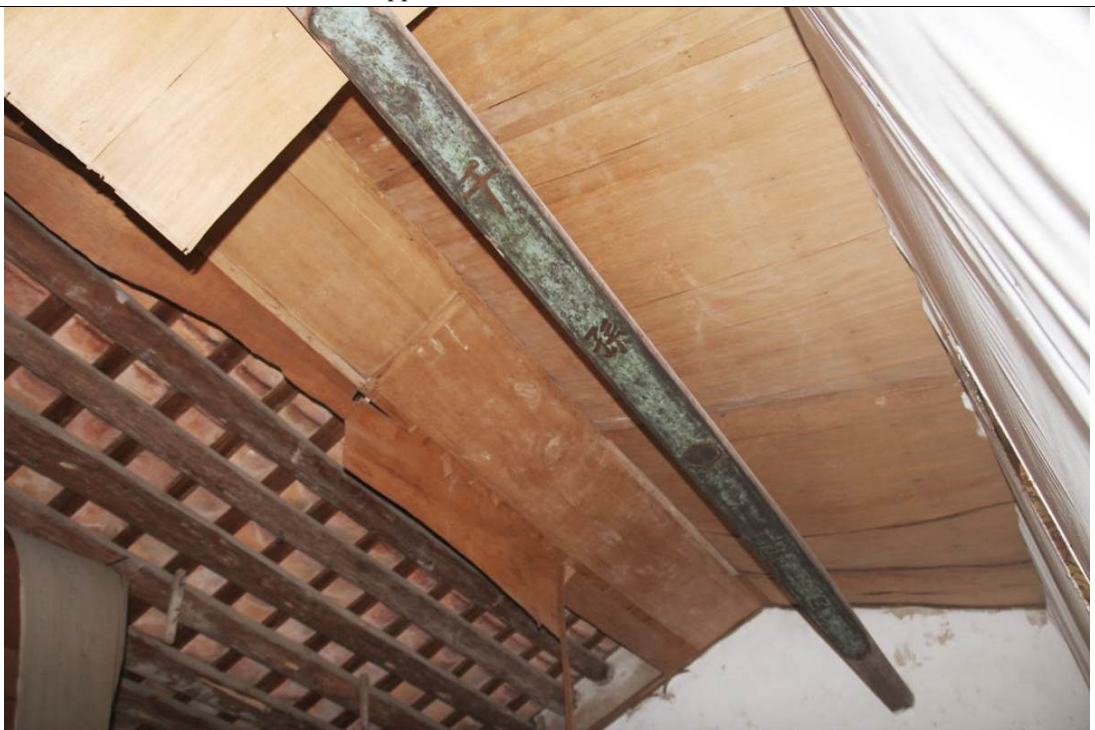
BS64-1-P31

The "tie-beam" are carved with "百子千孫" (literally means "a hundred sons and thousand grandsons") 繫樑飾有「百子千孫」

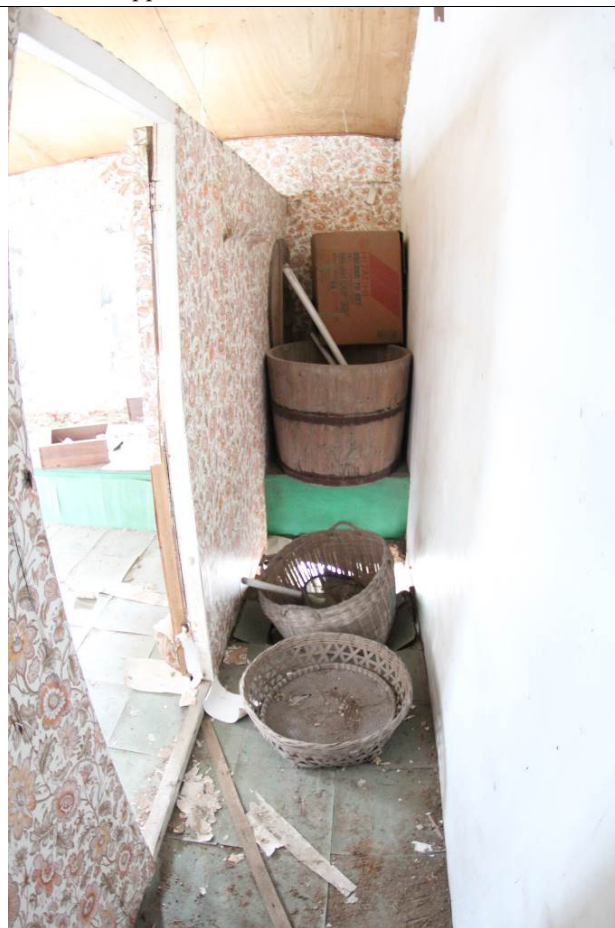
| Site Code | Photo No. | Content | Categories |
|---|---|---|---|
| | BS64-1-P36 | Deteriorated wooden floor (above toilet) 霉爛的地板 (廁所上方) | Interior (b) |

Deteriorated wooden floor (above toilet) 霉爛的地板 (廁所上方)

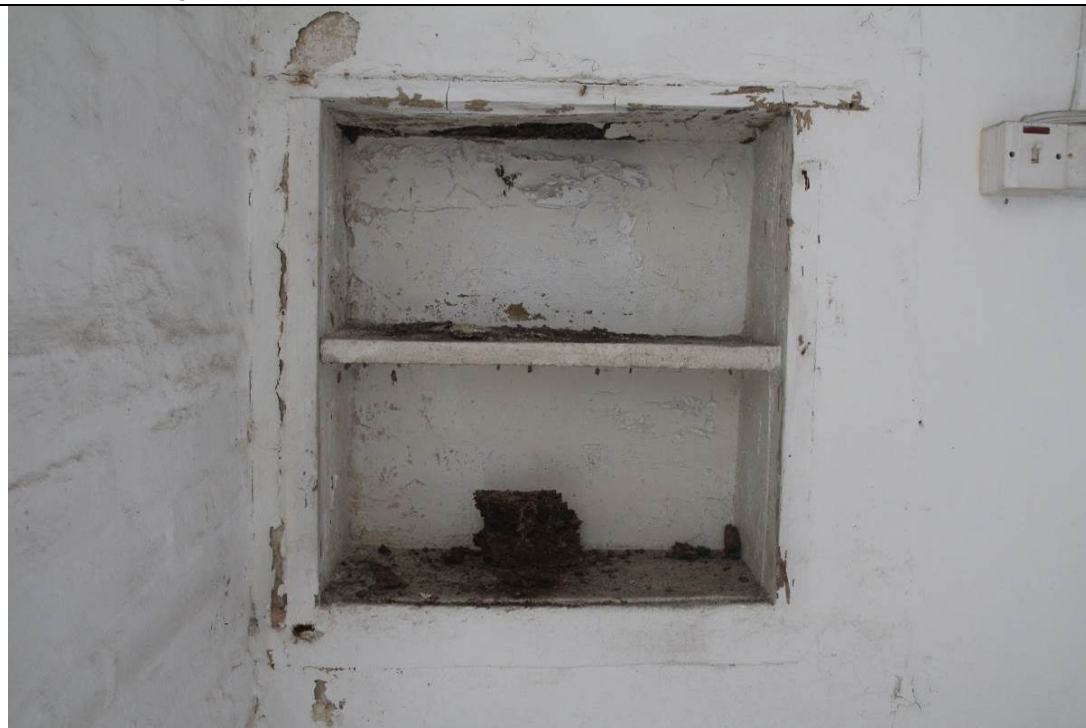
BS64-1-P38

Cupboard embedded on wall of the ground floor 一層嵌於牆上的傢具

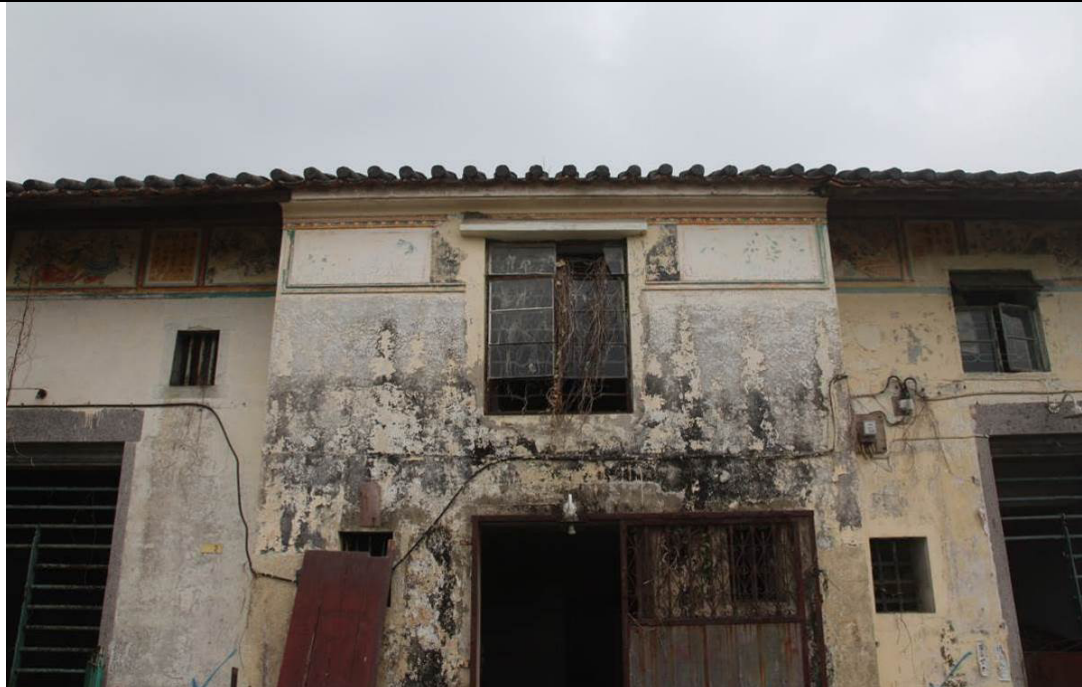
BS64-2-P1

Façade of BS64-2 BS64-2正立面

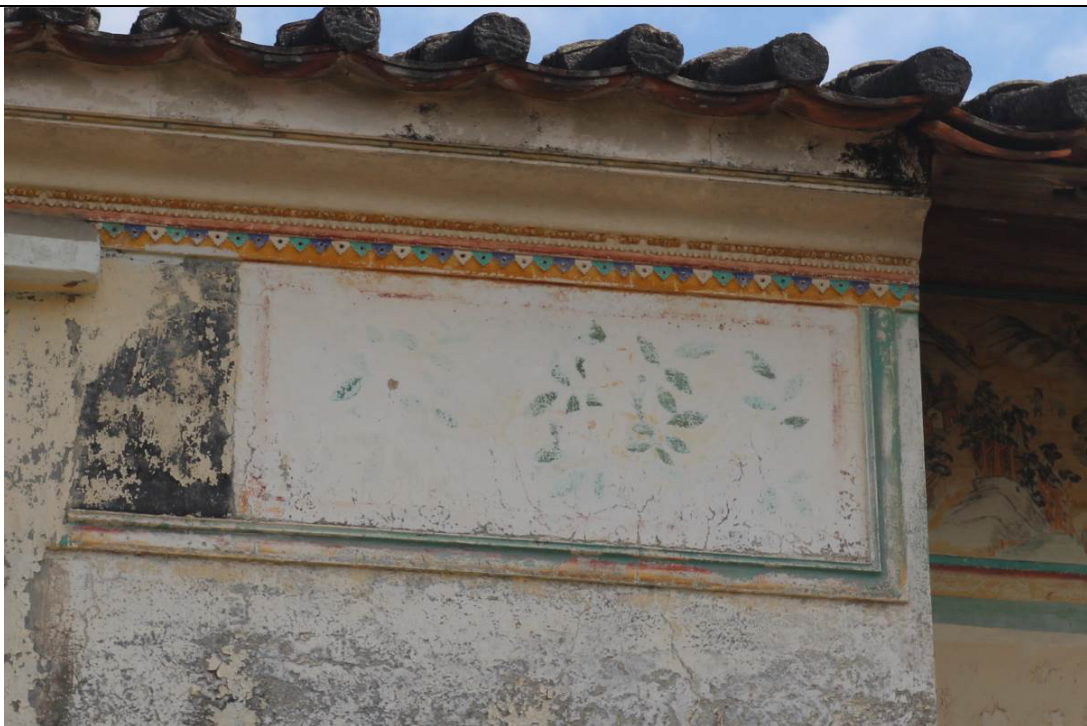
BS64-2-P3

Faded murals on the façade of BS64-2. BS64-2正立面牆上已褪色的彩畫

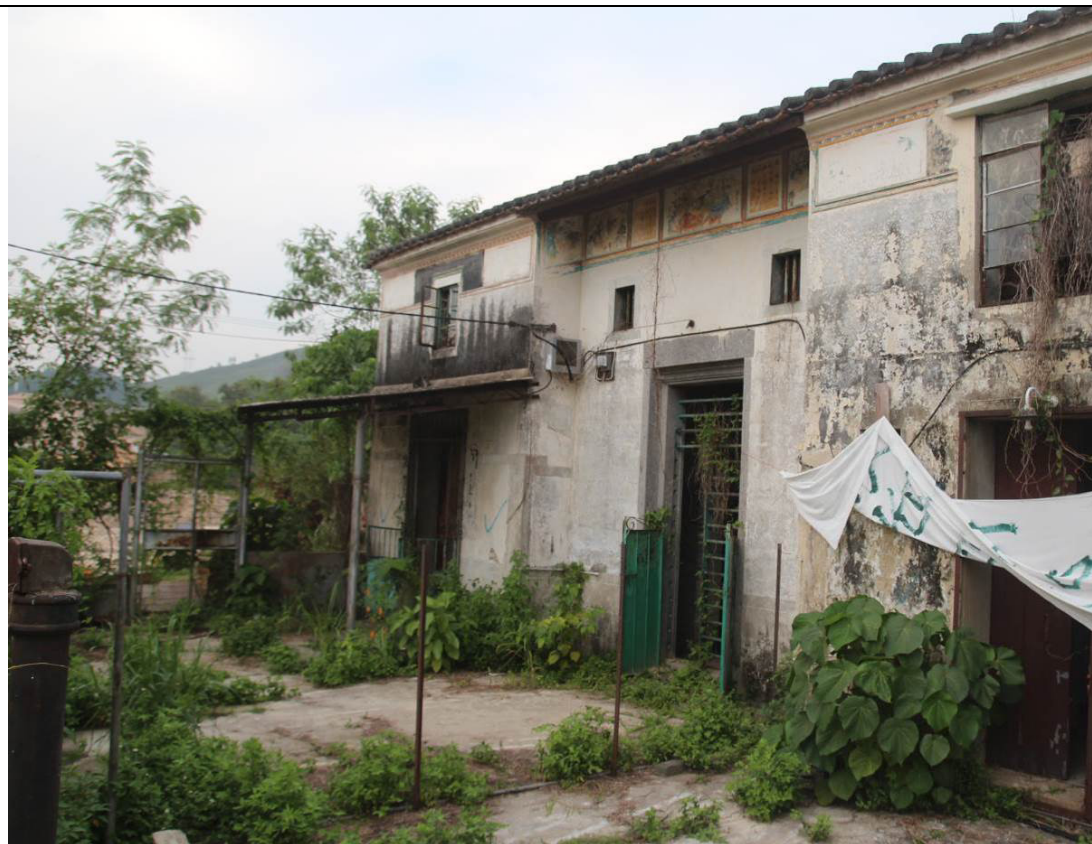
BS64-3-P1

General view of BS64-3 BS64-3概貌

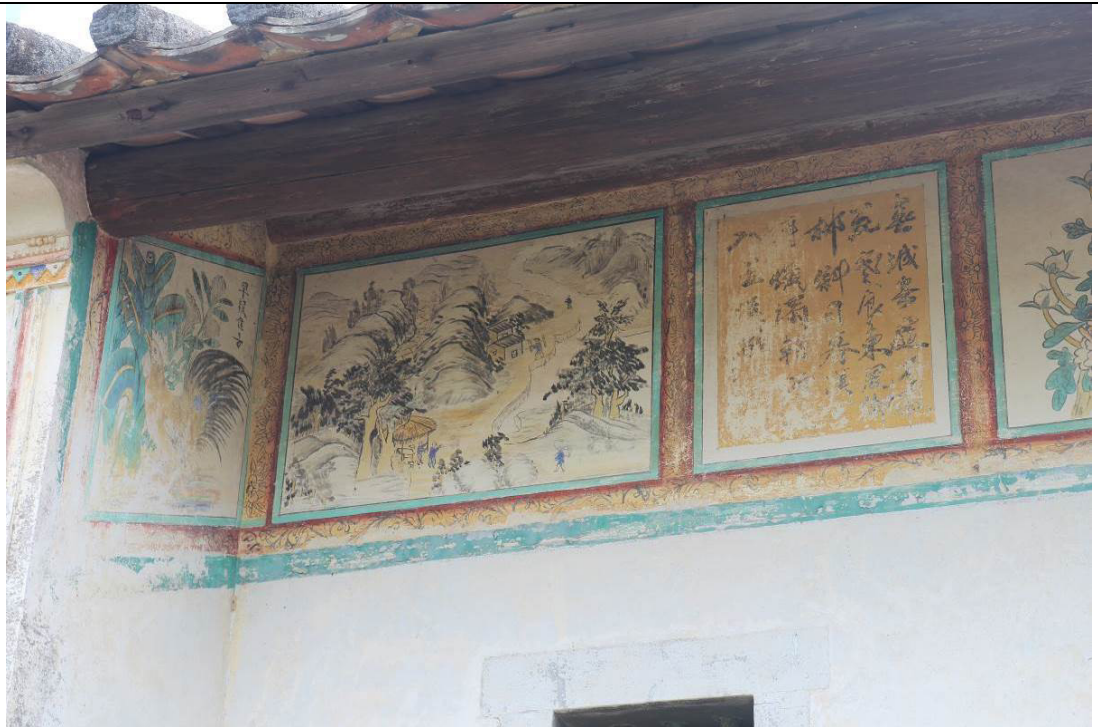
BS64-3-P4

Murals on the façade of BS64-3. BS64-3正立面牆上彩畫，引詩「春城無處不飛花，寒食東風御柳斜。日暮漢宮傳蠟燭，輕煙散入五侯家。」（《寒食》韓翃）

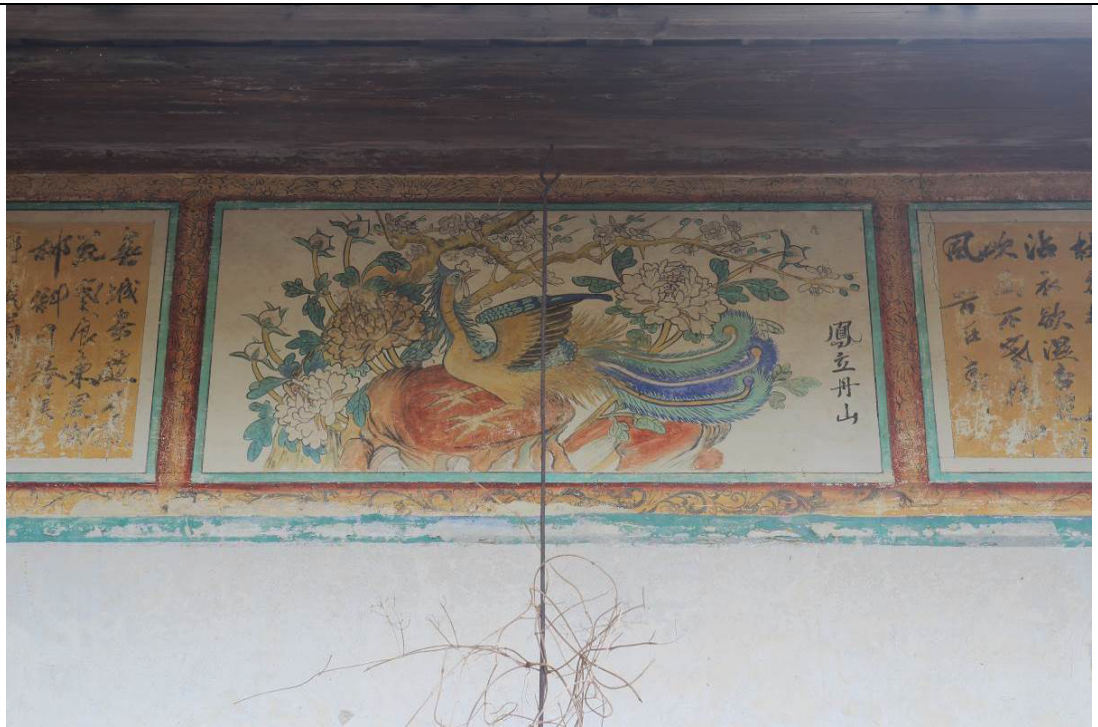
BS64-3-P5

Murals on the façade of BS64-3. BS64-3正立面牆上彩畫，主題「鳳立丹山」

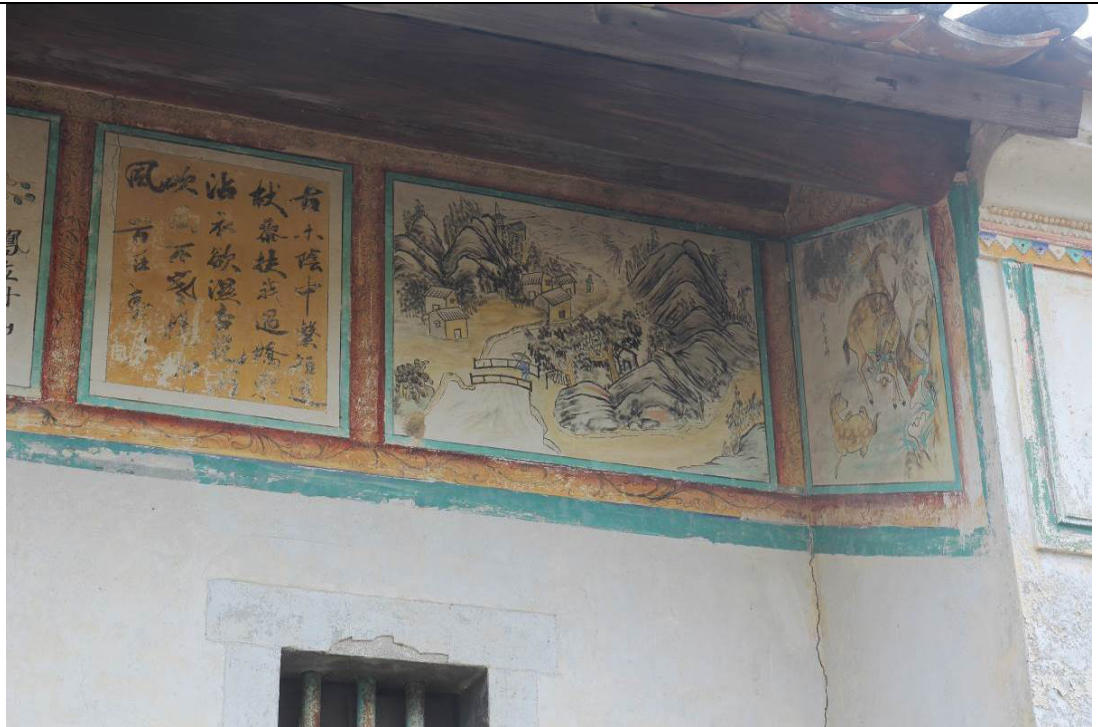
BS64-3-P6

Murals on the façade of BS64-3. BS64-3正立面牆上彩畫，引詩「古木陰中系短篷，杖藜扶我過橋東。沾衣欲濕杏花雨，吹面不寒楊柳風。」（《絕句》僧志南）

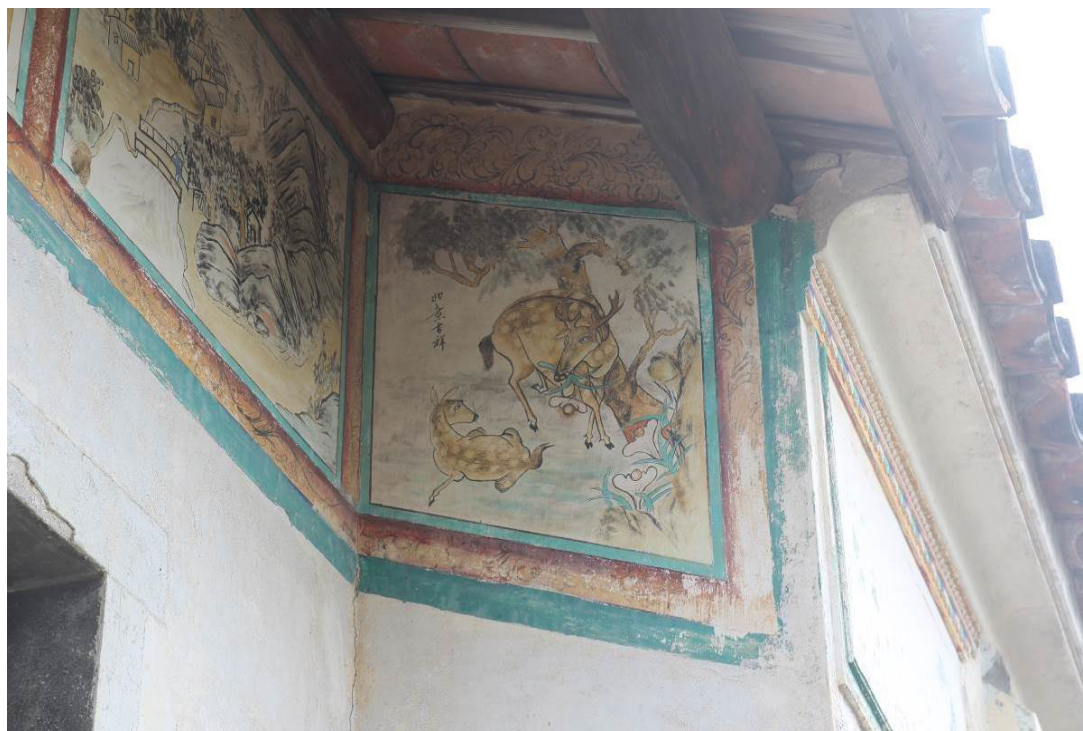
BS64-3-P7

Murals on the façade of BS64-3. BS64-3正立面牆上彩畫，主題「早報佳音」

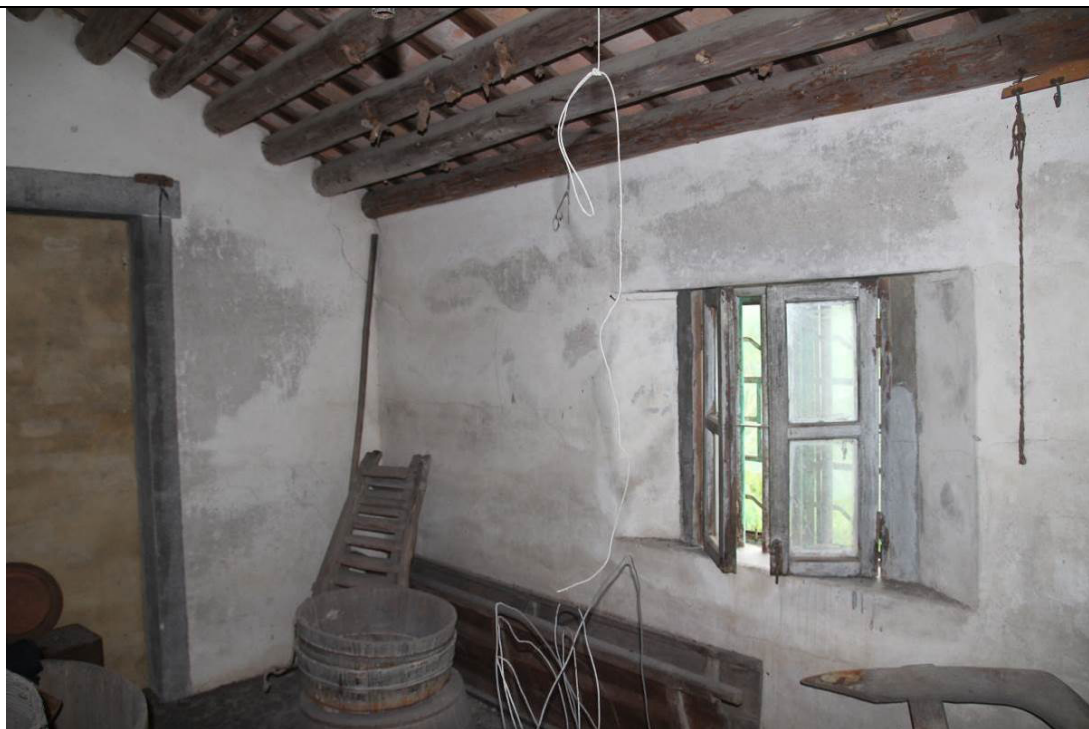
BS64-3-P23

Blocked doorway leading to BS64-2 at the cockloft 閣樓通往BS64-2的已封的門洞

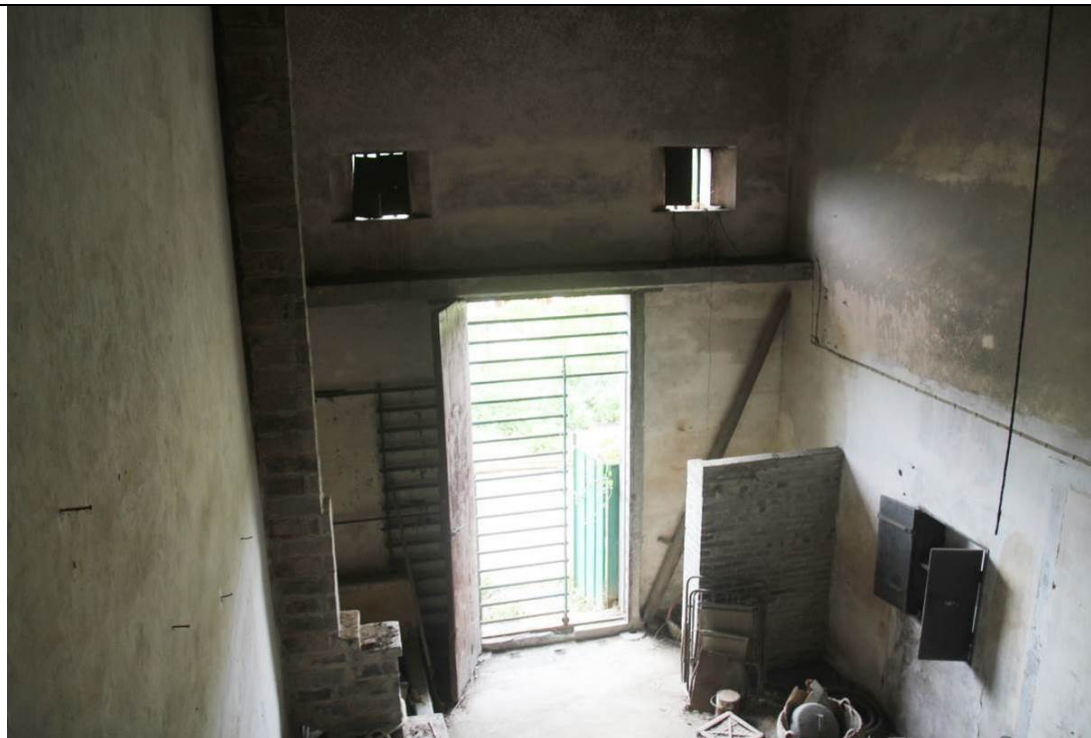
BS64-3-P25

Blocked doorway leading to BS64-4 at the cockloft 閣樓已封的通往BS64-4的門洞

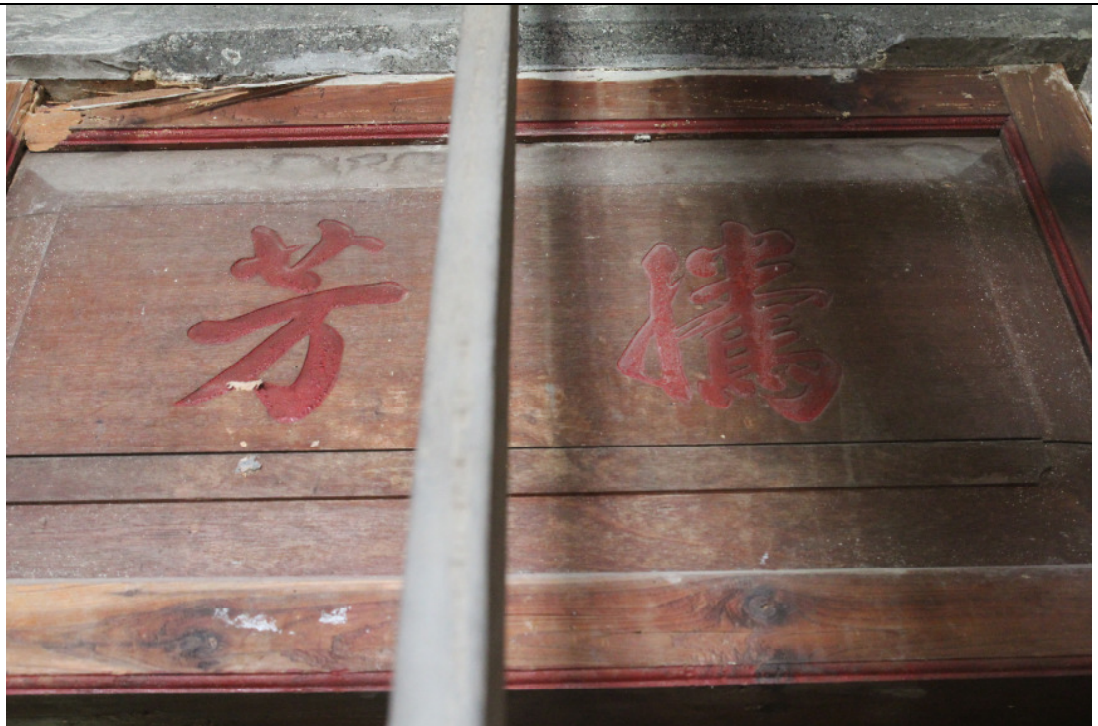
BS64-3-P32

Room door on the ground floor carved with characters “騰芳” in BS64-3. BS64-3中刻有“騰芳”二字的下層房門

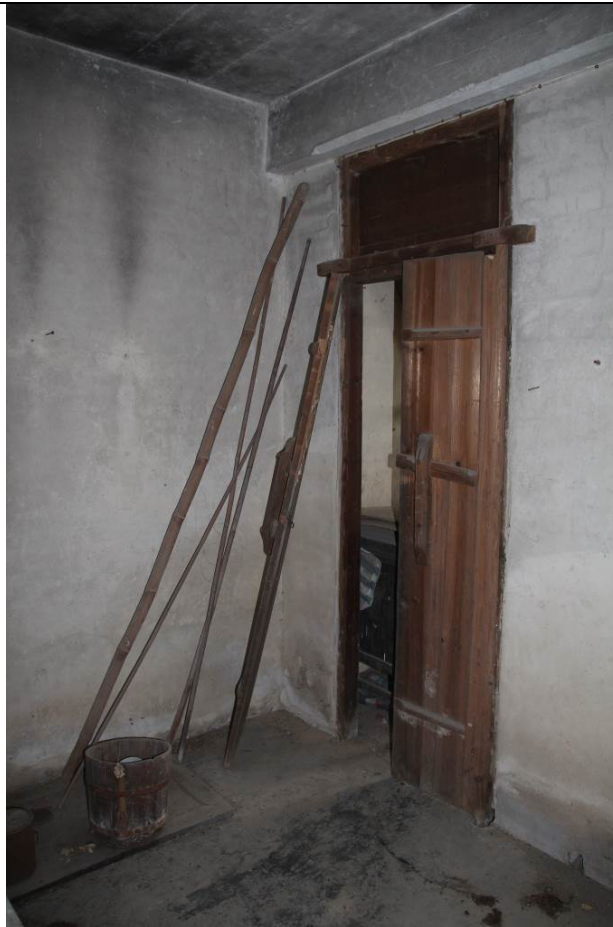
| Site Code | Photo No. | Content | Categories |
|---|---|--|---|
| | BS64-3-P35 | Room door observed from room, beam has decoration 房間中看房門，橫樑上有裝飾 | Interior (b) |

BS64-3-P35
Room door observed from room, beam has decoration 房間中看房門，橫樑上有裝飾

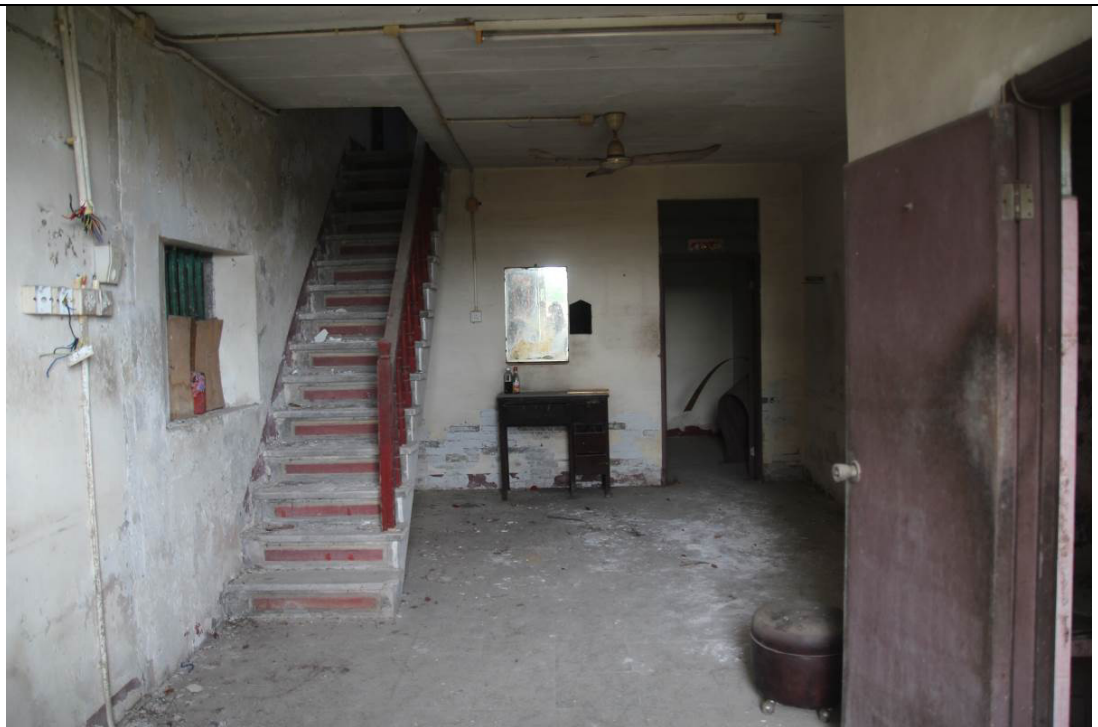
BS64-4-P4

General view of indoor area, viewing blocked doorway leading to BS64-3 室內概貌，見已封的通往BS64-3的門洞

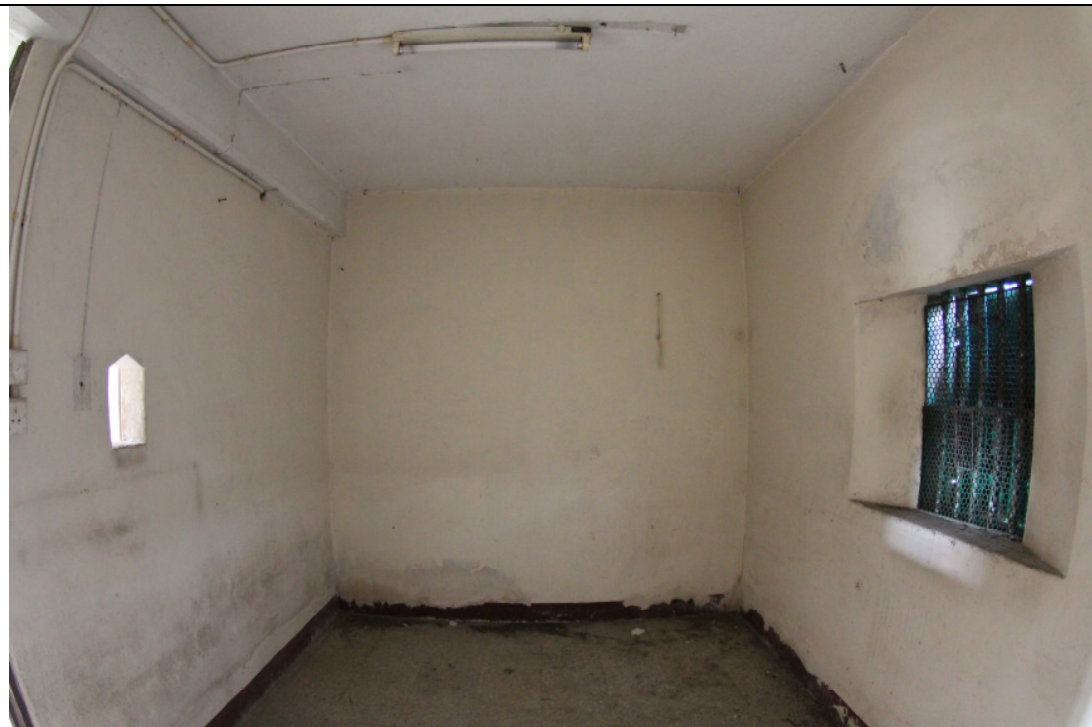
BS64-4-P8

General view of the room 房間概貌
