Contract No. CV/2013/08
Liantang / Heung Yuen Wai Boundary Control Point
Site Formation and Infrastructure Works – Contract 6

Environmental Permit No. EP-404/2011/C
Condition 2.16 – Photographic and Cartographic Survey Report

Contract No. CV/2013/08
Liantang/Heung Yuen Wai
Boundary Control Point Site
Formation and Infrastructure
Works – Contract 6
*Cartographic and Photographic
Survey Report*

December 2015

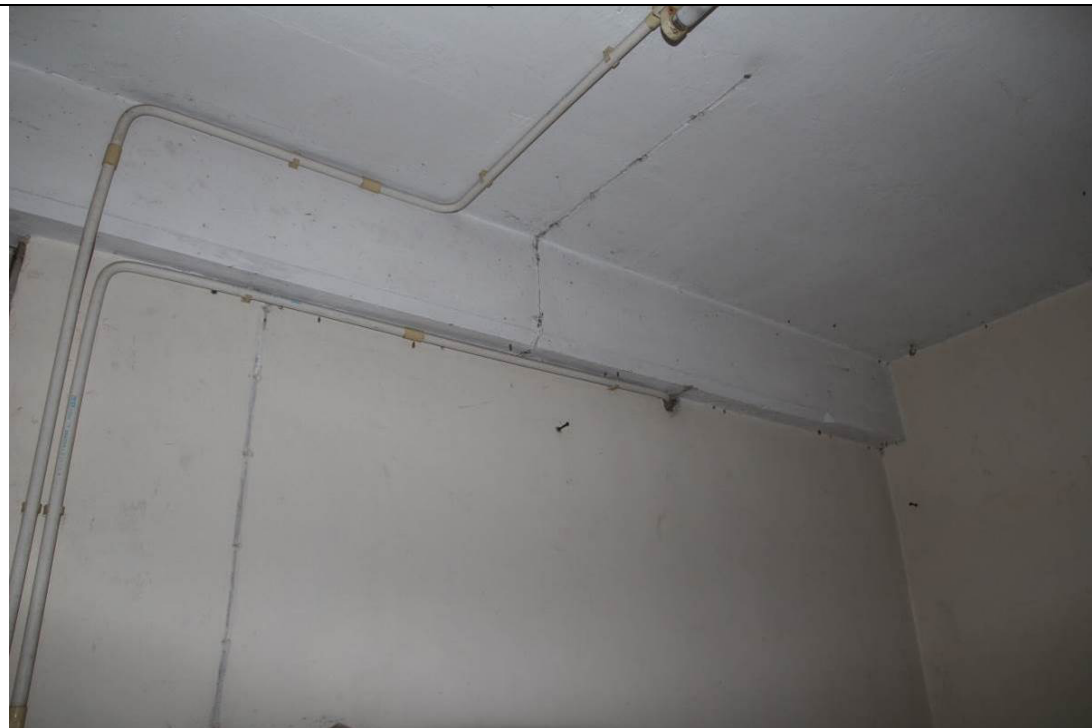
BS64-4-P9

Beam viewing inside the room on the ground floor 下層房間的橫樑

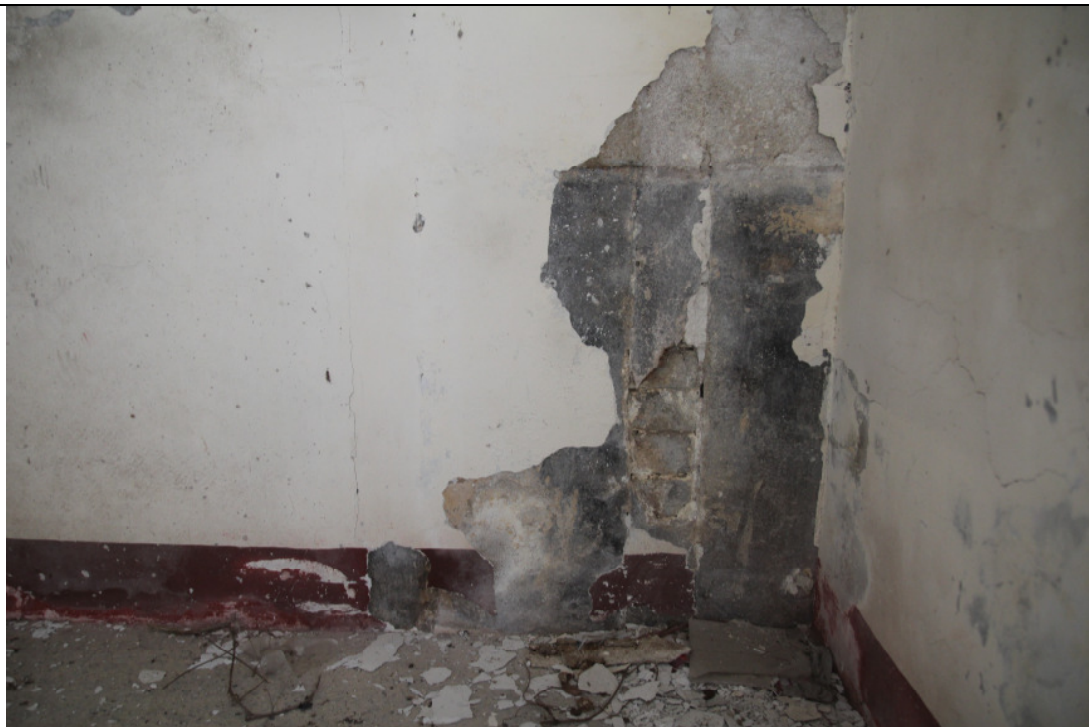
BS64-4-P12

Separation wall between BS64-3 and BS64-4 constructed with green bricks BS64-3及BS64-4 隔牆以青磚砌成

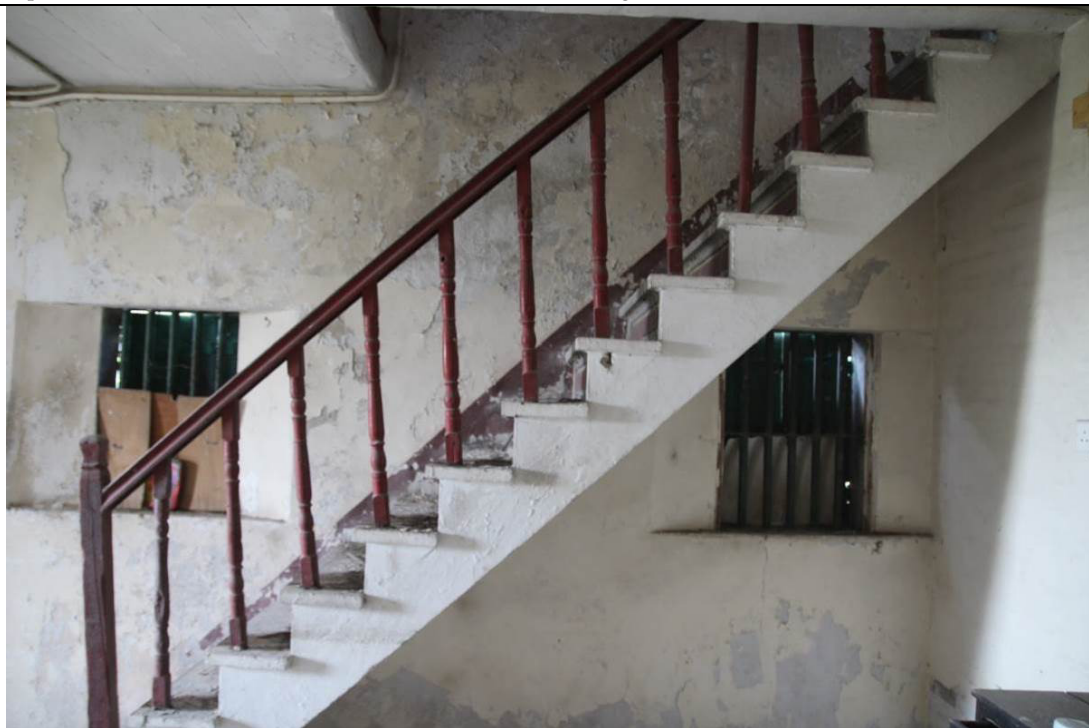
BS64-4-P13

Stairs to the upper floor and the windows beneath it 往上層的樓梯及其下的窗戶

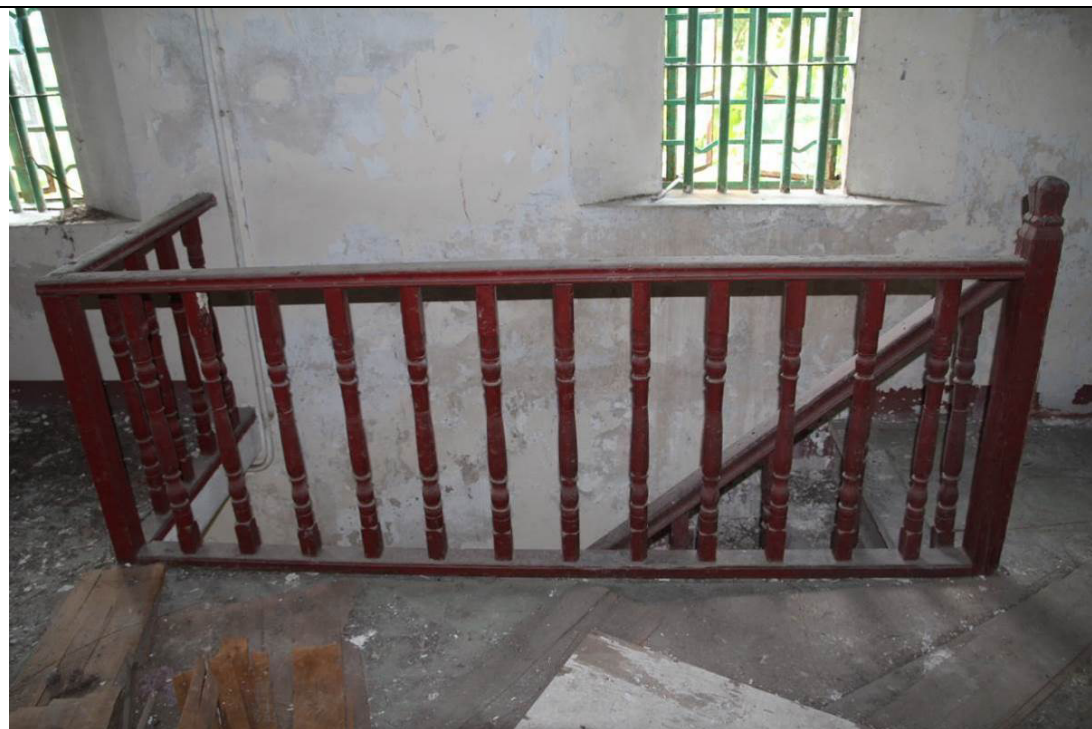
BS64-4-P14

Wooden balustrade of the stairs 樓梯的木欄杆

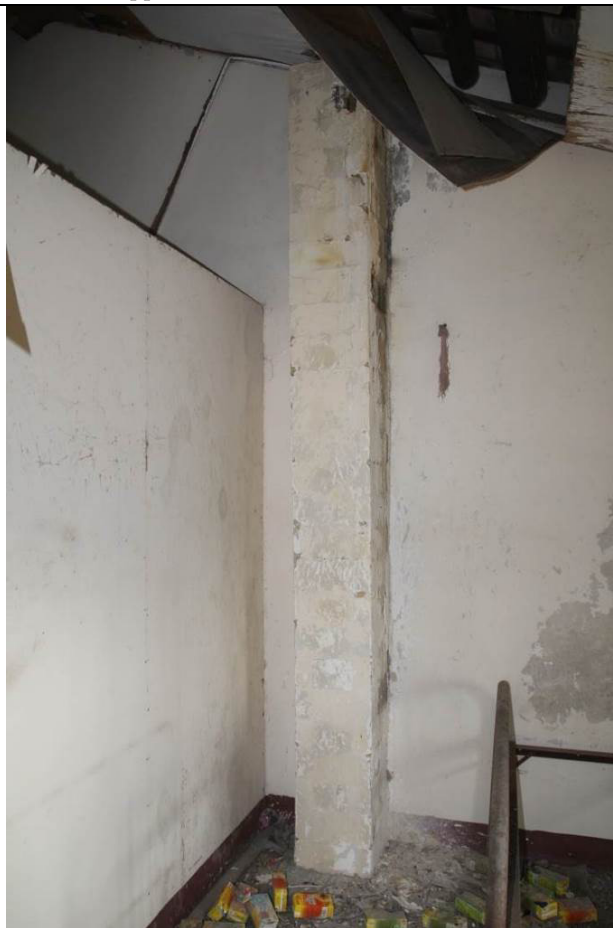
BS64-4-P25

Remains of chimney of stove in front room on the upper floor 上層前室有灶煙囪殘跡

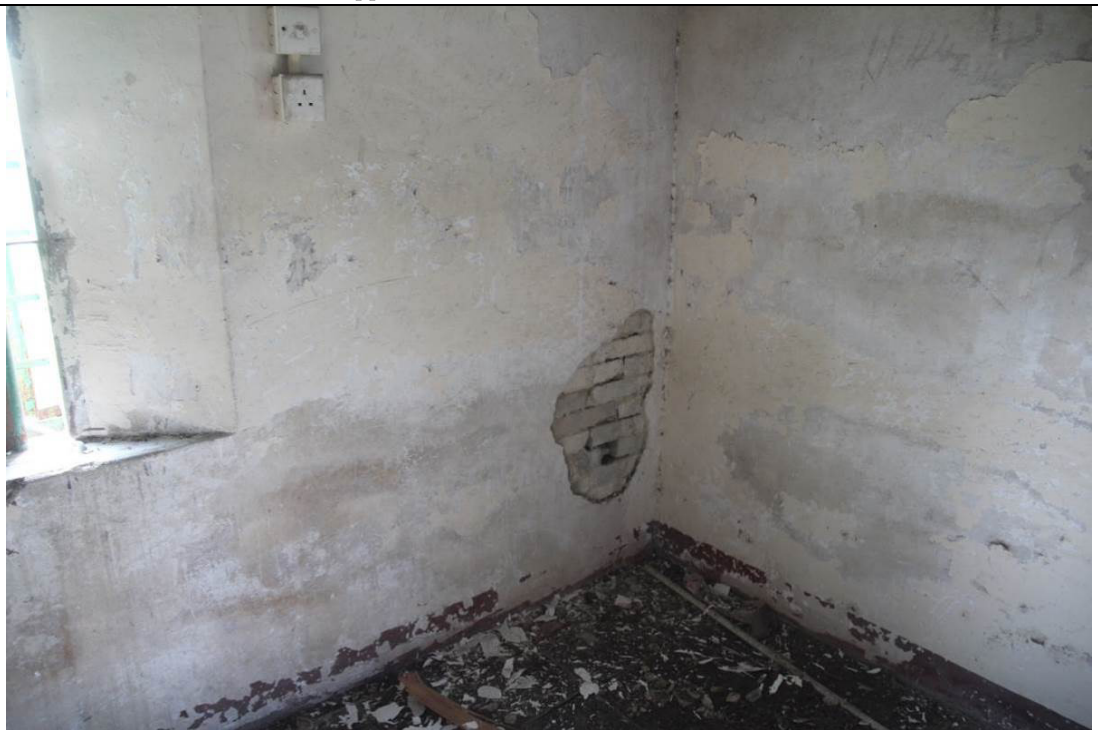
BS64-4-P27

Corner of the front room showing front wall constructed with brick 前室角落可見前壁由磚砌成

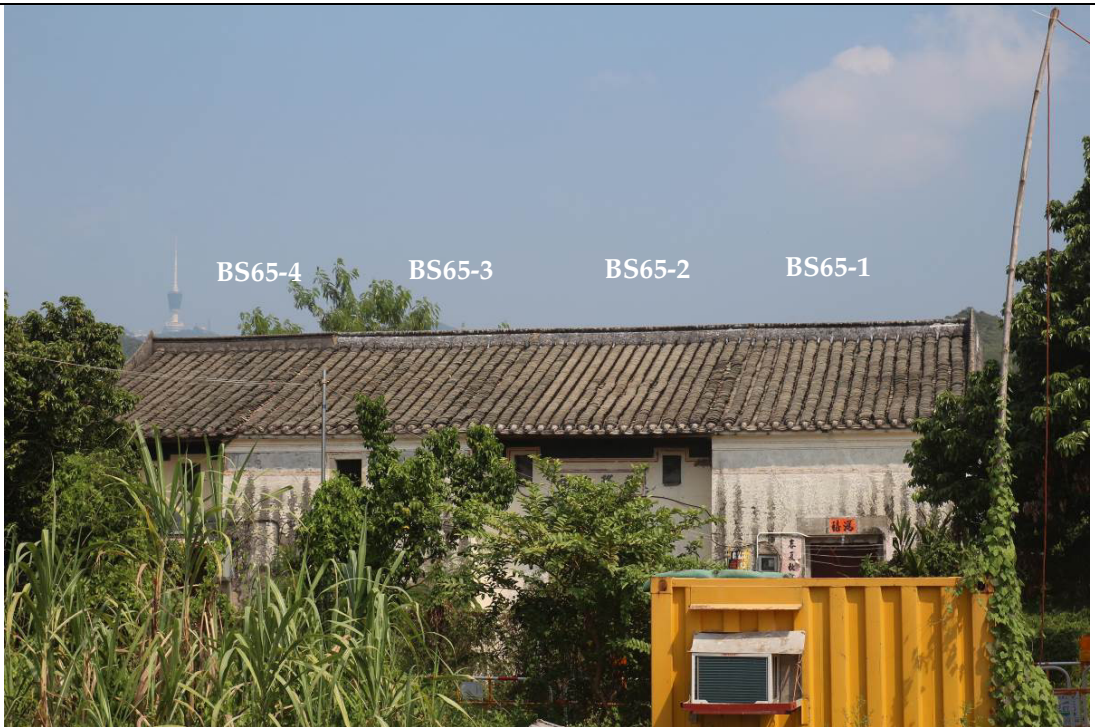
BS65-overall-P6

Roof of BS65 (view from southwest) BS65屋面(攝自西南方)

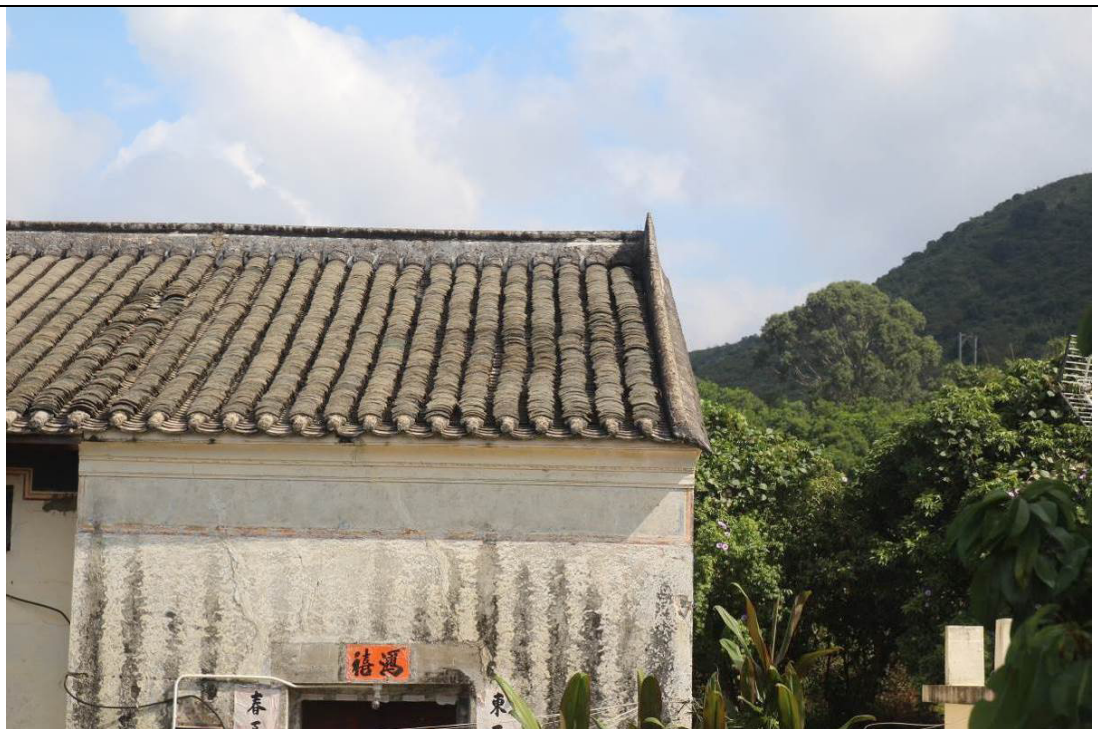
BS65-overall-P8

Elevation of gable ridge of BS65 (view from southwest) BS65垂脊正立面(攝自西南方)

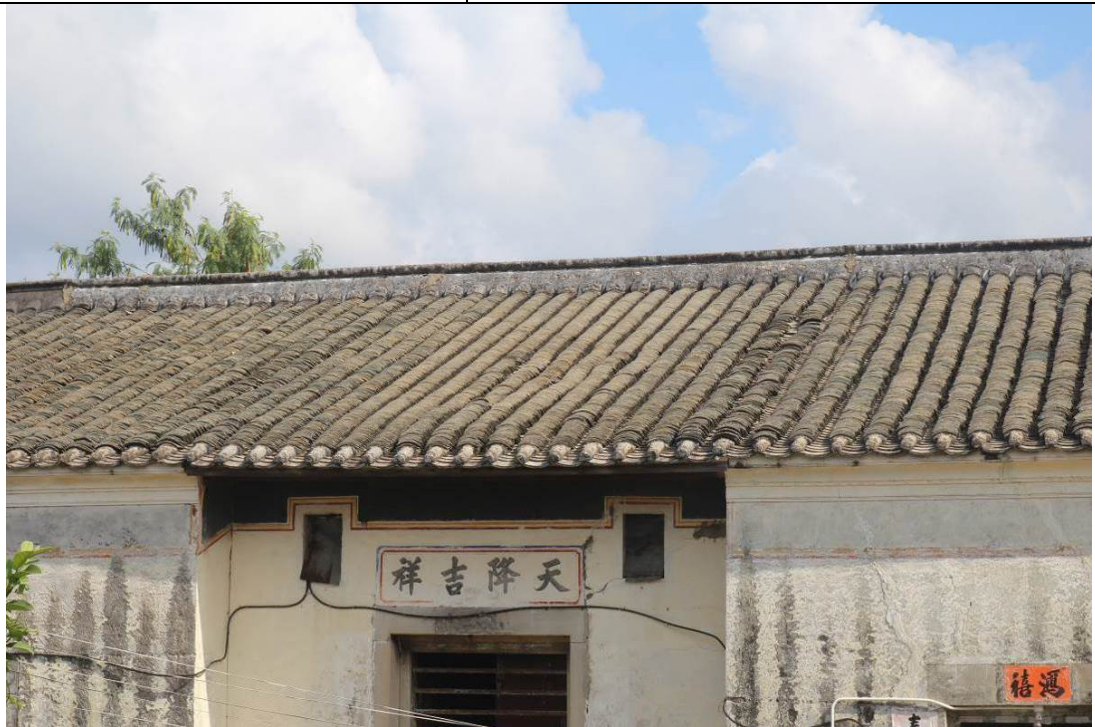
**BS65-overall-P9**

Main ridge of BS65 (view from southwest) BS65正脊(攝自西南方)

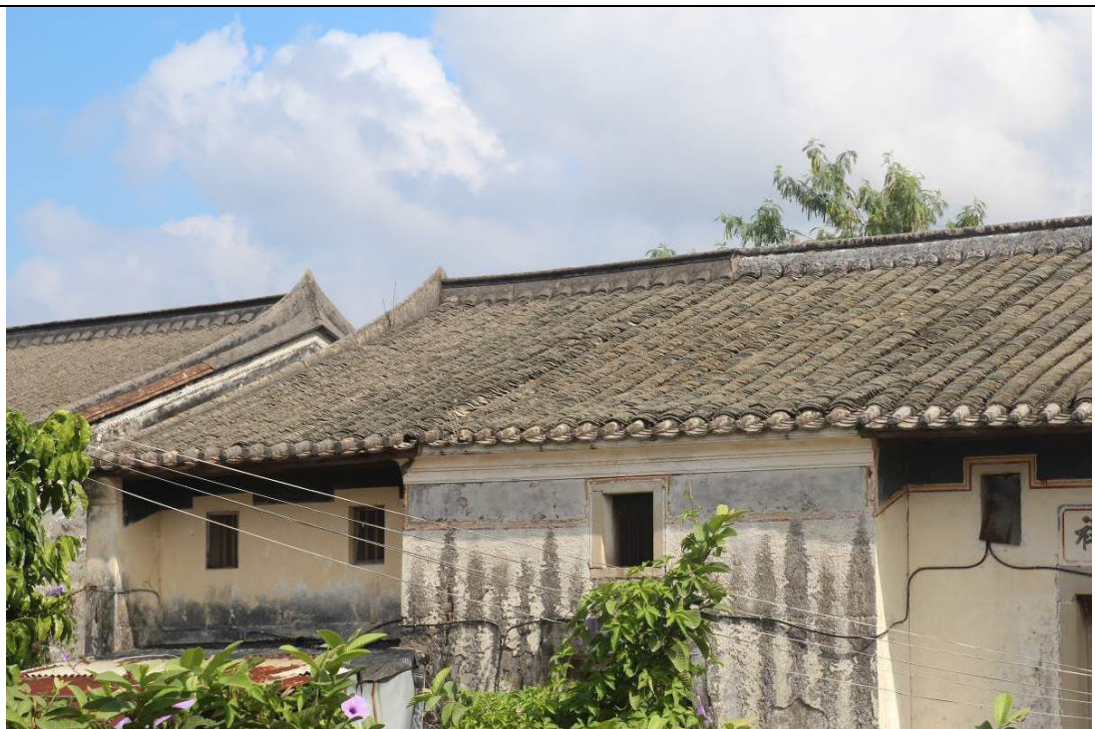
**BS65-overall-P10**

Main ridge of BS65, showing the joint between BS65-3 and BS65-4 (view from southwest) BS65屋面(攝自西南方)·見BS65-3 及BS65-4 間的接位

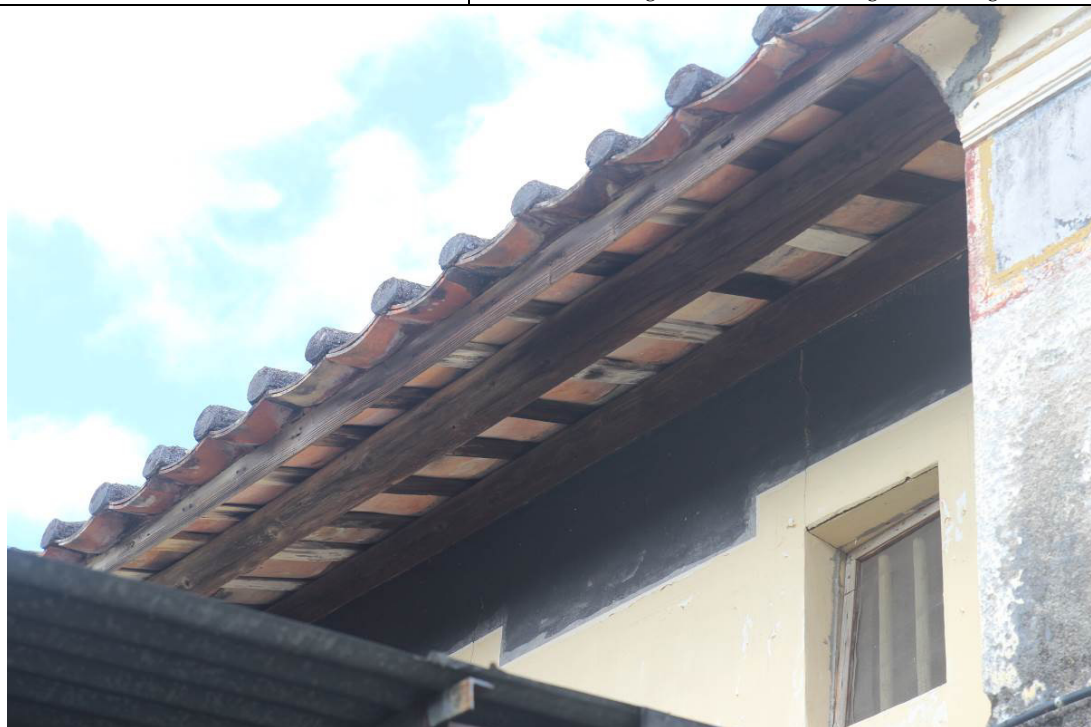
BS65-overall-P11

Lower red clay pan tile is used in BS65-4. BS65-4使用紅板瓦。

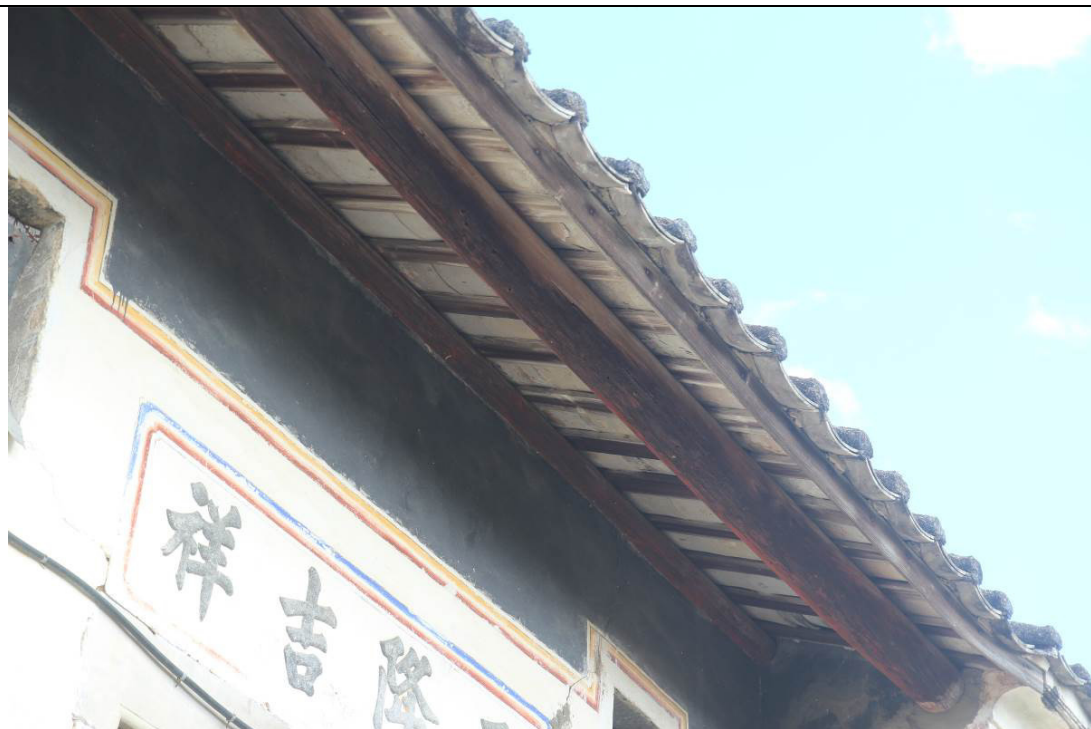
BS65-overall-P12

Lower grey clay pan tile is used in BS65-2. BS65-2使用紅板瓦。

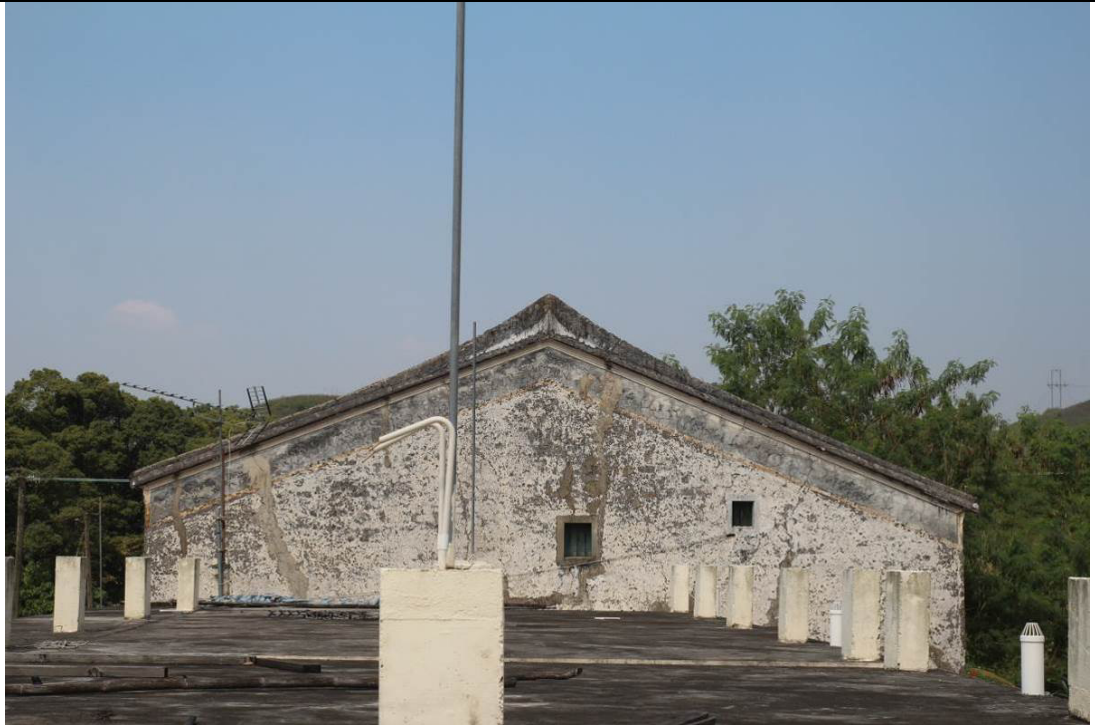
BS65-overall-P13

Gable wall of BS65 (view from southeast) BS65山牆(攝自東南方)

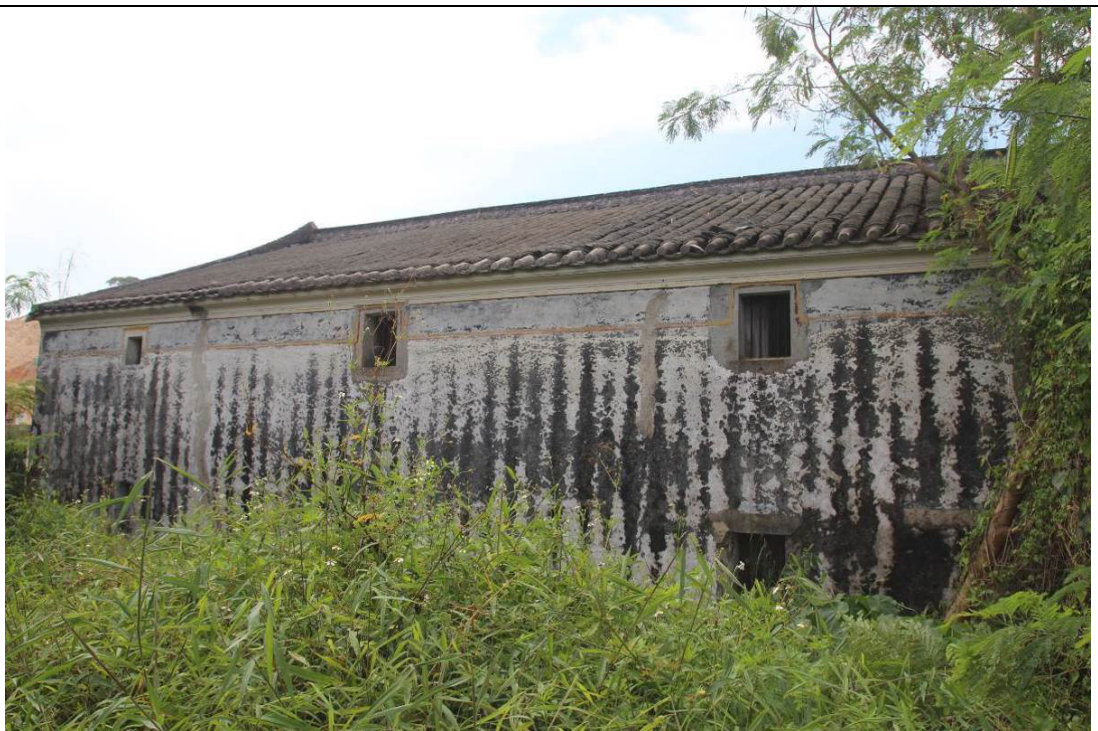
BS65-overall-P16

Back wall of BS65 (view from northeast) BS65後壁(攝自東北方)

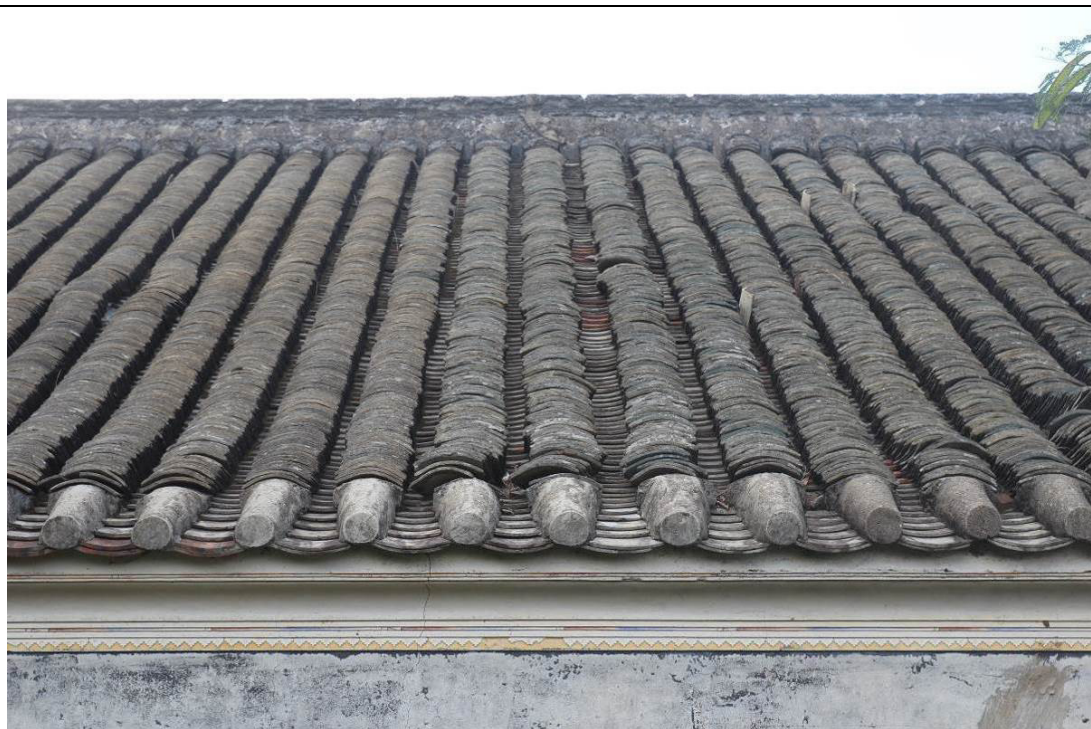
BS65-overall-P18

Close up of the roof of BS65 (view from northeast) BS65屋頂近拍(攝自東北方)

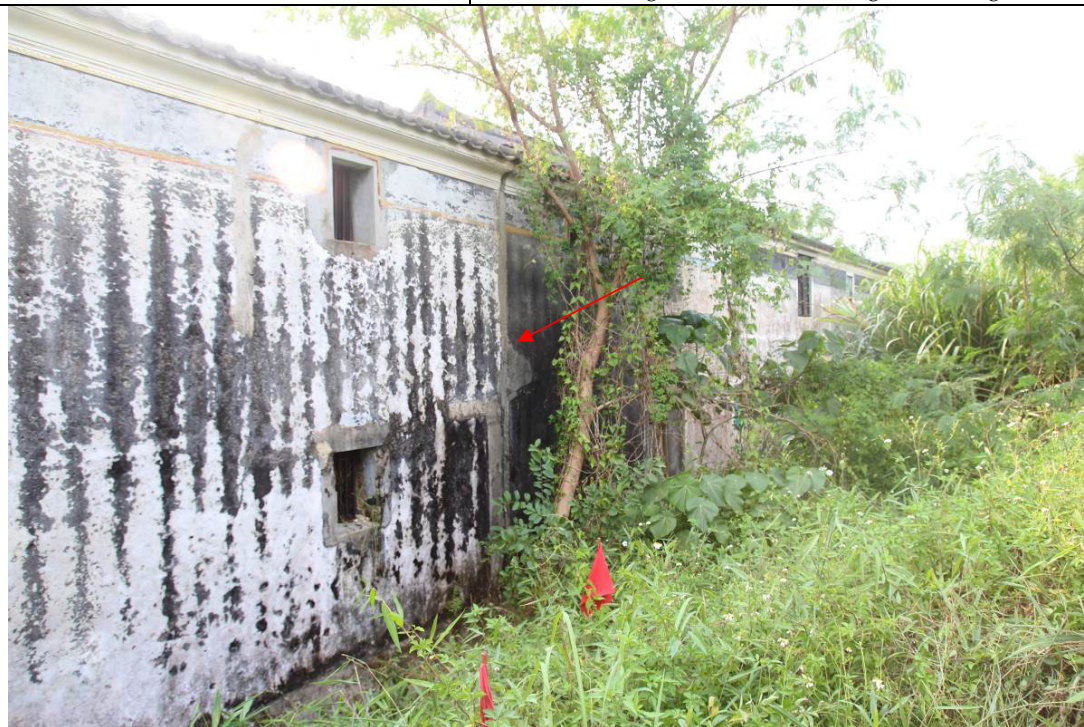
**BS65-overall-P19**

Back wall of BS65 (view from east), original building corner is shown in red arrow. BS65-4 is a later addition. BS65後壁(攝自東方)，原來的建築物轉角見紅箭頭所示。BS65-4是後期加建的。

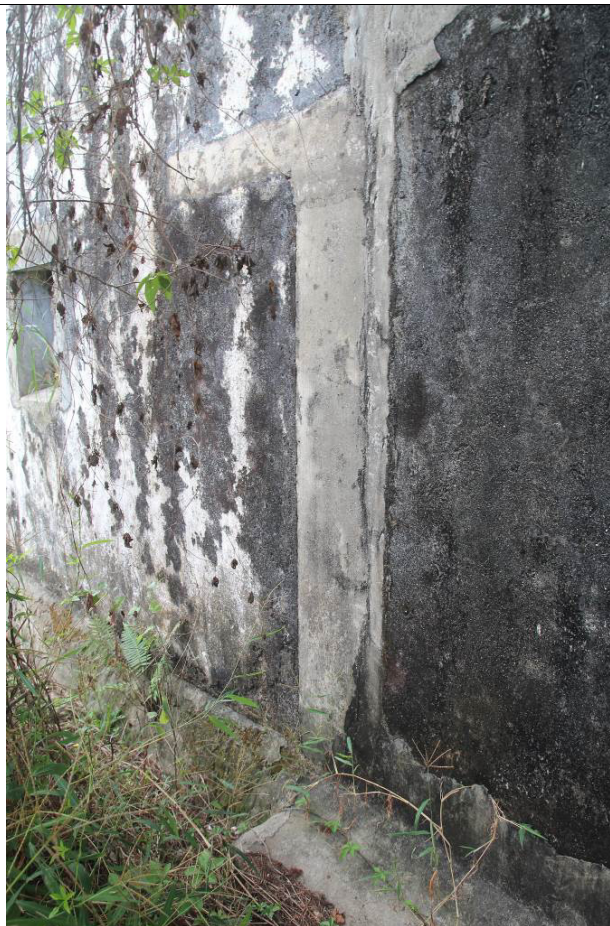
**BS65-overall-P20**

The original building corner shown on back wall 初建的建築物轉角處見於後壁

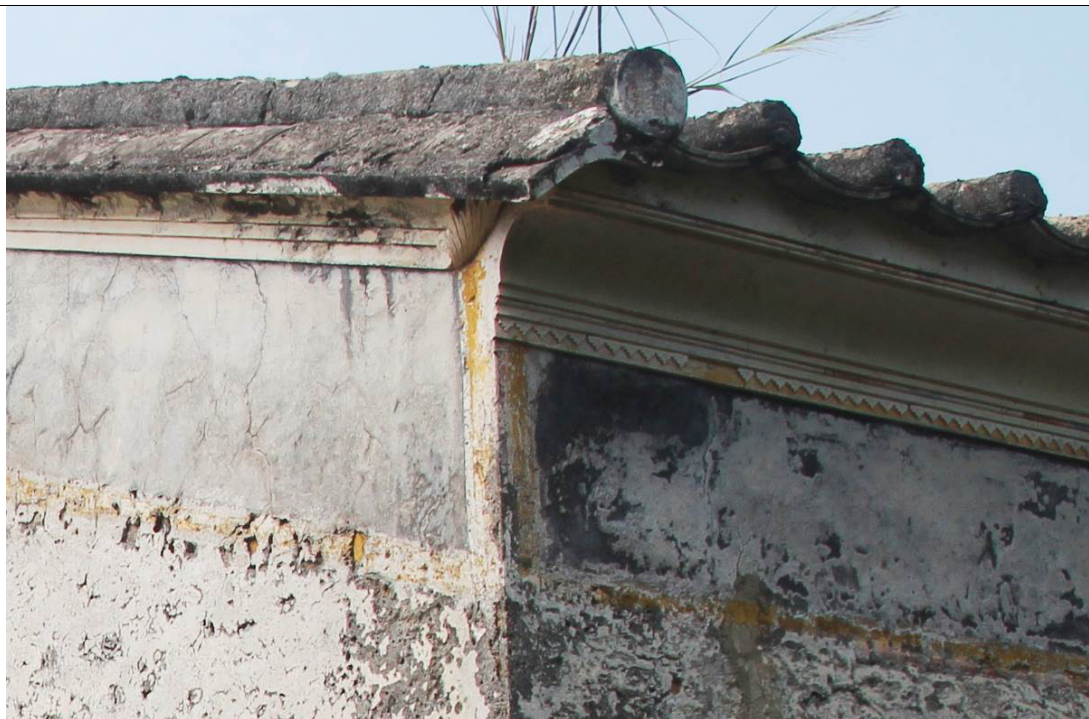
BS65-overall-P24

Eave decorations of back wall and gable wall of BS65-1 (view from southeast) BS65-1後壁及山牆檐口裝飾(攝自東南方)

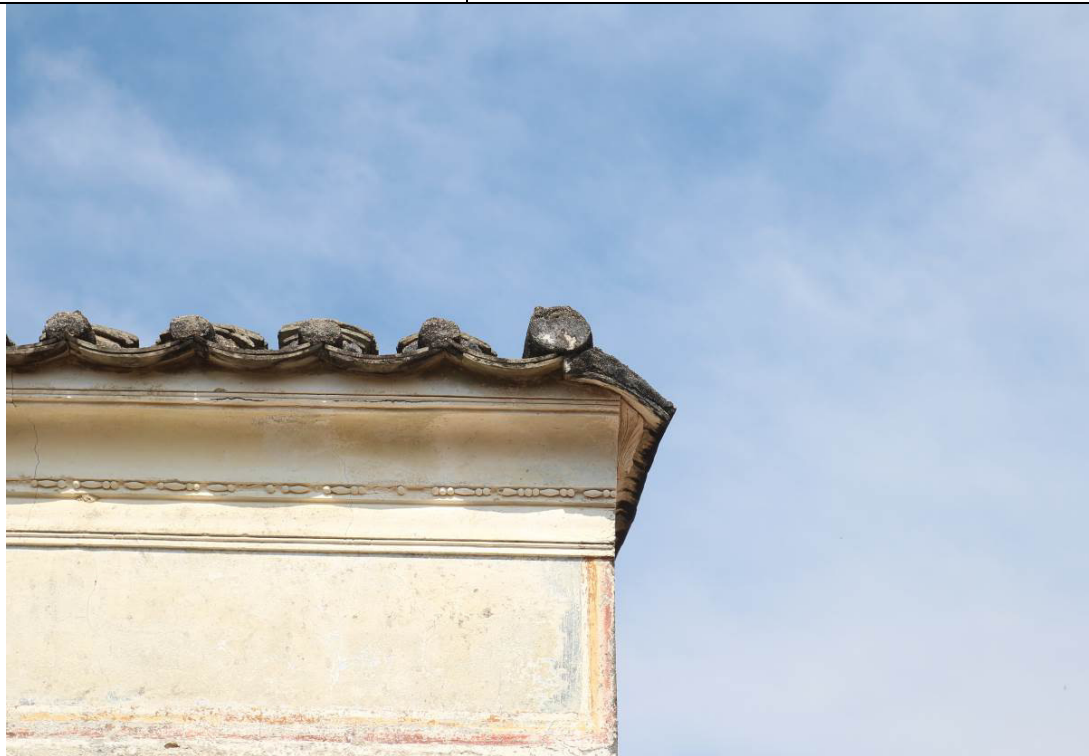
BS65-overall-P25

Eave decorations of front wall BS65-1 (view from southwest) BS65-1前壁檐口裝飾(攝自西南方)

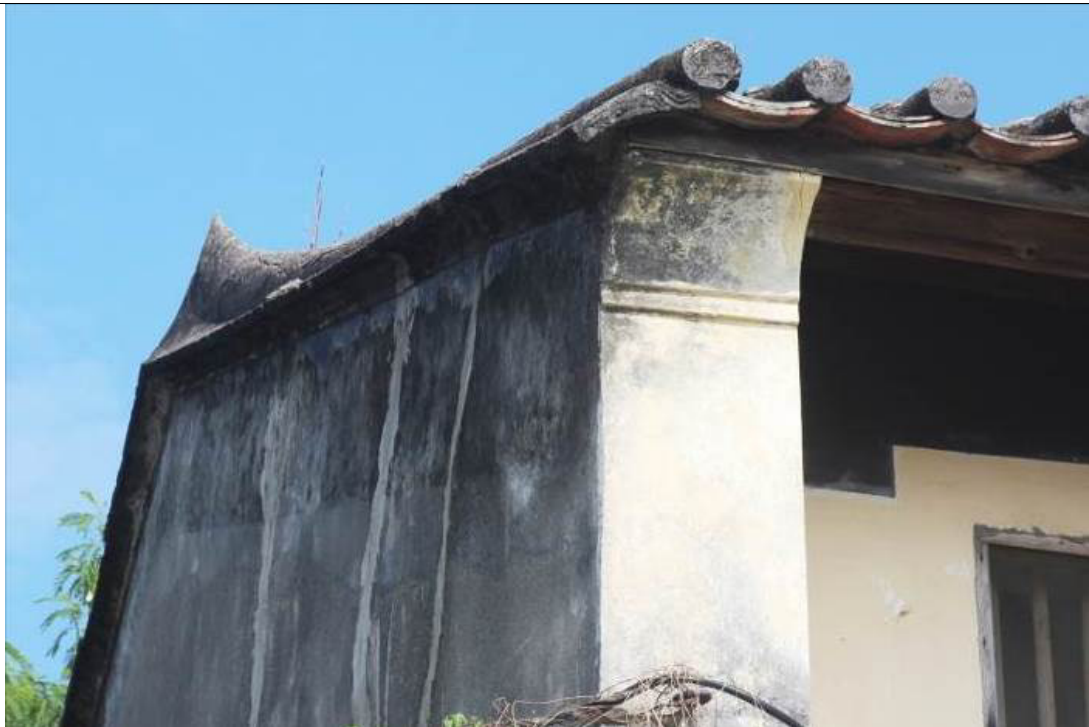
BS65-overall-P26

Eave of gable wall of BS65-4 (view from west) BS65-4山牆(攝自西方)

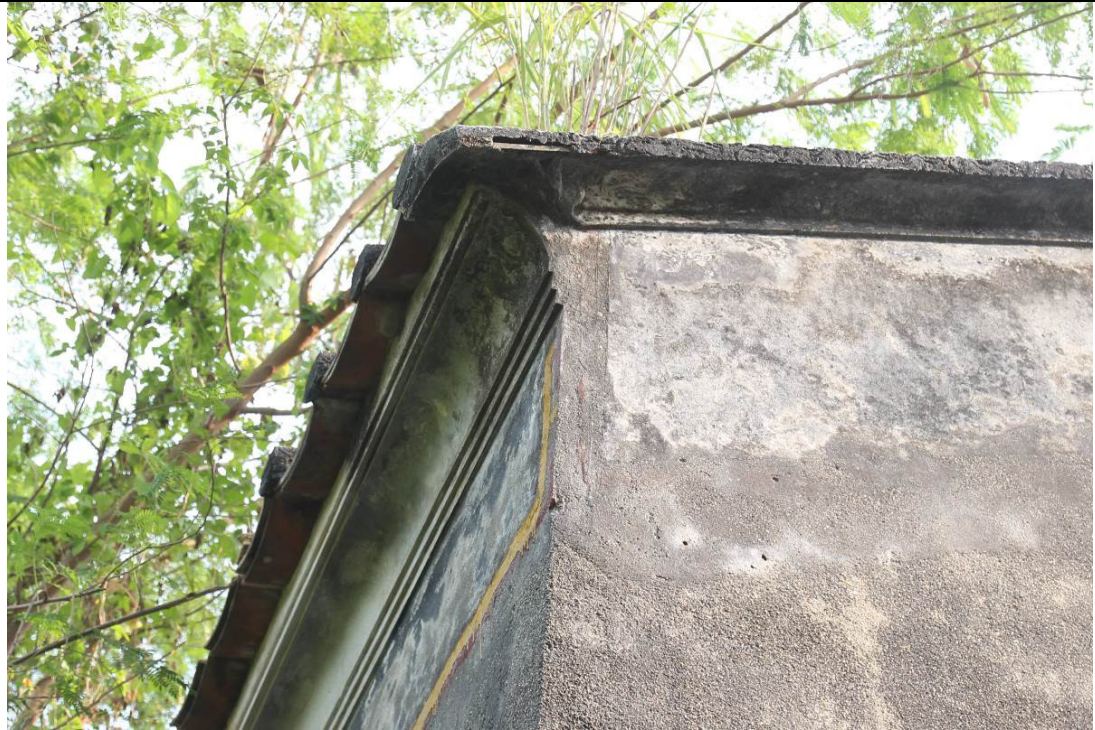
BS65-overall-P27

Eave decorations of back wall and gable wall of BS65-4 (view from north) BS65-4後壁及山牆檐口裝飾(攝自北方)

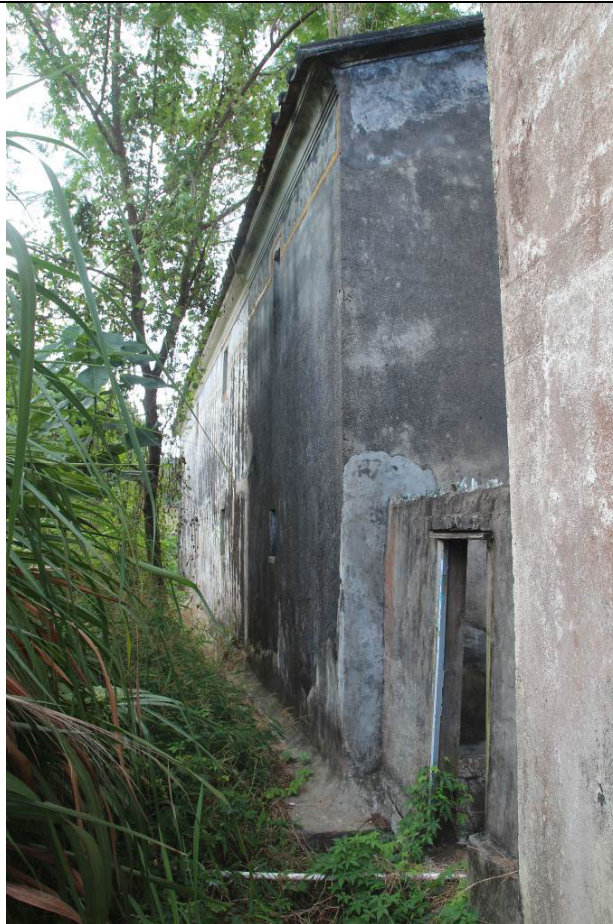
BS65-overall-P28

A door between BS64 and BS65 (view from north) BS64及BS65之間的門(攝自北方)

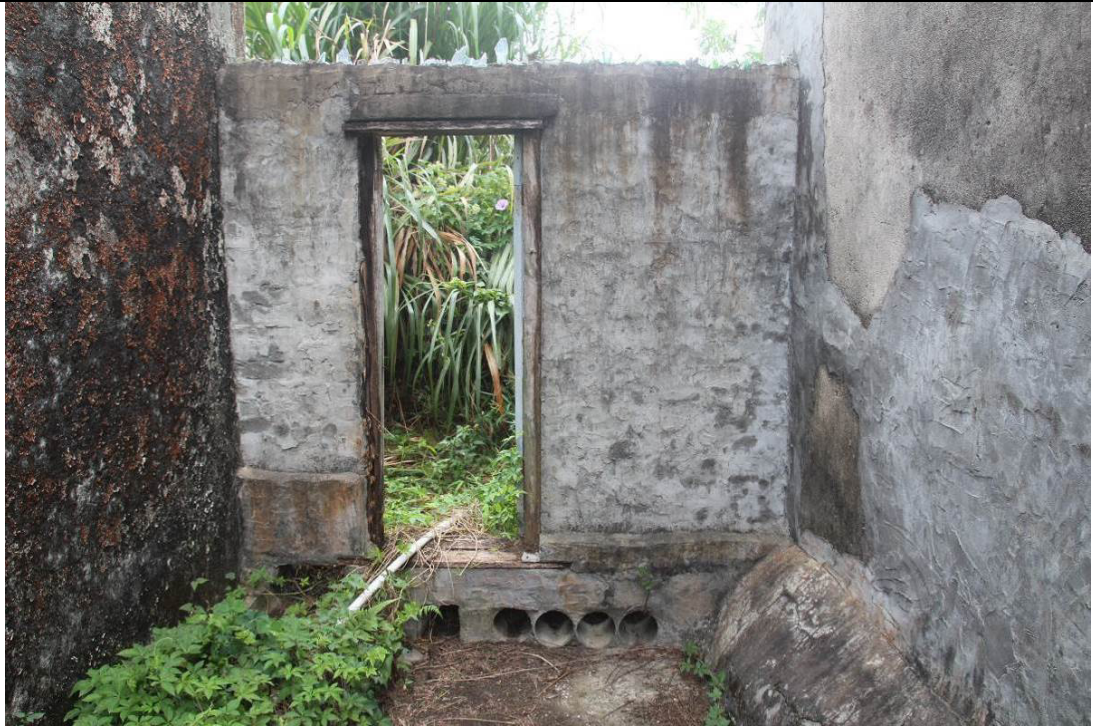
BS65-overall-P29

A door between BS64 and BS65 (view from southwest) BS64及BS65之間的門(攝自西南方)

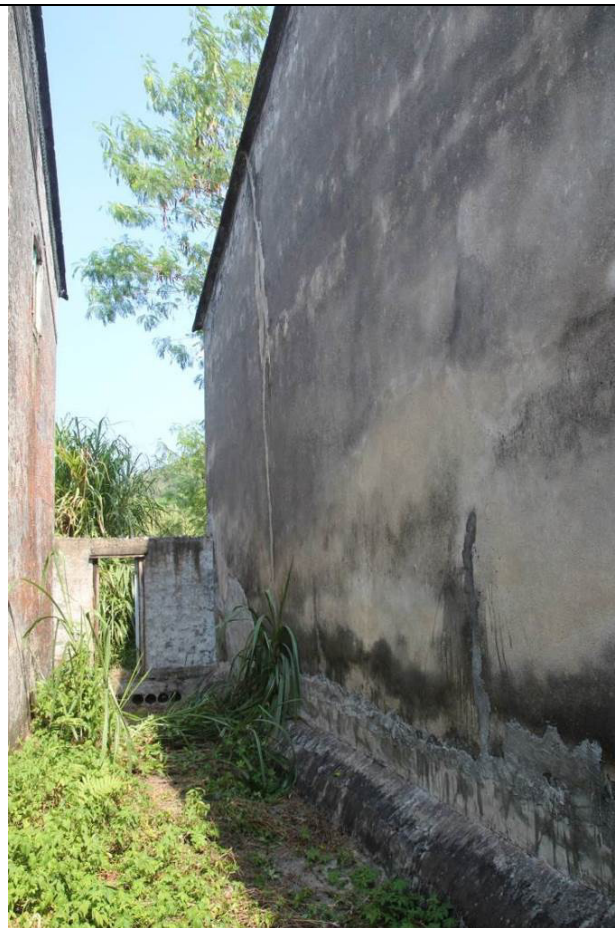
BS65-overall-P30

Area between BS64 and BS65 (view from southwest) BS64及BS65之間的空間(攝自西南方)

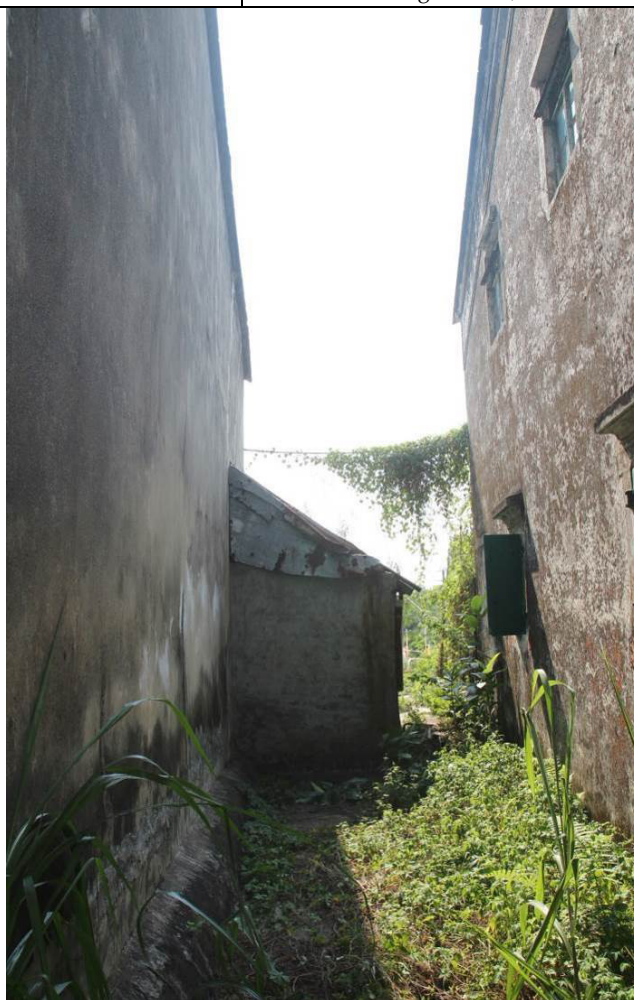
BS65-overall-P31

Area between BS64 and BS65(view from northeast) BS64及BS65之間的空間(攝自東北方)

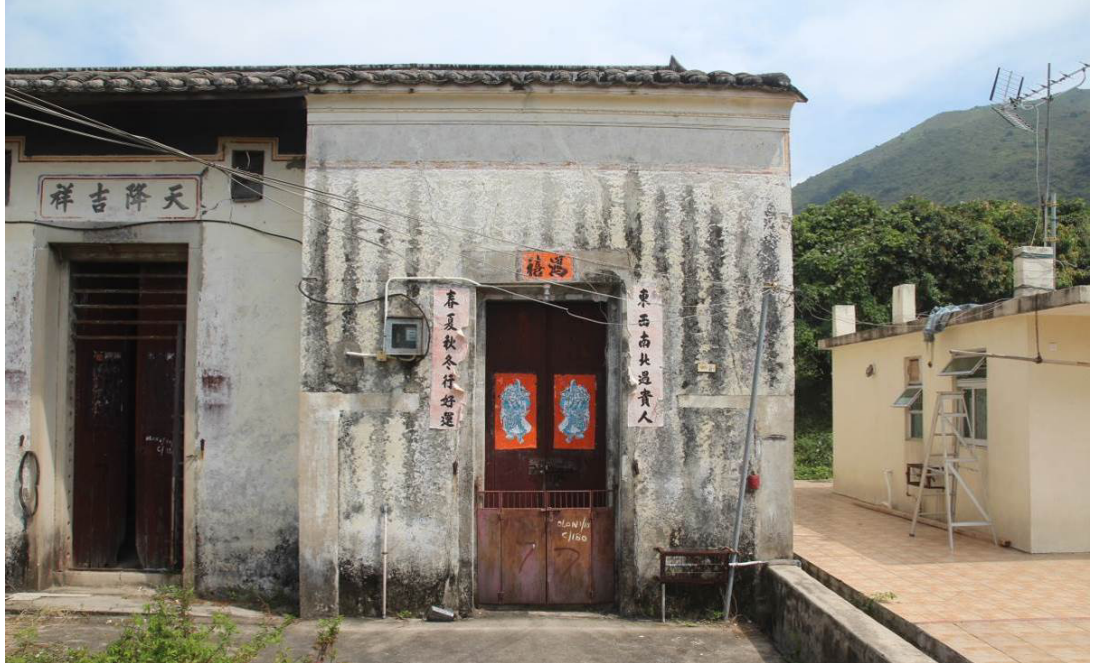
BS65-1-P1

Façade of BS65-1 BS65-1正立面

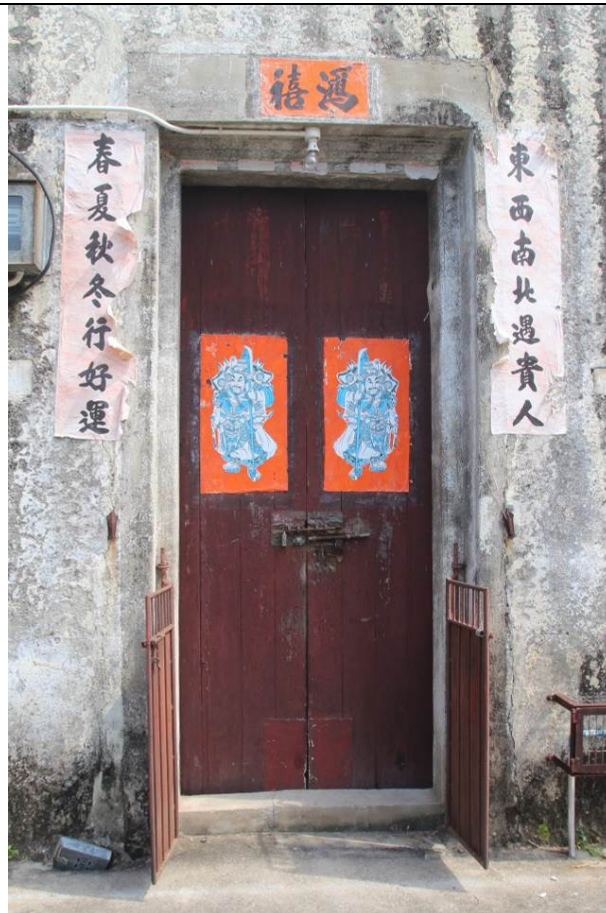
BS65-1-P2

Entrance is decorated with door frame with cement plastered. 入口以水泥抹灰的門框作裝飾

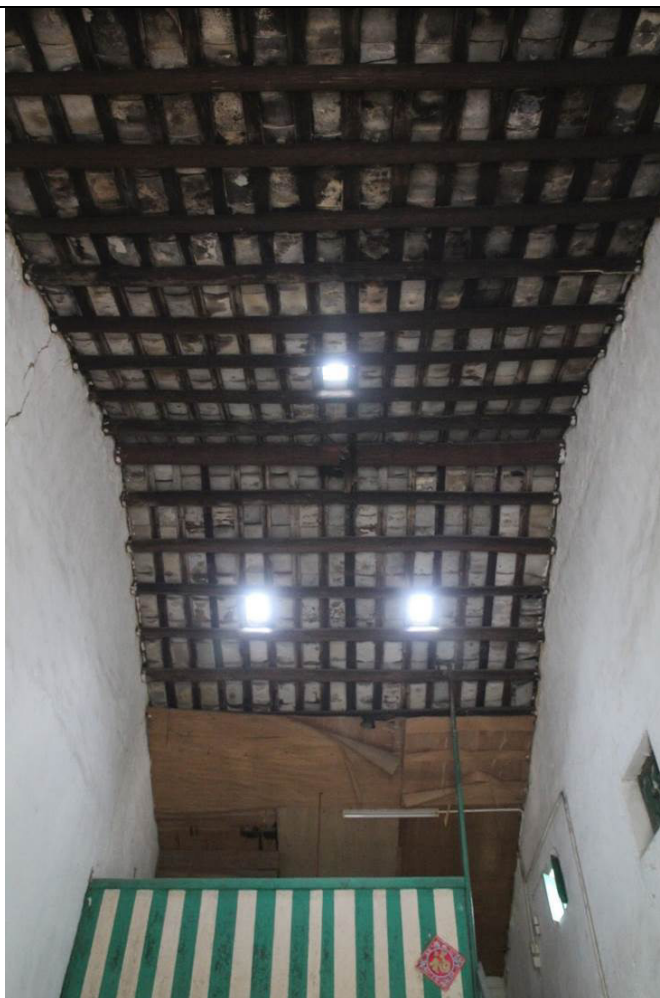
BS65-1-P6

The roof is partially covered with wooden board at the cockloft. 閣樓部份的屋頂用木板覆蓋。

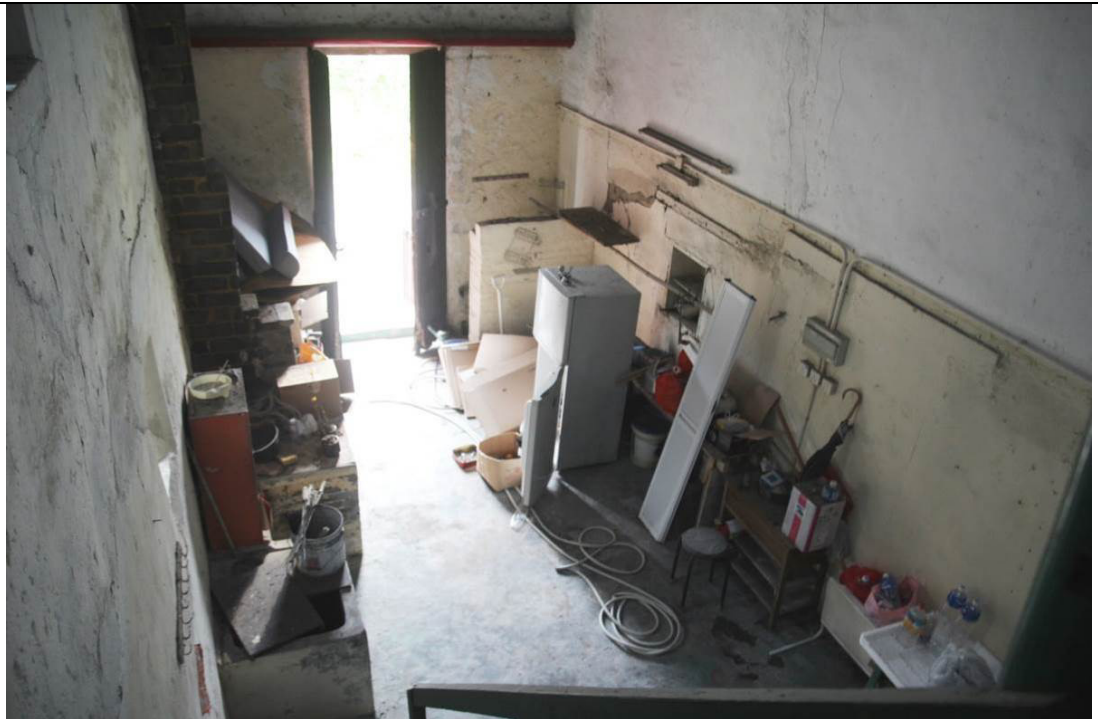
BS65-1-P19

Overlooking from the cockloft, viewing the blocked doorways on the separation wall between BS65-1 and BS65-2 由閣樓俯視，看BS65-1及BS65-2隔牆上的被封的門洞

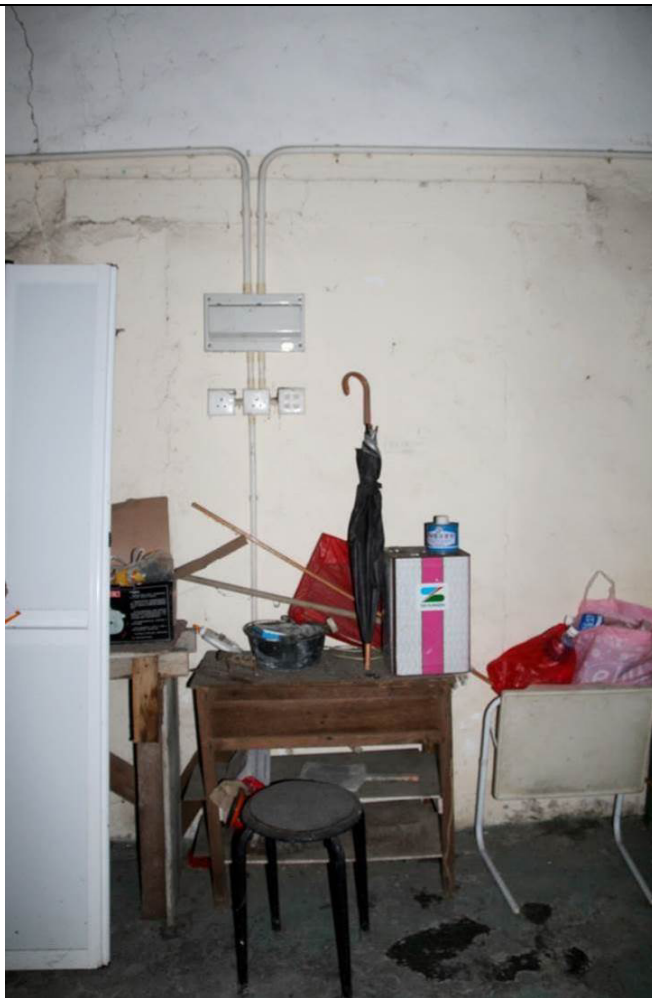
BS65-1-P23

Blocked doorways on the separation wall between BS65-1 and BS65-2 BS65-1及BS65-2隔牆上的被封的門洞
