Contract No. CV/2013/08
Liantang / Heung Yuen Wai Boundary Control Point
Site Formation and Infrastructure Works – Contract 6

Environmental Permit No. EP-404/2011/C
Condition 2.16 – Photographic and Cartographic Survey Report

Contract No. CV/2013/08
Liantang/Heung Yuen Wai
Boundary Control Point Site
Formation and Infrastructure
Works – Contract 6
*Cartographic and Photographic
Survey Report*

December 2015

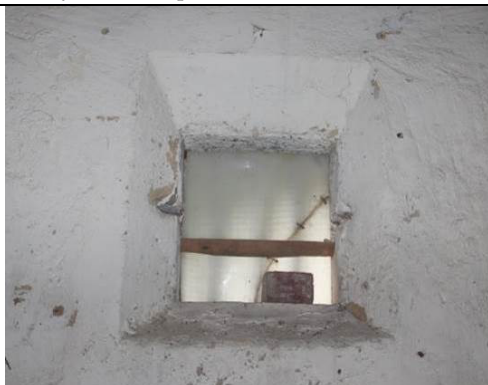
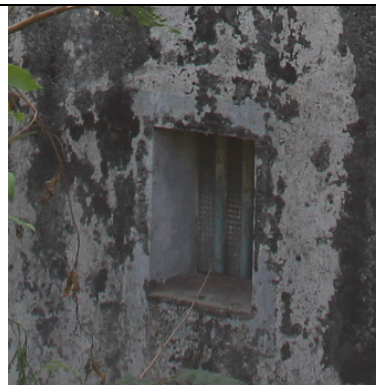
BS65-1-P24

Indoor view (left) and outdoor view (right) of window at the back wall (ground floor) 室內看後壁(一層)窗戶

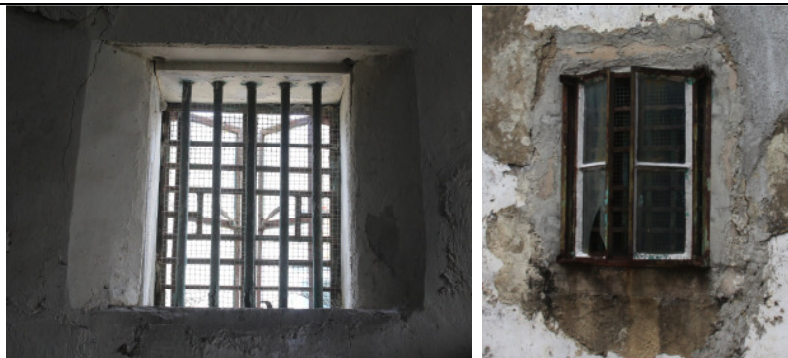
BS65-1-P28

Indoor view (upper) and outdoor view (lower) of western window at the gable wall 室內(上)及室外(下) 看山牆較西面的窗戶

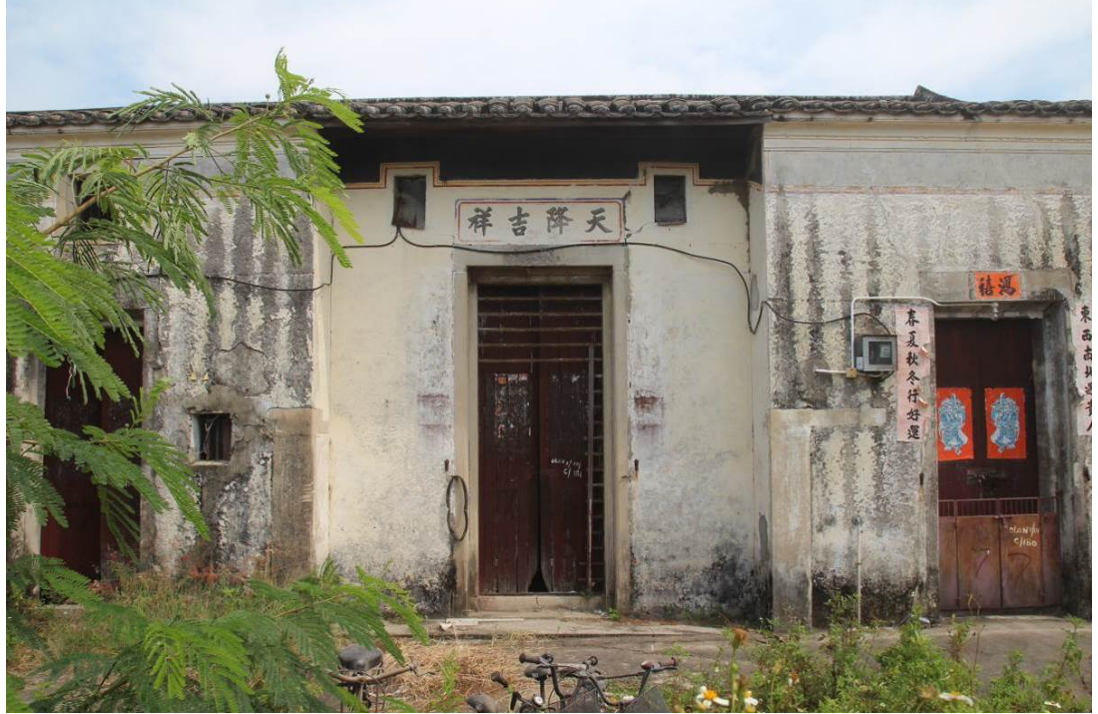
BS65-2-P2

Entrance is decorated with door frame with cement plastered. It is installed with iron sliding grille door and wooden door panels 入口以水泥抹灰的門框作裝飾，裝有鐵柵拉門及木門扇。

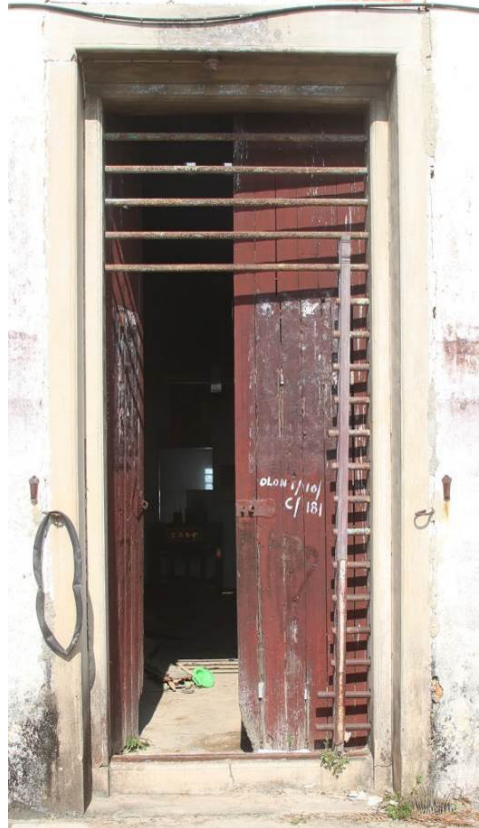
BS65-2-P3

Eaves, door frame and sliding grille door 屋檐、門框及鐵柵拉門

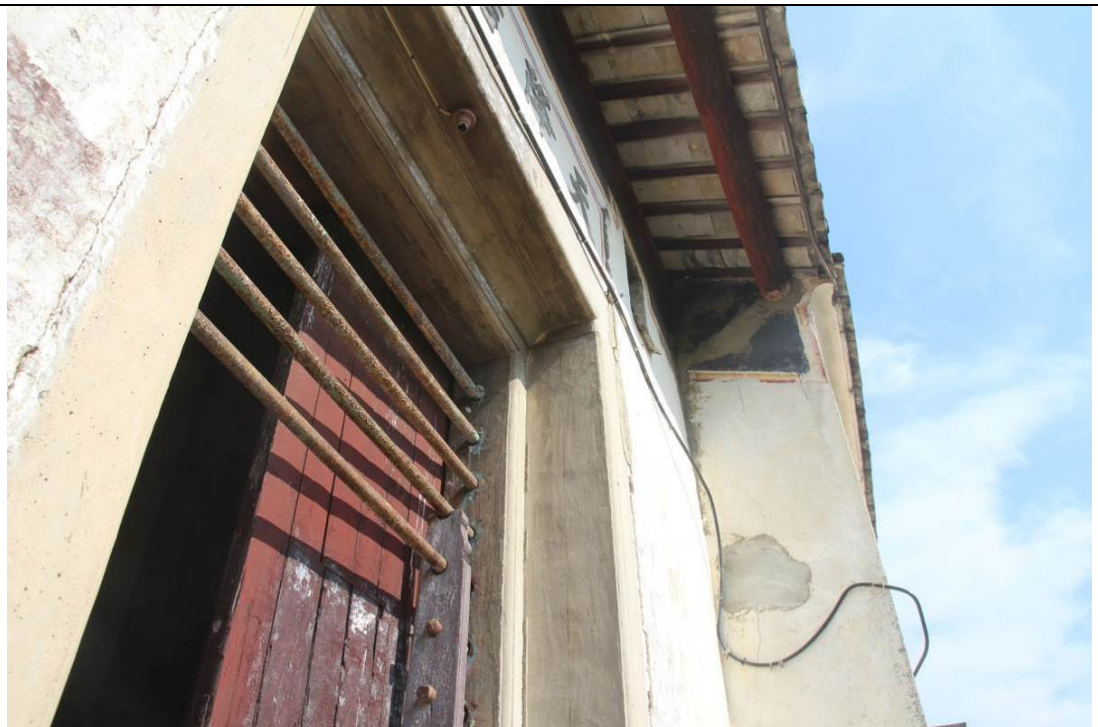
BS65-2-P4

Decorations of the door frame and the track of the sliding grille door 門框裝飾及鐵柵拉門的路軌

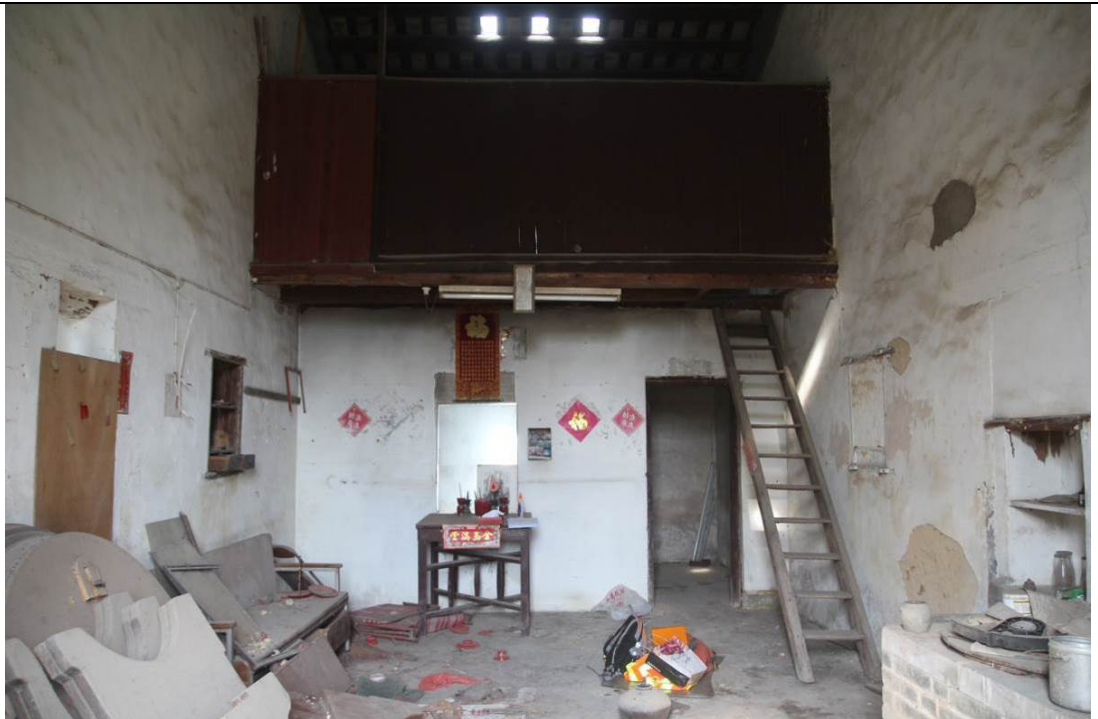
BS65-2-P9

General view of the indoor area, showing the main door in the middle, toilet area on the right and stove on the left. 室內概貌，中間為大門，廁所在右邊，灶在左邊。

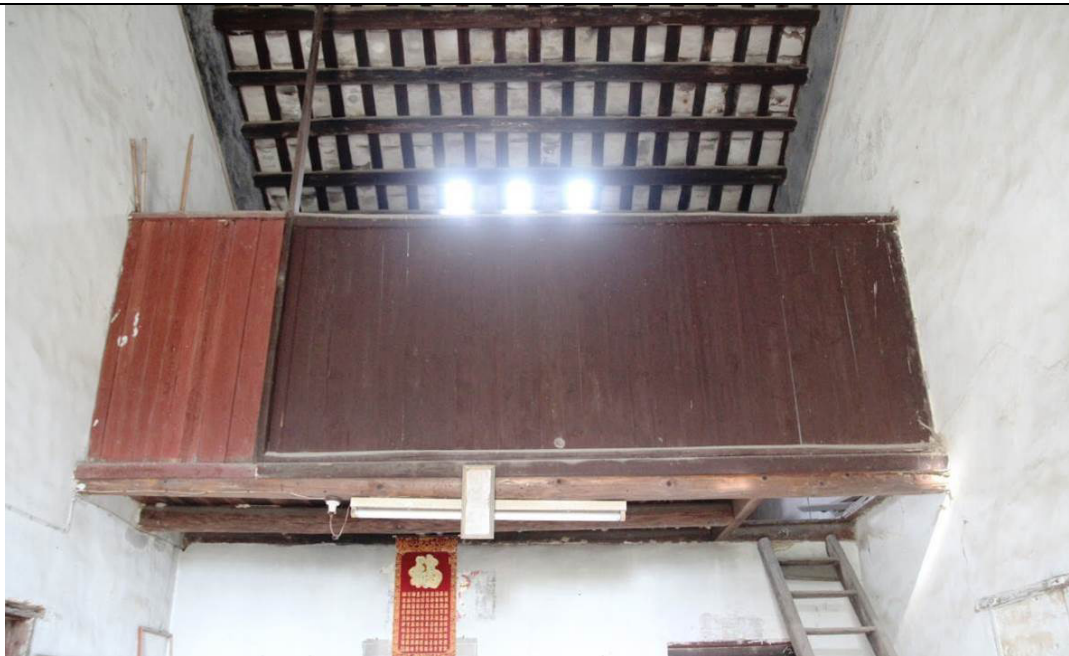
BS65-2-P13

Viewing decorations on the separation wall between BS65-2 and BS65-3 from the cockloft 自閣樓望向BS65-2及BS65-3之間隔牆的裝飾

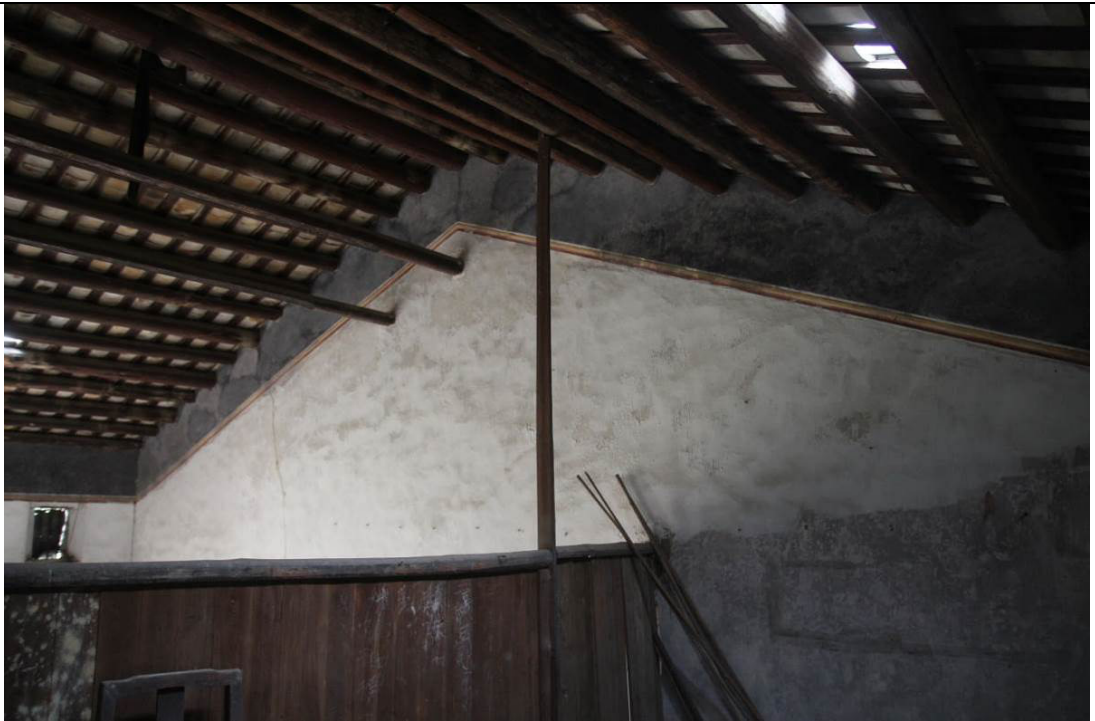
BS65-2-P14

General view of the wooden cockloft 木閣樓概貌

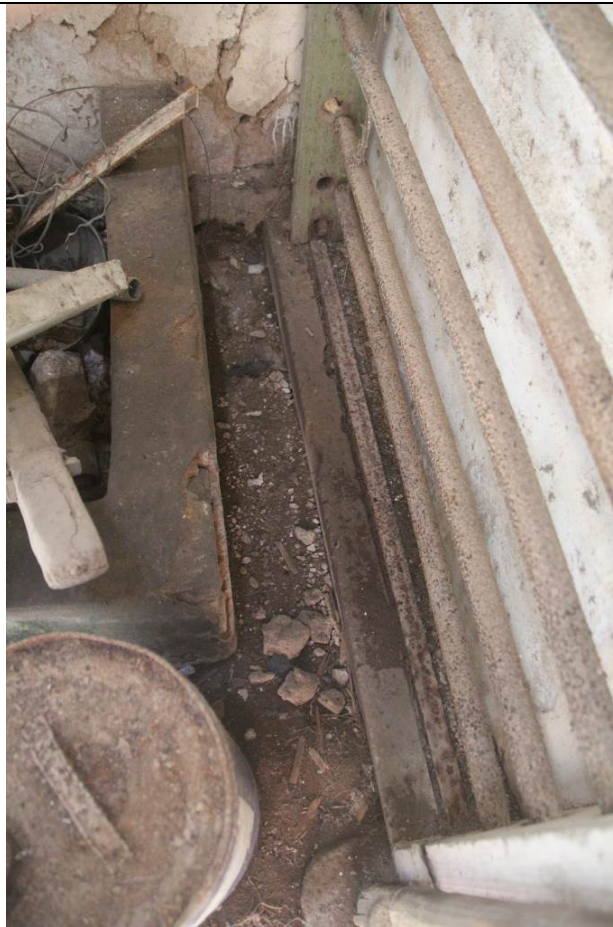
BS65-2-P26

General view of the stove 灶概貌

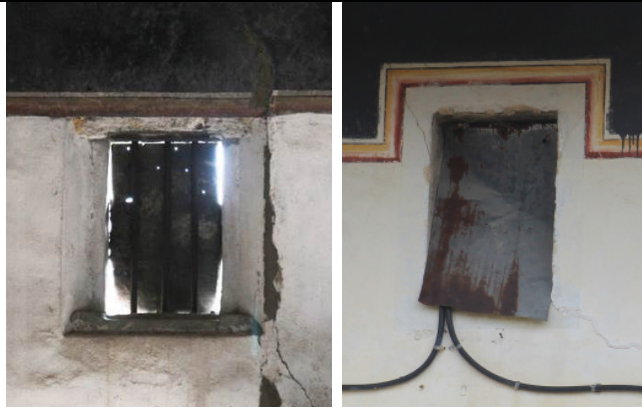
BS65-2-P31

Indoor view (upper) and outdoor view (lower) of the window on the back wall (ground floor) 室內(左)及室外(右)看後壁(一層)的窗戶

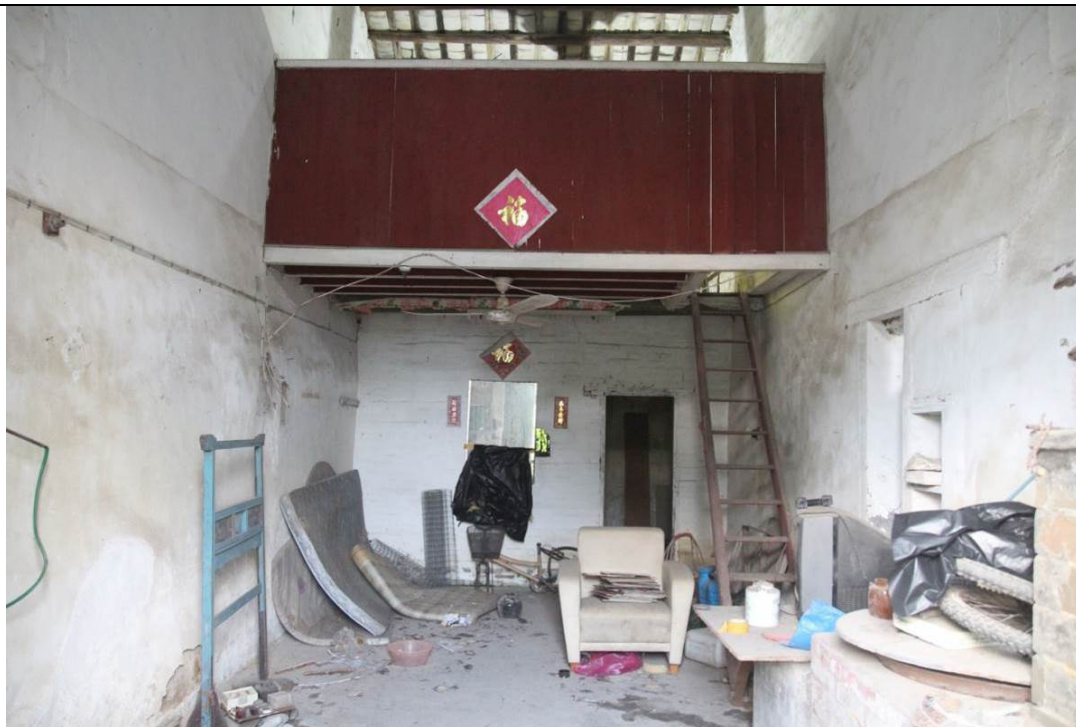
BS65-3-P6

General view of the indoor area. A door way linking to BS65-1 is observed on the right wall. 室內概貌，右壁的門洞與BS65-2相連。

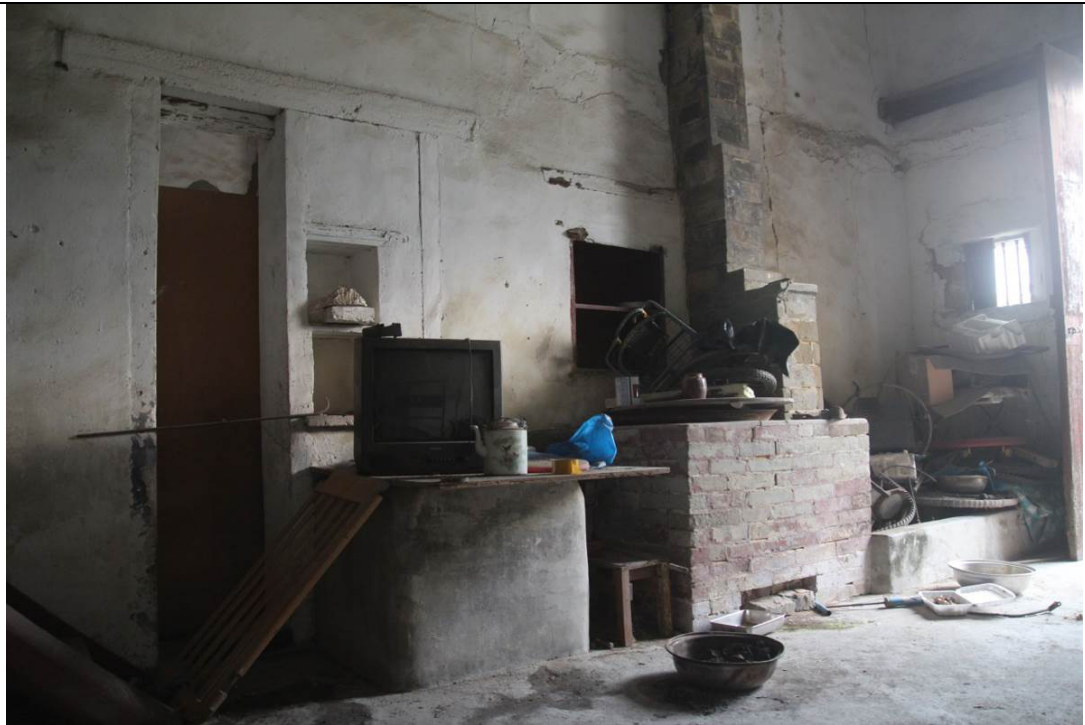
| Site Code | Photo No. | Content | Categories |
|---|---|---|---|
| | BS65-3-P8 | A door way linking to BS65-2 is observed behind the water tank and stove. The cupboard is embedded within the door way. Therefore the tank, stove and cupboard are constructed after the door way is blocked. 水缸及灶後見連接至BS65-2的門洞，碗櫃亦於門洞位置，可知水缸及灶建於門洞被封後。 | Interior (b) |

A door way linking to BS65-2 is observed behind the water tank and stove. The cupboard is imbedded within the door way. Therefore the tank, stove and cupboard are constructed after the door way is blocked. 水缸及灶後見連接至BS65-2的門洞，碗櫃亦於門洞位置，可知水缸及灶建於門洞被封後。

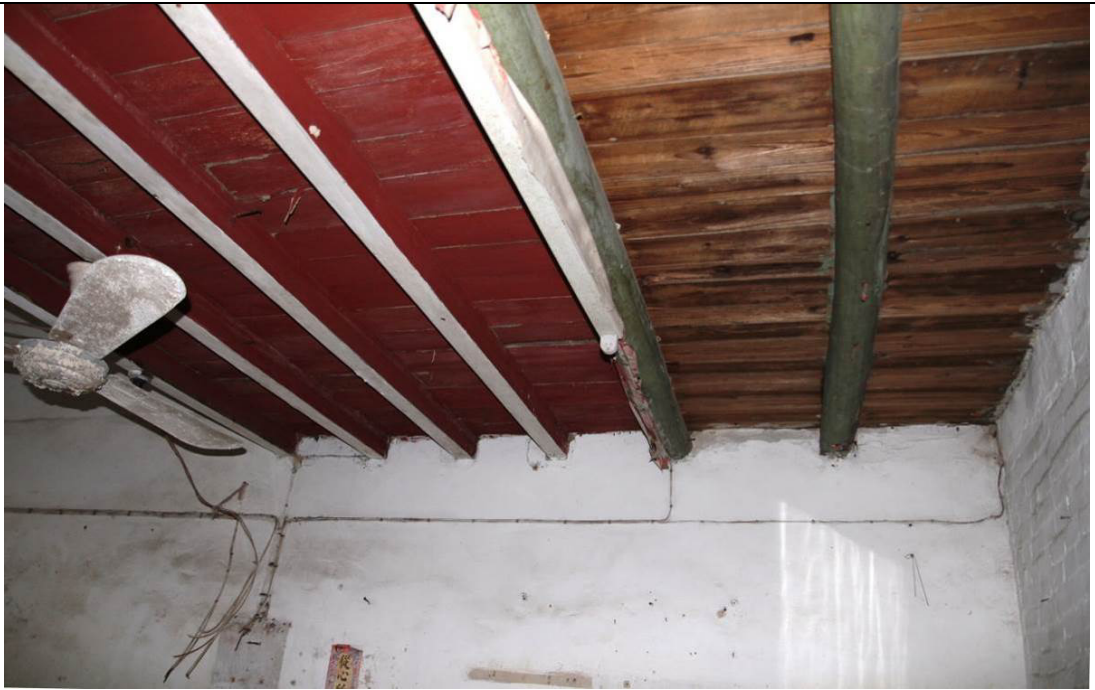
BS65-3-P14

Extended part of the cockloft use rectangular beams. 閣樓延伸部份用長方形的樑。

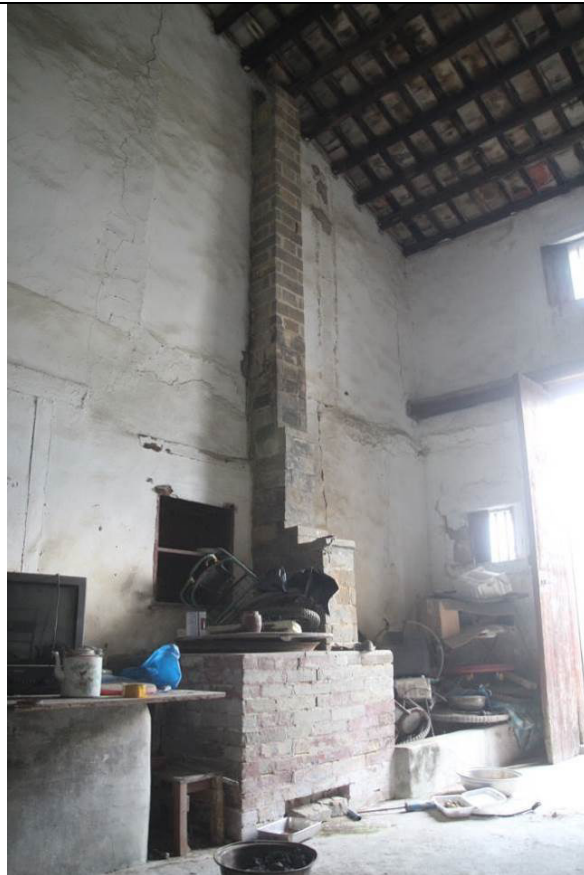
| Site Code | Photo No. | Content | Categories |
|---|---|---|---|
| | BS65-3-P29 | General view of the stove. Trace of the chimney could be observed on the wall which suggests the stove had been displaced in the past. 灶概貌，煙囪的痕跡見於牆上，這代表灶的位置在過去曾被移動。 | Interior (b) |

General view of the stove. Trace of the chimney could be observed on the wall which suggests the stove had been displaced in the past. 灶概貌，煙囪的痕跡見於牆上，這代表灶的位置在過去曾被移動。

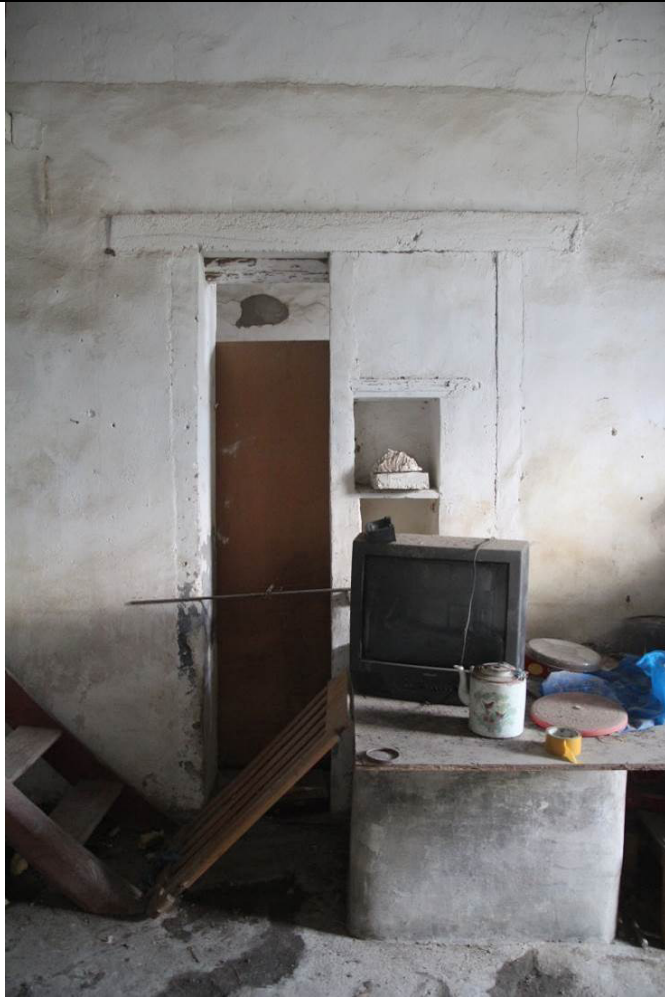
BS65-3-P31

Blocked doorway on the separation wall between BS65-2 and BS65-3 BS65-2及BS65-3隔牆上被封的門洞

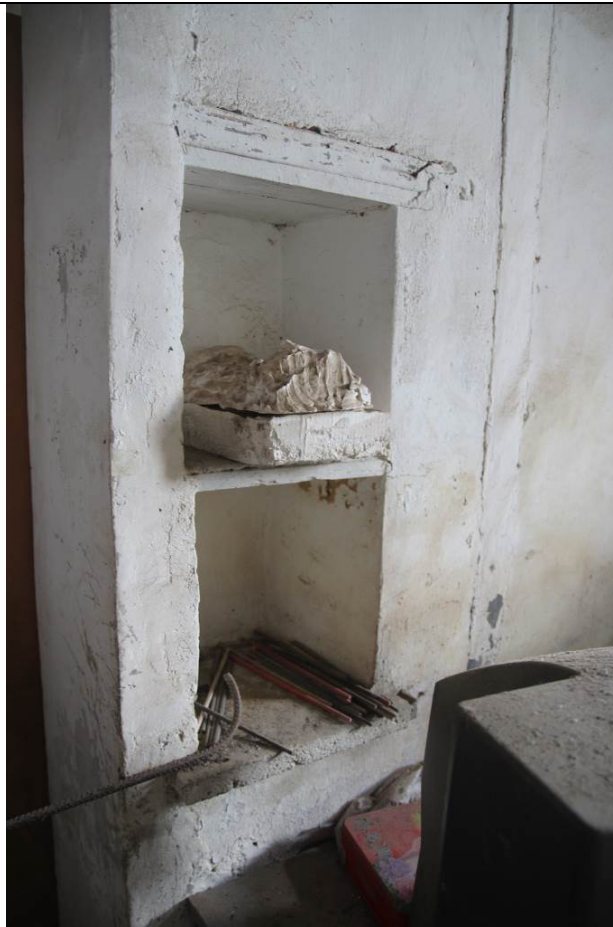
BS65-3-P37

Cupboard imbedded in the blocked doorway 嵌於已封門洞中的壁櫃

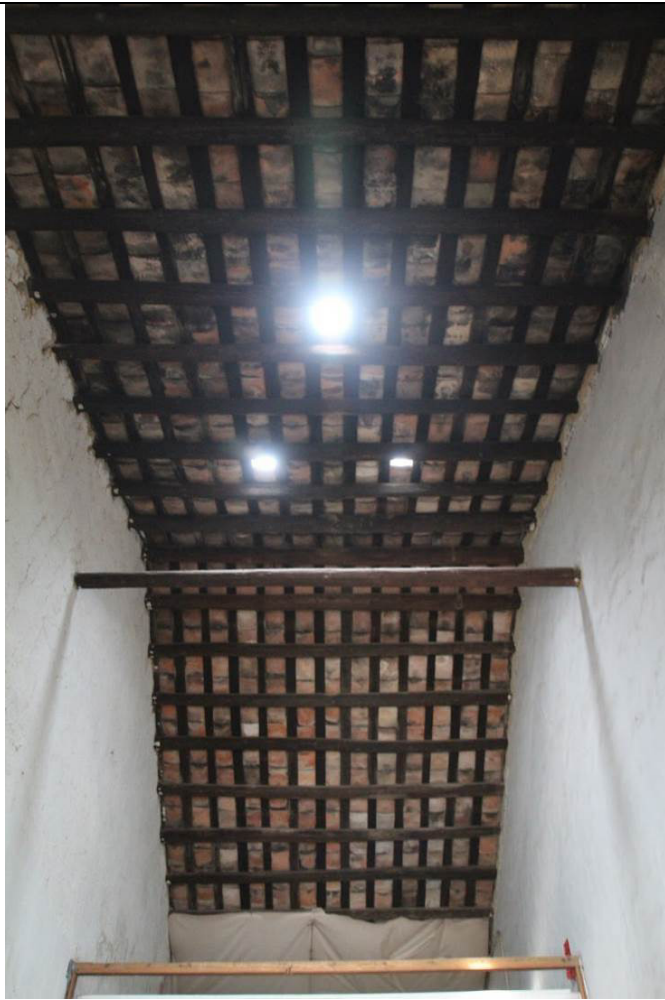
BS65-4-P7

Timber purlins and rafters of the roof, the part above cockloft is covered with cloths 桁樑及椽子，閣樓上方的部份用布覆蓋。

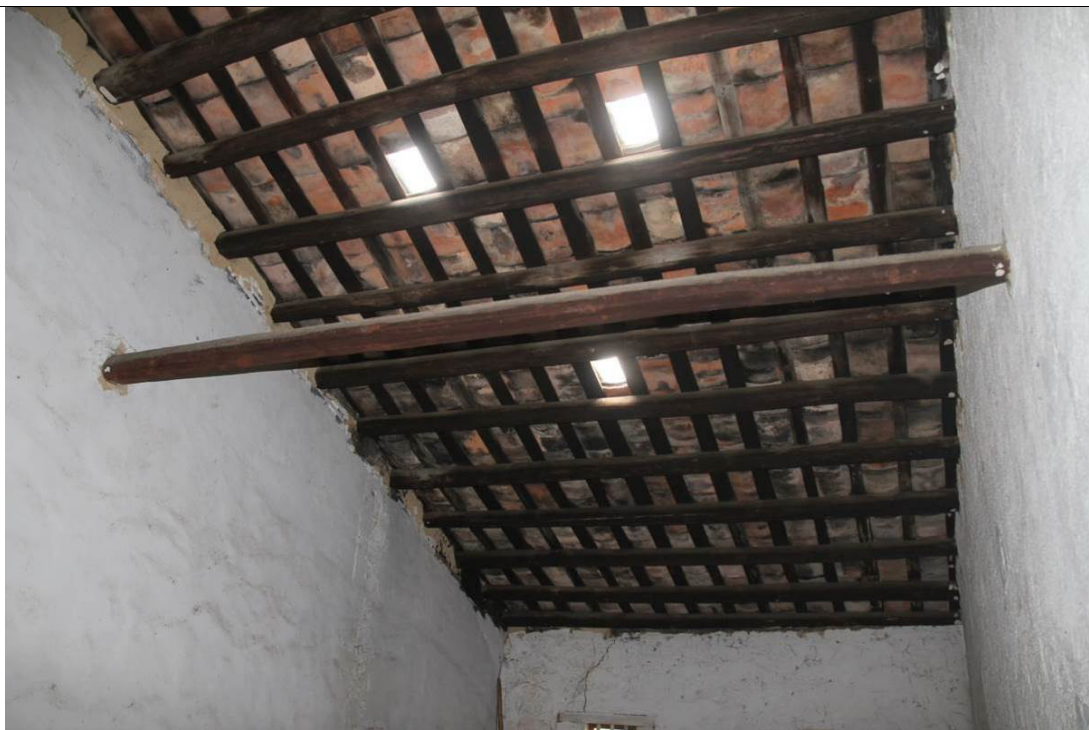
BS65-4-P16

Tie-beam without decoration 無裝飾的繫樑

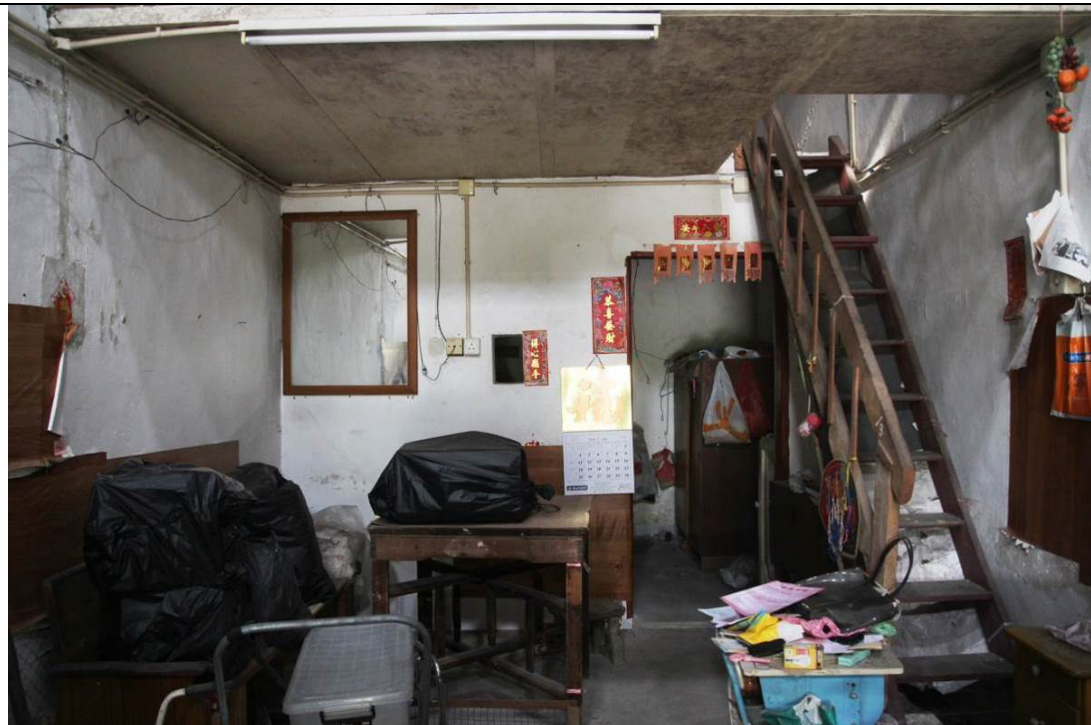
| Site Code | Photo No. | Content | Categories |
|---|---|---|---|
| | BS65-4-P20 | Brick wall of the room under the cockloft, no purlin for supporting the cockloft is observed 閣樓下房間的磚牆，未見支撐閣樓的桁樑。 | Interior (b) |

Brick wall of the room under the cockloft, no purlin for supporting the cockloft is observed 閣樓下房間的磚牆，未見支撐閣樓的桁樑。
