TUEN MUN - CHEK LAP KOK LINK  
CONTRACT NO. HY/2013/12 –  
NORTHERN CONNECTION TOLL PLAZA AND  
ASSOCIATED WORKS

12<sup>TH</sup> MONTHLY ENVIRONMENTAL MONITORING AND  
AUDIT (EM&A) REPORT – OCTOBER 2015

PREPARED FOR  
CRBC AND KADEN JOINT VENTURE

Date	Reference No.	Prepared By	Certified By
12 November 2015	TCS00715/14/600/R00144v2

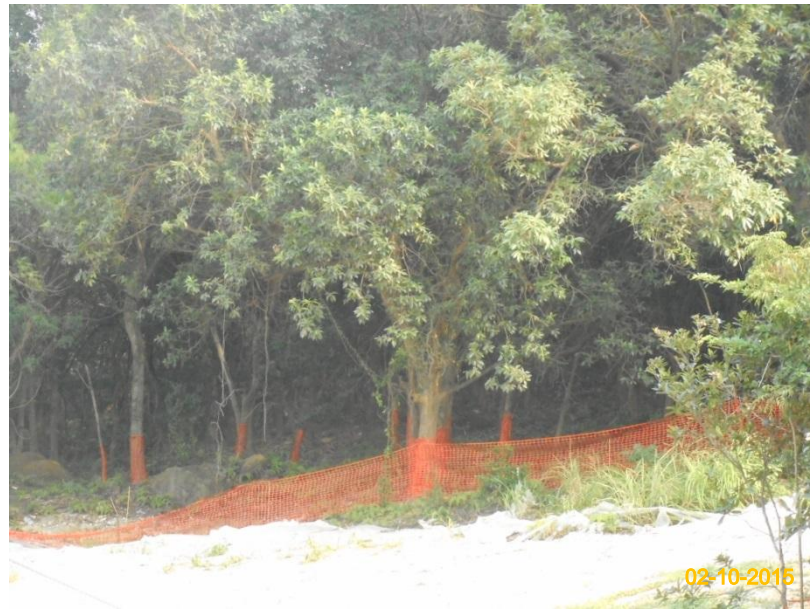
Item 1. Existing trees on boundary of the Project Area have been protected carefully during construction.

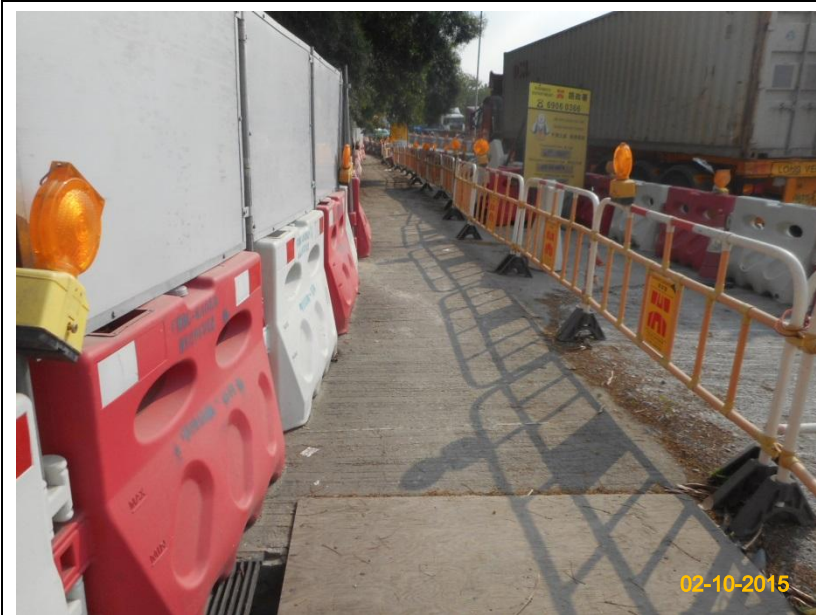
Item 5. Hoarding with panel around works area & Item 6. Temporary traffic management lighting.

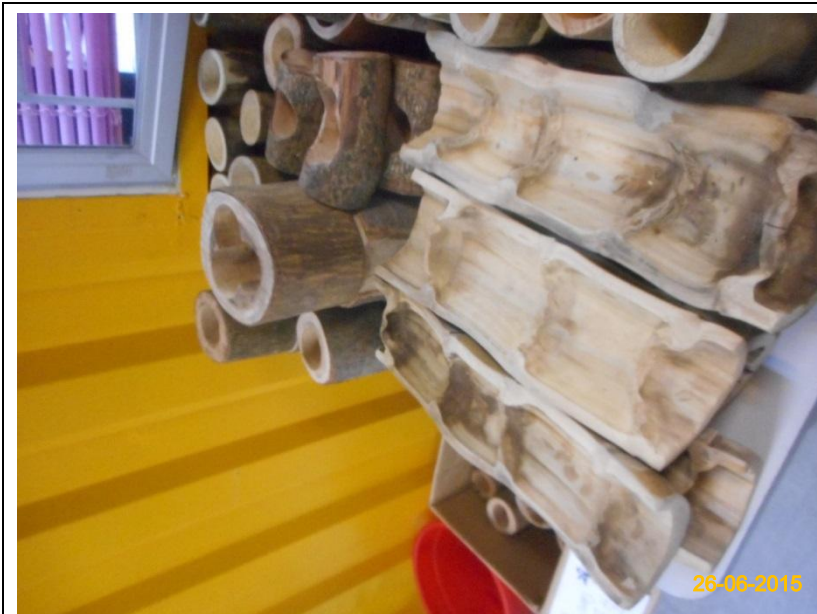
Item 9. Recycle of felled trees as flowerpot.

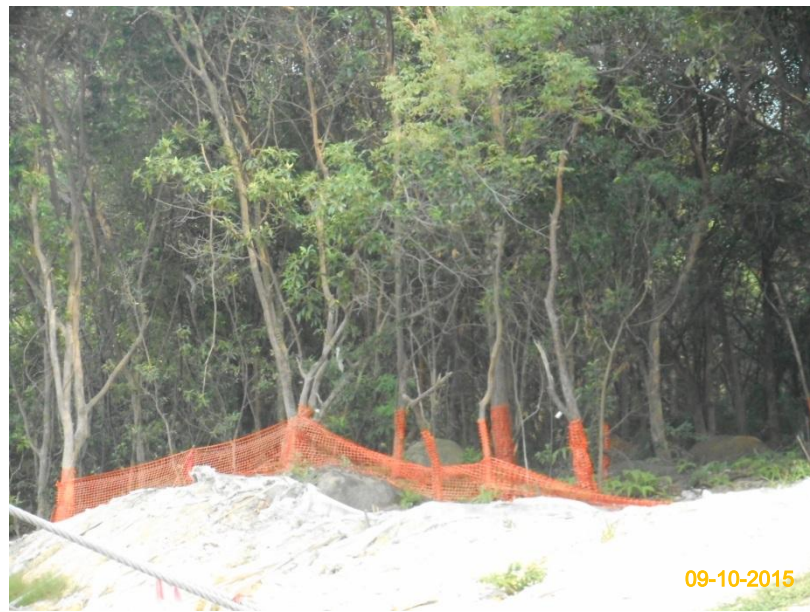
Item 1. Existing trees on boundary of the Project Area have been protected carefully during construction.

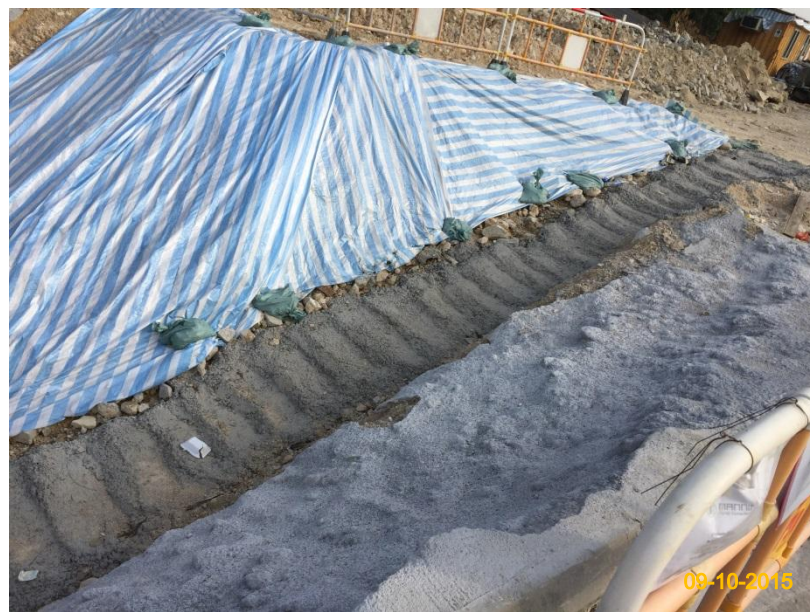
Item 4. Hydro-seeding or sheeting provided at stockpile.

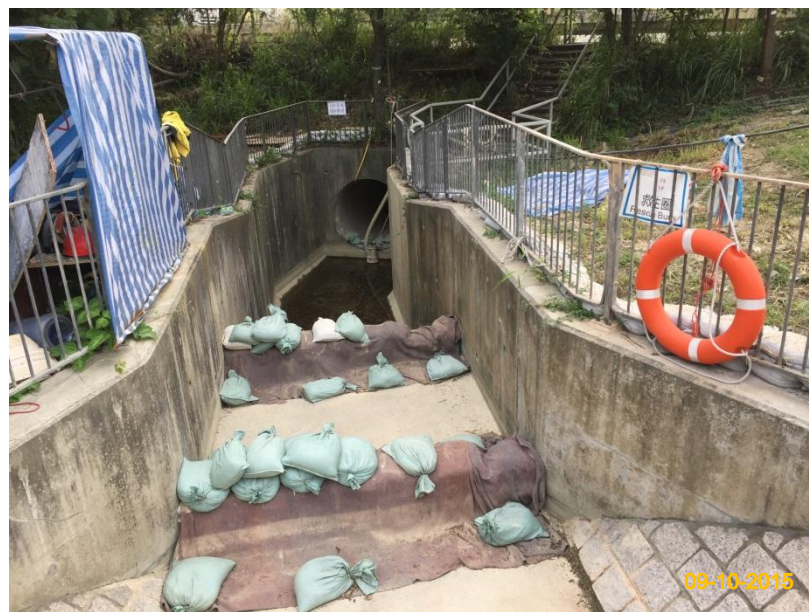
Item 7. Ensure no run-off into water body.

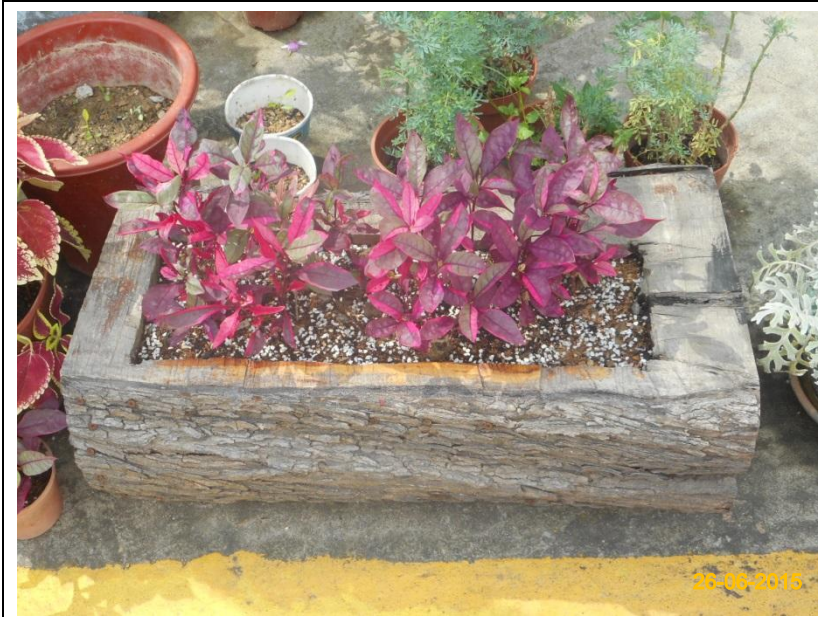
Item 9. Recycle of felled trees as flowerpot with plant and display in school.

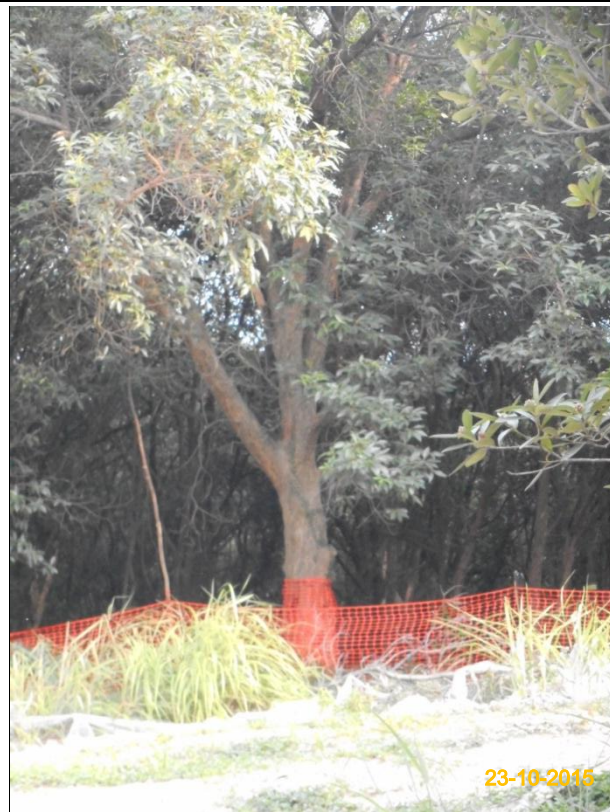
Item 1. Existing trees on boundary of the Project Area have been protected carefully during construction.

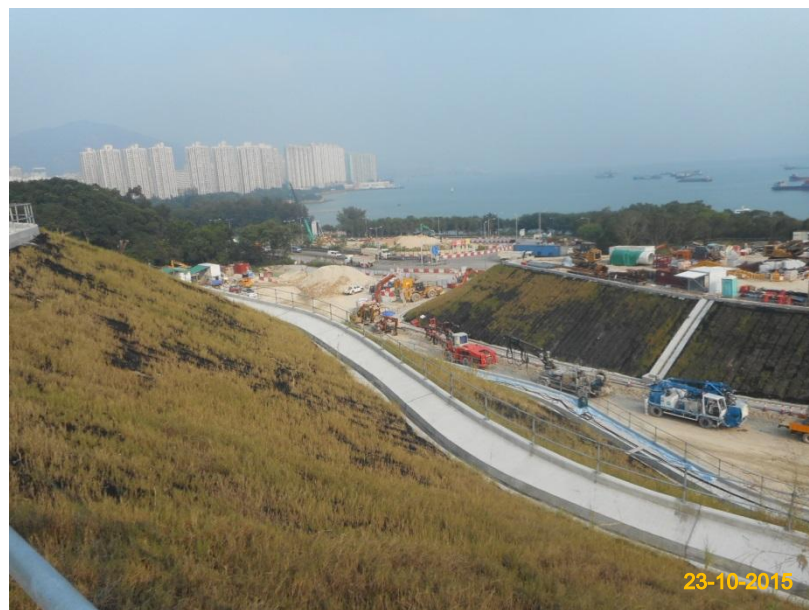
Item 4. Hydro-seeding or sheeting provided at stockpile.

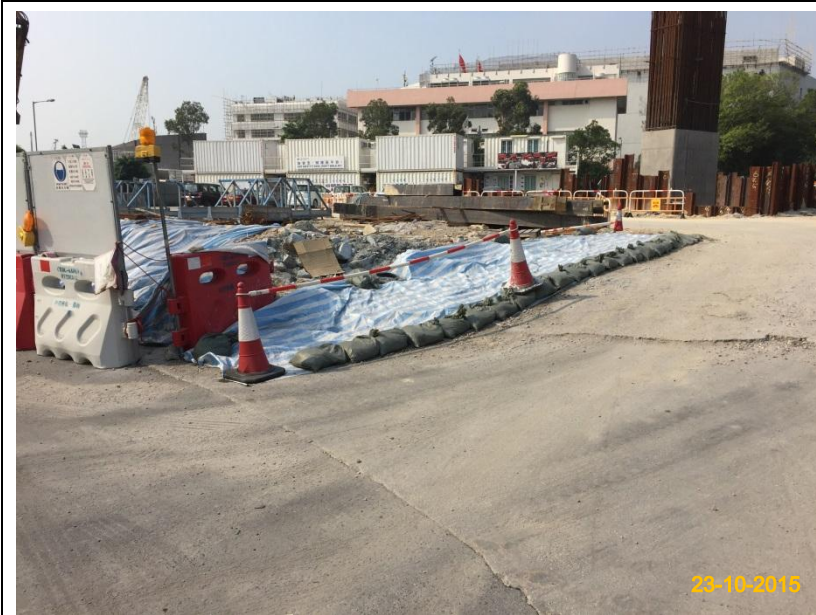
Item 7. Ensure no run-off into water body.

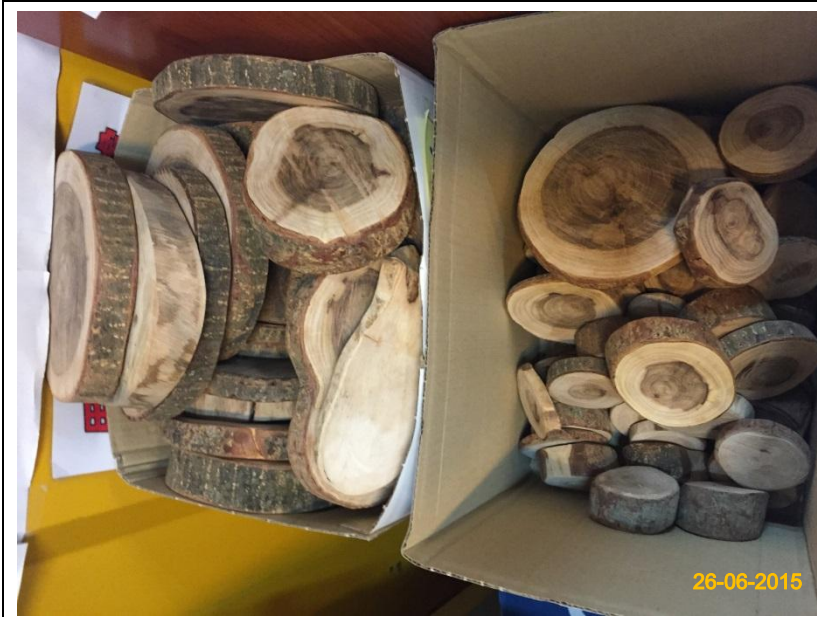
Item 9. Recycle of felled trees as decoration.

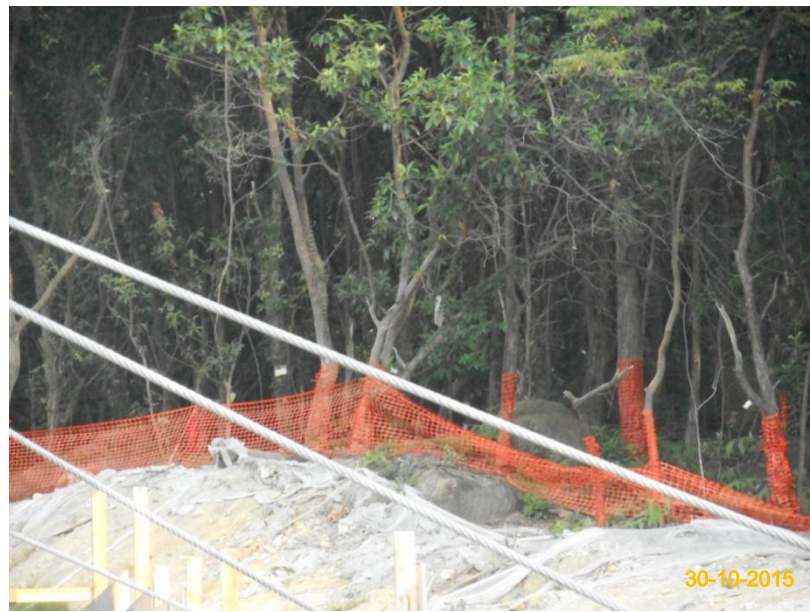
Item 1. Existing trees on boundary of the Project Area have been protected carefully during construction.

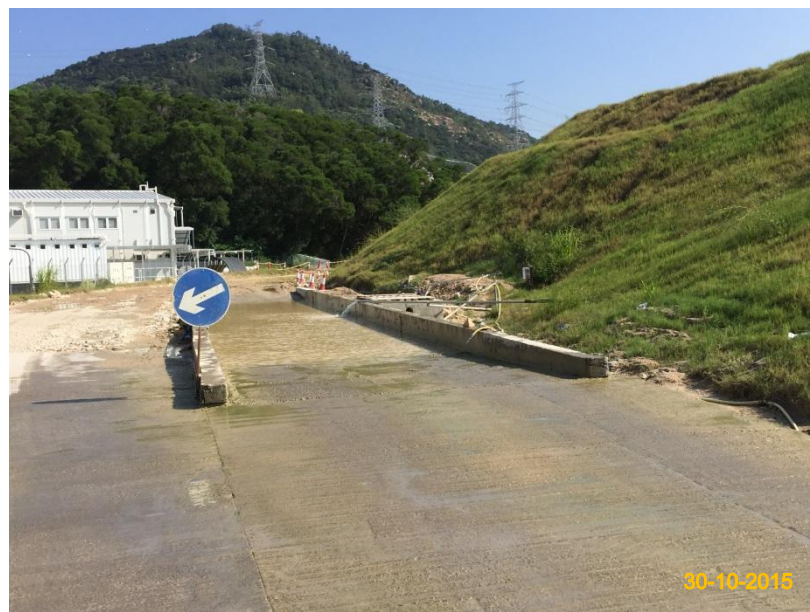
Item 4. Hydro-seeding or sheeting provided at stockpile.

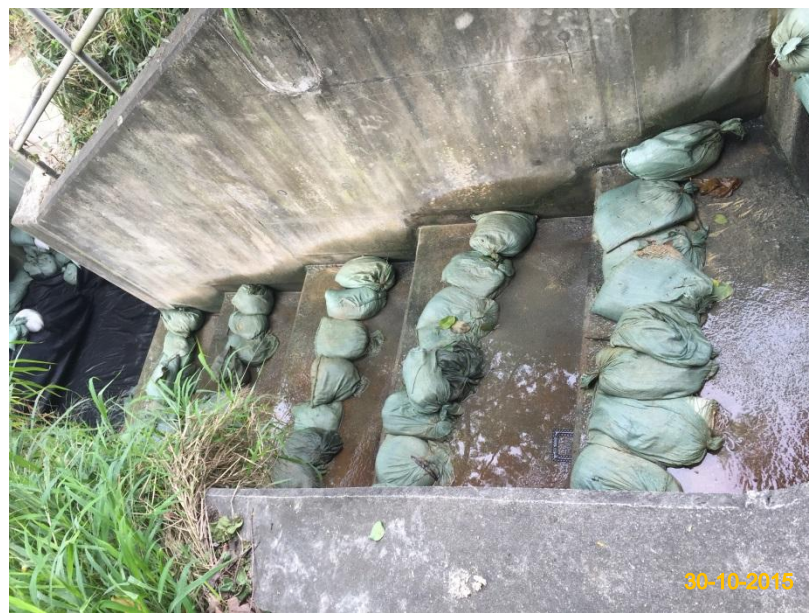
Item 7. Ensure no run-off into water body.

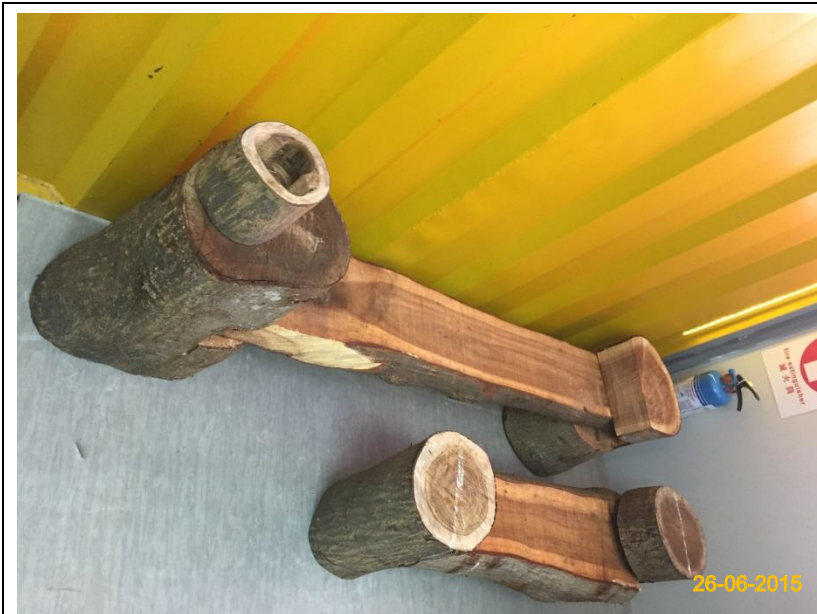
Item 9. Recycle of felled trees as facilities to reuse.

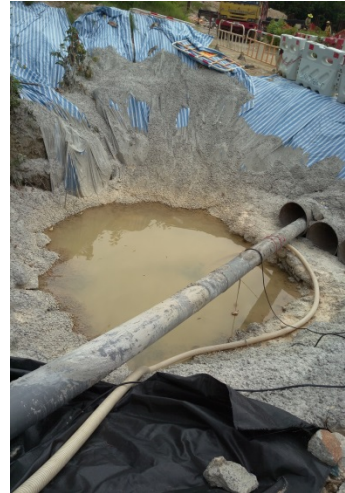
Stream A: In normal condition, and outfall pit should be cleaned.

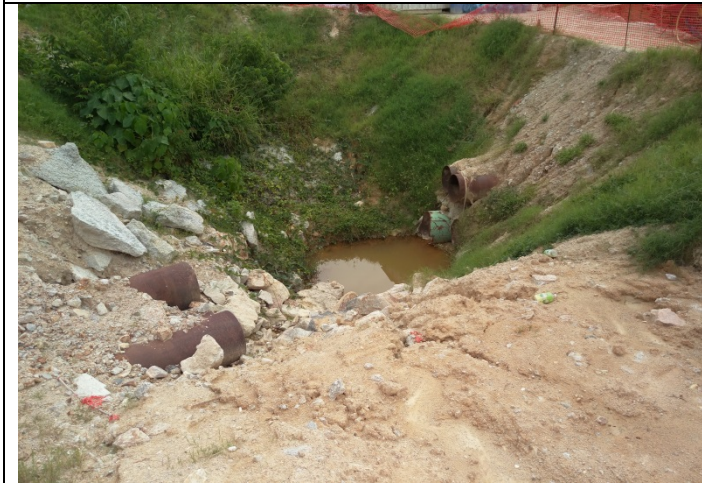
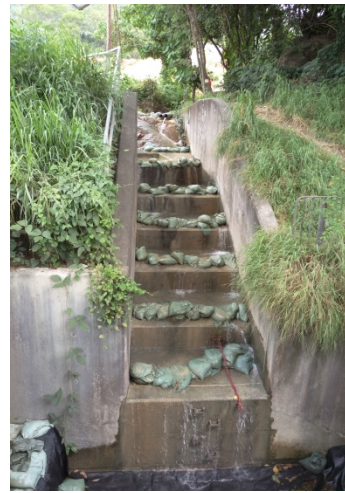
Stream B: Pit 2 in normal condition

Stream B: Cascade step channel condition

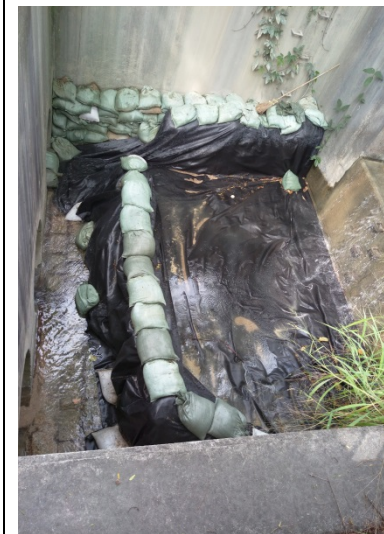
Stream B: Cascade condition

MH5: Cascade condition

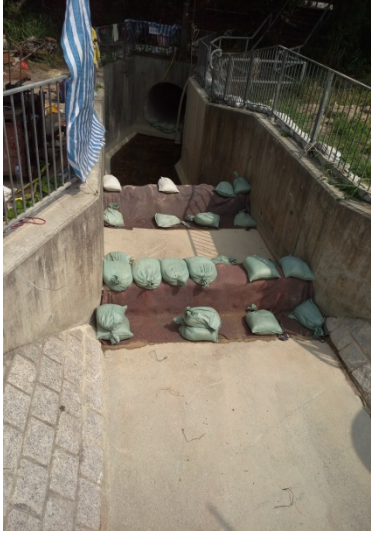
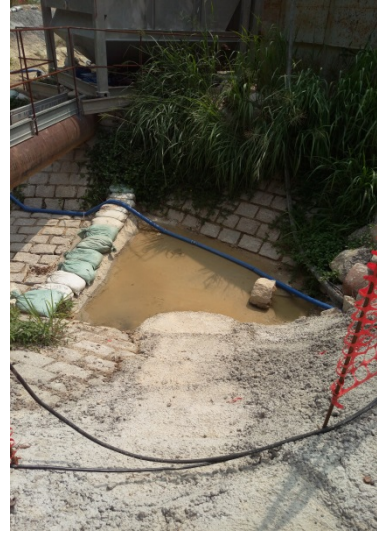
East Portal: Cascade condition

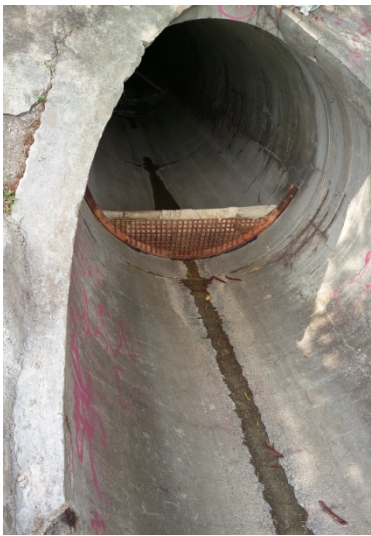
Outfall 1: No muddy water leaking out

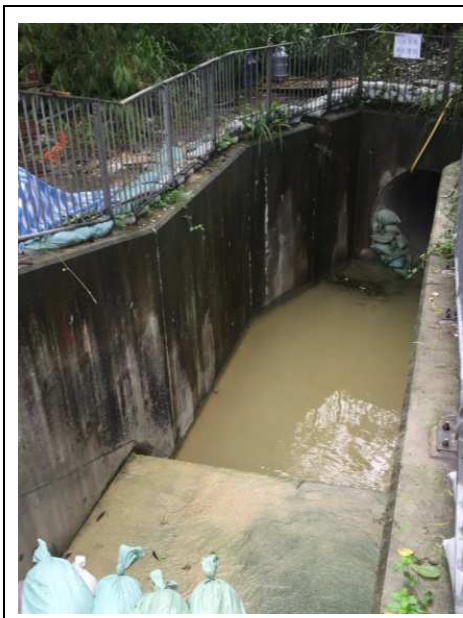
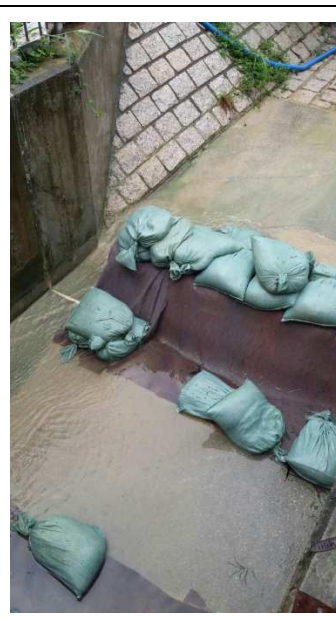
East Portal: Cascade condition

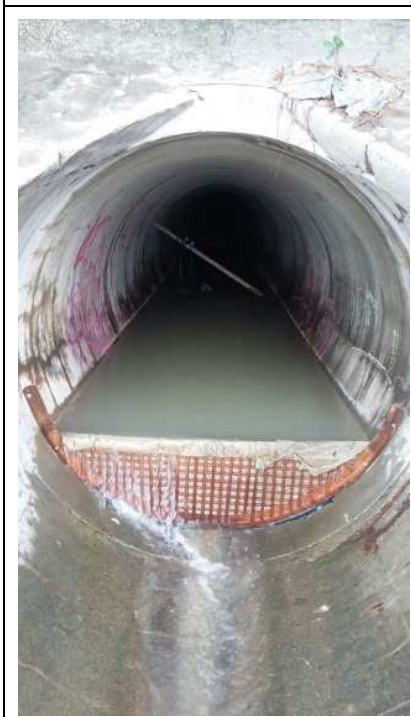
Outfall 1: No muddy water leaking out

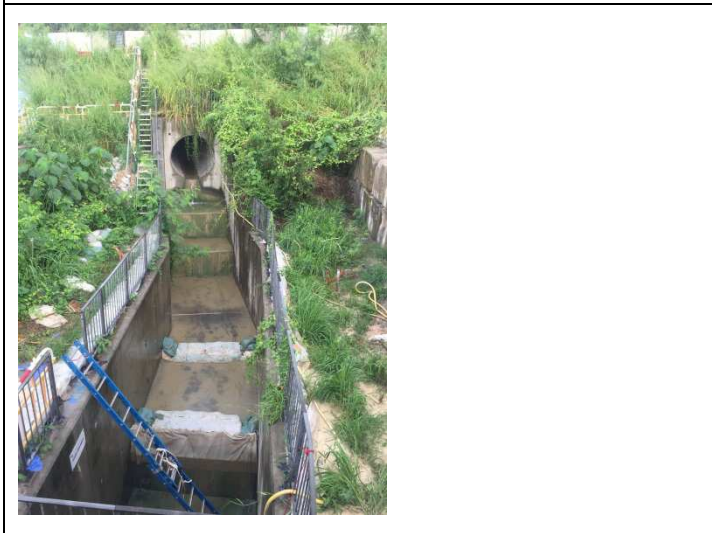
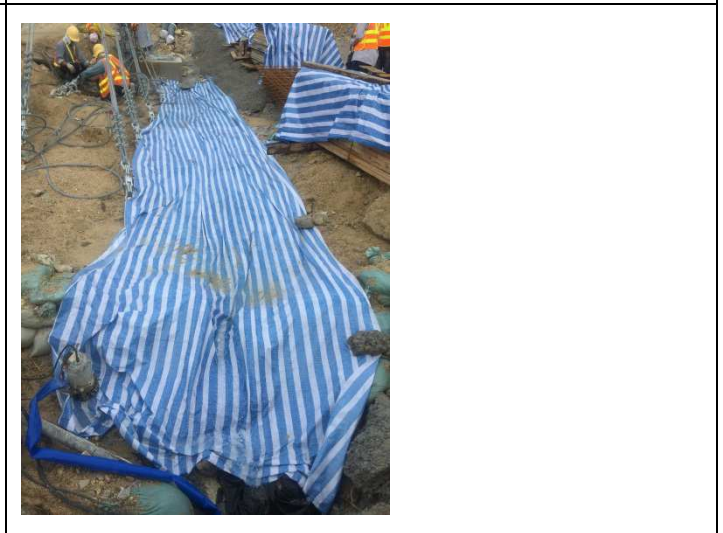
<p>MH5: Cascade condition</p>	<p>East Portal: Tarpaulin sheet was provided.</p>

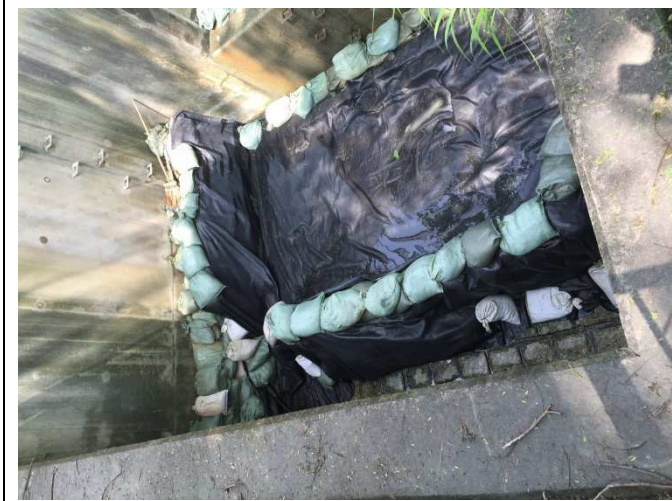
Stream B: Cascade is in normal condition.

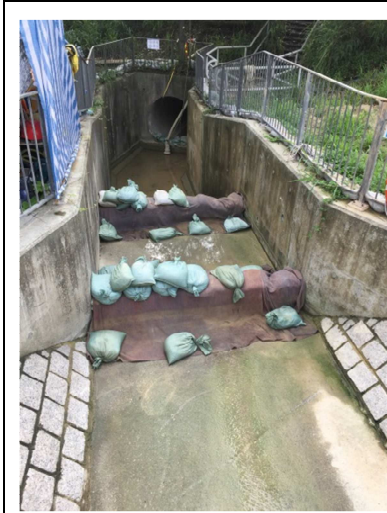
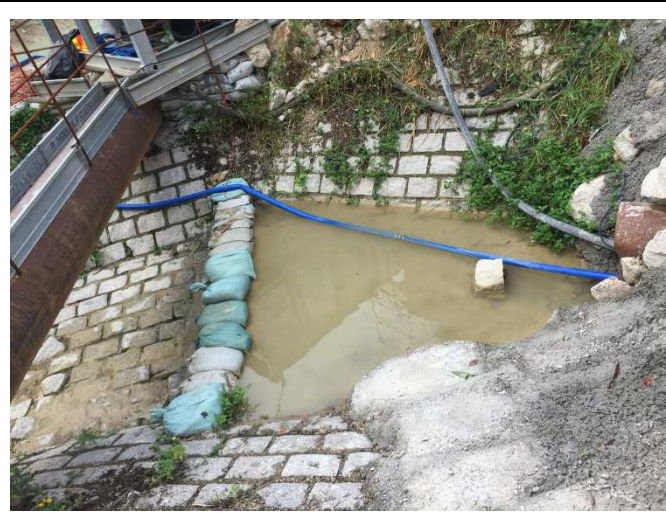
East Portal: Cascade condition

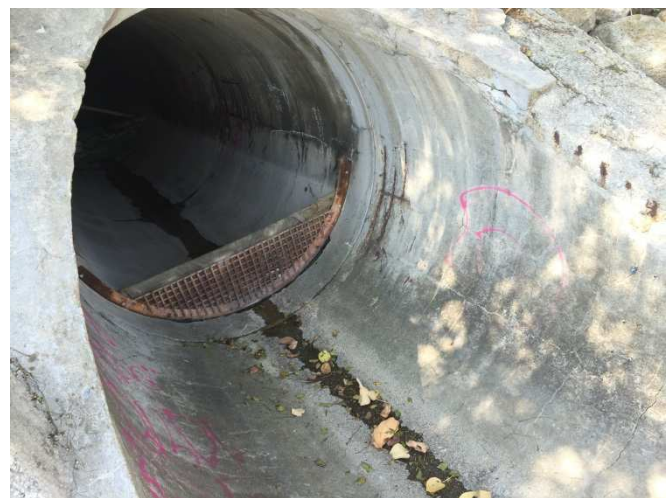
Outfall 1: No water is discharging.

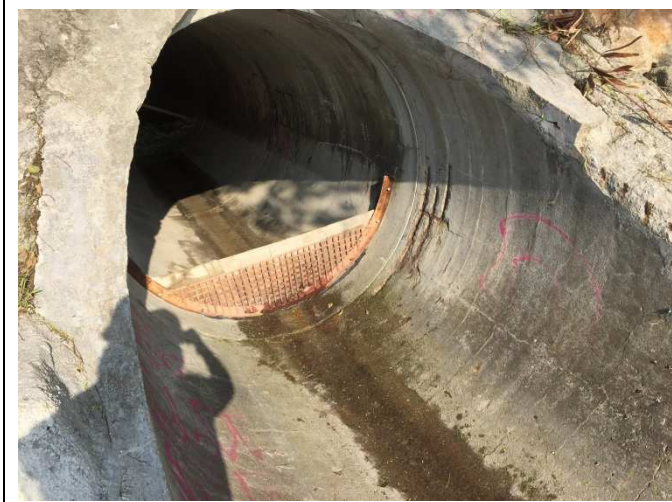
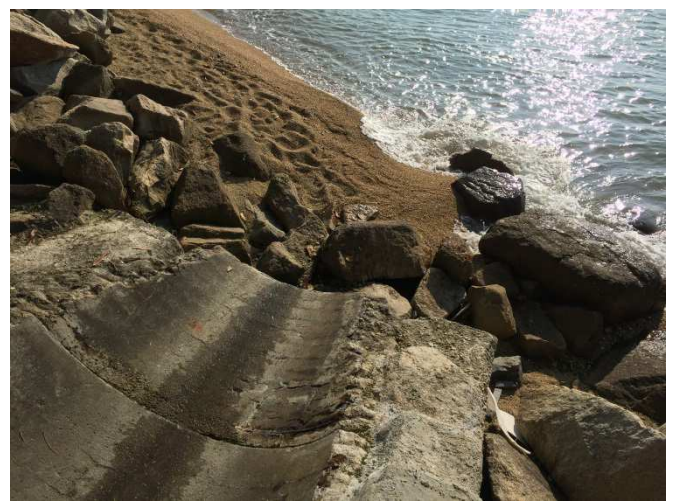
Outfall 1: No water is discharging.

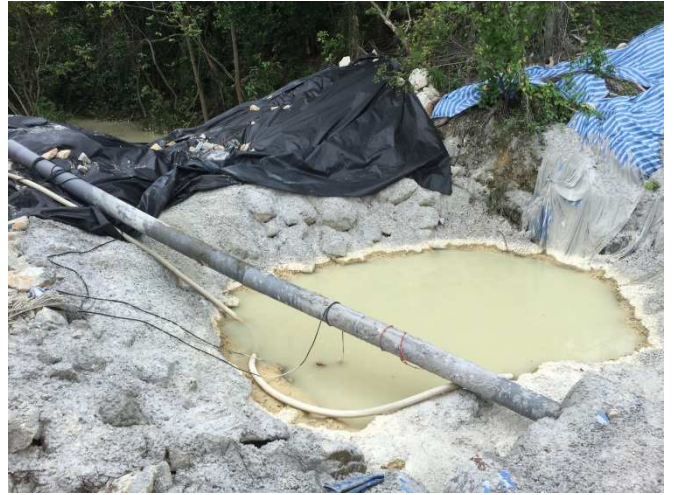
Stream B: Pit 1 was in normal condition.

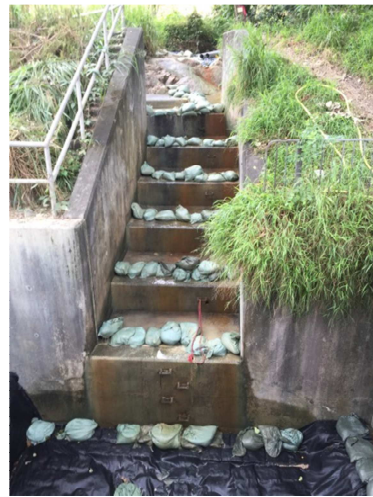
Stream B: Cascade step channel condition

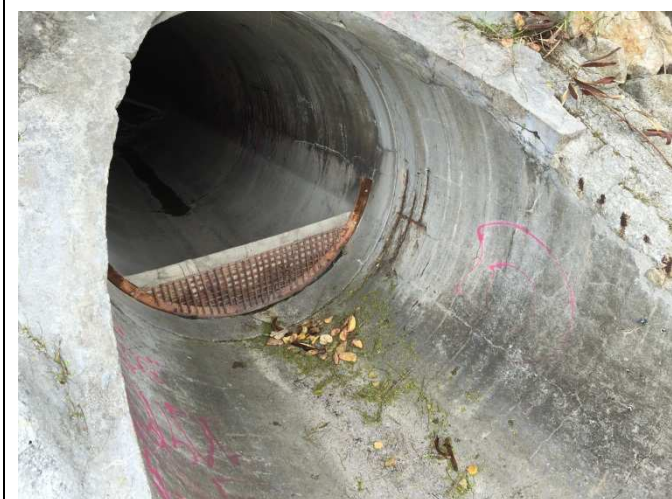
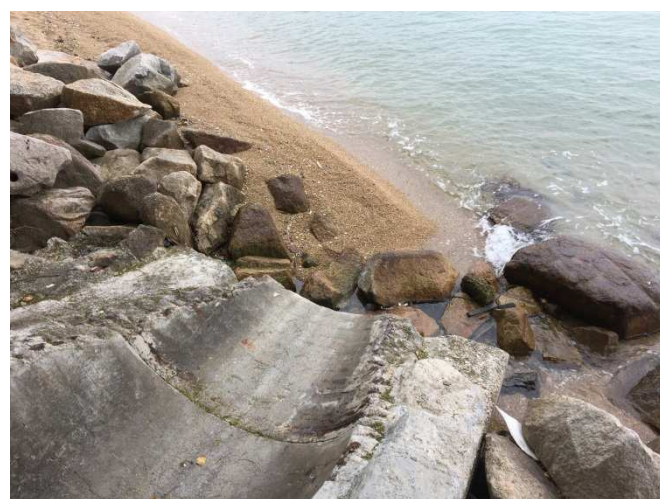
Outfall 1: No water is discharging.

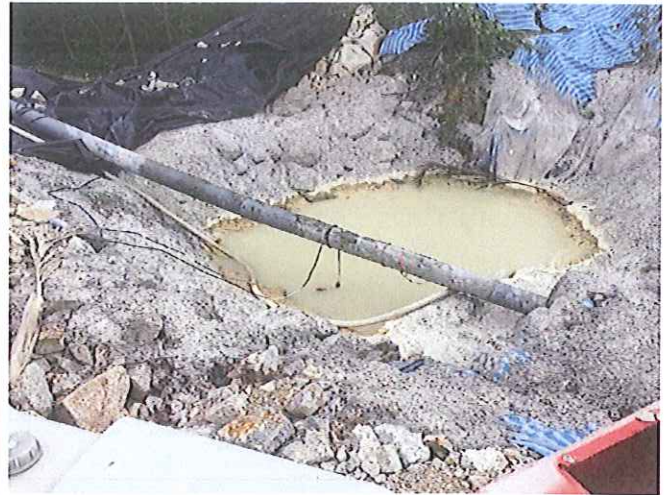
Stream B: Pit 1 was in normal condition.

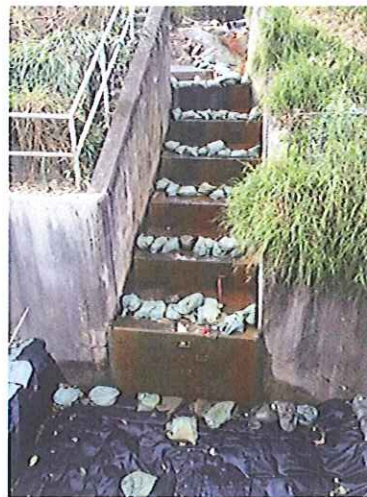
Stream B: Cascade step channel condition

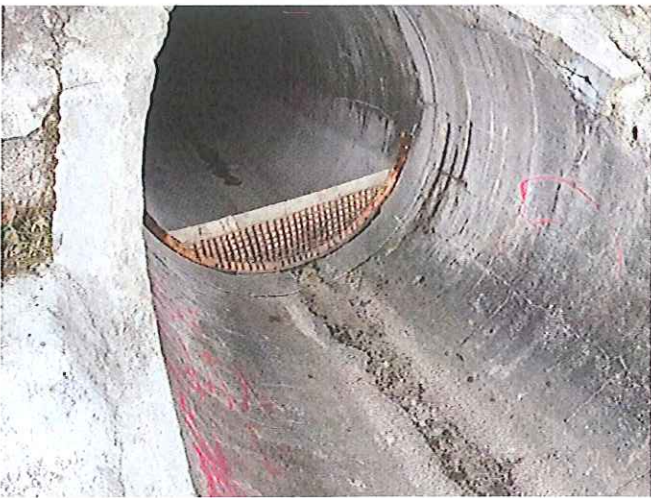
Outfall 1: No water is discharging.

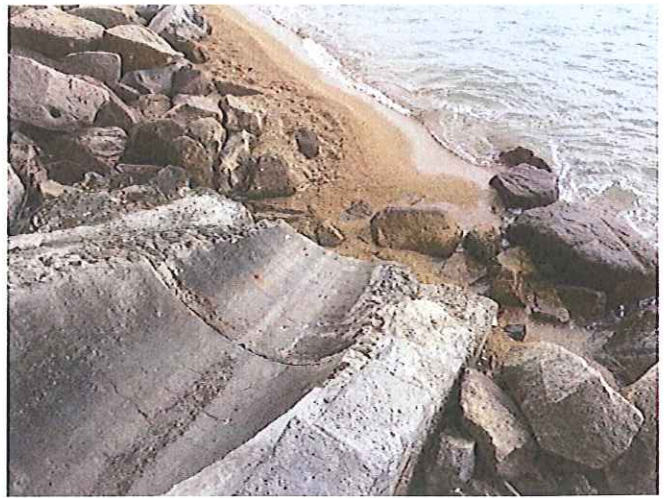
Outfall 1: No water is discharging.

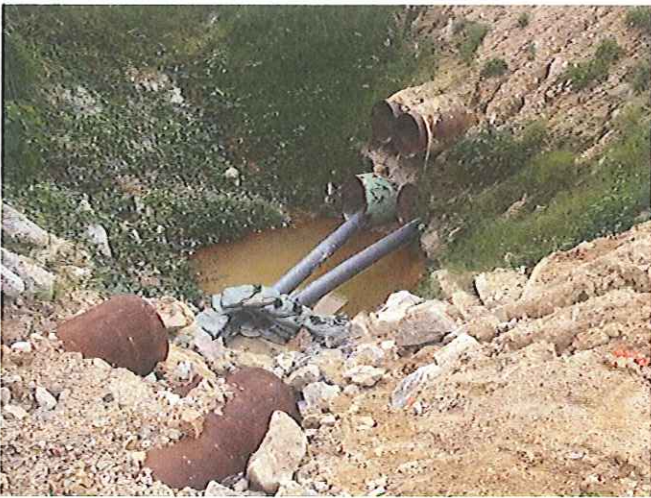
Stream B Pit 2: Treated water was directly discharged to downstream bypass.

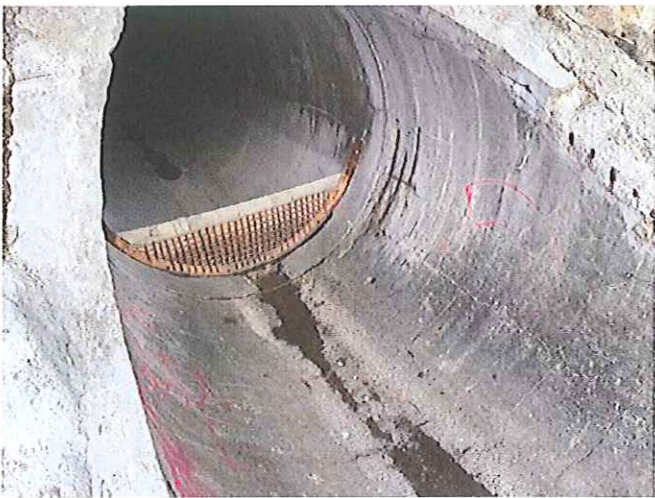
Outfall 1: No water is discharging.

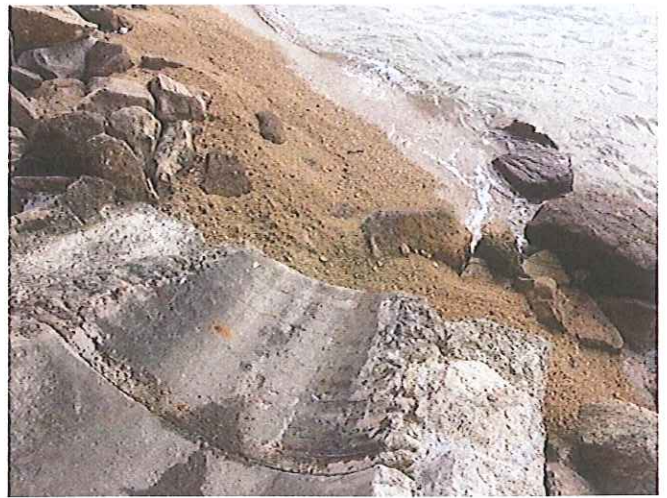
Outfall 1: No water is discharging.

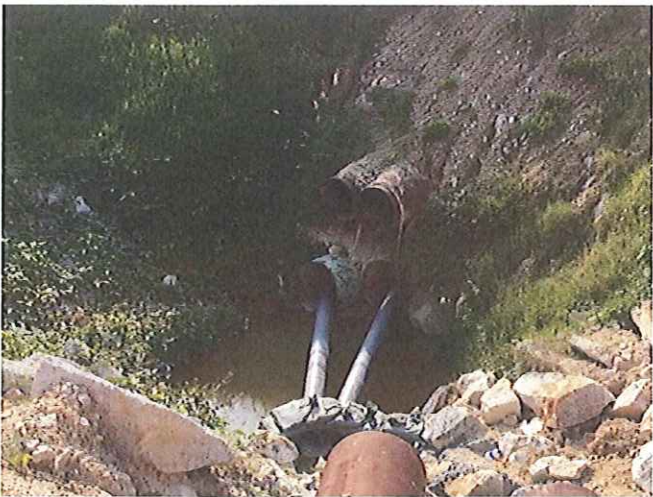
Stream B Pit 2: Treated water was directly discharged to downstream bypass.

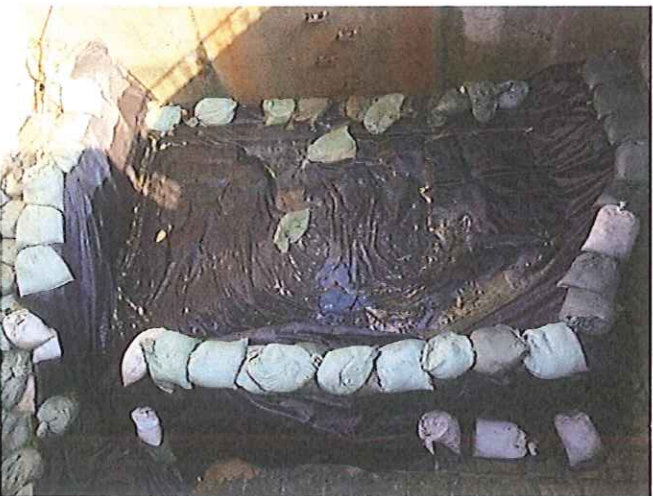
Stream B Outfall: Cascade was in normal condition.

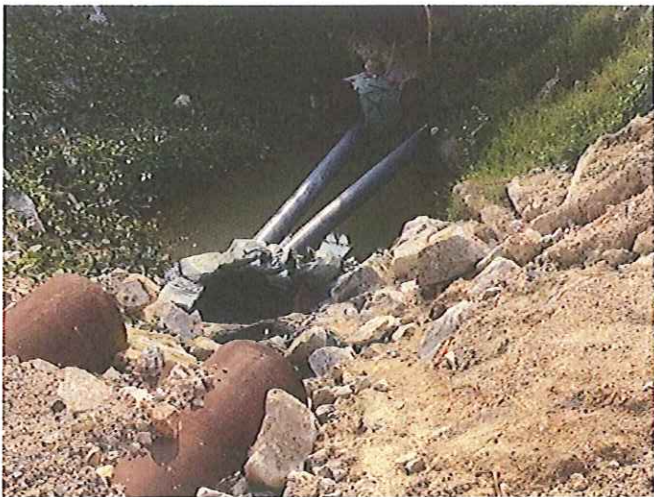
Stream B Pit 2: Treated water was directly discharged to downstream bypass.

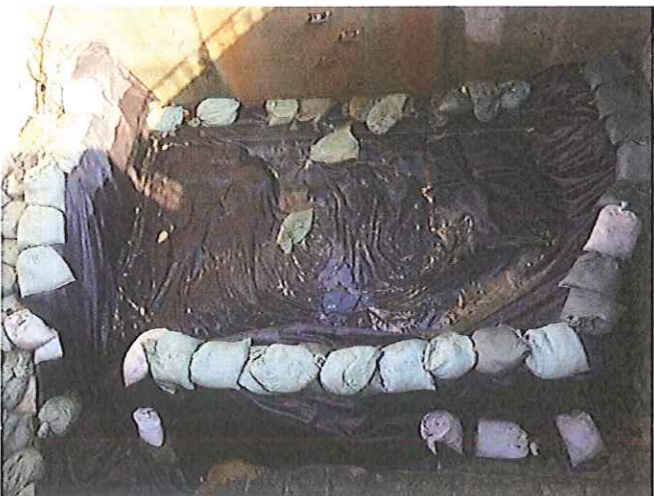
Stream B Outfall: Cascade was in normal condition.

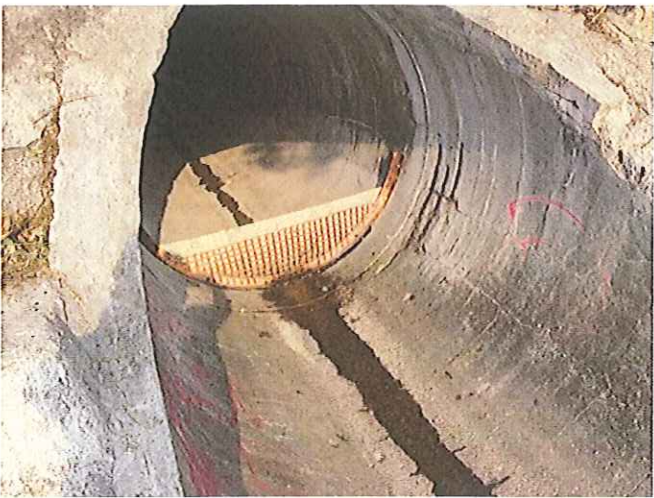
Outfall 1: No water is discharging.

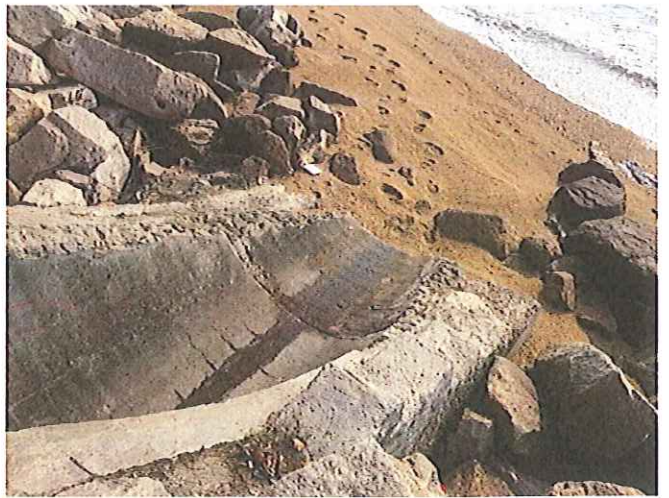
Outfall 1: No water is discharging.

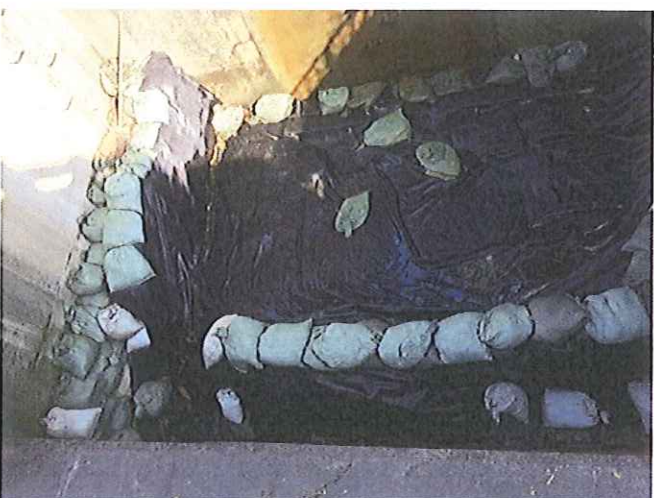
Stream B Outfall: Cascade was in normal condition.

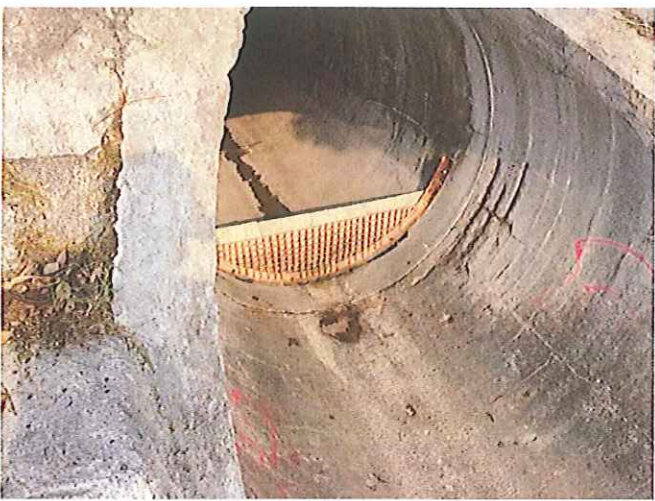
Outfall 1: No water is discharging.

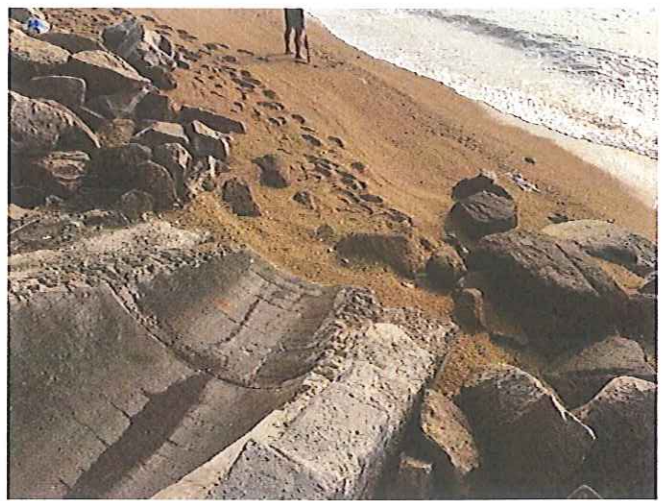
Outfall 1: No water is discharging.

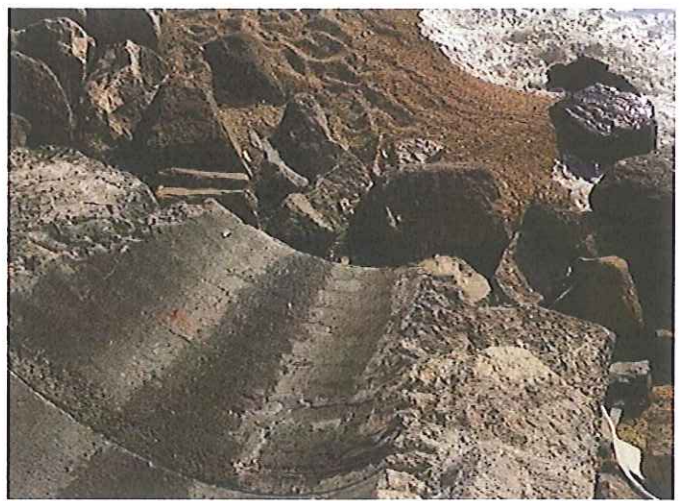
Outfall 1: No water is discharging.

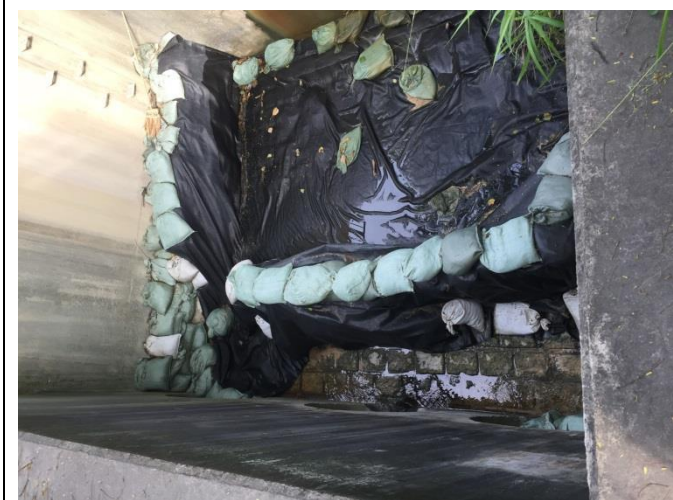
Stream B Outfall: Cascade was in normal condition.

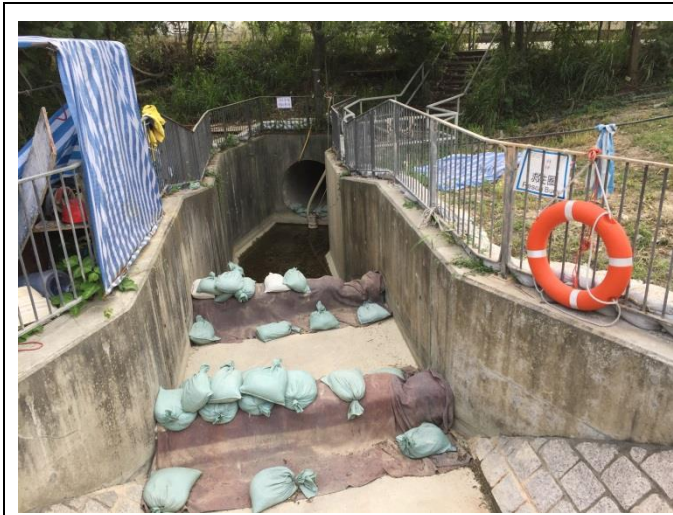
East Portal Cascade: No water is discharged.

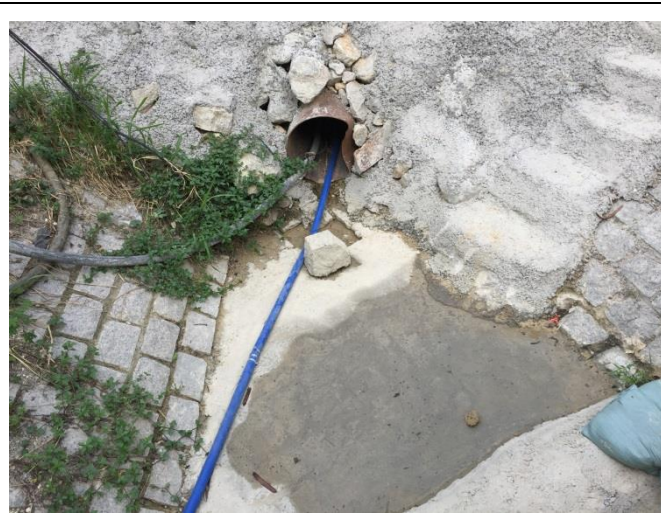
East Portal Cascade condition

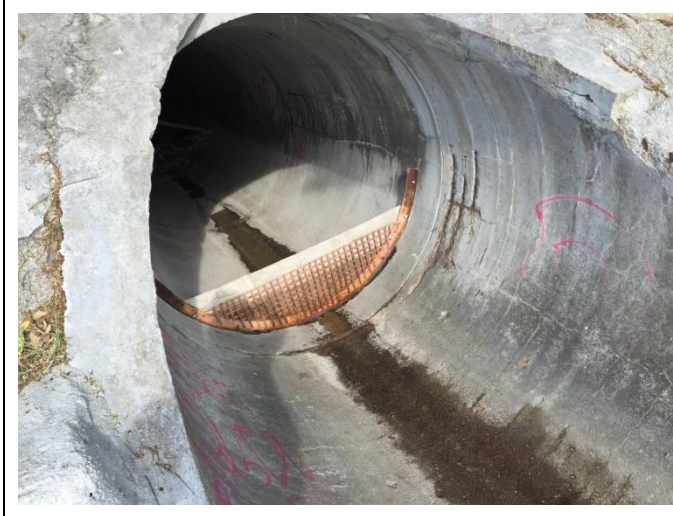
Outfall 1: No water is discharging.

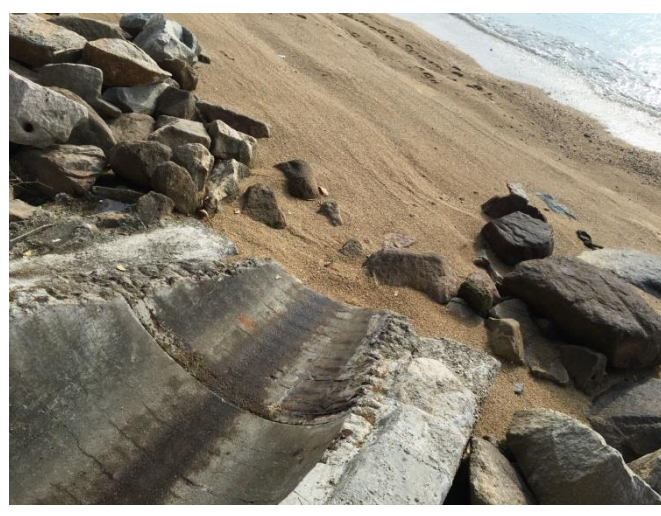
Outfall 1: No water is discharging.

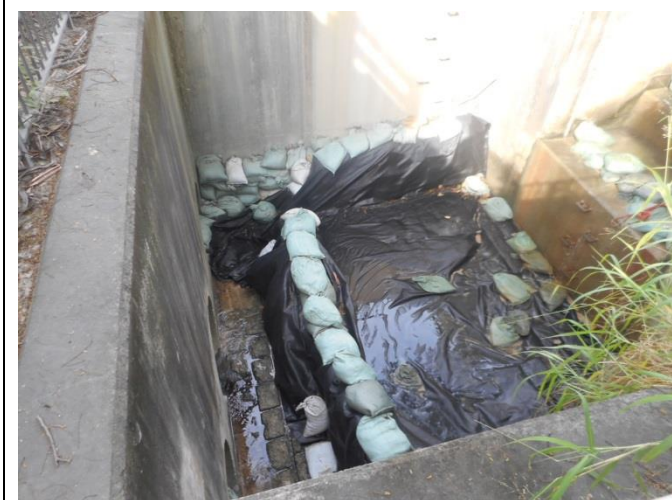
Stream B Outfall: Cascade step channel condition

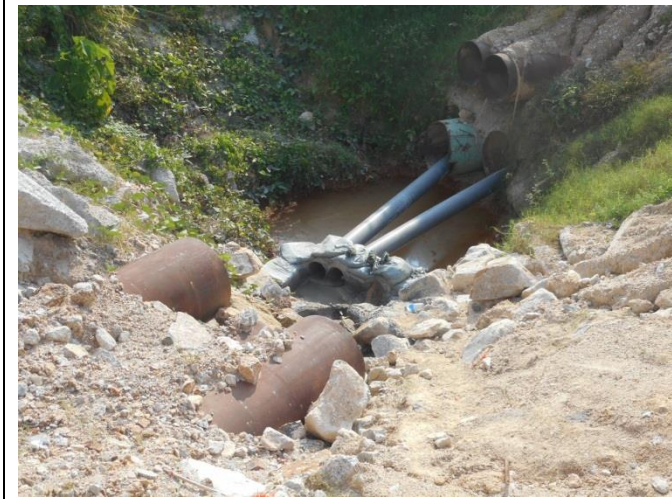
Stream B Pit 2: Treated water was directly discharged to downstream bypass.

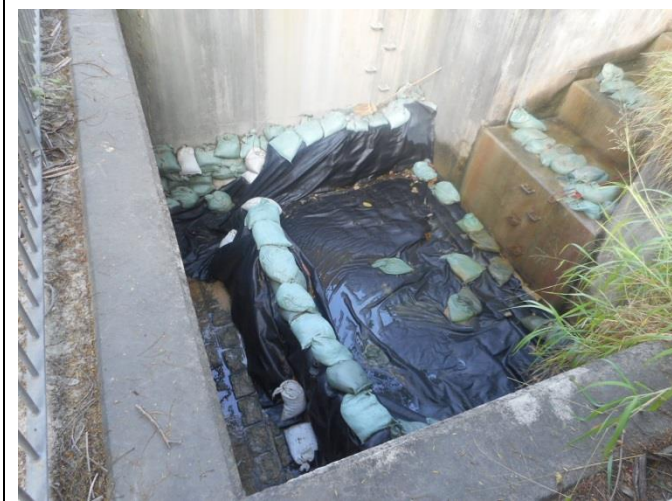
Stream B Outfall: Cascade was in normal condition.

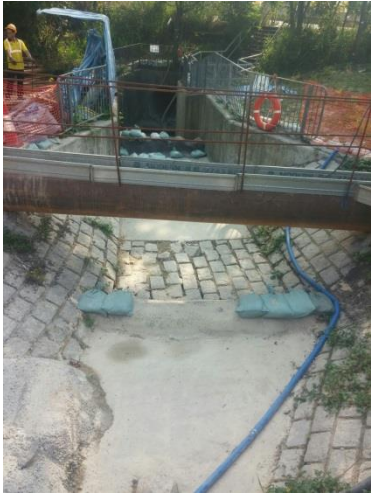
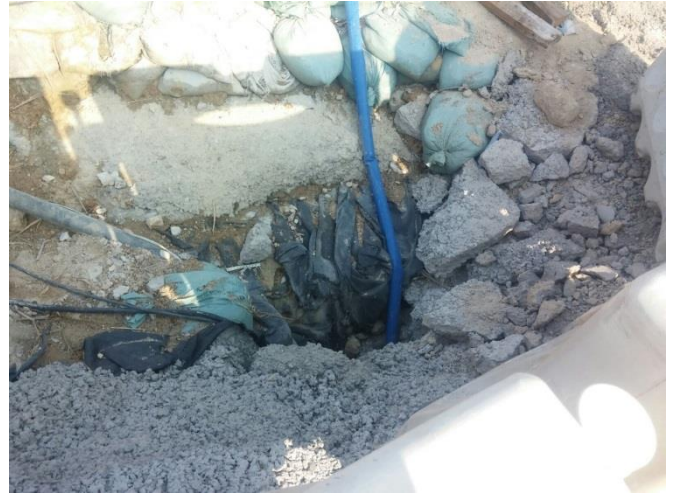
East Portal Cascade: No water is discharged.

East Portal Cascade condition
