TUEN MUN - CHEK LAP KOK LINK  
CONTRACT NO. HY/2013/12 –  
NORTHERN CONNECTION TOLL PLAZA AND  
ASSOCIATED WORKS

12<sup>TH</sup> MONTHLY ENVIRONMENTAL MONITORING AND  
AUDIT (EM&A) REPORT – OCTOBER 2015

PREPARED FOR  
CRBC AND KADEN JOINT VENTURE

Date	Reference No.	Prepared By	Certified By
12 November 2015	TCS00715/14/600/R00144v2

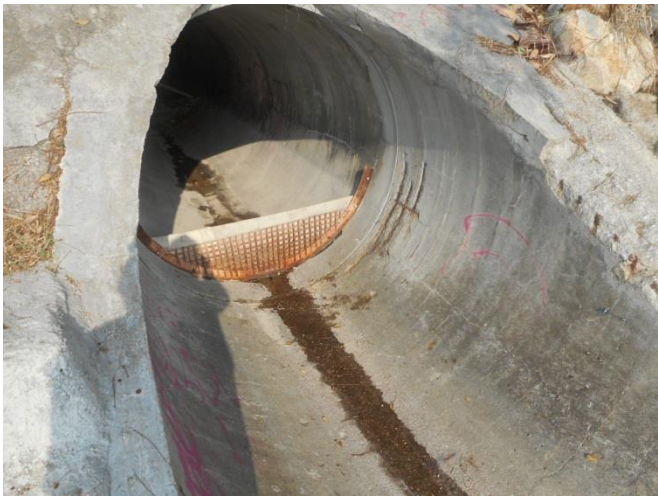
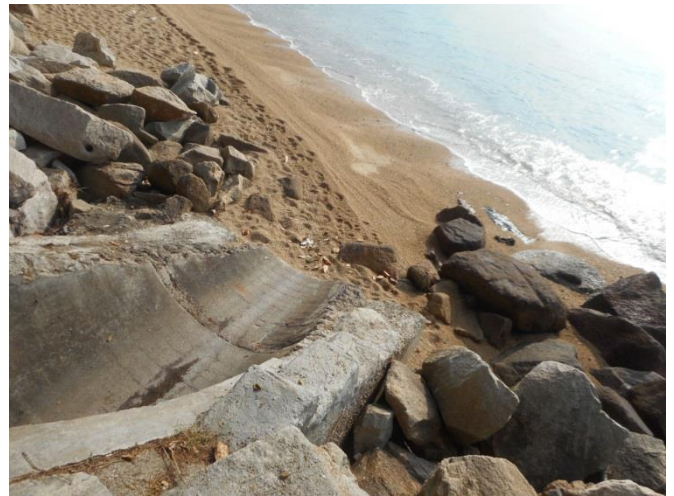
Outfall 1: No water is discharging.

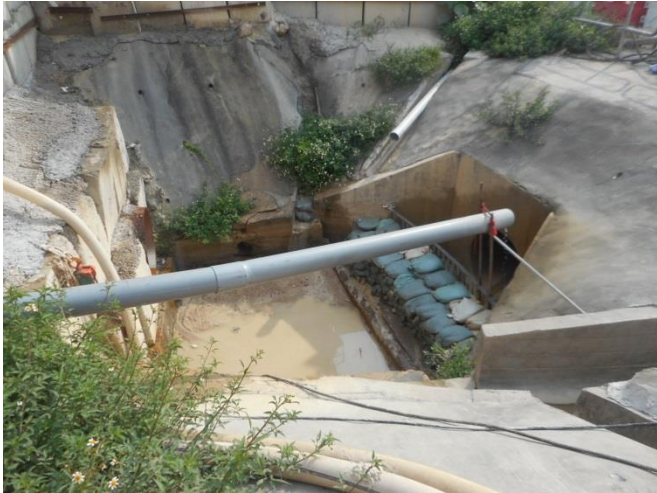
Stream A Outfall: pumped muddy water and discharged after treatment.

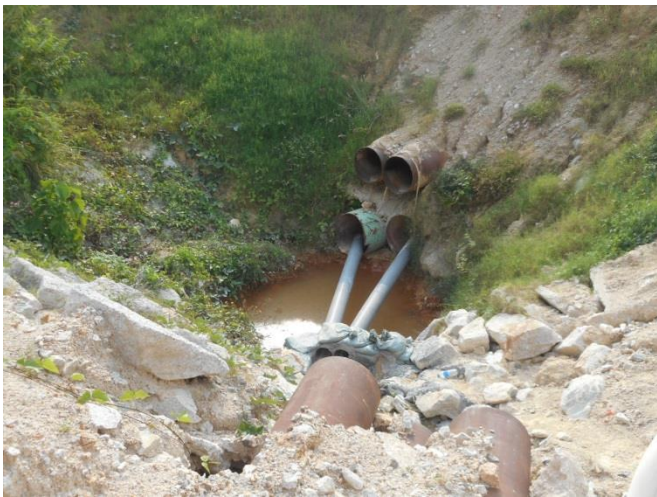
Stream B Pit 2: Treated water was directly discharged to downstream bypass.

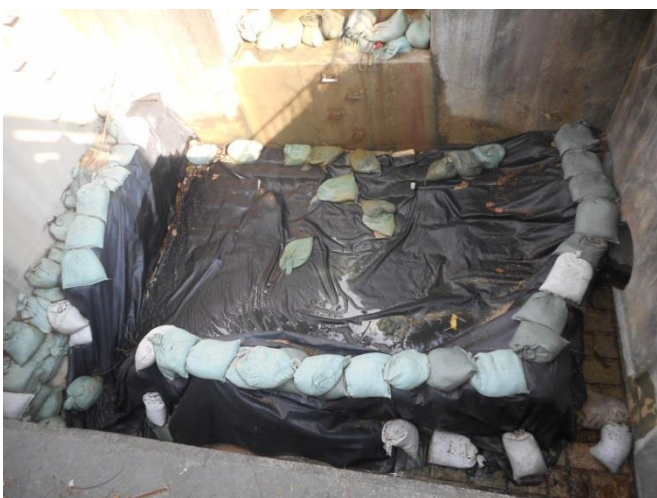
Stream B Outfall: Cascade was in normal condition.

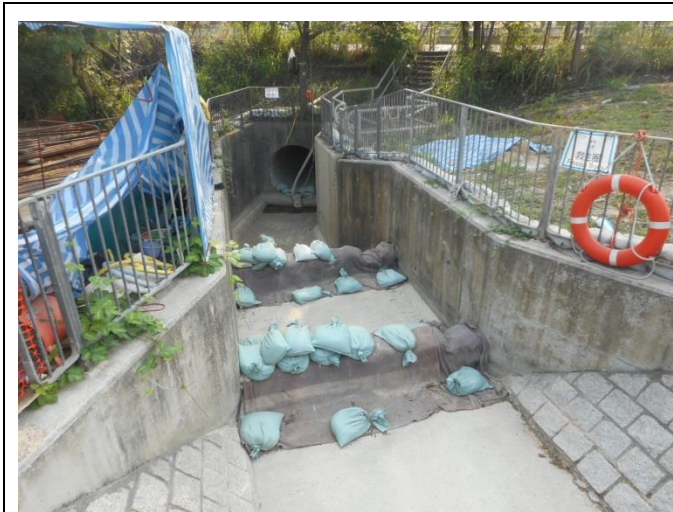
East Portal Cascade: No water is discharged.

East Portal Cascade condition

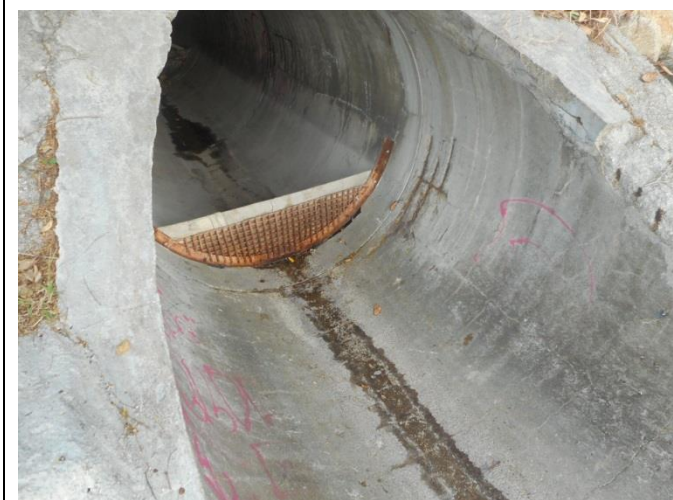
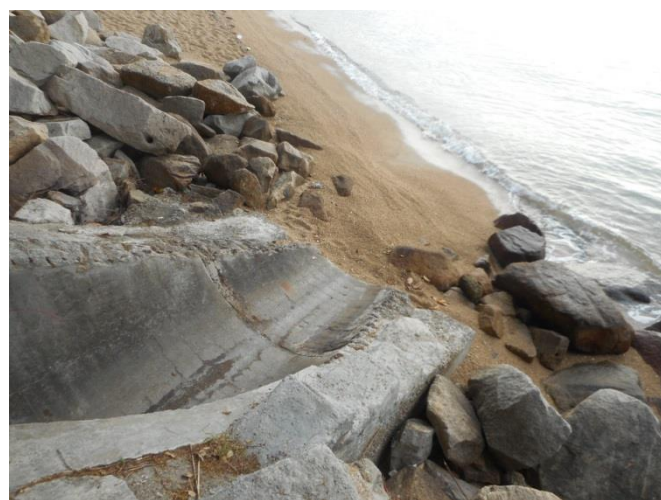
Outfall 1: No water is discharging.

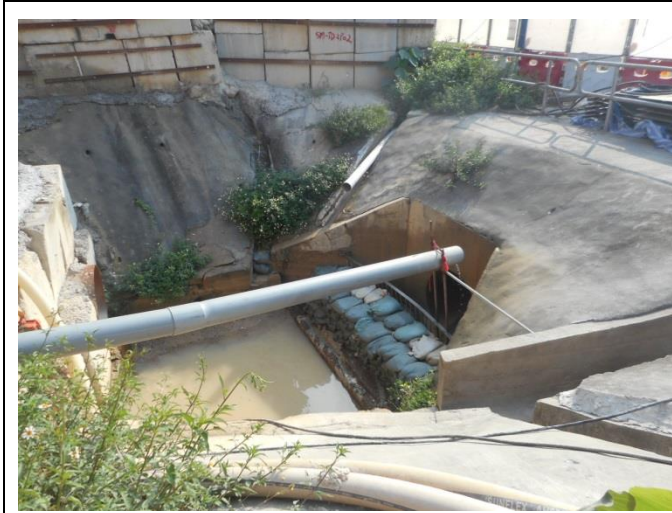
Stream A Outfall: pumped muddy water and discharged after treatment.

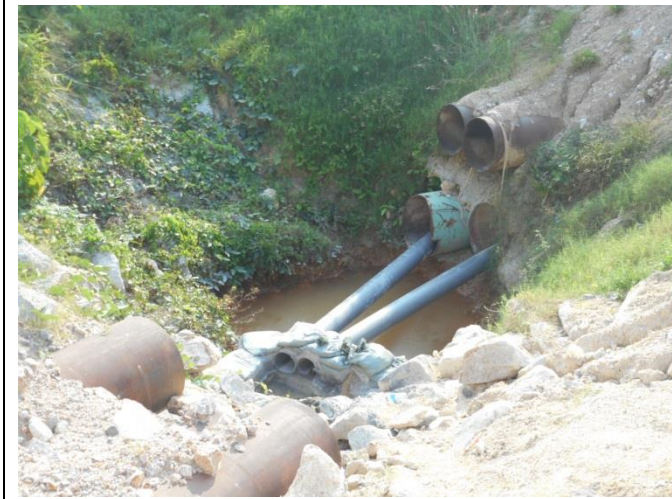
Stream B Pit 2: Treated water was directly discharged to downstream bypass.

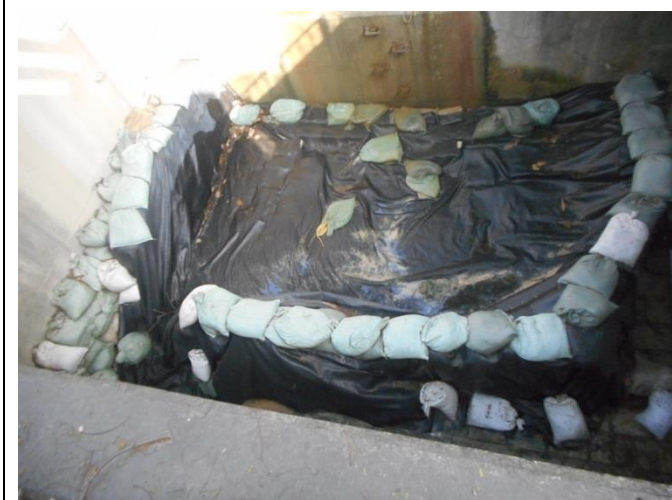
Stream B Outfall: Cascade was in normal condition.

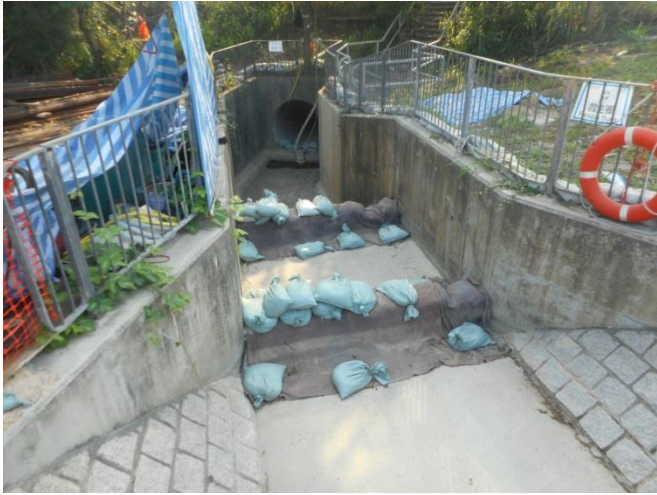
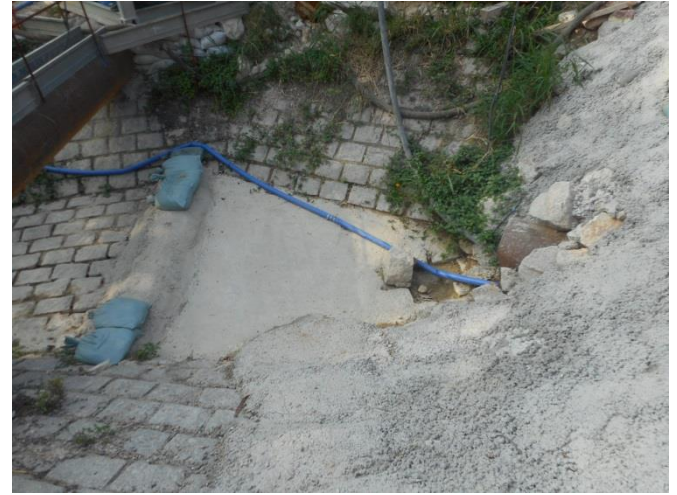
East Portal Cascade: No water is discharged.

East Portal Cascade condition

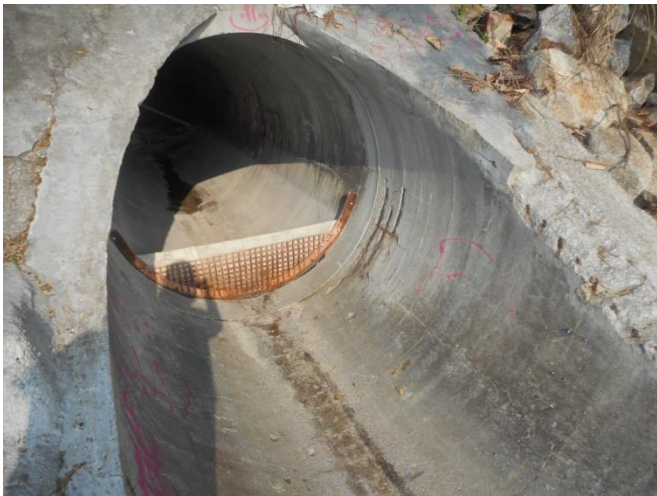
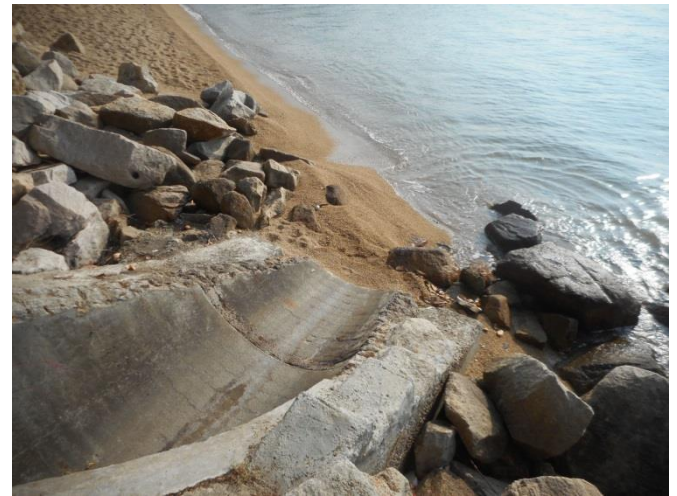
Outfall 1: No water is discharging.

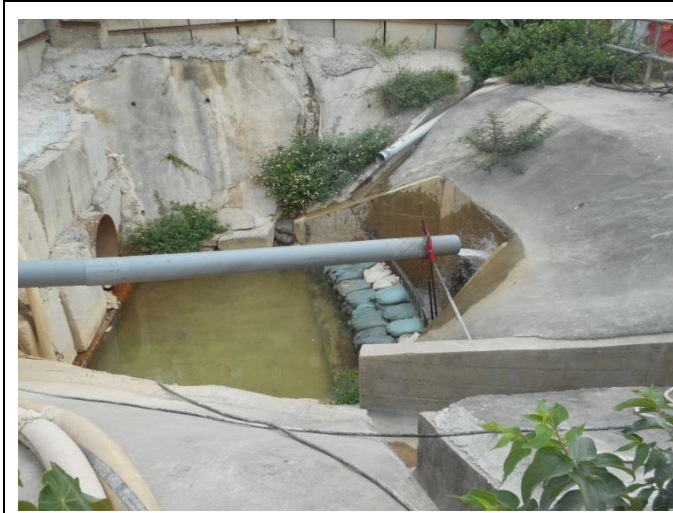
Stream A Outfall: pumped muddy water and discharged after treatment.

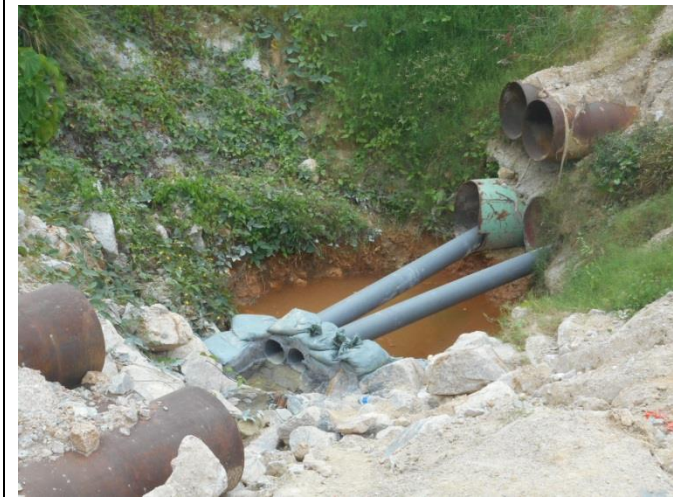
Stream B Pit 2: Treated water was directly discharged to downstream bypass.

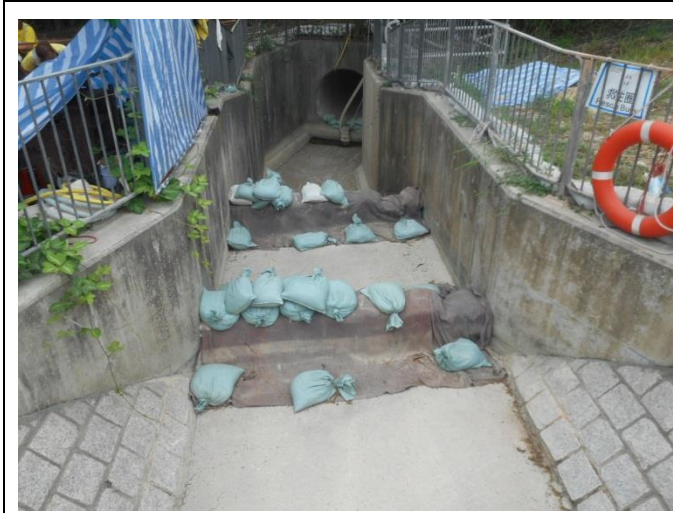
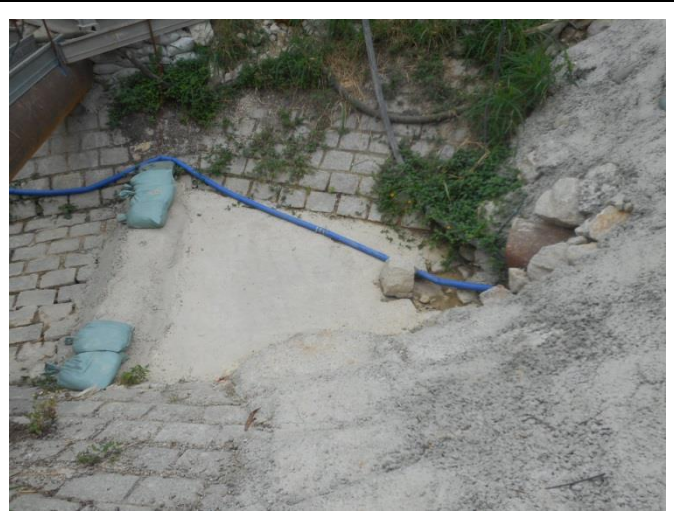
East Portal Cascade: No water is discharged.

East Portal Cascade condition

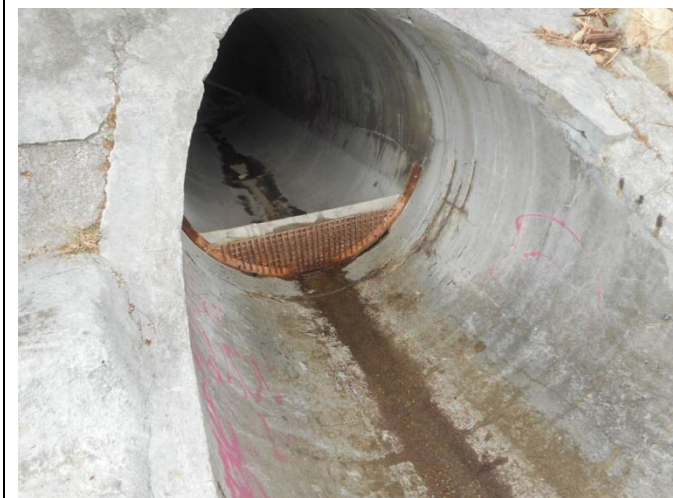
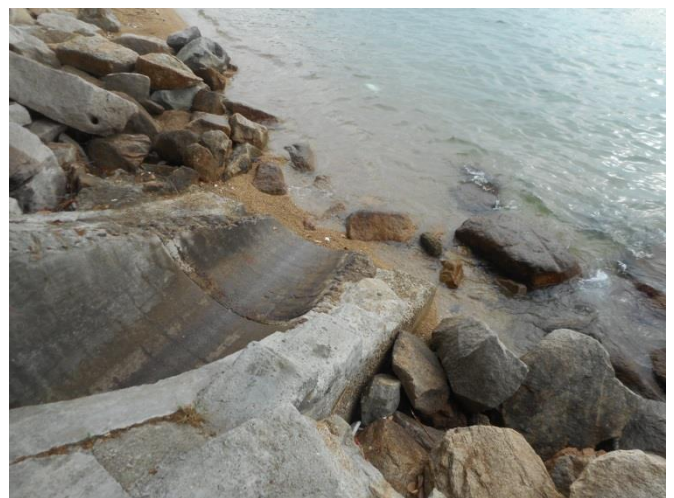
Outfall 1: No water is discharging.

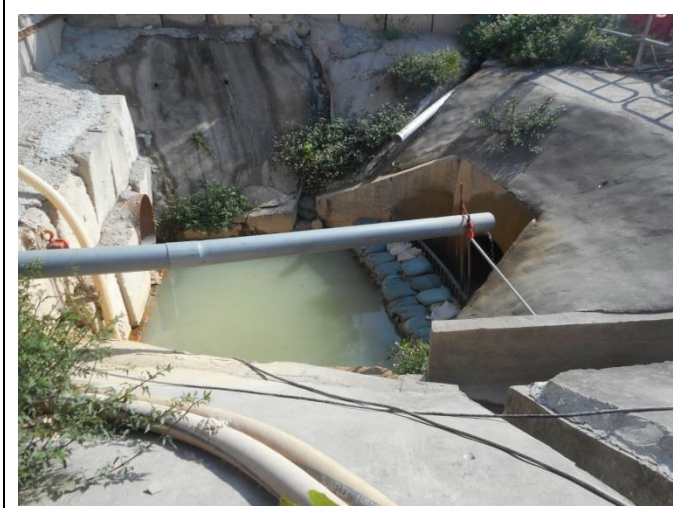
Stream A Outfall: pumped muddy water and discharged after treatment.

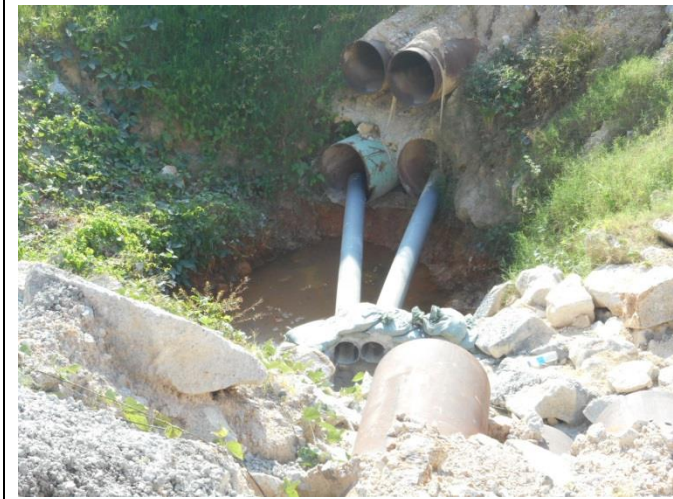
Stream B Pit 2: Treated water was directly discharged to downstream bypass.

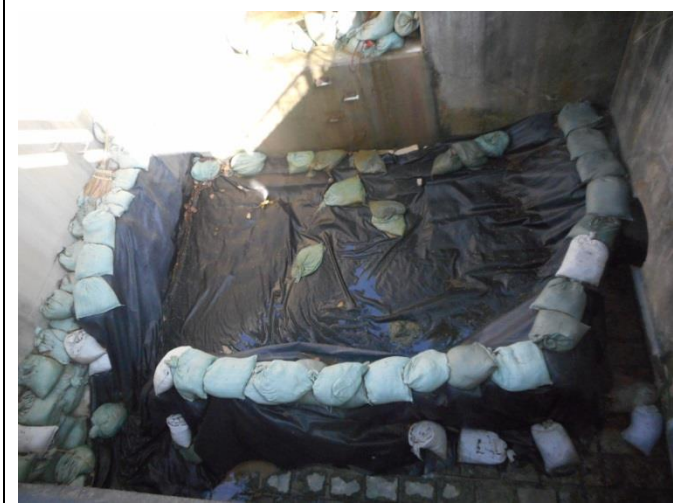
Stream B Outfall: Cascade was in normal condition.

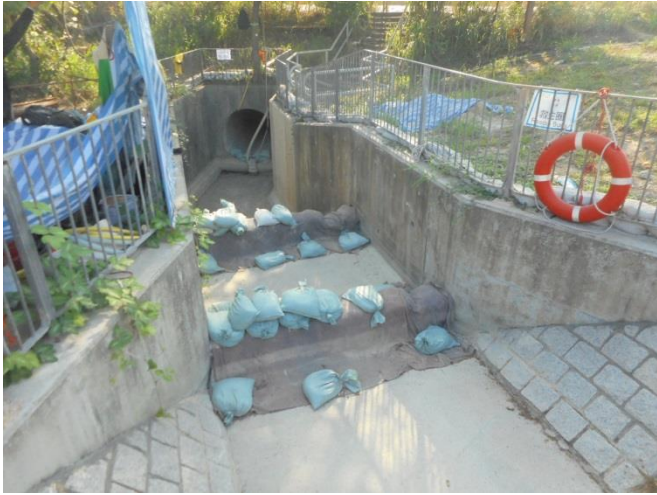
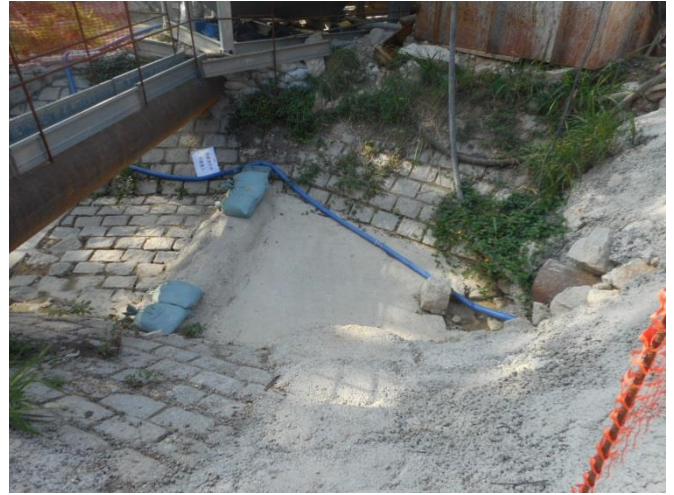
East Portal Cascade: No water is discharged.

East Portal Cascade condition

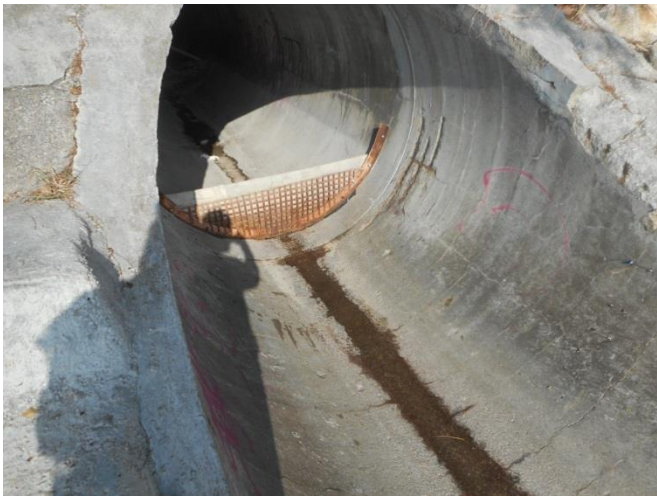
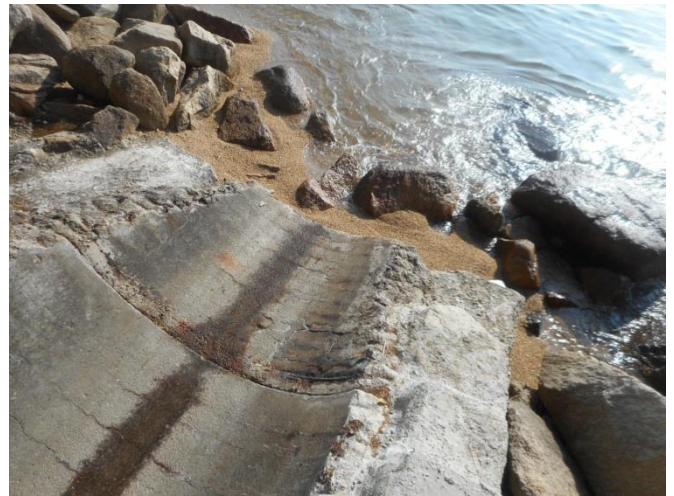
Outfall 1: No water is discharging.

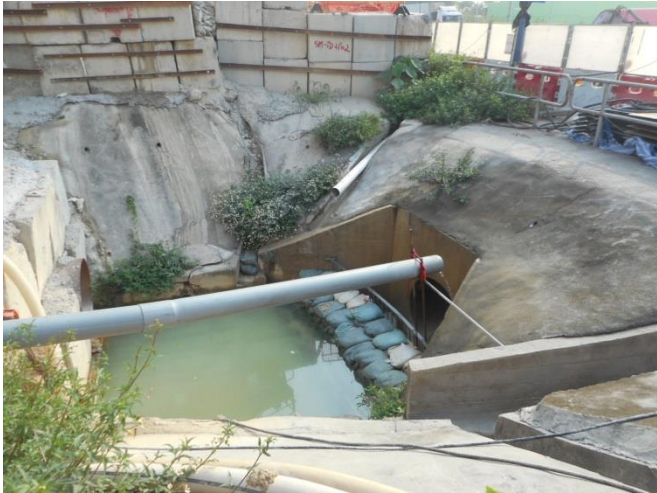
Stream A Outfall: pumped muddy water and discharged after treatment.

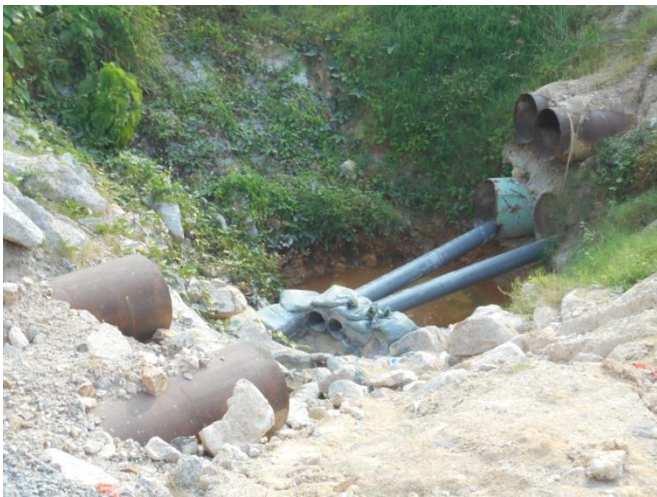
Stream B Pit 2: Treated water was directly discharged to downstream bypass.

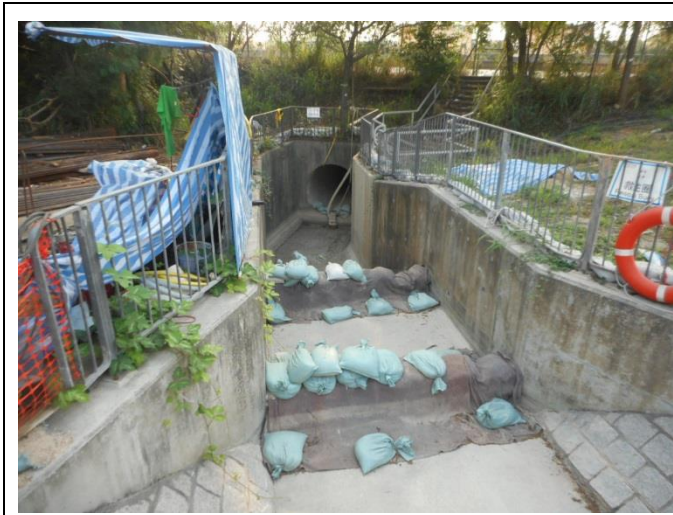
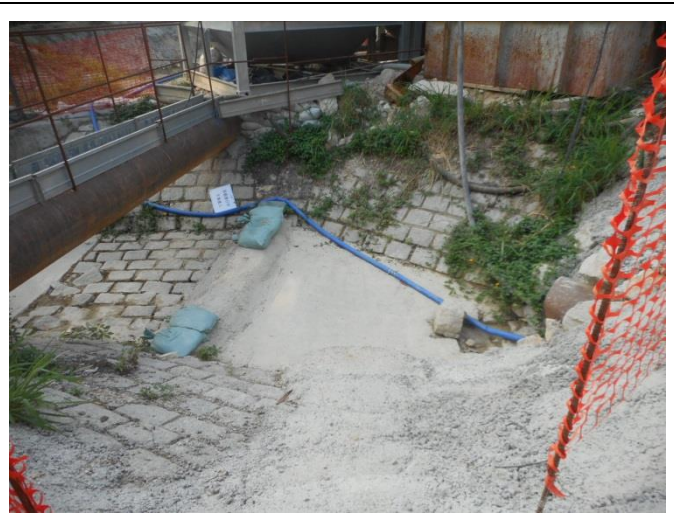
East Portal Cascade: No water is discharged.

East Portal Cascade condition

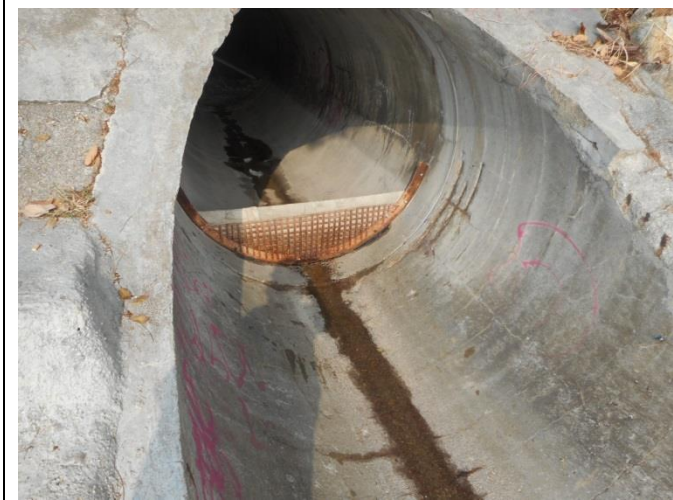
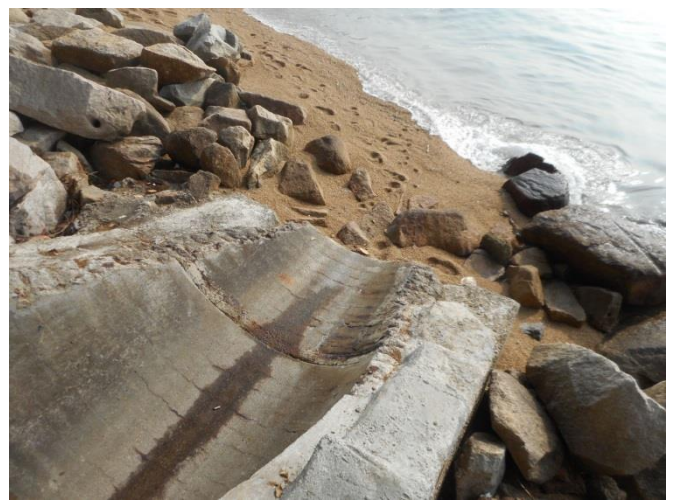
Outfall 1: No water is discharging.

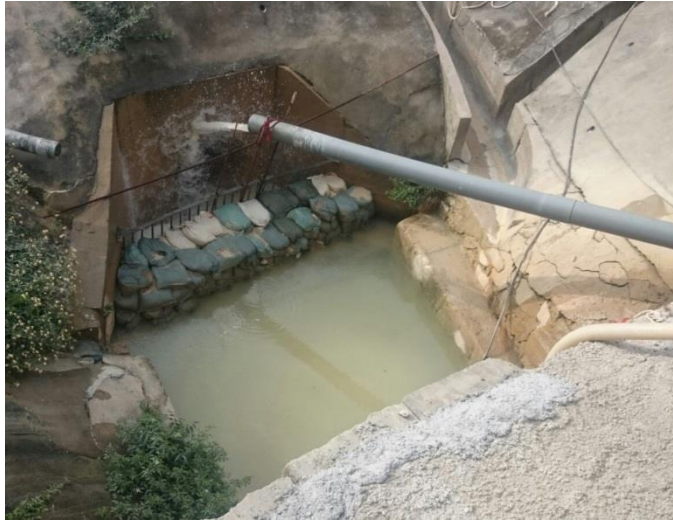
Stream A Outfall: pumped muddy water and discharged after treatment.

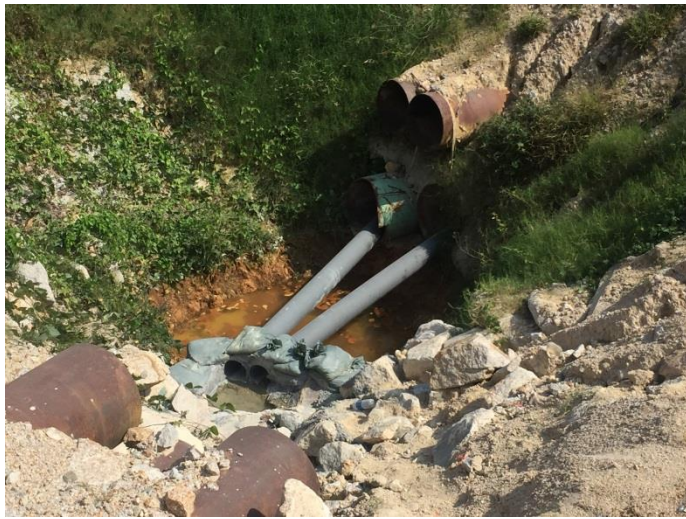
Stream B Outfall: Cascade step channel condition

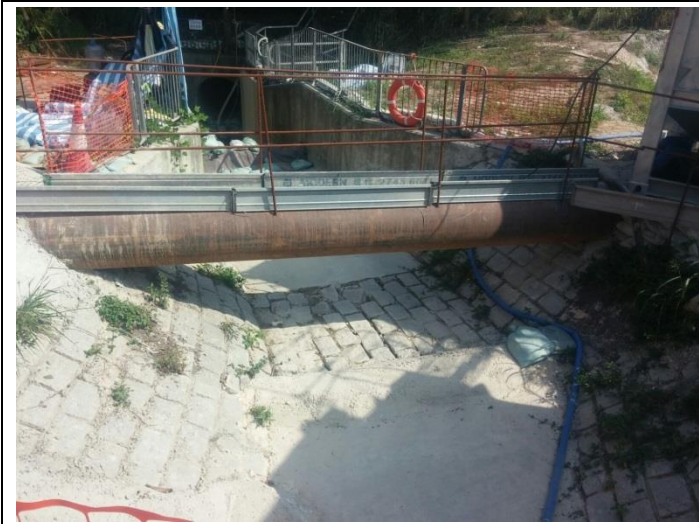
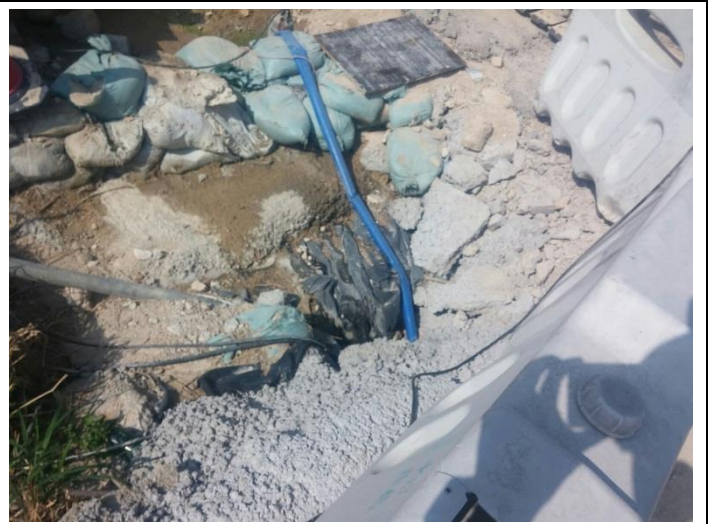
East Portal Cascade: No water is discharged.

East Portal Cascade condition

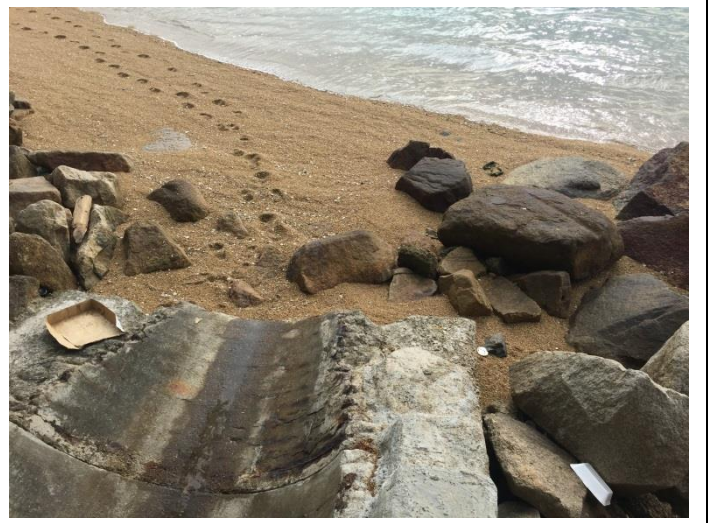
Outfall 1: No water is discharging.

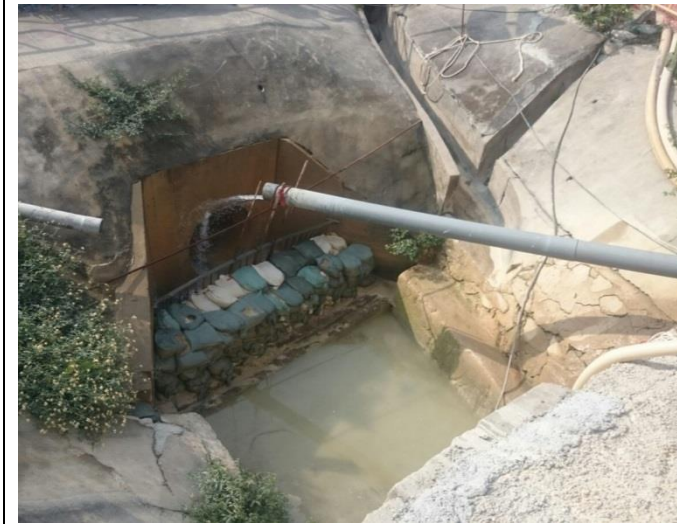
Stream A Outfall: pumped muddy water and discharged after treatment.

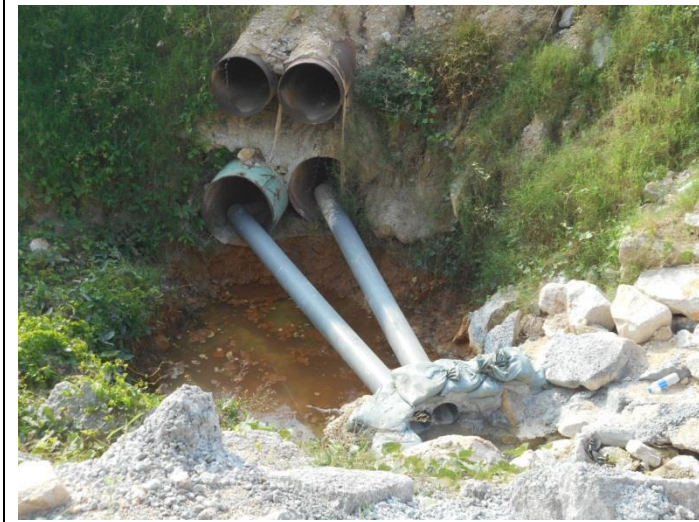
Stream B Pit 2: Treated water was directly discharged to downstream bypass.

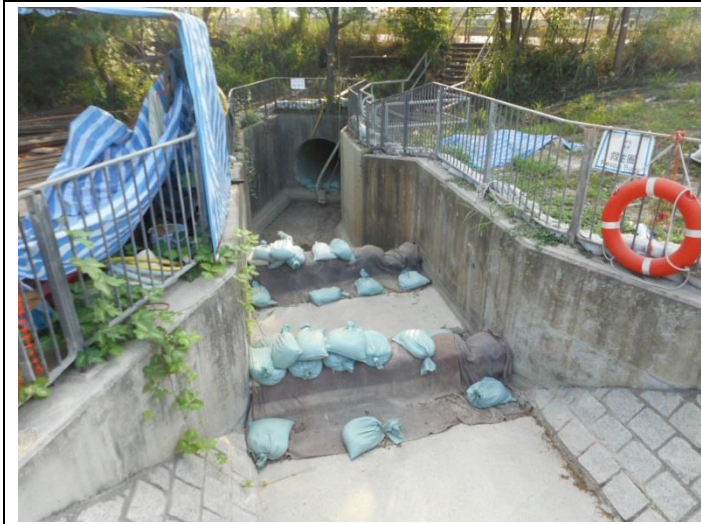
MH5 Cascade: No water is discharging.

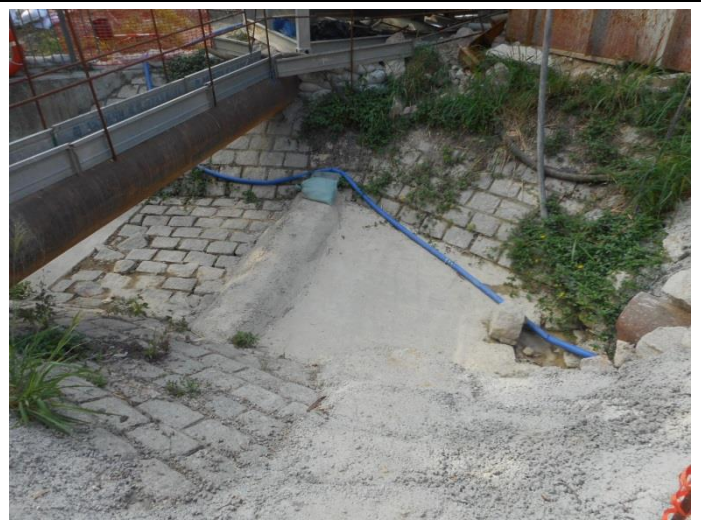
East Portal Cascade: No water is discharged.

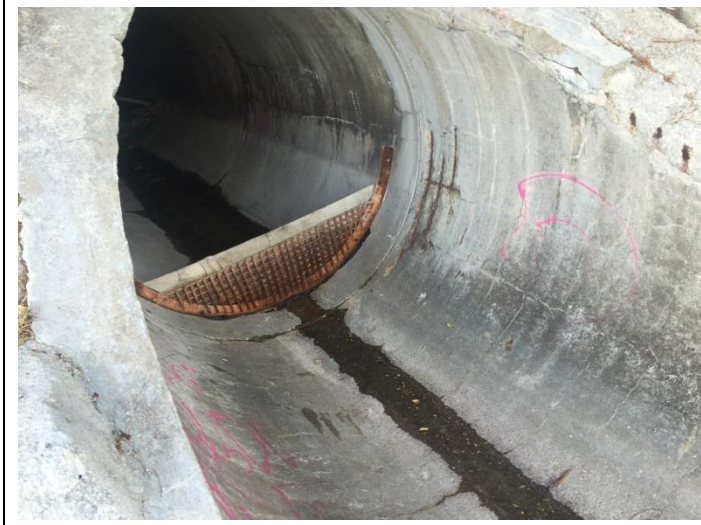
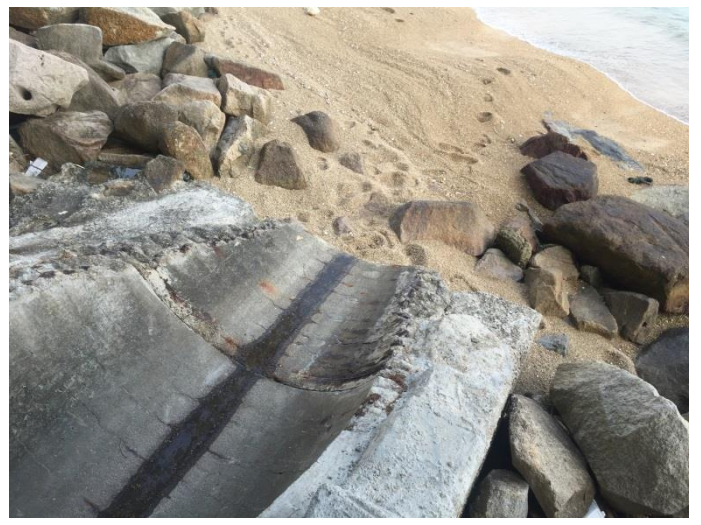
Outfall 1: No water is discharging.

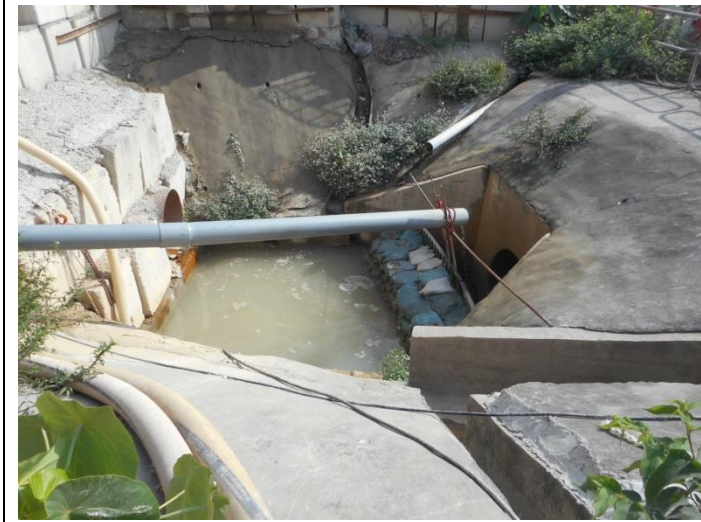
Stream A Outfall: pumped muddy water and discharged after treatment.

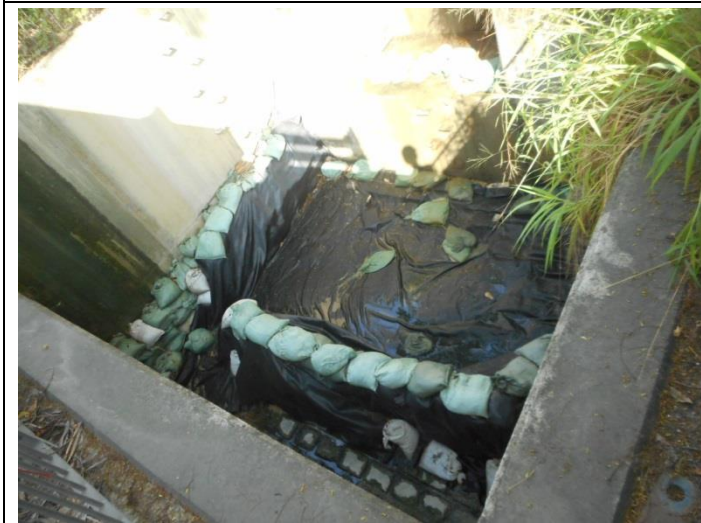
Stream B Outfall: Cascade was in normal condition.

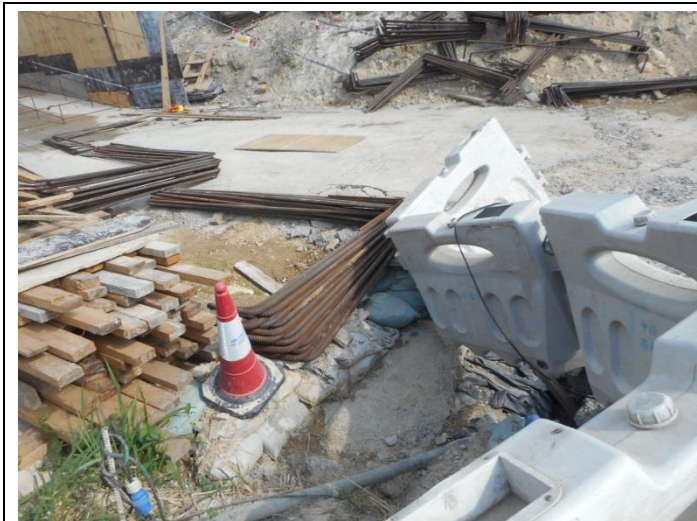
East Portal Cascade condition

Outfall 1: No water is discharging.
