**TUEN MUN - CHEK LAP KOK LINK
CONTRACT NO. HY/2013/12 –
NORTHERN CONNECTION TOLL PLAZA AND
ASSOCIATED WORKS**

**36TH MONTHLY ENVIRONMENTAL MONITORING AND
AUDIT (EM&A) REPORT – OCTOBER 2017**

PREPARED FOR
CRBC AND KADEN JOINT VENTURE

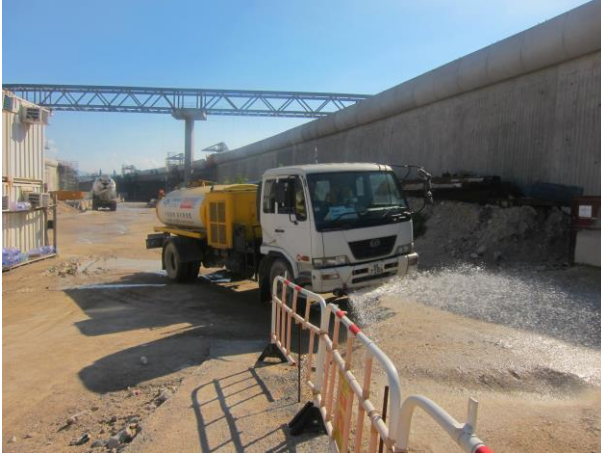
Photo 1 Watering of haul road by water truck to keep road surface wet

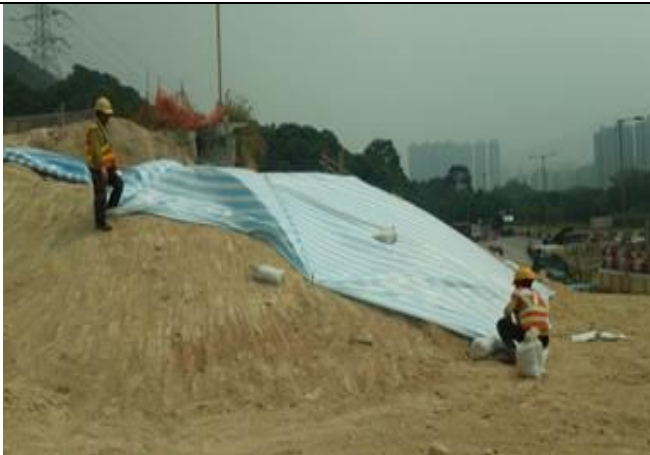
Photo 3 Covered part of the exposed slopes and stockpile by tarpaulin sheet.

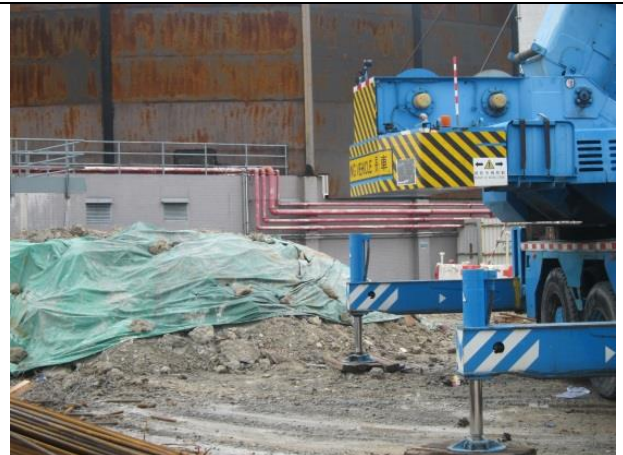
Photo 4 Covered part of stockpile by tarpaulin sheet at Portion F.

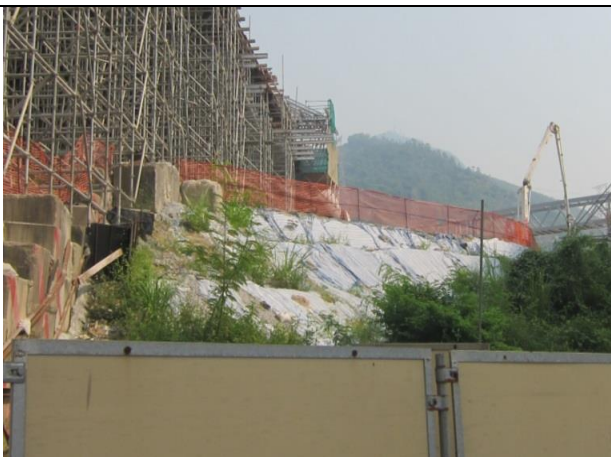
Photo 5 Covered part of the exposed slopes and stockpile by tarpaulin sheet.

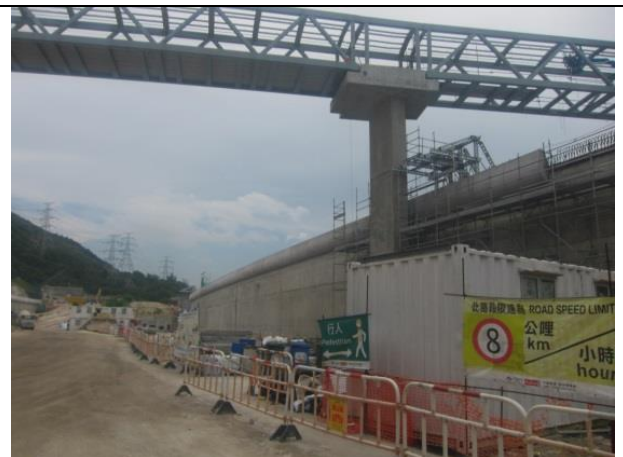
Photo 6 Set speed control at ~8km/hr for all vehicles using the haul road

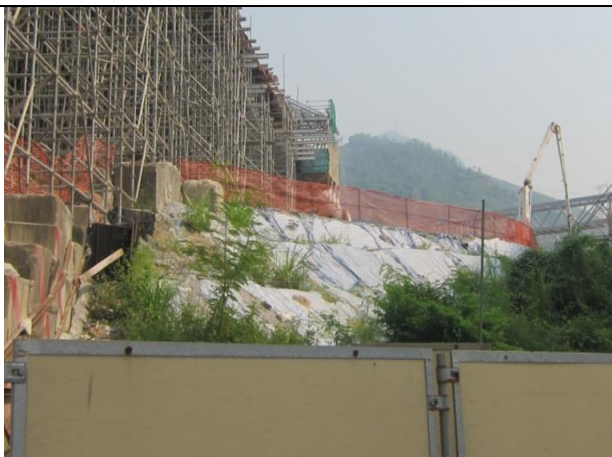
Photo 5 Covered part of the exposed slopes and stockpile by tarpaulin sheet.

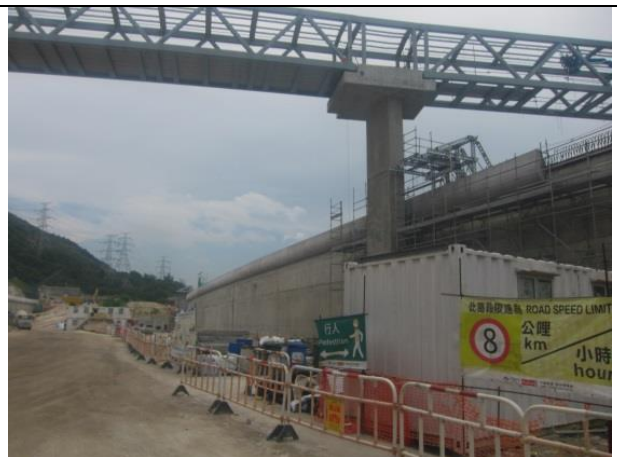
Photo 6 Set speed control at ~8km/hr for all vehicles using the haul road

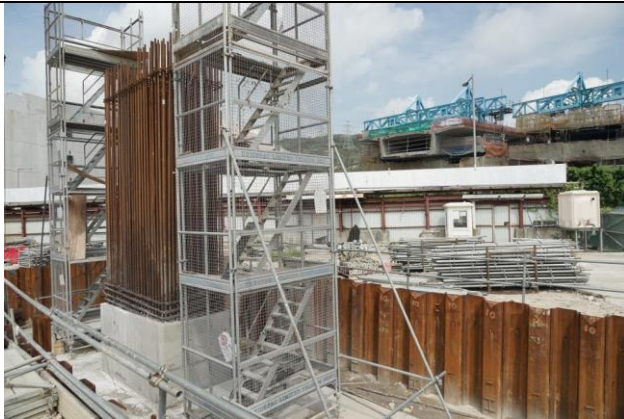
Photo 9 Most of works area at Portion F were hard paved.

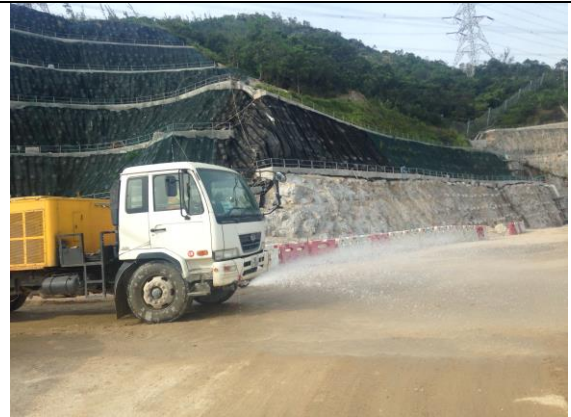
Photo 12 Water spraying at Portion H.

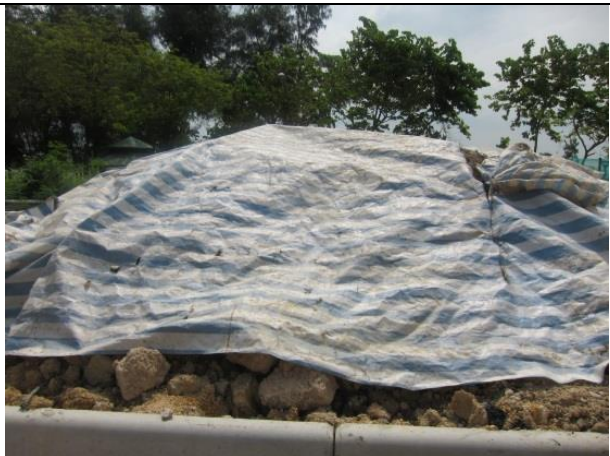
Photo 3 Covered part of the exposed slopes and stockpile by tarpaulin sheet.

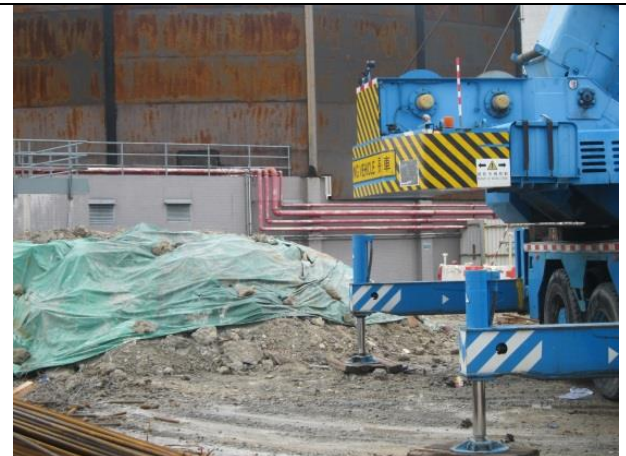
Photo 4 Covered part of stockpile by tarpaulin sheet at Portion F.

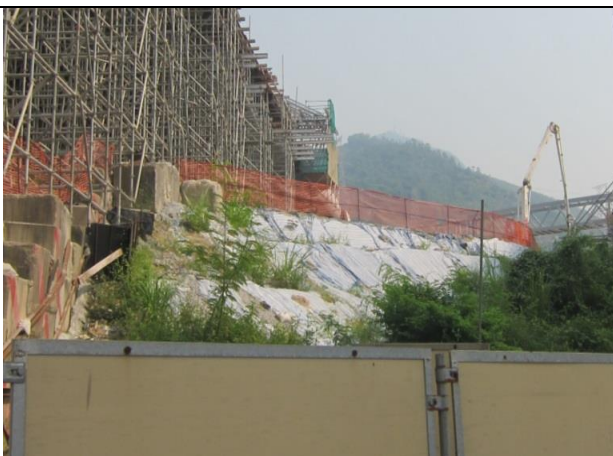
Photo 5 Covered part of the exposed slopes and stockpile by tarpaulin sheet.

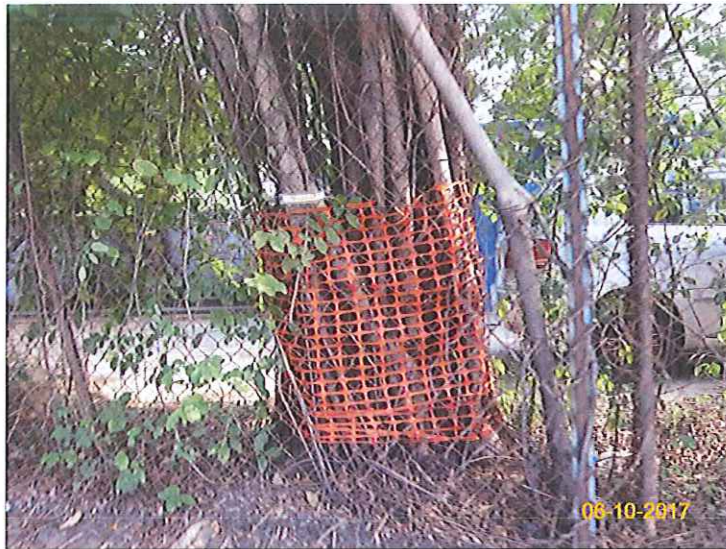
Item 1. Existing trees on boundary of the Project Area should be protected carefully during construction.

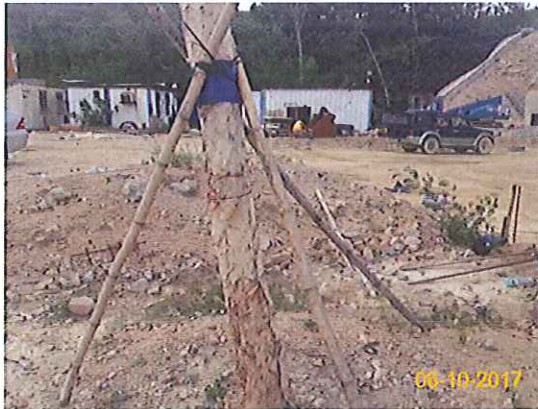
Item 2. Tree Transplanting works conducted on 22-May-17.

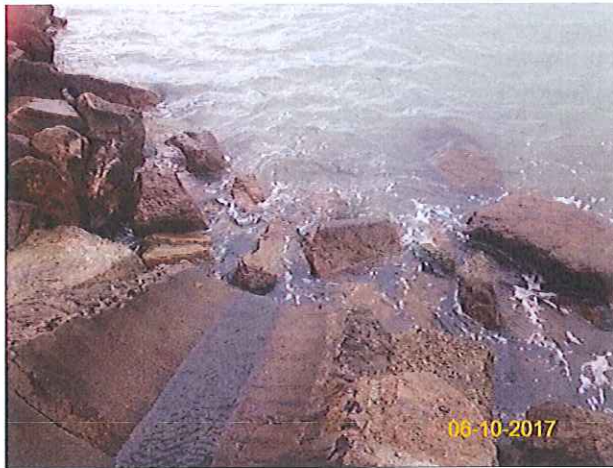
Item 7. Ensure no run-off into water body.

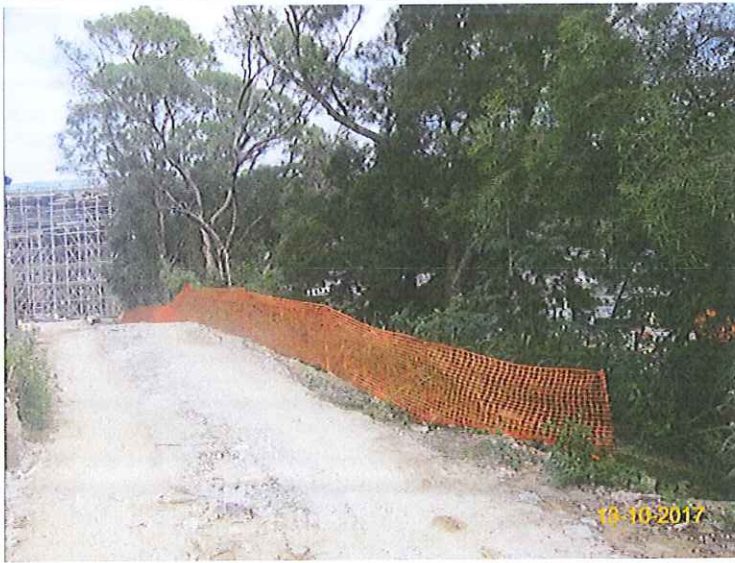
Item 1. Existing trees on boundary of the Project Area should be protected carefully during construction.

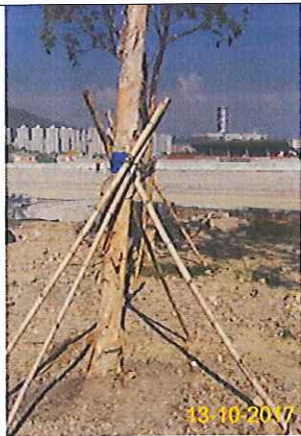
Item 2. Tree Transplanting works conducted on 22-May-17.

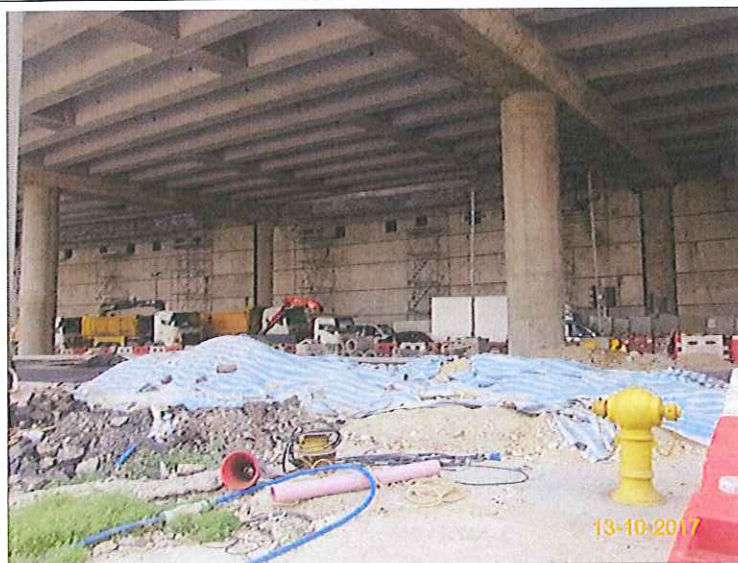
Item 4. Hydro-seeding or sheeting provided at stockpile.

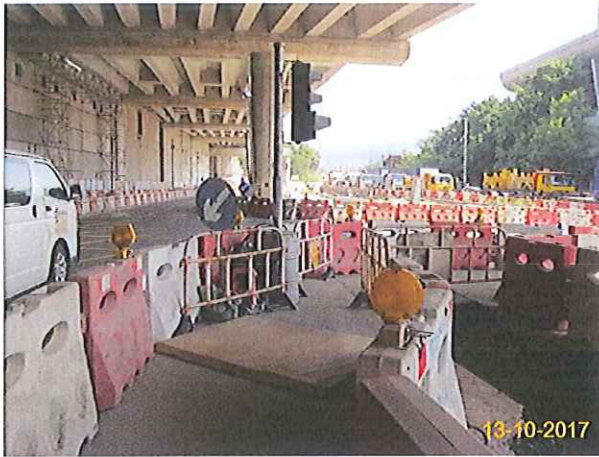
Item 5. Hoarding with panel around works area & Item 6. Temporary traffic management lighting.

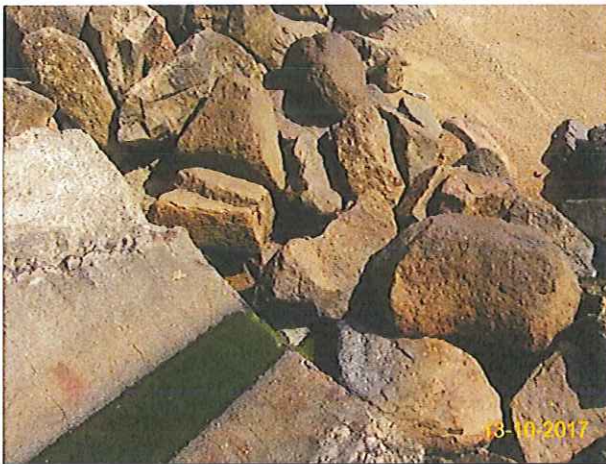
Item 7. Ensure no run-off into water body.

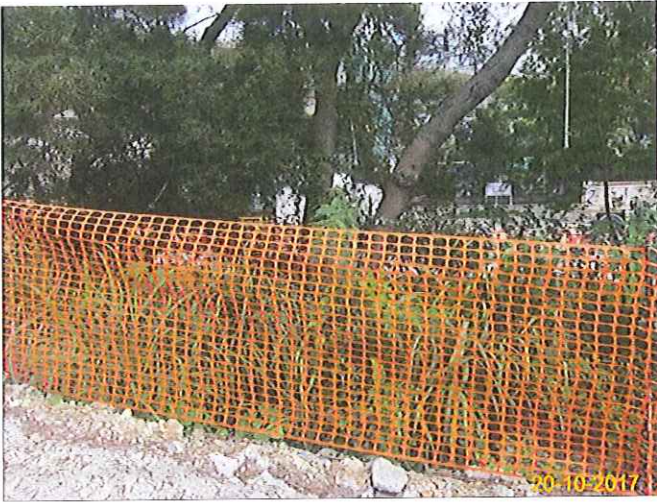
Item 1. Existing trees on boundary of the Project Area should be protected carefully during construction.

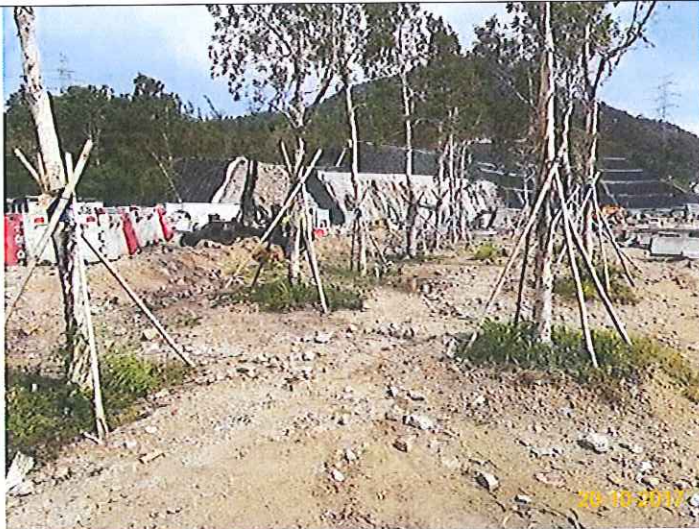
Item 2. Tree Transplanting works conducted on 22-May-17.

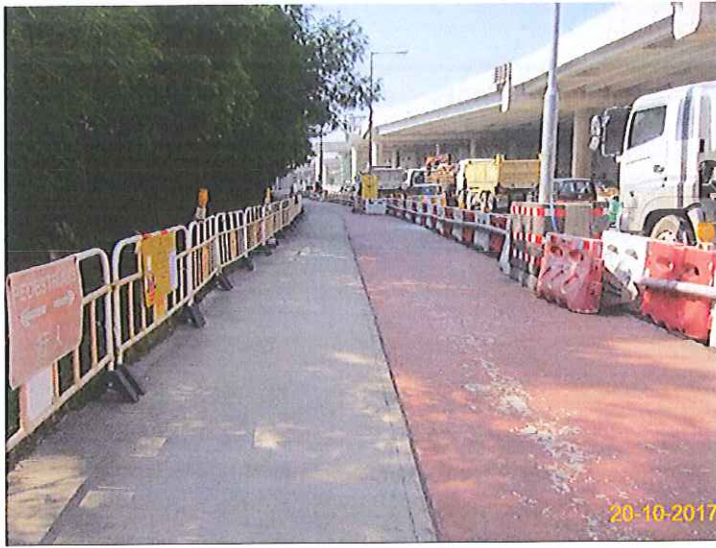
Item 5. Hoarding with panel around works area & Item 6. Temporary traffic management lighting.

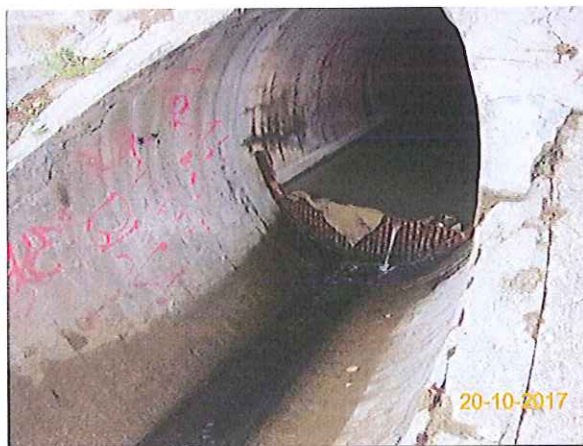
Item 7. Ensure no run-off into water body.

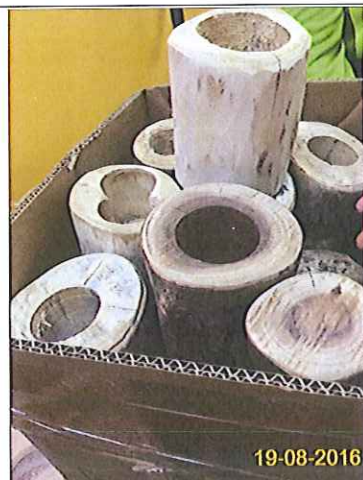
Item 9. Recycle of felled trees as facilities to reuse.

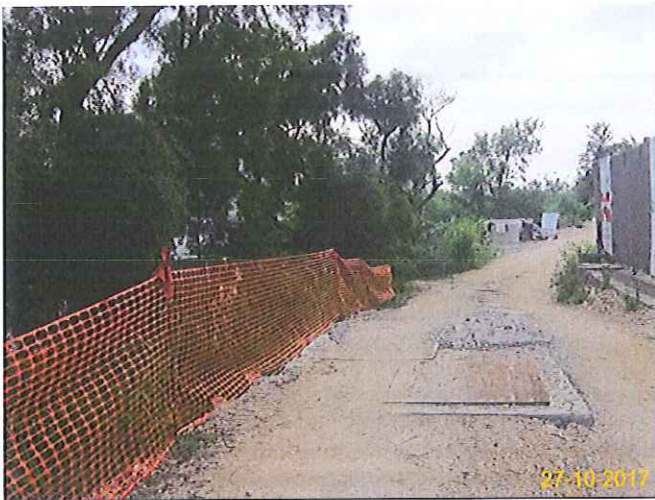
Item 1. Existing trees on boundary of the Project Area should be protected carefully during construction.

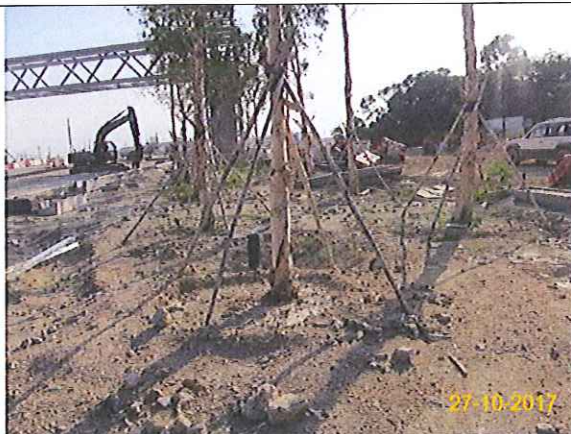
Item 2. Tree Transplanting works was conducted on 22-May-17.

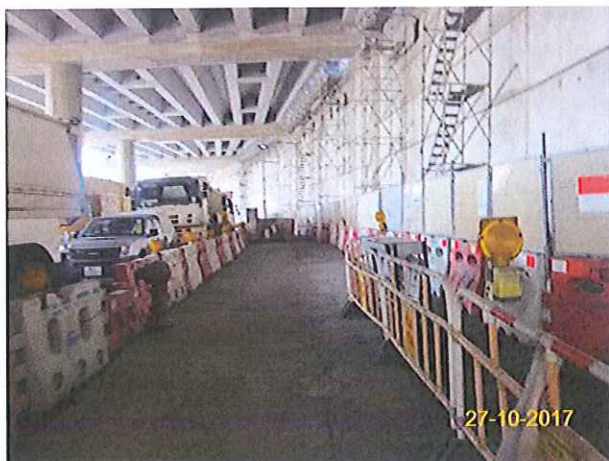
Item 5. Hoarding with panel around works area & Item 6. Temporary traffic management lighting.

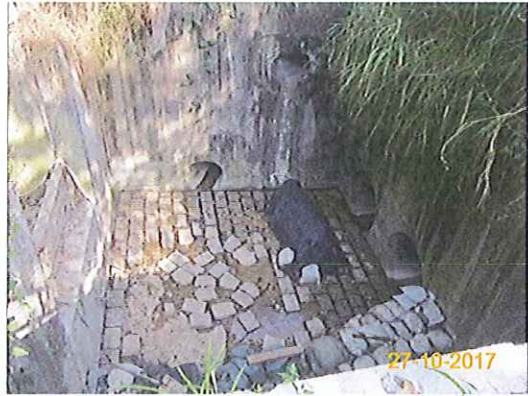
Item 7. Ensure no run-off into water body.

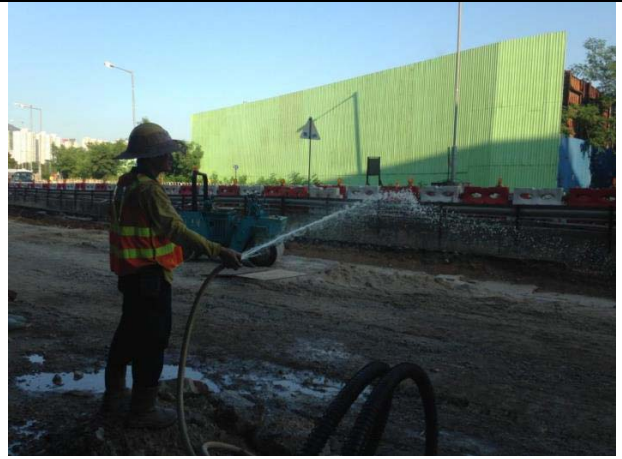
Photo 8
Water spraying at nearby exposed area to reduce dust suppression.

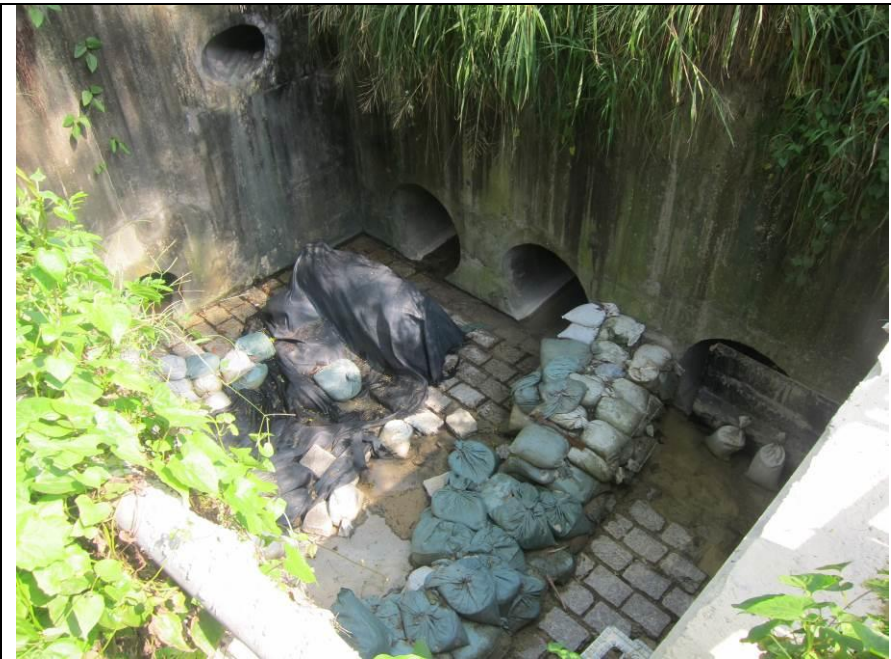
Stream B Outfall: No water is discharging.

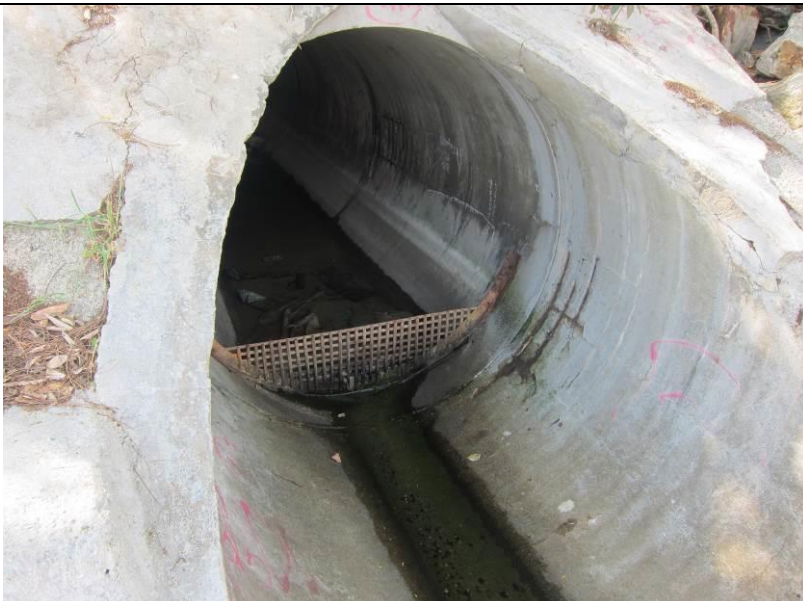
Outfall 1: No water is discharging.

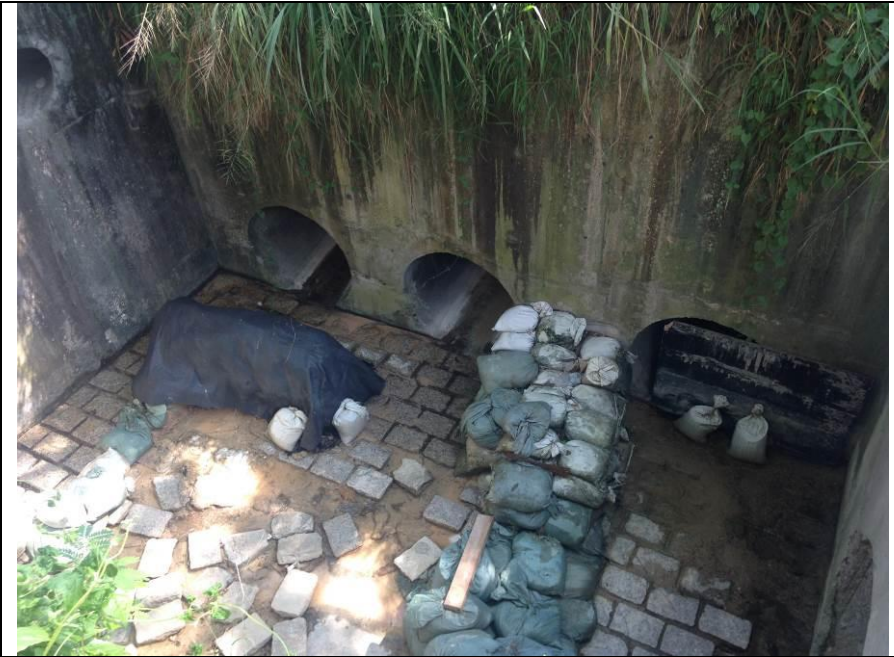
Stream B Outfall: No water is discharging.

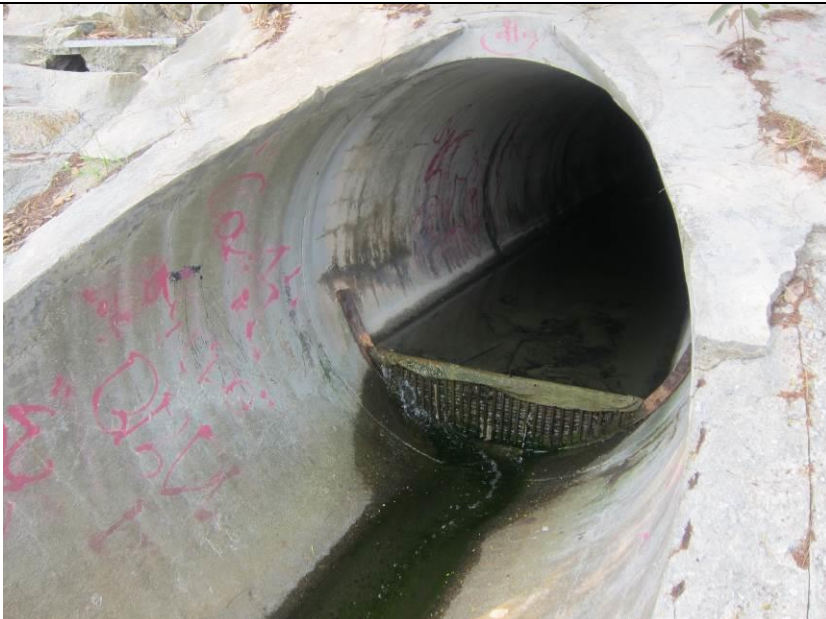
Outfall 1: No water is discharging.

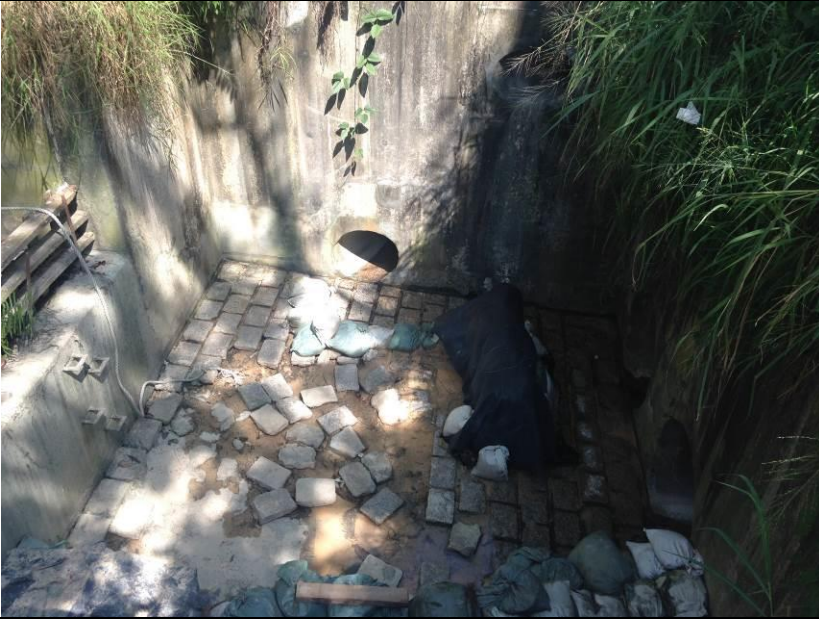
Stream B Outfall: No water is discharging.

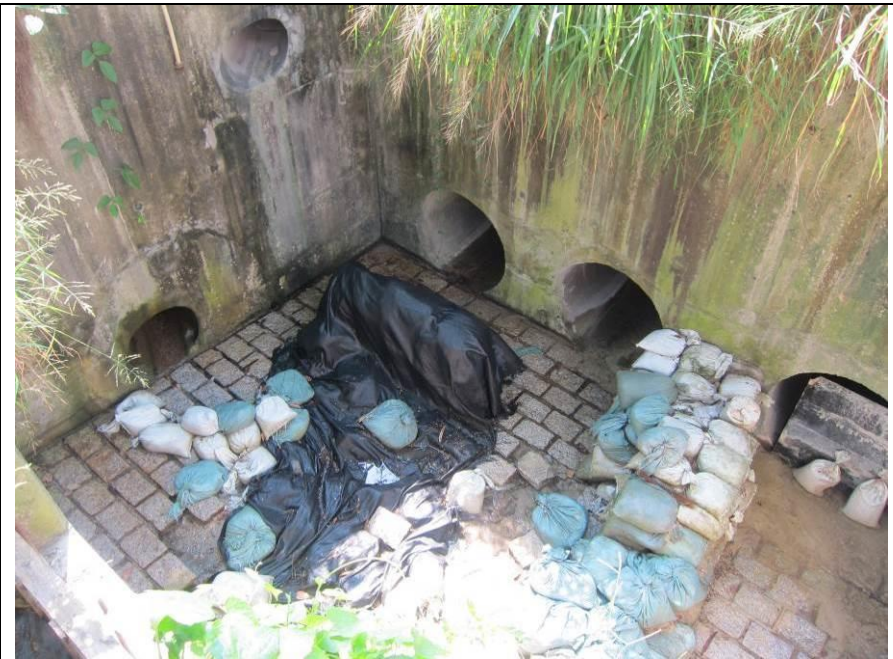
Stream B Outfall: No water is discharging.

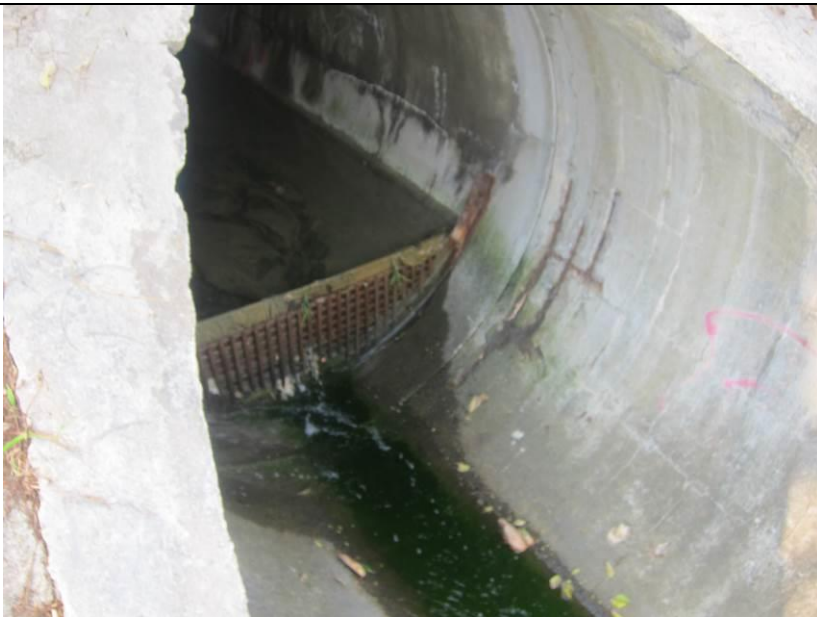
Outfall 1: No water is discharging.

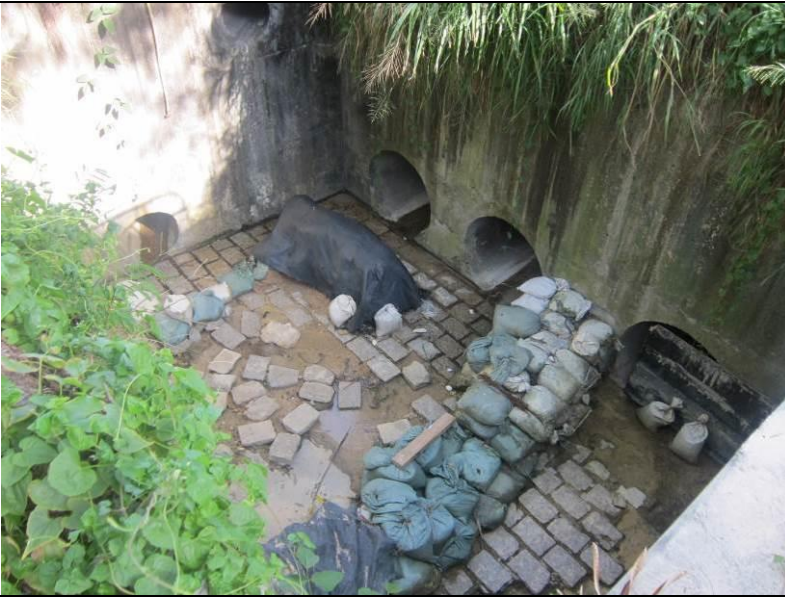
Stream B Outfall: No water is discharging.

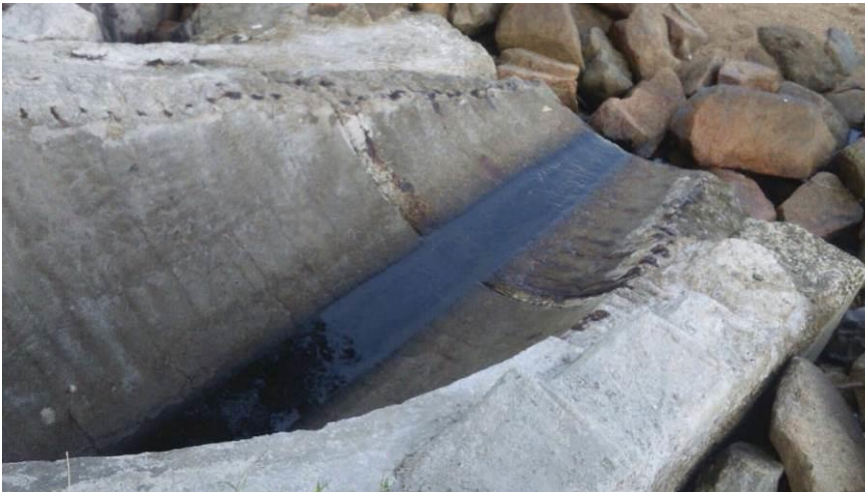
Outfall 1: Clean water is discharging.

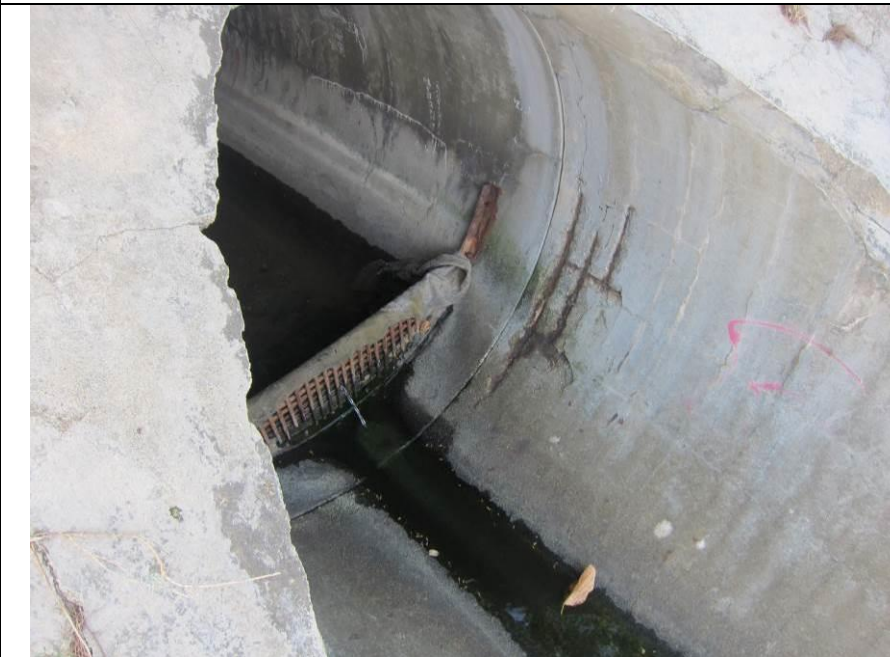
Outfall 1: No water is discharging.

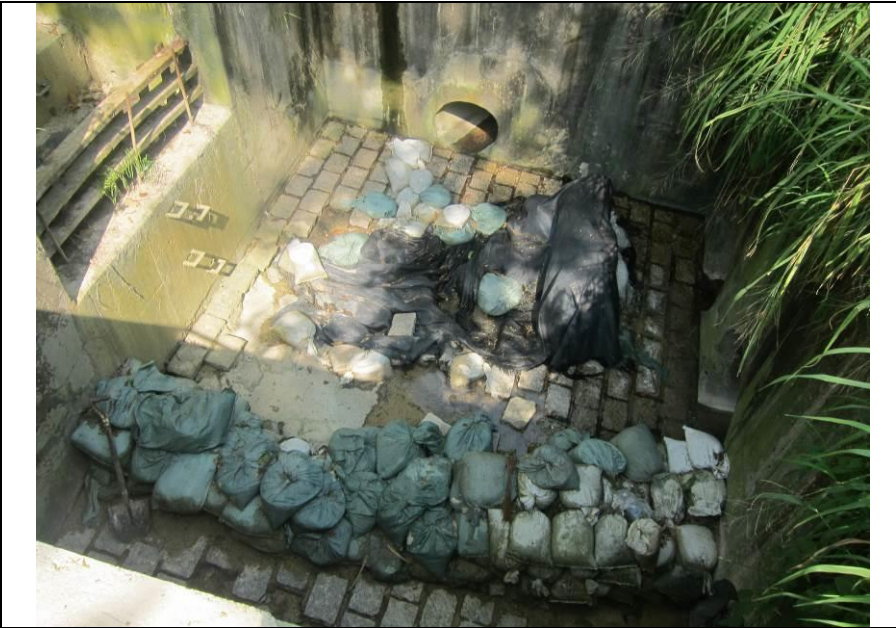
Stream B Outfall: No water is discharging.

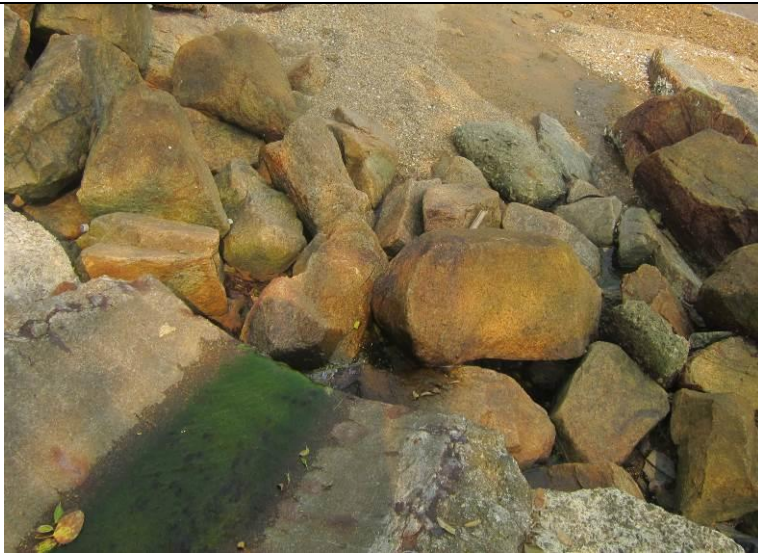
Outfall 1: Clean water is discharging.

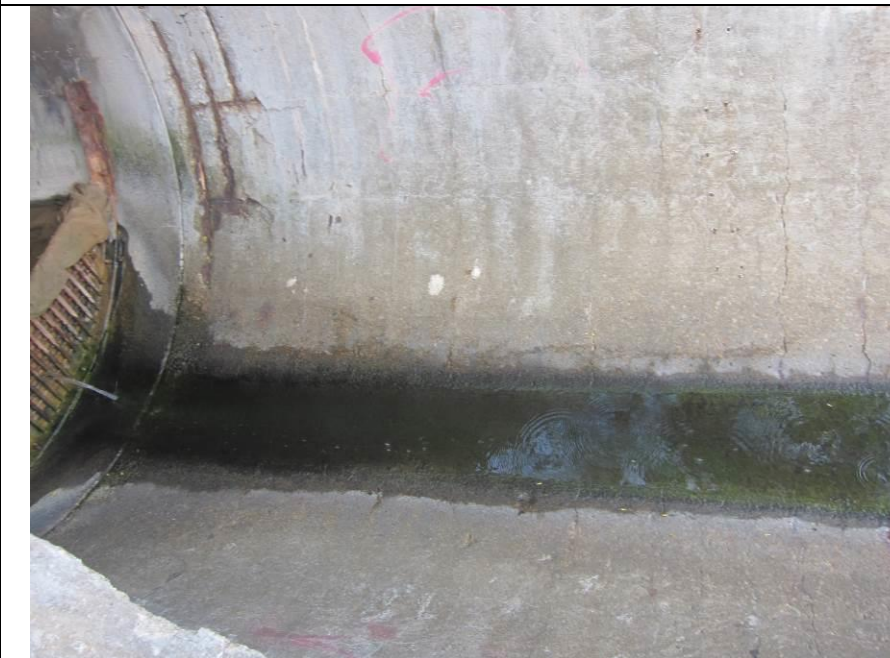
Outfall 1: No water is discharging.

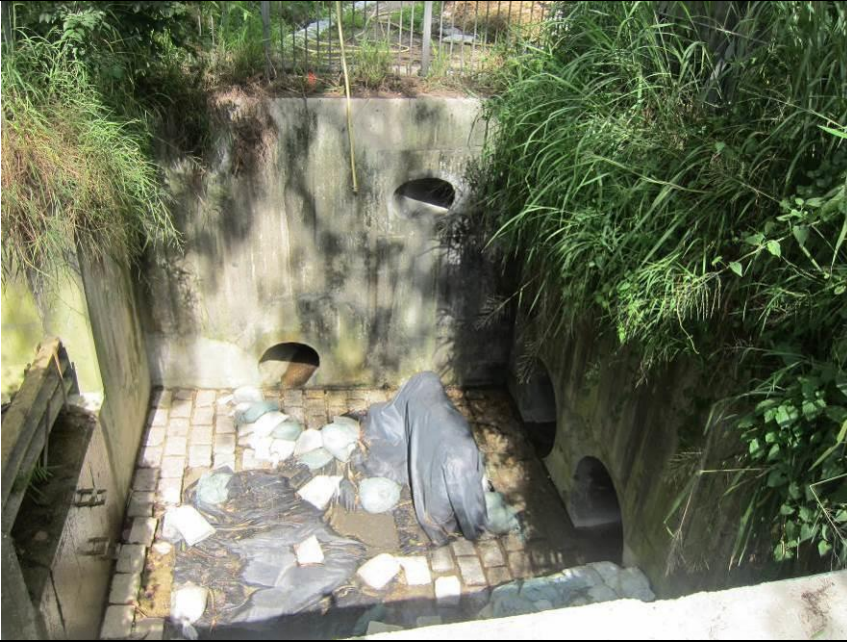
Stream B Outfall: No water is discharging.

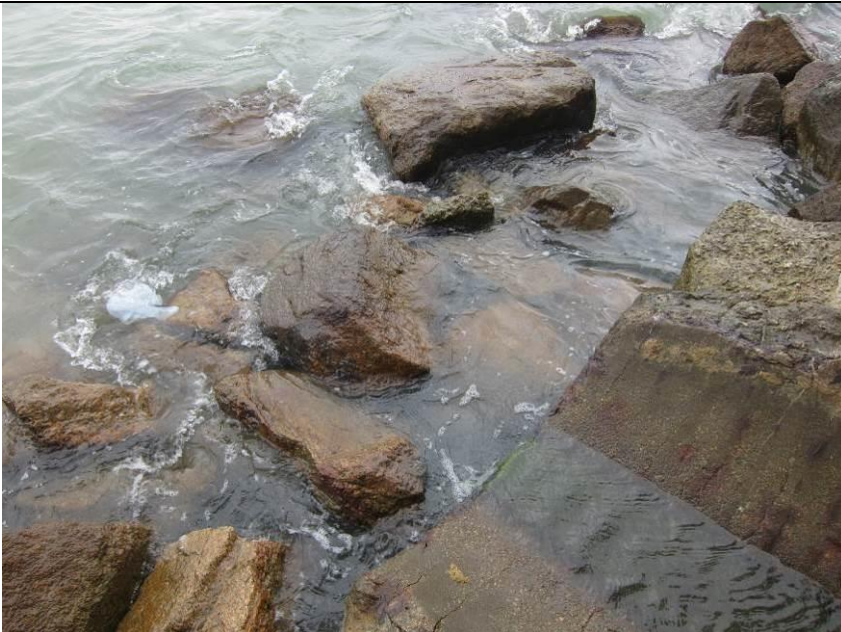
Outfall 1: Clean water is discharging.

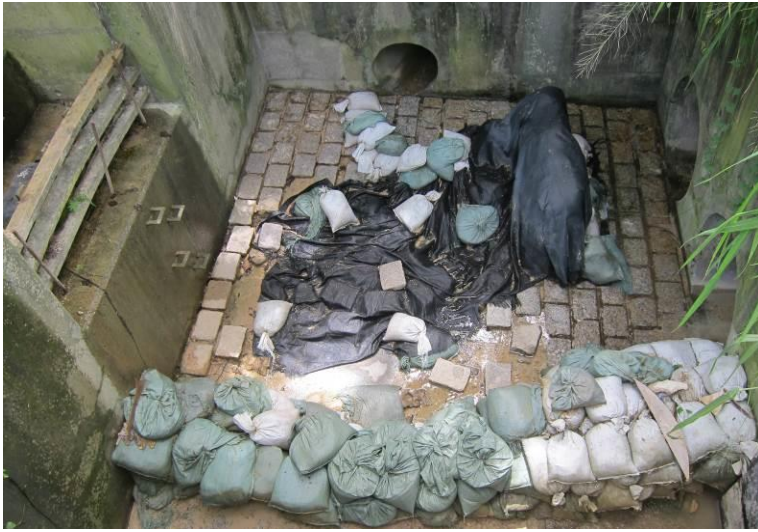
Stream B Outfall: No water is discharging.

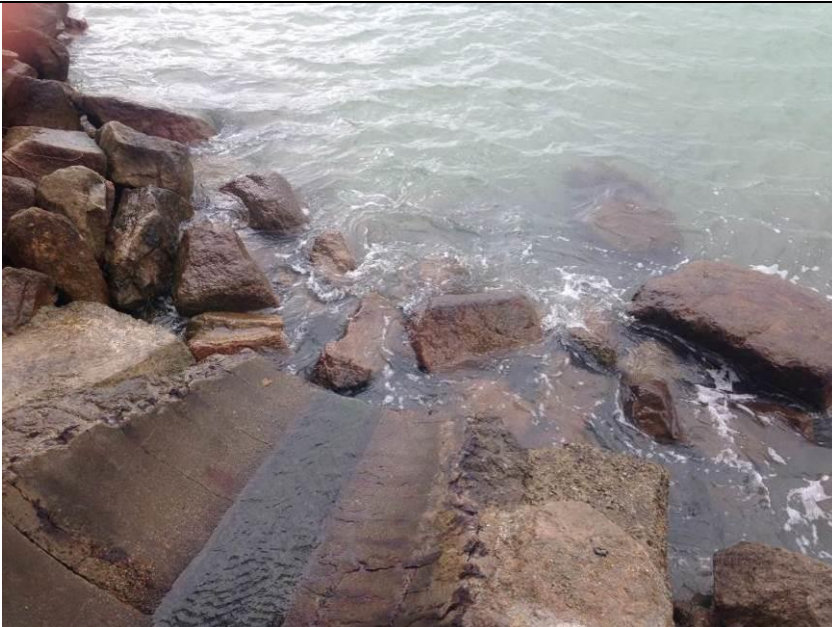
Outfall 1: Clean water is discharging.

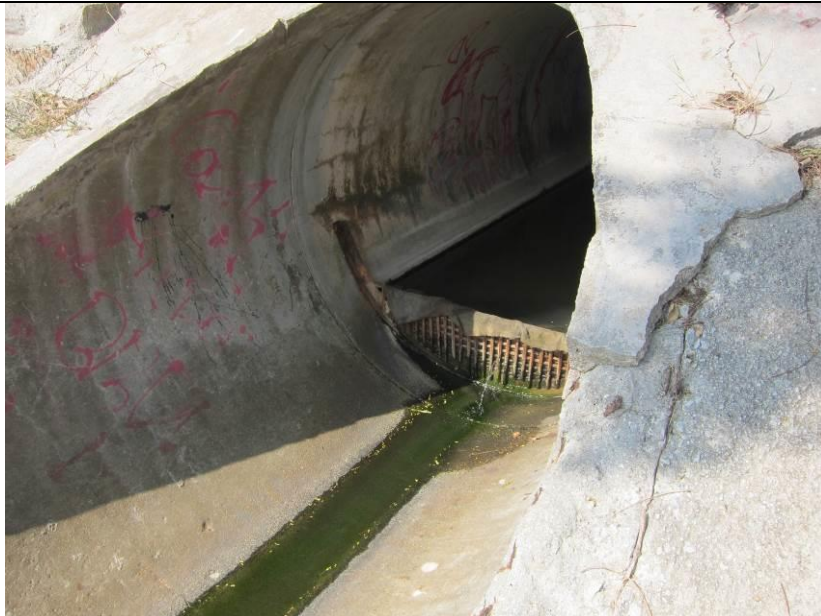
Outfall 1: No water is discharging.

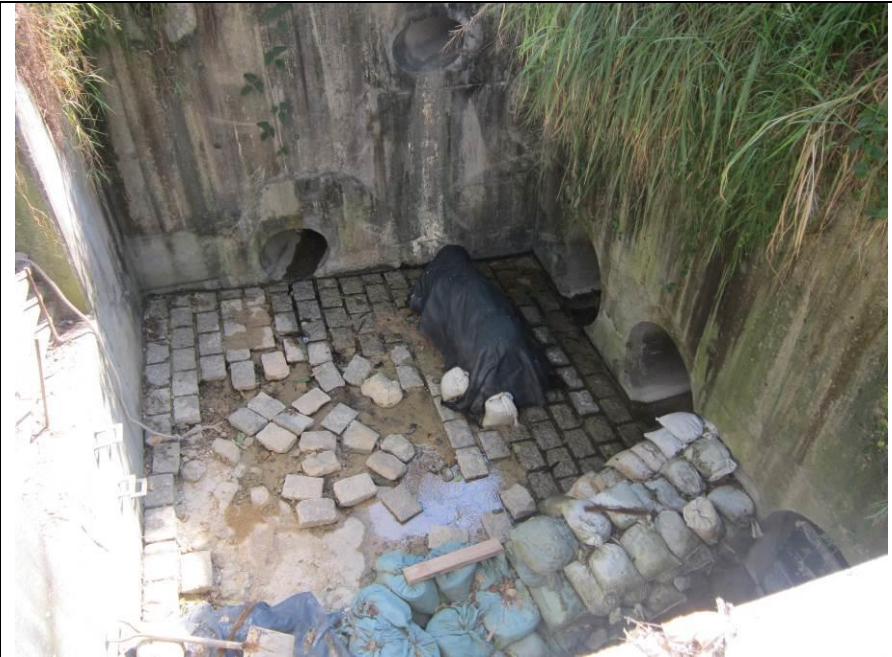
Stream B Outfall: No water is discharging.

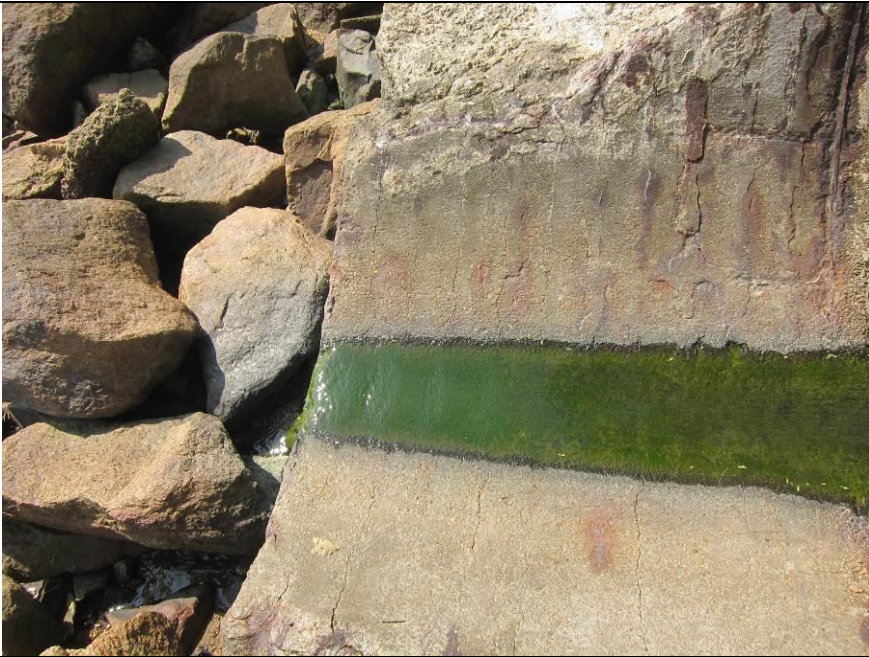
Outfall 1: No water is discharging.

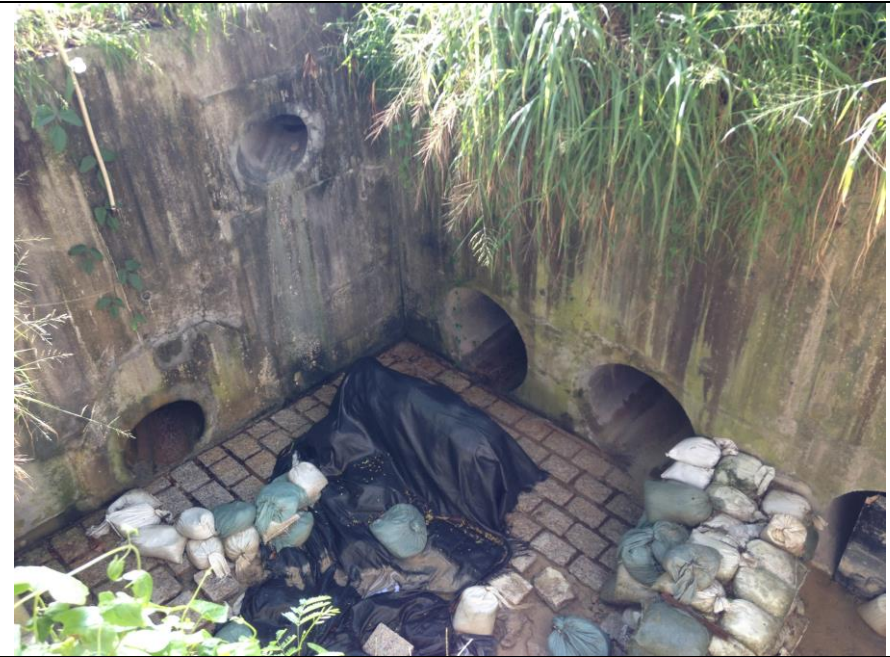
Stream B Outfall: No water is discharging.

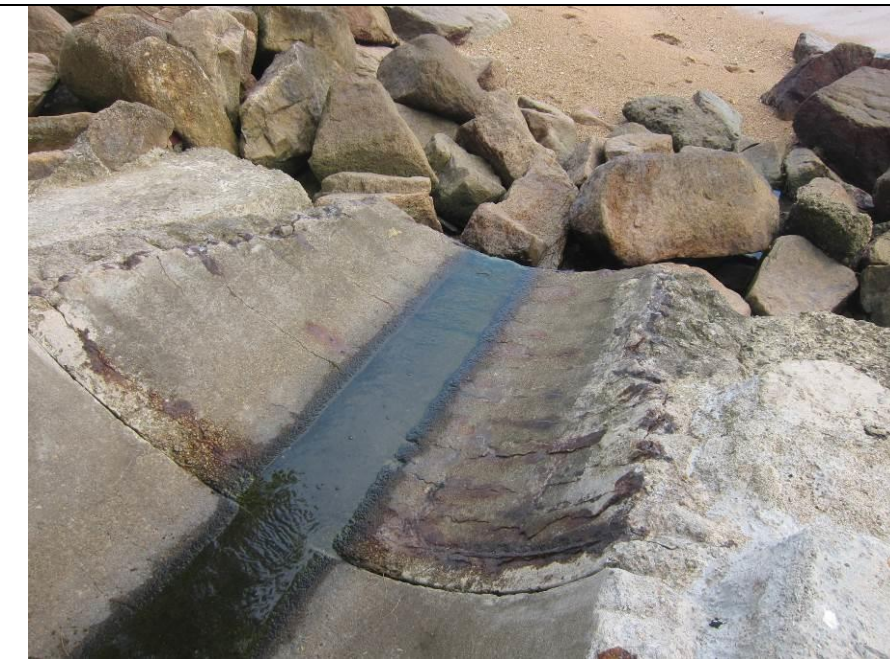
Outfall 1: No water is discharging.

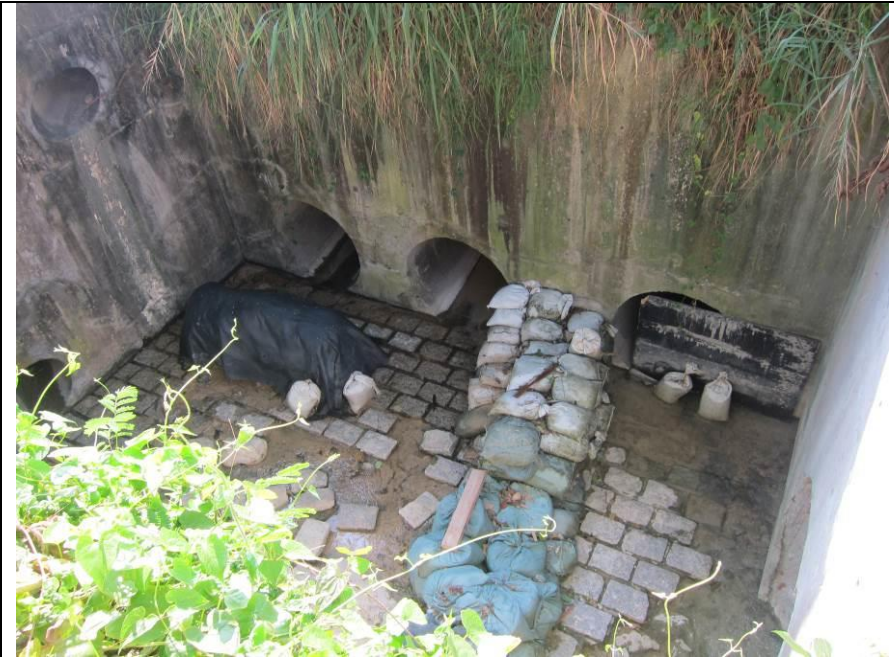
Stream B Outfall: No water is discharging.

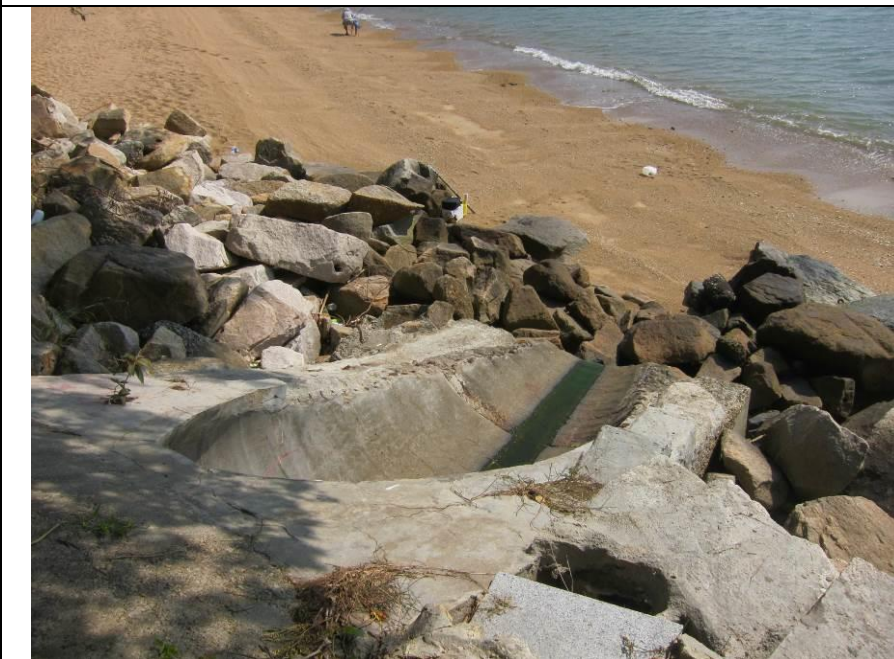
Outfall 1: No water is discharging.

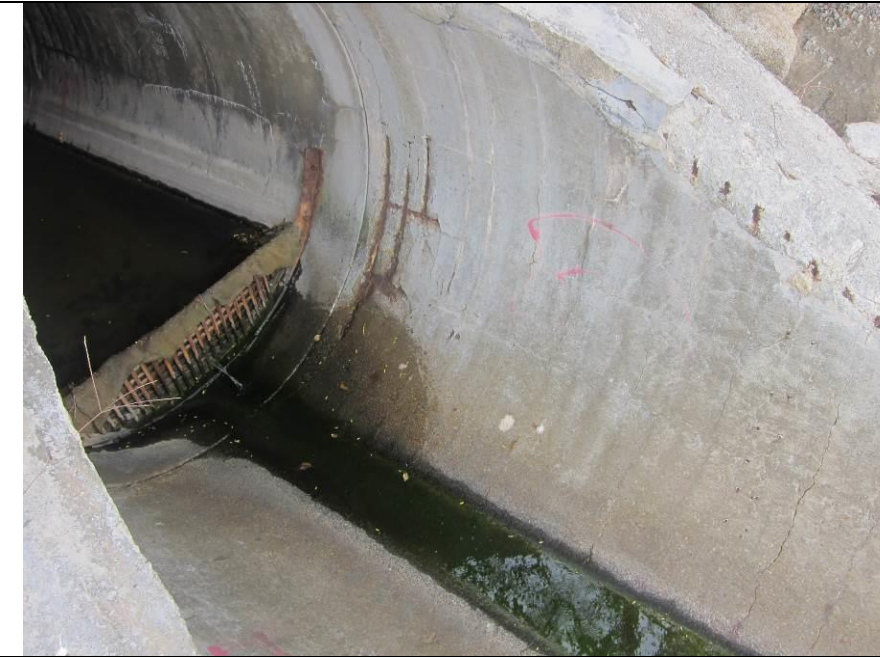
Outfall 1: No water is discharging.
