Annex A1

Built Heritage Resources: Baseline Studies and Impact Assessments

Police Headquarters Block (01)

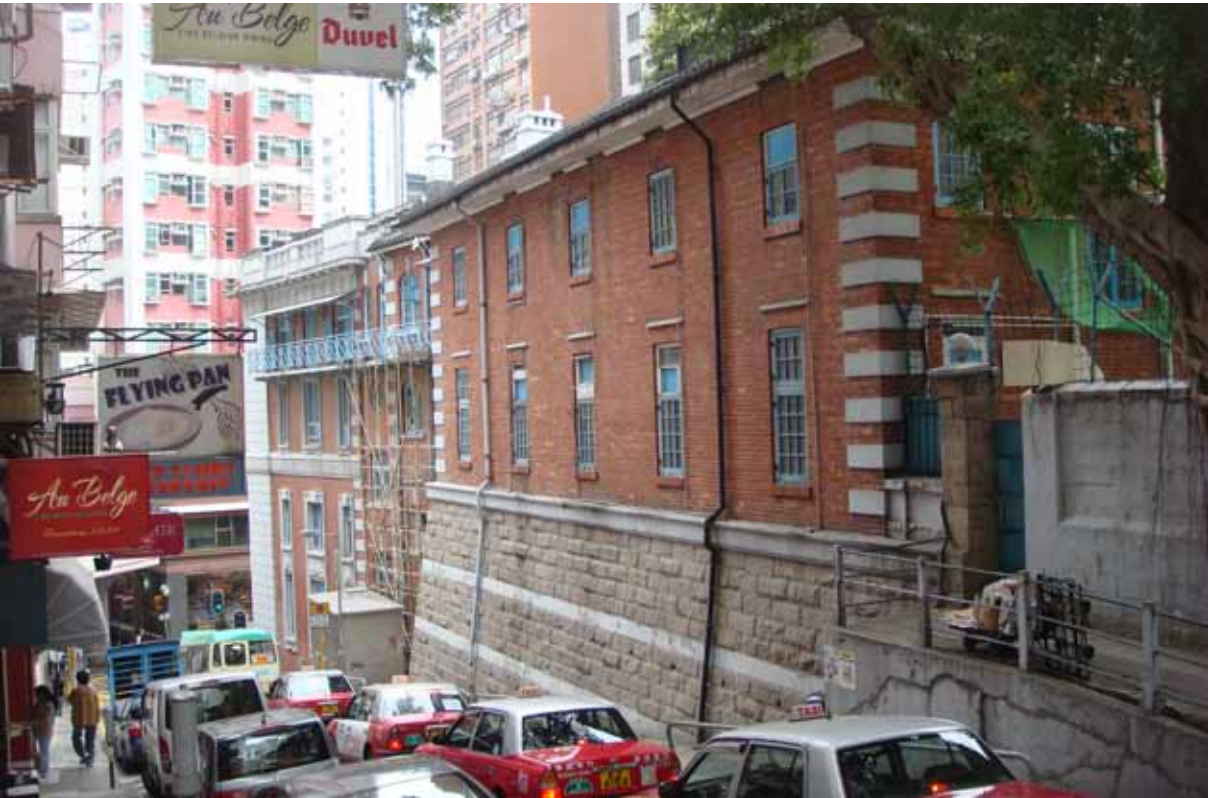
Figure 2 - West (Old Bailey Street) elevation

6.5 West Elevation	1	Repair and reinstatement of the windows to a consistent glazing pattern with new windows of painted hardwood.	See Section 5.1
7	Interiors

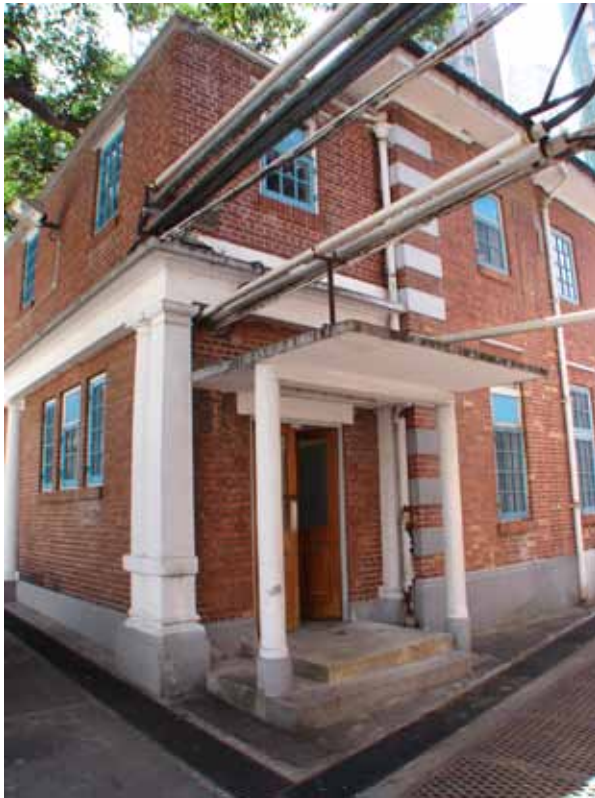
Figure 4 - Canopy on north elevation

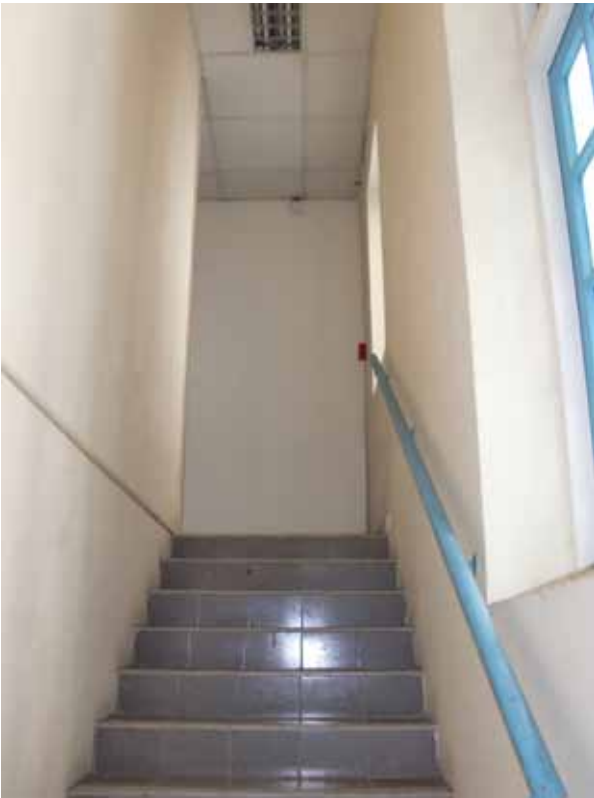
Figure 5 - Existing staircase in the south part of the building

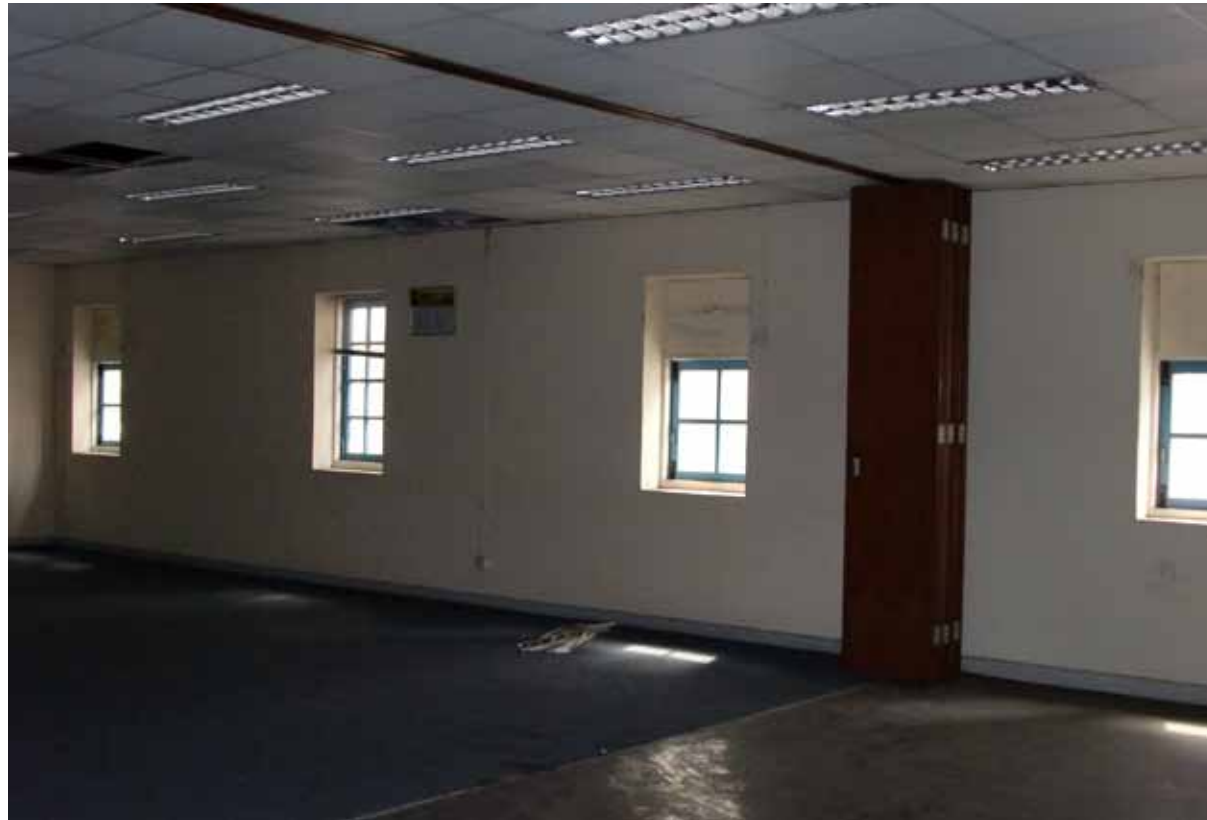
Figure 6 - First floor interior as fitted out for its final use by the Traffic Police

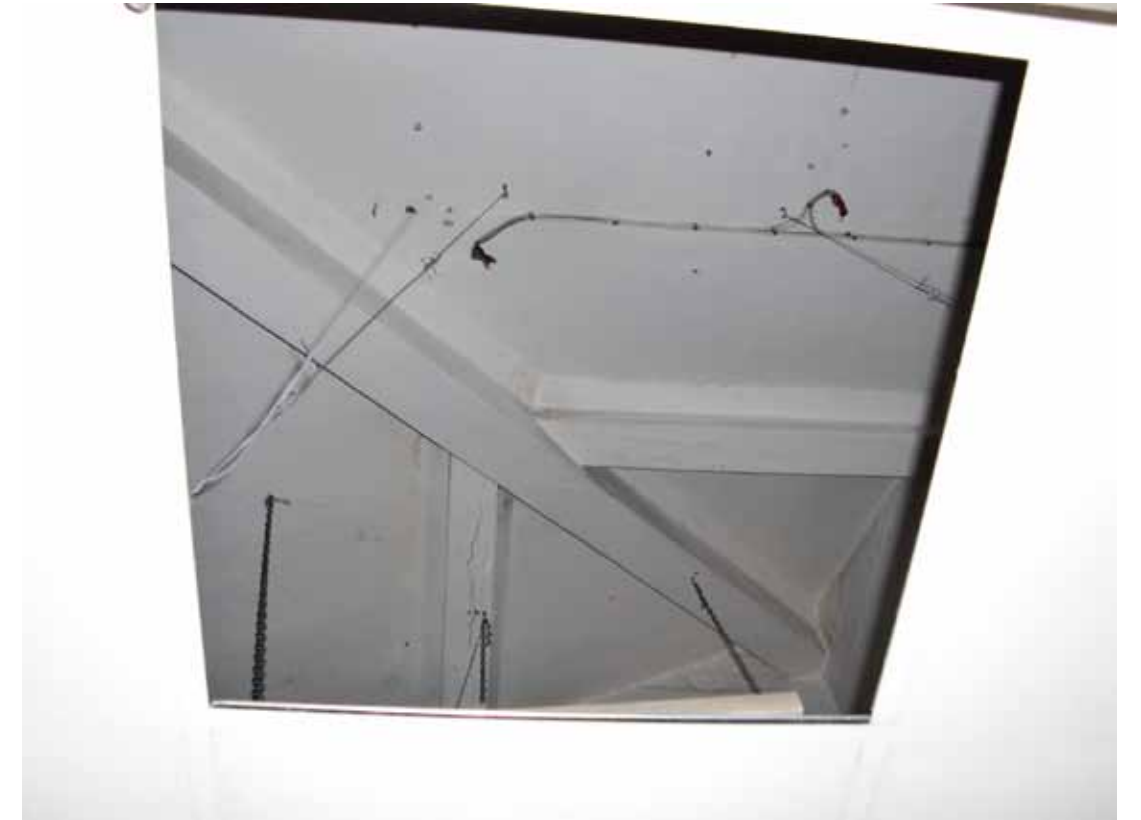
Figure 7 - Ceiling structure in 02/F/09

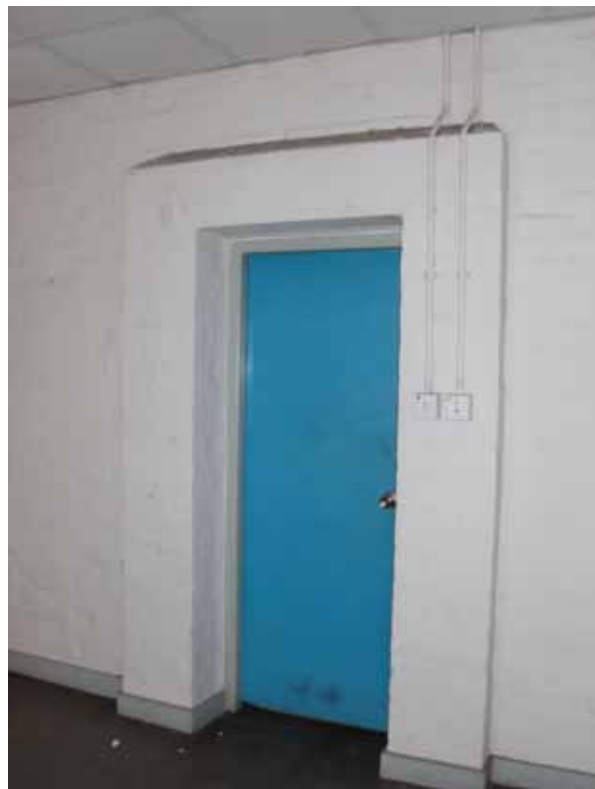
Figure 8 - Door into room 02/F/09

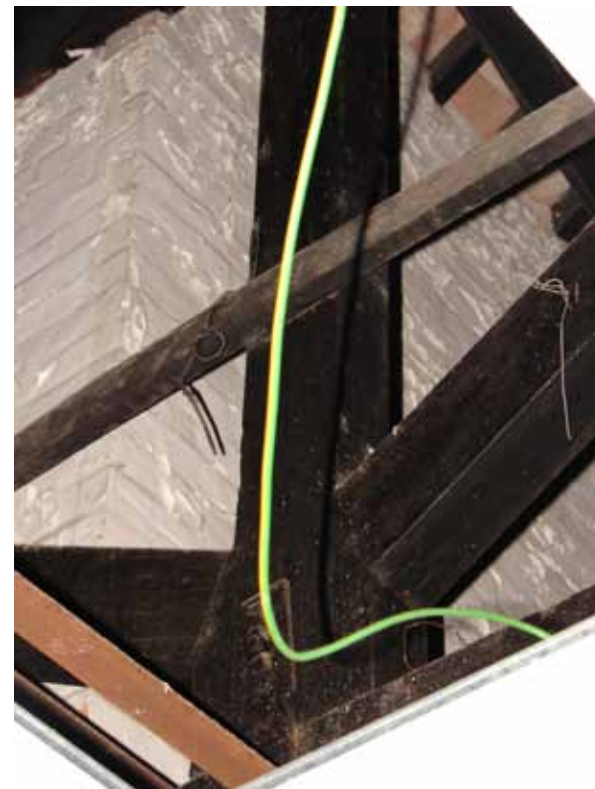
Figure 9 - Roof truss

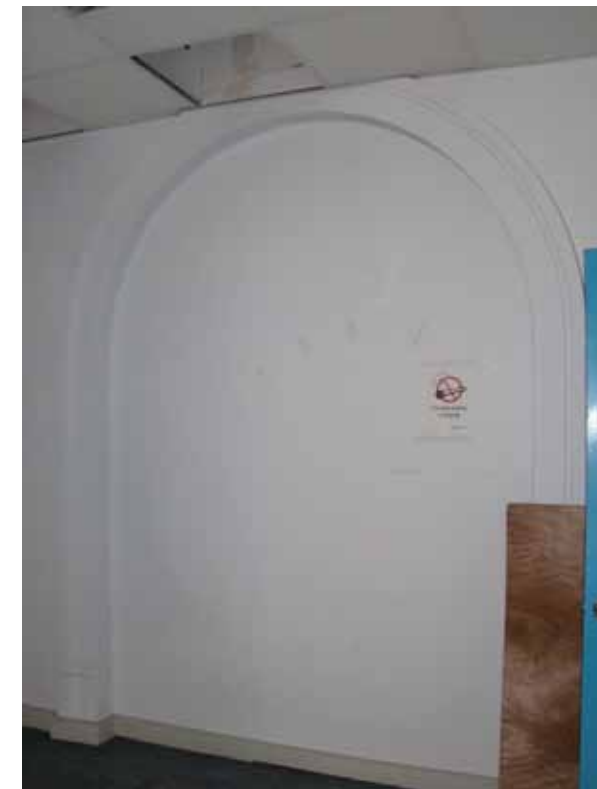
Figure 10 - Blocked archway in 02/G/03

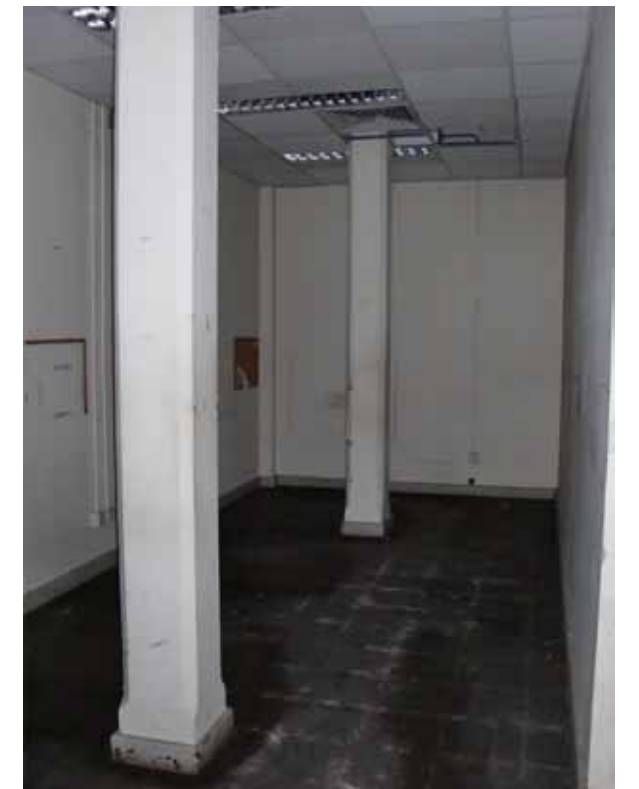
Figure 11 - Original columns in 02/G/09

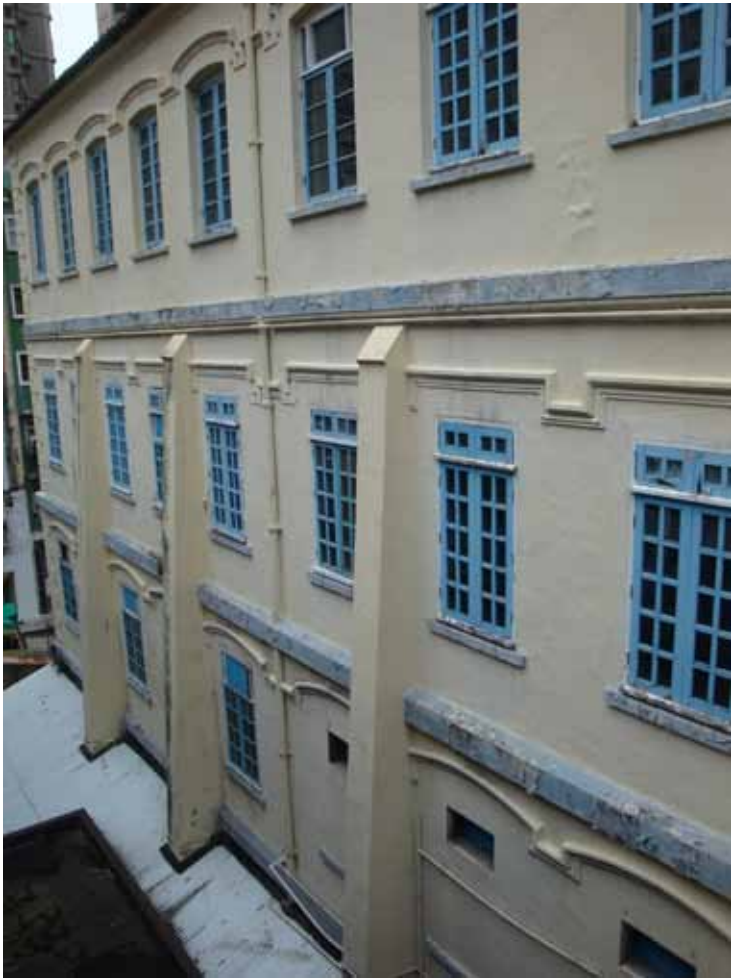
Figure 3 - Partial view of the south elevation showing blocked windows on the ground floor, and buttresses added c.1906

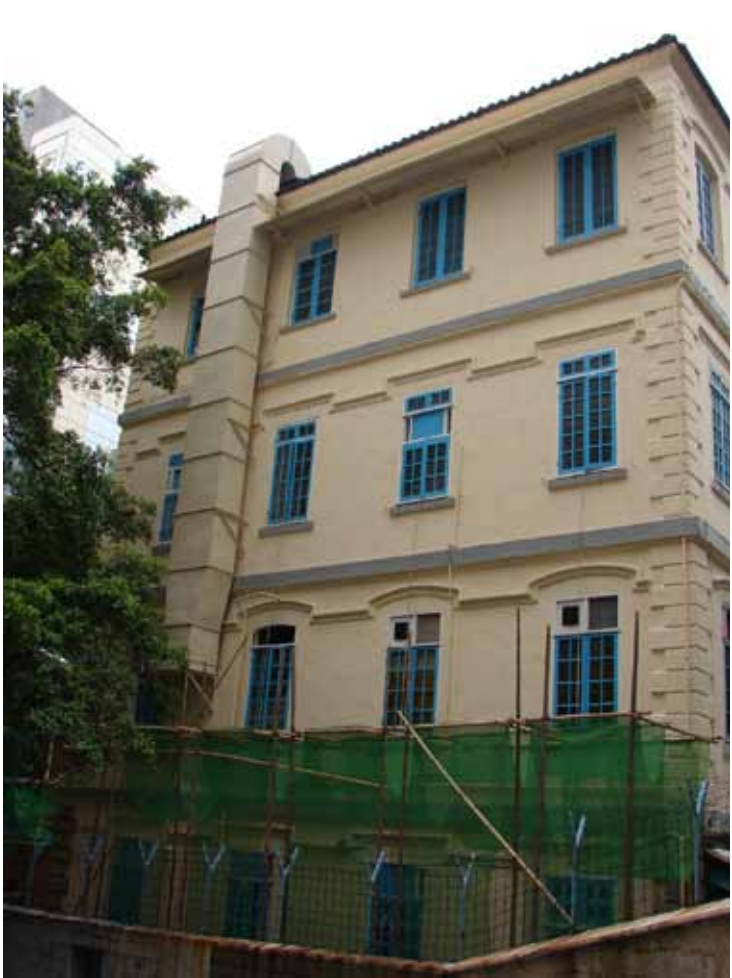
Figure 4 - West elevation showing large ductwork for one of the modern kitchens and third floor corrugated metal sunshade

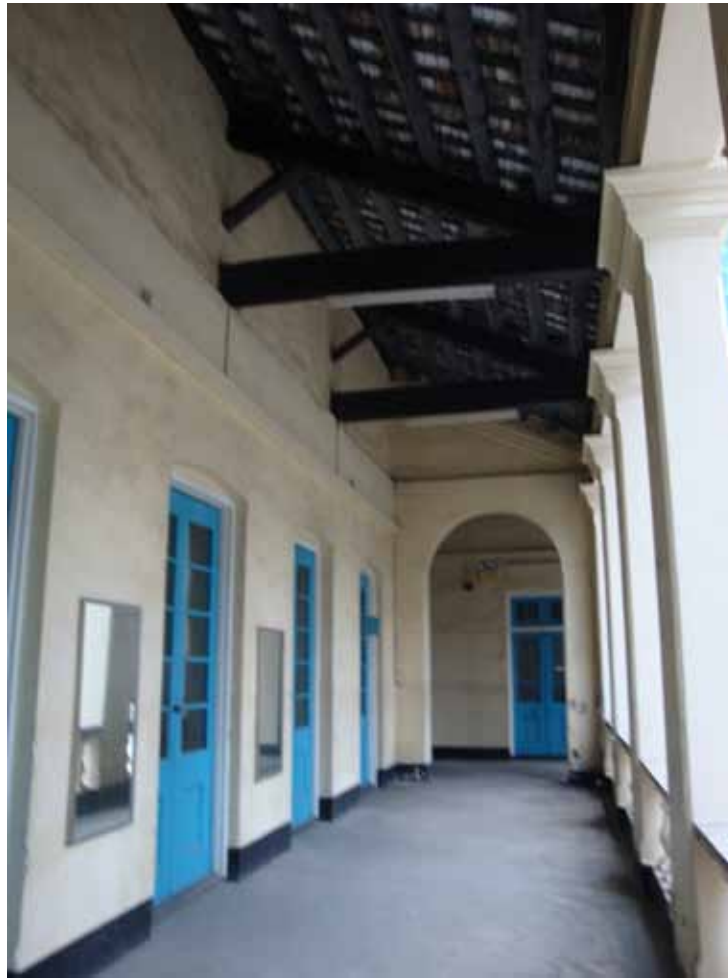
Figure 5 - Third floor verandah with exposed ceiling structure

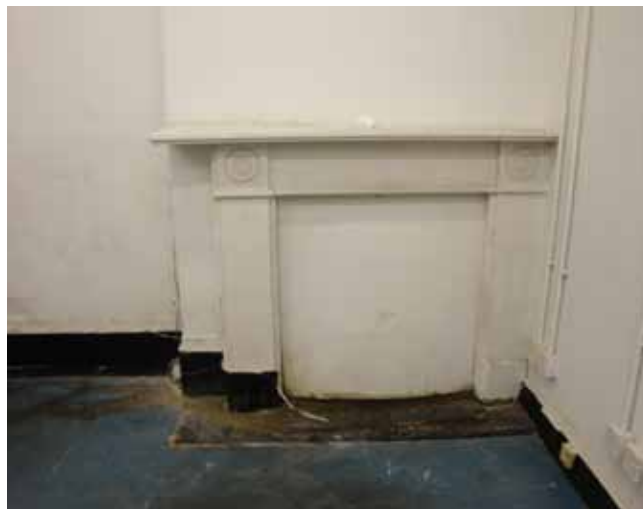
Figure 8 - The last surviving fireplace in the building, in one of the ground floor west rooms

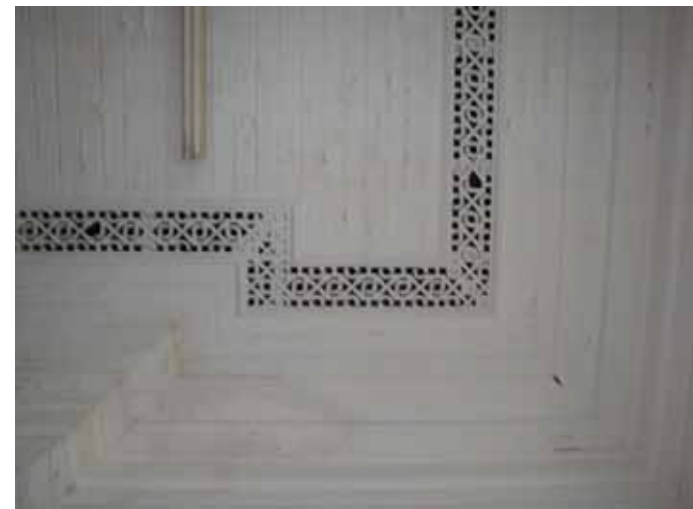
Figure 10 - Third floor ceiling with metal ventilation grille c.1929

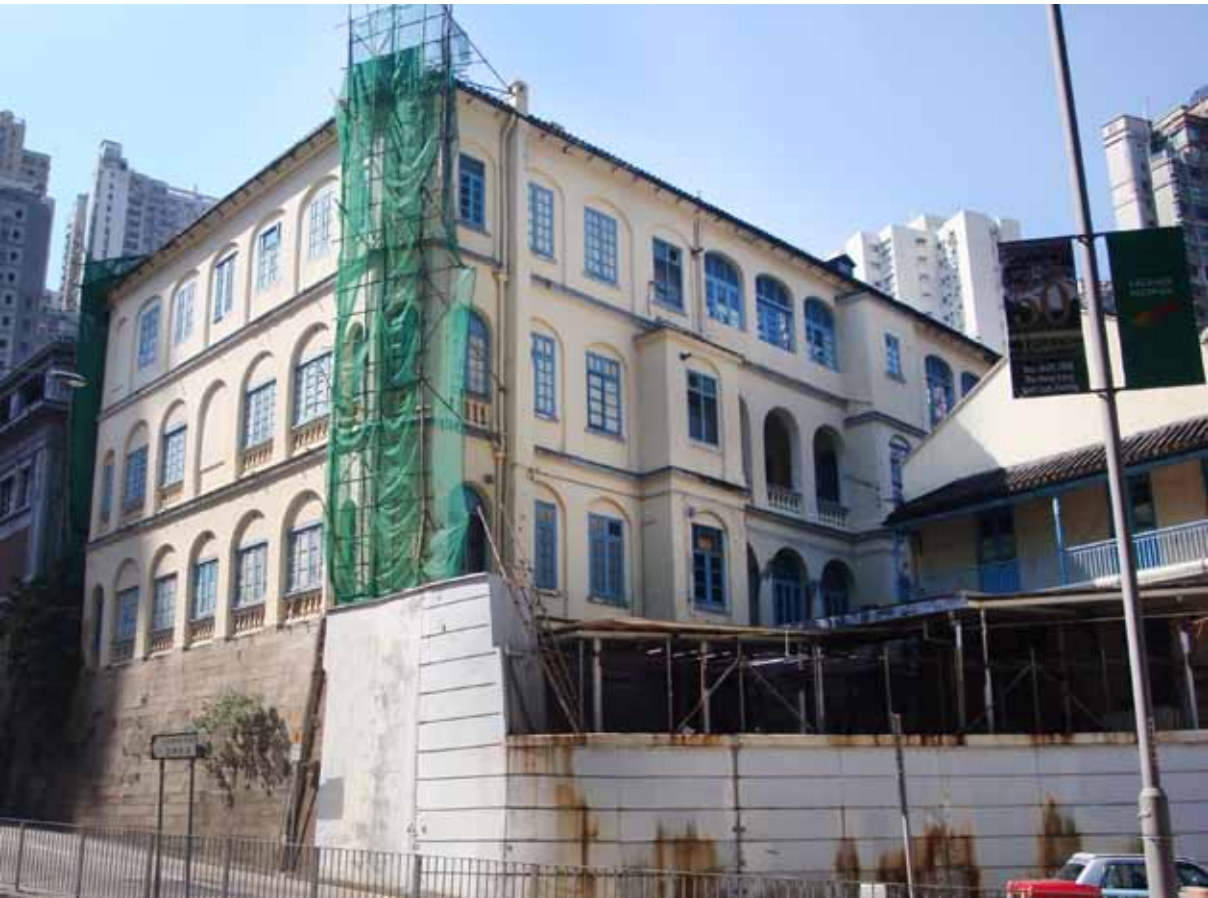
Figure 3 - North and east elevations

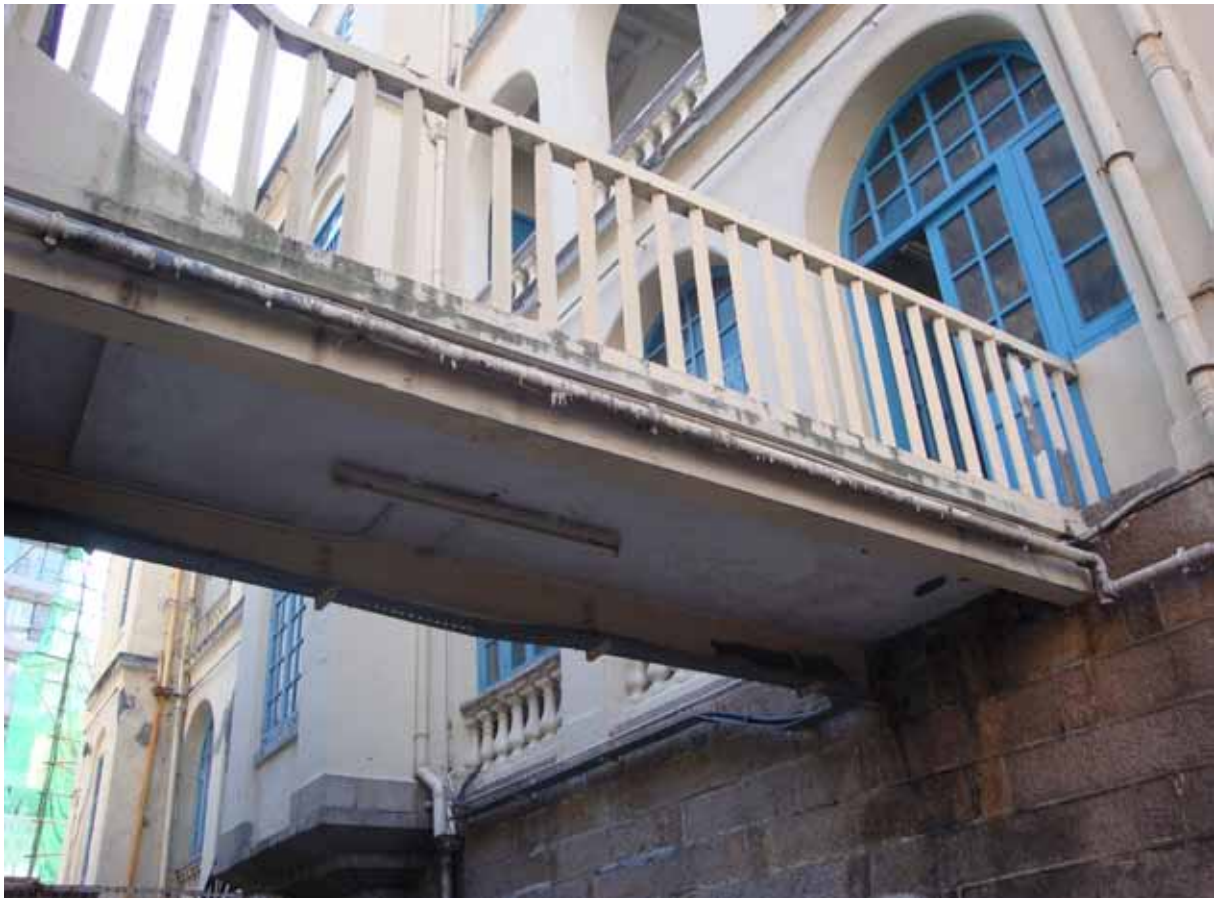
Figure 4 - Link bridge between the north side of Building 04 and the south side of Building 06

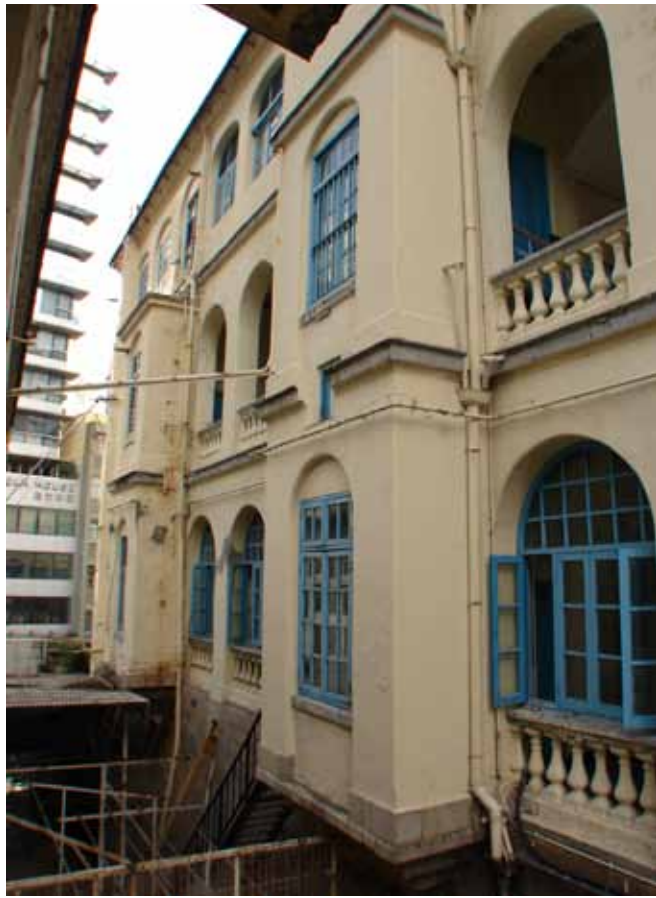
Figure 5 - North elevation detail showing projecting bay

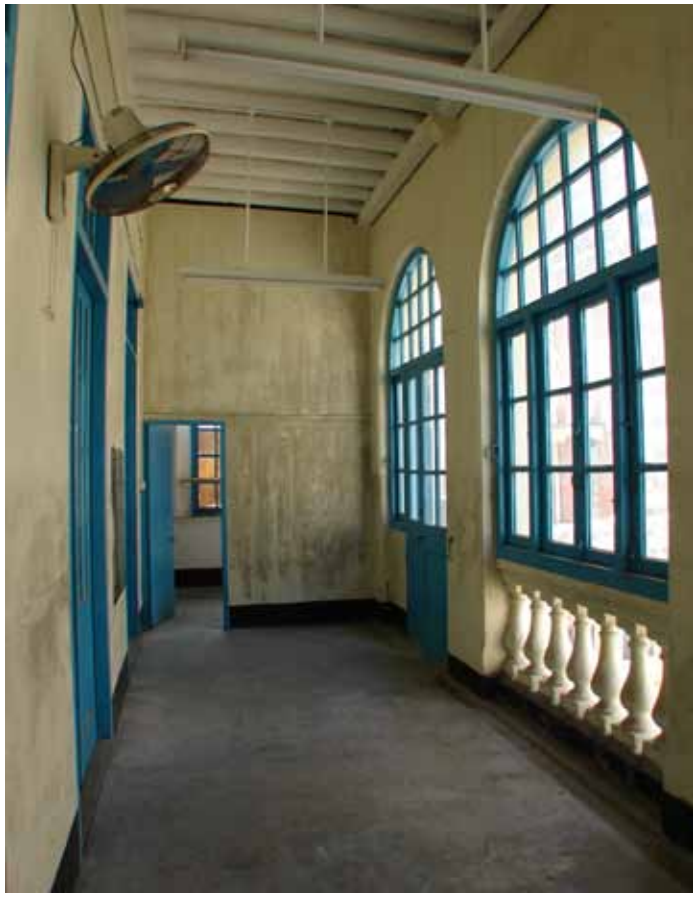
Figure 7 - Typical north verandah

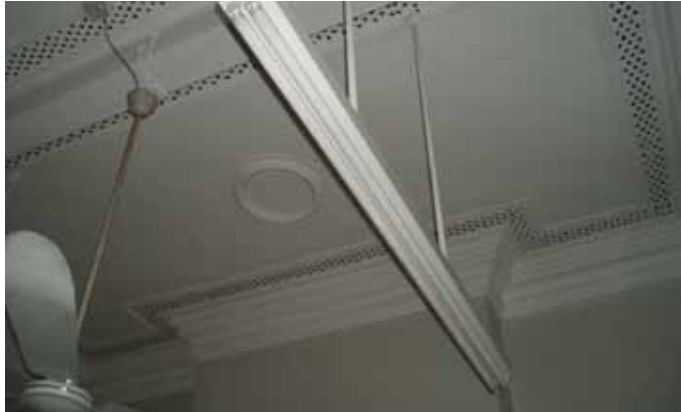
Figure 8 - View of the ceiling in the second floor Married Inspector's Quarters (west block)

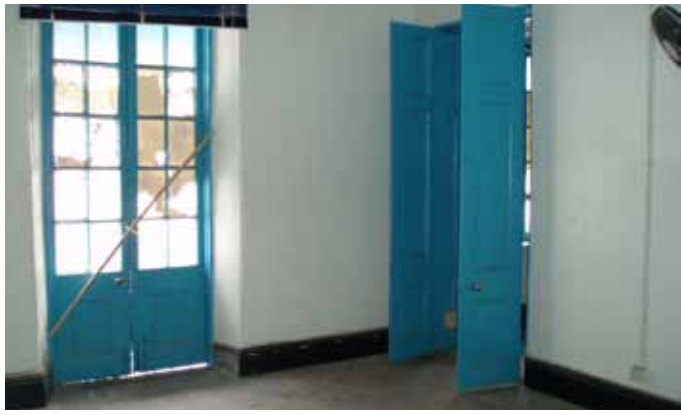
Figure 9 - View of the second floor Married Inspector's Quarters (west block)

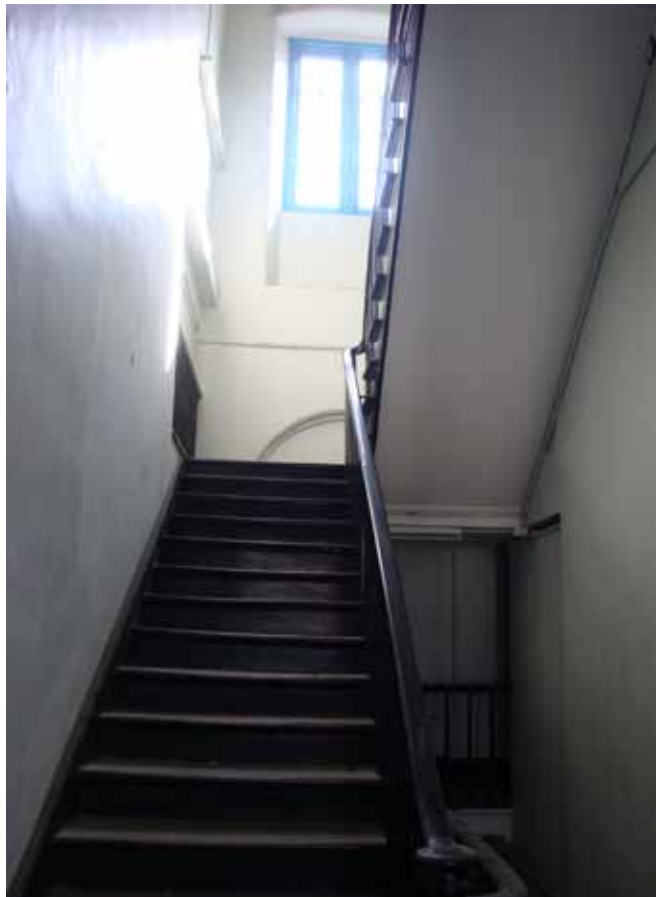
Figure 10 - West block stair

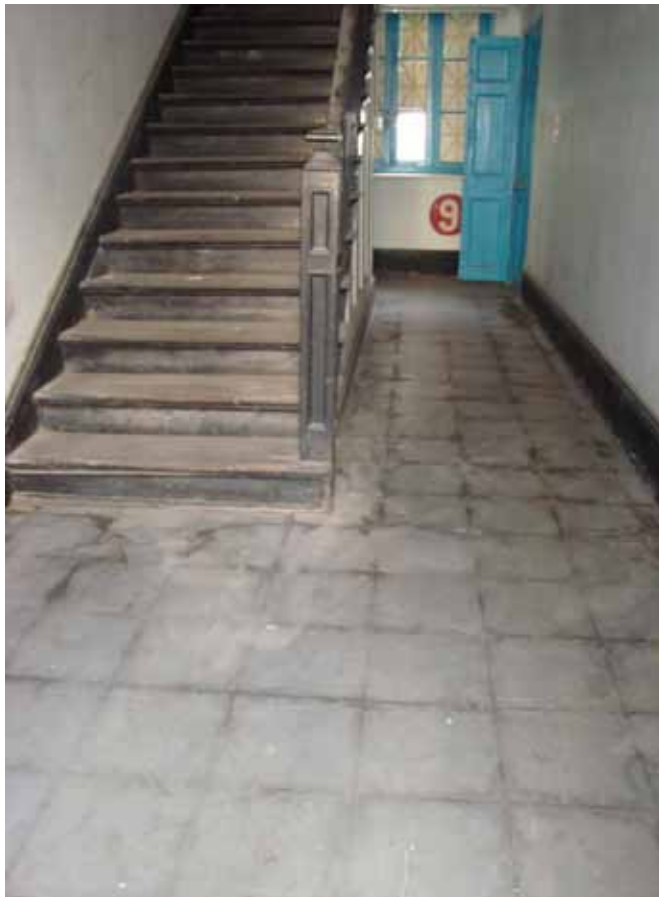
Figure 11 - View of the ground floor of the Deputy Superintendents' House (east block) staircase

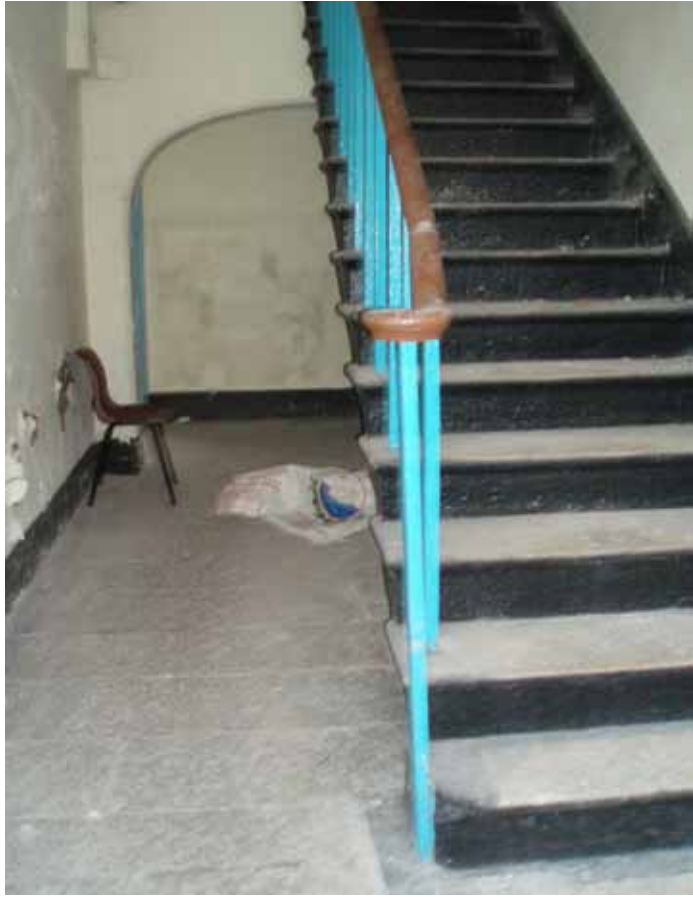
Figure 12 - View of the ground floor of the Married Inspector's Quarters west entrance hall

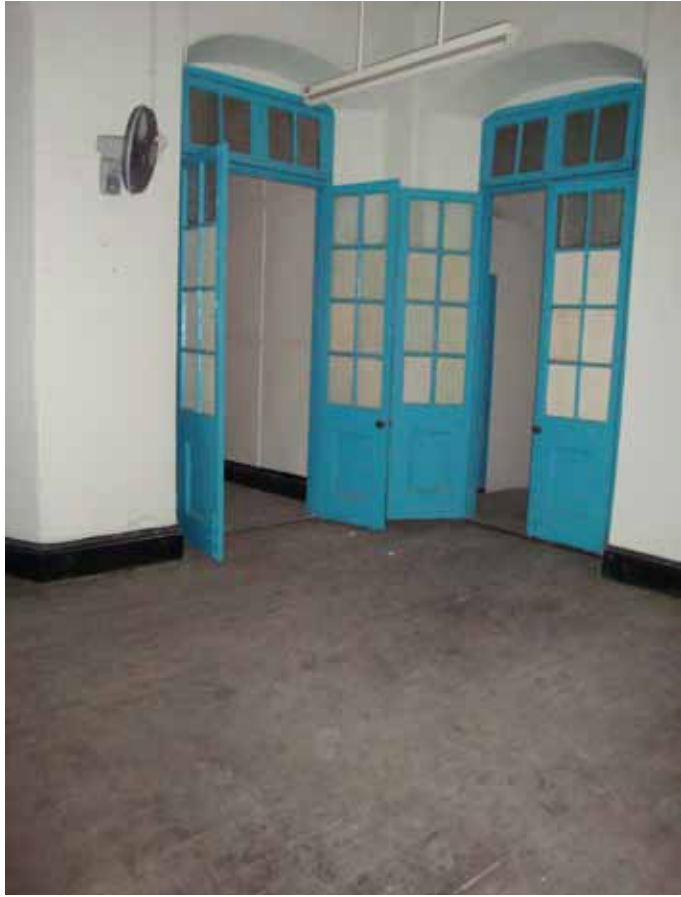
Figure 13 - Internal doors

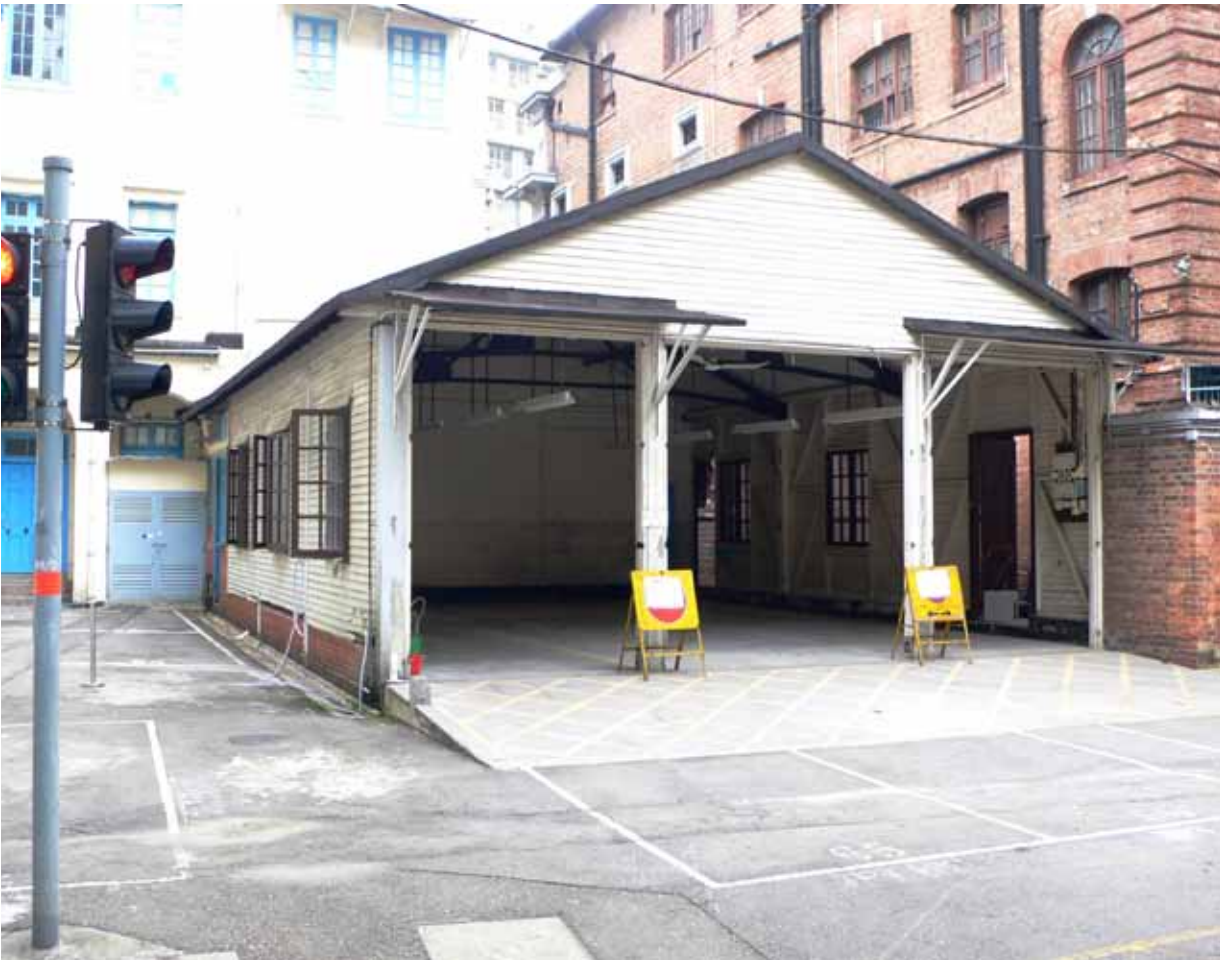
Figure 1 - View of the building from the Parade Ground to the west

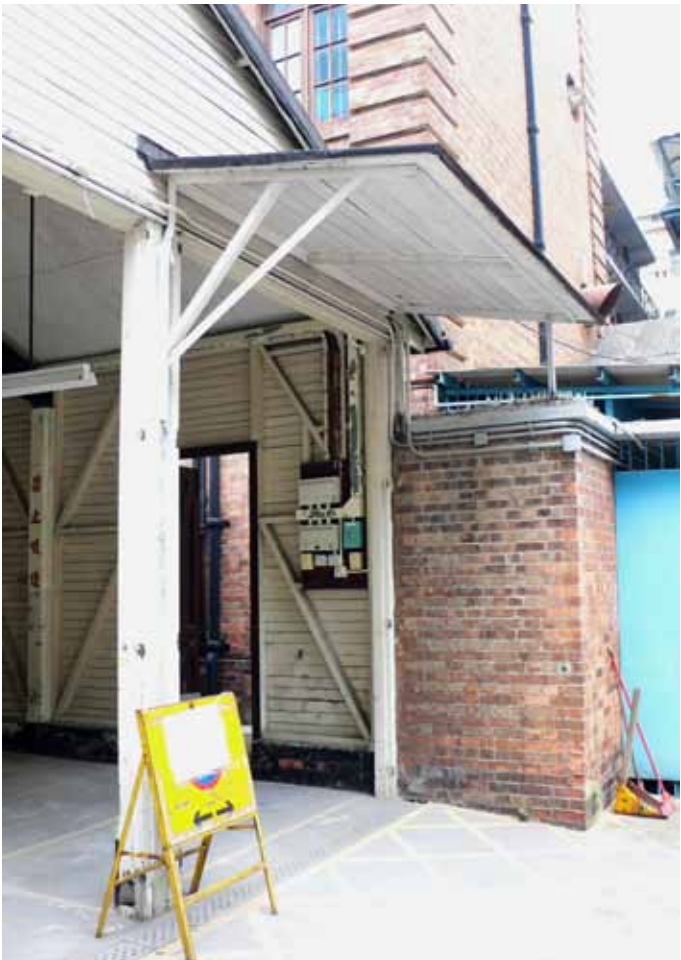
Figure 2 - Detail view of a sunshade on the west side

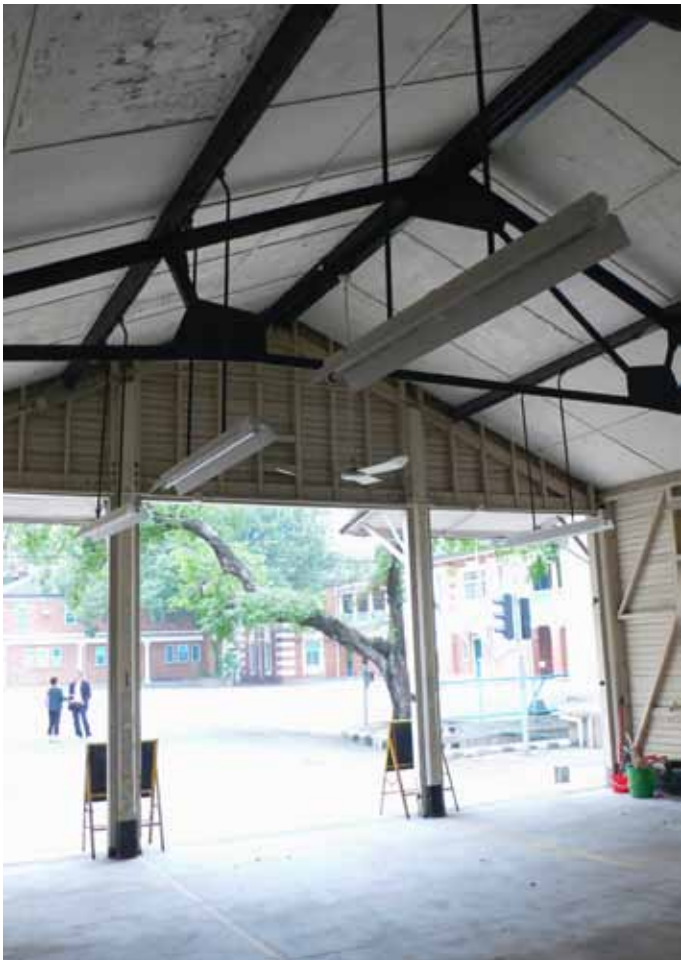
Figure 3 - View of the interior looking west

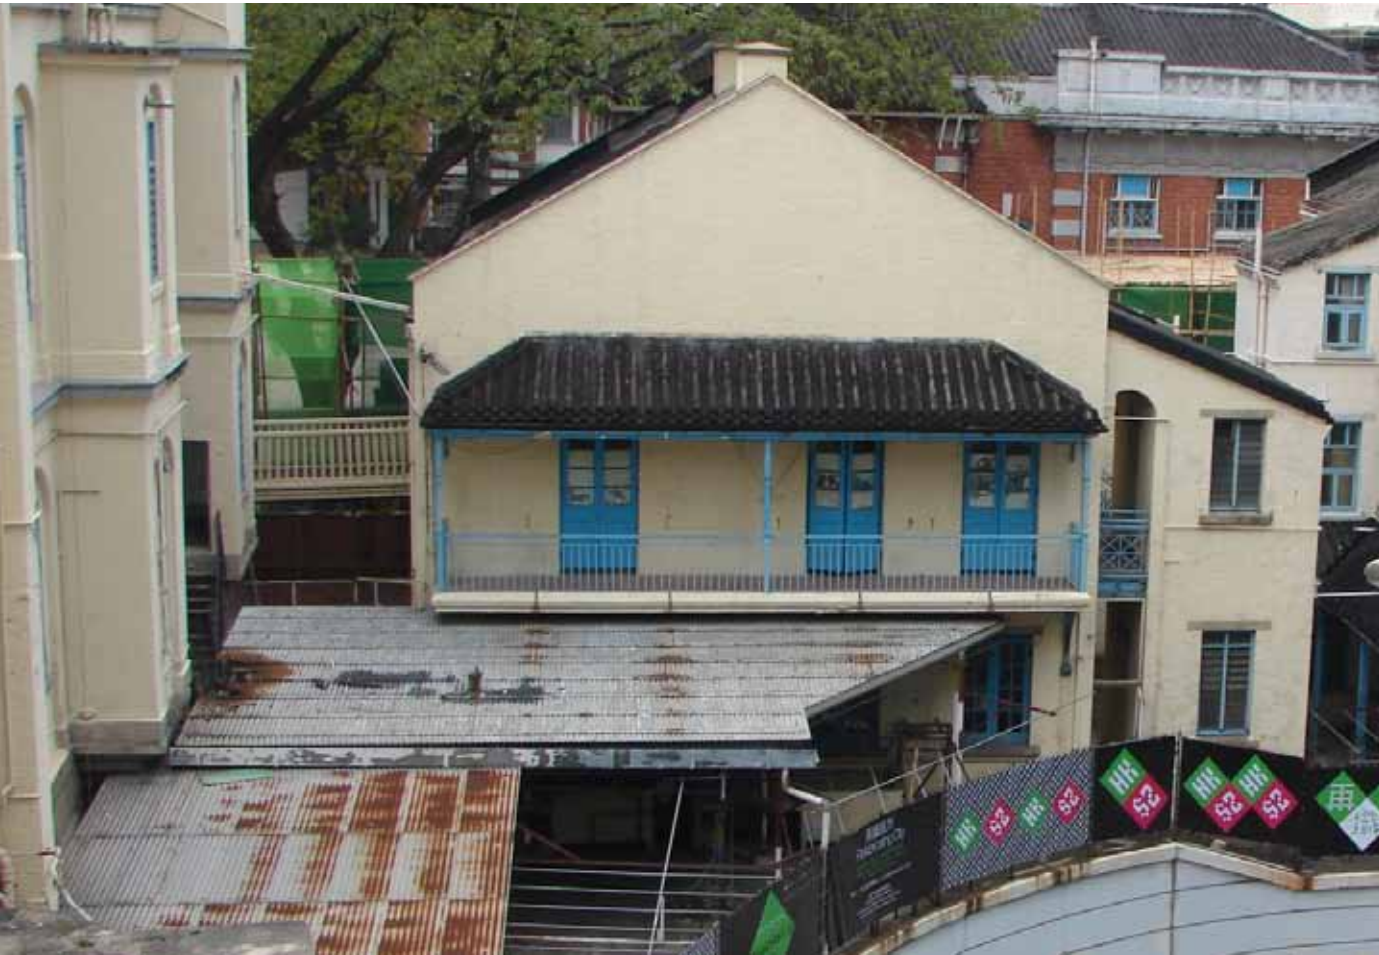
Figure 1 - East elevation of the building. The corrugated iron coverings have been partially removed since this photograph was taken.

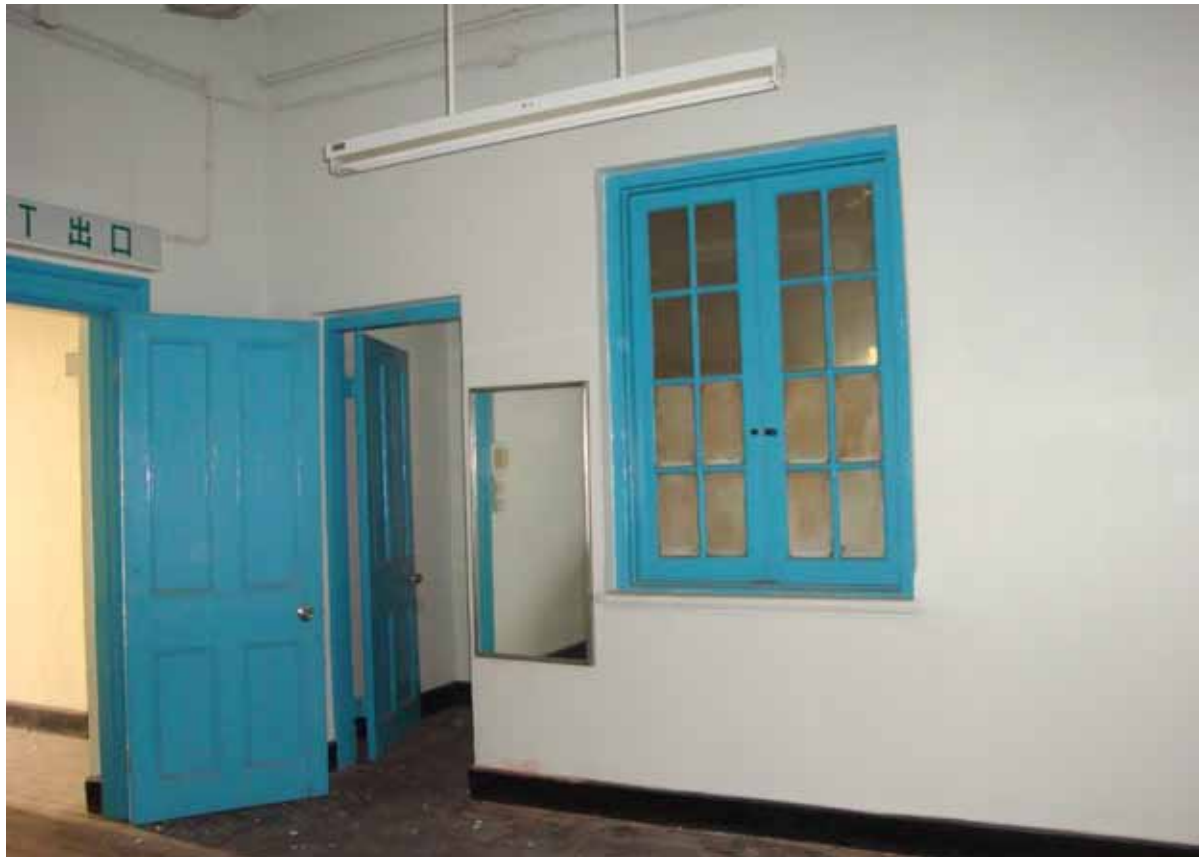
Figure 11 - Typical interior room with most of the original fittings and finishes intact

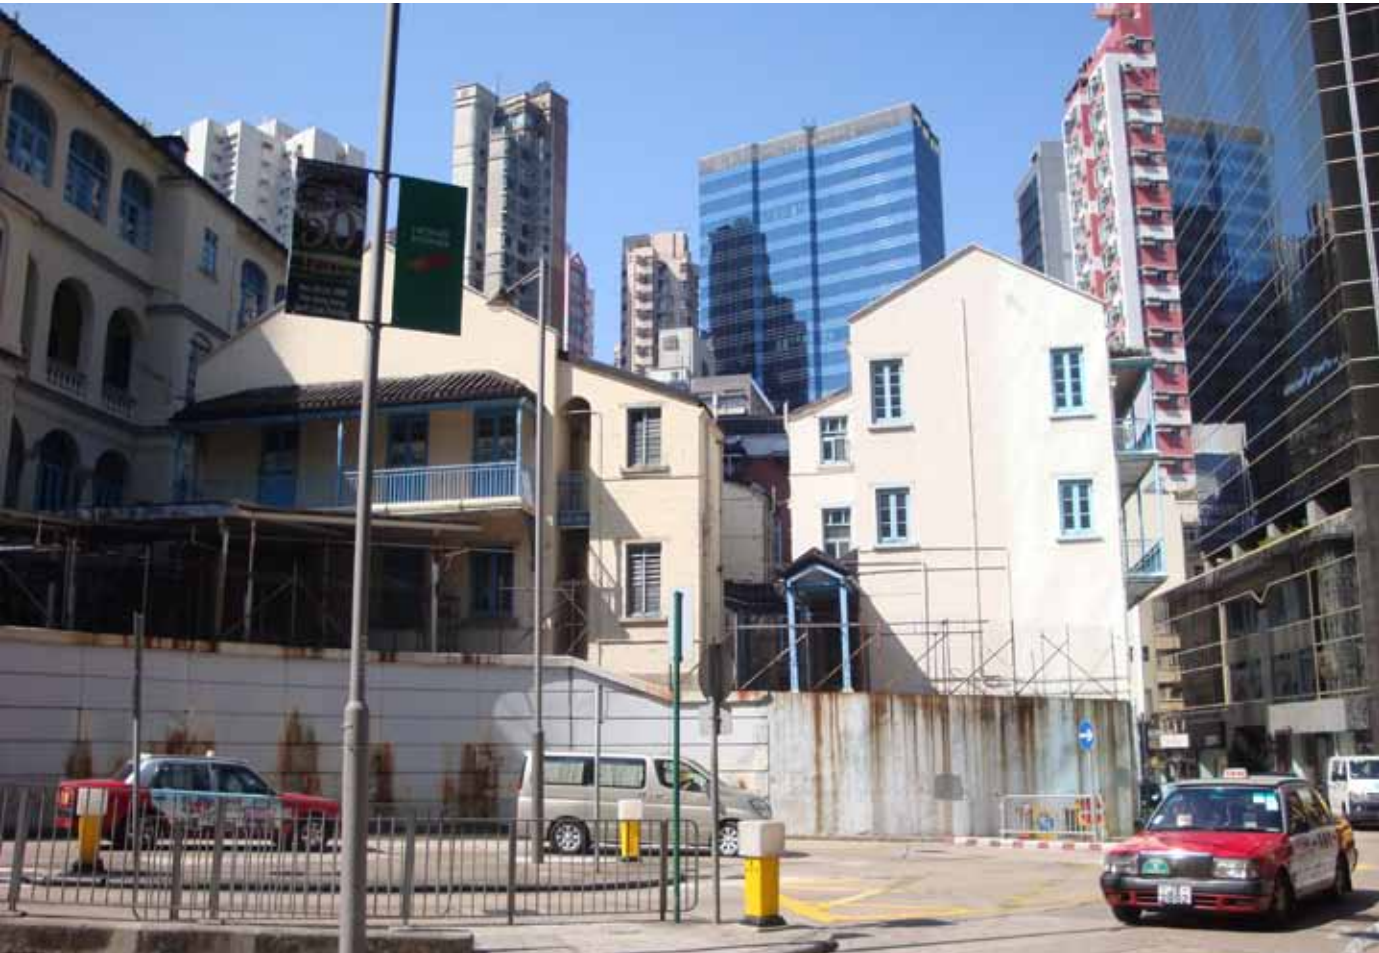
Figure 1 - East elevation of the building overlooking Arbuthnot Road. Building 07 is on the right side of the image.

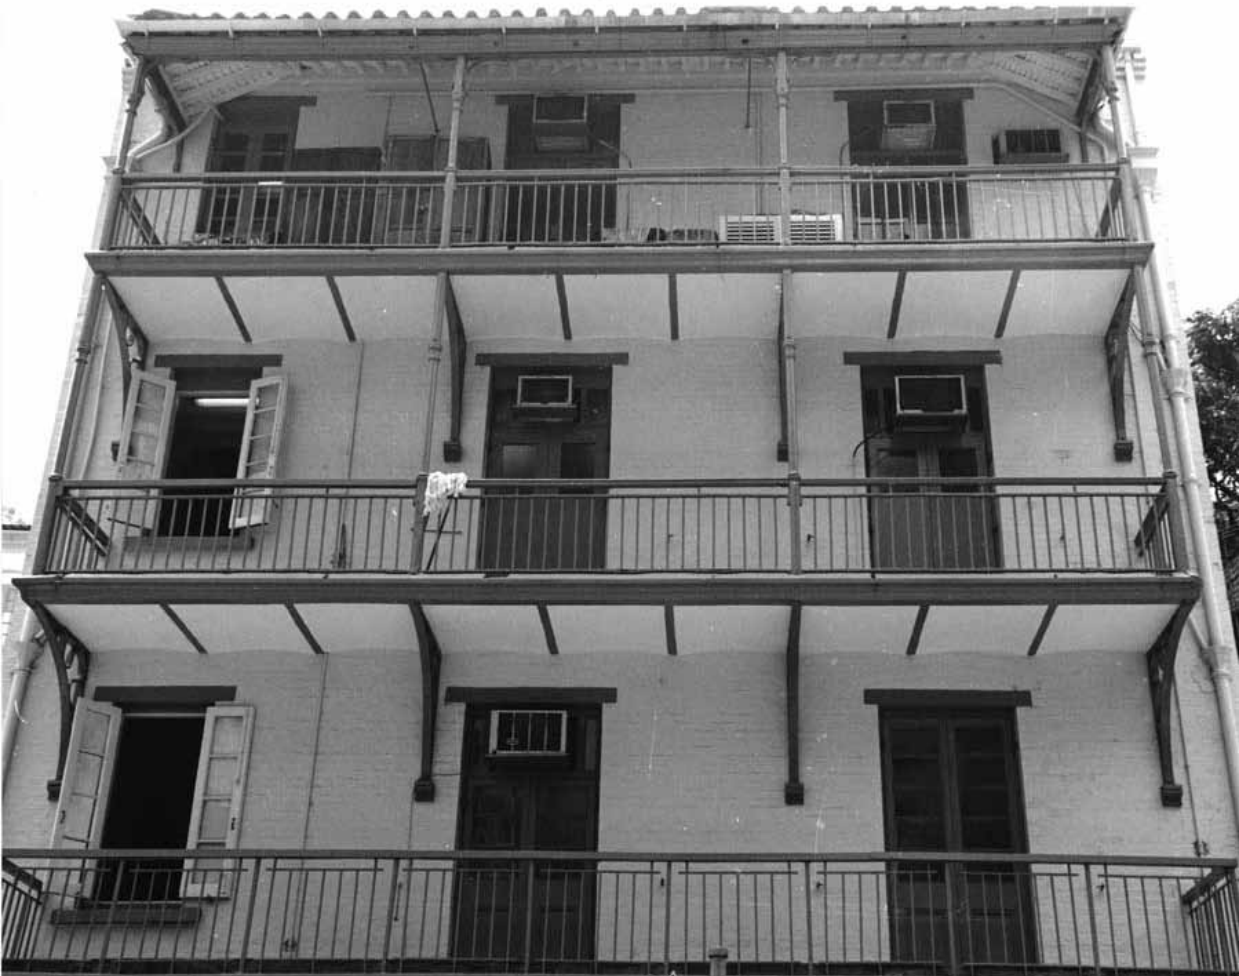
Late 20th century photograph (exact date not known) of the north elevation showing the ground floor balcony still in place and air-conditioning units installed.
