Annex A1

Built Heritage Resources: Baseline Studies and Impact Assessments

Police Headquarters Block (01)

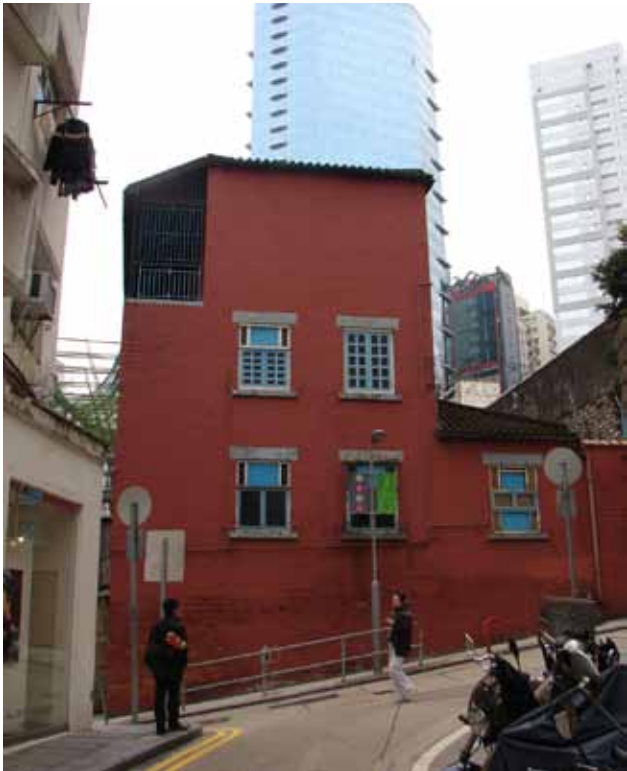
Figure 1 - West elevation as viewed from Staunton Street. Various alterations to the windows can be seen.

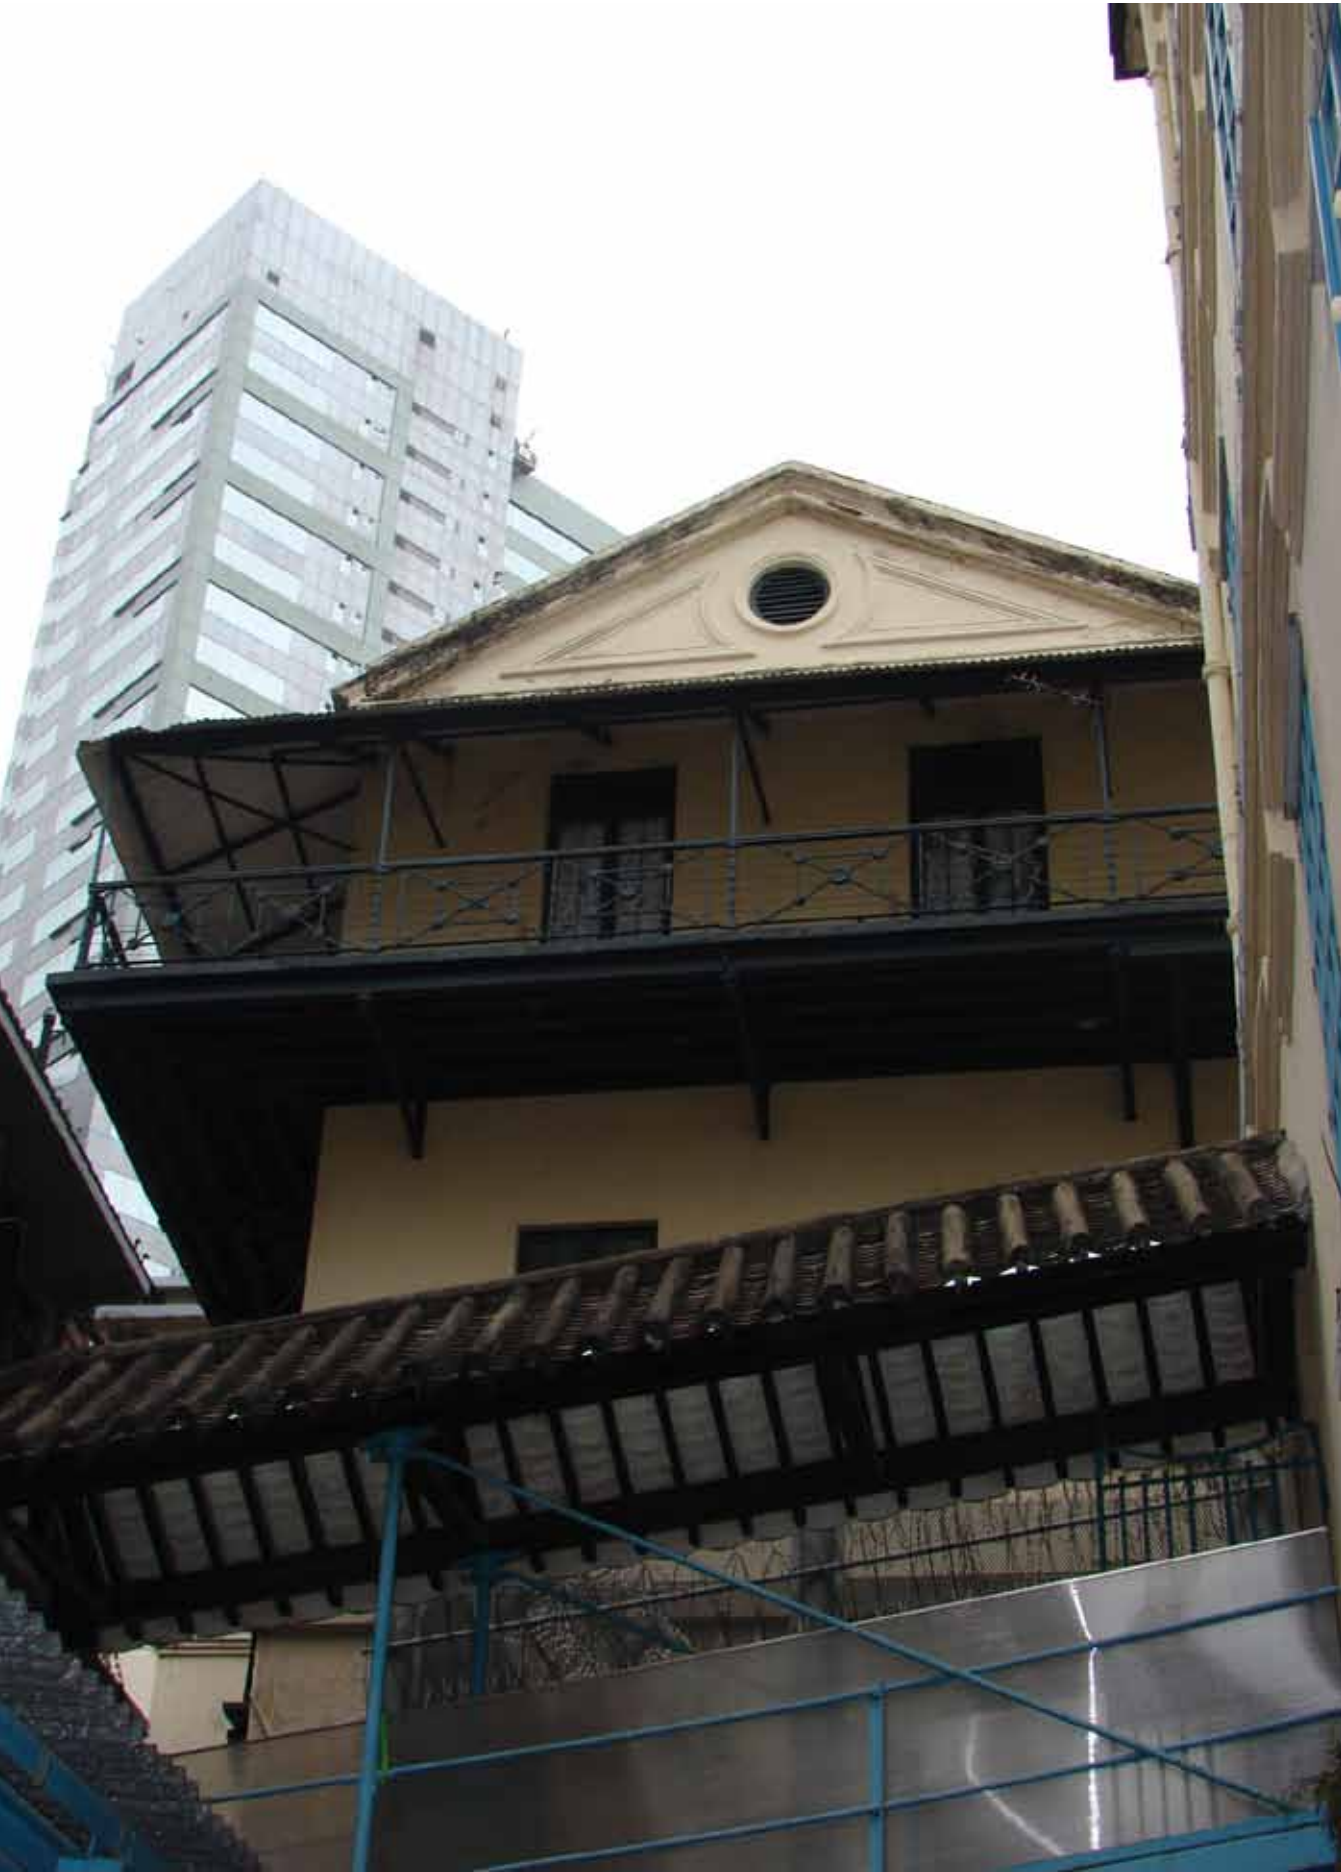
Figure 1 - North elevation of the building showing the gable end with oculus window

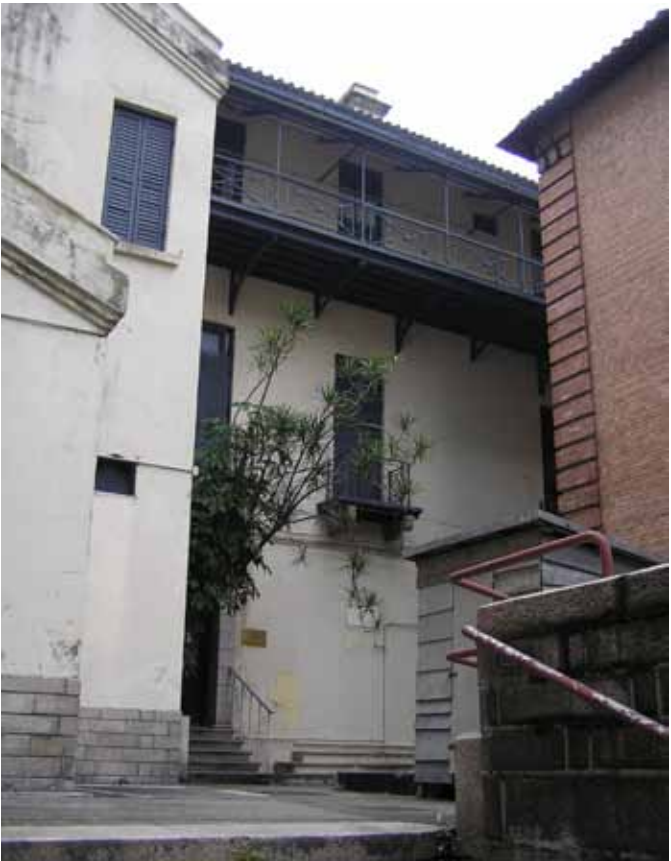
Figure 2 - East elevation

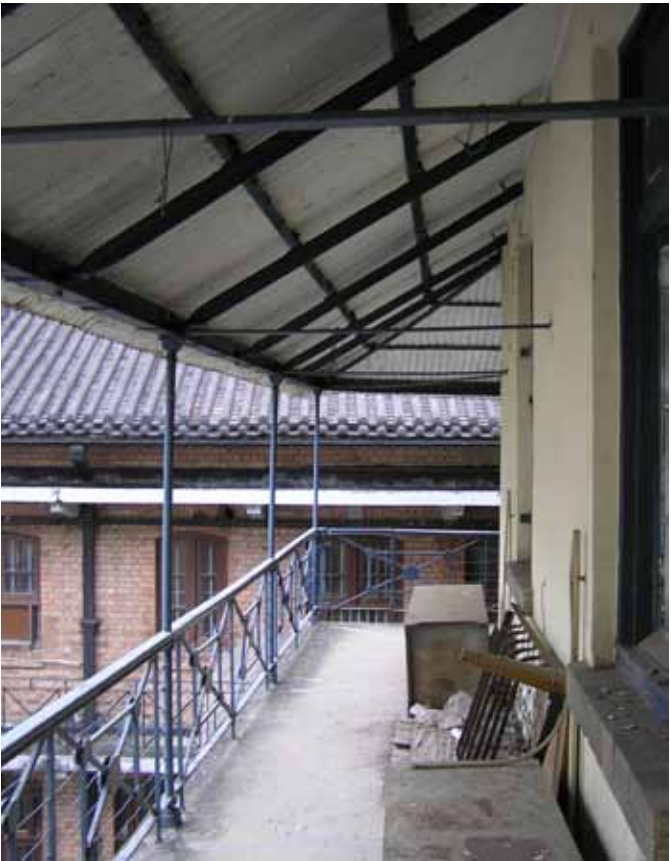
Figure 3 - Balcony on the north side

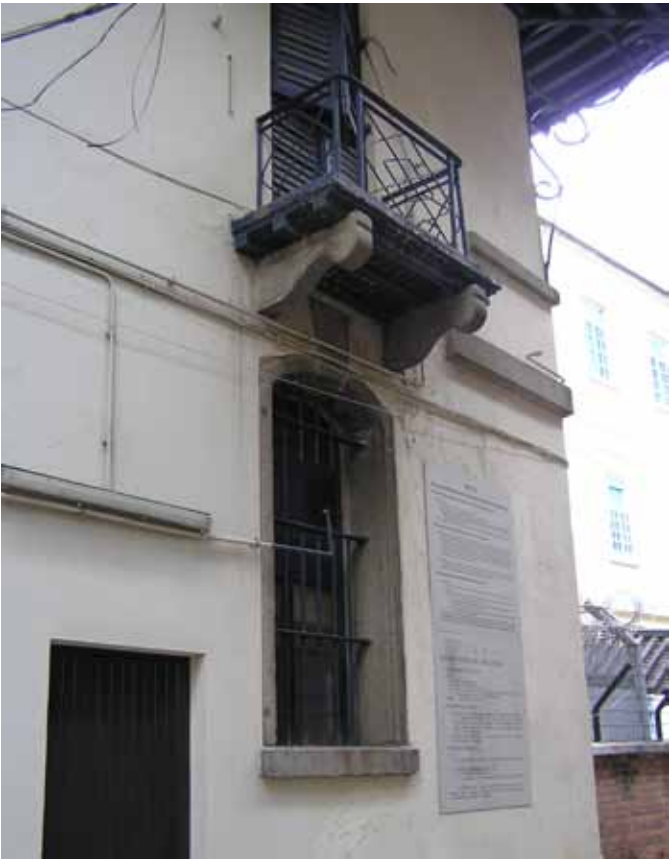
Figure 4 - Ground floor window and first floor balcony on east elevation

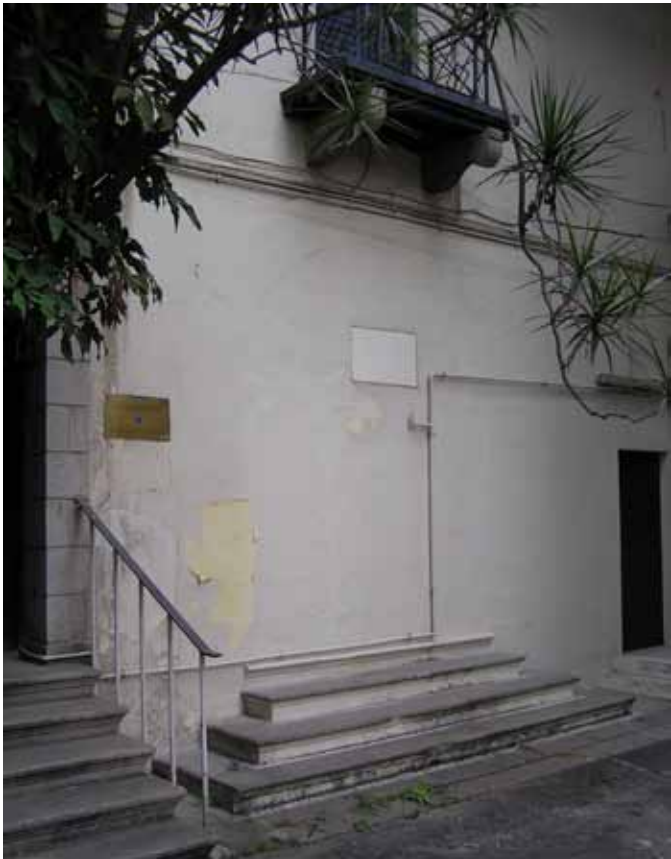
Figure 5 - Large archway on east wall which was early prison entrance but has since been blocked

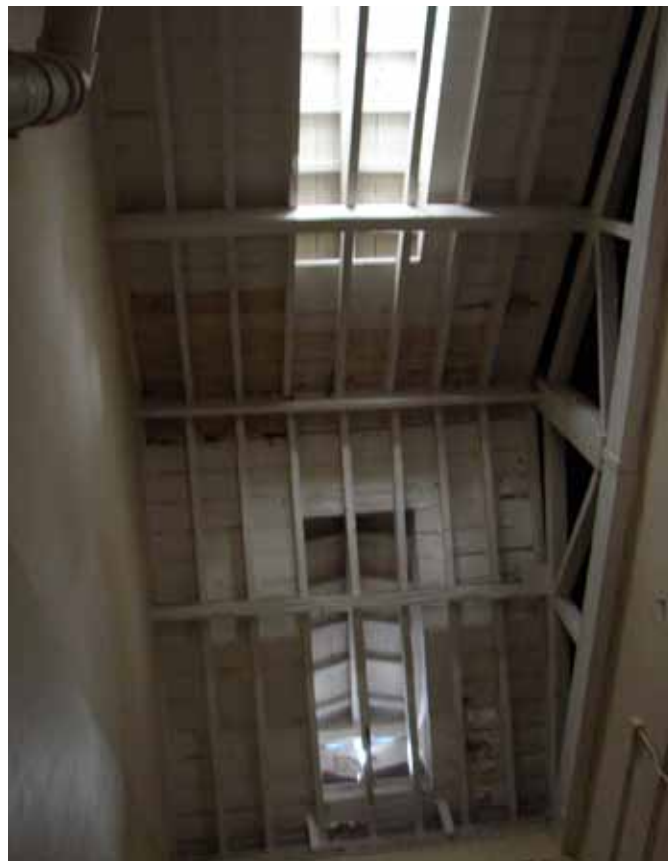
Figure 6 - Gabled roof over the main staircase

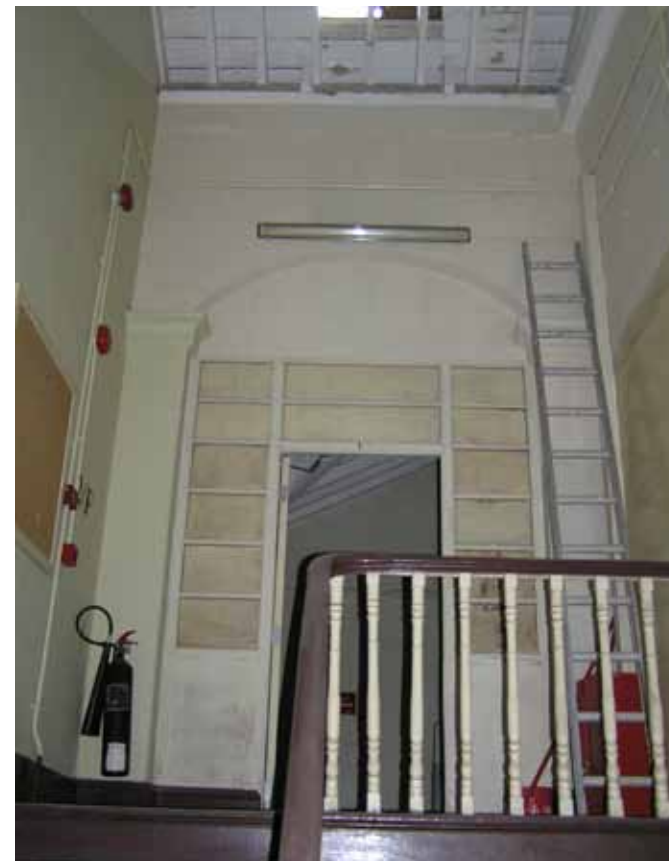
Figure 7 - Blocked archway leading into the west rooms on the first floor; these are thought to have been verandahs

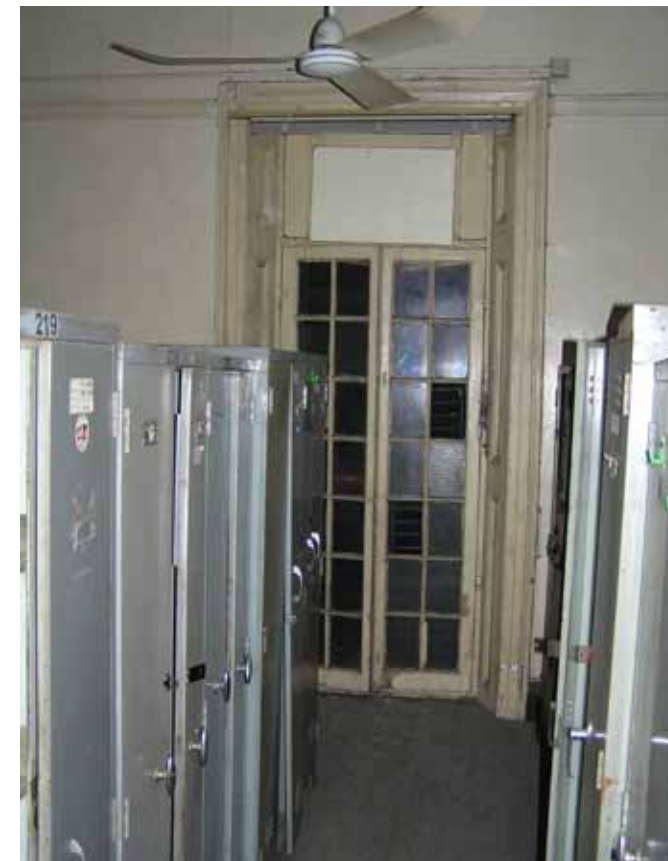
Figure 8 - Double French doors with panelled surrounds

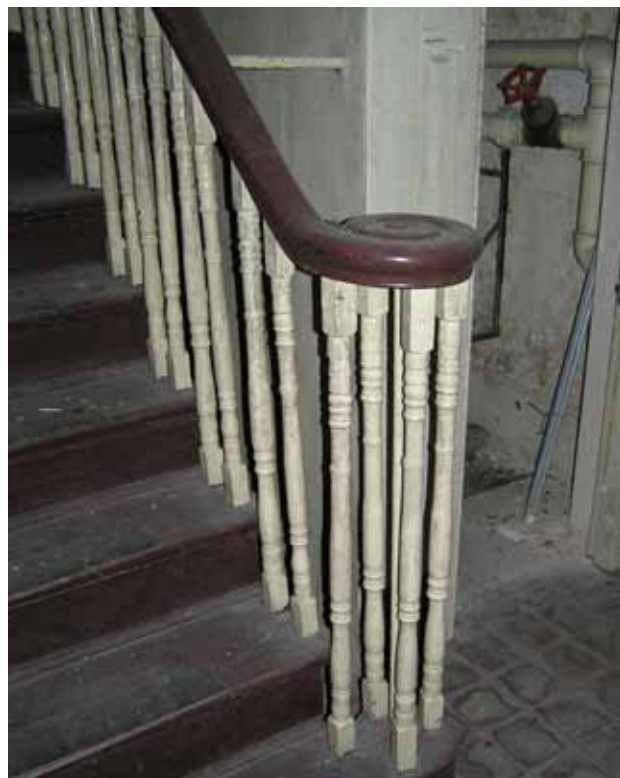
Figure 9 - Main staircase balustrade and moulded timber handrail, as viewed on the ground floor.

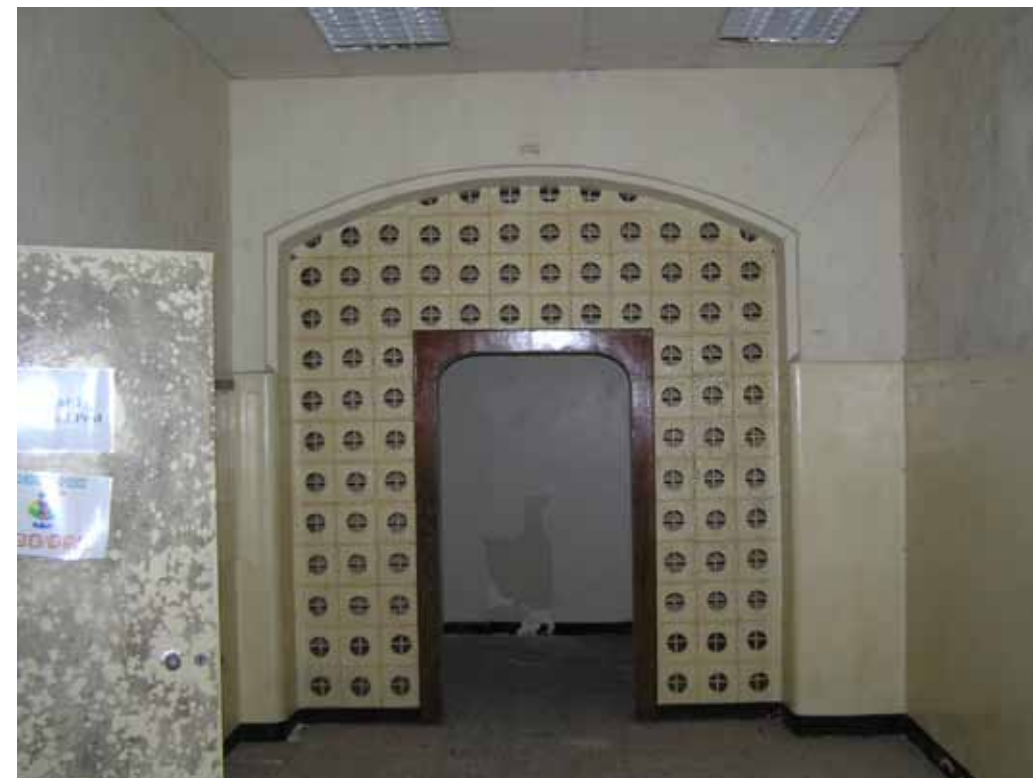
Figure 10 - Blocked ground floor arch which would have been the west end of the prison entrance pre-1930s

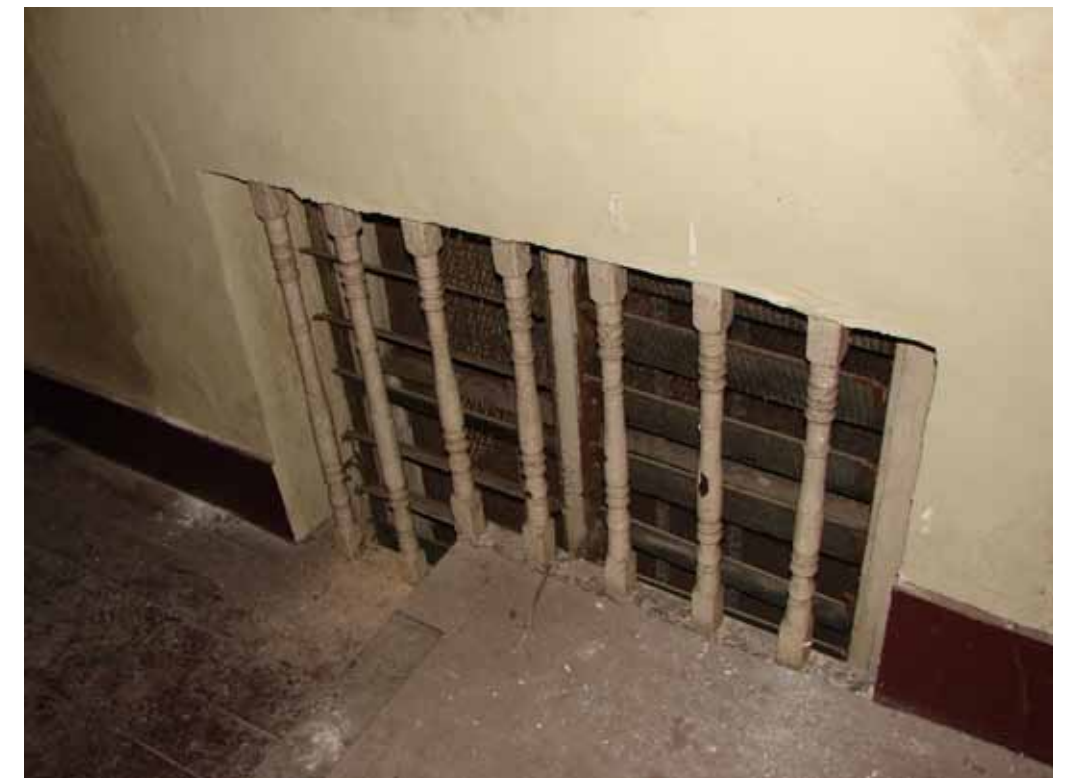
Figure 11 - Balustrade on a window opening in the main staircase wall

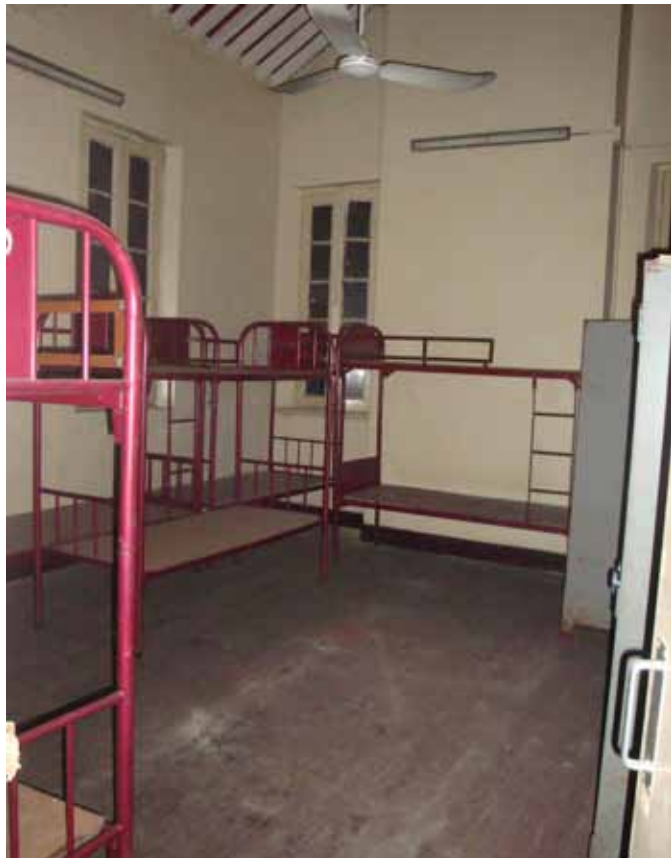
Figure 12 - Interior of the large southwest extension, last used as a bedroom

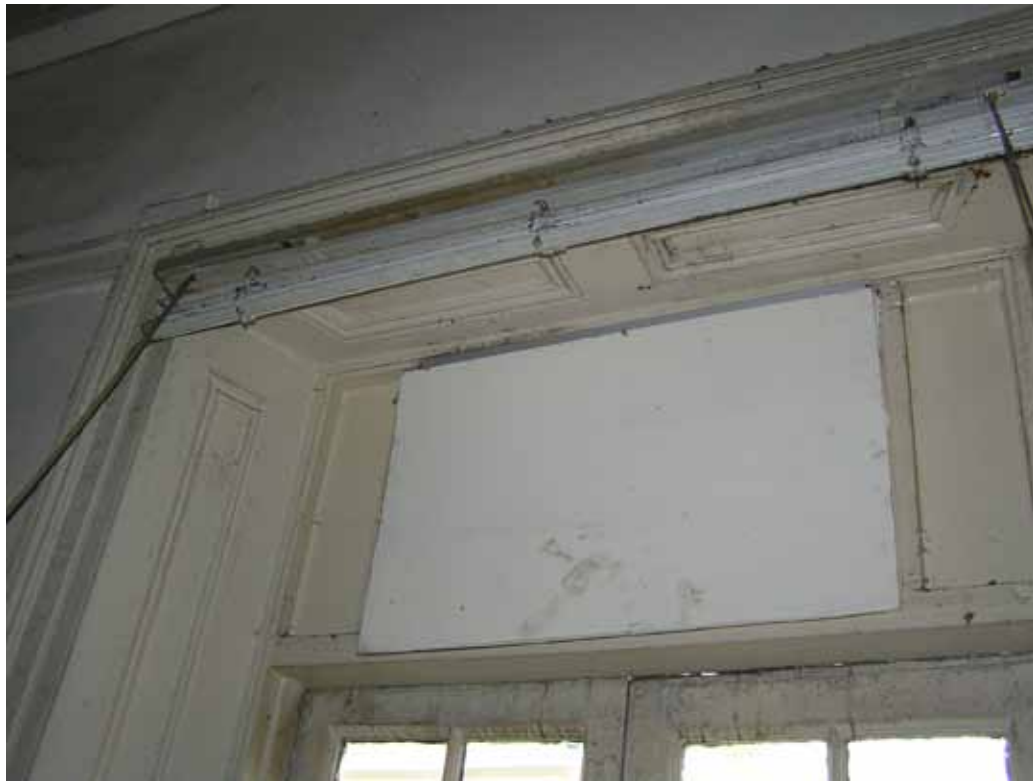
Figure 14 - Detail of panelled surrounds to a window

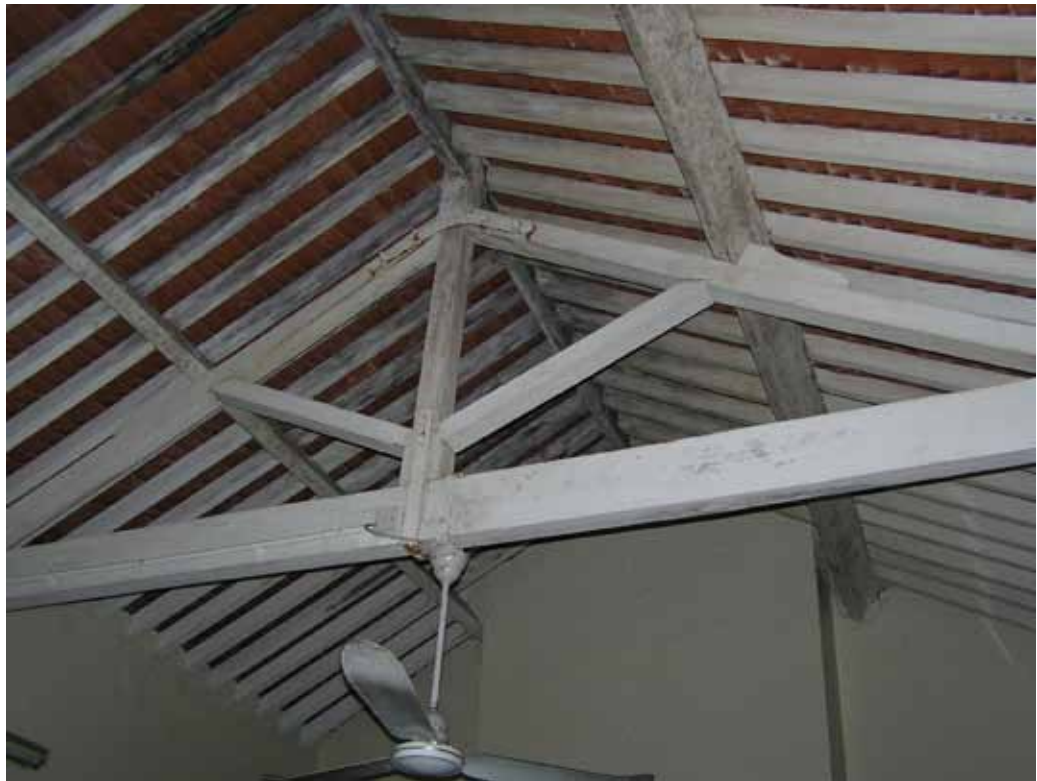
Figure 15 - Timber frame roof structure visible on the first floor of the southwest extension

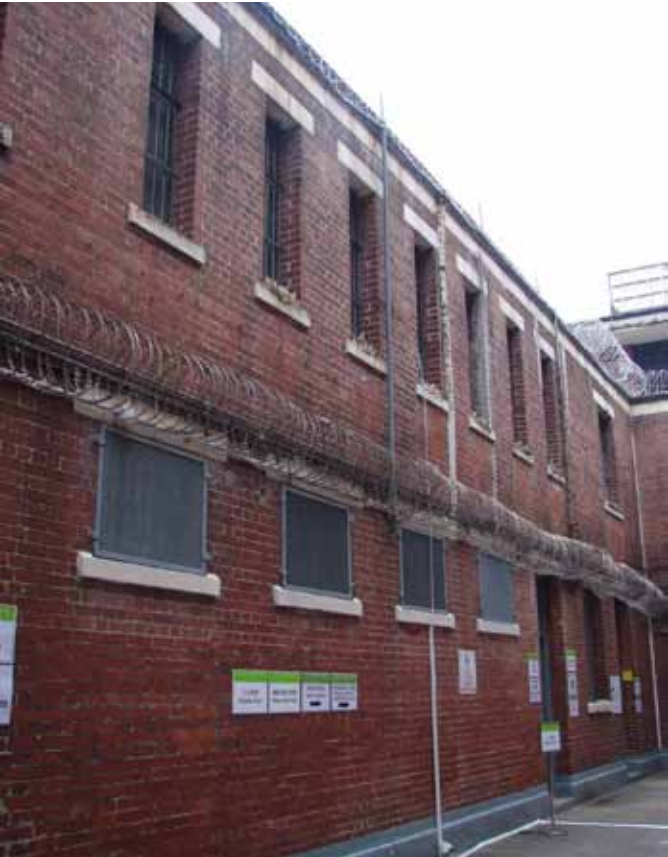
Figure 1 - The south elevation

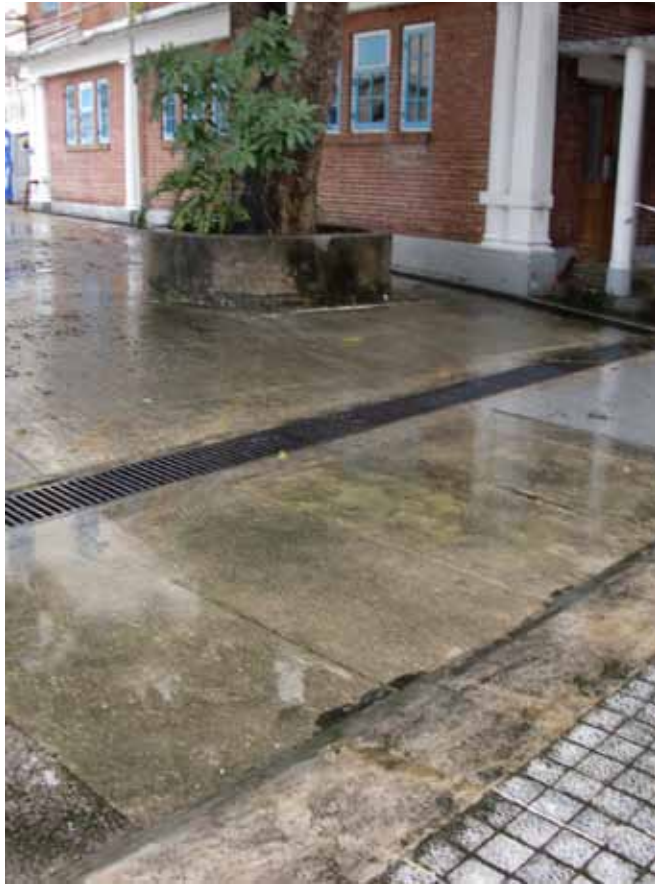
Paving slabs to the south of Building 01, adjacent to which are cast iron grilles for drainage and some areas of small concrete tiles

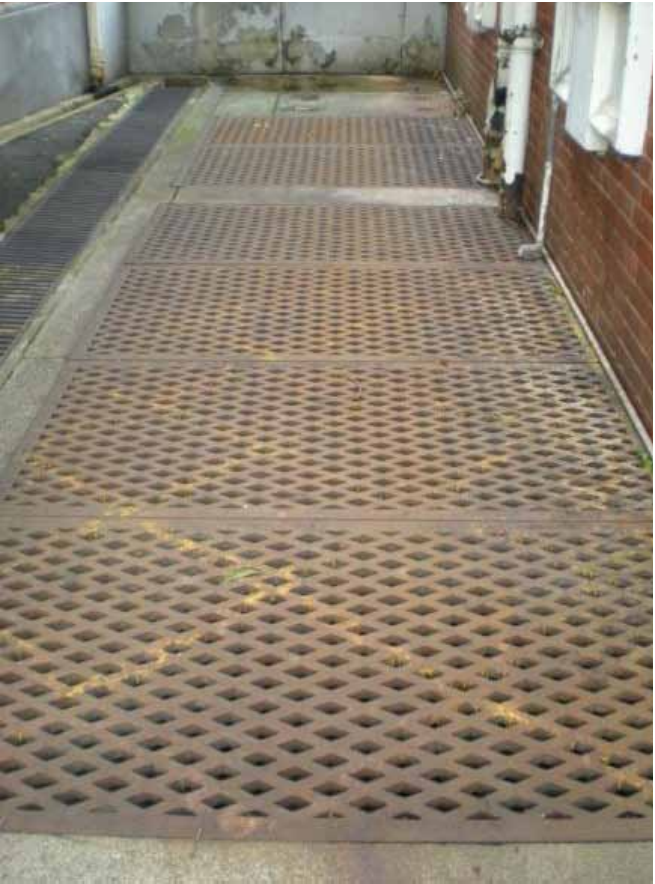
The cast iron grilles to the south of Building 01, some of which are covered in diamond plate

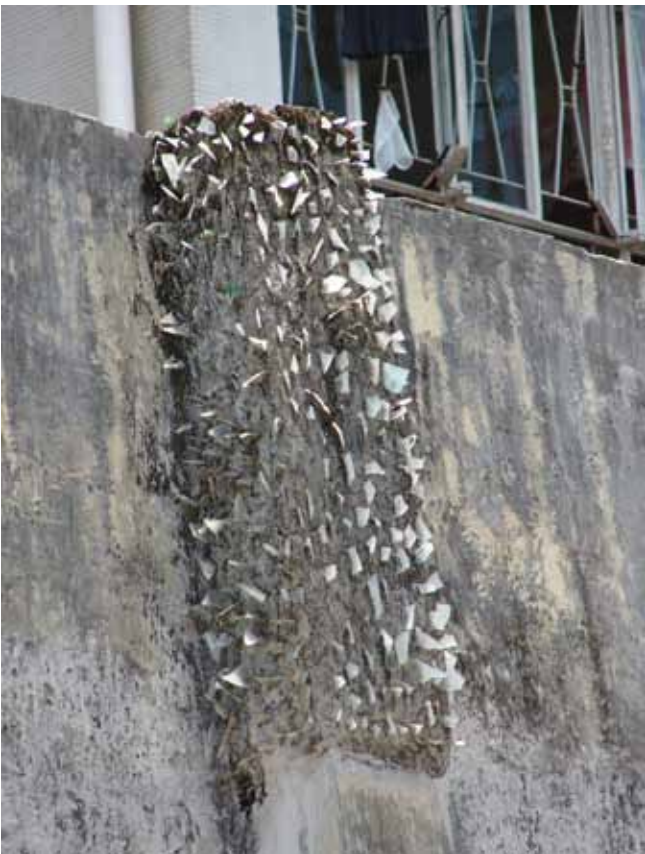
Shards of glass embedded in cement at the tops of the buttresses along the south wall

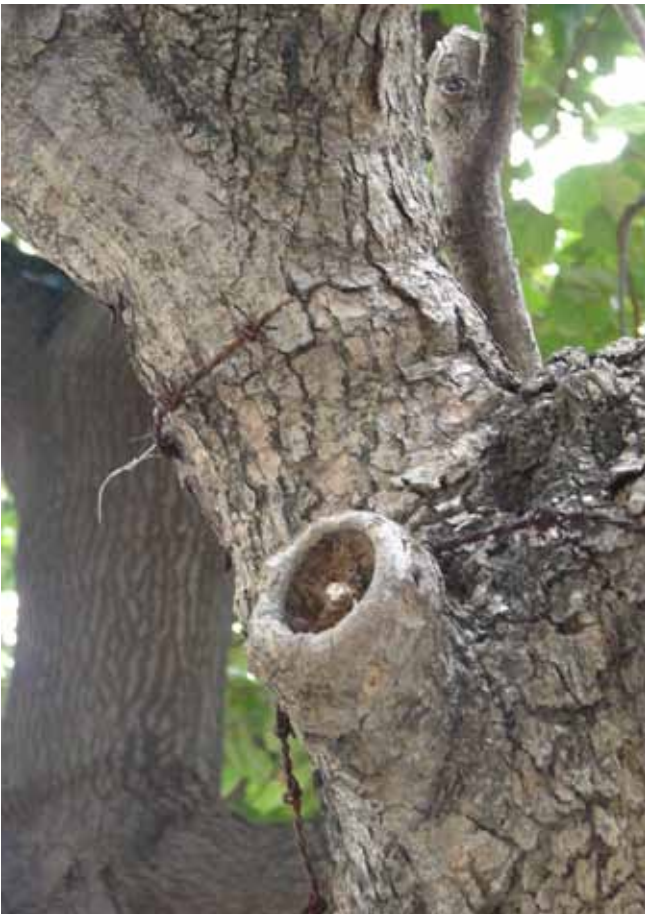
One of the trees with remnants of barbed wire

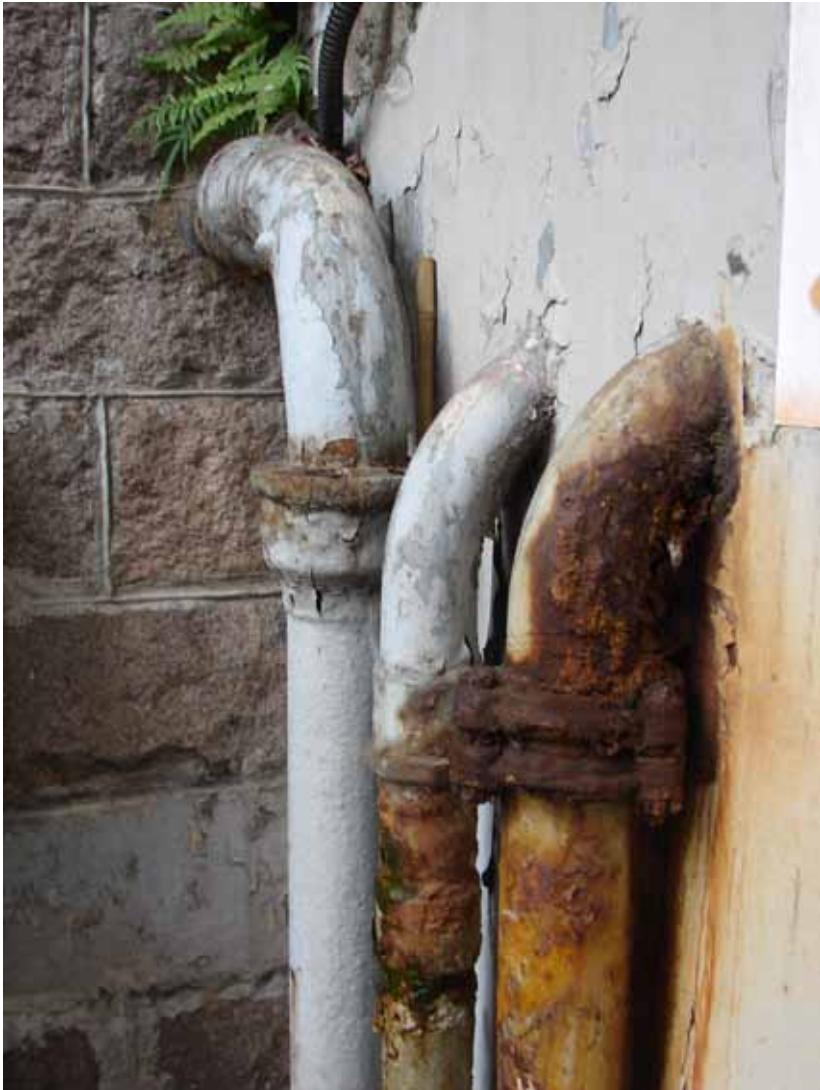
Pipes inserted into wall EX12

EX12	1	The steel and wire fencing will be removed from the top of the wall, the paintwork will be stripped off to allow the original granite work to be revealed. Other than this the work will be limited to minor repairs.	No mitigation work is needed.
EX14	2	A new wider entrance will be made in the area of the existing gateway at the north end of the wall, this will leave in place the surviving complete gatepost and the short section of original iron fence. A new gate will be installed designed and drawings provided by Herzog and de Meuron. The ramp outside the gate will be retained and be repaired with a new handrail and balustrade and new steps down to the pavement at the north end of the ramp.	The only potential adverse impact will be the new gateway. It is thought necessary to have a wider gateway at this point as this will be one of the major cross route entry points as well as being one of the main escape routes off the site. The new opening, gates and balustrade will all be designed as simple modern interventions to avoid any confusion with the original work.

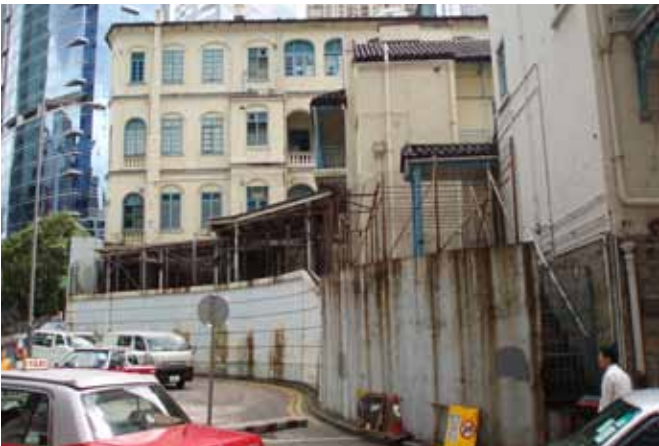
Revetment wall constructed of granite blocks which forms part of the original boundary walls of the site c.1840s. It runs along the north part of Arbuthnot Road, forming the east foundation wall for Building 04.

HIGH Significance

EX03 - A	2	This section of wall is to be strengthened with ground anchors as described by Arup. The visual impact on the wall will be minimal. Other than this the wall will be cleaned and some of the previous cement pointing will be removed. The vegetation will be removed and the wall will be re-pointed as necessary with a hydraulic lime mortar.	Little will be needed by way mitigation. The work to remove cement mortar and the cleaning will be beneficial. The insertion of the ground anchors will require the careful removal and replacement of stones but should have no residual impact on the character of the wall.
EX03 - B	1	This section of wall will be cleared of vegetation and be treated with systemic weed killers. The existing drain pipe will be replaced when the site drainage is reordered. The wall will be strengthened with ground anchors as described by Arup. The visual impact on the wall will be largely beneficial. Other than this the wall will be cleaned and some of the previous cement pointing will be removed and the wall will be re-pointed as necessary with a hydraulic lime mortar.	No mitigation work will be required. The insertion of the ground anchors will require the careful removal and replacement of stones but should have no residual impact on the character of the wall.

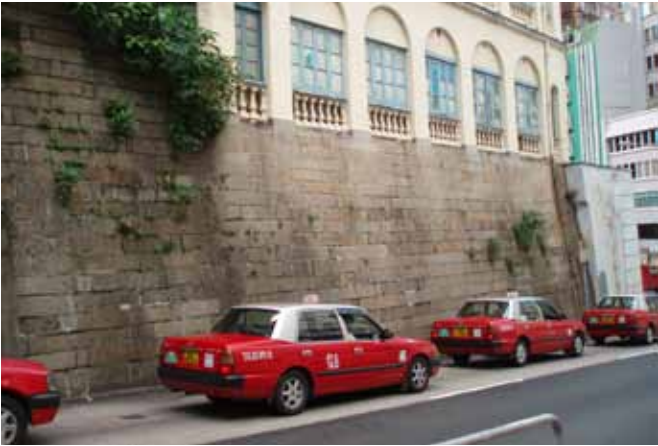
EX03 – B

A small part of the east revetment wall constructed of granite block, and likely contemporary with the wall immediately to the north. This is an important part of the historic walls and forms the east end of the alleyway between Buildings 04 and 09.

HIGH Significance

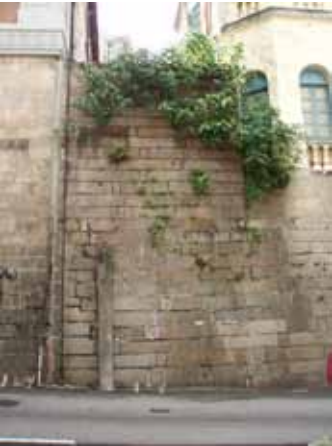
EX03 – C

Battered granite revetment wall forming the east foundation wall for the Magistracy (Building 09), behind which is the basement storey of the structure. While the wall is constructed in large part from the historic boundary wall granite, it was almost entirely rebuilt when the Magistracy was constructed c.1914.

HIGH Significance

EX03 - C	1	Minimal work only on this wall to clean it and repair minor areas of pointing. There should be no heritage impact other than an improvement in visual appearance.	No mitigation work will be required.
EX03 - D	1	This section of wall will be cleared of vegetation and be treated with systemic weed killers. The existing drain pipes will be replaced when the site drainage is reordered. The wall will be strengthened with ground anchors as described by Arup. The visual impact on the wall will be largely beneficial. Other than this the wall will be cleaned and some of the previous cement pointing will be removed and the wall will be re-pointed as necessary with a hydraulic lime mortar.	No mitigation work will be required. The insertion of the ground anchors will require the careful removal and replacement of stones but should have no residual impact on the character of the wall.
EX04	1	The only work intended to this door is some minor repair and conservation work to the stone door case. The door will be left in full working order though it is unlikely to be used to any significant extent.	No mitigation work will be required.

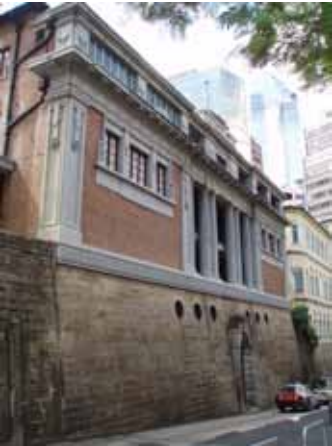
EX03 – D

A small part of the east revetment wall constructed of granite block, and likely dating to the 1840s. This is an important part of the historic walls and forms the east end of the terrace to the south of the Magistracy (Building 09).

HIGH Significance

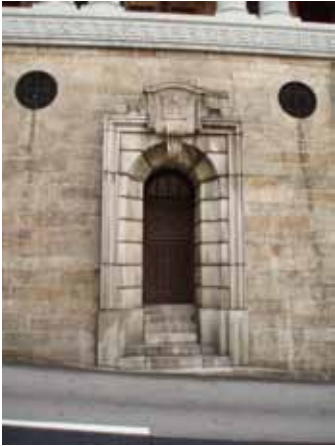
Granite archway accessing a set of stairs leading up to the Magistracy; both of which are some of the earliest features of the site c.1850s. There are a set of modern steel gates here which are not of historic interest and of low significance.

HIGH Significance

EX05	1	This section of wall will be cleared of vegetation including the substantial shrub in the north abutment. The area will be treated with systemic weed killers. The arch and small section of wall will be cleaned and some of the previous cement pointing will be removed and the wall will be re-pointed as necessary with a hydraulic lime mortar. The modern iron gates will be removed and will be replaced with new gates designed and drawings provided by Herzog and de Meuron.	No mitigation work will be required.

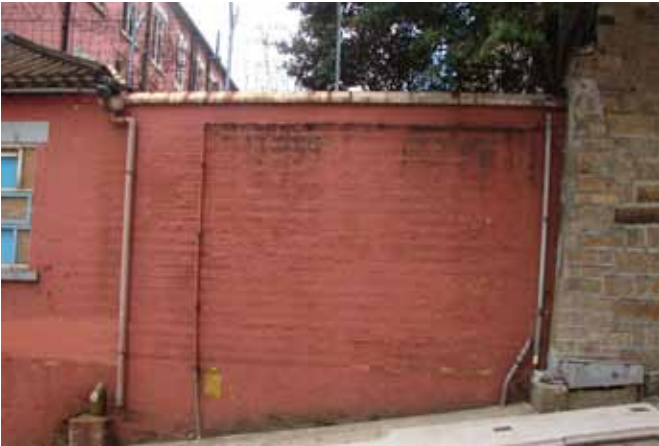
EX12

Granite block boundary wall along Old Bailey Street running adjacent to the west side of Building 03 (Barracks Block). Some sections probably date from the construction of Building 03, and there has been much alteration and some in-fill. Northern section has been painted white, and a new door (EX13) has been created. The wall is topped with a steel fence and there is a modern ramp and railing adjacent to the west (EX15).

MODERATE Significance

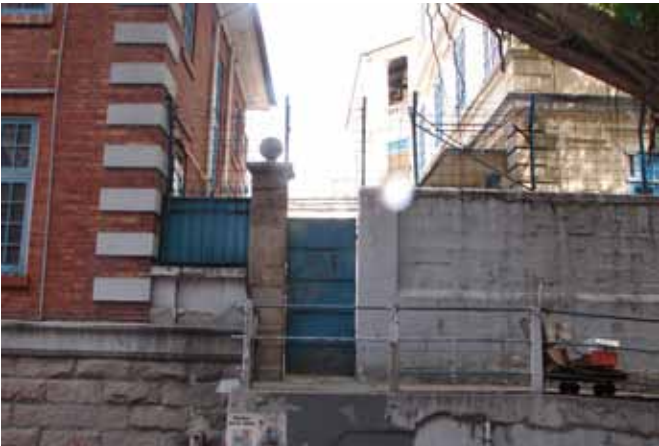
Battered granite revetment wall forming the plinth to Building 02 (Armoury) and forming the northernmost part of the site wall along Old Bailey. The wall is contemporaneous with construction of the Armoury and forms an integral part of the perimeter treatment.

HIGH Significance

EX16	2	The significant work will be the removal of some stones on the north face of the wall to provide a bearing for the proposed new bridge from the mid-levels escalator. It is not thought that any ground anchor work will be required. No other intervention should be necessary other than minor repointing and cleaning of the stonework.	The new bridge off the mid levels escalator is seen as a key access point to the site for most visitors and as such the minor damage to the stone work of the wall is seen as an acceptable price to pay to achieve this
LL01	2	The upper section of this wall will be removed to create the new access from the bridge to the parade Ground. The lower section (brick wall, timber entrance door and stone door case) will all be left unaltered.	The new bridge off the mid levels escalator is seen as a key access point to the site for most visitors and as such the removal of the stone work and railing at the top of the wall is seen as an acceptable price to pay to achieve this.

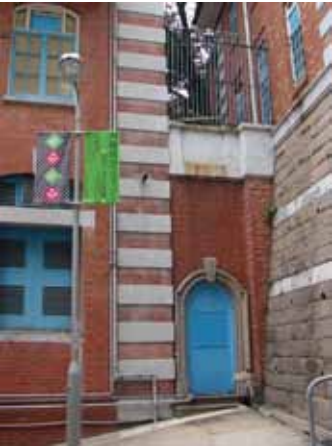
Granite block retaining wall on the east side of the Parade Ground, running south from Building 01 (Headquarters Block) and forming part of the western edge of the Pottinger Street ramped entrance road. This is at least contemporaneous with Building 01 c.1919 if not earlier.

HIGH Significance

LL09	3	The condition of this section of wall is poor as it has been disrupted by the trees previously growing adjacent to it. The intention is to take the wall down and to rebuild it with a new retaining structure behind. This will be followed by the replanting of trees to replace those lost. A new balustrade will need to be fitted for safety reasons – this will be designed and drawings provided by Herzog and de Meuron.	The wall needs major repair if it is to survive. The proposal will allow for the blocks to be carefully dismantled and to be numbered allowing the reconstruction of an exact replica. The new balustrade is required for code compliance and safety reasons and will be a discreet modern intervention with no possible confusion with earlier work.
LL10	2	There will be limited work on this wall to carry out minor repairs and a new balustrade may be necessary for safety purposes – this will be designed and drawings provided by Herzog and de Meuron.	The new balustrade is required for code compliance and safety reasons and will be a discreet modern intervention with no possible confusion with earlier work.

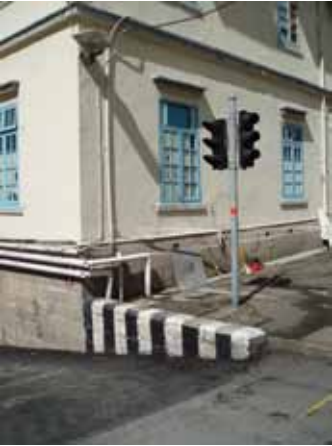
Battered revetment wall form the plinth at the north side of Building 04. This is part of the original perimeter wall of the site c.1840s, and features granite corbels on the north side which would have originally been part of guard houses (see Building 04 for more information).

HIGH Significance

Item / Issue	Category Rating	Identification of Impact & Reason	Mitigation
LL11	1	This wall is in need of significant repair where the corbelling to the bottom of one of the bays has previously been propped and has now partially collapsed. This area will be rebuilt and some general strengthening of this wall will be needed by ground ties through the wall. This will be done by removing stones and replacing after the anchors have been inserted. Other than this the work will be of minor repair after the removal of the adjacent modern iron structure and cleaning and repointing.	All the proposed work should be beneficial and no mitigation work is needed.
LL11 - A	2	Work to this section of wall will be largely limited to minor repairs and the removal of cement ribbon pointing and its replacement in lime mortar. The corroded steel doors and frame will be replaced with new doors of similar design. The corroded iron staircase will also be removed and be replaced with a new stair. This will be a simple new design and drawings provided by Herzog and de Meuron.	The majority of the work here will be beneficial. The new stair will be designed in a simple modern style so that there is no confusion with the stair to be replaced. The existing stair will be carefully recorded and photographed prior to its removal

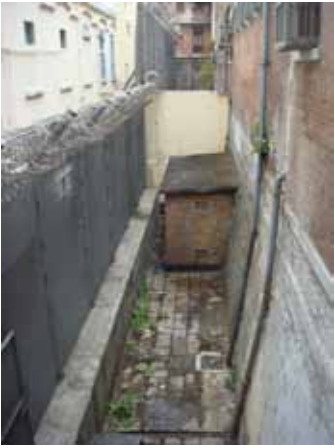
A granite wall, slightly battered, that is both a retaining wall for the level change and the base for building 8 (Ablutions Block). The wall has several small buildings attached to it as well as the concrete brackets supporting the balcony of building 8. The wall has been painted white and is of regular granite blocks laid in stretcher bond.

The wall was almost certainly rebuilt when building No.8 was erected after the demolition of the stables and the earlier latrine block.

MODERATE Significance

LL13	1	The modern buildings which have been built up against this section of wall will be removed though the stair at the west end will remain in position as will the concrete brackets for the Ablutions Block balconies. Any damage caused by the modern buildings will be made good and where appropriate modern finishes will be removed. The full extent of the wall should be visible on completion.	The proposed work should be beneficial to the understanding of the site both improving circulation and helping the division between the Prison and the Police Station to be clearly seen.
LL14	3	<p>The impact of the proposed work on this wall will be substantial. The condition of the wall is already poor. There is a substantial Banyan tree growing at the western end of the wall which will, in time, bring the wall down. There is also a substantial bulge along the length of the wall which is, of course, a substantial retaining wall with some 5.0metres difference in the ground levels. The potential structural failure has been dealt with, as a temporary solution, by installing a heavy concrete base and a very substantial steel cradle providing raking shoring.</p> <p>The proposal is to take this wall down to ground level to allow the excavation of the proposed basement to the new wing. A new concrete wall will be constructed as the edge of the basement and the granite wall will be rebuilt as a replica. The wall will hold its full original height at the west end where it meets the wall down Old Bailey Street and where it is most visible. The height is reduced as the wall runs eastward and meets the new building.</p> <p>The other major change to its appearance will be the provision of a new doorway into the new basement. The yard to the north of this wall will be the primary service yard and the new door will provide access for all deliveries (both everyday items to the shop and restaurant and also for works of art) to the new building and to the Prison Yard area. This yard is the only feasible location to provide delivery to the site.</p>	Very substantial work would have to be carried out to this wall to deal with the existing structural failure and, to a lesser extent, to remove the wall-tree. The proposed work will allow the construction of the new building in a less disruptive way enabling lorries to get off the road into the loading bay for carting away the spoil from the excavation. The proposal is to take careful records of the wall and to take it down by hand, course by course, setting aside the granite by courses to allow the replica wall to be built from the original material.

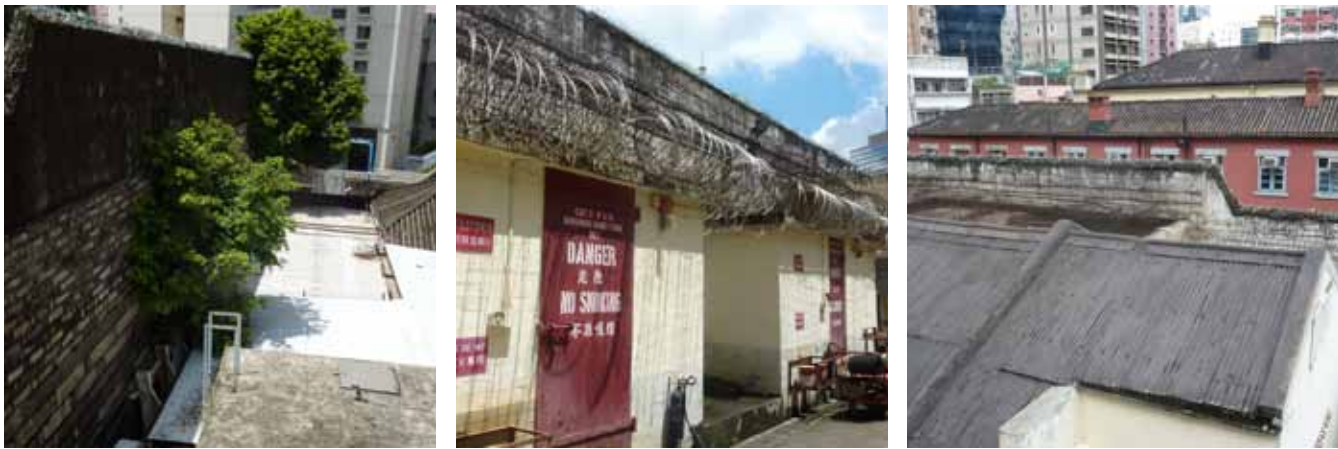
LL15

A slightly battered granite wall laid in large blocks. The wall has been painted grey at low level and cream above, now much disfigured with green algae. The wall forms the base to the 'D' Hall at the east end where it is abutted by the staircase. At the west end the wall now forms the back to the single storey extension to 'D' Hall which occupies the location of the demolished central block. It may have been slightly altered when the central block was demolished (mid 20th century) but appears to be substantially the mid 19th century wall.

HIGH Significance
