PROJECT No.: TCS/00408/08

DSD CONTRACT NO. DC/2007/17
DRAINAGE IMPROVEMENT WORKS IN
CHEUNG PO, MA ON KONG, YUEN KONG SAN TSUEN
AND TIN SAM TSUEN OF YUEN LONG DISTRICT AND
SEWERAGE AT TSENG TAU CHUNG TSUEN, TUEN MUN

MONTHLY EM&A REPORT FOR KT13
(FEBRUARY 2010)

PREPARED FOR
CHINA ROAD & BRIDGE CORPORATION

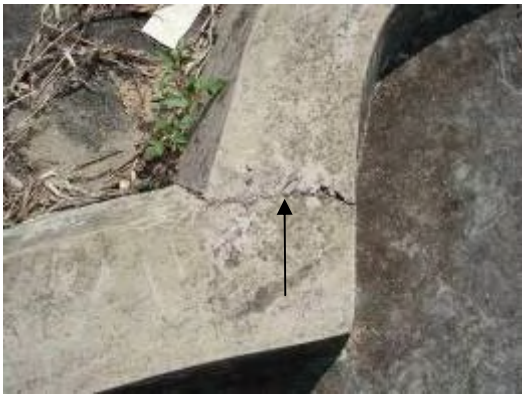
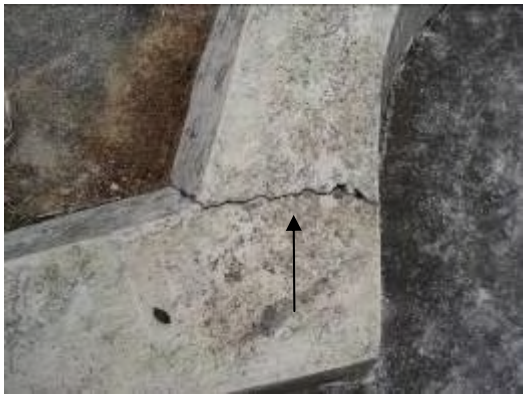
| Crack No. | Crack Width (mm) | Photographic Record | |
|---|---|---|---|
| 6 | 1.6 | | |

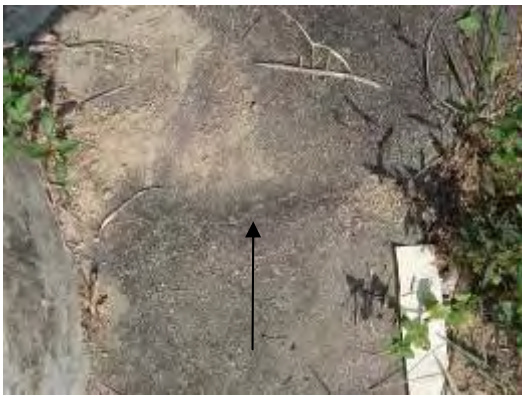
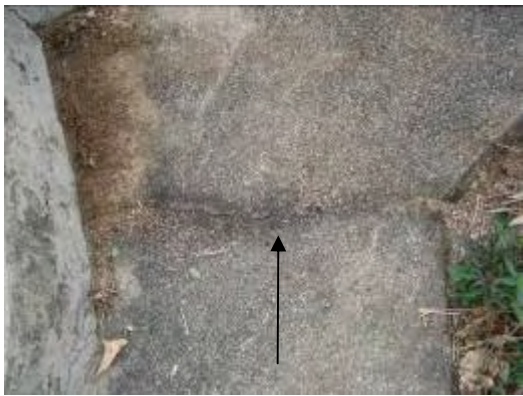
| Crack No. | Crack Width (mm) | Photographic Record | |
|---|---|---|---|
| 7 | 1.6 | | |

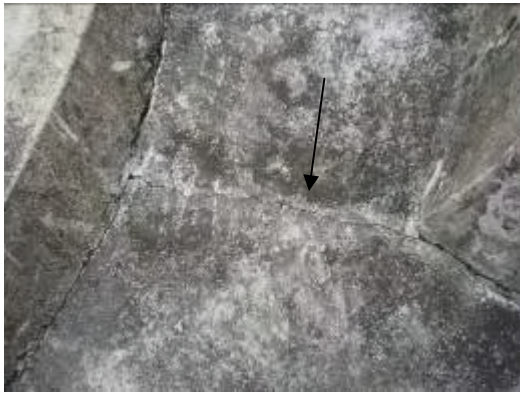
| Crack No. | Crack Width (mm) | Photographic Record | |
|---|---|---|---|
| 9 | Hair-line | | |

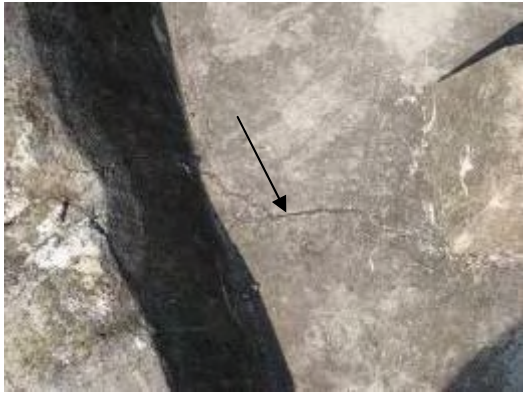
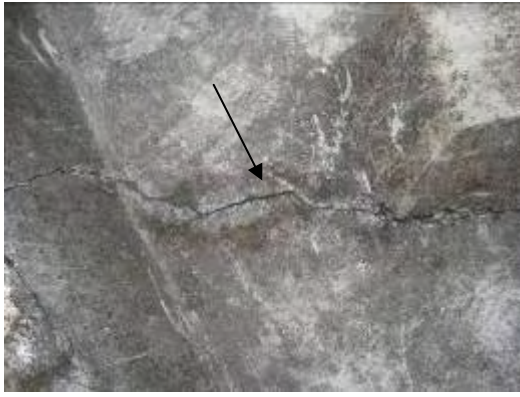
| Crack No. | Crack Width (mm) | Photographic Record | |
|---|---|---|---|
| 10 | 0.2 | | |

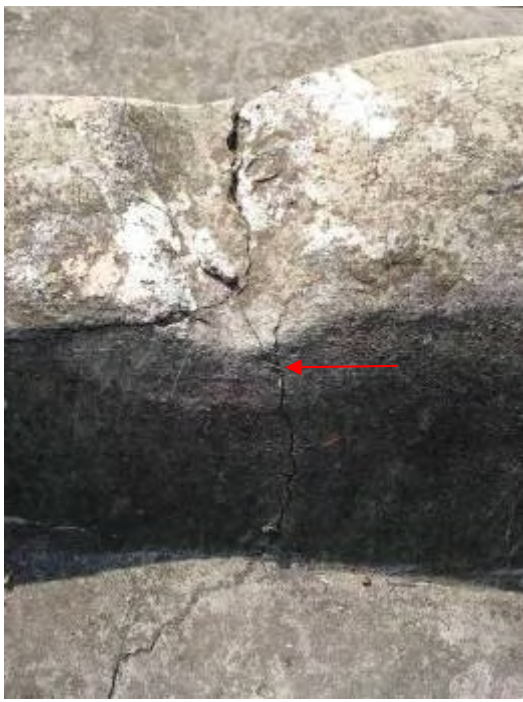
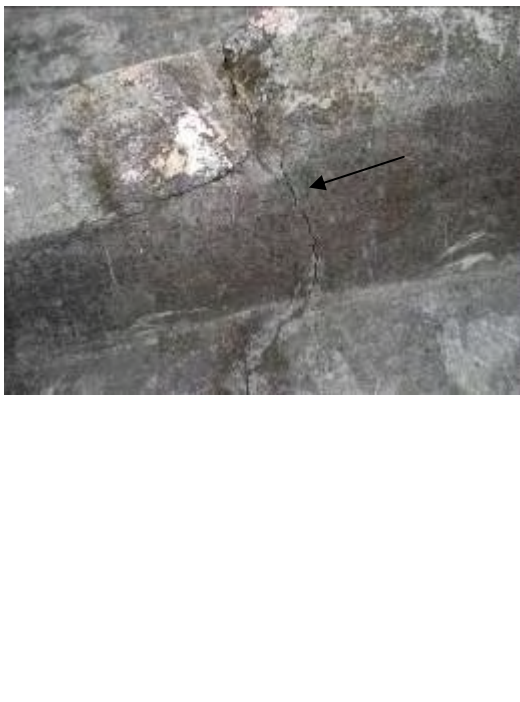
| Crack No. | Crack Width (mm) | Photographic Record | |
|---|---|---|---|
| 11 | 1.5 | | |

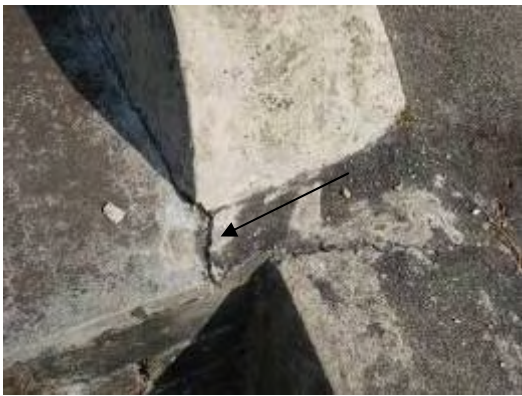
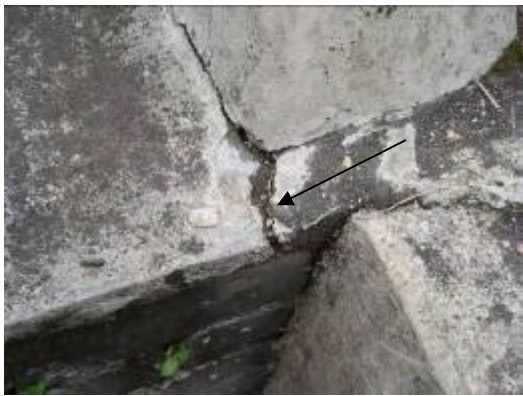
| Crack No. | Crack Width (mm) | Photographic Record | |
|---|---|---|---|
| 14 | 1.3 | A photograph showing a crack at the corner of a concrete structure. An arrow points to the crack. | A photograph showing the same crack at the corner, with an arrow pointing to it. |

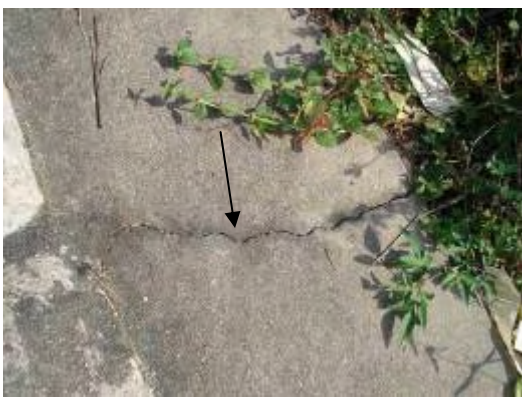
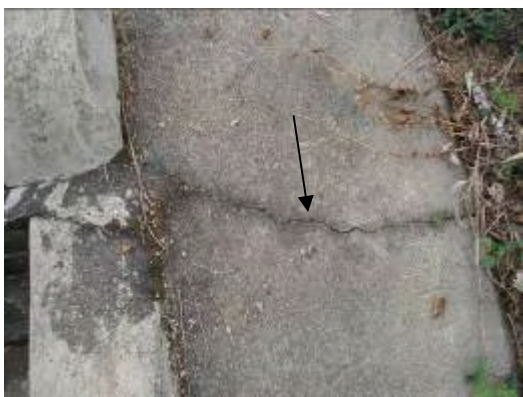
| Crack No. | Crack Width (mm) | Photographic Record | |
|---|---|---|---|
| 15 | 2 | A photograph showing a crack in a concrete surface with some vegetation nearby. An arrow points to the crack. | A photograph showing the same crack in the same surface, with an arrow pointing to it. |

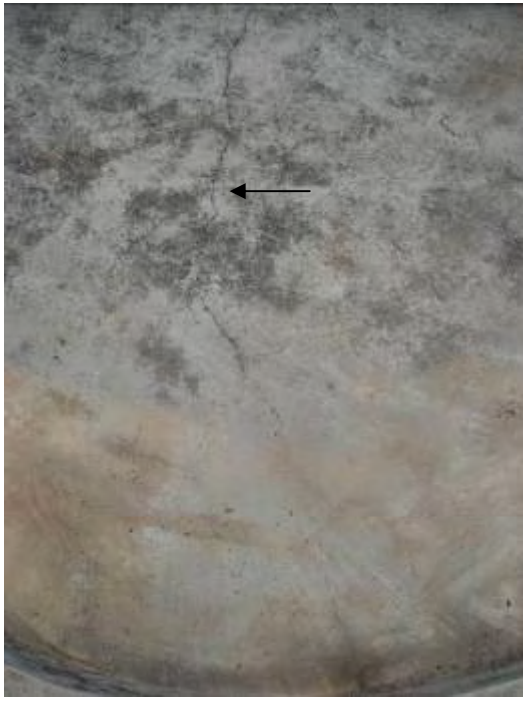
| Crack No. | Crack Width (mm) | Photographic Record | |
|---|---|---|---|
| 20 | 0.1 | | |

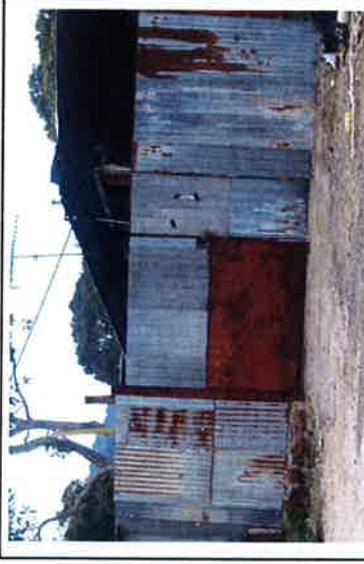
Photo No. B11—LCA 6 Industrial Landscape Character Area

| 10.7.17 | LCA6 (Industrial Landscape Character Area) | B11 & B12 | This comprise collection of slummy-built temporary structure and open storage uses land, which are characterized with metallic hoarding and used for poultry, recycling, vehicle repairing etc. The sensitivity to change of this area is low. | Reconstruction of hoarding was conducted by the land owner |

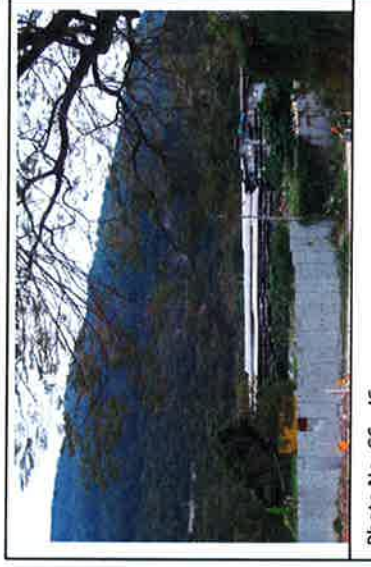
Photo No. C3-13 Plant Nursery at the east of Ma On Kong Channel

| Section in EIA Report | Identify number – VSR | Photo No. | Baseline Study, Environmental Impact Assessment Final Report [382047/E/EIA/Issue 9] | Current Situation |
|---|---|---|---|---|
| 10.7.23 | I3 | C3 | Plant Nursery at the west of Ma On Kong Channel The VSRs is workers of the plant nursery. The number of individual is very few and their sensitivity to visual impacts is low. | Temporary stockpiling was observed |
