PROJECT No.: TCS/00408/08

DSD CONTRACT NO. DC/2007/17
DRAINAGE IMPROVEMENT WORKS IN
CHEUNG PO, MA ON KONG, YUEN KONG SAN TSUEN
AND TIN SAM TSUEN OF YUEN LONG DISTRICT AND
SEWERAGE AT TSENG TAU CHUNG TSUEN, TUEN MUN

MONTHLY EM&A REPORT FOR KT13
(JUNE 2010)

Scope: Condition survey and settlement monitoring of a Qing Dynasty Grave.

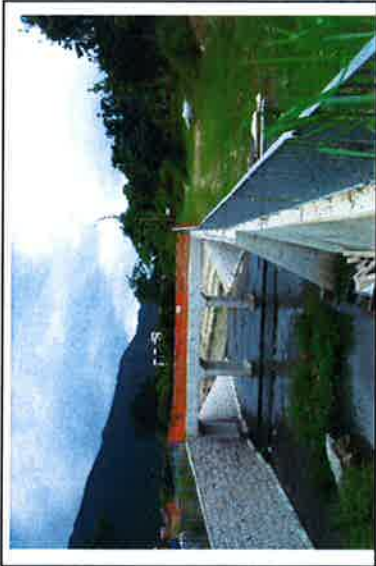
Photo No. A1 – LR1

River/Stream

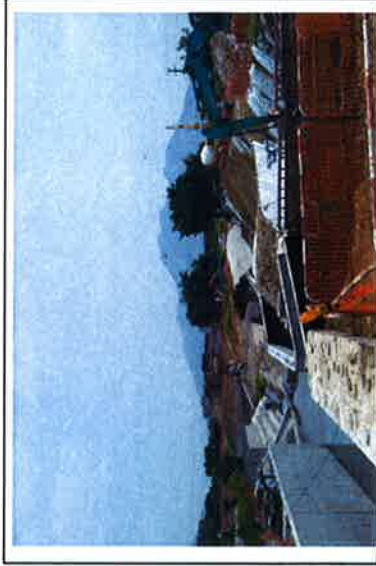
Photo No. A2 – LR1

River/Stream

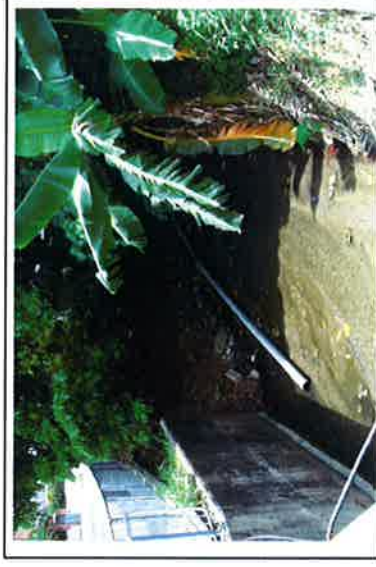
Photo No. A3 – LR1

River/Stream

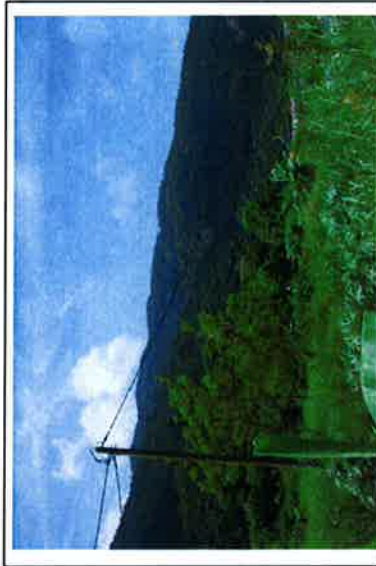
Photo No. A4 – LR1

River/Stream

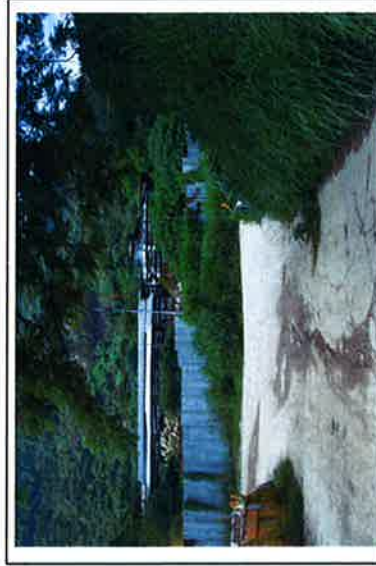
Photo No. A5 – LR1

River/Stream

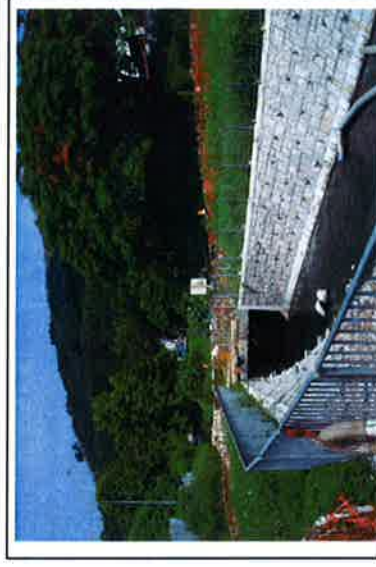
Photo No. A6 – LR2.1

Fish Pond within site boundary

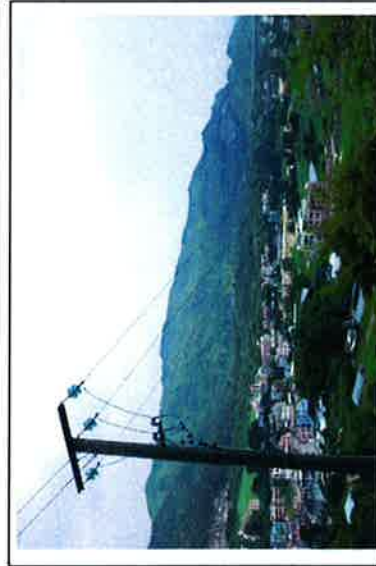
Photo No. A7 – LR2.2

River/Stream

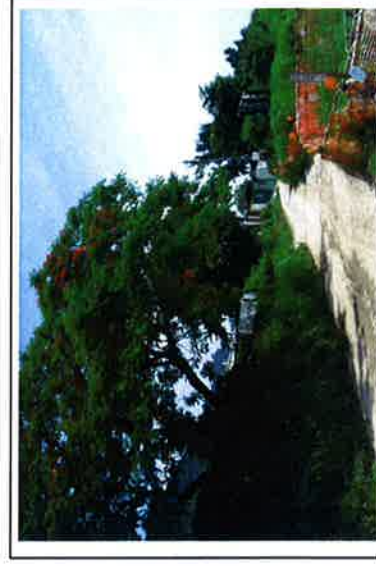
Photo No. A9 – LR4

Woodland/Wooded Area

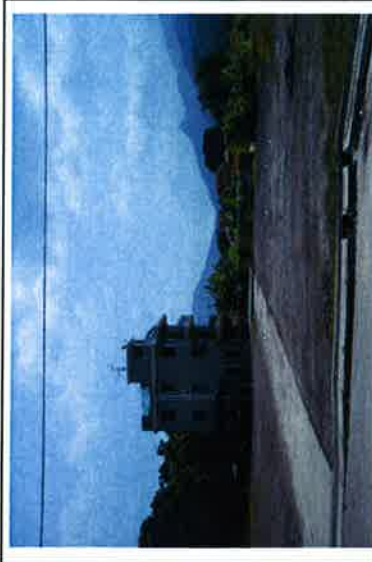
Photo No. A10 – LR4

Woodland

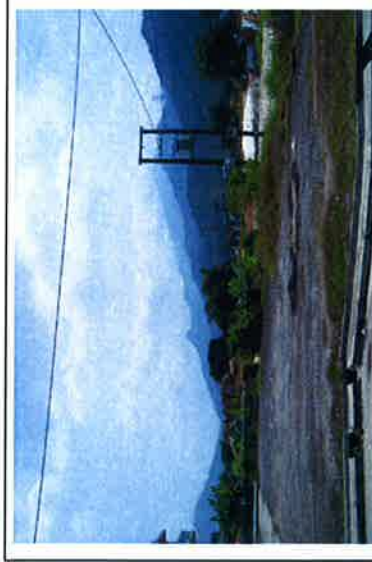
Photo No. A11 – LR5

Orchard/ Horticultural Trees

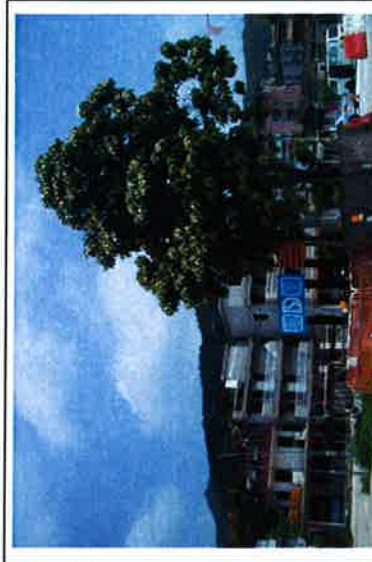
Photo No. A13 –LR7

Sitting-Out Area at Ma On Kong

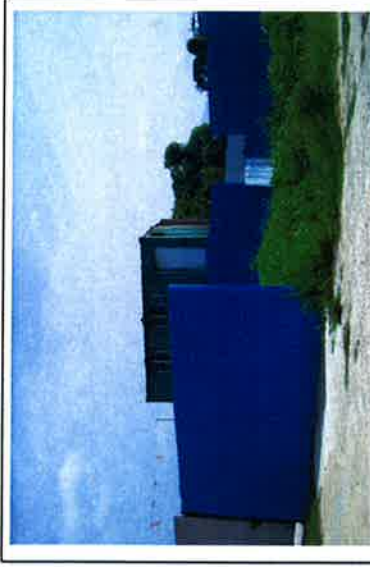
Photo No. B11—LCA 6 Industrial Landscape Character Area

10.7.17	LCA6 (Industrial Landscape Character Area)	B11 & B12	This comprise collection of slummy-built temporary structure and open storage uses land, which are characterized with metallic hoarding and used for poultry, recycling, vehicle repairing etc. The sensitivity to change of this area is low.	Reconstruction of hoarding was conducted by the land owner
