The Jockey Club CPS Limited

Central Police Station Conservation  
and Revitalisation Project:  
*First Monthly EM&A Report*  
*(From 24 October 2011 to 30*  
*November 2011)*

Issue Date: December 2011

**Environmental Resources Management**

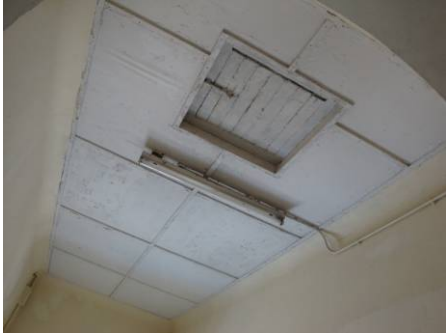
Element no.	Description	Photo ref	Significance
01.001	Flat plywood ceiling lining with plain rectangular cover battens

Adverse
01.002	Plaster coving at abutments of walls and ceilings

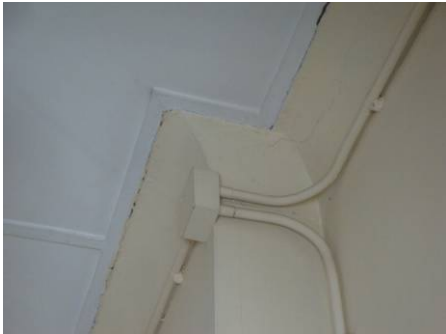
Low
01.003	Lay-in grid suspended ceiling

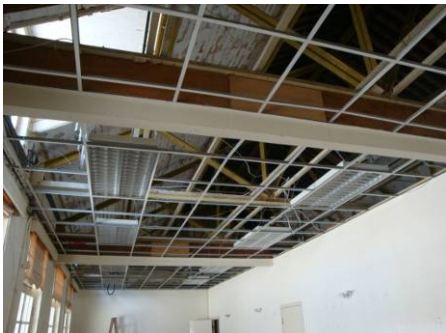
Adverse
01.004	Timber thresholds at external doors and internal doors between main corridor and individual rooms

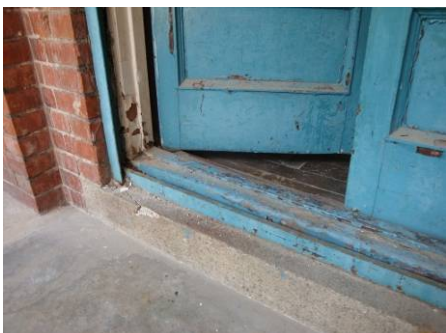
Low

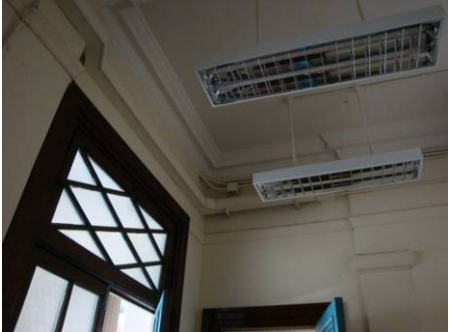
Element no.	Description	Photo ref	Significance
01.005	Plaster box cornice

Moderate
01.006	Panelled doors

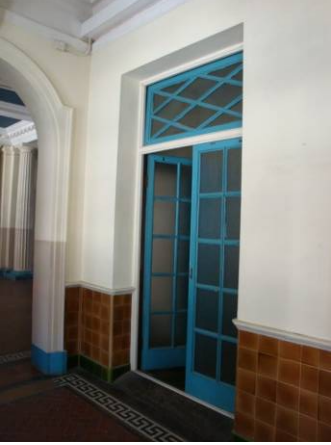
Moderate
01.007	External shutters

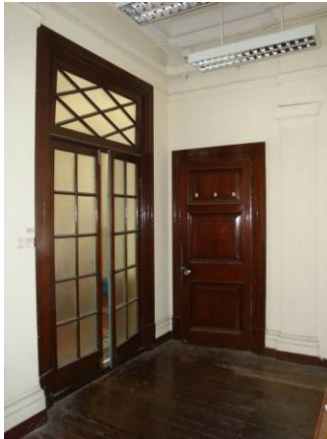
Moderate
01.010	Timber door frames and architraves

Moderate

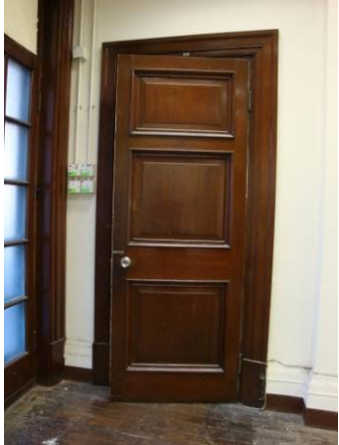
Element no.	Description	Photo ref	Significance
01.014	Existing door openings

Moderate
01.015	Existing walls

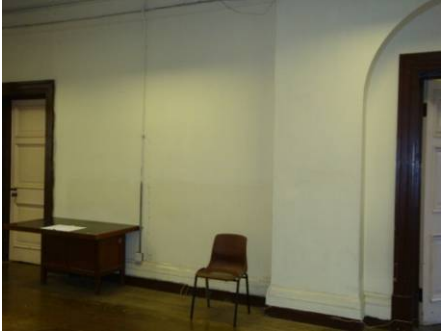
Moderate
01.016	Altered doors and windows

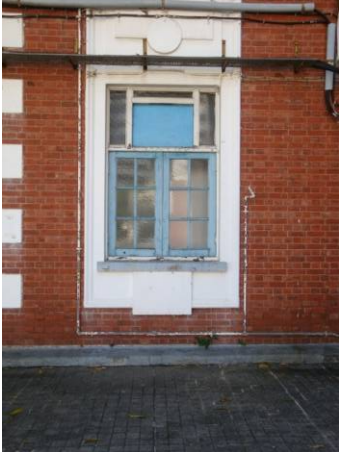
Adverse

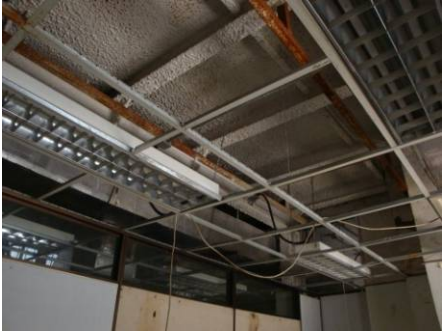
Element no.	Description	Photo ref	Significance
01.017	Mezzanine floor in room 01/LG1/13

Adverse
01.018	Cast iron grilles above Service Corridor 01/LG1/35

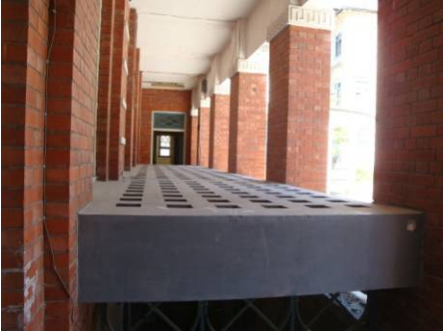
High
01.019	Perforated concrete deck above lightwell

Adverse

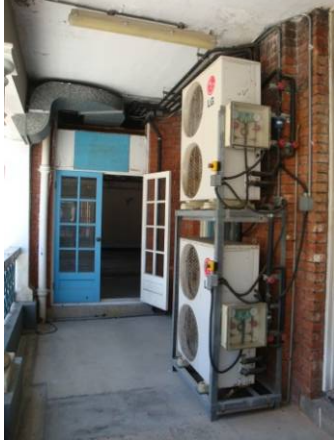
Element no.	Description	Photo ref	Significance
01.020	External airconditioning units and other external services

Adverse
01.021	Stair balustrades

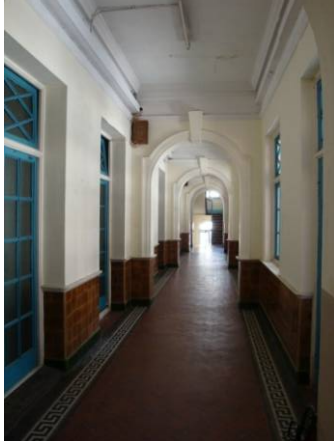
High
01.022	Main corridors

High

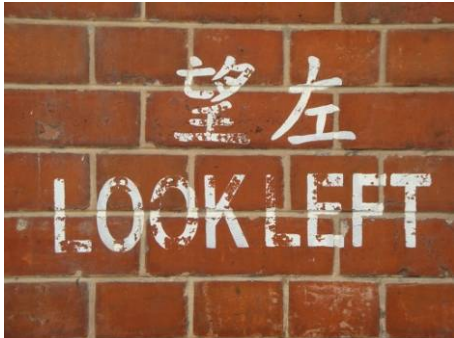
Element no.	Description	Photo ref	Significance
01.023	Painted signs

High
01.024	Fixed signs

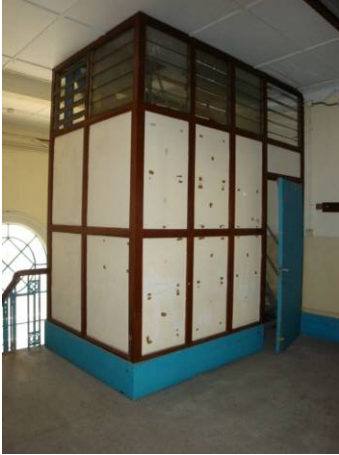
Element no.	Description	Photo ref	Significance
01.026	Enclosure at First Floor landing of main stair

Adverse
01.027	Steel railing enclosure at FF level

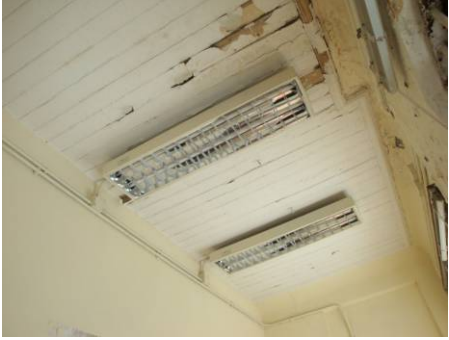
Element no.	Description	Photo ref	Significance
01.028	Tongued and grooved timber boarded ceilings in East and West wings

Moderate
01.029	Modern partitions

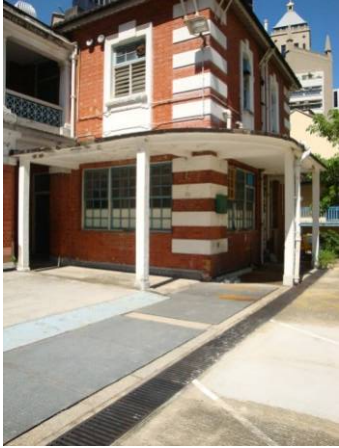
Element no.	Description	Photo ref	Significance
01.031	Reinforced concrete canopy and sash windows

Moderate

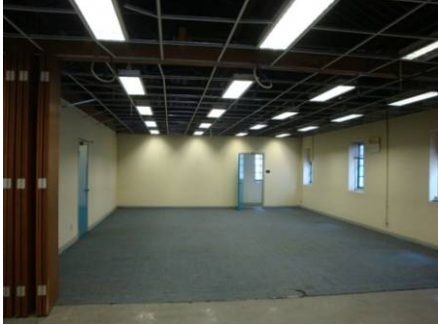
Element no.	Description	Photo ref.	Significance
02.001	Lay-in grid suspended ceiling

Adverse
02.002	Modern internal doors

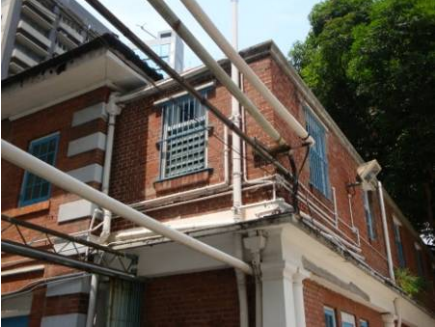
Element no.	Description	Photo ref.	Significance
02.004	External airconditioning units and other external services

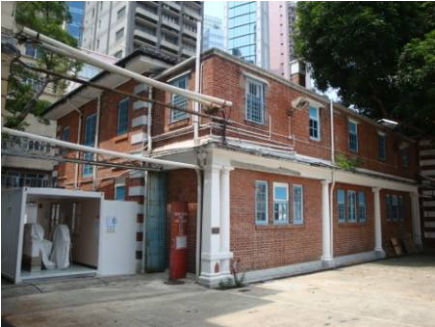
Adverse
02.005	Brickwork walls enclosing rooms at GF and FF East side

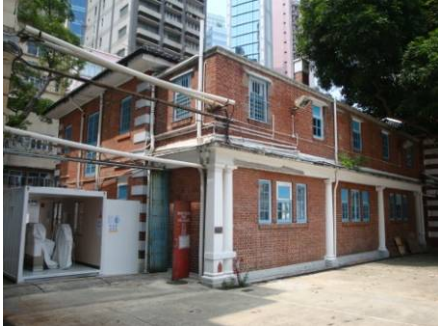
Element no.	Description	Photo ref.	Significance
02.007	Rainwater goods

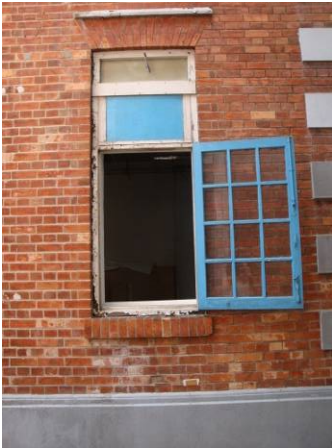
Adverse
02.008	Altered doors and windows

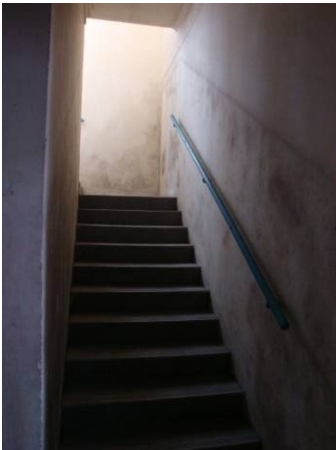
Adverse
02.009	Concrete stairs

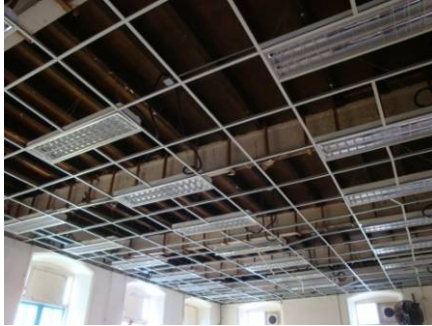
Element no.	Description	Photo ref.	Significance
03.001	Lay-in grid suspended ceiling

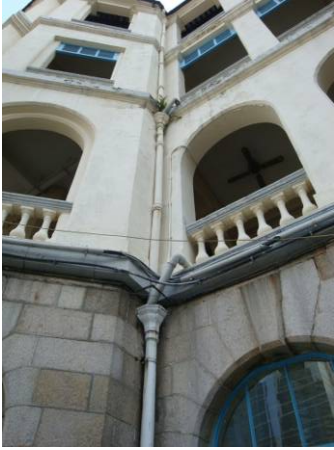
Element no.	Description	Photo ref.	Significance
03.007	Rainwater goods

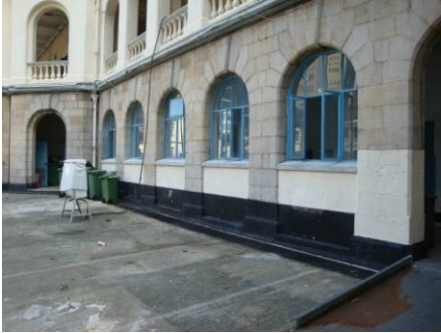
Adverse
03.008	Exterior decorations

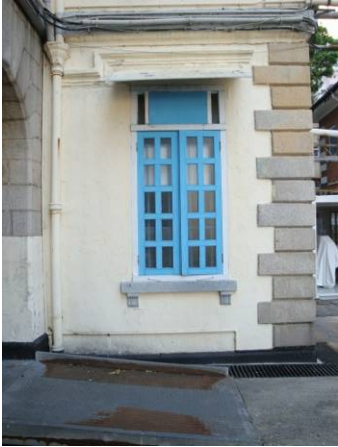
Low
03.011	Altered doors and windows

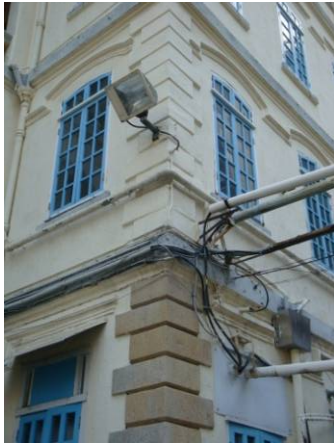
Adverse
03.012	External airconditioning units and other external services

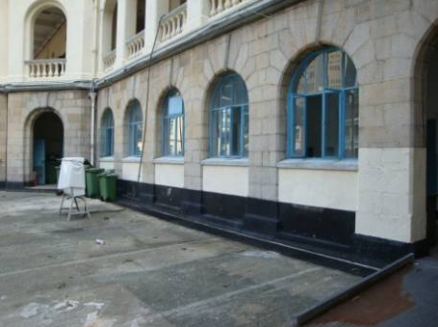
Moderate
03.018	Metal-frames windows at GF North elevation

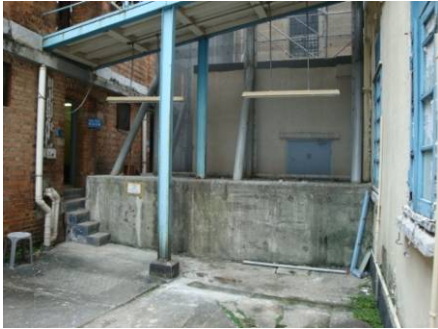
High
03.023	Single storey outbuildings on south side

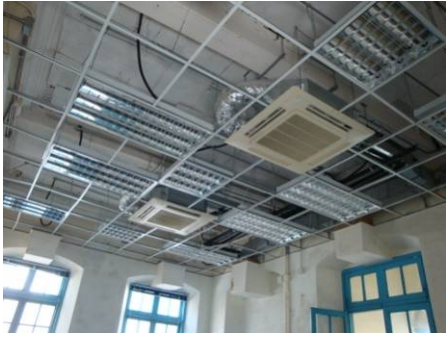
Element no.	Description	Photo ref.	Significance
04.001	Lay-in grid suspended ceiling

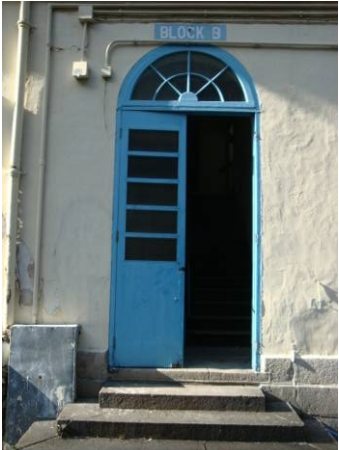
Moderate
04.008	Altered doors and windows

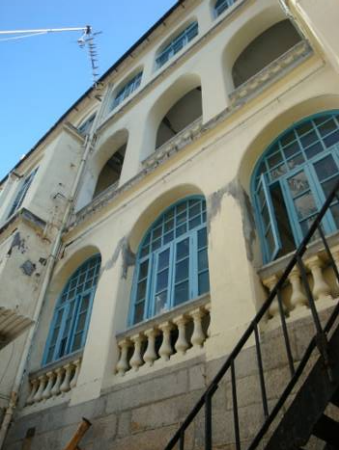
Adverse
04.009	Window frames in arcades of North and East elevations

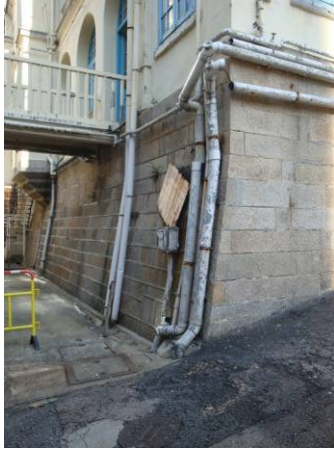
Element no.	Description	Photo ref.	Significance
04.010	External airconditioning units and other external services

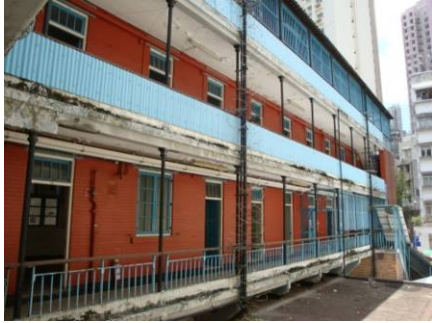
Element no.	Description	Photo ref.	Significance
08.001	Panelled doors

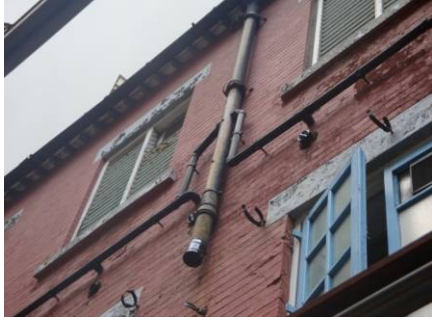
Low
08.002	Rainwater goods

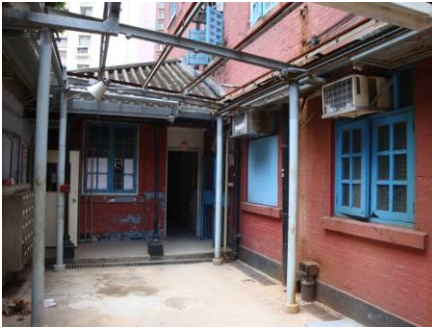
Adverse
08.003	Exterior decorations

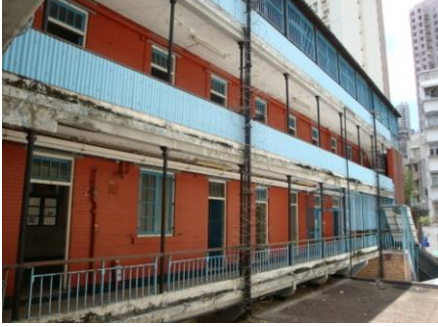
Element no.	Description	Photo ref.	Significance
08.004	Block existing door openings

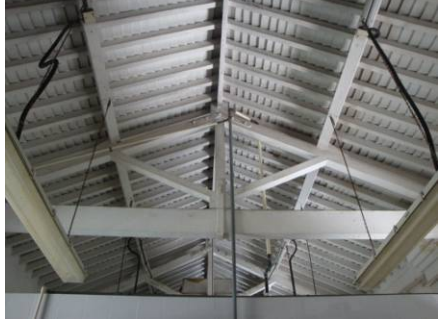
Moderate
08.005	Timber roof structure

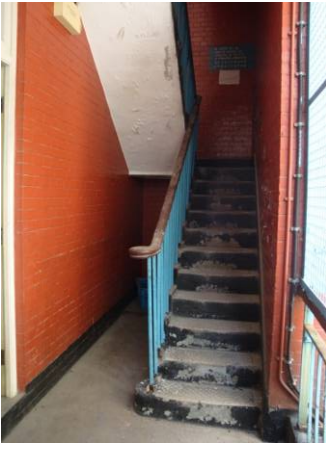
High
08.006	External stair at west end

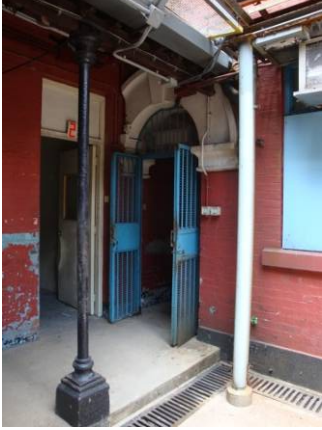
Element no.	Description	Photo ref.	Significance
08.007	External airconditioning units and other external services

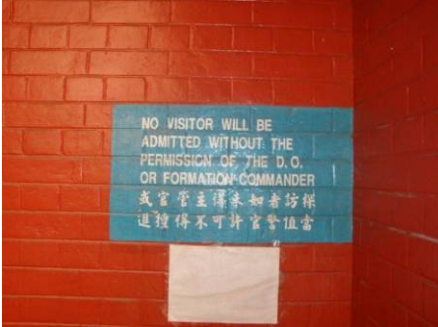
Adverse
08.008	Painted signs

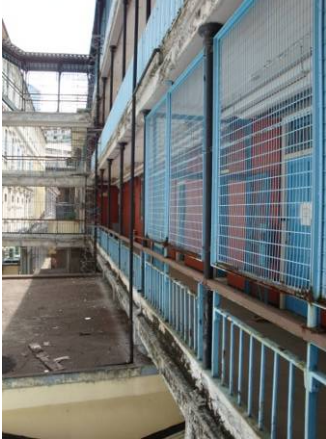
High
08.009	Wire mesh screens

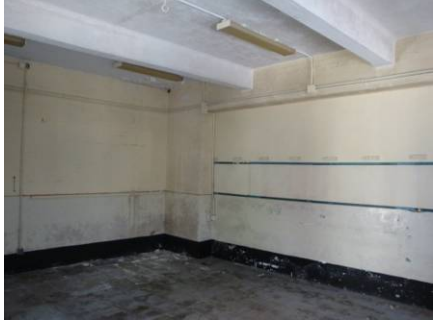
Element no.	Description	Photo ref.	Significance
08.010	Internal walls and concrete floors

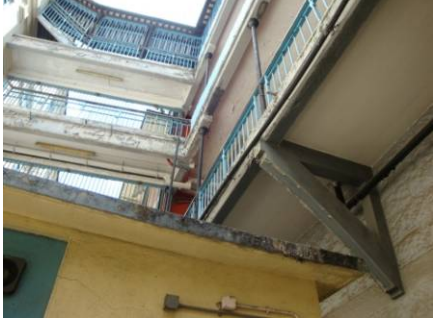
Low
08.011	Cantilever balconies on north side

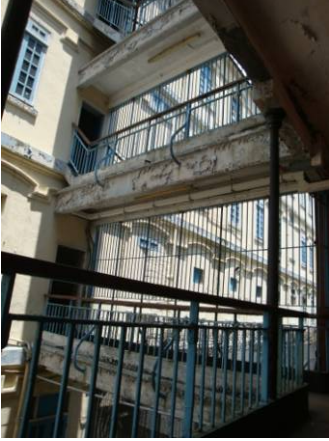
Moderate
08.012	Bridge access to Barrack Block

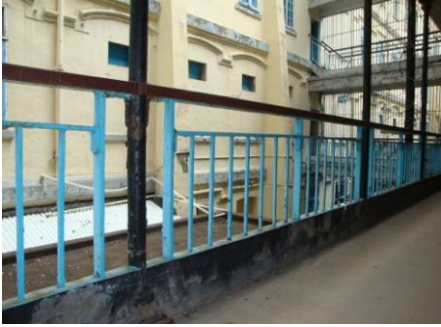
Element no.	Description	Photo ref.	Significance
08.013	Balcony balustrades

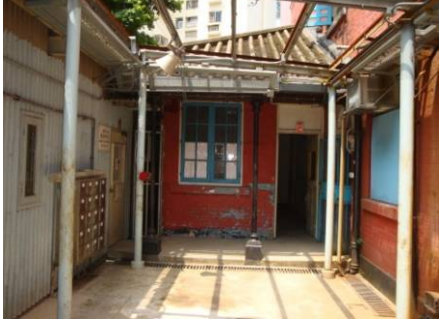
Low
08.014	Single-storey outbuilding with pitched roof over

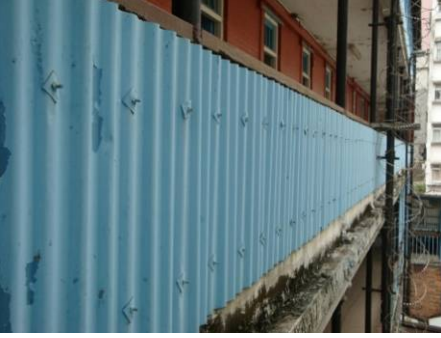
Low
08.015	Corrugated steel sheet on balcony balustrades

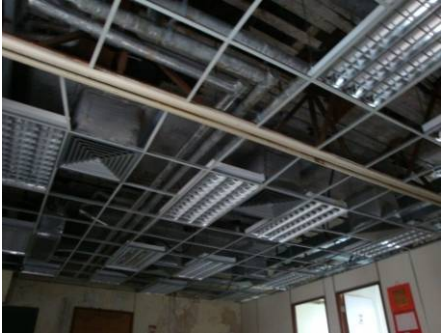
Element no.	Description	Photo ref.	Significance
09.001	Lay-in grid suspended ceiling

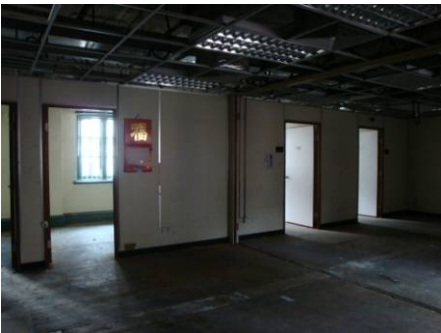
Adverse
09.002	Modern partitions

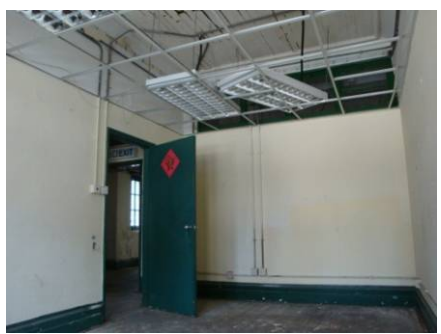
Adverse
09.003	Internal walls

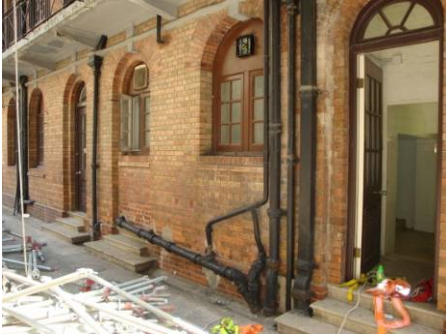
Element no.	Description	Photo ref.	Significance
09.012	Rainwater goods

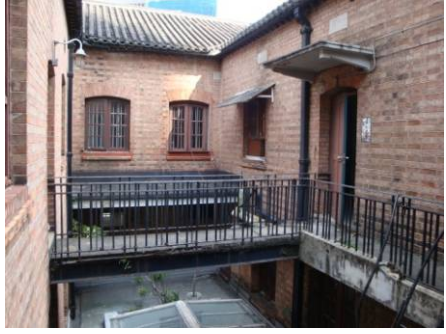
Moderate
09.013	Metal walkways across lightwell

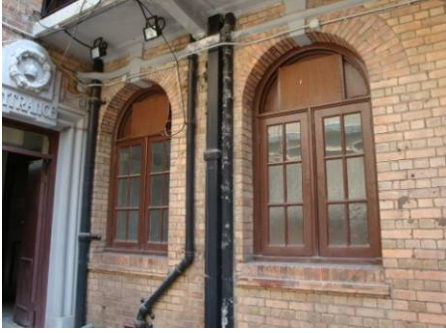
Adverse
09.014	Altered doors and windows

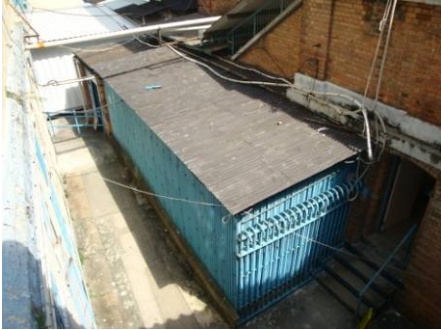
Element no.	Description	Photo ref.	Significance
09.016	Single storey secure shelter at North West corner

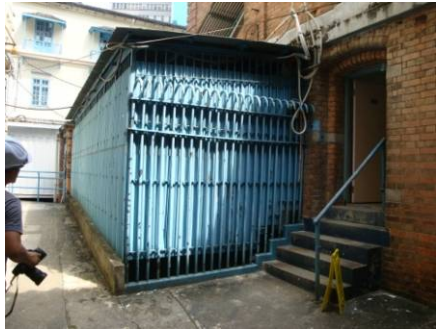
Low
09.017	Iron railing adjacent south side of item 09.016 above

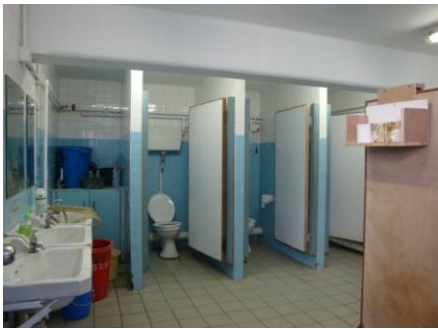
Moderate
09.018	Public toilets in 09/LG1/17, 24

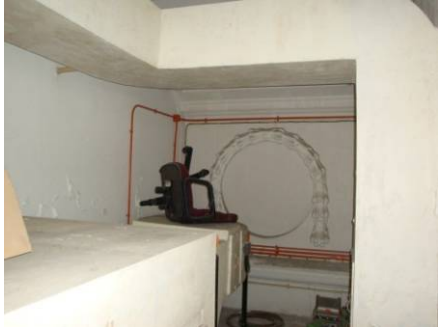
Element no.	Description	Photo ref.	Significance
09.022	Public galleries on FF

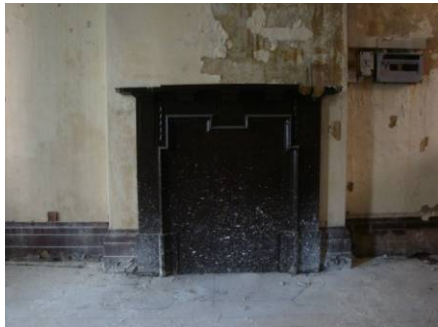
Adverse
09.023	Chimney piece

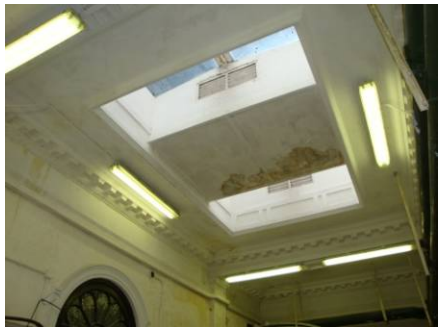
Moderate
09.024	Lanterns above entrance hall

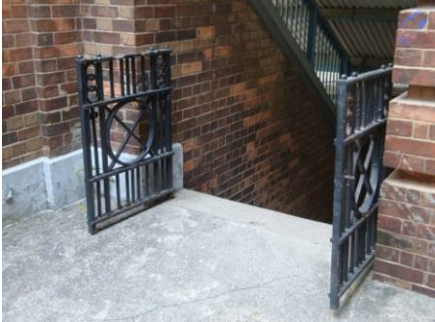
Element no.	Description	Photo ref.	Significance
09.026	Iron gates at top of external stair

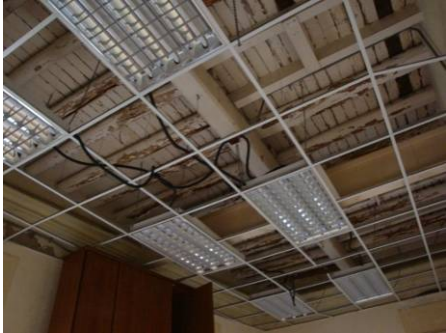
Element no.	Description	Photo ref.	Significance
10.001	Lay-in grid suspended ceiling

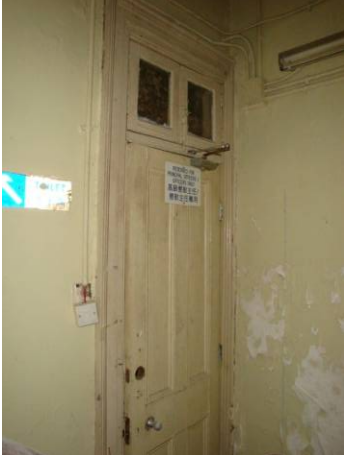
Moderate
10.003	Panelled doors and linings

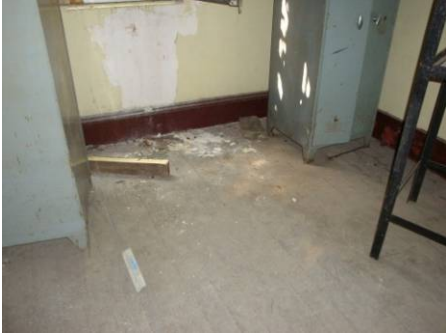
Element no.	Description	Photo ref.	Significance
10.004	Timber boarded floor with moulded skirtings

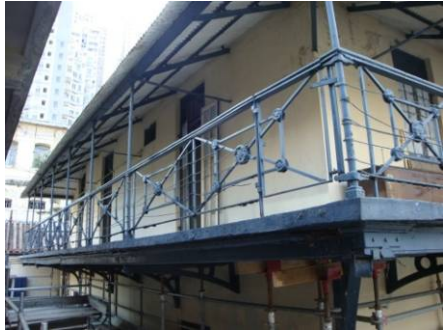
High
10.005	Exterior decorations

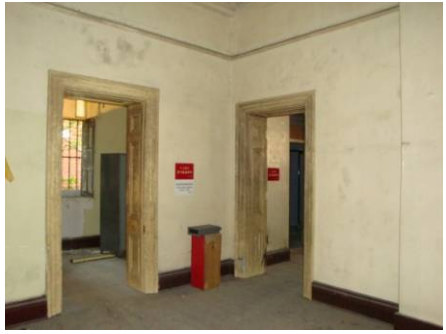
Adverse
10.006	Block existing door openings

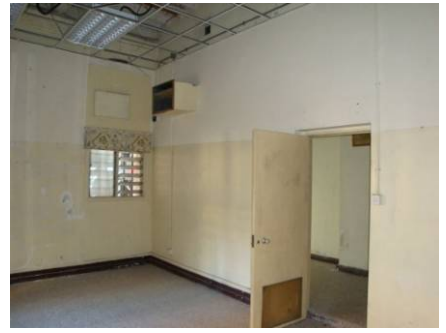
Moderate
10.007	Form new door openings

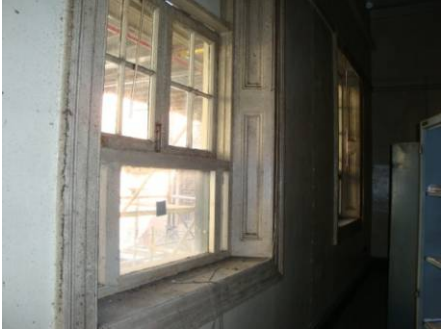
Element no.	Description	Photo ref.	Significance
10.008	Altered doors and windows

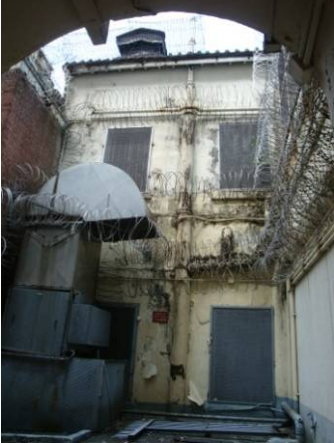
Adverse
10.009	External airconditioning units and other external services

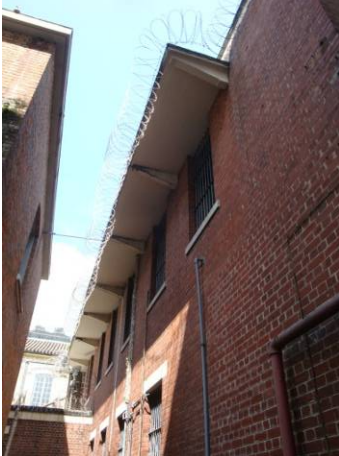
Low
13.006	Cantilever reinforced concrete canopy

Low

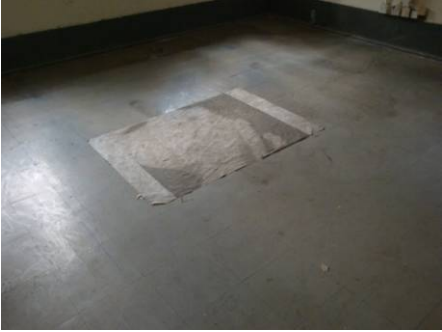
<b>Element no.</b>	<b>Description</b>	<b>Photo ref.</b>	<b>Significance</b>
13.015	Vinyl tile floor

Adverse

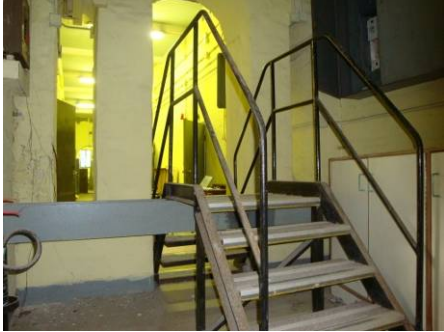
Element no.	Description	Photo ref.	Significance
14.013	Structural steelwork bracing and temporary access stair

Adverse
14.014	RC staircase at north-east corner

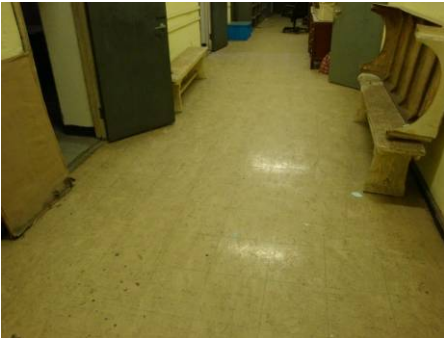
Low
14.015	Vinyl tile floor on suspended timber floor

Adverse

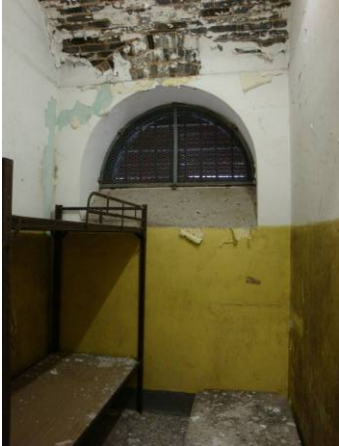
Moderate
14.035	Brickwork spandrels below cell windows on south side at Ground Floor

Moderate

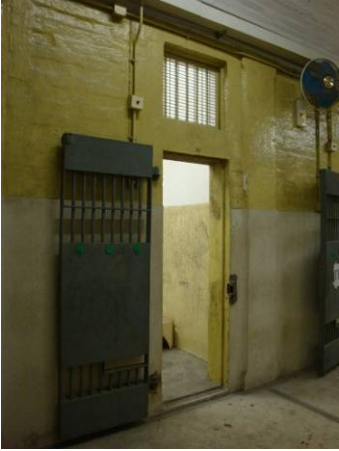
Element no.	Description	Photo ref.	Significance
14.036	Cell walls flanking central hall

High
14.037	Cell floors

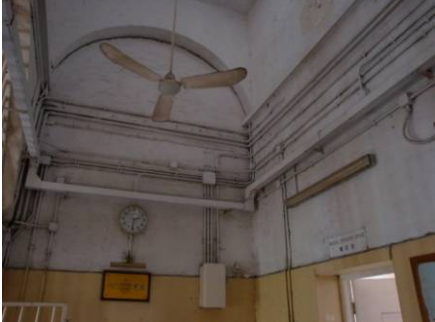
Element no.	Description	Photo ref.	Significance
14.048	Services installations

Adverse
14.049	Metalwork and structural steel framing on exterior (typical)

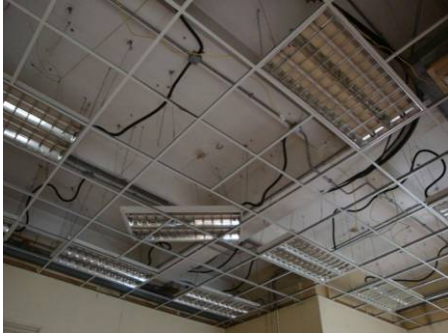
Element no.	Description	Photo ref.	Significance
17.001	Lay-in grid suspended ceiling

Adverse
17.002	Rainwater goods

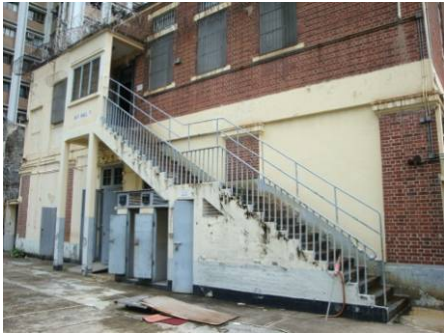
Adverse

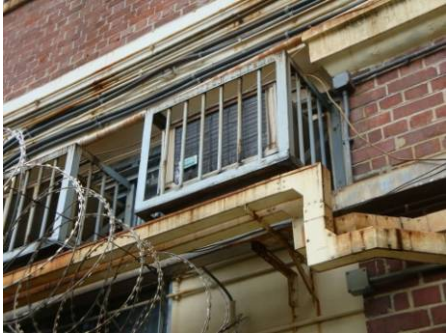
Element no.	Description	Photo ref.	Significance
17.004	External airconditioning units and other external services

Adverse
17.005	Fixed signs

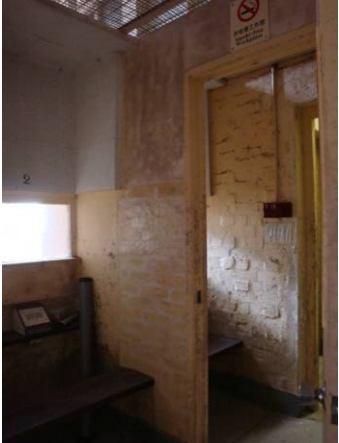
Moderate
17.014	Interview booths

High

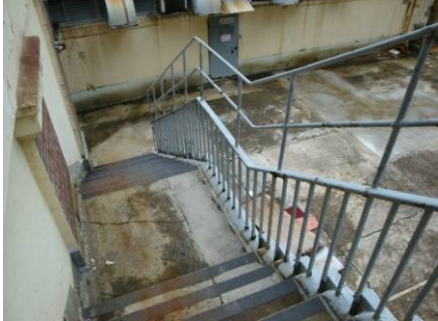
Element no.	Description	Photo ref.	Significance
17.015	External stair to First Floor

Moderate
17.016	Ground Floor main entrance

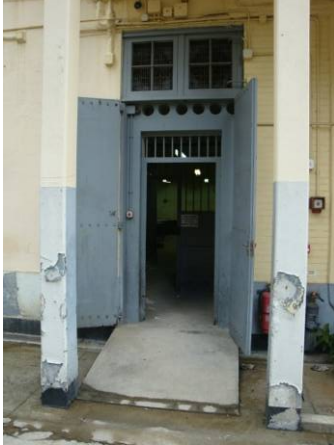
Low
17.017	Security screen at Ground Floor main entrance

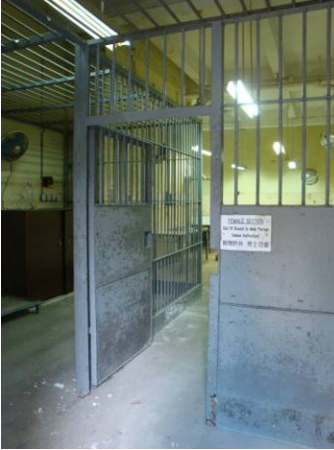
Low

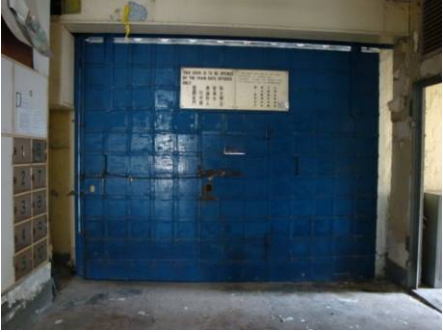
Element no.	Description	Photo ref.	Significance
17.018	Blue Entrance Gate (facing Old Bailey Street)

High
17.019	Blue Entrance Gate (inner) and enclosed yard

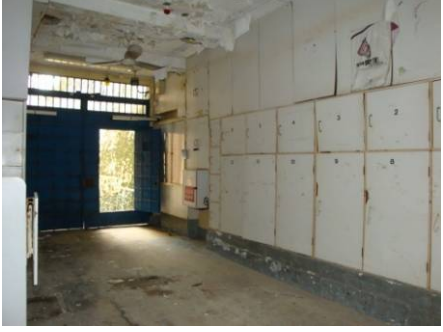
Moderate
17.020	Blue Entrance Gate (inner) facing Prison Yard

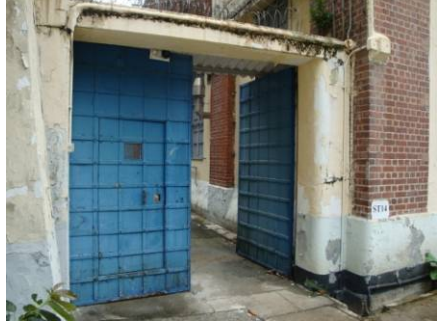
Moderate

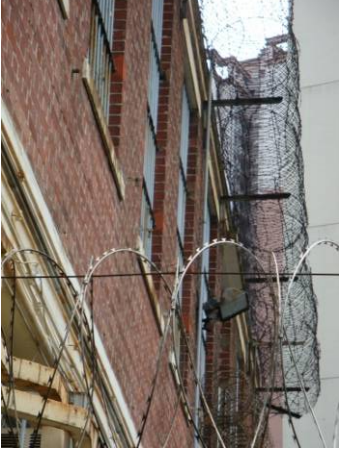
Element no.	Description	Photo ref.	Significance
17.021	Barbed wire

Moderate
17.022	Metal security bars at windows

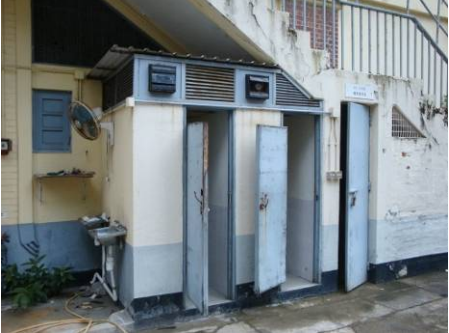
Low

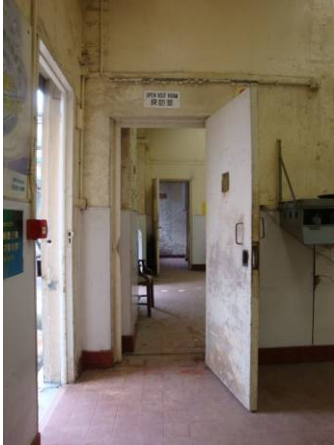
Element no.	Description	Photo ref.	Significance
17.024	Open Visit Room

Low

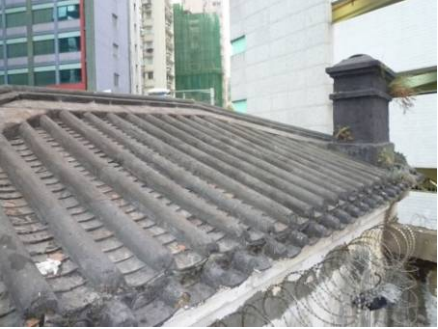
Element no.	Description	Photo ref.	Significance
19.001	Pitched roofs

High
19.002	Chimney

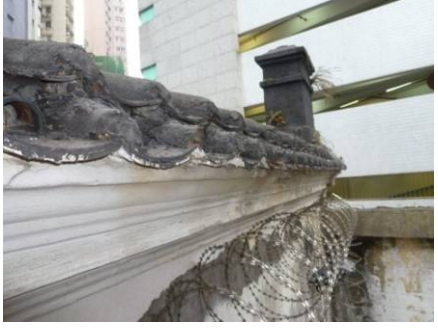
High
19.003	Rainwater goods and other external services

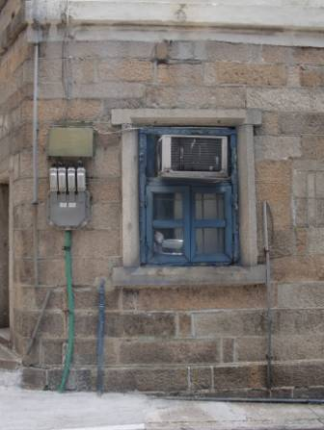
Adverse

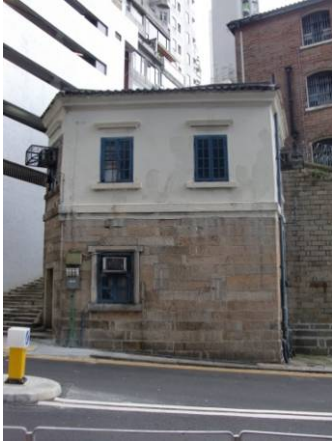
Element no.	Description	Photo ref.	Significance
19.004	External stone wall facing

High
19.005	Gun loops

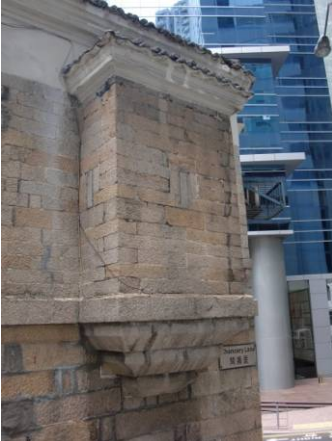
High
19.006	Look-out turret

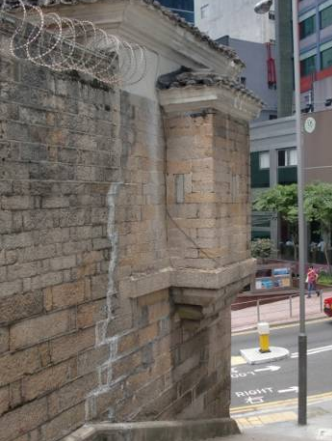
High

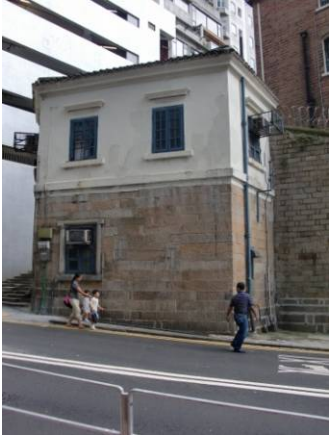
Element no.	Description	Photo ref.	Significance
19.007	Windows

Moderate
19.008	Modern partitions

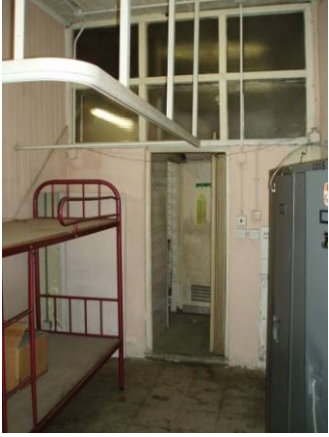
Adverse
19.009	Electrical services

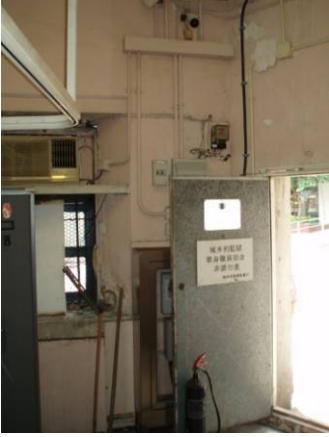
Adverse

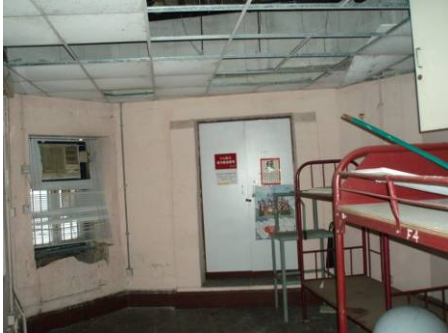
Element no.	Description	Photo ref.	Significance
19.010	Lay-in grid suspended ceiling

Adverse
19.011	Exposed timber roof structure

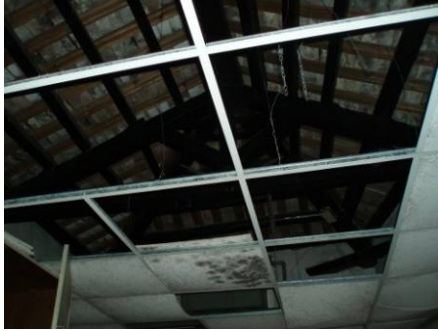
High
19.012	Timber stair

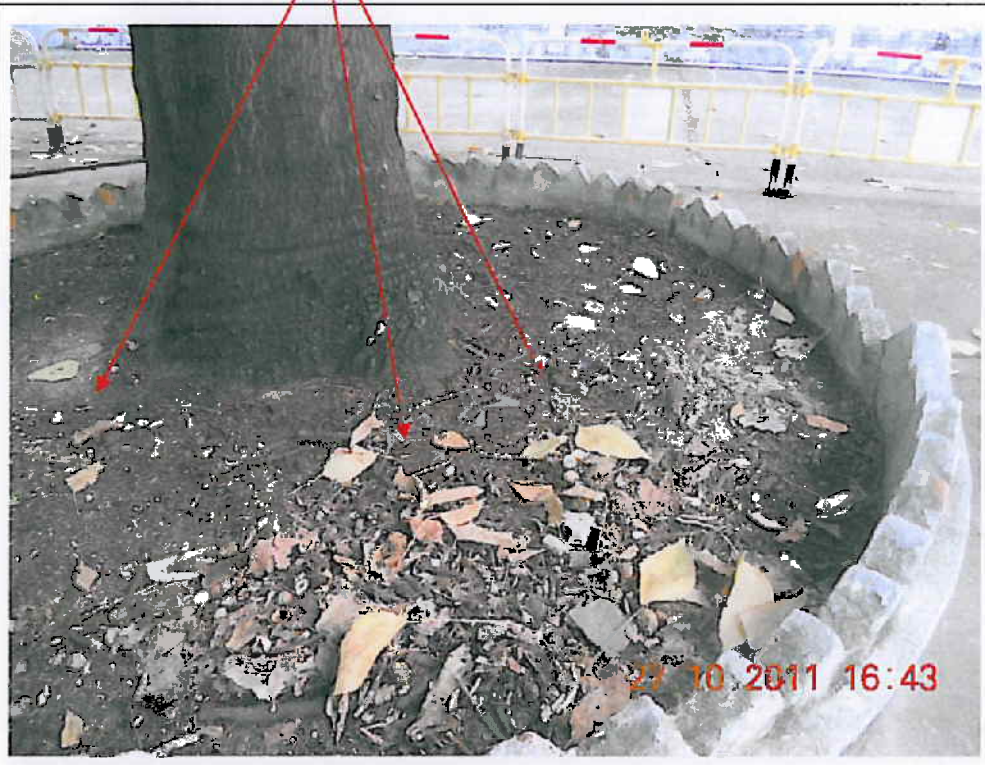
Fig 3 Too much top soil accumulated on the root collar.

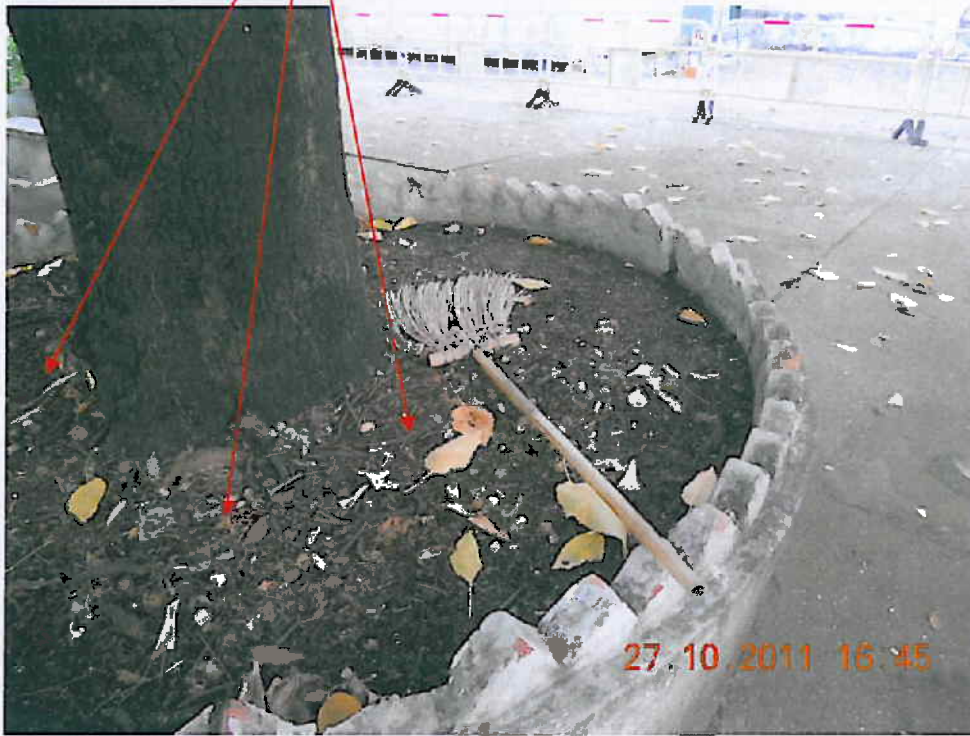
Fig. 3 Too much top soil accumulated on the root collar.

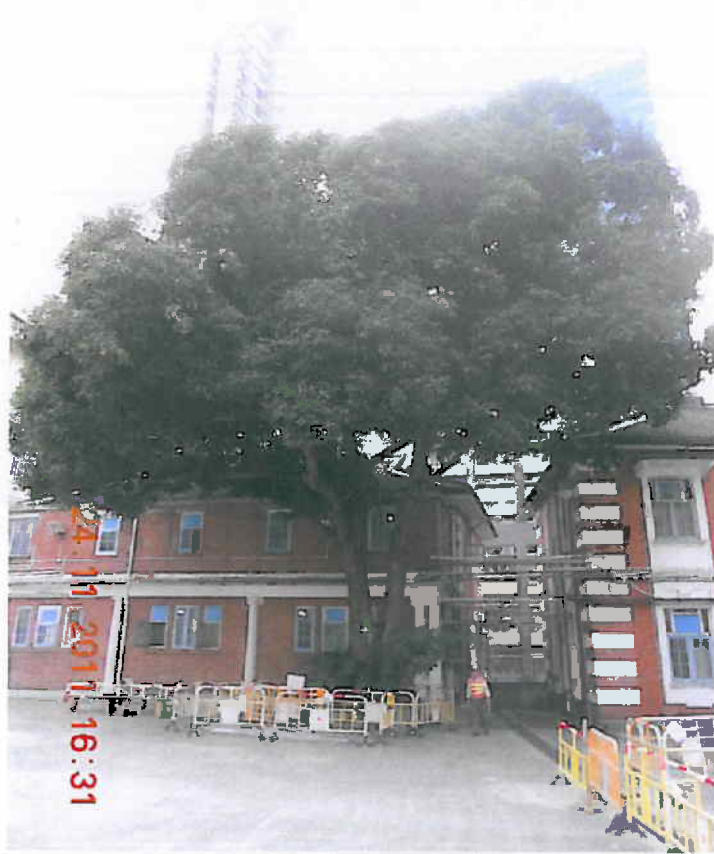
1. Overall health condition of the tree is good.
2. The tree is growing at a planter surrounded by protective rails.
3. Cleaning tools and rubbish at the planter have been removed prior to inspection.
4. The planter appears clean and tidy at the time of inspection.

Fig 2. Overall view of the tree.

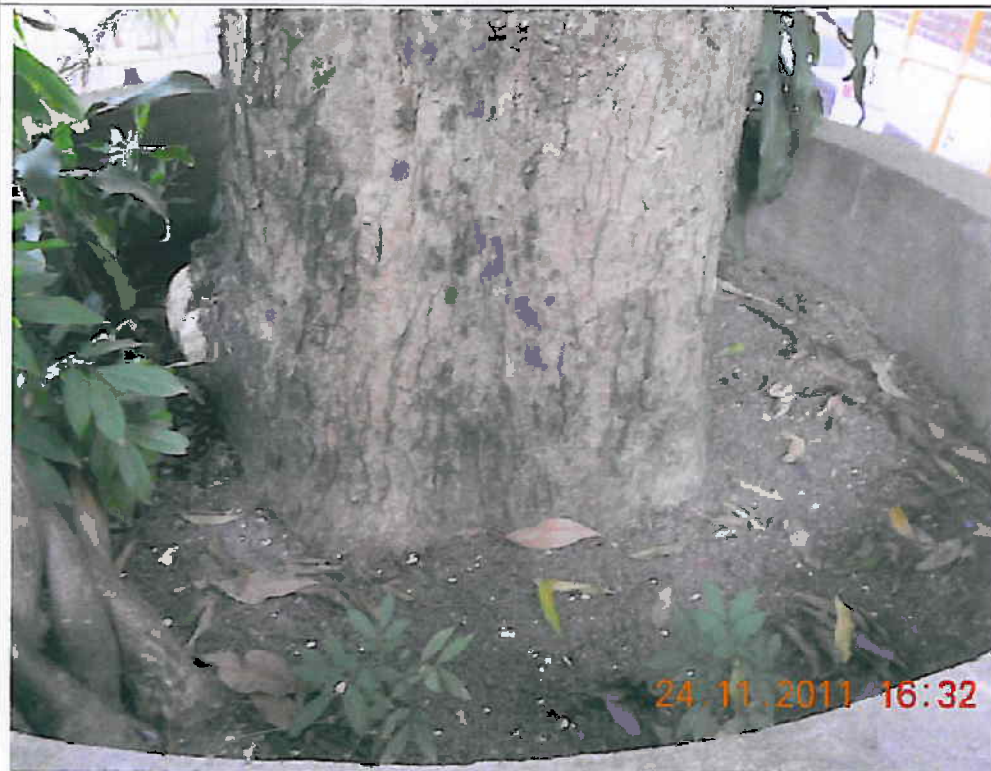
Fig. 3 Cleaning tools and rubbish have been removed prior to inspection, the planter appears clean and tidy.

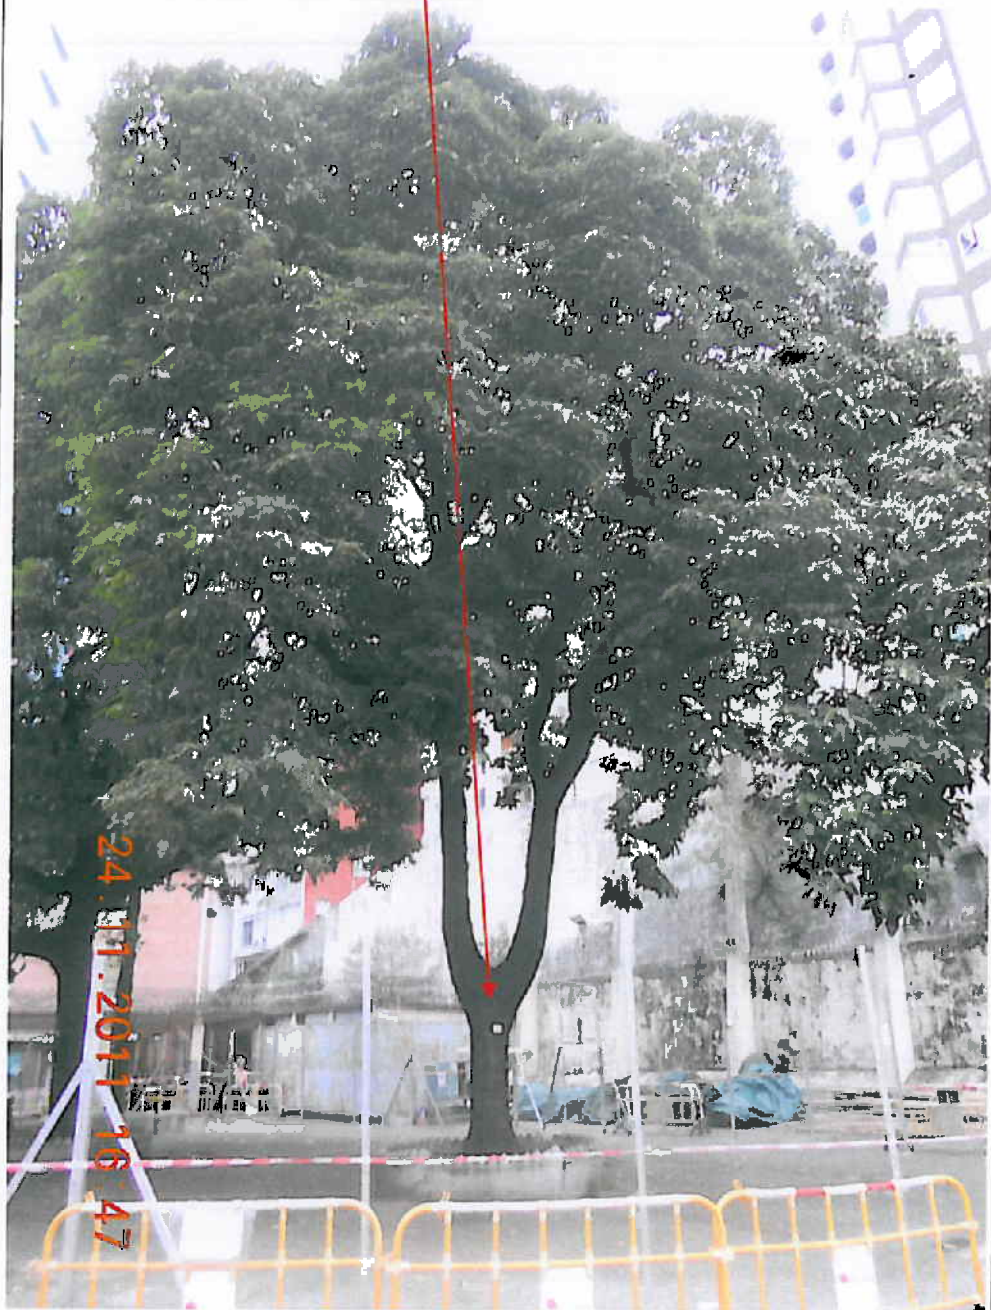
1. Overall health condition of the tree is fair.
2. Construction debris and rubbish have been removed prior to inspection.
3. The planter keeps clean and tidy at the time of inspection.

Fig 2. Overall view of the tree.

1. To erect a protective fence 2.5m high with a padlocked door beyond the crown spread or the designated protection zone of all the existing trees.

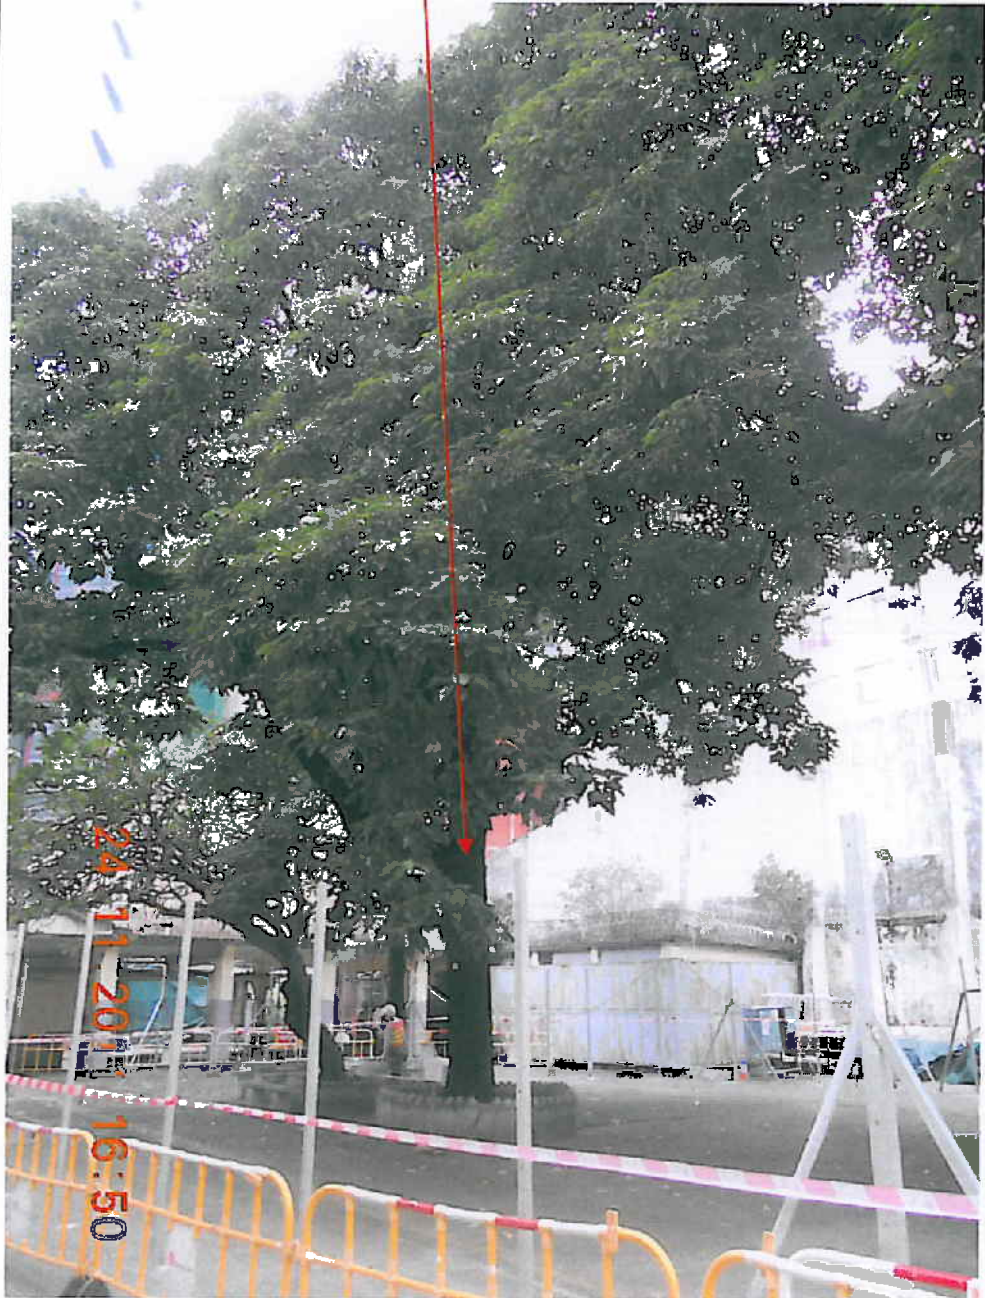
1. Overall health condition of the tree is fair.
2. The planter keeps clean and tidy at the time of inspection.

Fig 2. Overall view of the tree.
