The Jockey Club CPS Limited

Central Police Station Conservation  
and Revitalisation Project:  
*First Monthly EM&A Report*  
*(From 24 October 2011 to 30*  
*November 2011)*

Issue Date: December 2011

**Environmental Resources Management**

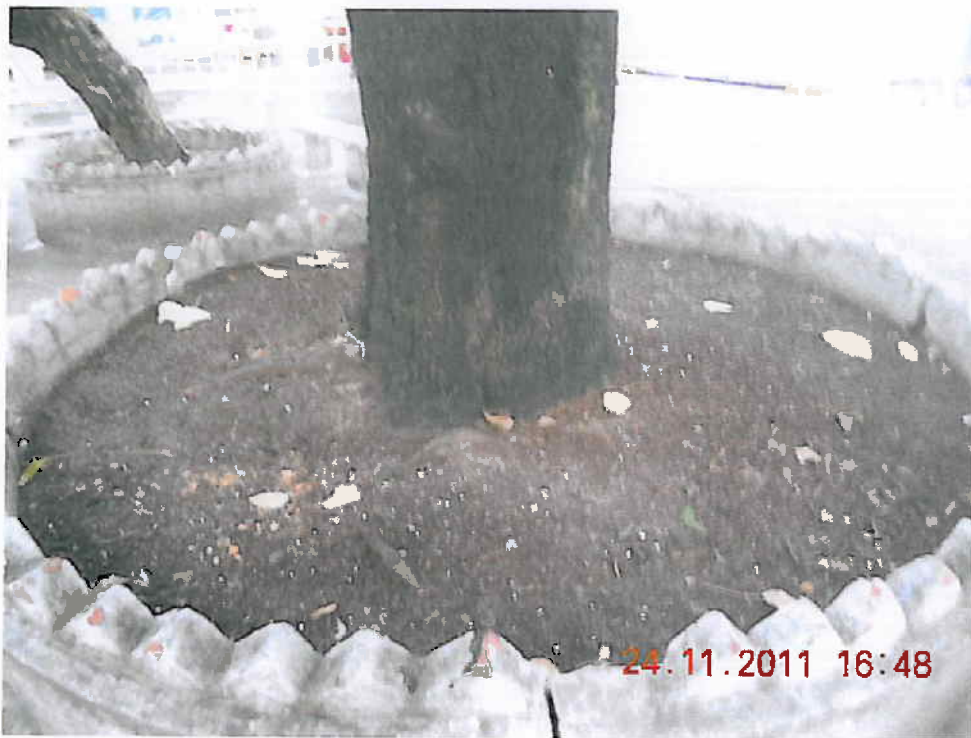
Fig. 3 The planter is clean and tidy at the time of inspection.

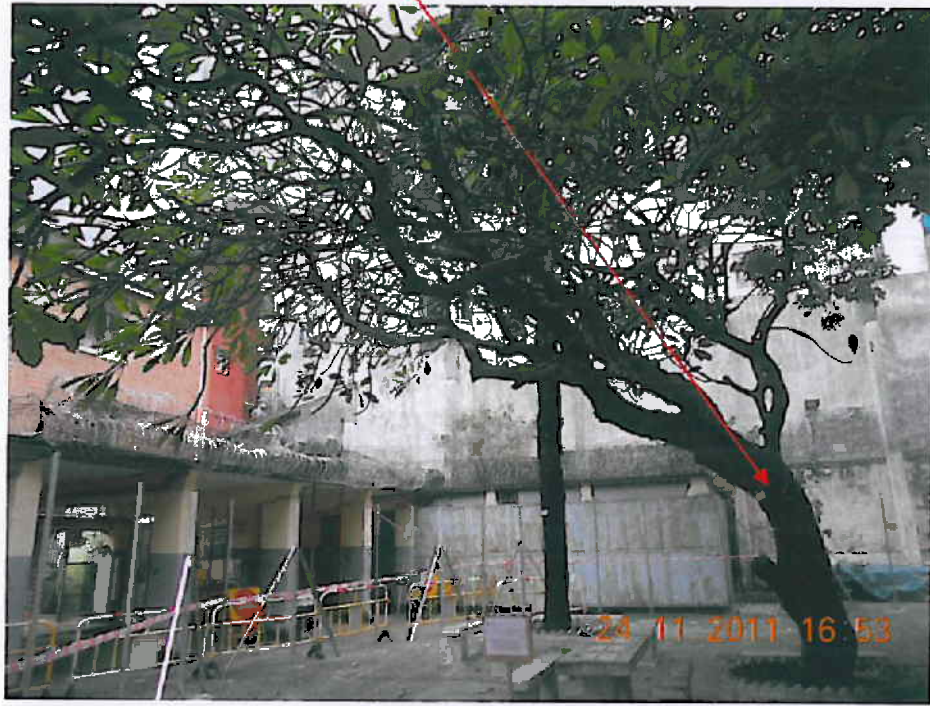
1. Overall health condition of the tree is fair.
2. The construction debris at the planter had been cleared prior to inspection.
3. The planter is clean and tidy at the time of inspection.

Fig 2. Overall view of the tree.

1. To erect a protective fence 2.0m high with a padlocked door beyond the crown spread or the designated protection zone of all the existing trees.

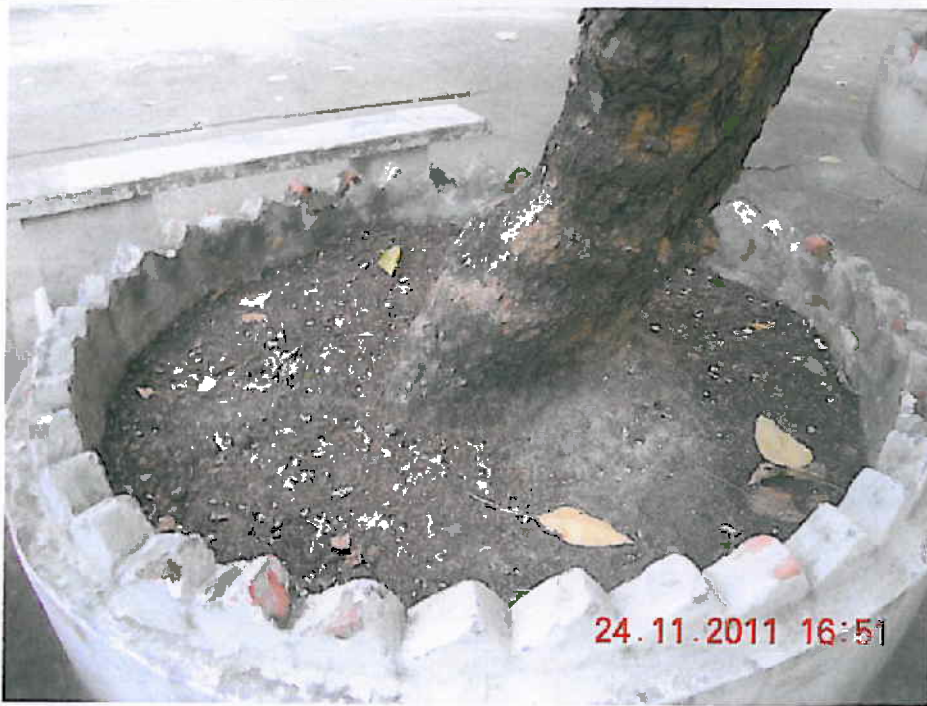
Fig. 3 The planter is clean and tidy at the time of inspection.

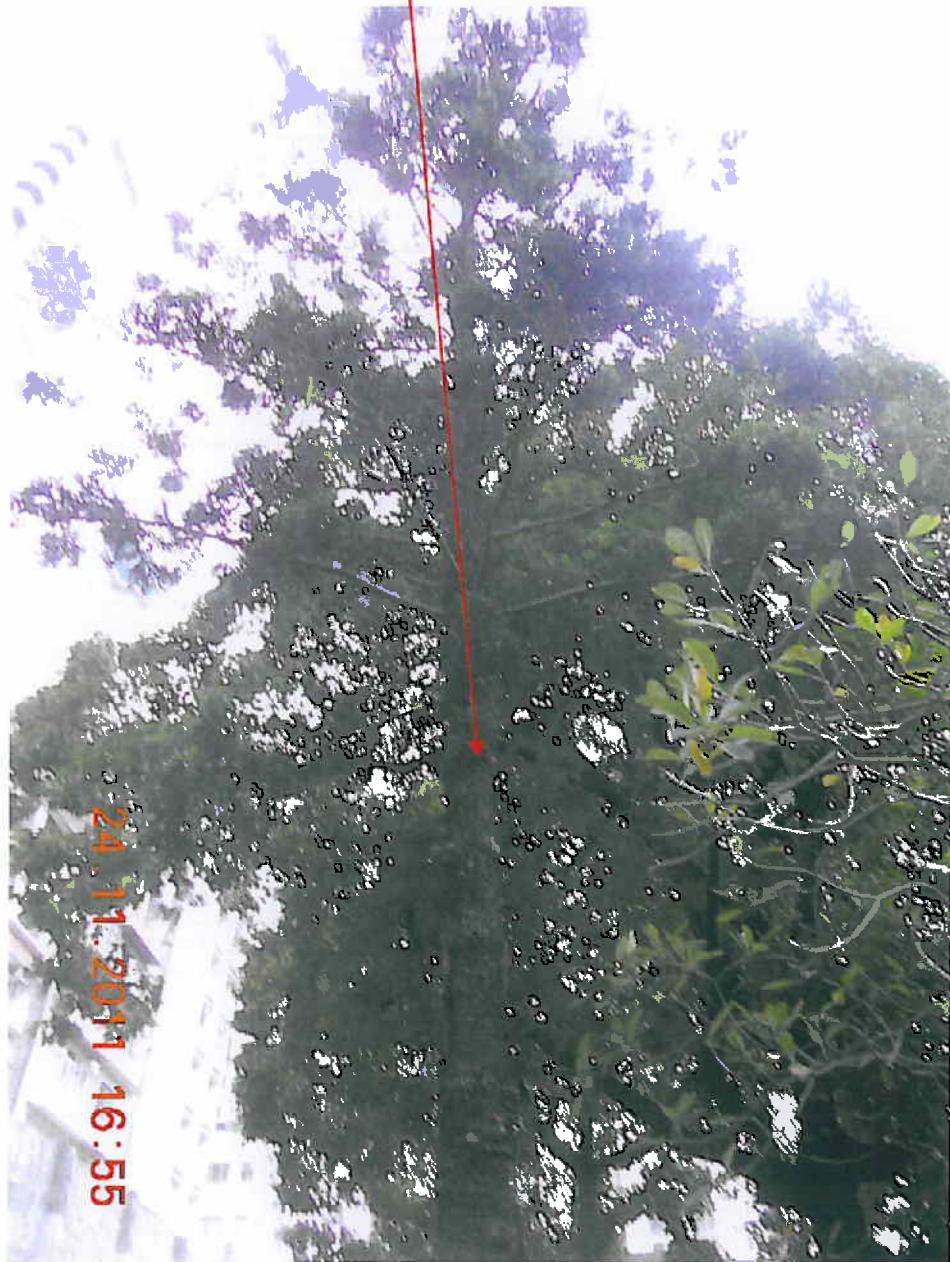
1. Overall health condition of the tree is fair.
2. Under-growth and rubbish had been cleared prior to inspection.
3. The planter is clean and tidy at the time of inspection.

Fig 2. Overall view of the tree.

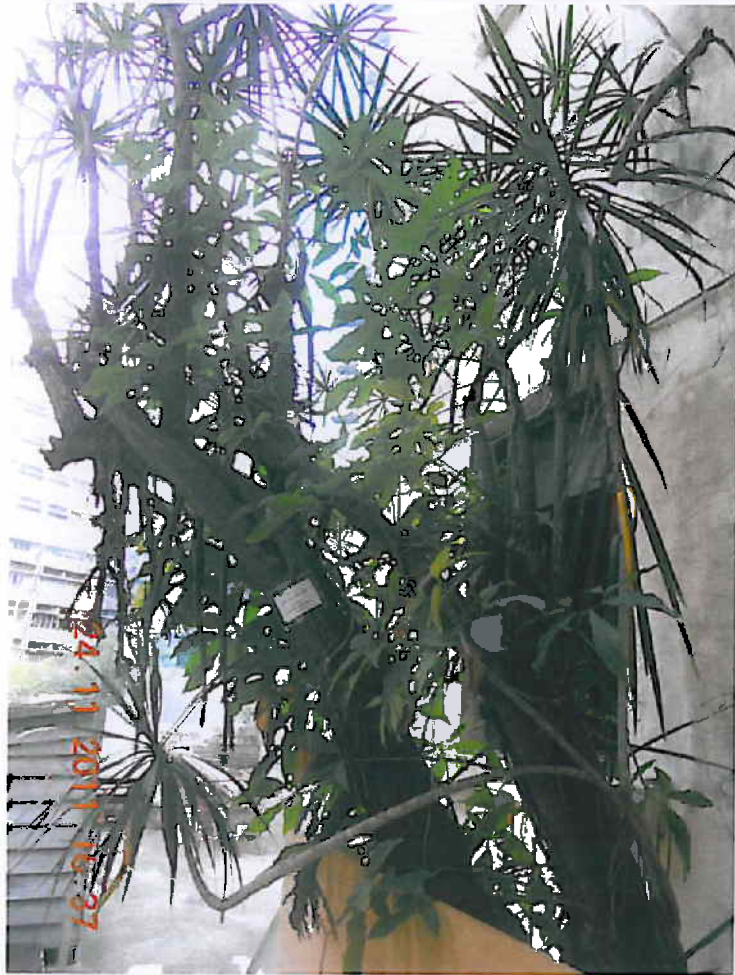
1. Overall health condition of the tree is fair.
2. Temperate fence has been erected at the planter.
3. Under-growth and rubbish have been cleared prior to inspection.
4. The planter is clean and tidy at the time of inspection.

Fig 2. Overall view of the tree.

1. To erect a protective fence 2.0m high with a padlocked door beyond the crown spread or the designated protection zone of the existing tree.

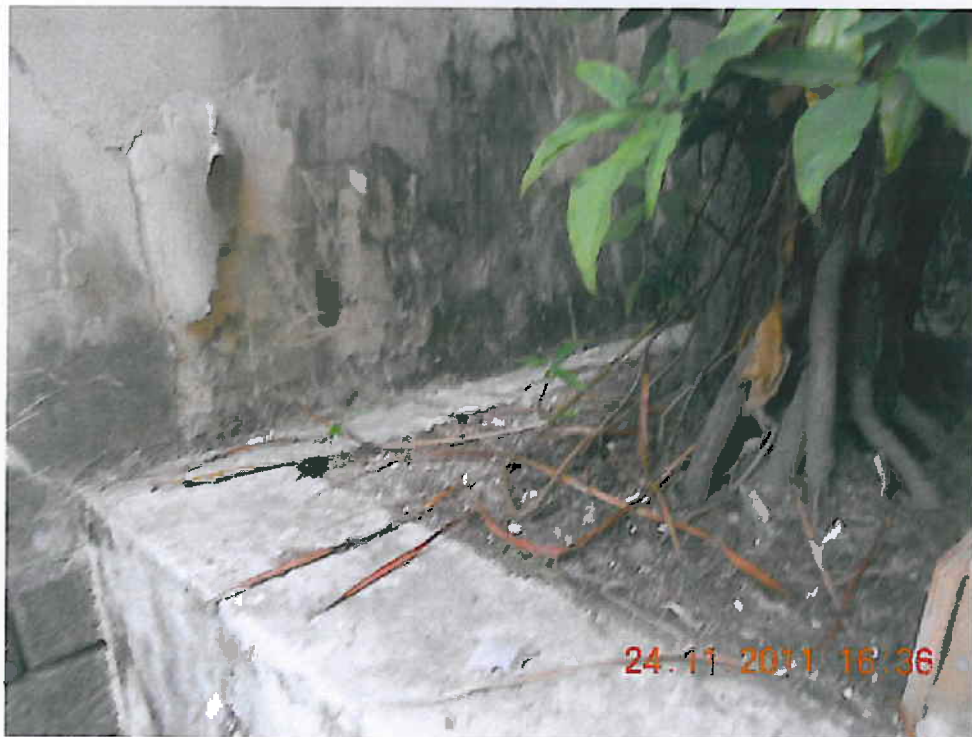
Fig 3 The planter is clean and tidy at the time of inspection.
