Document Details					
Client Drainage Services Department					
Project Contract No. DC/2007/24 Harbour Area Treatment Scheme Stage 2A Construction of Sewage Conveyance System from Aberdeen to Sai Ying Pun					
Document Title Monthly Environmental Monitoring and Audit Report No. 22 Covering the Period from 1 October 2011 to 31 October 2011					
Document No. EMA/027					
Distribution					
Copy No.	Issued To	Copy No.	Issued To		
01-02	Leighton-LNS JV	10	Metcalf & Eddy-AECOM JV		
03	Mott MacDonald Hong Kong Ltd	11	ACL (Project Office)		
04-08	EPD	12	ACL (Head Office)		
09	DSD				
Submission Ref			Controlled Copy No.		
SUBM Ref.	DC/2007/24/31.20/OG3180/EC/SH/EY				
Atkins Ref.(s)					
Revision History					
B	17 November 2011	Submission to IEC and ER for Further Review	Various	Susana Halliday	Eric Chui
A	14 November 2011	Submission to IEC and ER for Review	Various	Susana Halliday	Eric Chui
Rev.	Date	Description	Prepared	Checked & Reviewed	Approved

Contract No. DC/2007/24
Harbour Area Treatment Scheme Stage 2A
Construction of Sewage Conveyance System from Aberdeen to Sai Ying Pun

Contract No. DC/2007/24
Construction of Sewage Conveyance System from Aberdeen to Sai Ying Pun
Condition 4.4

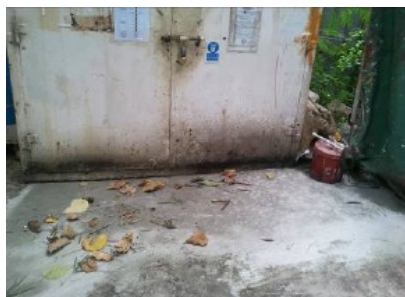
1. Waste oil drum near chemical storage was found without drip tray since last inspection.
2. Another oil spot was cleared in front of chemical waste storage. (Photo 5)

Photo 5 Another oil spot was cleared in front of chemical waste storage.

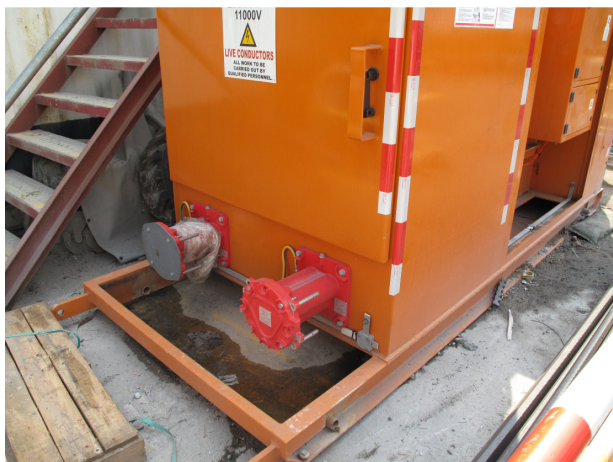
1. Drip tray has been provided to the chemical drum near the chemical storage (Photo 4).
2. Oil spots in front of chemical waste storage have been treated (Photo 5).

Photo 4 Drip tray has been provided to the chemical drum near the chemical storage

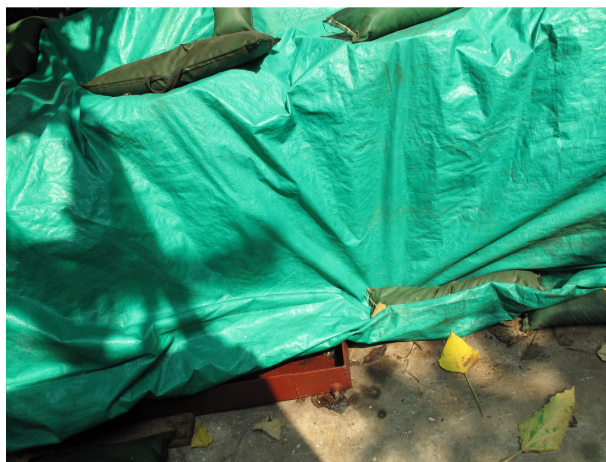
Photo 5 Oil spots in front of chemical waste storage have been treated

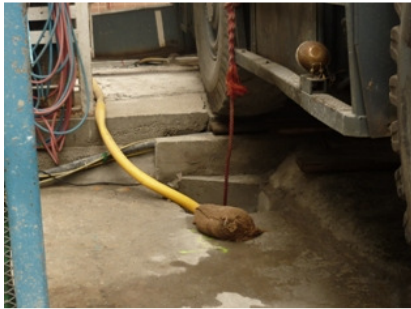
1. Trashes were found in metal case near water barriers and drip tray under the air compressor.(Photos 2 and 3)

Photo 2 Trashes were found in metal case near water barriers

1. The contractor is reminded to clear trashes in metal case and drip tray and cover the metal case to prevent water accumulation.
