Document Details					
Client <b>Drainage Services Department</b>					
Project <b>Contract No. DC/2007/24 Harbour Area Treatment Scheme Stage 2A Construction of Sewage Conveyance System from Aberdeen to Sai Ying Pun</b>					
Document Title <b>Monthly Environmental Monitoring and Audit Report No. 26 Covering the Period from 1 February 2012 to 29 February 2012</b>					
Document No. <b>EMA/032</b>					
Distribution					
Copy No.	Issued To	Copy No.	Issued To		
01-02	Leighton-LNS JV	10	Metcalf & Eddy-AECOM JV		
03	Mott MacDonald Hong Kong Ltd	11	ACL (Project Office)		
04-08	EPD	12	ACL (Head Office)		
09	DSD				
Submission Ref				Controlled Copy No.	
SUBM Ref.					
Atkins Ref.(s)		DC/2007/24/31.20/OG3513/EC/SH/EY			
Revision History					
B	14 March 2012	Submission to IEC and ER for Further Review	Various	Susana Halliday

Contract No. DC/2007/24  
Harbour Area Treatment Scheme Stage 2A  
Construction of Sewage Conveyance System from Aberdeen to Sai Ying Pun

## Environmental Certification Sheet – 36

**Contract No. DC/2007/24  
Construction of Sewage Conveyance System from Aberdeen to Sai Ying Pun  
Condition 4.4 – Submission of Monthly EM&A Report for February 2012 (no. 26)**

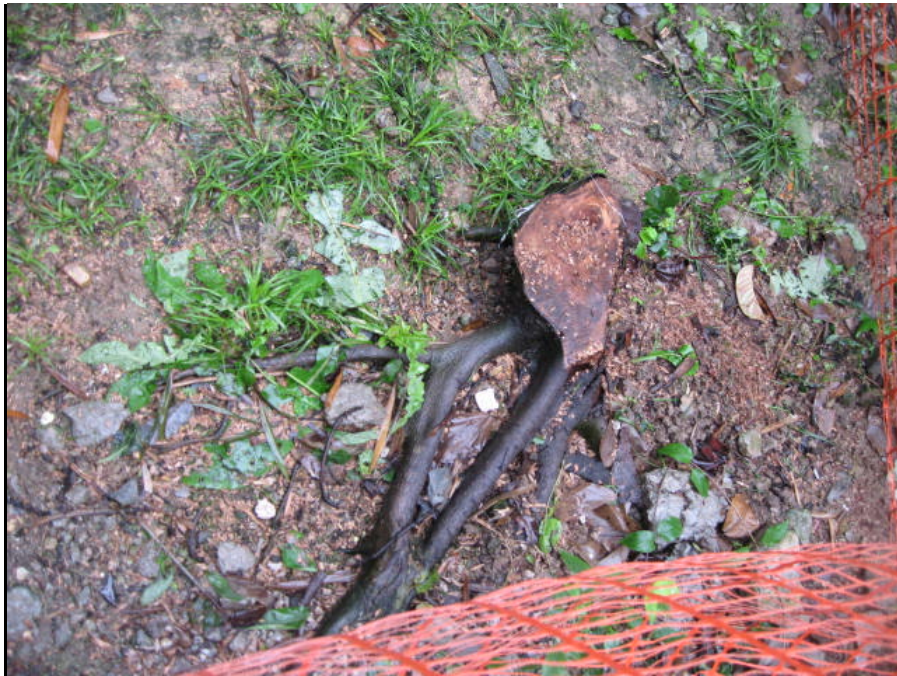
**Sandy Bay site --- Photo 1**

Retained trees T036(R) was confirmed dead by the Contractor's tree consultant last December 2011 and it was felled and removed on February 23, 2012. ..

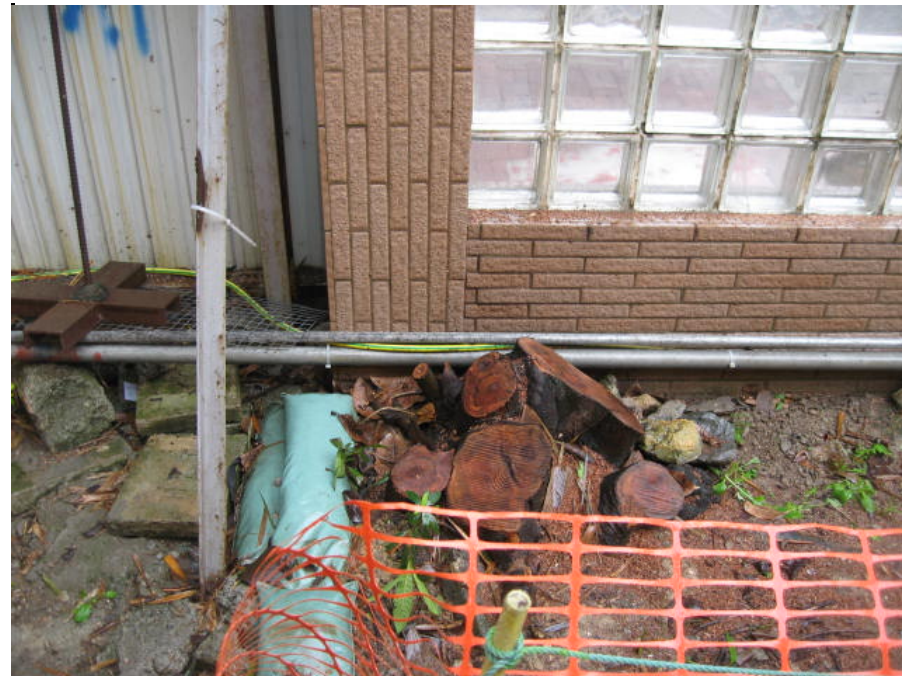
**Sandy Bay site --- Photo 2**

Retained tree T037(R) was confirmed dead by the Contractor's tree consultant last December 2011 and it was felled and removed on February 23, 2012. ..

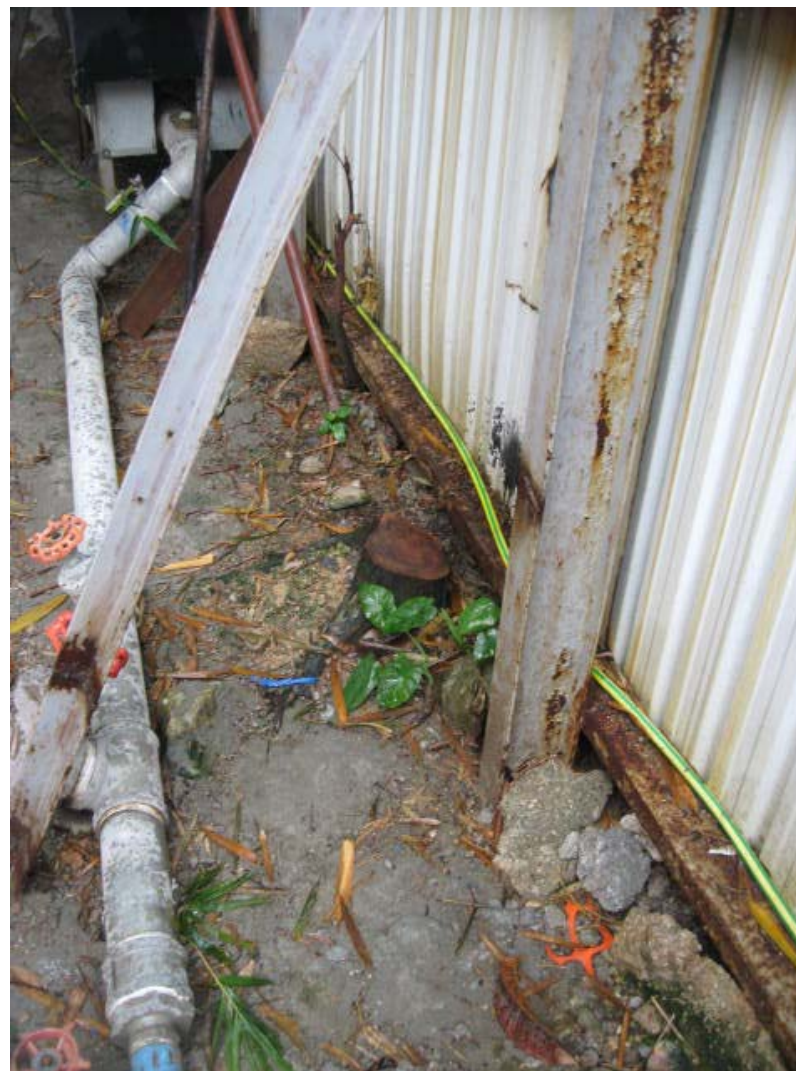
**Sandy Bay site --- Photo 4**

Retained tree T061(R) was confirmed dead in December 2011 and it was removed on February 23, 2012.

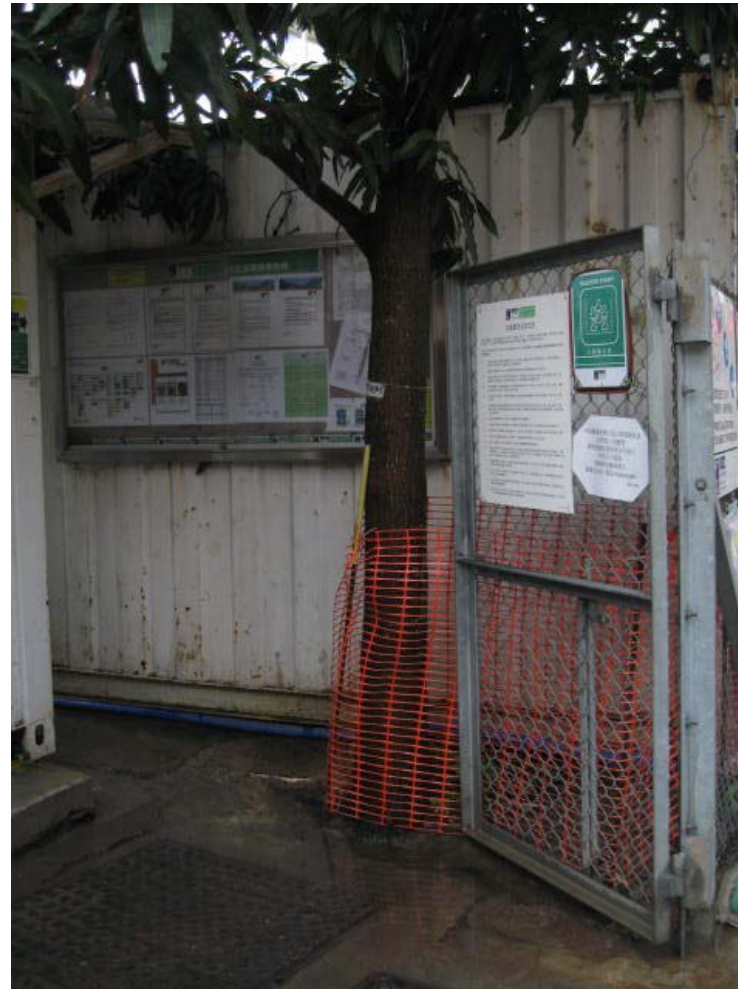
**Cyberport site --- Photo 10**

There was a slight improvement on the formation of stagnant water around  
retained tree T048(R).

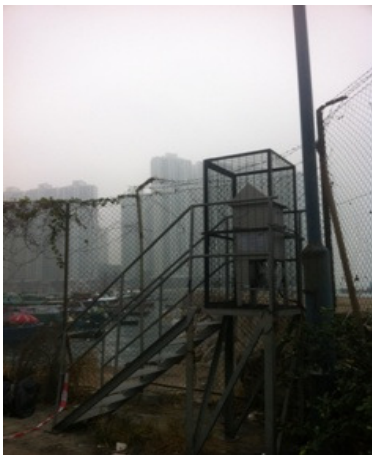
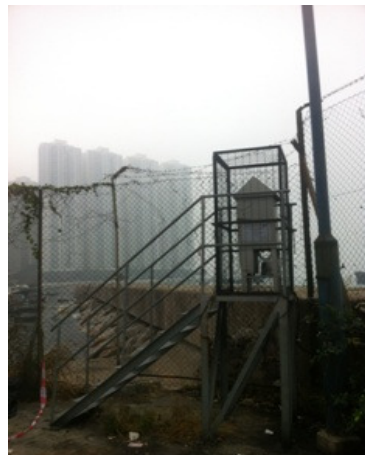
Photos 1 and 2 The hazy condition during monitoring at Aberdeen

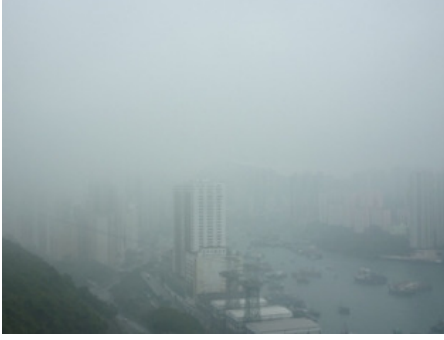
Photo 1 The hazy condition during monitoring at Aberdeen

<b>Contract No. DC/2007/24</b> <b>Harbour Area Treatment Scheme Stage 2A</b> <b>Construction of Sewage Conveyance System from Aberdeen to Sai Ying Pun</b> <b>Notifications of Environmental Quality Limits Exceedances</b>					Notification No.: 120
<b>Date of Notification:</b> 7 March 2012					
<b>Works Inspected:</b> TSP-Data collected from sampling on 23 February 2012					
<b>Monitoring Location:</b> Station CM_WF1a, The Wah Ming House					
<b>Parameter:</b> 1 hour Total Suspended Particulates (1-hr TSP)					
<b>Action &amp; Limit Level (AL &amp; LL) / Measured Level:</b>					
PARAM	STATION	AL ( $\mu\text{g}/\text{m}^3$ )	LL ( $\mu\text{g}/\text{m}^3$ )	MEASURED LEVEL, $\mu\text{g}/\text{m}^3$	
1-hr TSP	CM_WF1a	284.5	500	<b>376.7</b>	
1-hr TSP	CM_WF1a	284.5	500	<b>305.2</b>	
1-hr TSP	CM_WF1a	284.5	500	<b>1845.5</b>	
<b>Possible reason for Action or Limit Level Non-compliance:</b>  On 23 February 2012, an exceedances of the Limit Level for 1-hr TSP were recorded at Station CM_WF1a, The Wah Ming House air quality monitoring station.  Key works carried out by Contractor during the monitoring period included the following: <ul style="list-style-type: none"> <li>Rock out and Rock Bolt</li> </ul> According to the site observation, no dust emission was found during the monitoring period. Other dust source during measurement is rock breaking with using hand held breaker of other contractor with laying cables. The weather conditions were very hazy with very low visibility during the dust sampling time period (9:18-12:18noon). The exceedances were likely contributed by hazy weather. The photos 1 and 2 were taken at Wah Fu to show the breaking process and the photo 3 is showing that there was very low visibility condition on 23 February 2012.  The record of 24-hr TSP level at CM_WF1a on 24 February 2012 was $40 \mu\text{g}/\text{m}^3$ , which was well below Action Level.  It is concluded that the above exceedances was not resulted from site activities but weather condition.

<b>Actions taken/ to be taken:</b>  As the 1-hr TSP exceedances were not related to project works, no immediate actions are considered necessary.

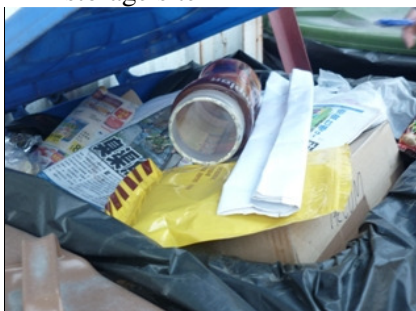
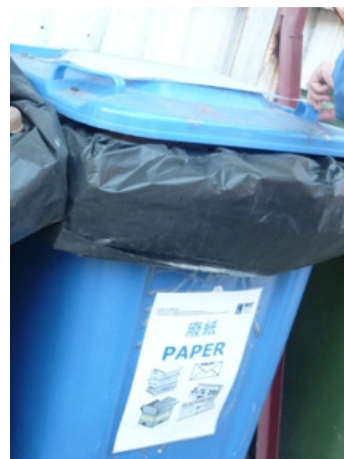
Photos 3 and 4 Some plastic matters were found in paper recycle bin in storage site

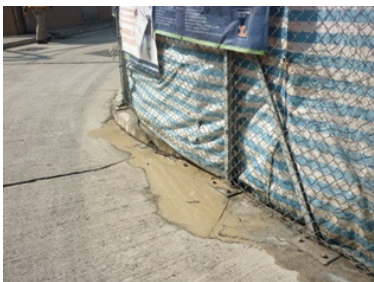
2. Some muddy water was found near the boundary behind the sedimentation tank.(Photos 4 and 5)

Photos 4 and 5 Some muddy water was found near the boundary behind the sedimentation tank

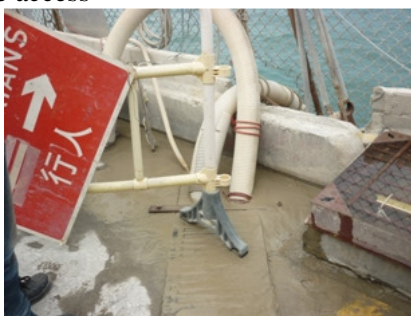
Photo 5 The pump was silted up with mud near the access

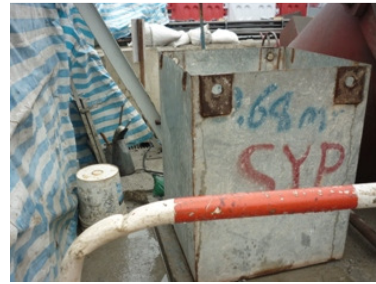
Photo 2 An unknown chemical drum near the entrance was removed

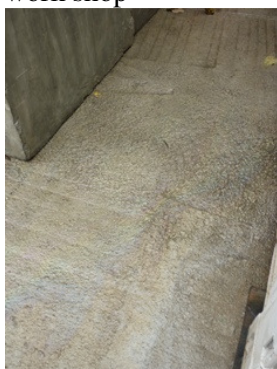
Photos 3 and 4 Oil stain was found near concert boxes in work shop
