Contract No. DC/2007/24
Harbour Area Treatment Scheme Stage 2A
Construction of Sewage Conveyance System from Aberdeen to Sai Ying Pun

Environmental Certification Sheet – 42

Document/ Plan/Changes/Information to be Certified/ Verified:	Quarterly Environmental Monitoring and Audit Report No.10 (EMA/038, Rev B)
Date of Report:	24 July 2012
Date of correspondence to IEC:	25 July 2012
Date received:	25 July 2012

**Contract no. DC/2007/24
Construction of Sewage Conveyance System from Aberdeen to Sai Ying Pun
Submission of 10th Quarterly EM&A Report for April to June 2012 (Rev. B)**

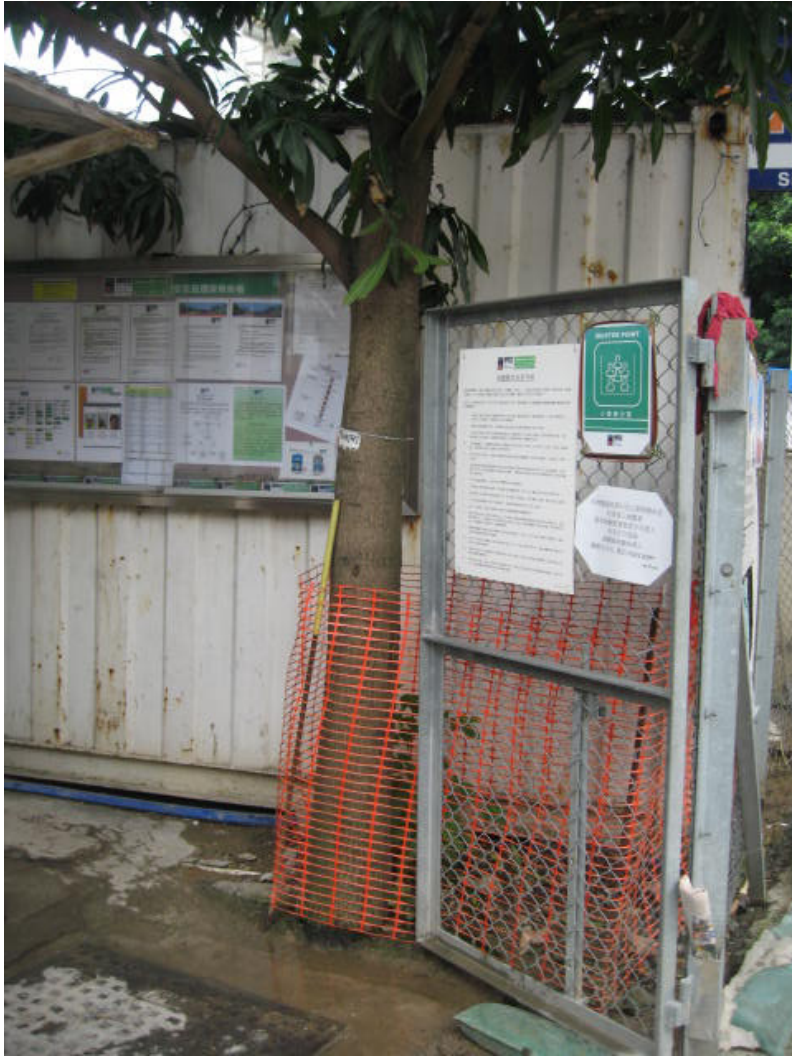
Cyberport site --- Photo 9

The area around retained tree T048(R) was damp due to the formation of water nearby.

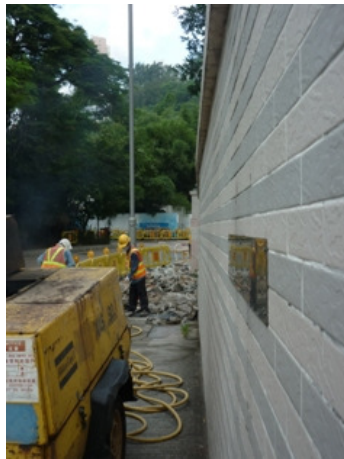
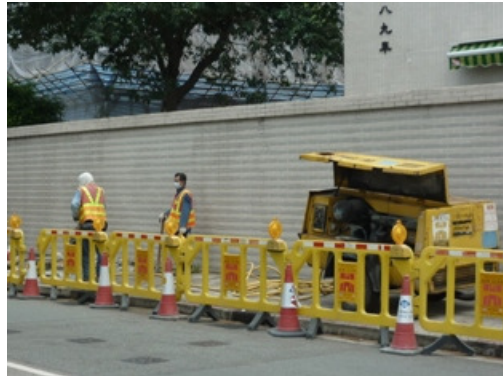
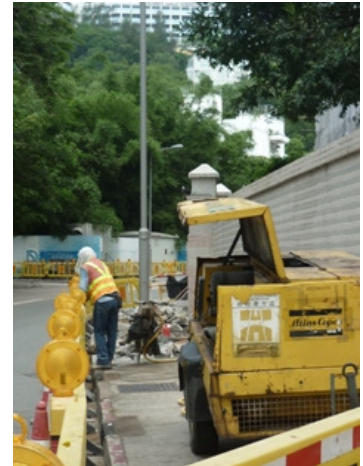
Photos 1 - 3 Road surface breaking with using hand held breaker of other contractor

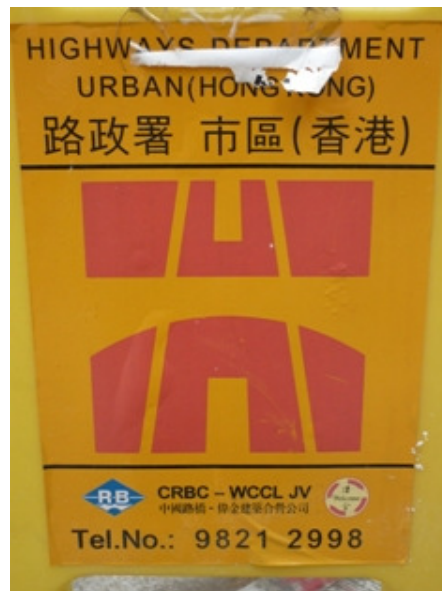
Photo 4 The contractor of CRBC-WCCL JV

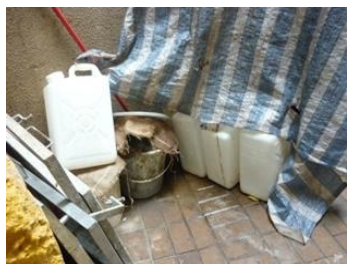
Photo 2 An unknown chemical drum was found in the noise enclosure

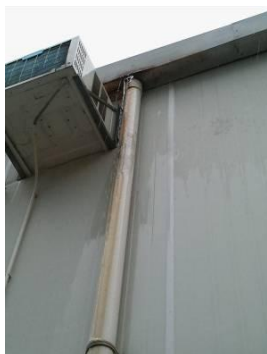
1. Water leakage was found at the roof of site office. (Photo 1)
2. A damage pipe was found of air conditioner of contractor office. (Photo 2)

Photo 1 Water leakage was found at the roof of site office

1. The contractor was reminded to clean the accumulated water to prevent mosquito breeding.
2. The contractor was reminded to repair the roof of site office to avoid the water leakage.
3. The contractor was reminded to repair the pipe of air conditioner.

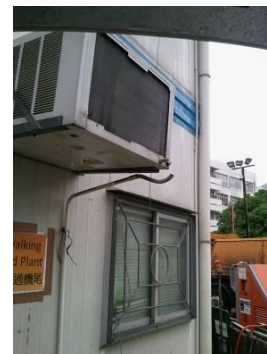
Photo 2 A damage pipe was found of air conditioner of contractor office

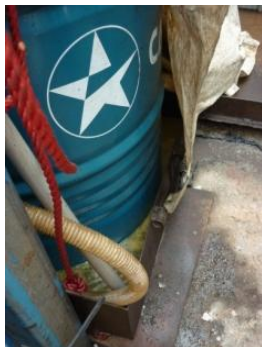
1. Stagnant water was found in drip tray near generator (Photos 1 and 2) and skip on noise cover. (Photo 3)

Photo 1 Stagnant water was found in drip tray near generator

1. The contractor was reminded to clean the accumulated water to prevent mosquito breeding.

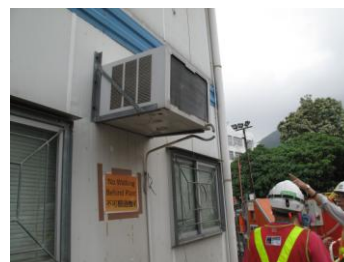
1. Water leakage was found at the roof of site office since last inspection. (Photo 1)
2. A damage pipe was found of air conditioner of contractor office since last inspection. (Photo 2)
3. Stagnant water found in mechanical equipment washing area (Photo 3), outside noise enclosure at the back lane (Photo 4), and in drip trays (Photo 5) and on tarpaulin (Photo 6) near chemical storage area.
4. A bag of cement was found broken at the back lane. (Photo 7)

Photo 2 The damage pipe of air conditioner at contractor office has shown no improvement since last inspection

1. The contractor was reminded to repair the roof of site office to avoid the water leakage.
2. The contractor was reminded to repair the pipe of air conditioner.
3. The contractor was reminded to clear all stagnant water pools to prevent mosquito breeding.
4. The contractor was reminded to clean and remove the broken bag of cement.

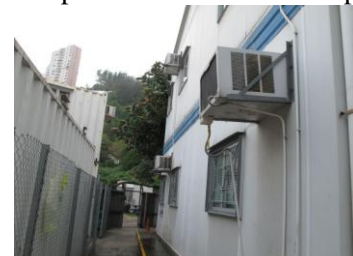
Photo 12 The water leakage at the roof of site office has shown no improvement since last inspection

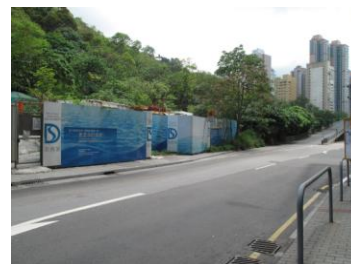
Photo 8 Trash was found at the site boundary

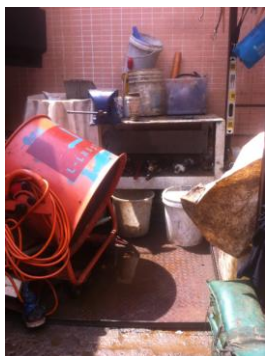
Photo 1 The contractor is reminded to keep the tidiness of the site area.

1. The contractor is reminded to keep the tidiness of the site area.
2. The contractor is reminded to remove stagnant water and rubbish inside container.

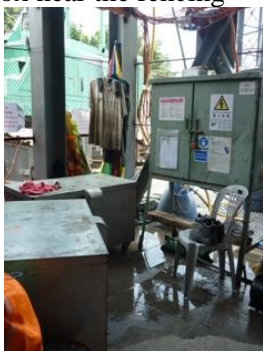
Photo 1 Water accumulation was found near the electric box near the fencing

1. The contractor is reminded to clear the accumulated water and prevent the accumulation.

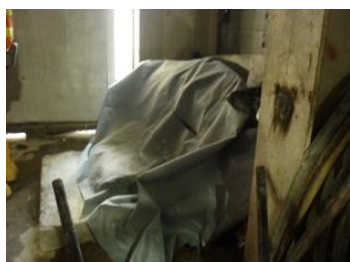
Photo 3 Cement bags were covered properly

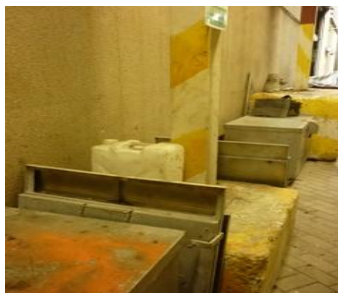
Photo 4 Water accumulation in chemical storage container was cleared

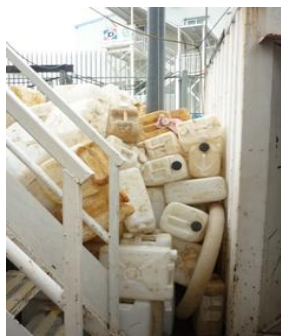
Photo 1 Empty chemical drums were accumulated near the First-Aid container since last inspection

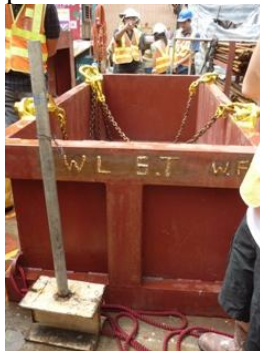
Photo 1 Water accumulation was found on the skip on the noise cover

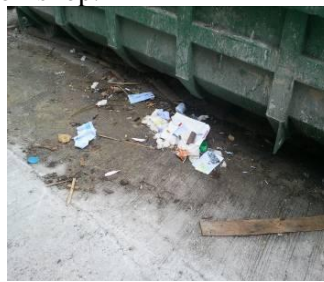
Photo 2 Trashes were found around the storage areas in the workshop.
