Central Police Station Conservation
and Revitalisation Project:
Thirty-third Monthly EM&A Report
(1 July to 31 July 2014)

Issue Date: August 2014

Environmental Resources Management

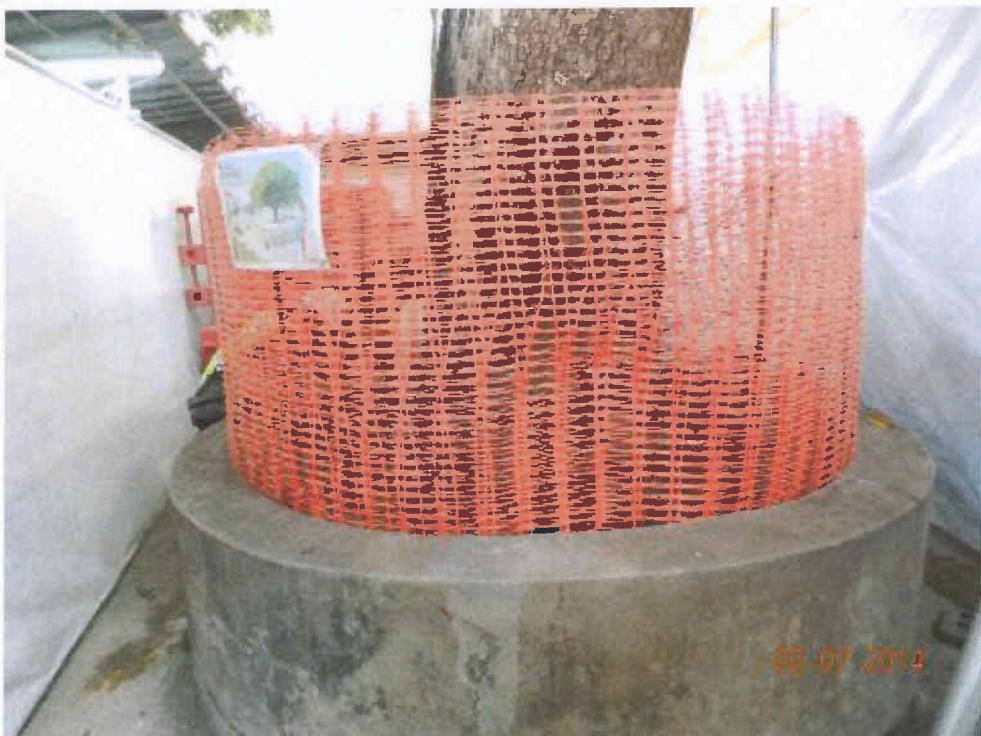
Fig. 4 The site near Tree-5 is clean and tidy.

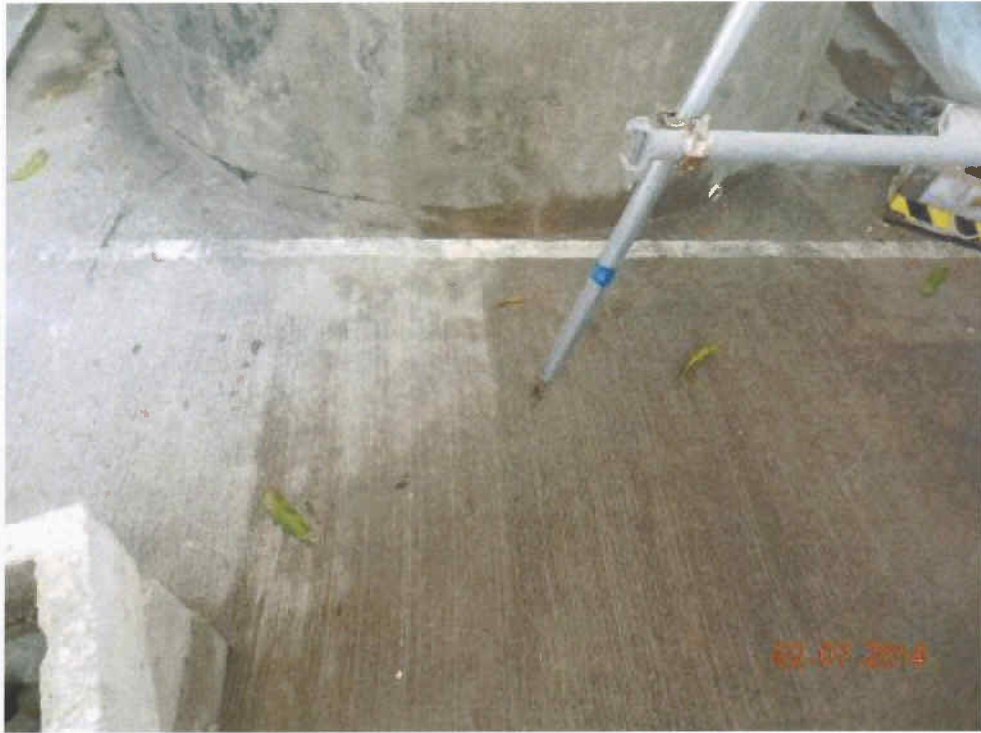
Fig. 5 Health condition of the mid trunk is good.

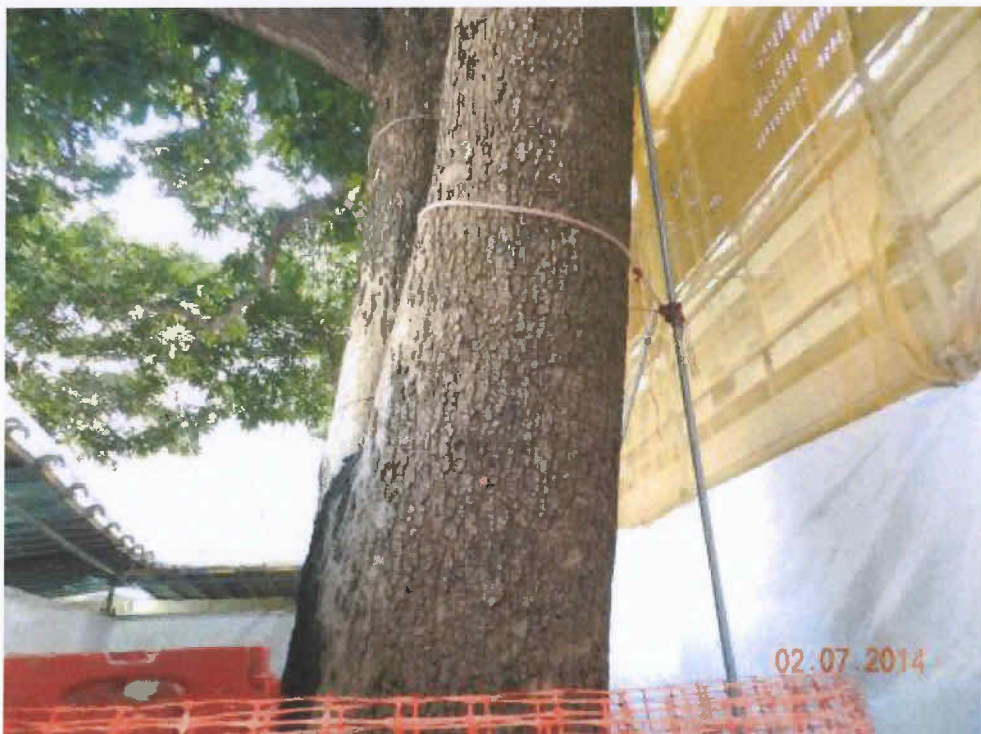
Fig. 6 A pipe leads water to tree top for irrigation.

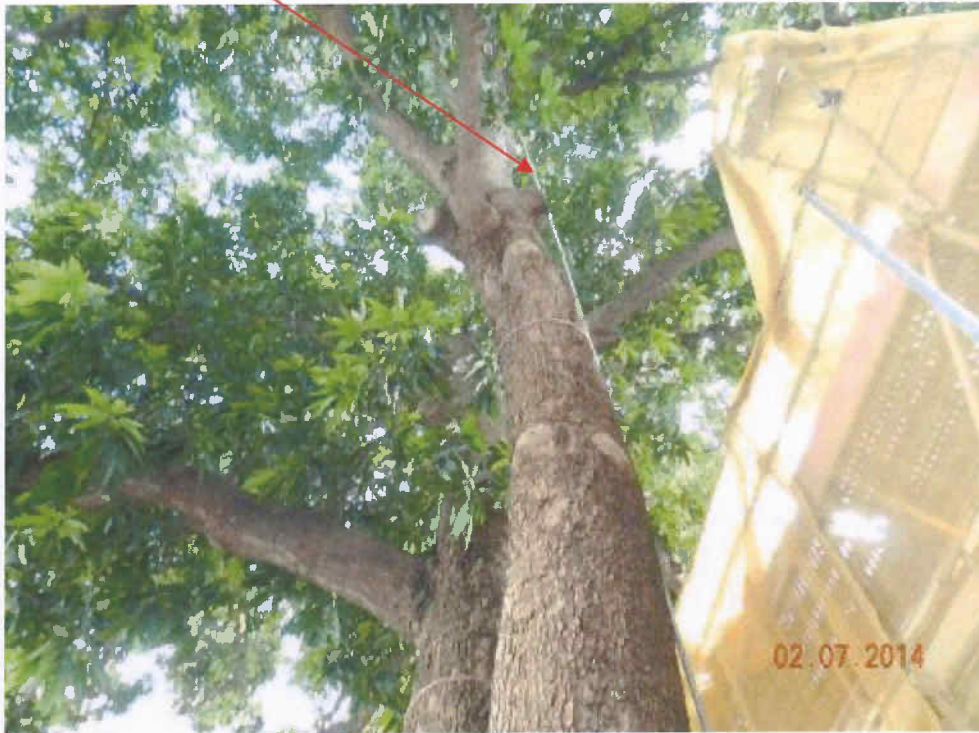
Fig. 7 The crown is full of dense and green leaves.

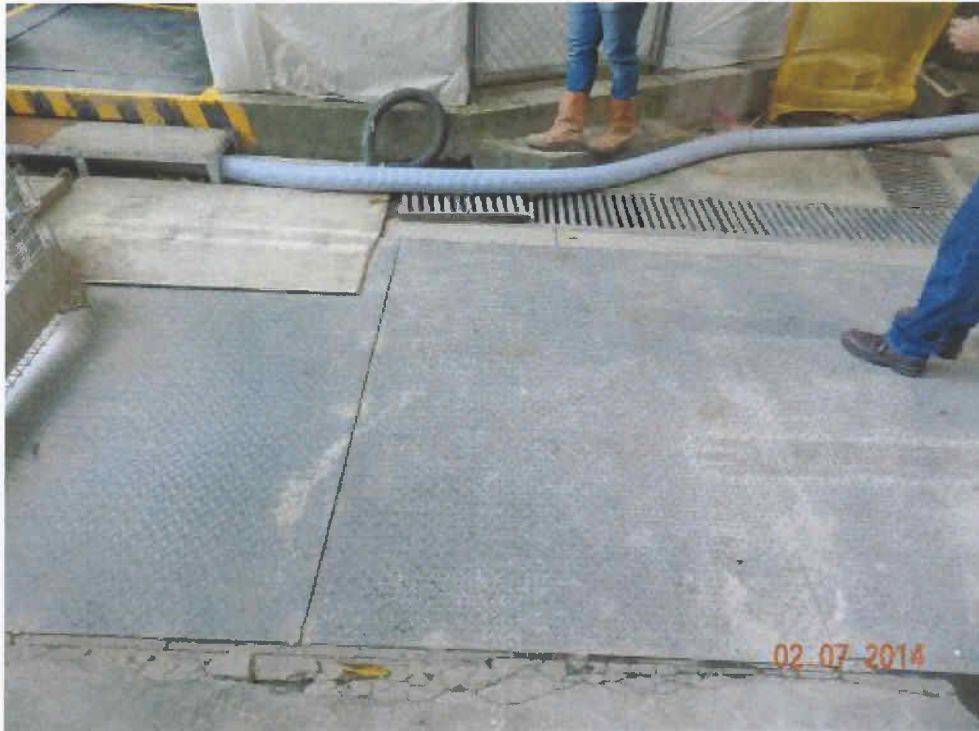
Fig. 11 Construction works are in progress outside the cordon zone.

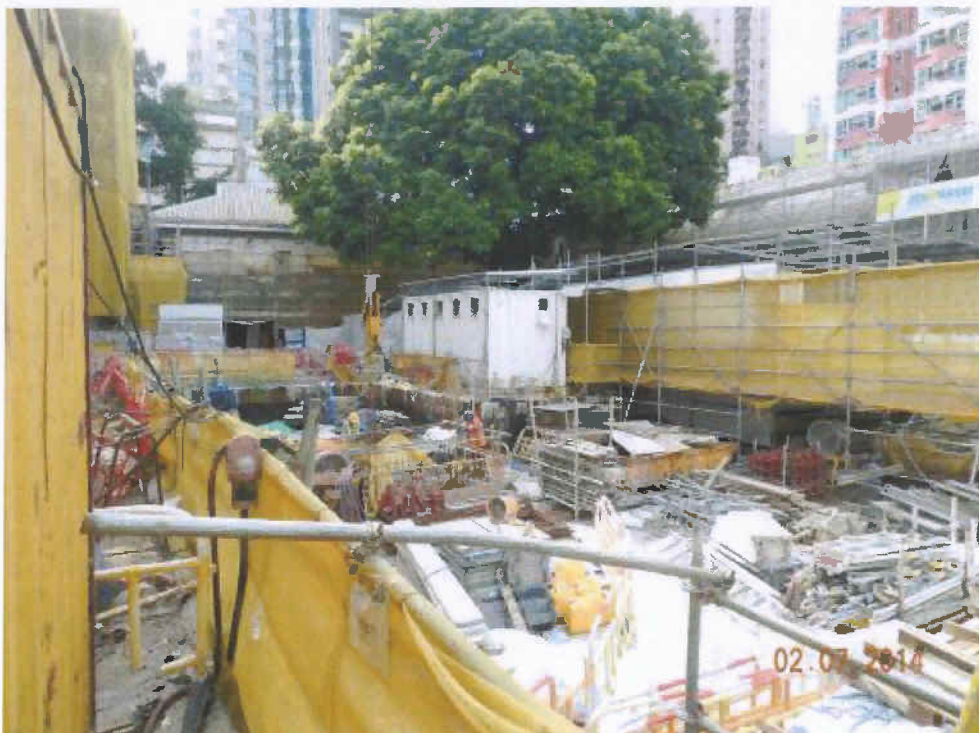
Fig. 12 Overall view of Tree-5 during inspection on 2nd July 2014.

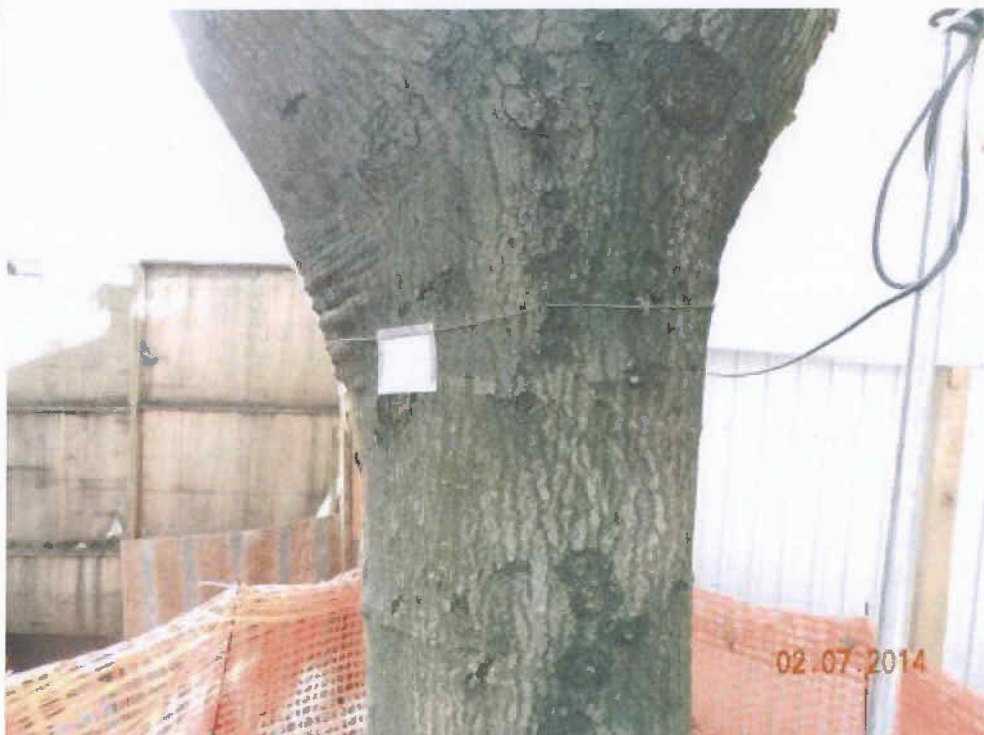
Fig. 4 Health condition of the upper trunk is fair.

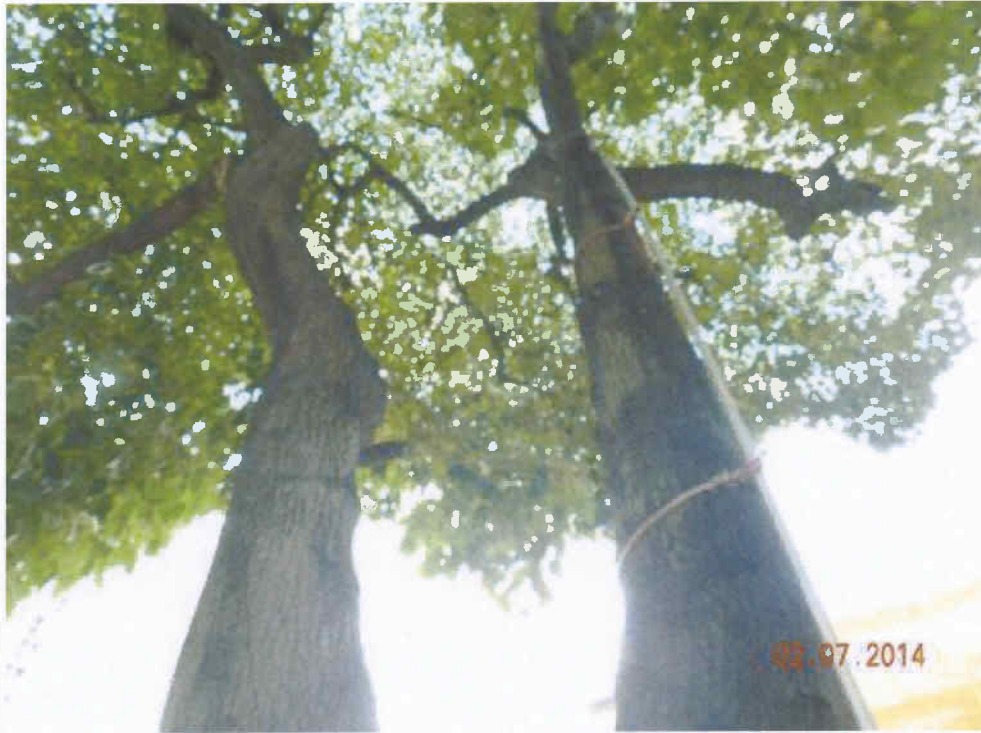
Fig. 5 The crown is full of green and dense leaves.

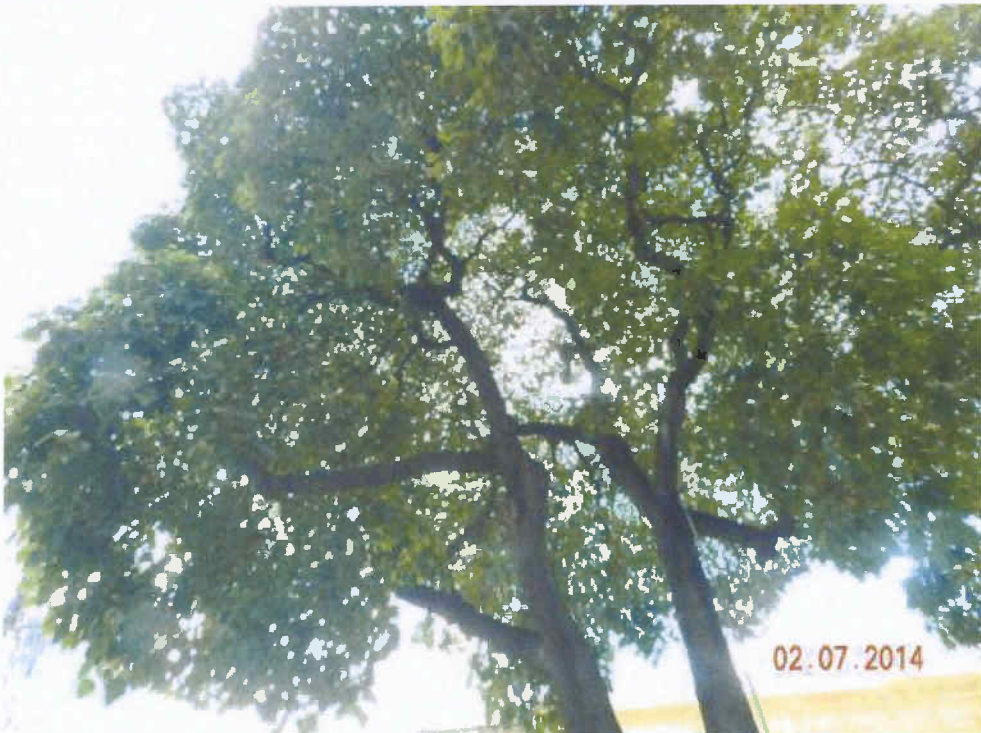
Fig. 6 The small cordon zone is in good order.

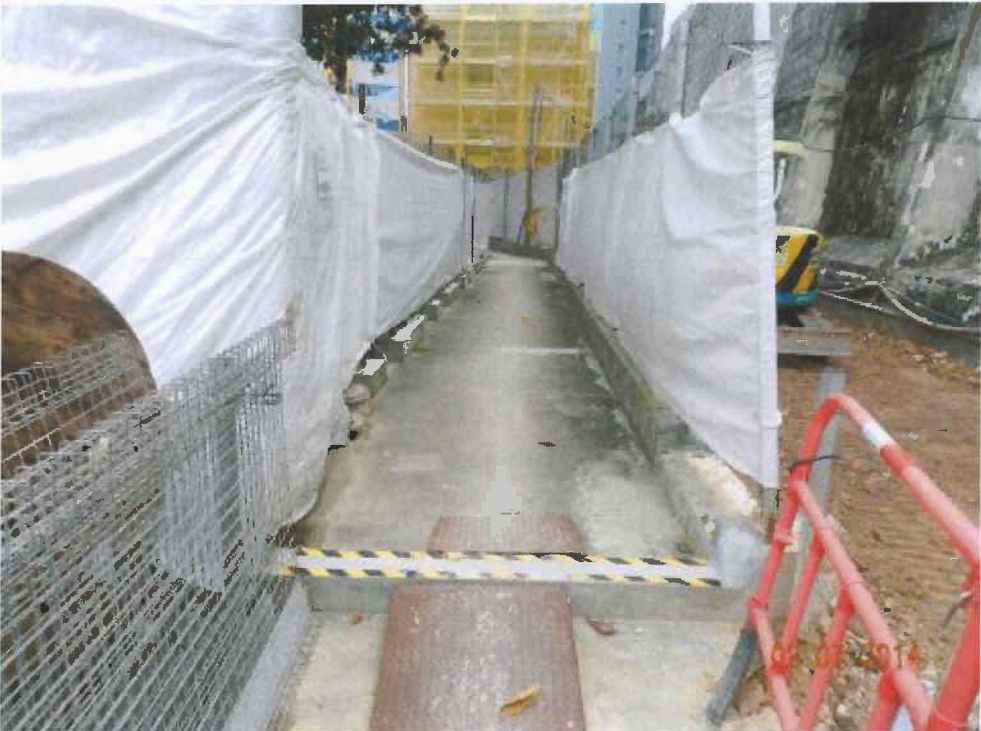
Fig. 8 Construction works are in progress outside the cordon zone.

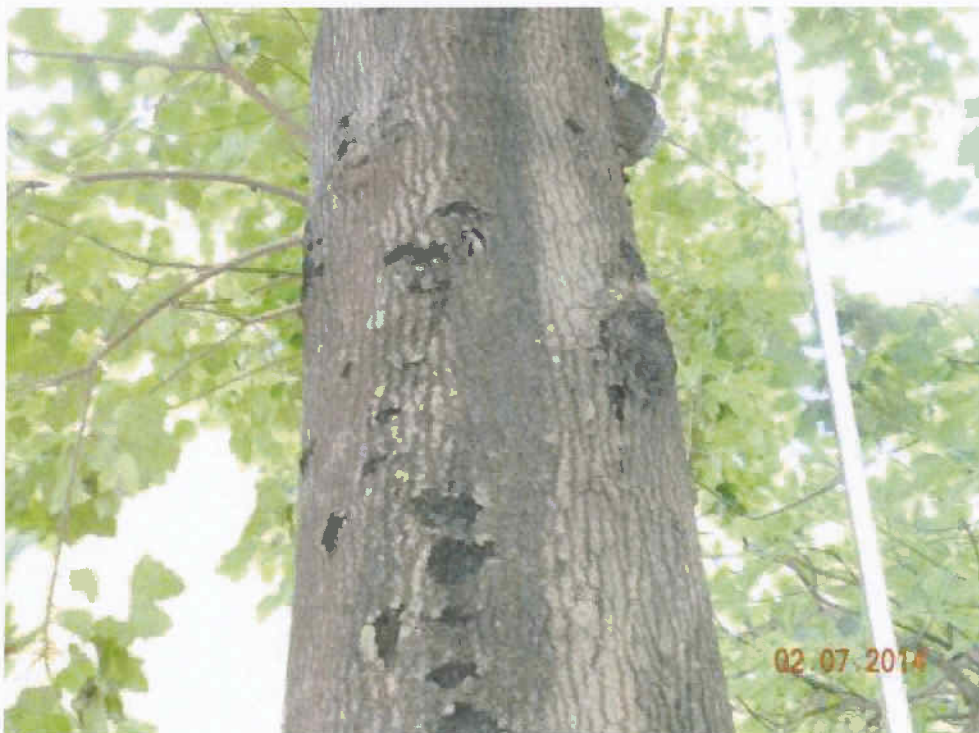
Fig. 4 Health condition of the upper trunk also is fair.

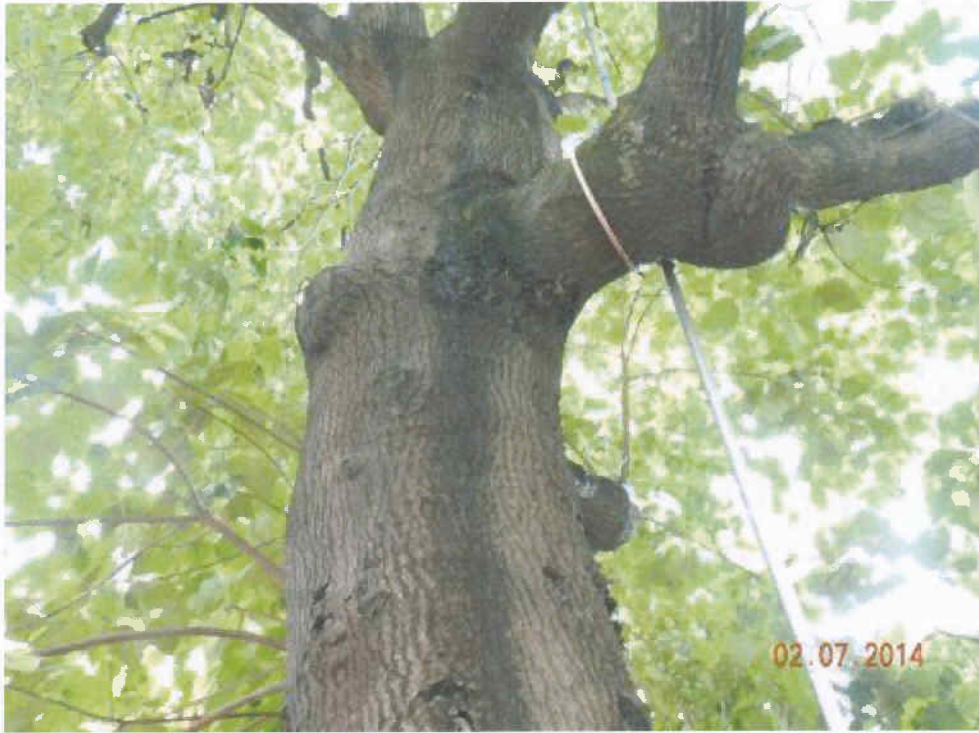
Fig. 5 The crown is full of vigorous and dense leaves.

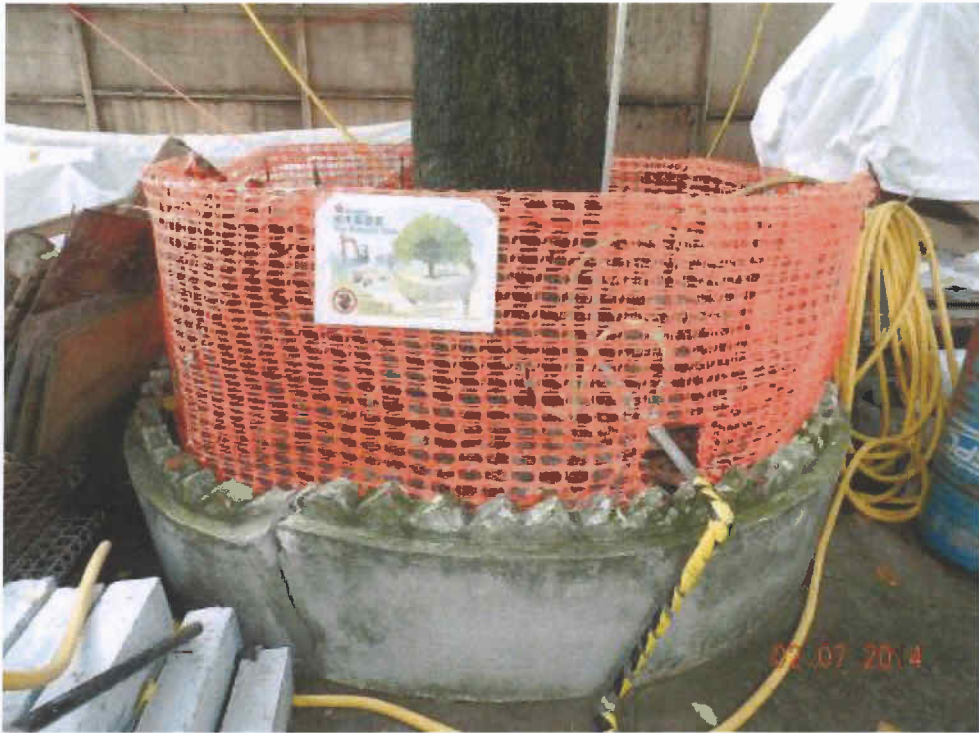
Fig. 7 Appropriate notice is displayed in front of the cordon zone.

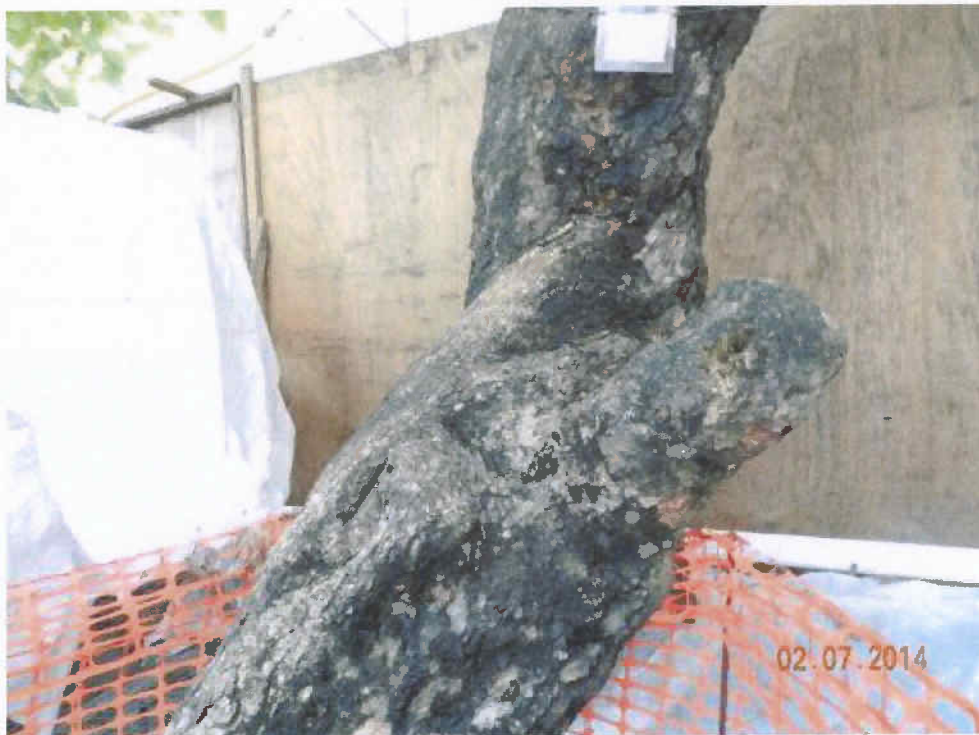
Fig. 4 Health condition of the upper trunk also is fair.

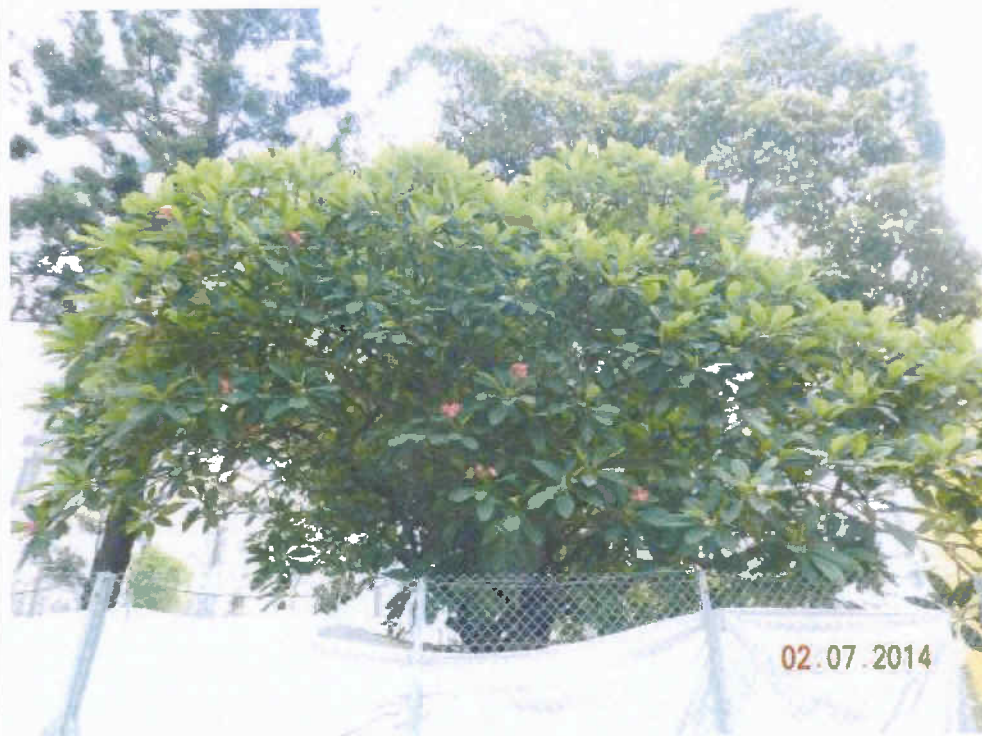
Fig. 6 The small cordon zone is in good order.

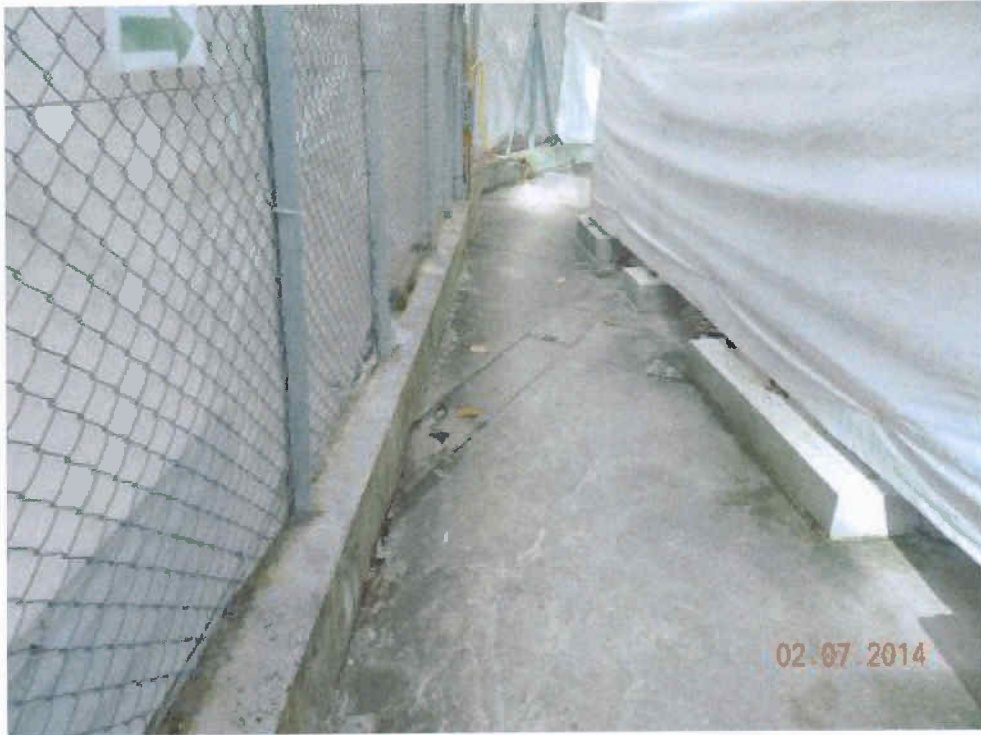
Fig. 9 Construction works are in progress outside the cordon zone.

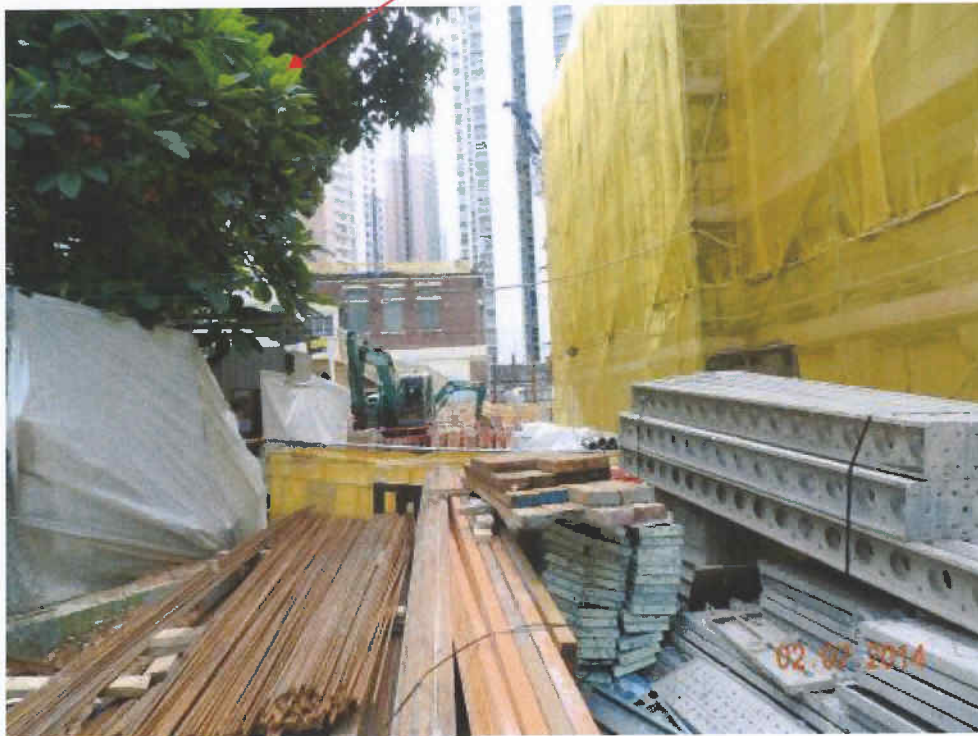
Fig. 10 Overall view of Tree-8 during inspection on 2nd July 2014

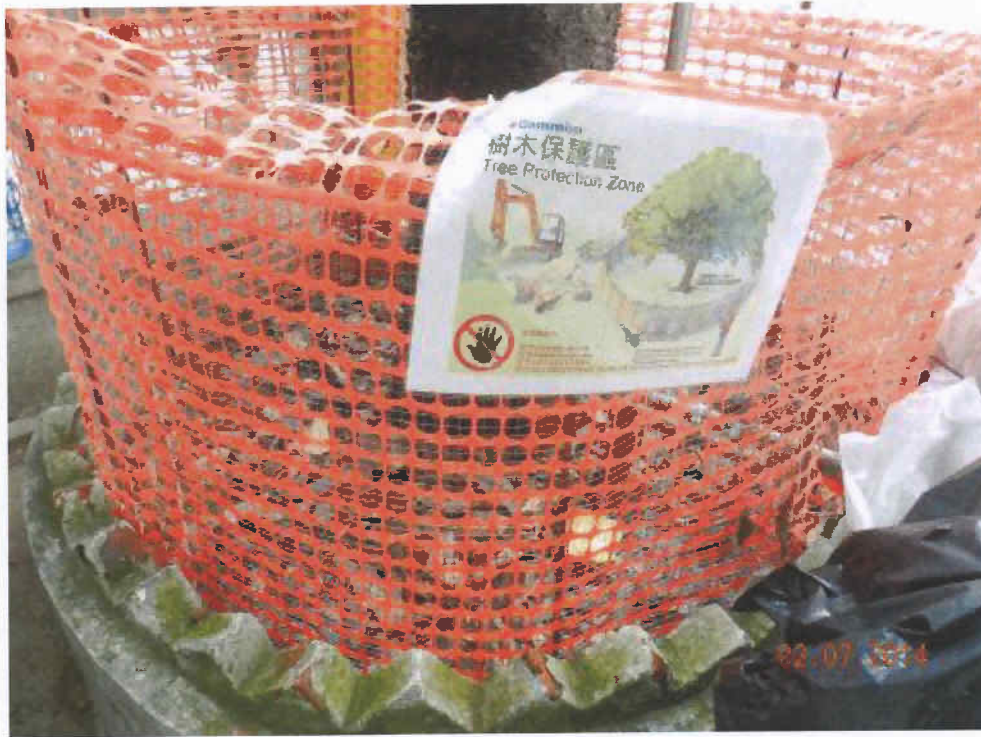
Fig. 7 Many bulky items are placed near the planter but they cause no disturbance to the tree.

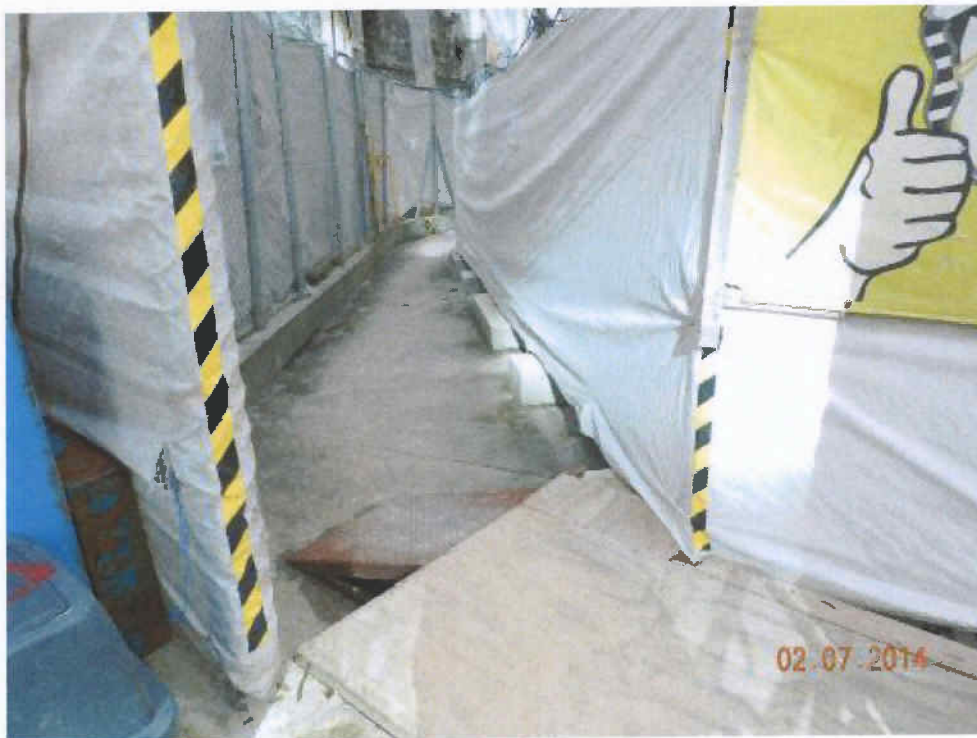
Fig. 10 Overall view of Tree-9 during inspection on 2nd July 2014.

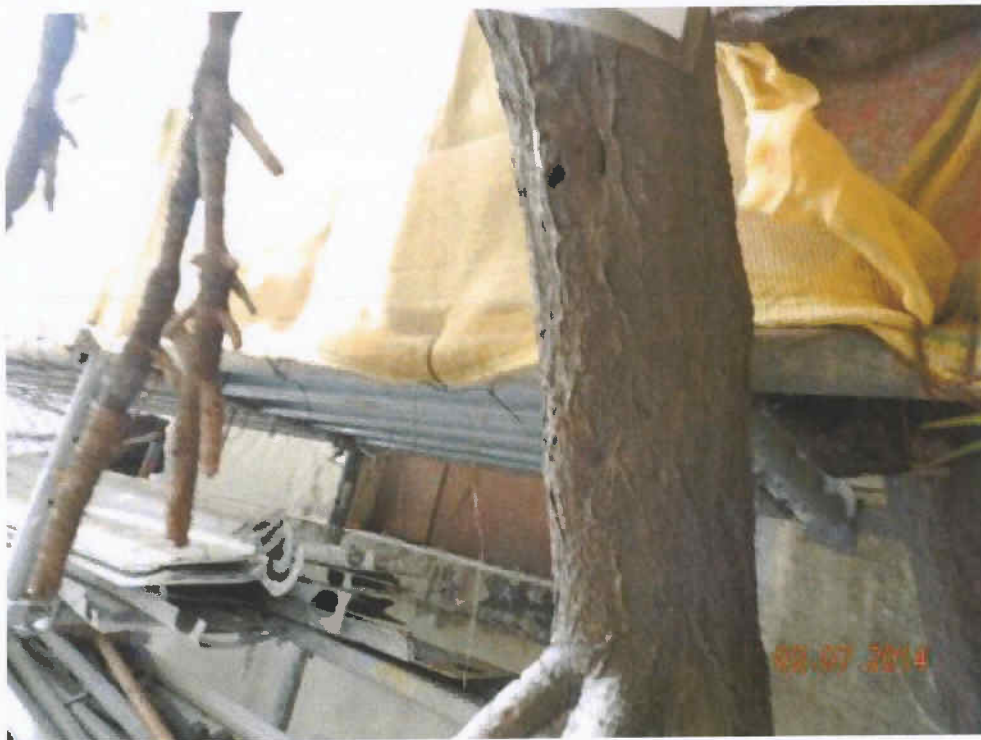
Fig. 4 The small cordon zone is in good order.

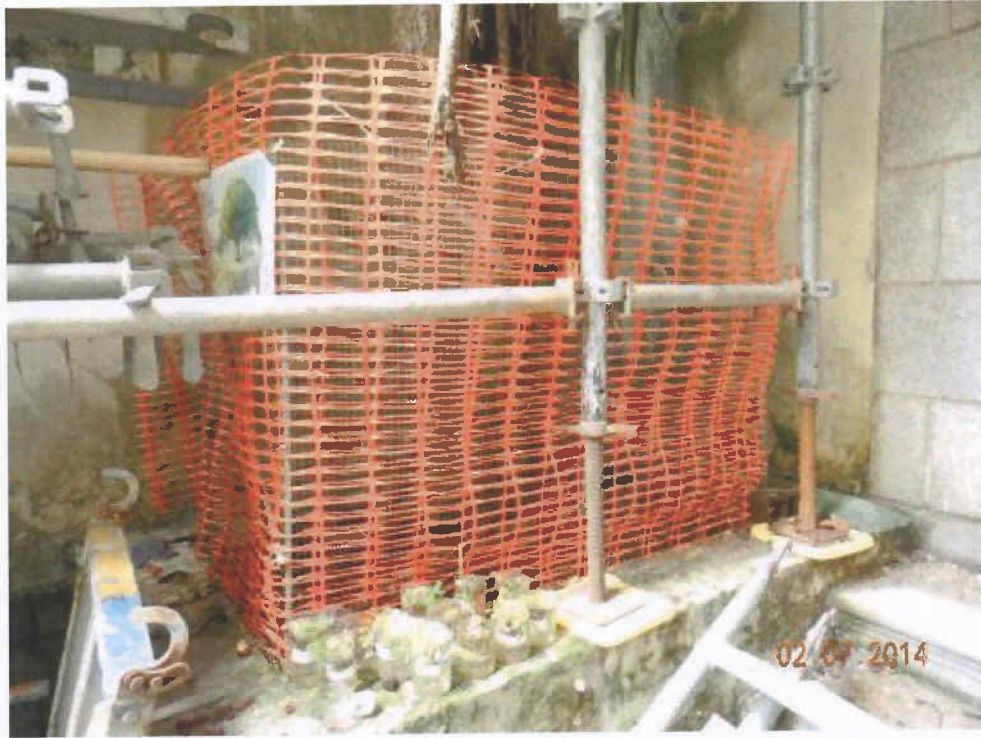
Fig. 5 Cleanliness of the site near the planter is acceptable.

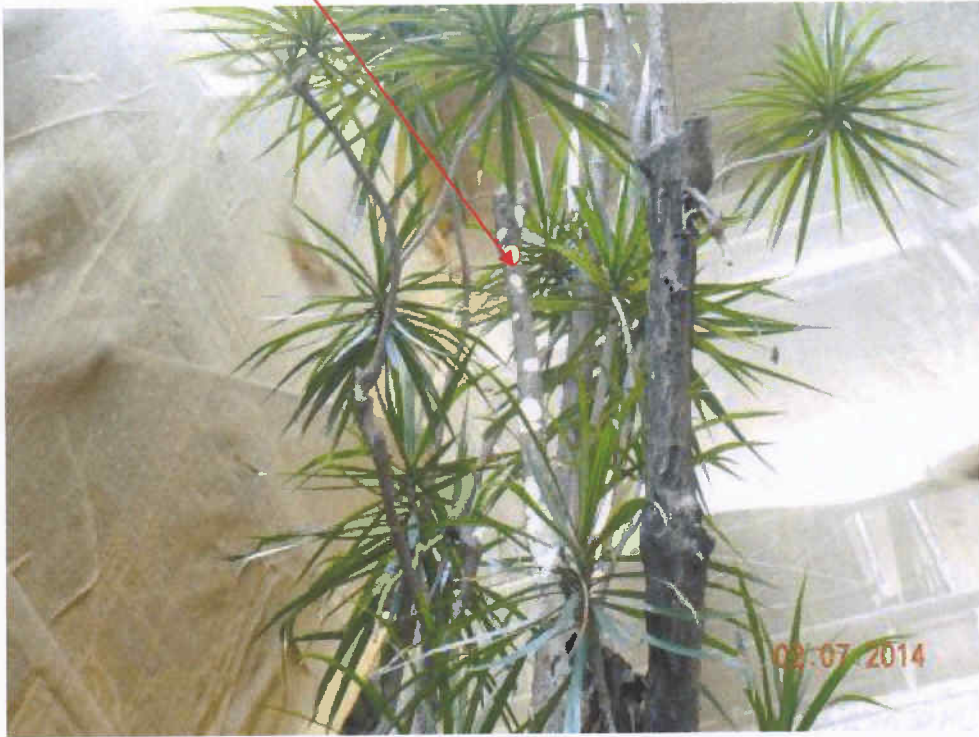
Fig. 7 Renovation works are in progress near the tree.

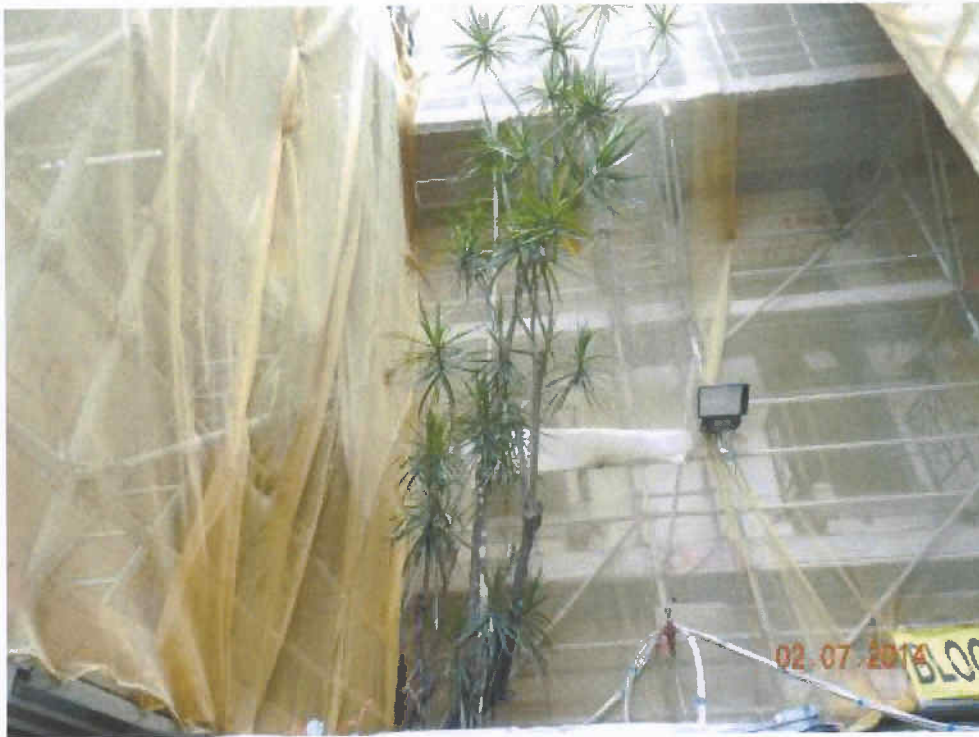
Fig. 9 The site outside the cordon zone is clean and tidy.
