Central Police Station Conservation  
and Revitalisation Project:  
*Thirty-sixth Monthly EM&A Report*  
*(1 October to 31 October 2014)*

Issue Date: November 2014

The Jockey Club CPS Limited

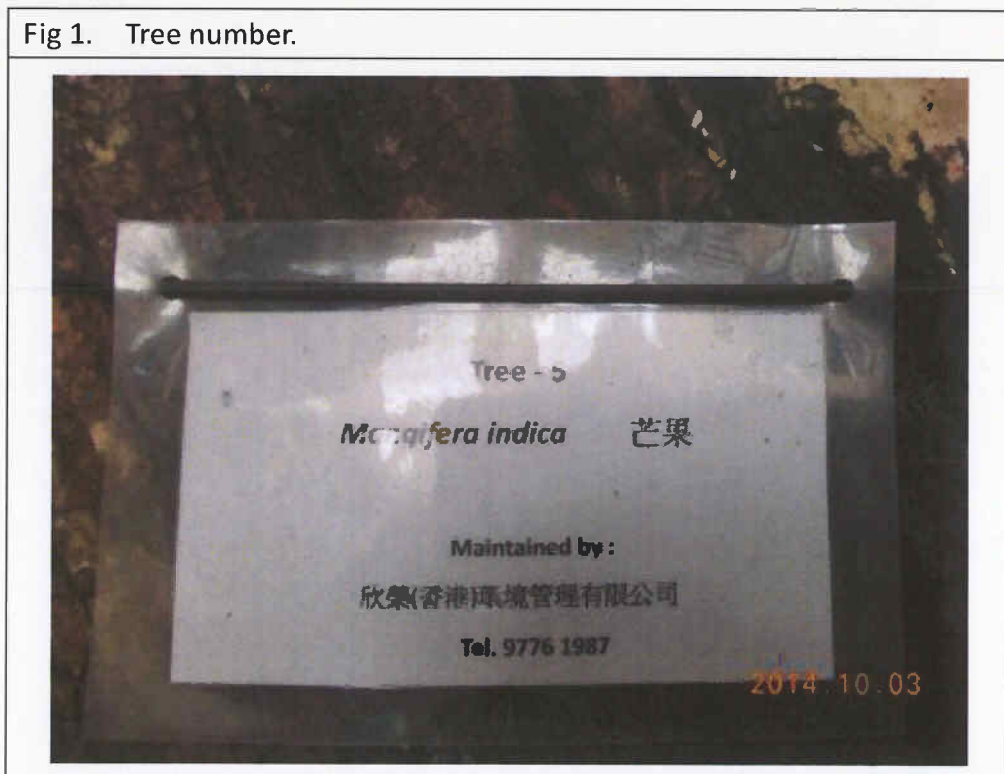
Fig 2. The root collar of Tree-5 is normal. A few litter has been found at the planter.

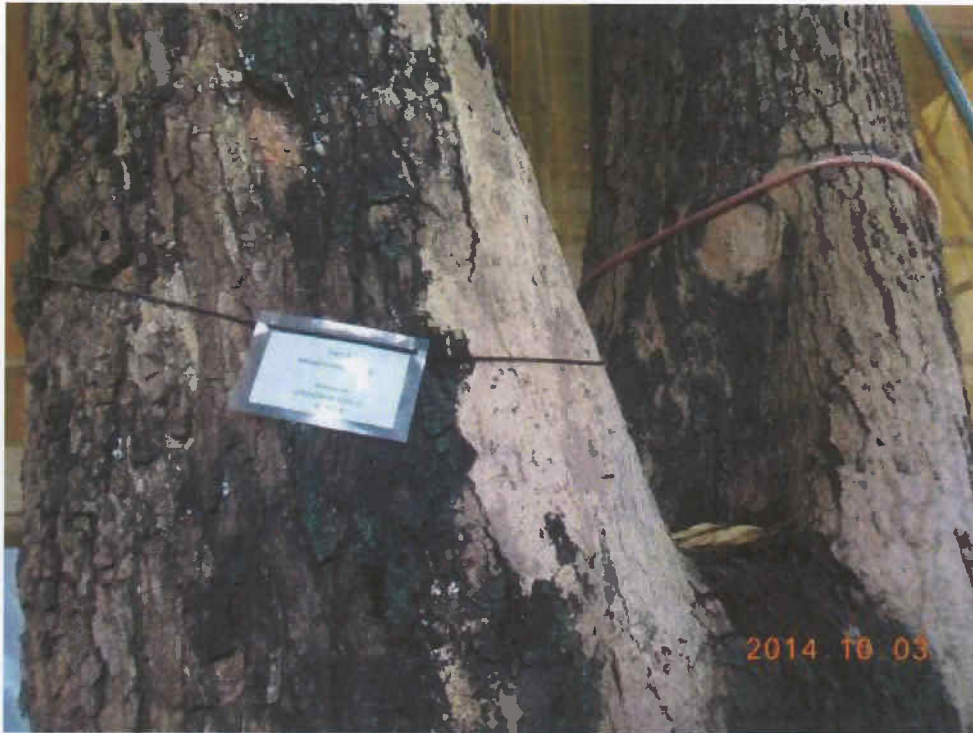
Fig. 5 Health condition of the upper trunk also is fair.

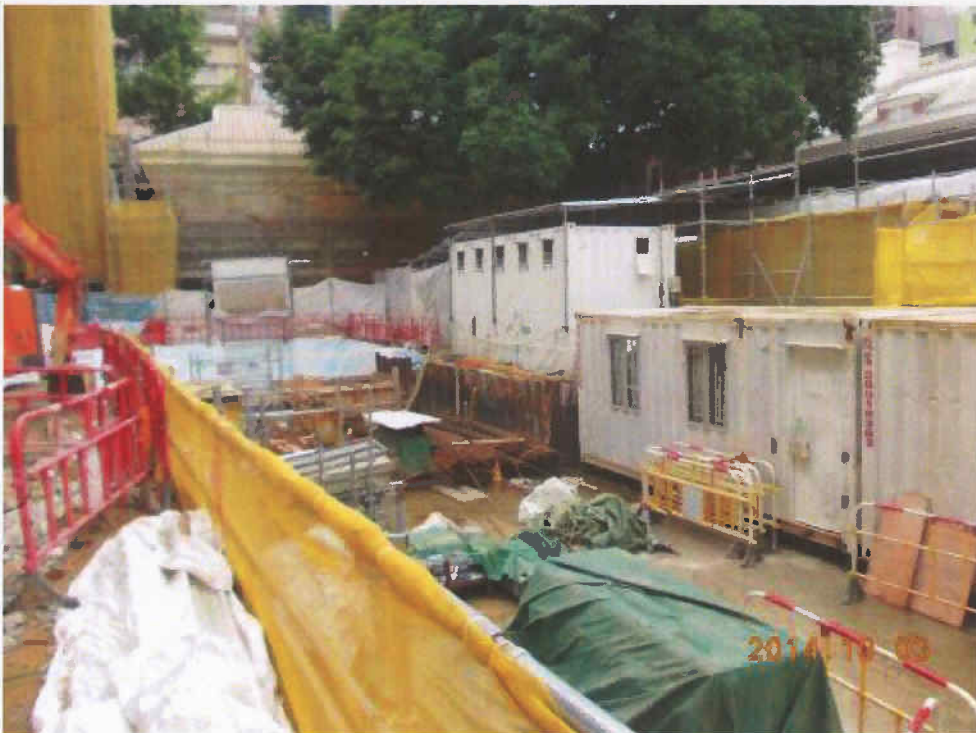
Fig. 10 Overall view of Tree-5 during inspection on 3<sup>rd</sup> Oct. 2014.

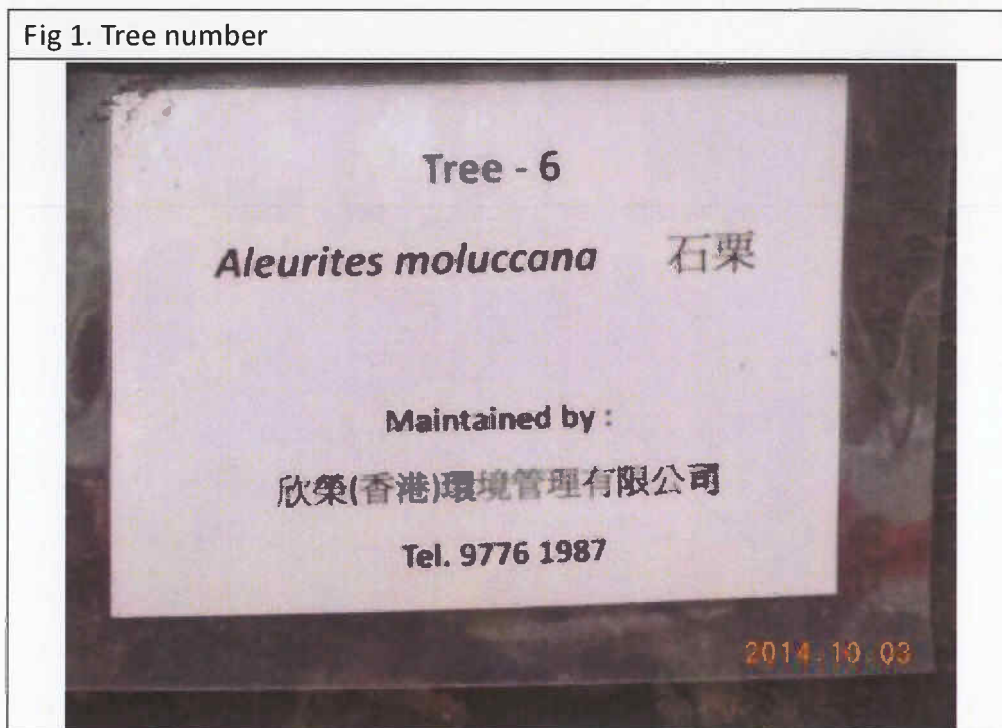
Fig 2. The root collar is normal. The planter is full of mulch.

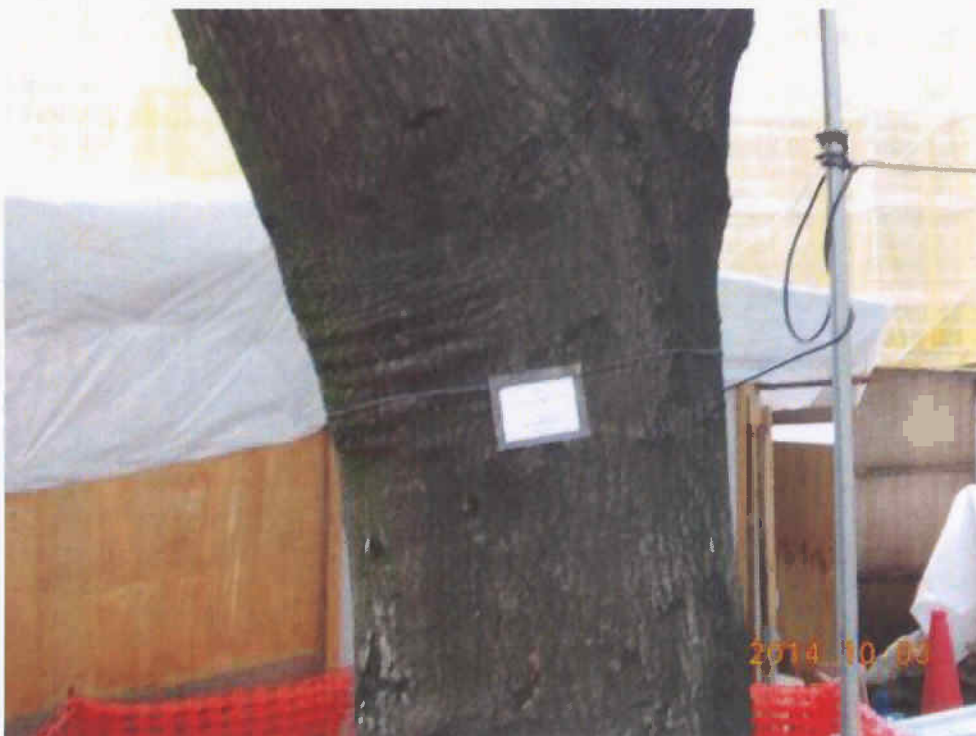
Fig. 4 Health condition of the upper trunk also is fair.

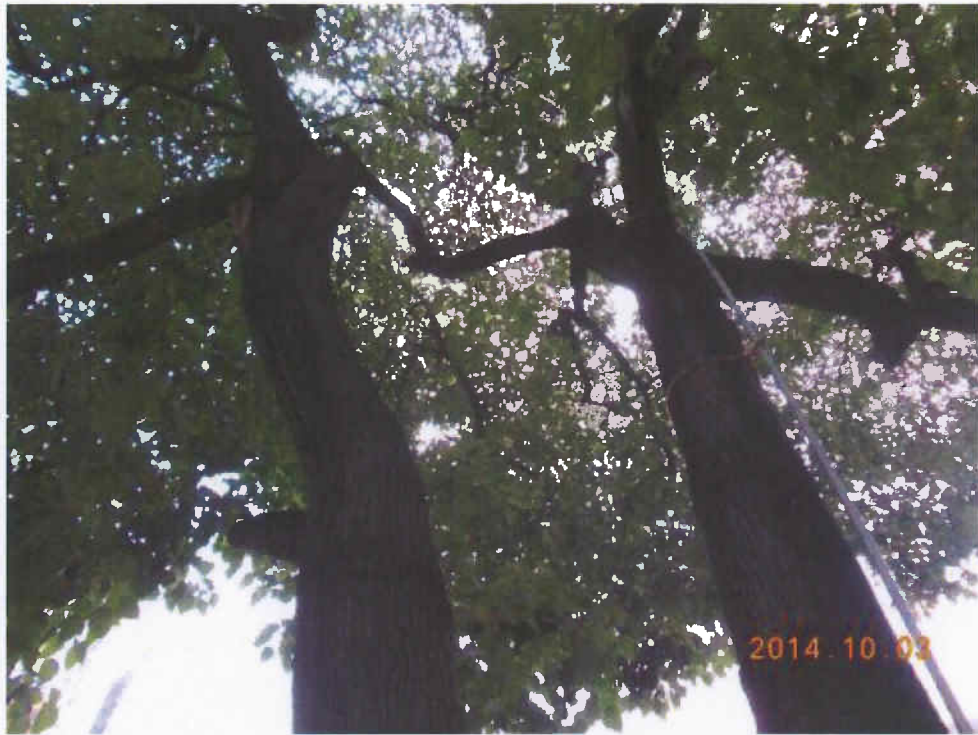
Fig. 5 The crown is full of green and dense leaves.

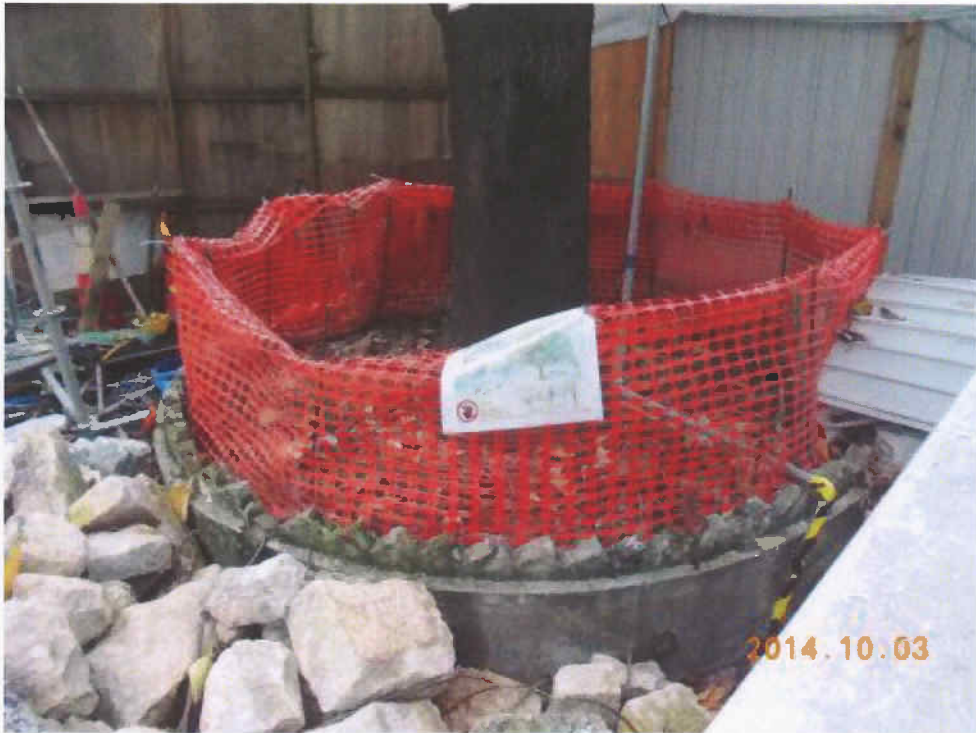
Fig. 7 Many construction items are placed near the planter. Tree-6

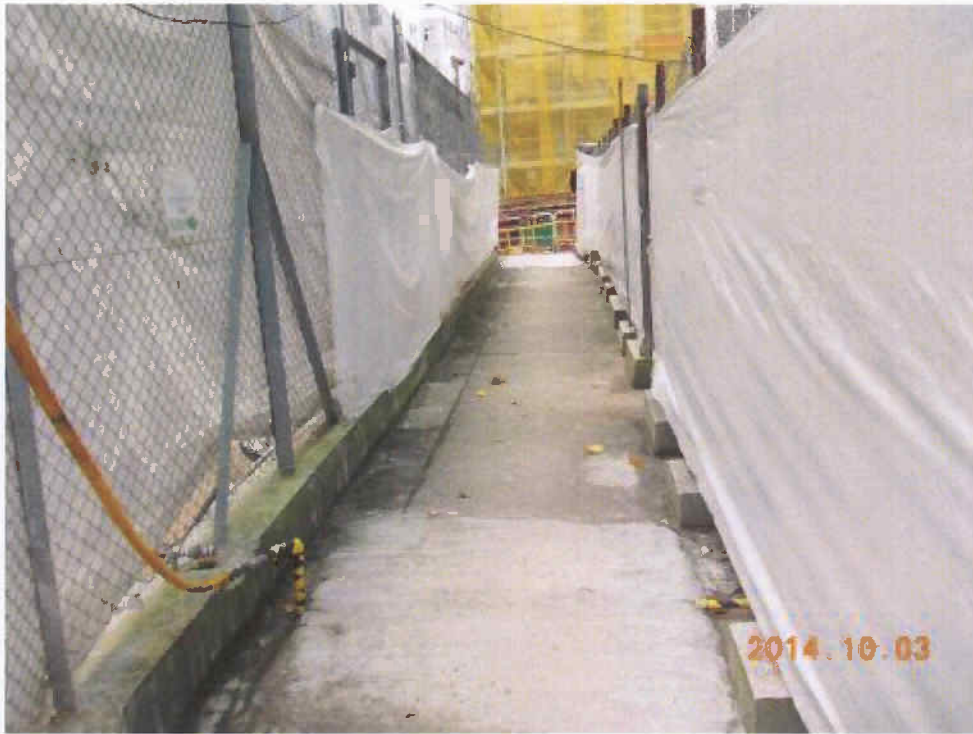
Fig. 9 Construction works are in progress outside the cordon zone.

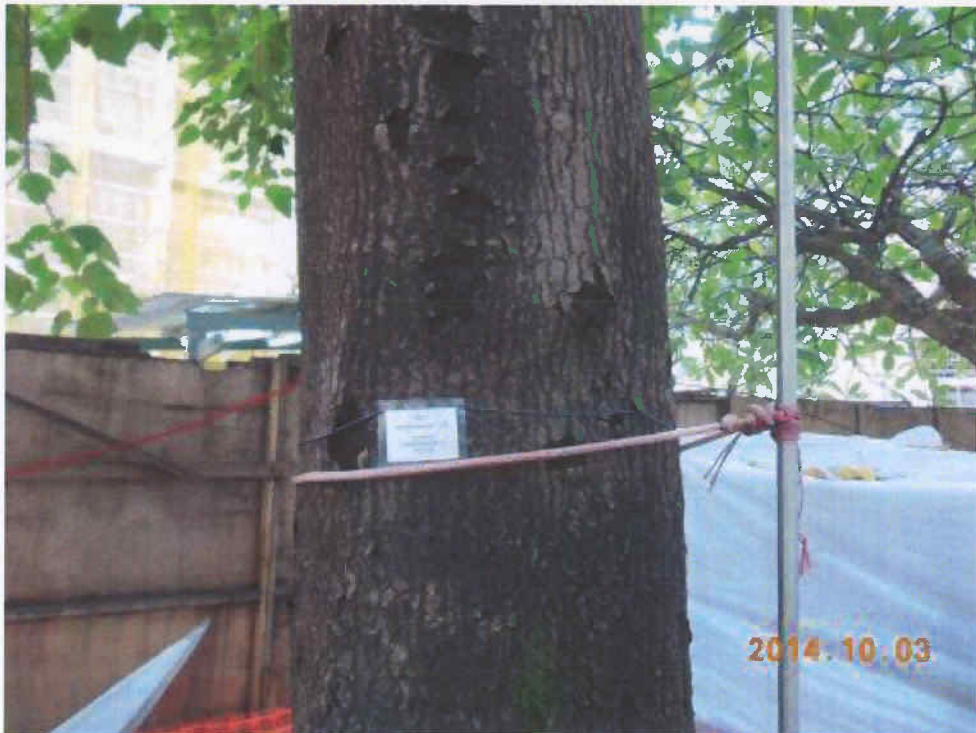
Fig. 4 Health condition of the upper trunk also is fair.

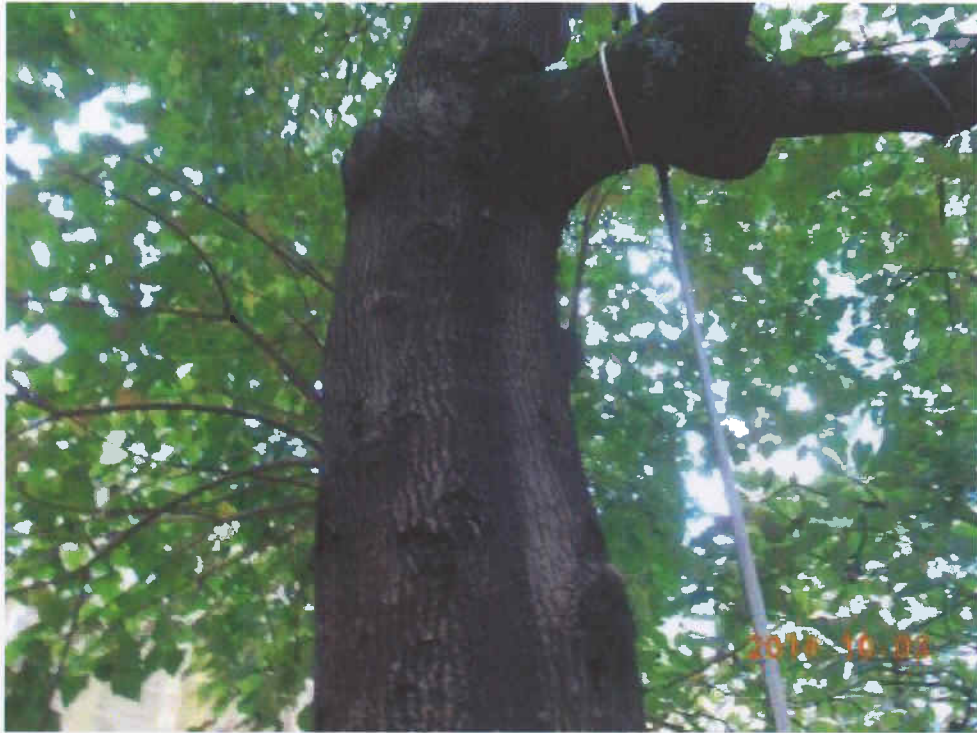
Fig. 5 The crown is full of green and dense leaves.

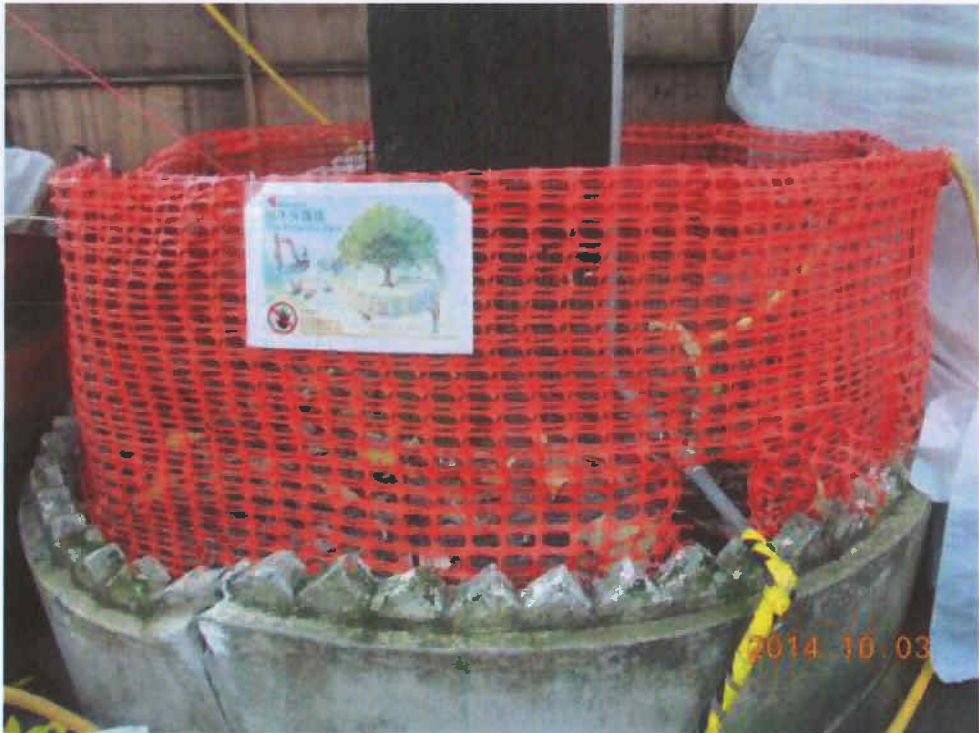
Fig. 8 The site near Tree-7 is clean and tidy.

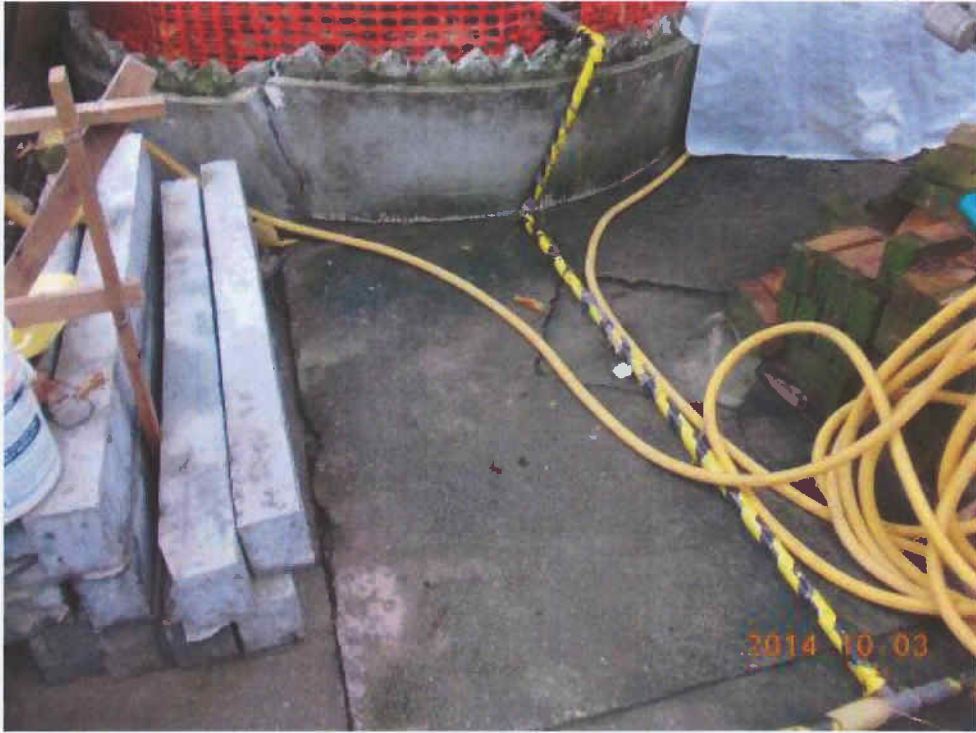
Fig. 9 Construction works are in progress outside the cordon zone.

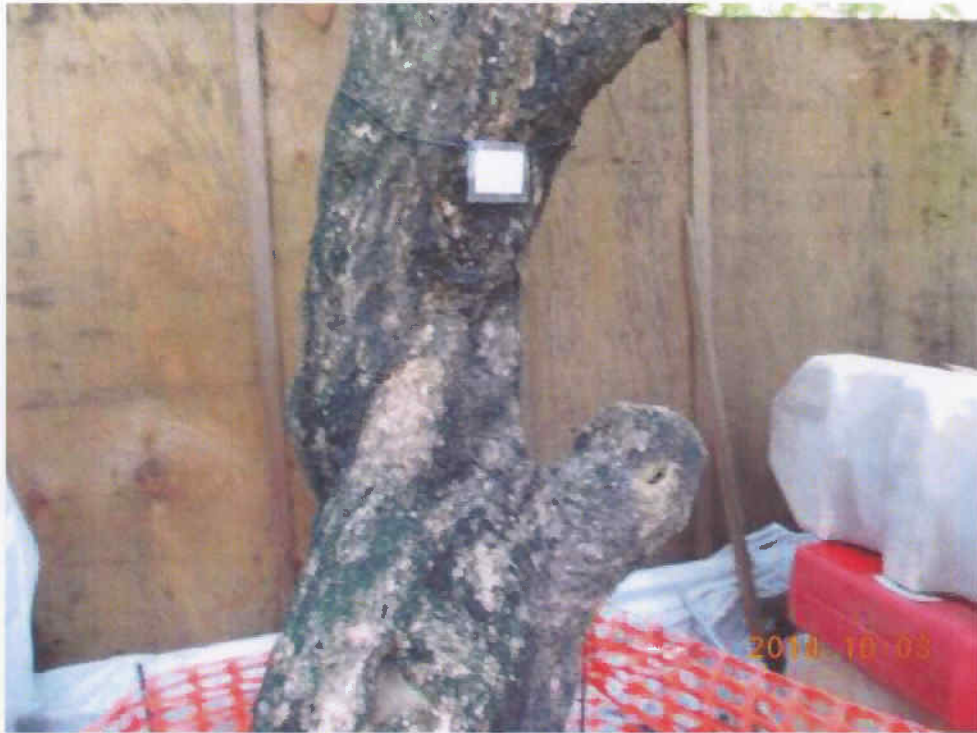
Fig. 3 Health condition of the upper trunk also is fair.

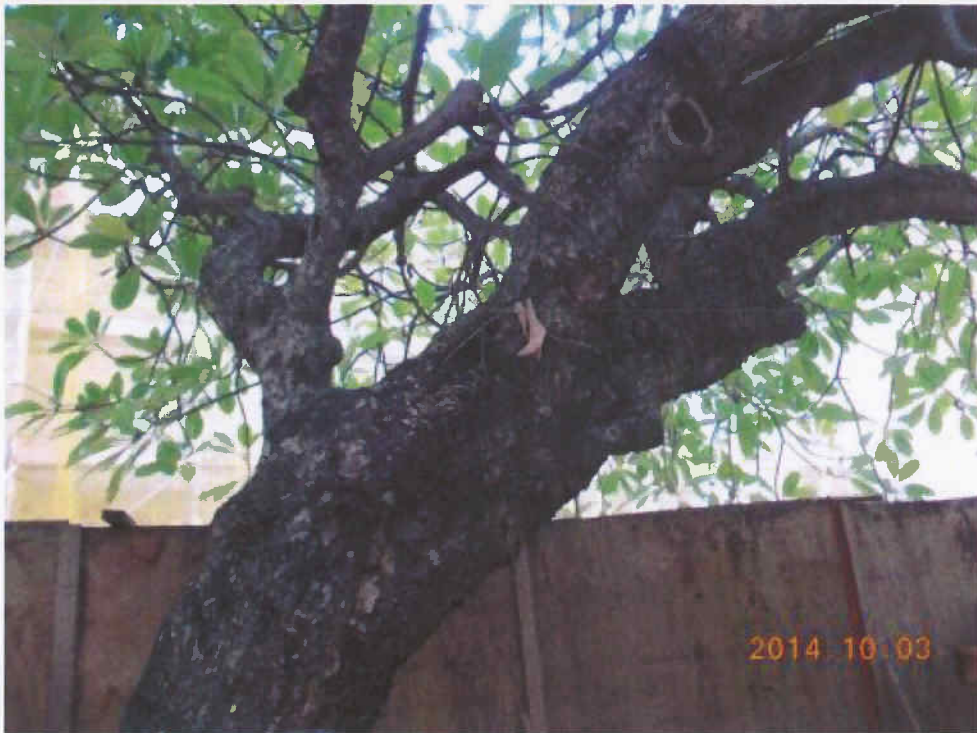
Fig. 4 The crown is full of green and vigorous leaves.

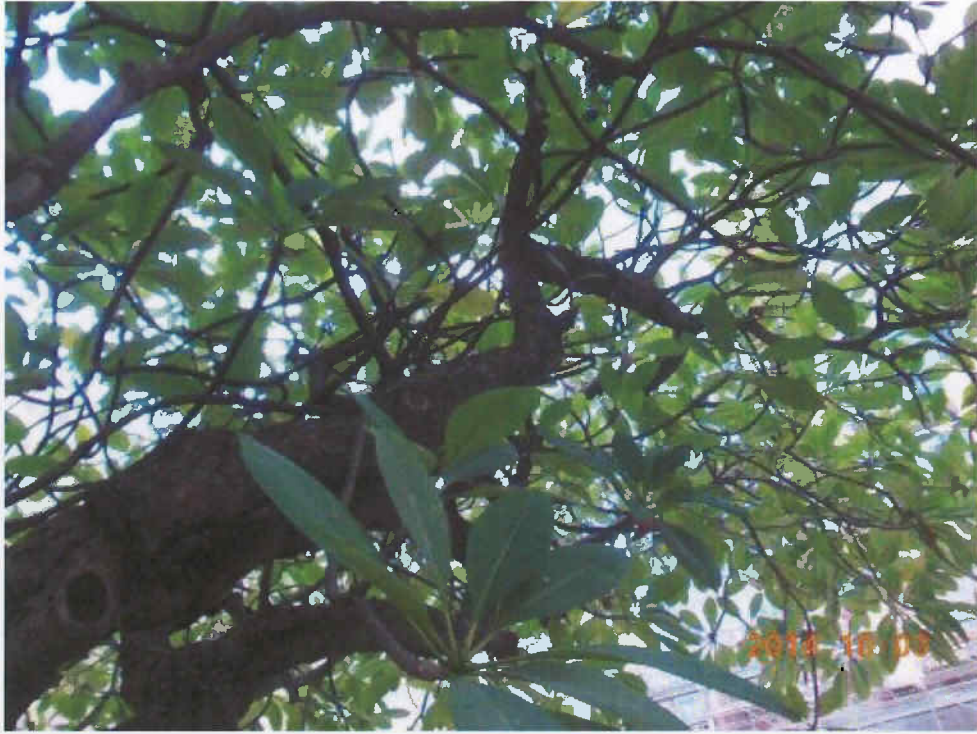
Fig. 5 Some red flowers still appear on the crown. Tree-8

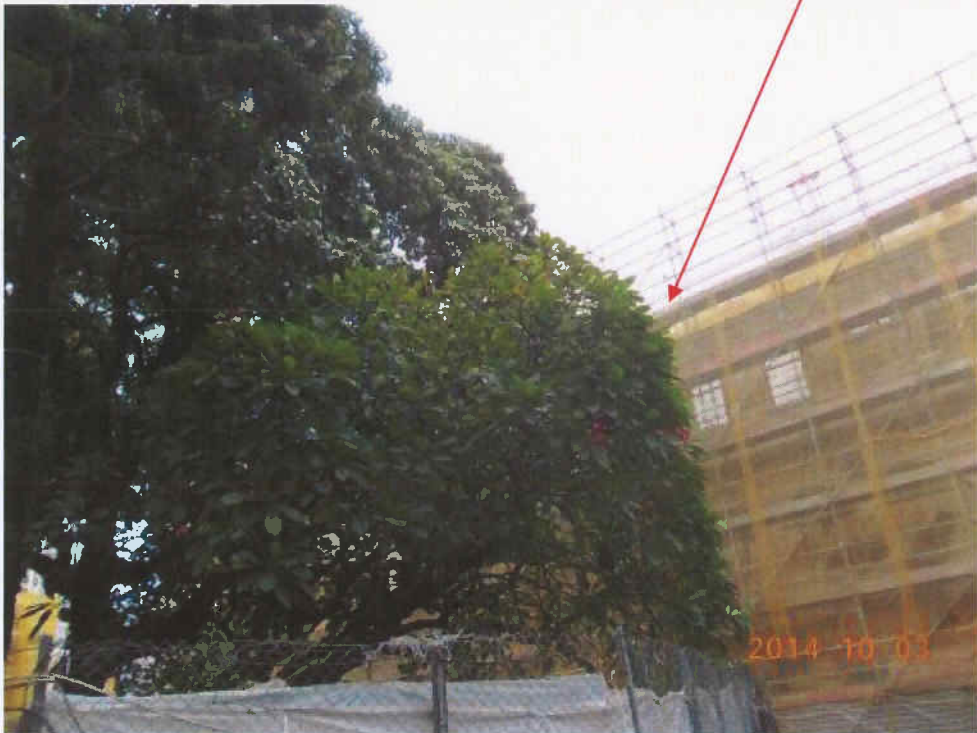
Fig. 6 The small cordon zone is in order.

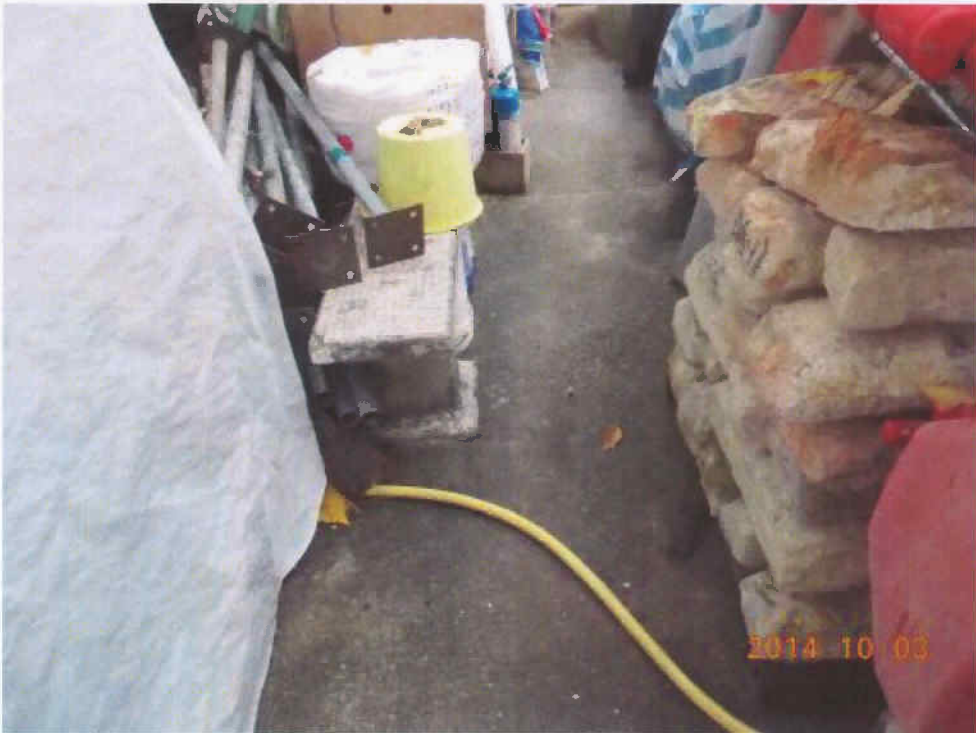
Fig. 8 Cleanliness of the access near Tree-8 is acceptable.

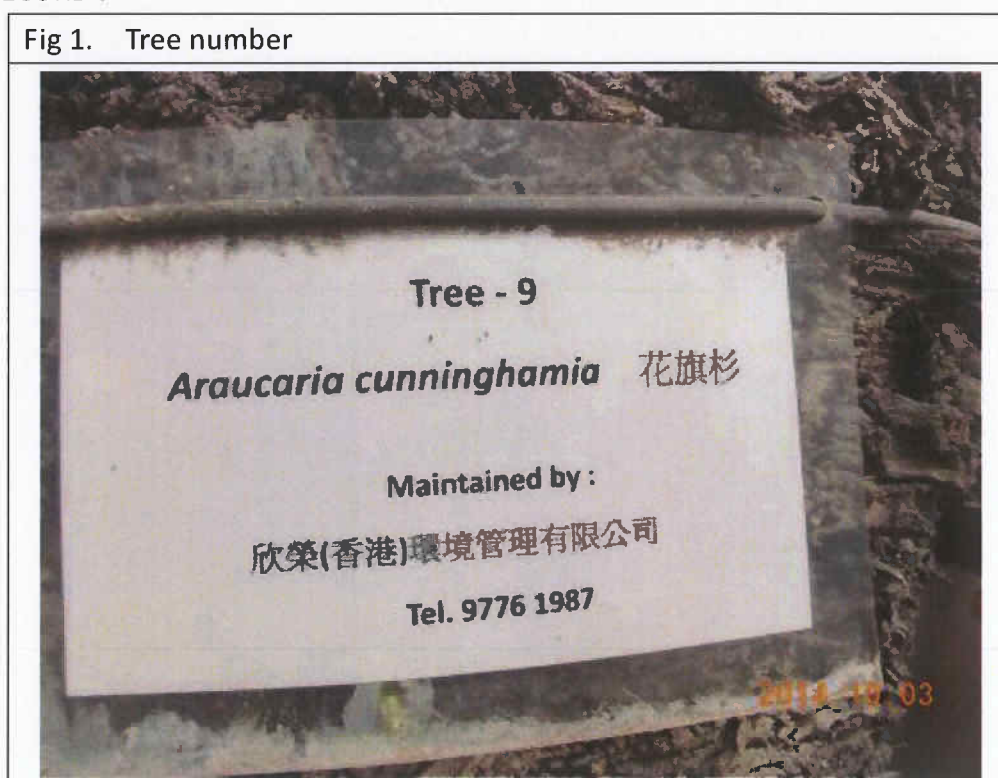
Fig 2. Root collar of Tree-9 is normal. The planter is full of mulch.

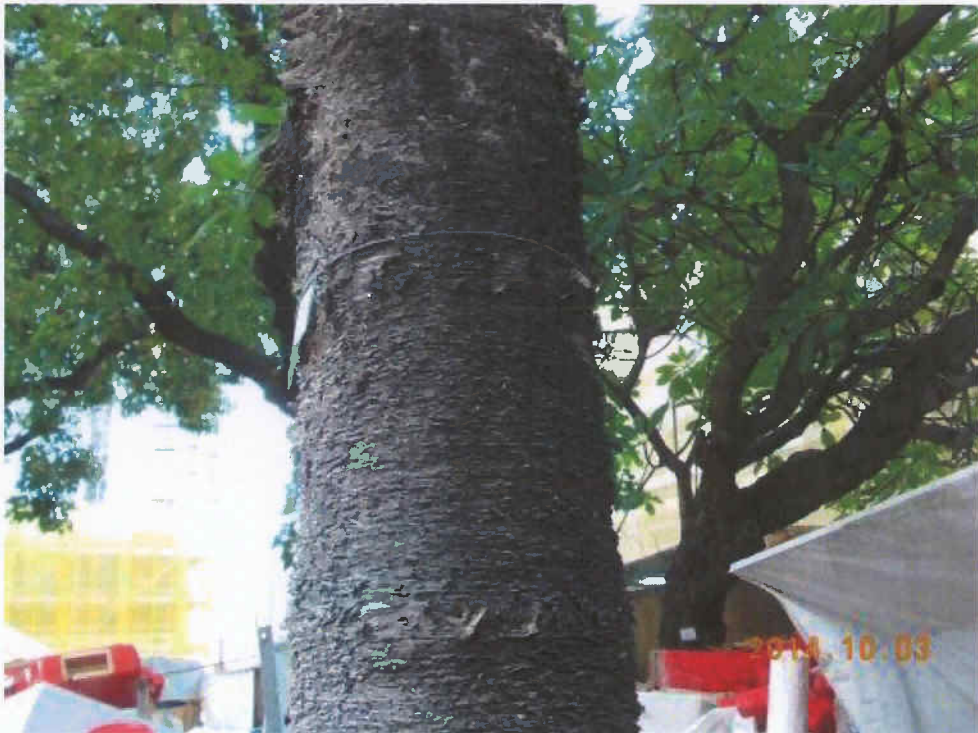
Fig. 4 Vigorous branches/leaves appear on the tree.

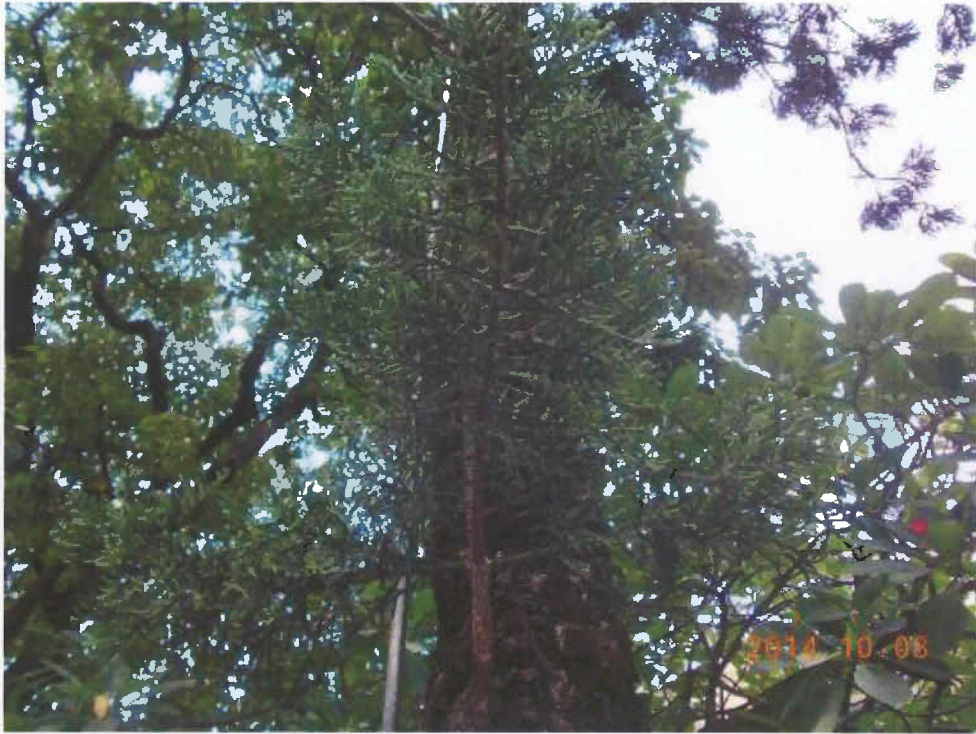
Fig. 5 A pipe leads water to the crown for irrigation.

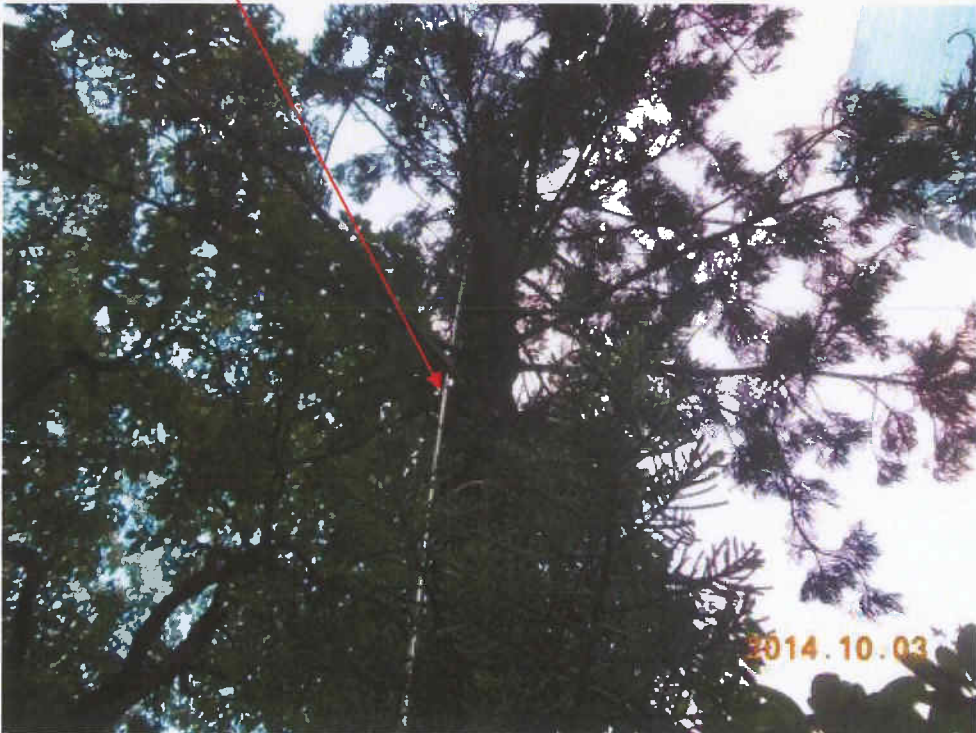
Fig. 6 Health condition of the crown is fair.

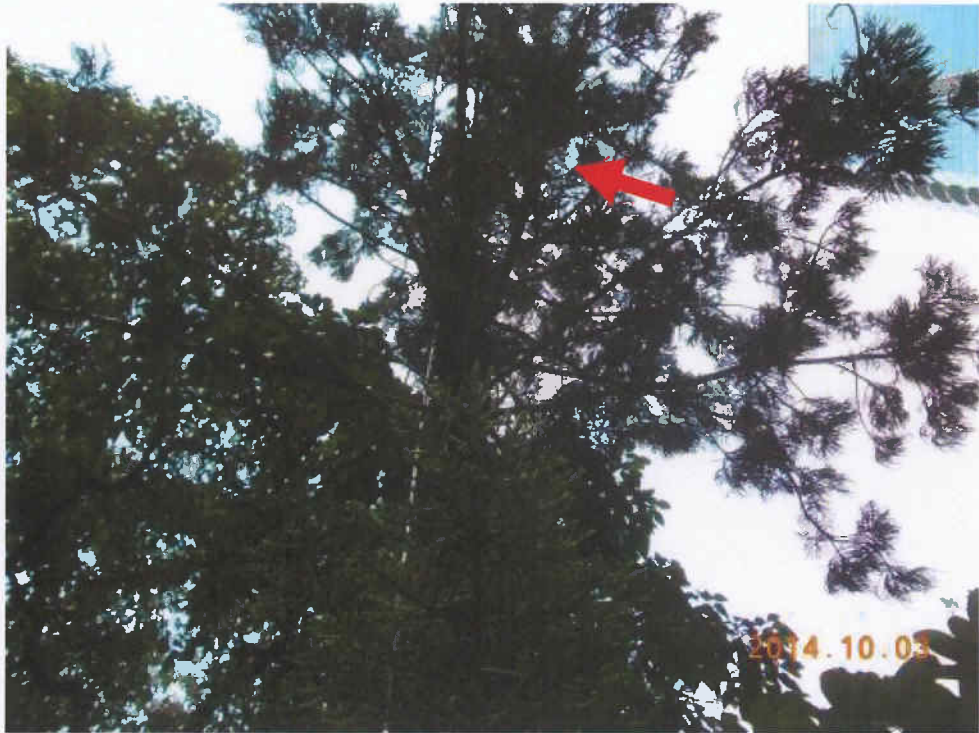
1. Overall health condition of the tree is fair.
2. Many bulky items are placed near the planter.
3. Vigorous branches/leaves appear on the tree.
4. The site near the tree is clean and tidy.
5. Construction works are in progress outside the cordon zone.

Fig. 7 Many bulky items are placed near the planter.

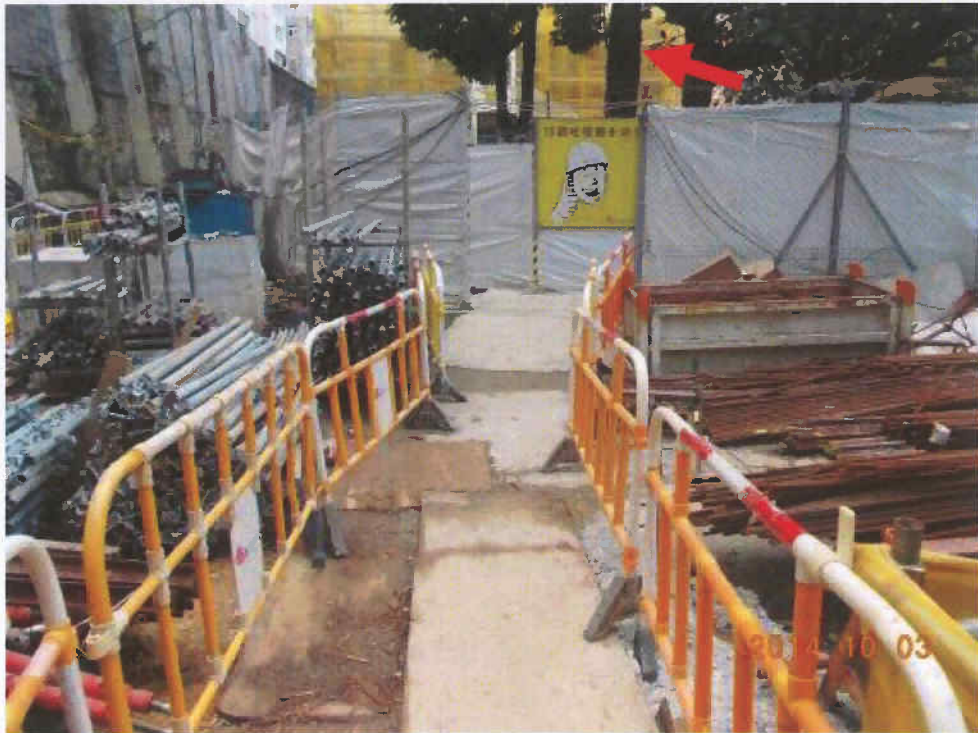
Fig. 10 Overall view of Tree-9 during inspection on 3<sup>rd</sup> October 2014.

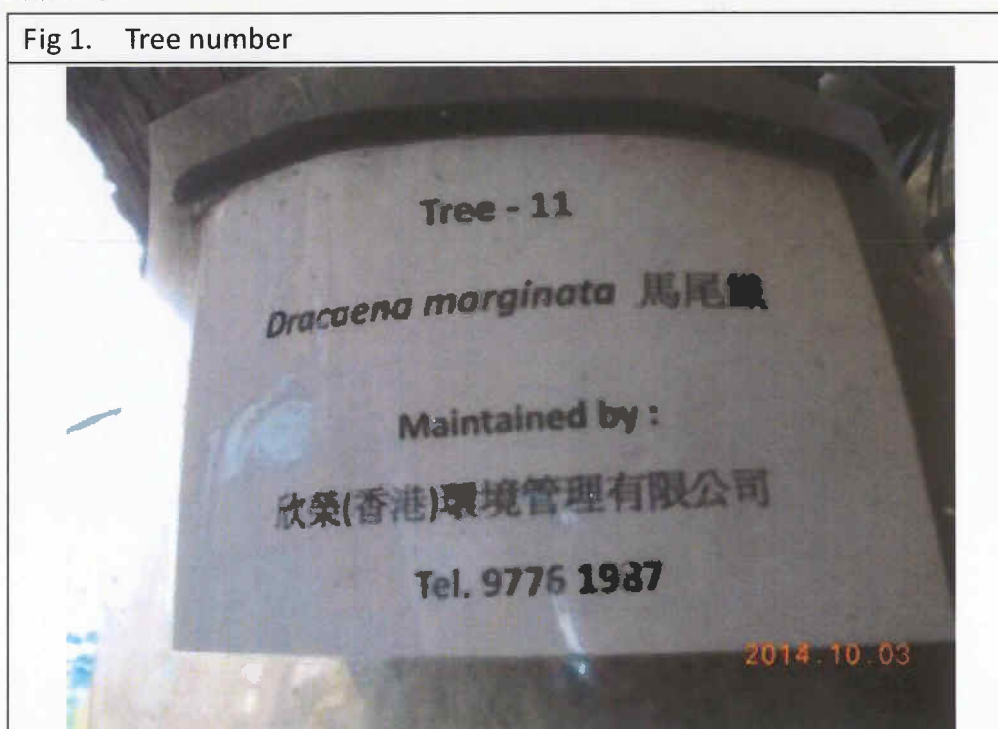
1. Overall health condition of the tree is poor.
2. The soil inside the planter has been polluted by construction debris and litter.
3. Withered leaves appear on the tree.
4. The small cordon zone is not in good order.
5. Renovation work is in progress near the tree.
6. The above incident has been reported to Ms. Oley C.T. WONG on 6/10/2014 morning.

Fig. 2 Cleanliness of the planter is poor. The top-soil near Tree-11 has been seriously polluted by the construction debris and litter.

1. To take immediate mitigation measures against the land pollution.
