# **Construction Waste Management Plan**

## **Central Police Station Conservation and Revitalisation Project (Rev.5)**

| | Central Police Station Conservation and<br>Revitalisation Project Management<br>Contract | Rev. No. : 5 |

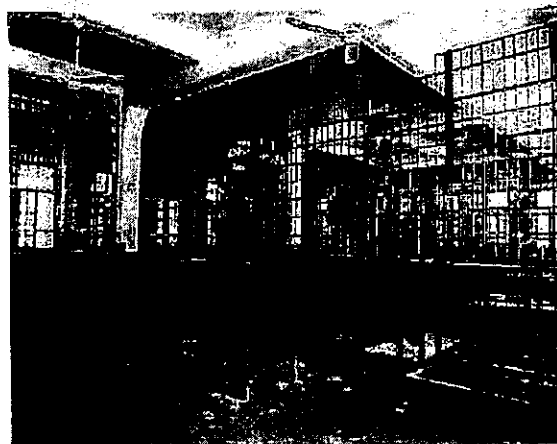
Photo 4. General view of the Block 17, F Hall, 1/F
