Contract No. DC/2007/24
Harbour Area Treatment Scheme Stage 2A
Construction of Sewage Conveyance System from Aberdeen to Sai Ying Pun

Environmental Certification Sheet – 47

Contract No. DC/2007/24
Construction of Sewage Conveyance System from Aberdeen to Sai Ying Pun
Condition 4.4 – Submission of Monthly EM&A Report for October 2012 (no. 34)

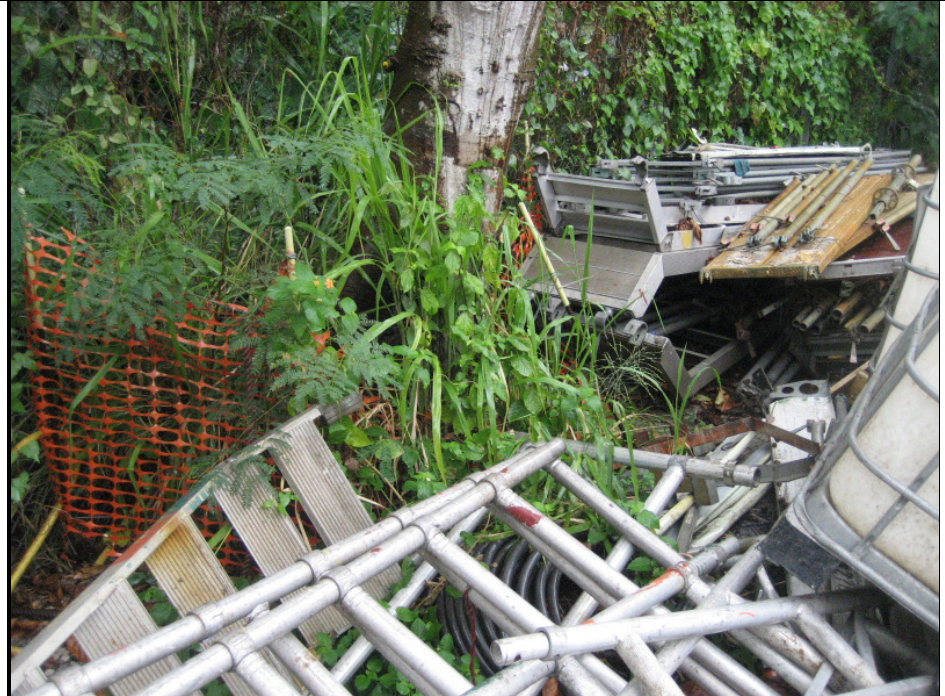
Aberdeen site --- Photo 2

Construction materials were still stored very close to the root area of the retained tree T081(R).

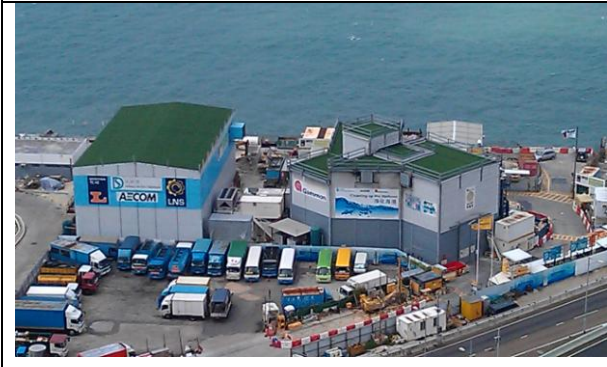
Photo 1: Site investigation on 28 October 2012

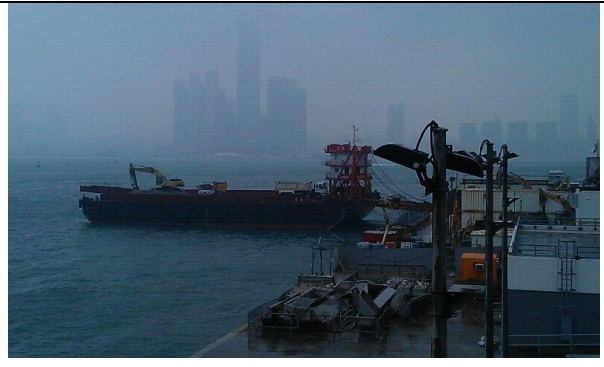
Photo 2: Site investigation on 30 Oct 2012

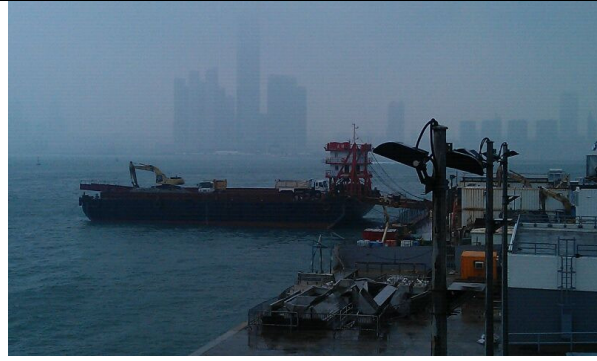
Photo 1: Site investigation on 30 Oct 2012

The Contractor was reminded to enhance watering for the materials before loading activities, and well as to provide watering of the loaded materials on barge. Air monitoring will still ongoing three times in every six-days for 1-hr and at least once in every six-days for 24-hr.
