Contract No. DC/2007/24
Harbour Area Treatment Scheme Stage 2A
Construction of Sewage Conveyance System from Aberdeen to Sai Ying Pun

Document/ Plan/Changes/Information to be Certified/ Verified:	Quarterly Environmental Monitoring and Audit Report No.11 (EMA/042, Rev B)
Date of Report:	31 October 2012
Date of correspondence to IEC:	31 October 2012
Date received:	31 October 2012

Contract no. DC/2007/24
Construction of Sewage Conveyance System from Aberdeen to Sai Ying Pun
Submission of 11th Quarterly EM&A Report for July to September 2012 (Rev. B)

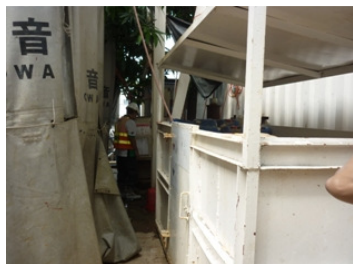
Photo 3 Some water accumulation was found in drip tray near the noise enclosure

- 1. The contractor is reminded to clear the water accumulated in drip tray.

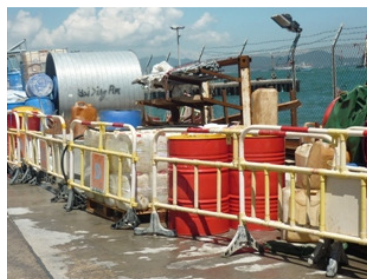
Photo 2 Chemical barrels without drip tray were found

1. The contractor was reminded to provide drip tray to chemical barrels in the stockpiles area.

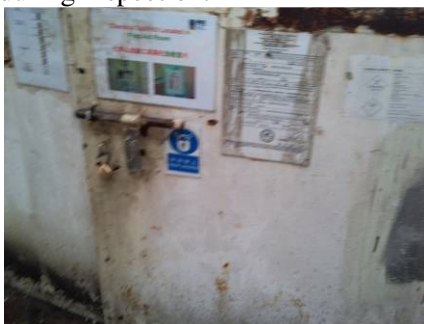
Photo 3 Chemical storage area was unlocked during inspection.

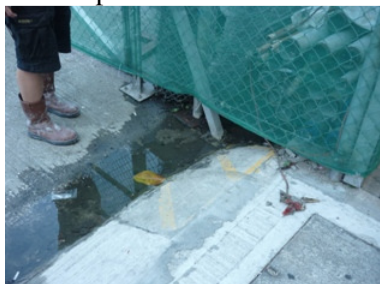
Photo 1 Water accumulation was found on the public access pathway that is 1.5m from the site boundary since last inspection.

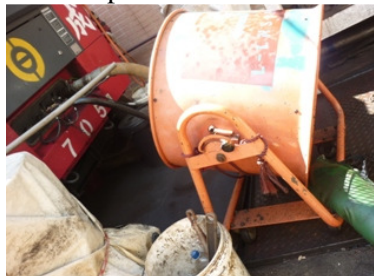
Photo 3 Oil and water mix in drip tray near the air compressor was cleared.

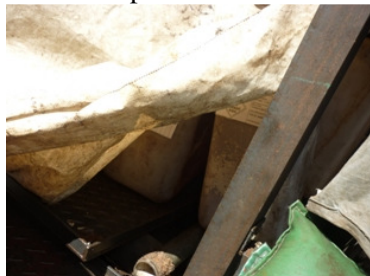
Photo 4 Labels had been provided to chemical in the skip.

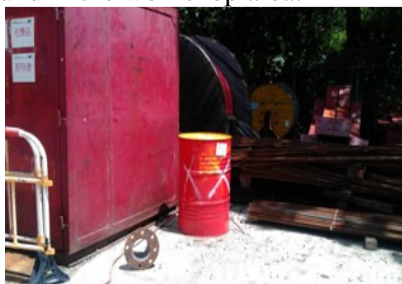
Photo 3 An oil barrel without drip tray was found in the workshop area.

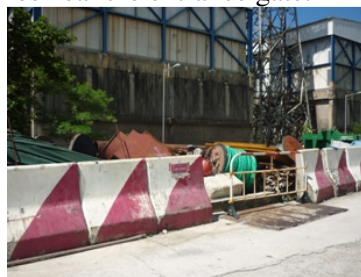
Photo 4 Stagnant water pools were found under the stockpiles near the entrance gate.

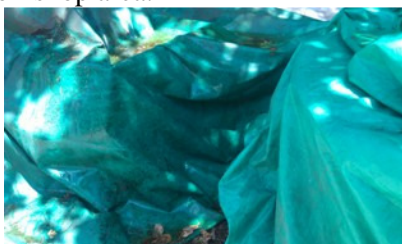
Photo 5 Stagnant water pools were found on the shelter of equipments in the workshop area.

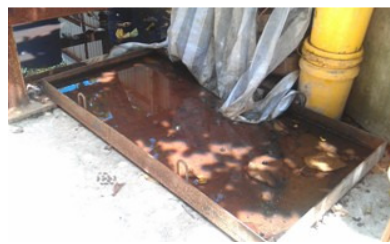
Photo 6 Stagnant water pools were found in the drip tray

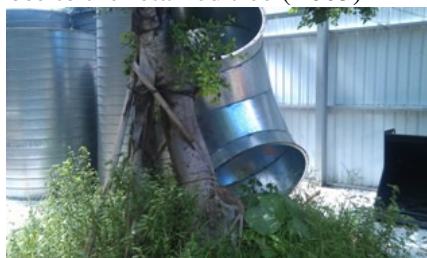
Photo 7 Construction material was stored very close to the retained tree (T003)

1. The Contractor was reminded to remove the construction materials from retained tree (T003).

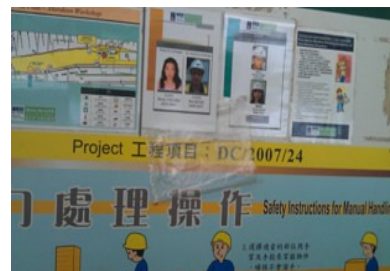
Photo 8 The record of larvicidal oil was missing

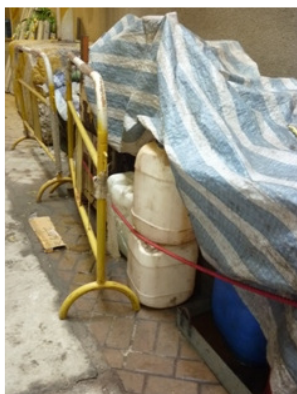
1. Chemicals without drip tray were found on the access near the noise enclosure since 19th June 2012. (Photo 1)
2. Empty chemical were stored improperly. (Photo 2)

Photo 1 Chemicals without drip tray were found on the access near the noise enclosure

1. The contractor is reminded to provide drip tray to chemical containers on the access near the noise enclosure.
2. The contractor is recommended that empty chemical were stored properly.

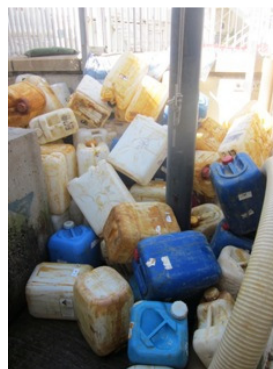
Photo 2 Empty chemical were stored improperly

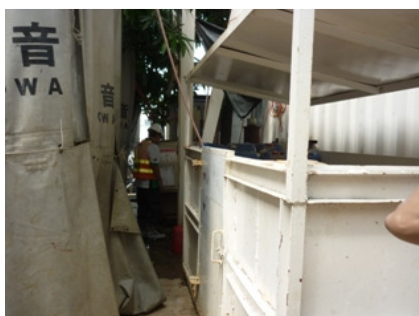
1. Water accumulation was found in drip tray since last inspection (Photo 3) and also found on shelter of stockpiles. (Photo 4)

Photo 3 Some water accumulation was found in drip near the noise enclosure

1. The contractor is reminded to clear the water accumulated in drip tray.

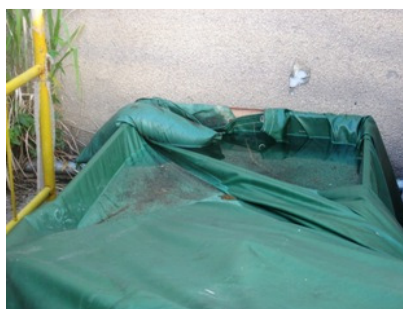
Photo 4 Water accumulation was found on shelter of stockpiles.

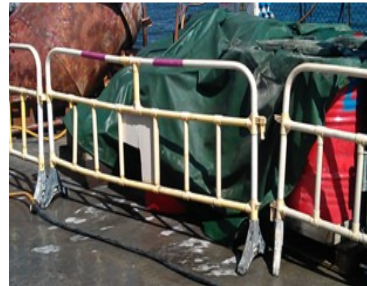
1. Chemical barrels without drip tray were found. (Photo 2)

Photo 2 Chemical barrels without drip tray were found

1. The contactor was reminded to provide drip tray to chemical barrels in the stockpiles area.

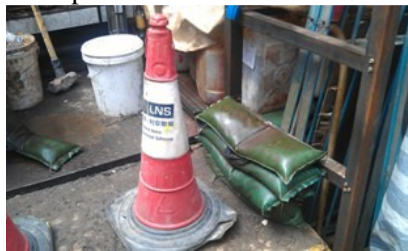
1. Oil droplets were found on sand bags near chemical container since last inspection. (Photo 2)

Photo 2 Oil droplets were found on sand bags near chemical container since last inspection.

1. The contractor is reminded to clear oil droplets on sand bags near chemical container.

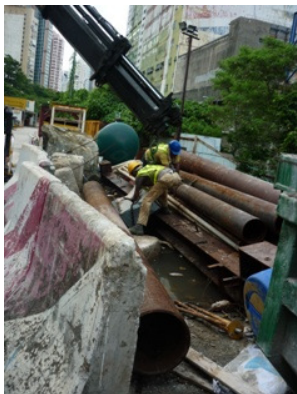
1. Stagnant water pool was found under the stockpiles near the entrance gate since last inspection. (Photo 3)
2. The larvicidal oil record was still missing since last inspection.

Photo 3 Stagnant water pool was found under the stockpiles near the entrance gate since last inspection

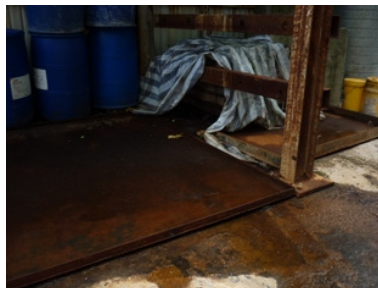
Photo 4 Stagnant water pools in the drip tray was cleared

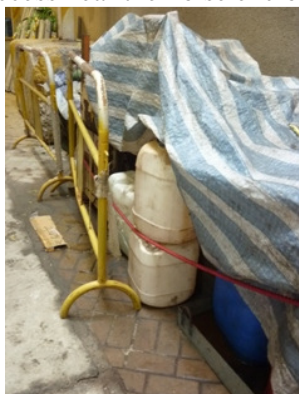
3. Chemicals without drip tray were found on the access near the noise enclosure since 19th June 2012. (Photo 1)
4. Empty chemical containers were stored improperly. (Photo 2)

Photo 1 Chemicals without drip tray were found on the access near the noise enclosure

3. The contractor is reminded to provide drip tray to chemical containers on the access near the noise enclosure.
4. The contractor is recommended that empty chemical containers shall be stored or disposed properly.
5. The contractor is reminded to cleared chemical properly avoid chemical leaking.

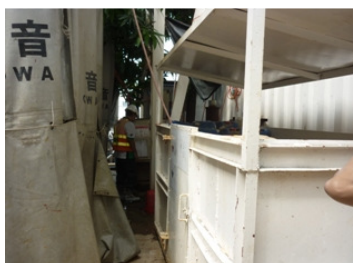
Water accumulation was found in drip tray since last inspection (Photo 3) and also found on shelter of stockpiles. (Photo 4)

Photo 3 Some water accumulation was found in drip tray near the noise enclosure

2. The contractor is reminded to clear the water accumulated in drip tray.
3. The contractor is suggested to avoid potential stagnant pool with garbage.

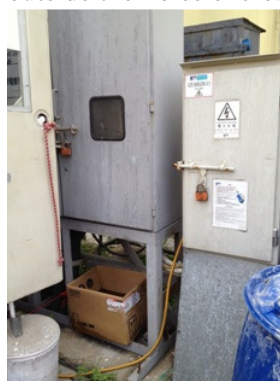
1. Garbage was found near the electric box outside the noise enclosure. (Photo6)

Photo 6 Garbage was found near the electric box outside the noise enclosure

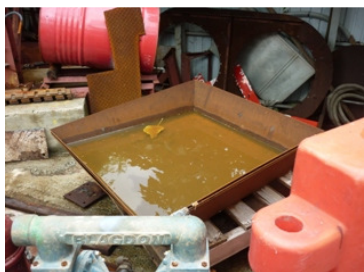
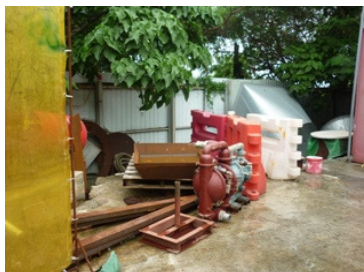
Photos 5 and 6 Water accumulation was found in drip tray near the Dangerous Goods Storage

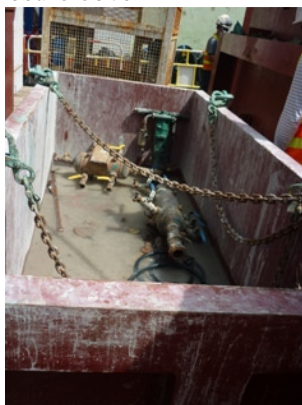
Photo 1 Stagnant water was found in skip on noise enclosure cover

1. The contractor was reminded to clean the accumulated water to prevent mosquito breeding.

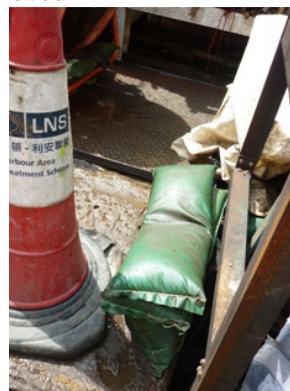
Photo 2 The sand bag with oil droplets was removed

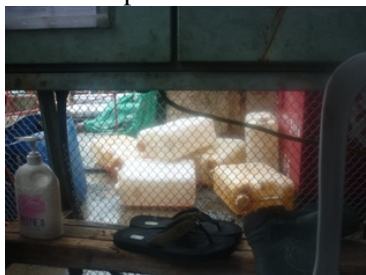
Photo 1 Some chemical drums were found without suitable labels and drip tray next to air compressor near the mobile crane.

- 1. The contractor was reminded to provide drip tray and labels to chemical next to air compressor near the mobile crane and near the retained tree near plants stockpiles in workshop.

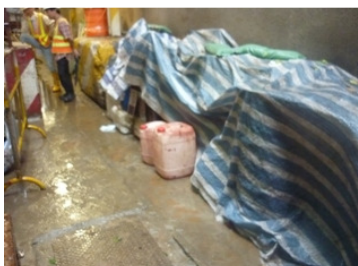
Photo 1 Chemicals without drip tray were found on the access near the noise enclosure

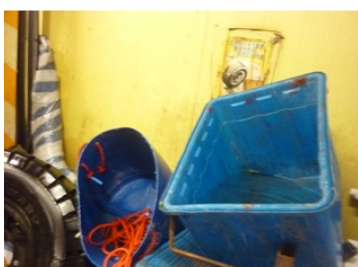
Photo 3 Water accumulation was found in the plastic containers near noise enclosure

2. The contractor is reminded to clear the water accumulated in drip tray and plastic containers near noise enclosure.

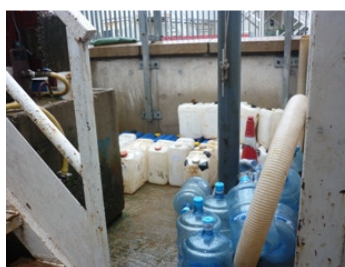
Photo 4 Empty chemical containers were reduced.

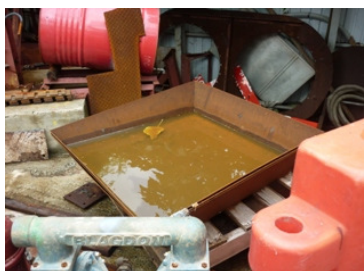
Photos 5 and 6 Water accumulation was found in drip tray near the Dangerous Goods Storage

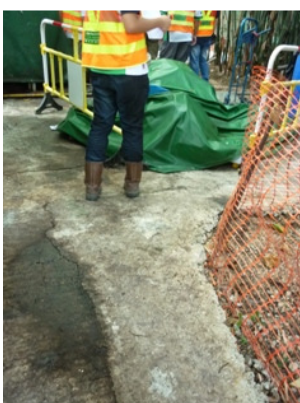
3. Oil remaining was found near the chemical storage (Photo 8) and near the plant next to noise enclosure. (Photos 9 and 10)

Photo 8 Oil remaining was found near the chemical storage

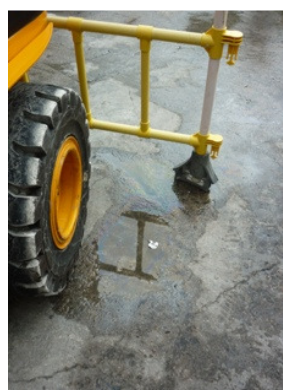
Photo 9 Oil was found near the plant next to noise enclosure

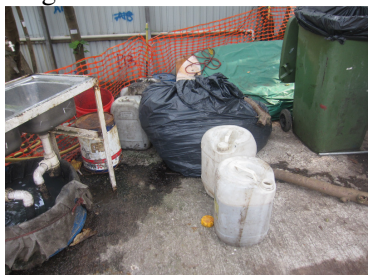
11. Chemicals were found outside the chemical storage area.(Photo 1)

Photo 1 Chemicals were found outside the chemical storage area.

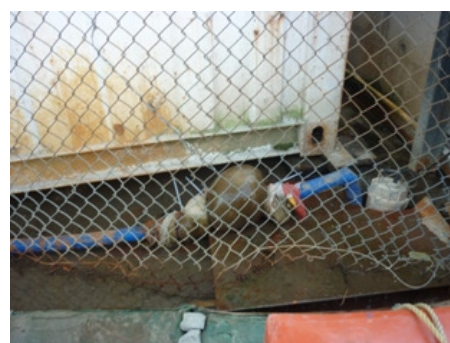
- 2. The temporary drainage pipe was found with breakage (Photo 2)

Photo 2 The temporary drainage pipe was found with breakage

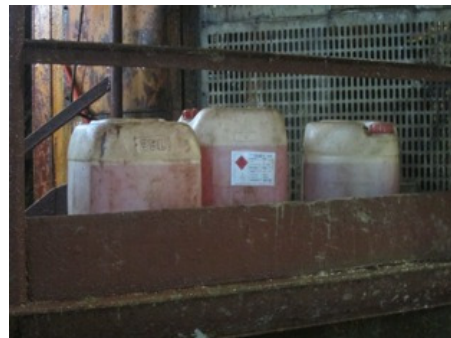
Photo 4 Drip tray has been provided to chemicals in the tunnel adit

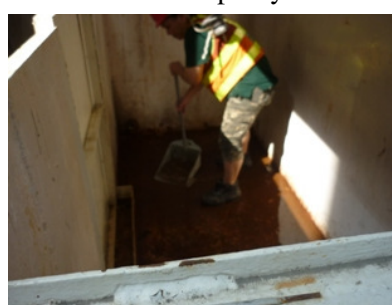
Photo 6 The contractor was clearing water accumulation in drip tray

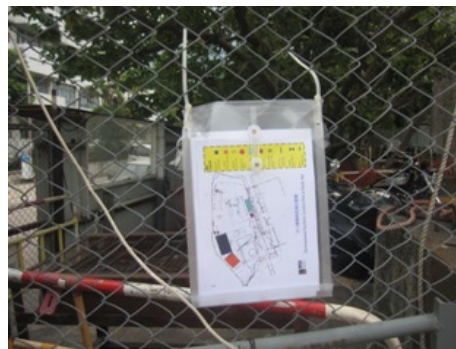
Photo 2 Copies of Environmental Permit were wet/loosened after heavy rain

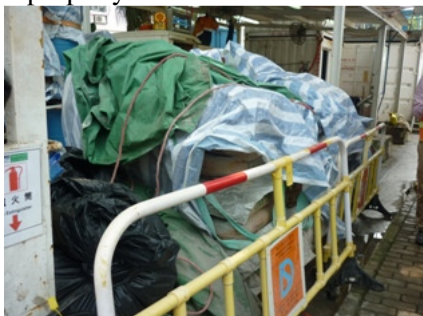
2. Cement bags were found without properly cover (Photo 1).

Photo 1 Cement bags were found without properly cover

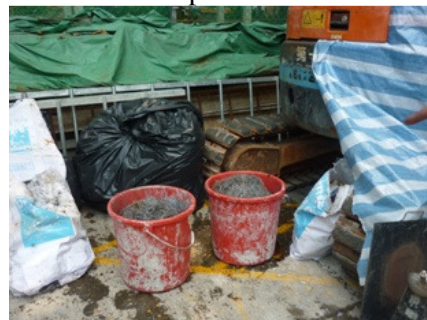
2. Oil droplets were found on the ground near the stockpiles (Photo 2).

Photo 2 Oil droplets were found on the ground near the stockpiles

2. The contractor was reminded to clear the oil droplets with oil dispenser.

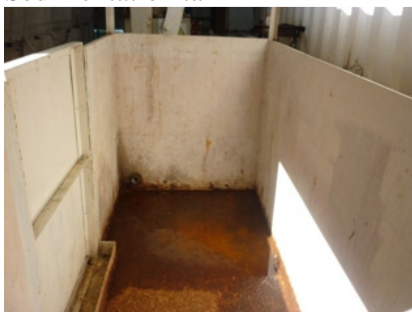
1. Water accumulation was found in the chemical storage near the Aqua. sedimentation tank (Photo 1).

Photo 1 Water accumulation was found in the chemical storage near the Aqua. Sedimentation tank

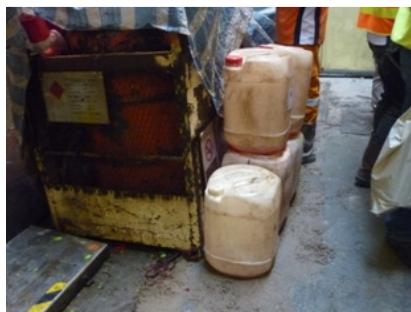
1. Some chemicals were found without drip tray near the noise enclosure (Photo 2).

Photo 2 Some chemicals were found without drip tray near the noise enclosure

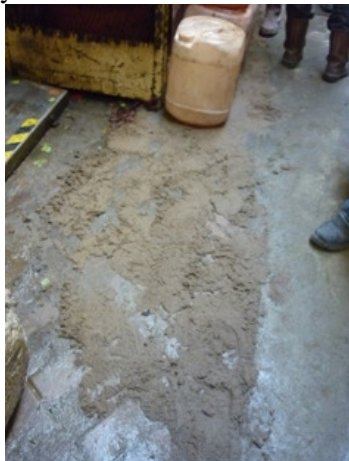
1. Contaminated soil was found near the drip tray (Photo 3).

Photo 3 Contaminated soil was found near the drip tray

1. The contractor was reminded to treat the contaminated soil as chemical waste.

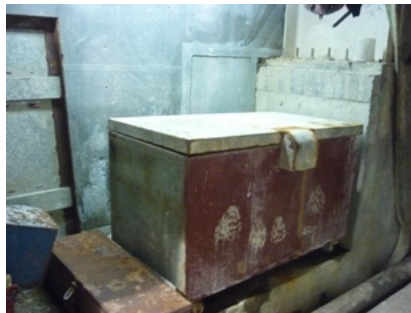
Photo 4 The skip inside the noise enclosure has been locked

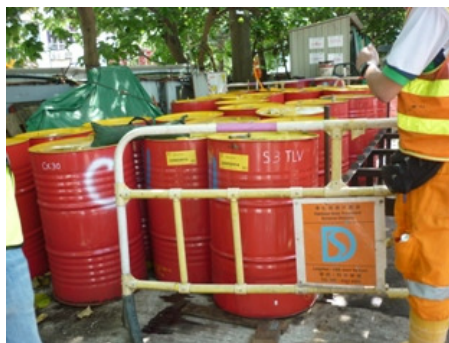
Photo 1 Chemicals were found outside the chemical storage area

Photo 2 Chemicals were found outside the chemical storage area

1. The contractor was reminded to place chemical properly, and sand bags should be provided for temporary storage.
2. The contractor was reminded to provide suitable labels to chemicals.

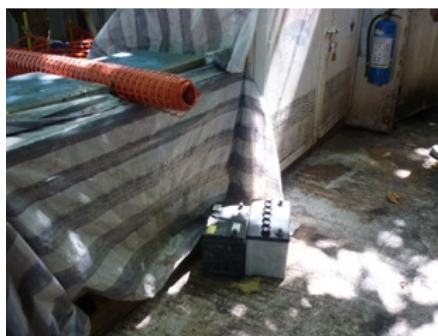
Photo 4 Rechargeable batteries were placed improperly

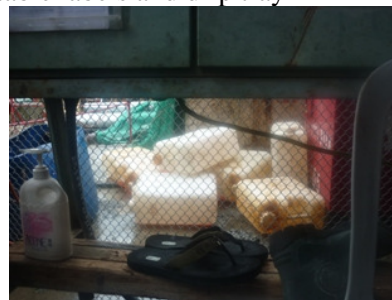
1. The issue of chemical drums without suitable labels and drip tray (Photo 2) will be inspecting in next inspection due to the access road had not been under site inspection.
2. Some chemical barrels were found in workshop without suitable labels and drip tray since the last inspection (Photo 3).

Photo 2 The issue of chemical drums without suitable labels and drip tray

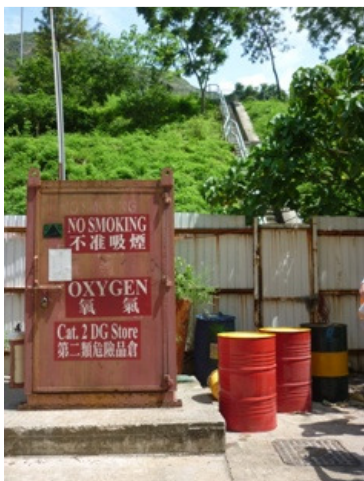
Photo 3 workshop without suitable labels and drip tray

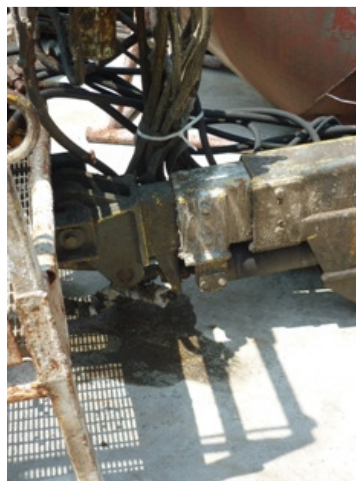
Photo 5 Oil spill out from drip tray was observed in workshop

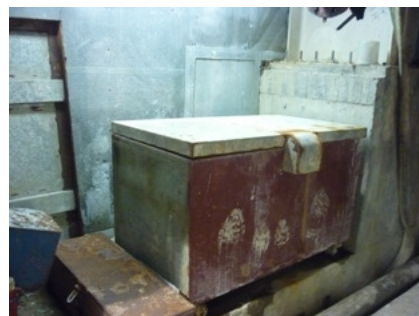
Photo 3 Accumulated water in chemical storage near the Aqua. Sedimentation tank was cleared

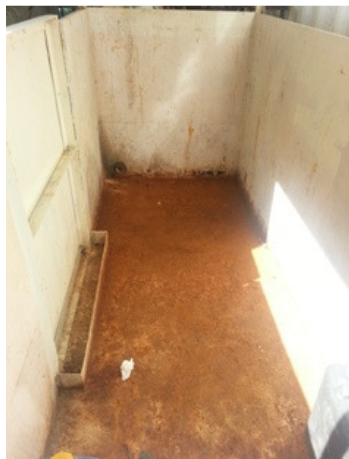
Photo 4 Chemicals near the noise enclosure were removed

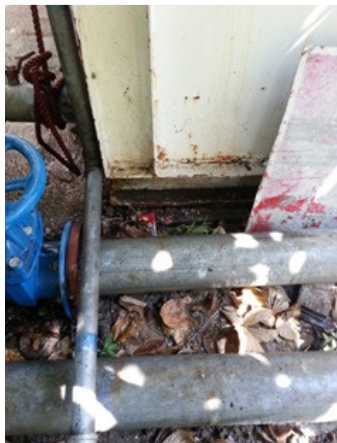
7. Water accumulation was found behind the sedimentation tank (Photos 2 and 3).

Photo 2 Water accumulation was found behind the sedimentation tank

Photo 3 Water accumulation was found behind the sedimentation tank

4. The contractor was recommended to clear the water accumulation behind the sedimentation tank and prevent mosquito breeding.

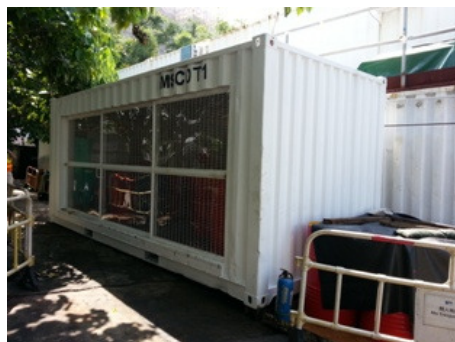
Photo 4 The new cargo for chemical storage had been arrived, but cargo without label

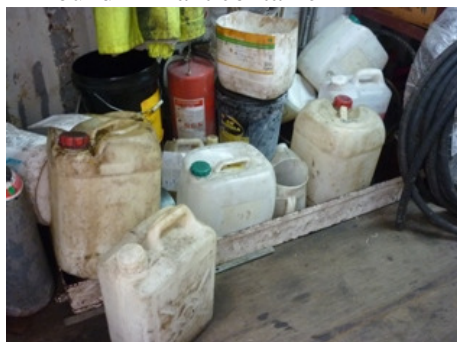
Photo 5 The issue of chemicals without labels was found in Plant container

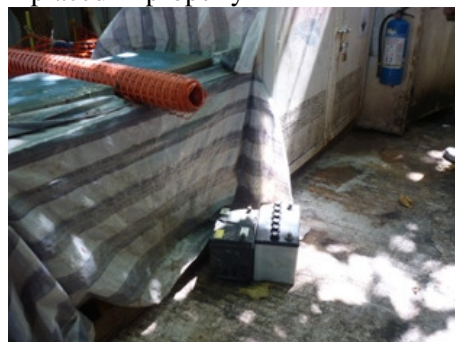
Photo 6 The issue of rechargeable batteries was placed improperly

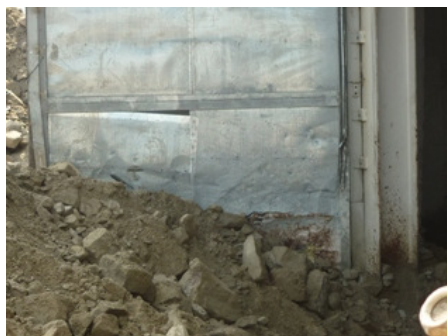
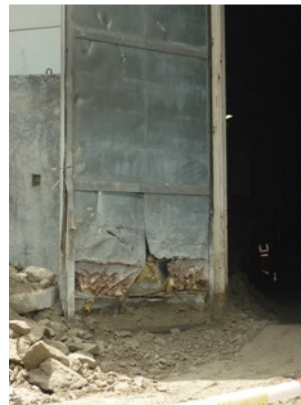
1. The door of noise enclosure was found broken since last site inspection (Photos 1 and 2).

Photo 1 The door of noise enclosure was found broken

Photo 2 The door of noise enclosure was found broken

1. According to contractor, acoustic mat would be provided to cover broken part for temporary treatment.

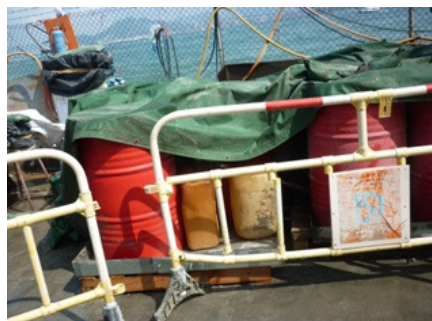
1. Chemical without suitable labels were found (Photo 3).

Photo 3 Chemical without suitable labels were found

1. The contractor was recommended to provide the suitable label to unknown chemical.

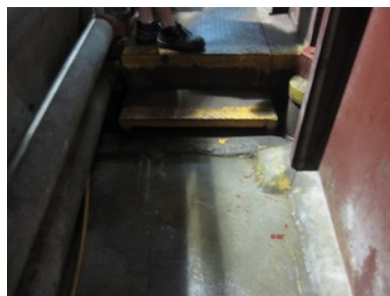
2. Stagnant pool was found in the noise enclosure (Photo 4).

Photo 4 Stagnant pool was found in the noise enclosure

1. The contractor was reminded to clear the stagnant pool and prevent the mosquito breeding.

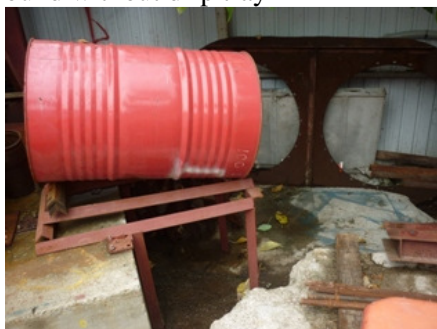
1. Chemical near welding zone was found without drip tray since last site inspection (Photo 1).
2. The chemicals without labels were found in Plant container since last site inspection (Photo 2).

Photo 1 Chemical near the welding zone was found without drip tray

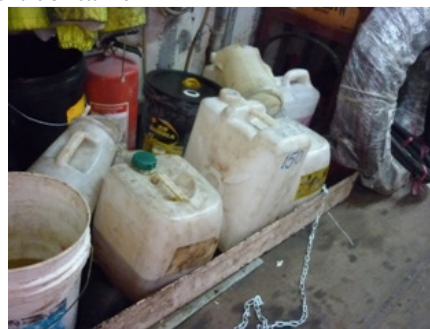
Photo 2 The chemicals without labels were found in Plant container

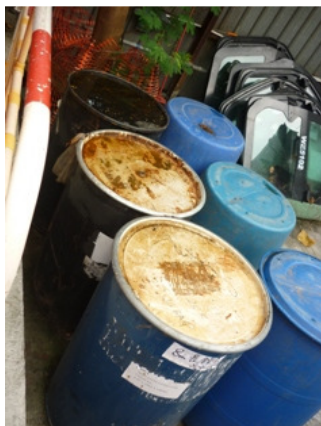
1. Potential stagnant pools were found on the cover of the barrels near the DG Storage (Photos 3 and 4).

Photo 3 Potential stagnant pools were found on the cover of the barrels near the DG storage area

5. The contractor was recommended to clear the water accumulation on the cover of the barrels near the DG storage area and prevent mosquito breeding.

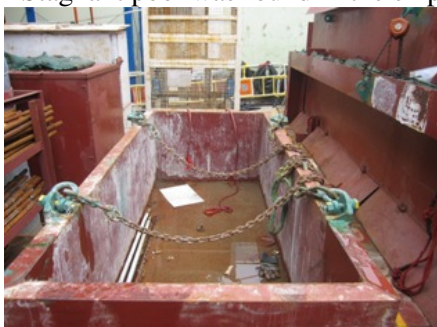
Photo 1 Stagnant pool was found in the skip

1. The contractor was recommended to clear the stagnant pool and prevent mosquito breeding.

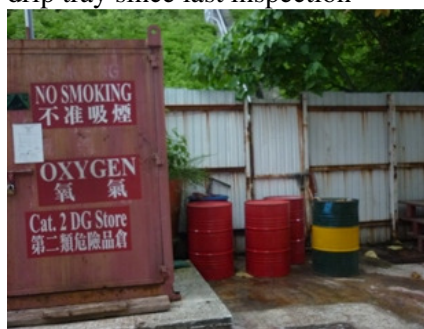
Photo 4 Some chemical barrels were found in workshop without suitable labels and drip tray since last inspection

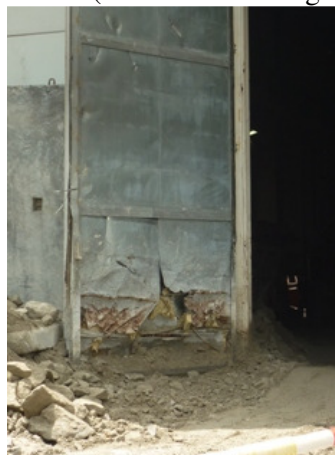
1. The door of noise enclosure was found broken since last inspection. (Photos 1 and 2)

Photo 1 The door of noise enclosure was found broken.

Photo 2 The door of noise enclosure was found broken. (Taken on 14th August 2012)

1. According to contractor, acoustic mat will be provided to cover broken part for temporary treatment.

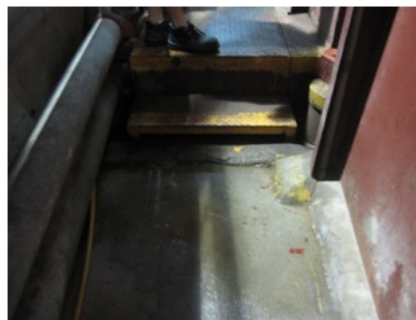
1. Stagnant pool was found in the noise enclosure. (Photo 4)

Photo 4 Stagnant pool was found in the noise enclosure

1. To clear the stagnant pool and prevent the mosquito breeding.

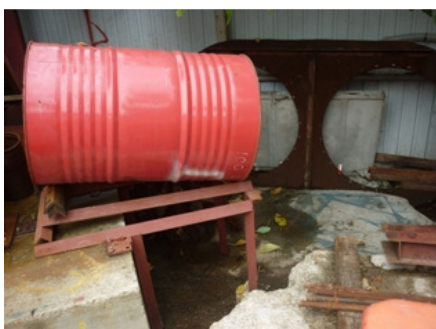
12. Chemical near welding zone was found without drip tray since last inspection.(Photo 1)
13. The chemicals without labels were found in Plant container since last inspection.(Photo 2)

Photo 1 Chemical near welding zone was found without drip tray

3. The Contractor is reminded to provide drip tray to chemical near the welding zone and provide suitable labels to chemicals stored in material container.

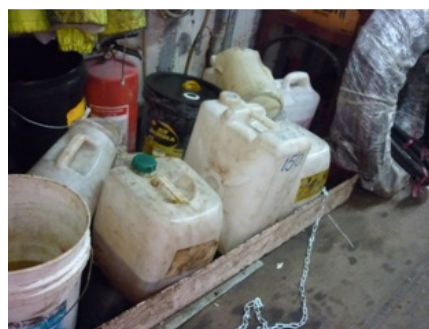
Photo 2 The chemicals without labels were found in Plant container

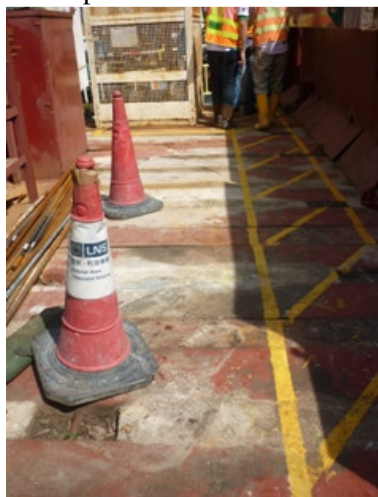
Photo 3 The skip had been removed.

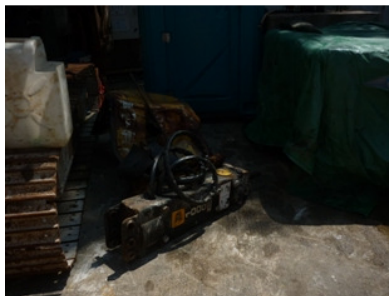
- 1. Oil droplets near the plants stockpile were found was cleared.(Photo 4)
- 2. Oil droplets under the plants near the entrance gate were cleared.

Photo 4 Oil droplets near the plants stockpile were found was cleared

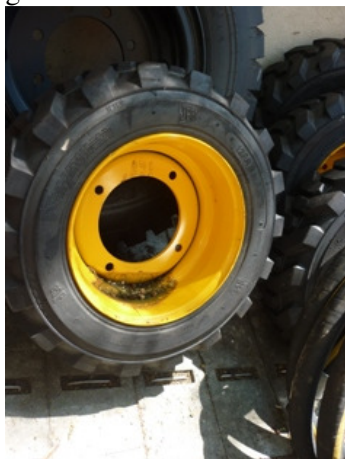
Photo 5 Stagnant pool in tyre near the entrance gate was cleared

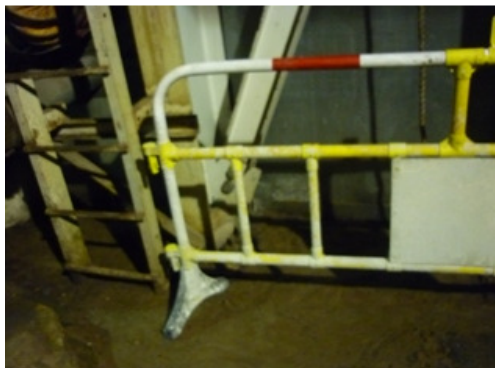
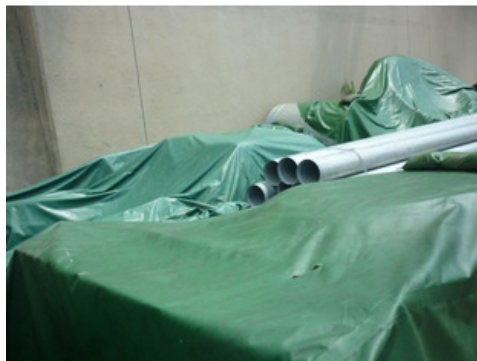
Photos 2 and 3 Water accumulation inside the enclosure and on the tarpaulin near the stockpiles was cleared

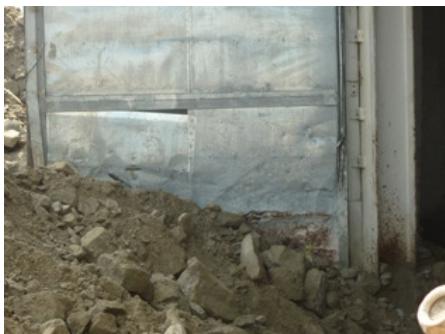
- 2. The door of noise enclosure was broken since last inspection. (Photos 1 and 2)

Photo 1 The door of noise enclosure was found broken.

Photo 2 The door of noise enclosure was found broken.(Taken on 14th August 2012)

- 2. According to contractor, acoustic mat will be provided to cover broken part for temporary treatment.

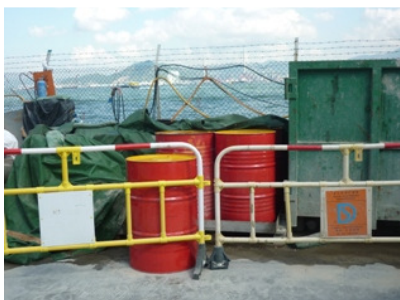
- 2. Chemical without trip dray was found. (Photo 3)

Photo 3 Chemical without trip dray was found

- 2. The contractor is recommended to provide the trip dray to chemical.

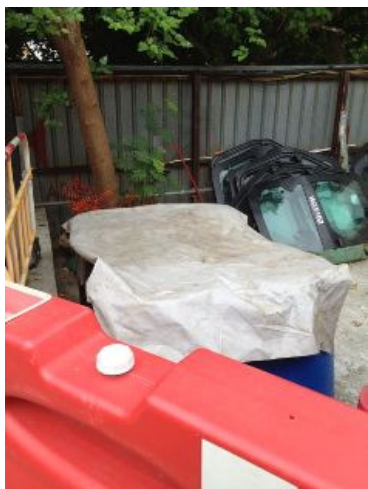
Photo 3 Tarpaulin had been provided to barrels near

the DG Storage to prevent water accumulation

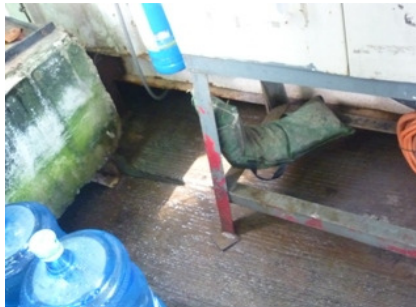
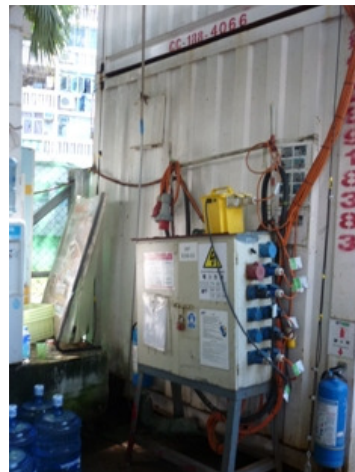
1. Dripping from air conditioner was found near material container. (Photos 1 and 2)

Photos 1 and 2 Dripping from air conditioner was found near material container

2. The contractor is recommended to fix the pipe and prevent potential stagnant pools cleared and mosquito breeding.

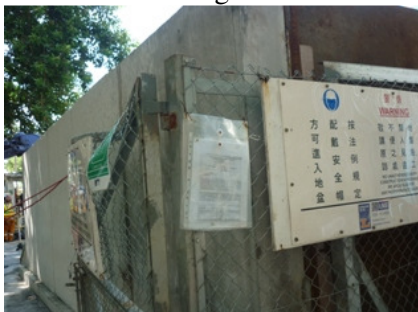
1. The Environmental Permit (EP-322/2008/E) had been displayed in the notice board at vehicle entrance gate. (Photo 3) However, the contractor is still recommended to provide a valid EP in the notice board near the exit.

Photo 3 The Environmental Permit (EP-322/2008/E) had been displayed in the notice board at vehicle entrance gate.

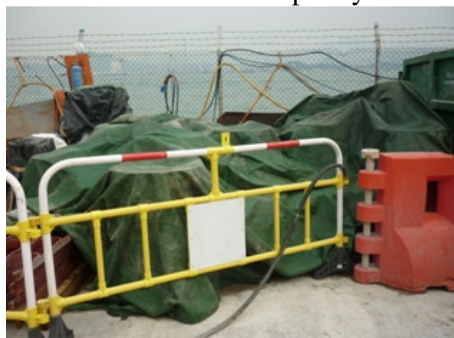
Photo 3 Chemical without trip dray was found

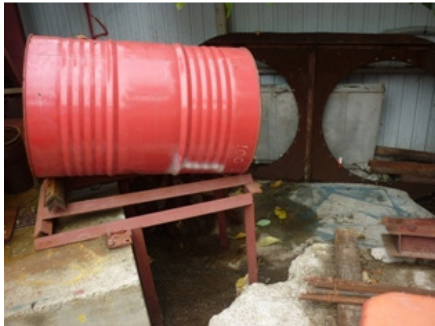
1. Chemical near welding zone was found without drip tray since inspection on 28 August .(Photo 1)
2. The chemicals without labels were found in Plant container since inspection on 28 August.(Photos 2 and 3)

Photo 1 Chemical near welding zone was found without drip tray

1. The Contractor is reminded to provide drip tray to chemical near the welding zone and provide suitable labels to chemicals stored in material container.

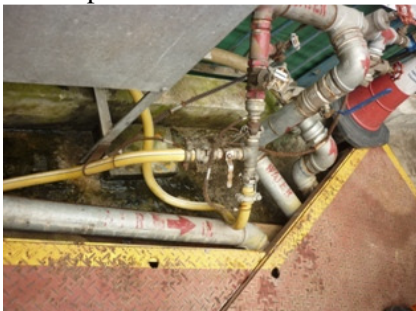
1. The dripping tap was found near the noise cover platform.(Photo 3)

Photo 3 The dripping tap was found near the noise cover platform

3. The contractor is recommended to fix the pipe and prevent potential stagnant pools cleared and mosquito breeding.

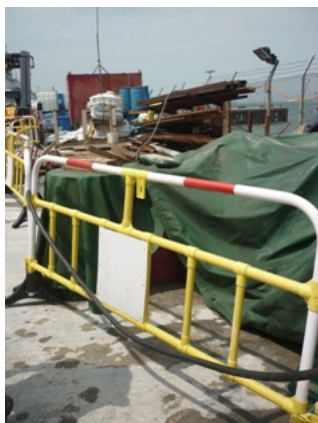
1. Chemical without trip dray was found since last inspection. (Photo 3)

Photo 3 Chemical without trip dray was found

1. The contractor is recommended to provide the trip dray to chemical.

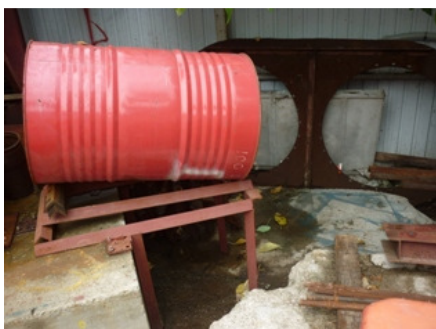
1. Chemical near welding zone was found without drip tray since inspection on 28 August 2012.(Photo 1)
1. The chemicals without labels were found in Plant container since inspection on 28 August 2012.(Photos 2 and 3)

Photo 1 Chemical near welding zone was found without drip tray

1. The Contractor is reminded to provide drip tray to chemical near the welding zone and provide suitable labels to chemicals stored in material container.

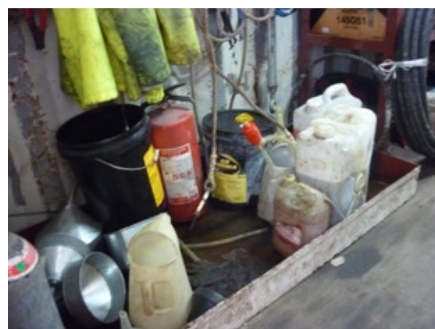
Photo 2 The chemicals without labels were found in Plant container

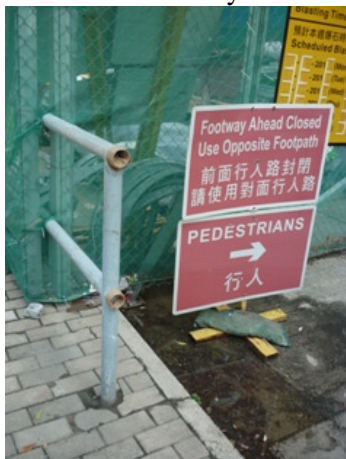
1. Water accumulation was found in the skip and near the boundary.(Photos 1 and 2)
2. The dripping tap was found near the noise cover platform since last inspection.(Photo 3)

Photos 1 and 2 Water accumulation was found in the skip and near the boundary

1. The contractor is recommended to fix the pipe and prevent potential stagnant pools in skip on noise cover.
