Document Details					
Client Drainage Services Department					
Project Contract No. DC/2007/24 Harbour Area Treatment Scheme Stage 2A Construction of Sewage Conveyance System from Aberdeen to Sai Ying Pun					
Document Title Quarterly Environmental Monitoring and Audit Report No. 12 Covering the Period from 1 October 2012 to 31 December 2012					
Document No. EMA/046					
Distribution					
Copy No.	Issued To		Copy No.	Issued To	
01-02	Leighton-LNS JV		10	Metcalf & Eddy-AECOM JV	
03	Mott MacDonald Hong Kong Ltd		11	ACL (Project Office)	
04-08	EPD		12	ACL (Head Office)	
09	DSD				
Submission Ref				Controlled Copy No.	
SUBM Ref.					
Atkins Ref.(s)	DC/2007/24/31.20/OG4004/EC/SH/SO				
Revision History					
A	28 January 2013	Submission to IEC and ER for Review	Various

Contract No. DC/2007/24
Harbour Area Treatment Scheme Stage 2A
Construction of Sewage Conveyance System from Aberdeen to Sai Ying Pun

Document/Plan/Changes/Information to be Certified/ Verified:	Quarterly Environmental Monitoring and Audit Report No.12 (EMA/046, Rev A)
Date of Report:	1 February 2013
Date of correspondence to IEC:	1 February 2013
Date received:	1 February 2013

**Contract no. DC/2007/24
Construction of

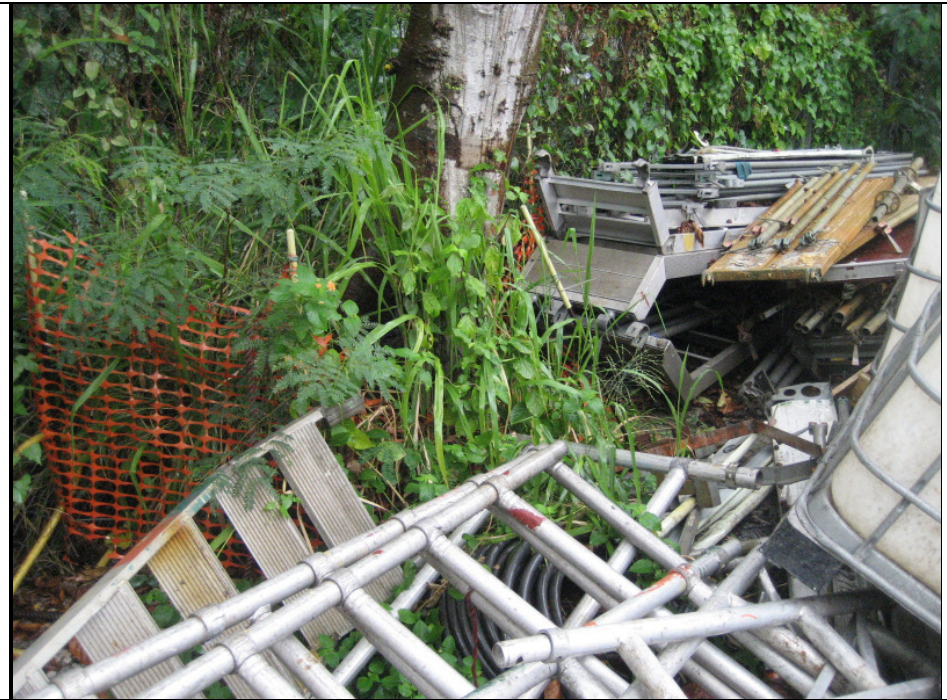
Aberdeen site --- Photo 2

Construction materials were still stored very close to the root area of the retained tree T081(R).

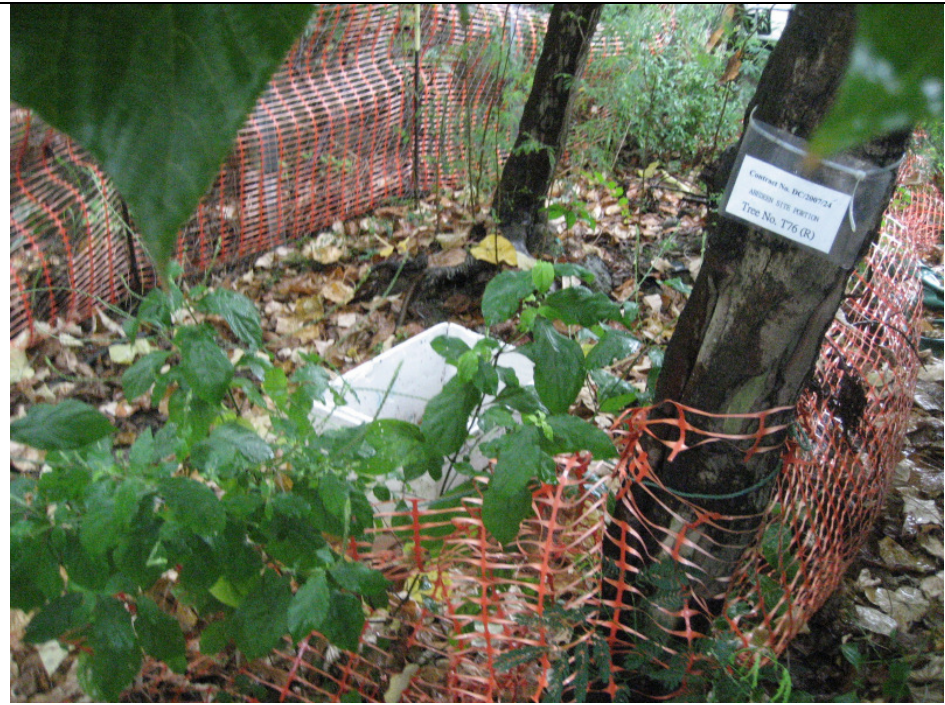
Aberdeen site --- Photo 5

General refuse was dumped within the tree protection zone of the retained tree T76(R).

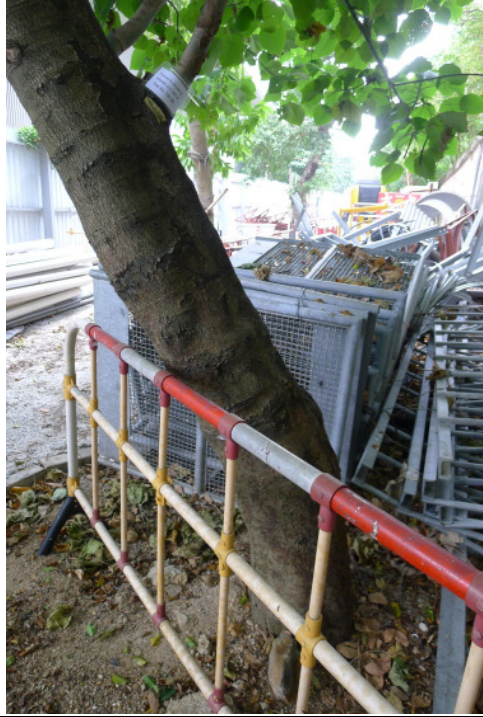
Aberdeen Site – Photo 10

- (1) Construction materials were still stored very close to the root area of the retained tree T084(R) (*Photo 10*) and an unlabelled tree (*Photo 11*). The Contractor was asked again to remove the construction materials and provide a proper tree tag for the unlabelled tree.

Construction materials were still stored very close to the root area of the retained tree T084(R).

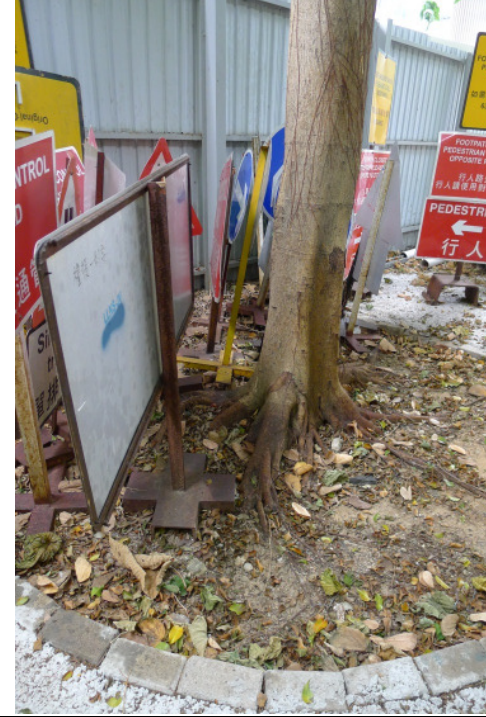
Aberdeen Site – Photo 11

Construction materials were still stored very close to the root area of the unlabelled tree.

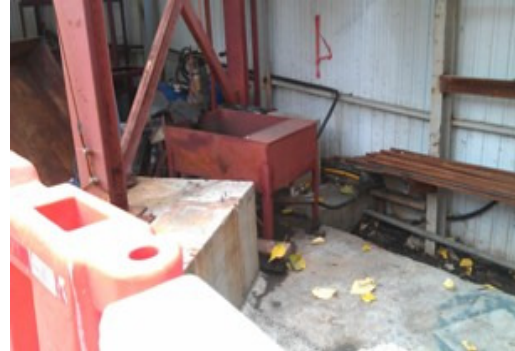
Photo 2 The chemical barrel next to Plant Department was removed.

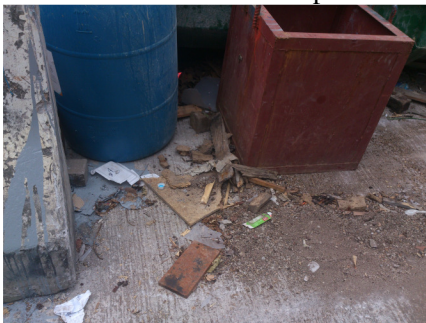
1. The general waste was found accumulated in the workshop area. (Photo 1)

Photo 1 The general waste was found accumulated in the workshop area.

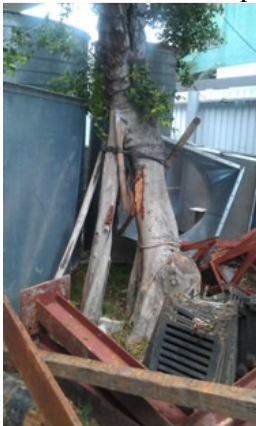
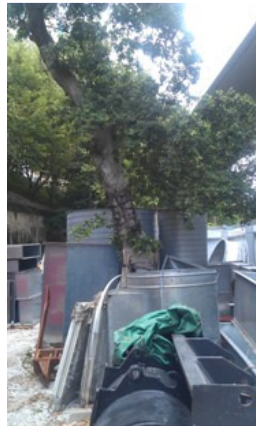
1. The items of “Construction materials were stored too close to the tree (T003 (T)) in Storage area. (Photos 2 and 3)” will be follow up in next inspection due to assess road was blocked.
2. The oil stains were found on the ground near the generator. (Photo 4)

Photos 2 and 3 The items of “Construction materials were stored too close to the tree (T003 (T)) in Storage area” will be follow up in next inspection due to assess road was blocked.

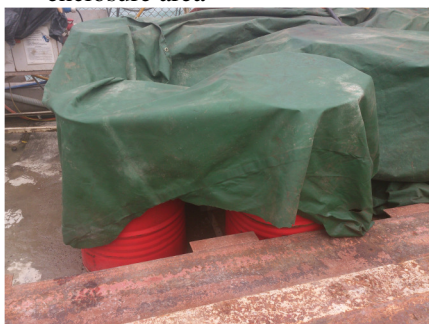
1. Chemical barrels were found to be without drip trays outside the noise enclosure area. (Photo 1)

Photo 1 Chemical barrels were found to be without drip trays outside the noise enclosure area

1. The contractor is recommended to provide drip trays for chemical containers.

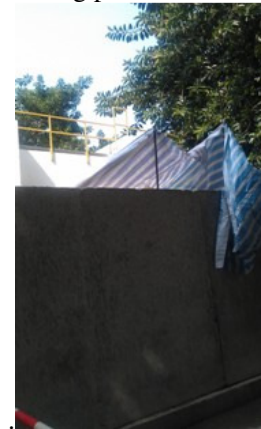
1. The cement plant was prepared to operation during the site inspection. The cover for cement mixing plant was found not properly cover the top and 3 sides of cement mixing plant on 9 October 2012. (Photos 1 and 2). This observation will be follow up on next inspection.

Photo 2 The cover for cement mixing plant was found not properly cover the top and 3 sides of cement mixing plant.

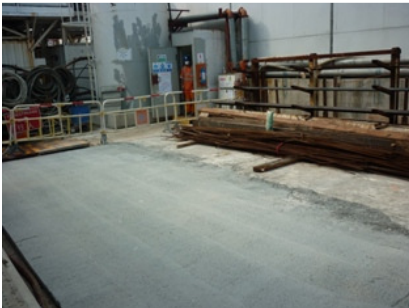
Photo 3 Chemical barrels were removed

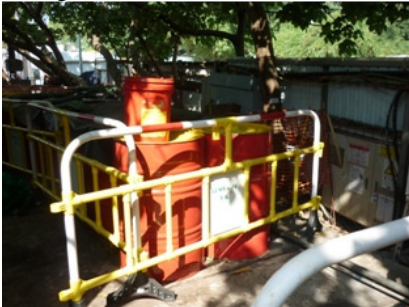
1. Some chemical barrels were found without drip tray next to chemical storage. (Photo 1)

Photo 1 Some chemical barrels were found without drip tray next to chemical storage.

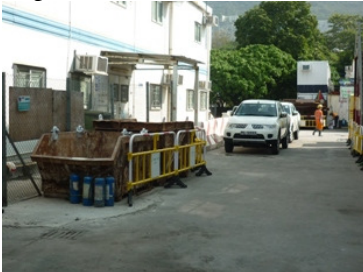
1. No oil stains was found during inspection.(Photo 3)

Photo 3 No oil stains was found during inspection.

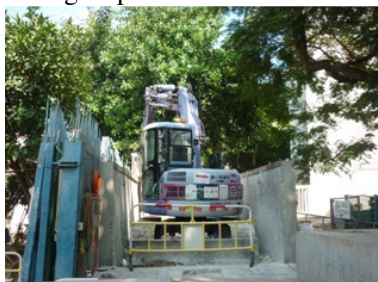
Photo 1 No cement mixing process was found during inspection.

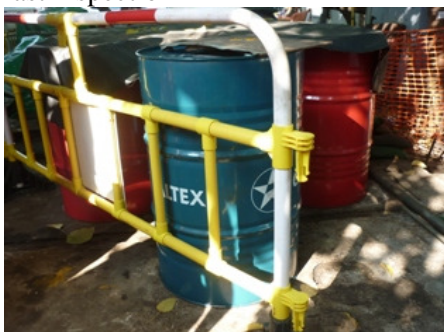
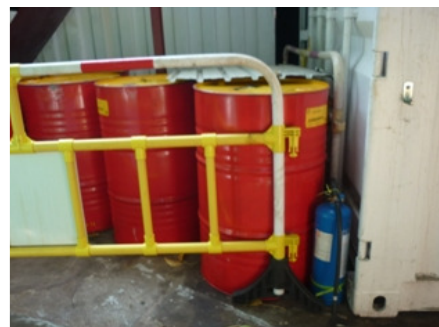
Photos 1 & 2 Some chemical barrels were found without drip tray next to stockpiles and plants since last inspection

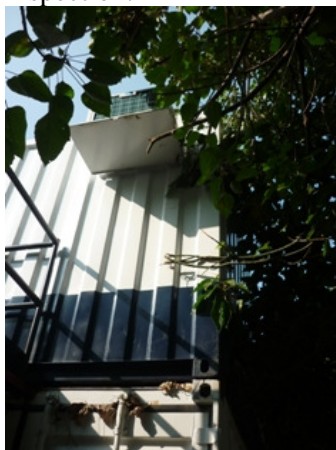
Photo 3 No dripping from air conditioner during site inspection.

1. Even no dripping had been found, the Contractor was reminded to provide suitable pipe to air conditioner next to new chemical storage to divert waste water.

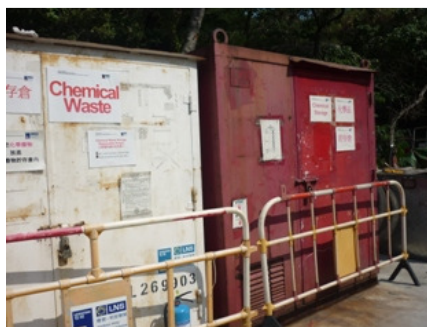
Photo 2 The chemical storage was found without chemical storage list

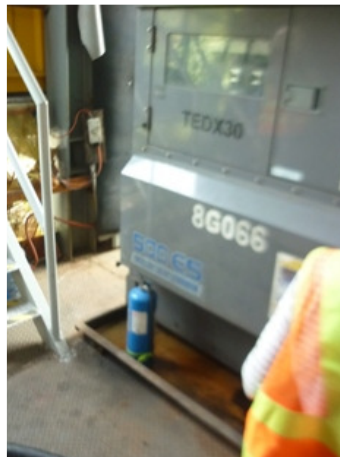
Photo 6 Waste oil was accumulated in drip tray of generator at 1st platform

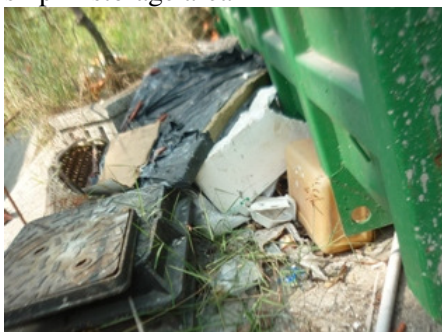
1. Some trashes were found next to the stairs in PTW and near the rubbish skip in storage area.(photos 8 and 9)
2. Accumulated of water was found in drip tray of oil barrels near the stockpiles in storage area. (Photo 10)

Photo 9 Some trashes were found near the rubbish skip in storage area

1. The Contractor is reminded to keep the site tidiness.

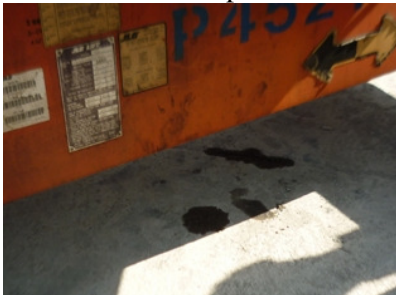
Photos 5 and 6 Some oil droplets were found under the cherry lifter near the stockpiles

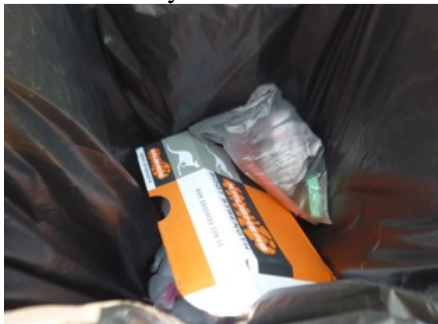
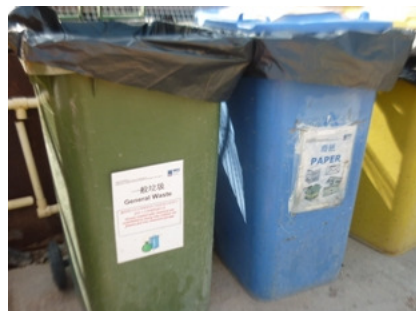
Photos 7 and 8 Recycle materials were found in general rubbish bin.

1. The Contractor is recommended to enhance the information of recycling site material to workers.

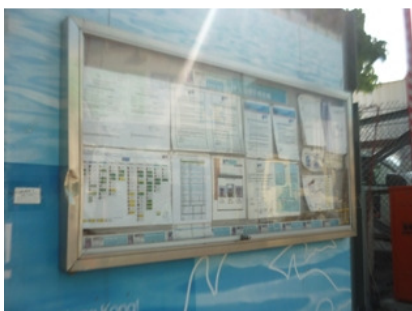
Photos 1 No valid EP was showed at major exit

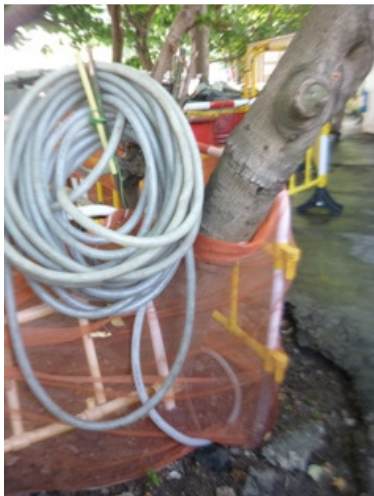
Photo 5 Non-use water plastic pipe hang from the branch of Tree 038.

1. The Contractor is suggested to remove the plastic pipe from the Tree 038.

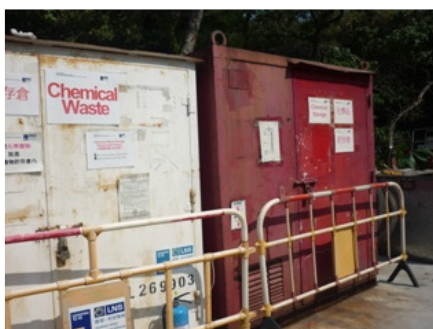
Photos 3 The chemical storage was found without chemical storage list since last inspection

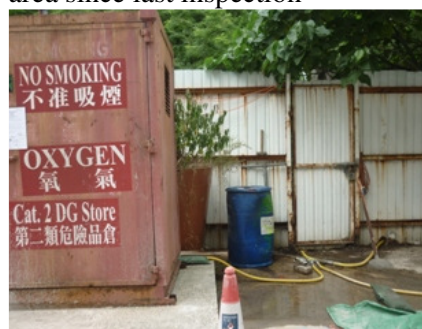
Photo 5 Some trashes were found near the rubbish skip in storage area since last inspection

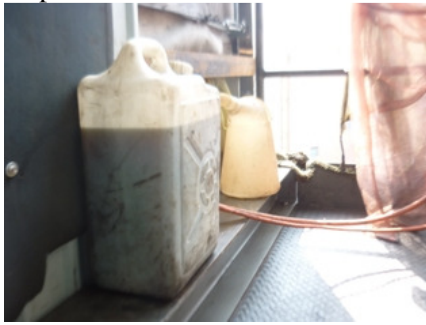
Photos 7 and 8 A chemical container was found near the generator at 1st platform without label

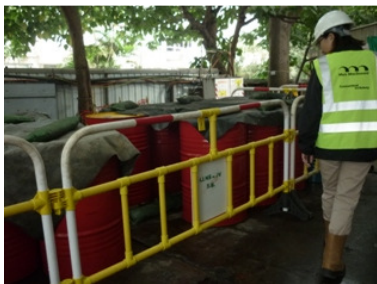
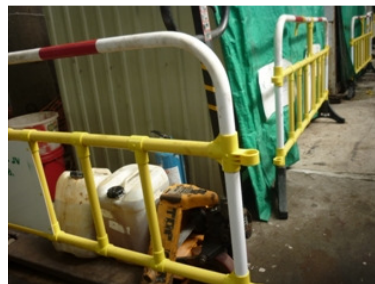
1. Some chemical barrels were found without drip tray next to chemical storage, Plants zone and near the site hoarding behind the chemical storage container. (Photos 1 to 4)

Photos 1 to 2 Some chemical barrels were found without drip tray next to chemical storage

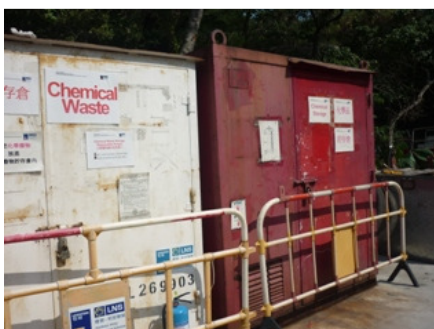
1. The chemical storage was found without chemical storage list since inspection on 30th October 2012. (Photo 3)
2. Some chemical barrels were found in PTW without drip tray next to the mobile crane and near the entrance gate. (Photos 4 and 5)

Photos 3 The chemical storage was found without chemical storage list since last inspection

1. The Contractor is reminded to provide suitable labels to the chemicals near the generator at 1st platform and in storage area.
2. The Contractor is recommended to display chemical storage list of the chemical storage.
3. The Contractor is reminded to provide drip tray to chemical barrels were found in PTW next to the

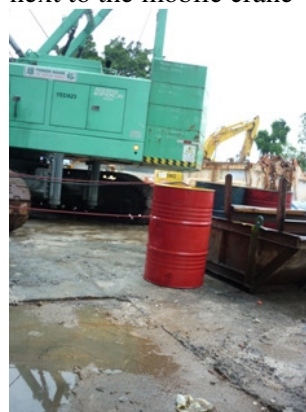
Photo 4 Some chemical barrels were found in PTW without drip tray next to the mobile crane

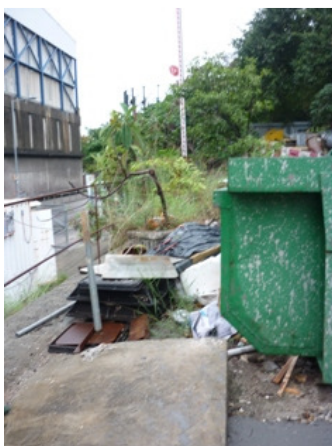
1. Some trashes were found near the rubbish skip in storage area since inspection on 13th November 2012. (photo 7)

Photos 7 Some trashes were found near the rubbish skip in storage area since last inspection

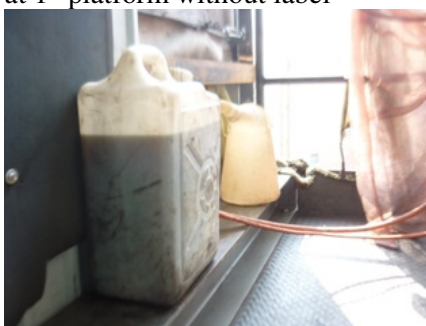
1. A chemical container was found near the generator at 1st platform without label. (Photos 9 and 10)

Photos 9 and 10 A chemical container was found near the generator at 1st platform without label

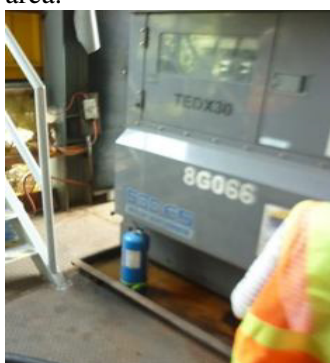
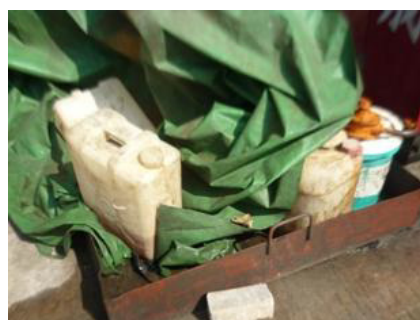
1. Waste oil was accumulated in drip tray of generator at 1st platform and drip tray of generator in storage area.(Photos 11 and 12)

Photos 11 and 12 Waste oil was accumulated in drip tray of generator at 1st platform and drip tray of generator in storage area.

1. The Contractor is reminded to remove the waste oil barrel near the Oxygen container in storage area
2. The Contractor is recommended to clear accumulated oil in drip tray of generator at 1st platform and drip tray of generator in storage area.

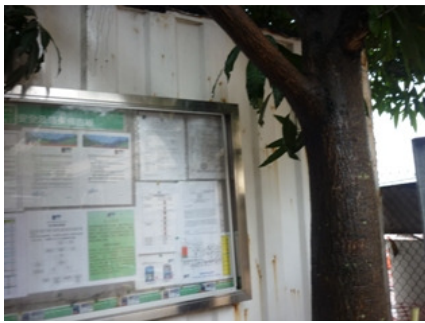
1. No valid EP was found on Notice Board. (Photo 1)

Photo 1 No valid EP was found on Notice Board

1. The Contractor is recommended to display valid EP.

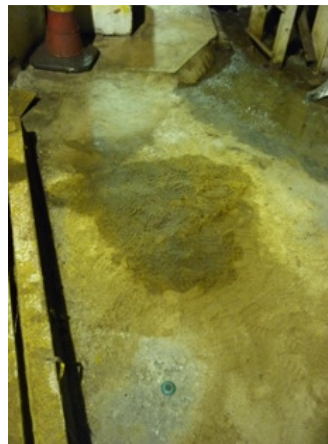
1. Some sand mix with oil was found in noise enclosure. (Photo 2)

Photo 2 Some sand mix with oil was found in noise enclosure

1. The Contractor is reminded to clear oil sand mixture as chemical waste.

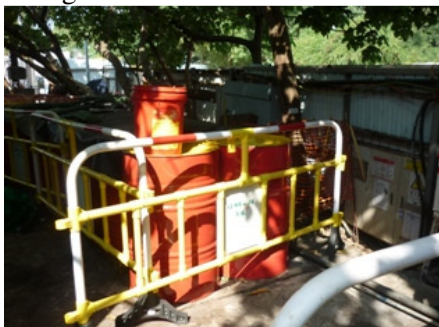
1. Some chemical barrels were found without drip tray next to chemical storage, Plants zone and near the site hoarding behind the chemical storage container. (Photos 1 to 4)

Photo 1 Some chemical barrels were found without drip tray next to chemical storage.

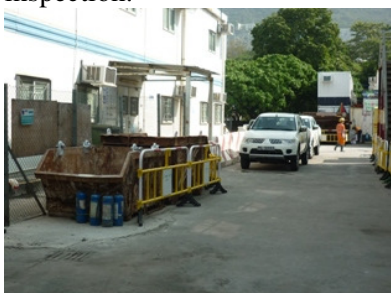
Photo 3 No oil stains was found during inspection.

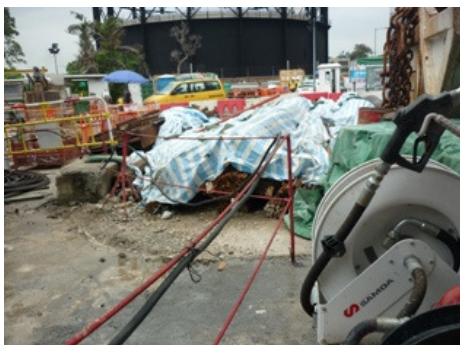
Photo _F 1 Chemical barrels without drip tray in PTW next to the mobile crane and near the entrance gate were removed.

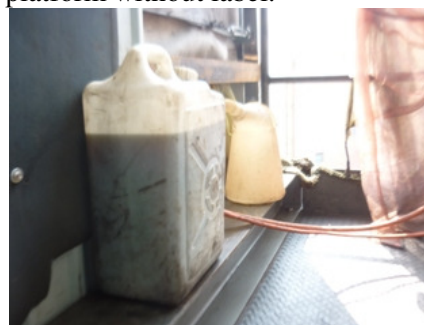
Photo 2 A chemical container was found near the generator at the first platform without label.

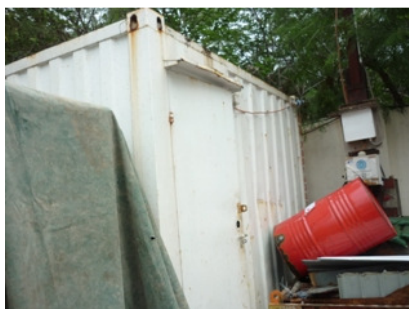
Photo 4 A waste oil barrel was found near the Oxygen Container in storage area since inspection on 13th November 2012.

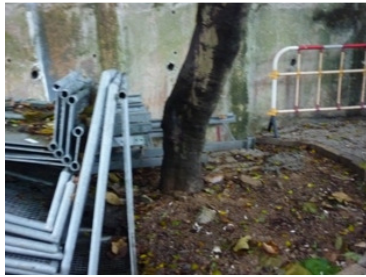
8. Construction materials were stored too close to the tree (T005 (T)) and tree (T84(R)) in storage area (Photo 8).

Photo 8 Construction materials were stored too close to the tree (T005 (T)) in storage area.

8. The Contractor was recommended to move the construction materials away from the tree (T005 (T)) and tree (T84(R)) in storage area and provide the tree protection fence.

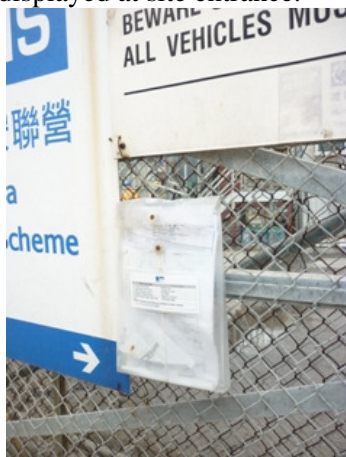
Photo_F 1 A valid EP (EP-322/2008/F) was displayed at site entrance.

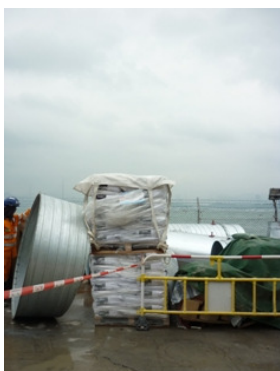
Photo_F 3 Dusty material was covered properly.

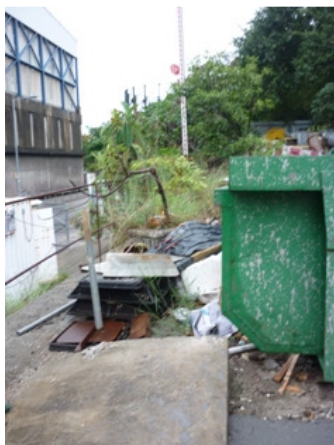
5. Some trashes were found near the rubbish skip in storage area since the site inspection undertaken on 13th November 2012. (photo 5)

Photo 5 Some trashes were found near the rubbish skip in storage area since the site inspection undertaken on 13th November 2012.

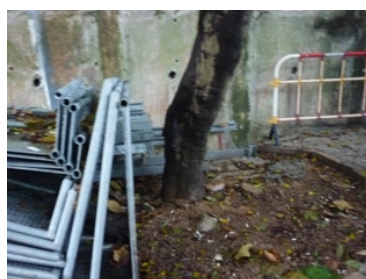
Photo 7 Construction materials were stored too close to the tree (T005 (T)) and tree (T84(R)) in storage area

7. The Contractor was recommended to move the construction materials away from the tree (T005 (T)) and tree (T84(R)) in storage area and provide the tree protection fence.

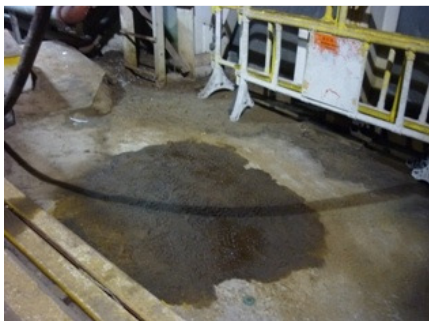
3. Some sand mix with oil was found inside noise enclosure. (Photo 3)

Photo 3 Some sand mix with oil was found inside noise enclosure

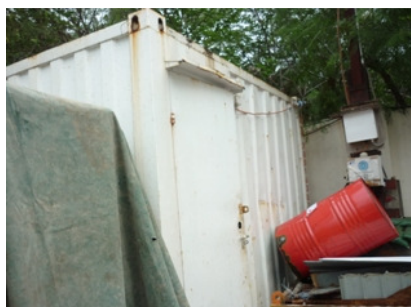
1. An unknown chemical drum was found in container next to entrance gate. (Photo 1)
2. The chemical storage was found without chemical storage list since the site inspection undertaken on 30th October 2012. (Photo 2)

Photo 1 An unknown chemical drum was found in container next to entrance gate.

1. The Contractor was recommended to display chemical storage list of the chemical storage.
2. The Contractor was reminded to provide labels to chemical drums next to entrance gate.

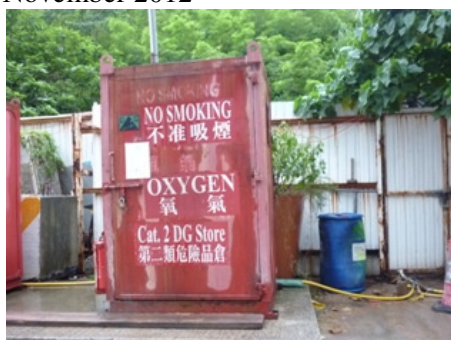
3. A waste oil barrel was found near the Oxygen Container in storage area since the site inspection undertaken on 13th November 2012. (Photo 3)

Photo 3 A waste oil barrel was found near the Oxygen Container in storage area since the site inspection undertaken on 13th November 2012

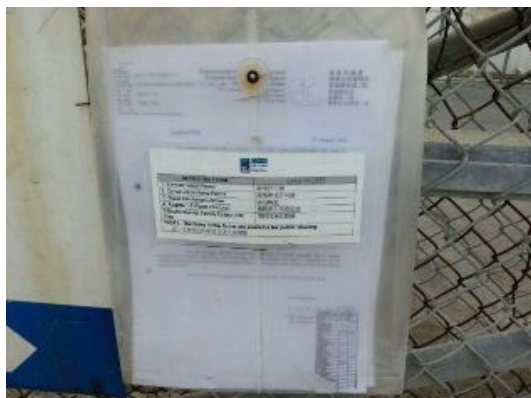
Photo_F 1 A valid CNP (GW-RS091412) was displayed at site entrance.

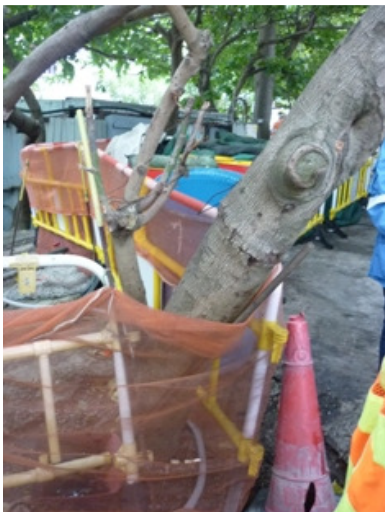
Photo_ The water plastic pipe had been removed
F 1

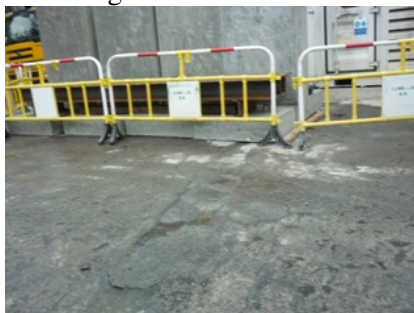
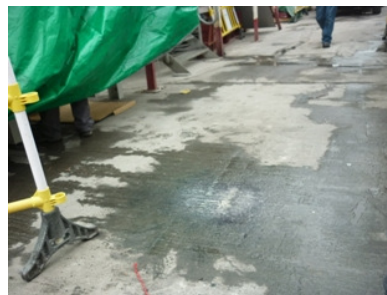
3. Some oil stains and unknown chemical stains were found near the noise enclosure and entrance gate.(Photo 3)

Photo 3 Some oil stains and unknown chemical stains were found near the noise enclosure and entrance gate

3. The Contractor is reminded to clear oil and unknown chemical stains and treat as chemical waste.

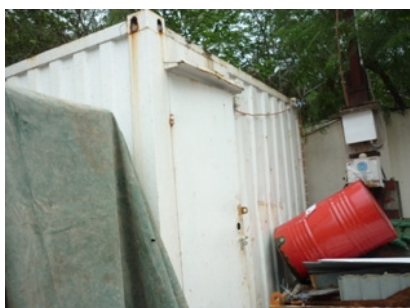
1. An unknown chemical drum was found in container next to entrance gate. (Photo 1)
2. The chemical storage was found without chemical storage list since the site inspection undertaken on 30th October 2012. (Photo 2)
8. An unknown chemical drum was found near the tree T005(T).(Photo 3)

Photo 1 An unknown chemical drum was found in
container next to entrance gate.

1. The Contractor was reminded to provide labels to chemical drums next to entrance gate.
2. The Contractor was recommended to display chemical storage list of the chemical storage.
3. The Contractor is reminded to provide drip tray and suitable label to chemical drum near the tree T005 (T).

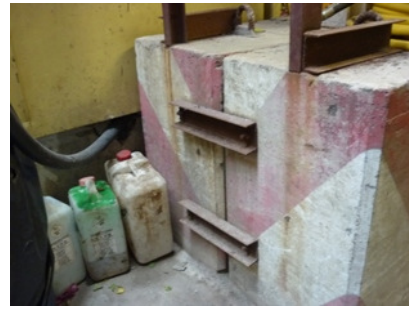
1. A chemical drum was found without chemical label and drip tray since the site inspection undertaken on 4 December 2012. and some unknown chemicals were found next to noise enclosure (Photo 1).

Some unknown chemicals were found next to noise enclosure

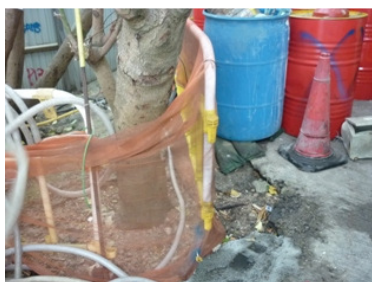
Photo_ F 1 The water plastic pipe had been removed

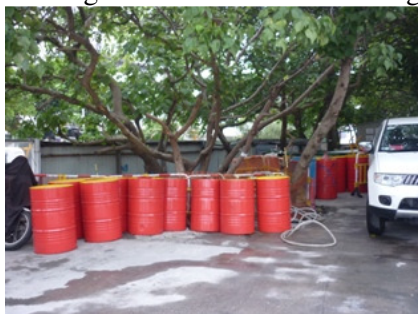
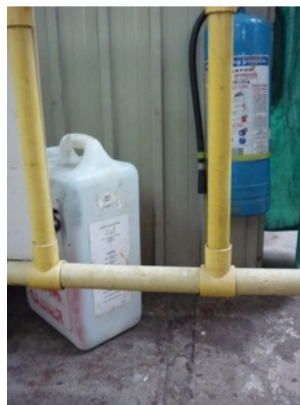
Photo 1 Some chemical barrels were found without drip tray next to chemical storage area and near the site hoarding behind the chemical storage container.

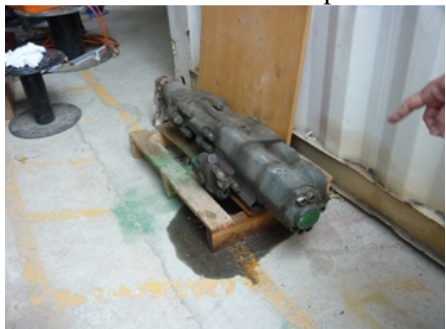
Photo 2 Oil stain was found near the plant zone

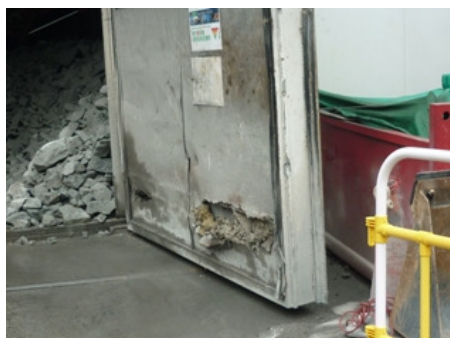
3. The enclosure door was damaged.(Photo 3)

Photo 3 The enclosure door was damaged.

3. The Contractor is recommended to fix the enclosure door.
