**Shatin to Central Link –  
Tai Wai to Hung Hom Section**

Conservation Plan  
for the Old Pillbox  
at the former Tai Hom Village site

# Shatin to Central Link Consultancy Agreement No. C1103 Detailed Design for Diamond Hill Station and Stabling Sidings

Further Structural Survey for the Old Pillbox

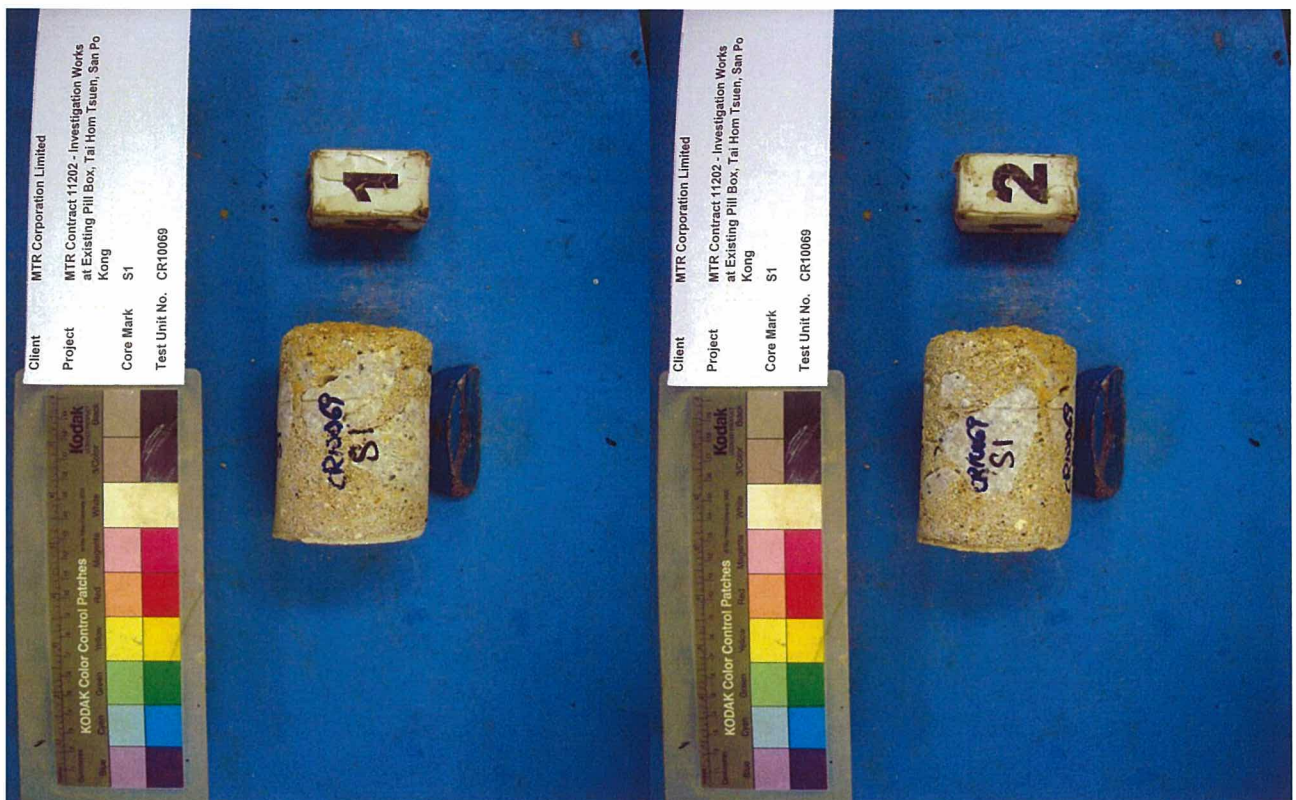
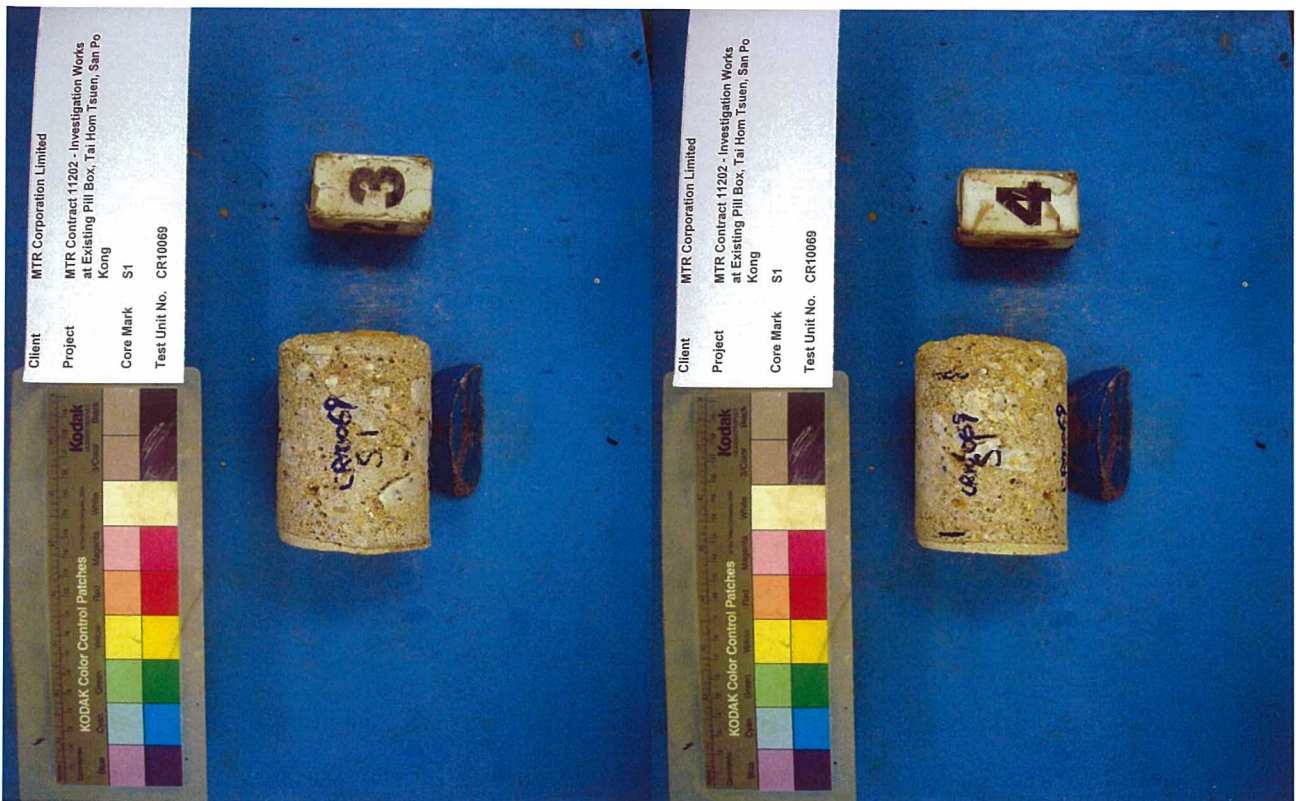
Sample Lab. Ref. No. : COR10080036

Presence of Cracks	: NIL	Distribution of Materials	: UNEVEN	General Type	: GRANITE
Maximum Size	: 40mm	Particle Shape	: ANGULAR		
Compaction of Concrete	-	Small Voids	Medium Voids	Large Voids	
Extent of Voids	-	CONSIDERABLE	N/A	N/A

Maximum Load at Failure	: 63.4 kN	Measured Compressive Strength	: 14.0 N/mm <sup>2</sup>
Estimated In-Situ Cube Strength	: 13.5 N/mm <sup>2</sup>	Type of Fracture	: NORMAL

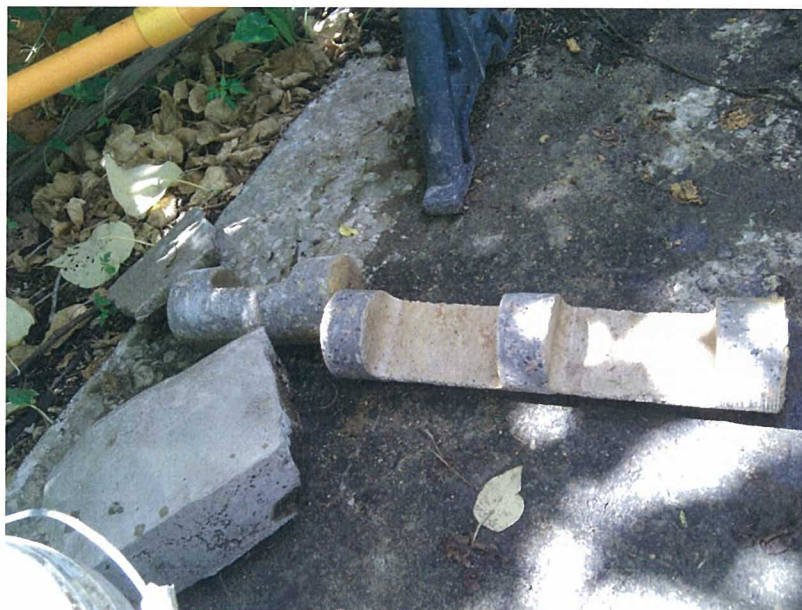
Date drilled : 15 July 2010  
Core location : Trial Pit (TP154) – Wing Wall  
Drill length : 665 mm

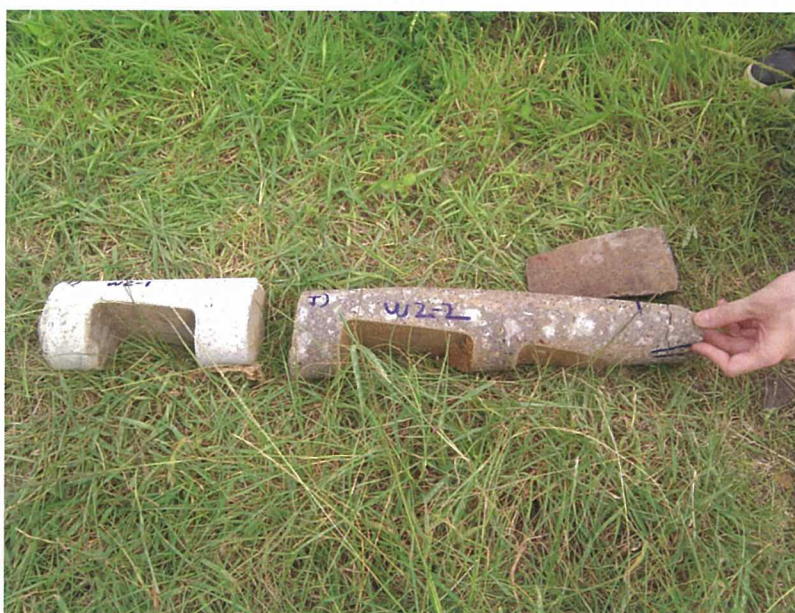
Date drilled : 15 July 2010  
Core location : Wall of pillbox just above existing ground level of trial pit, TP156  
Drill length : 665 mm

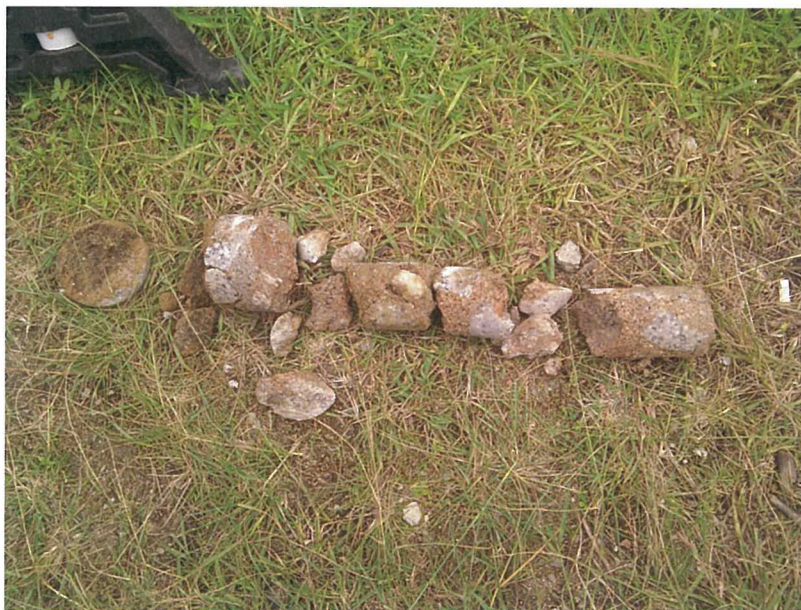
Date drilled : 20 July 2010  
Core location : Roof dome, R1  
Drill length : 515 mm with top 15mm screed

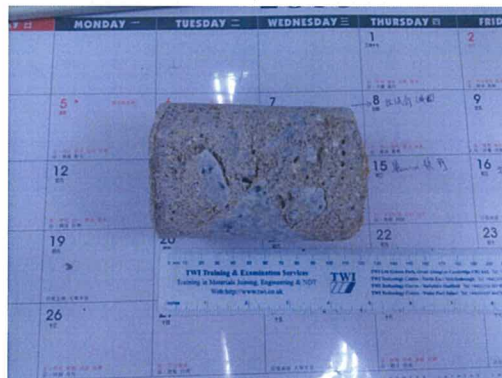
Thickness of slab is 120mm

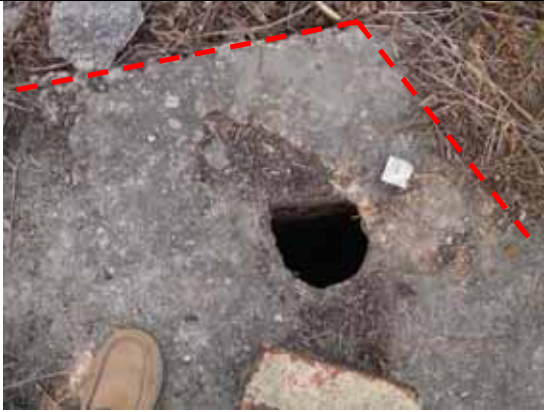
<p>(Covered) underground chamber</p>

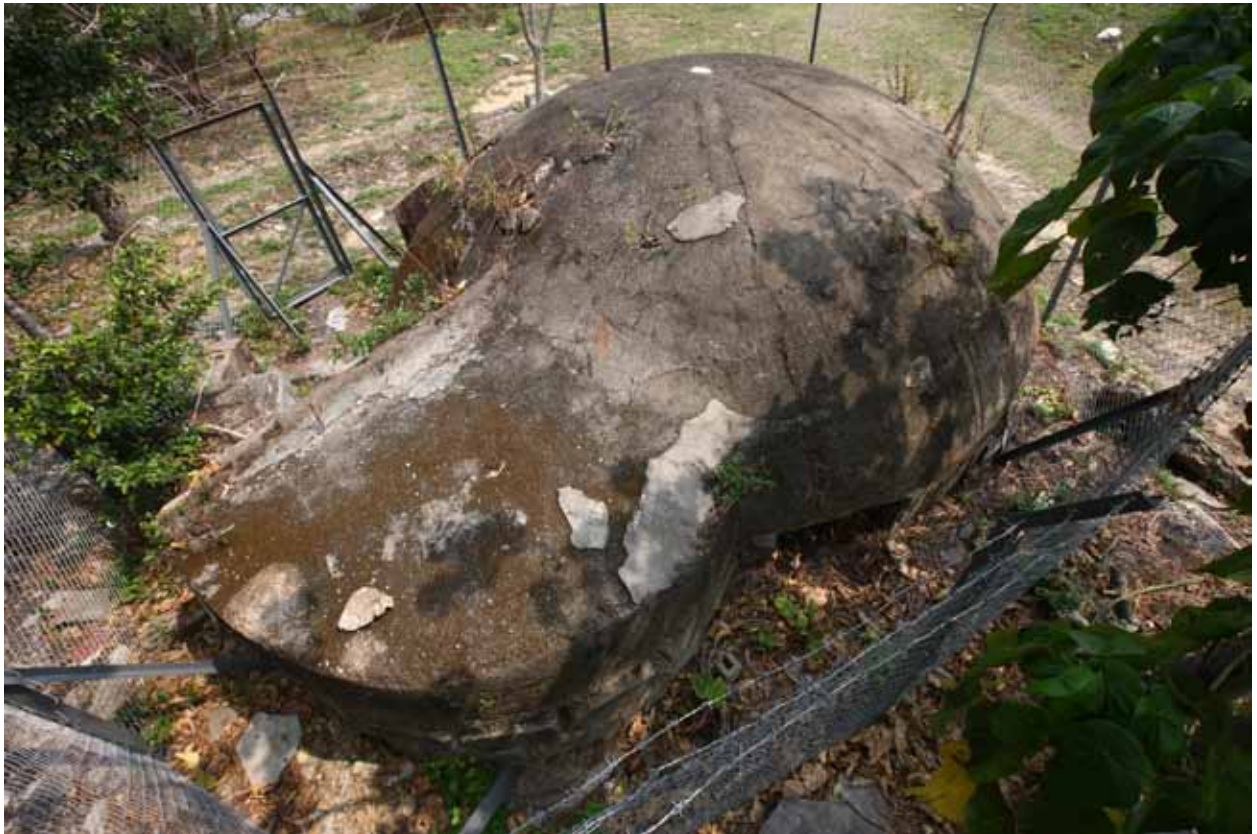
Photo # 1

View of pillbox roof.

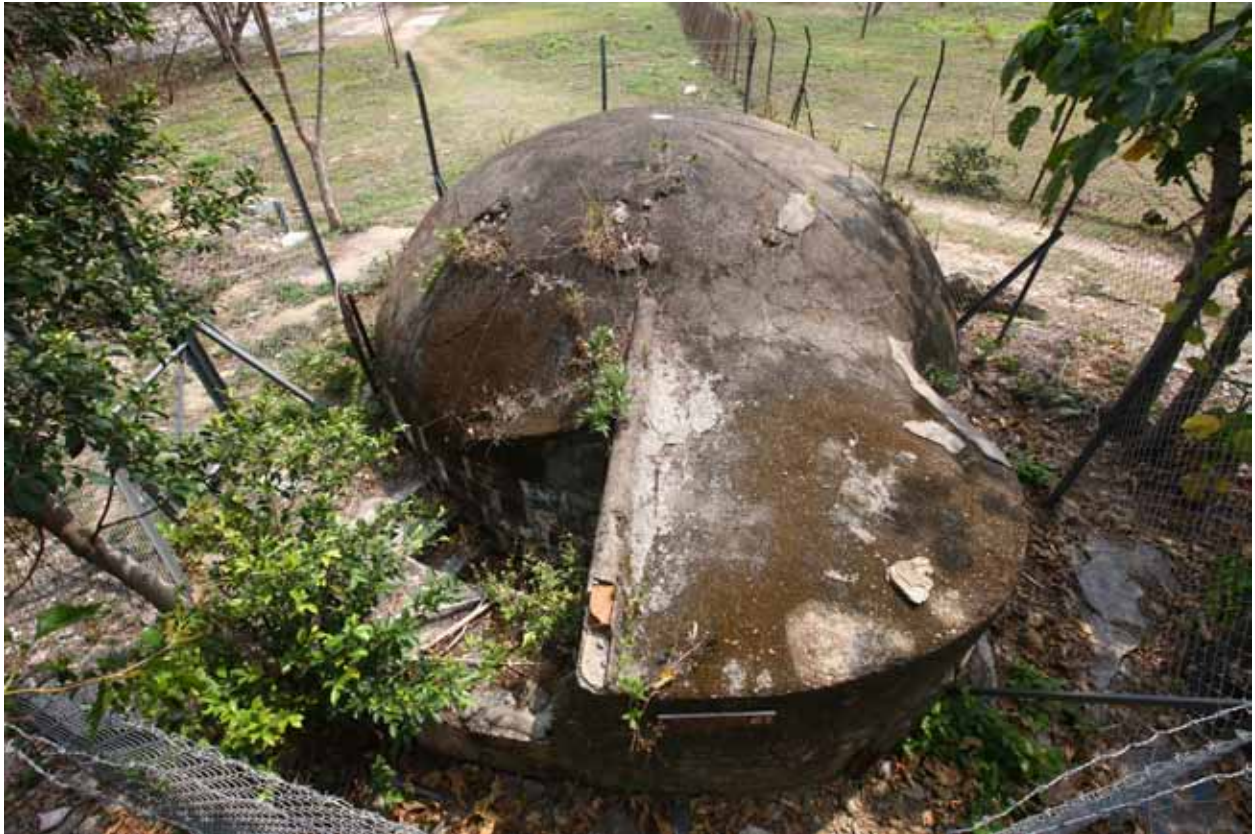
Photo # 2

View of pillbox roof.

2. The entrance roof (photo 2) is greatly distorted. Please submit a replacement photo taken at a higher level when available.	All photos were taken via standard camera lens as stated in Section 3.1 of the report. Photo no. 2 was taken at a front view of the Pillbox with an appropriate manner and reasonable skill. Distance factor should be taken into account for interpretation of the photo.

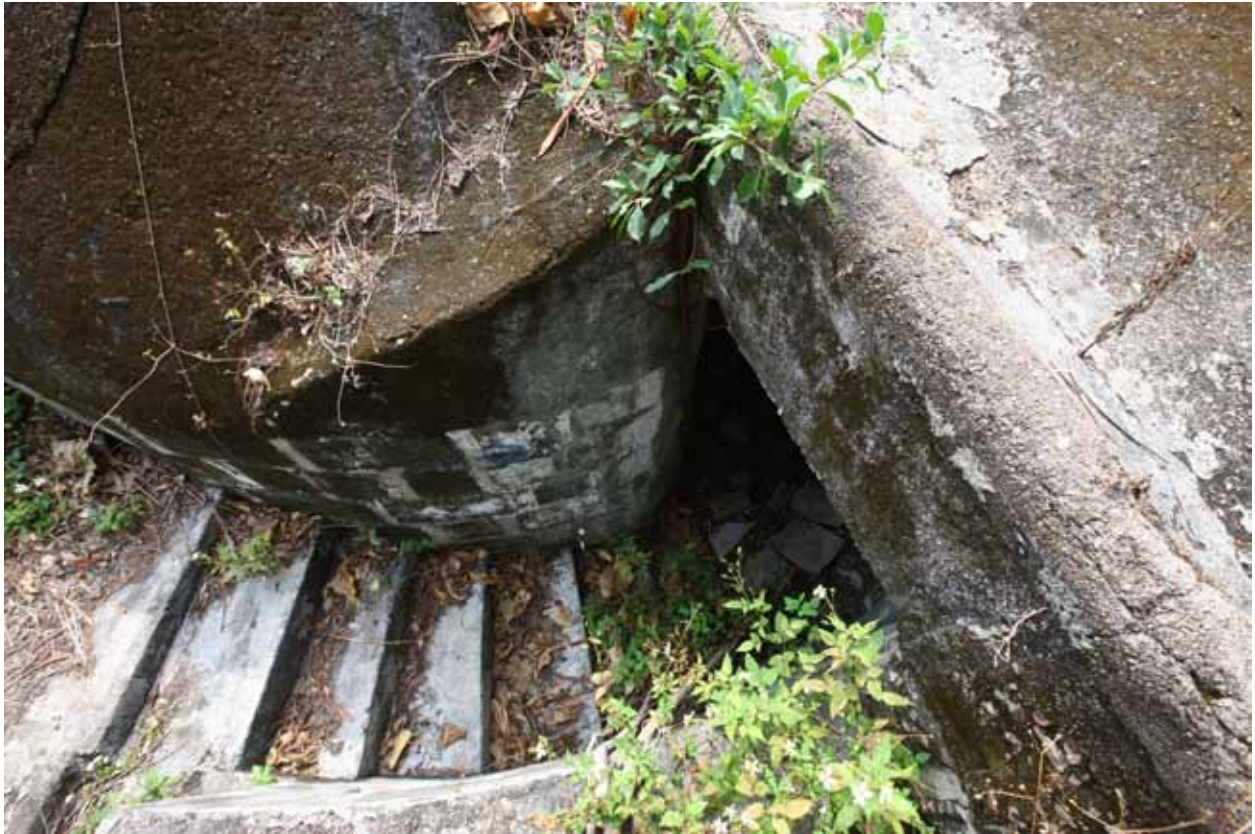
Photo # 3

Elevated view of pillbox entrance.

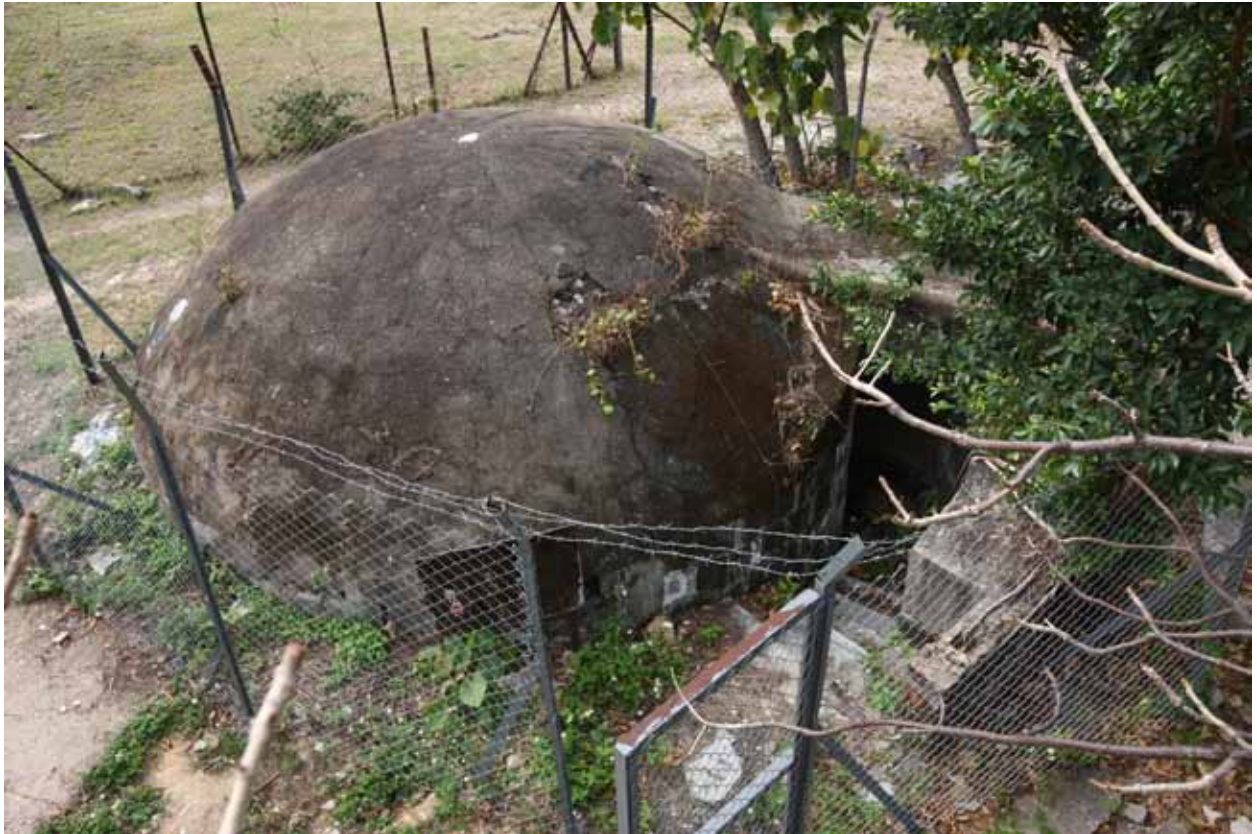
Photo # 4

Elevated view of pillbox.

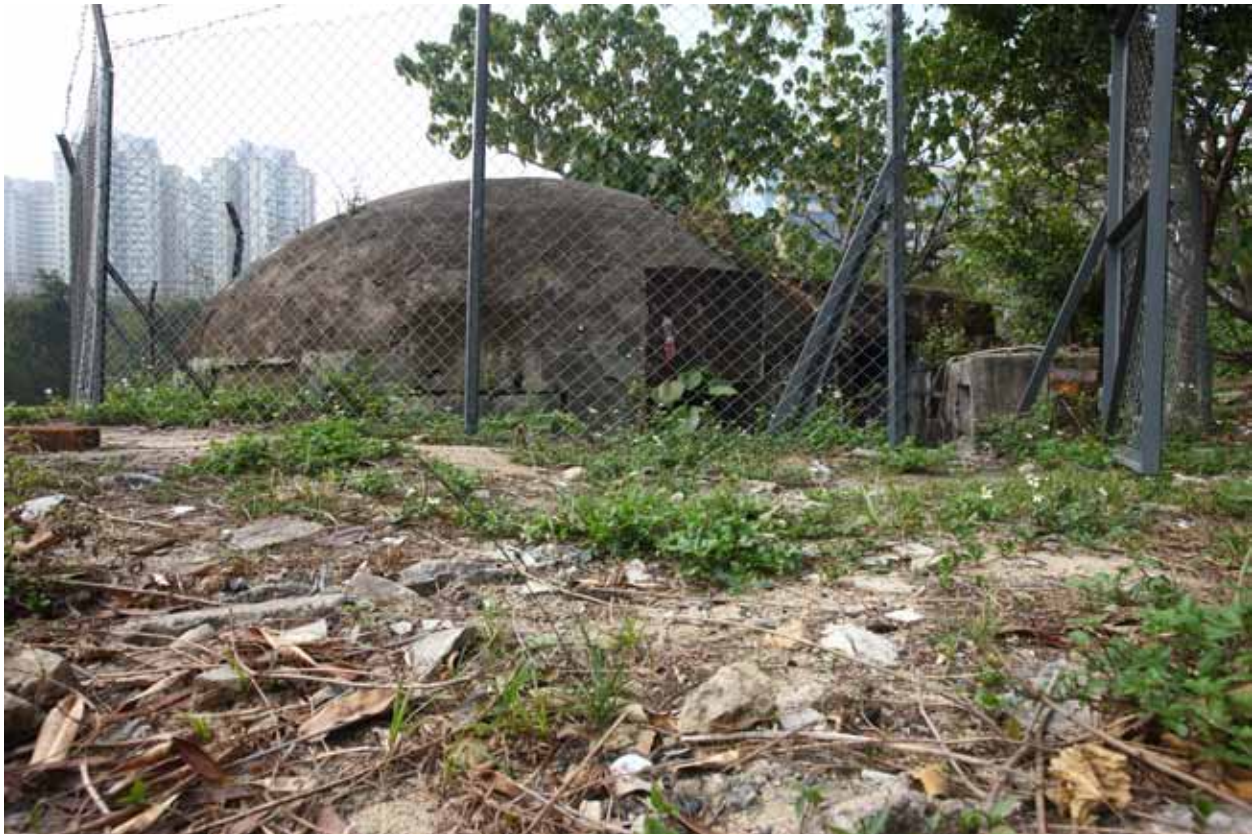
Photo # 5

Elevation of the pillbox.

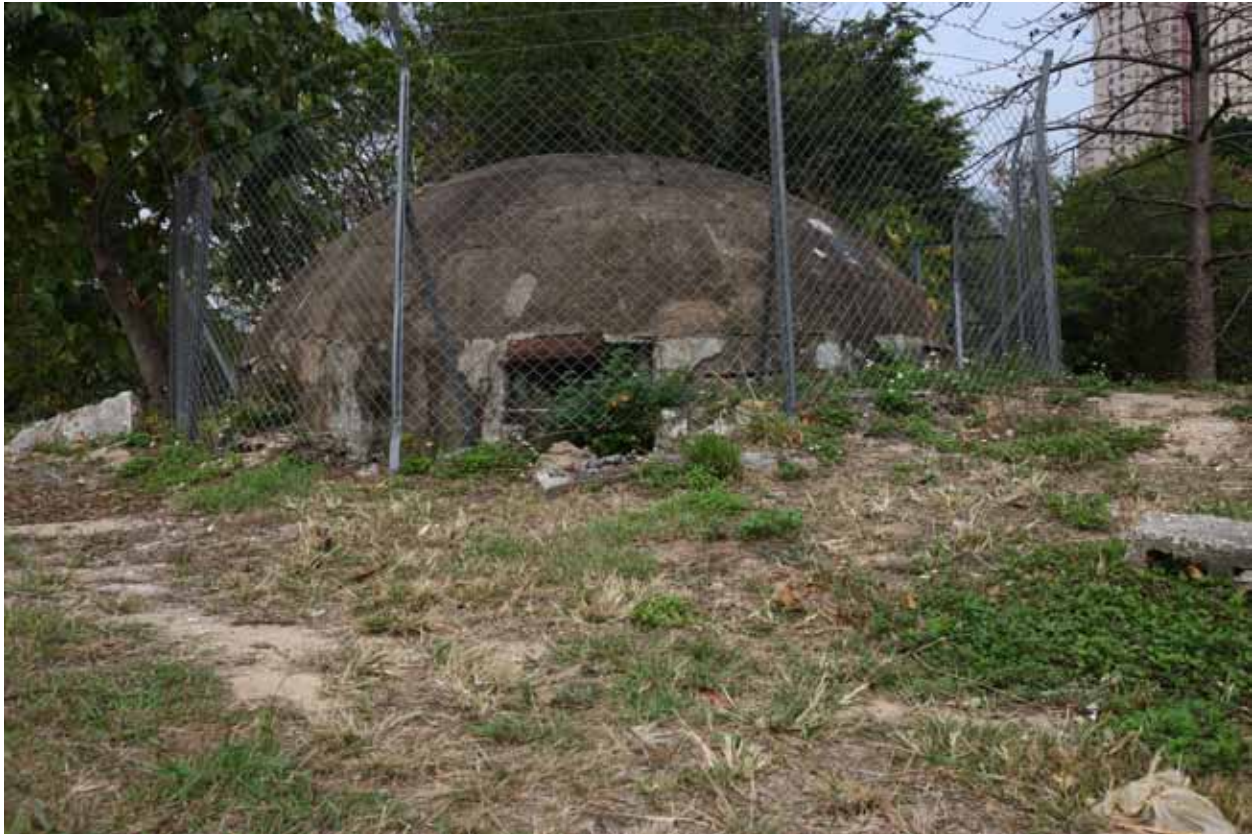
Photo # 6

Elevation of the pillbox. An above ground embrasure is seen.

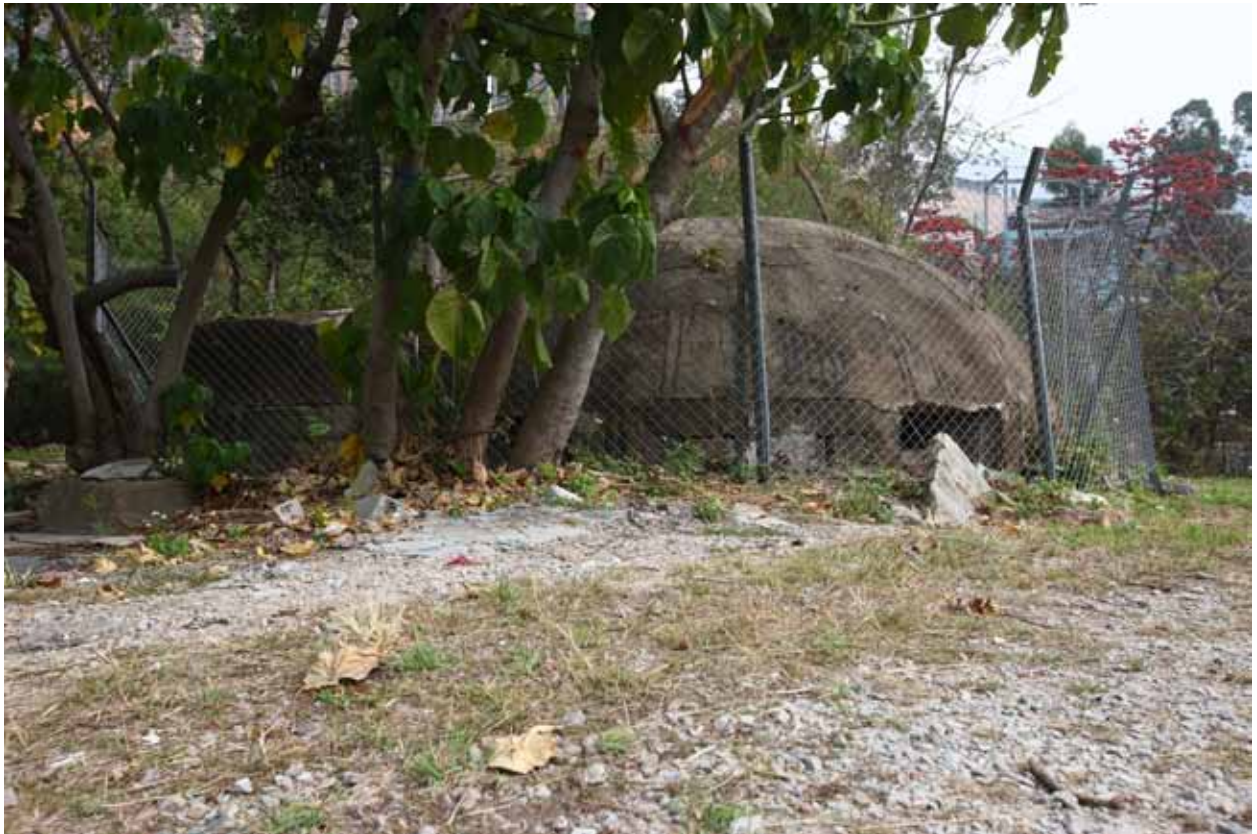
Photo # 7

Elevation of the pillbox.

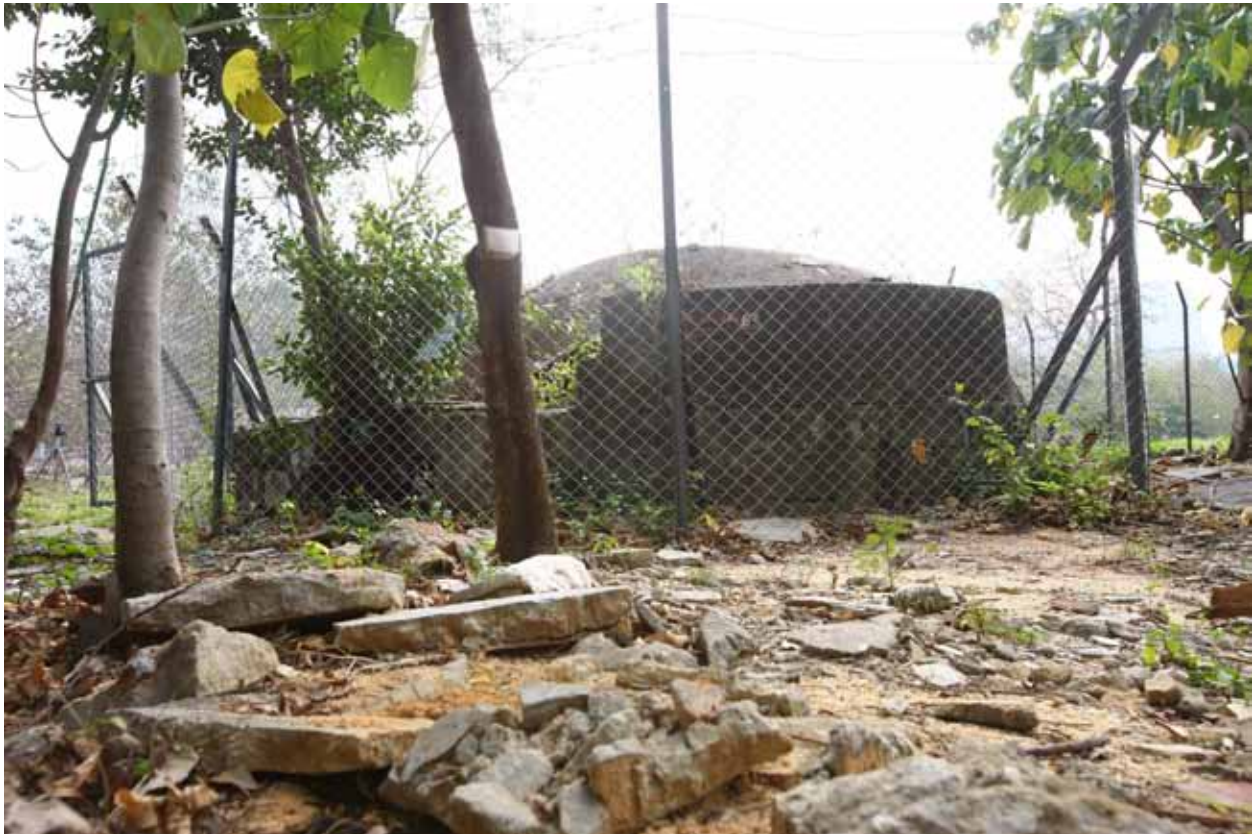
Photo # 8

Elevation of the pillbox.

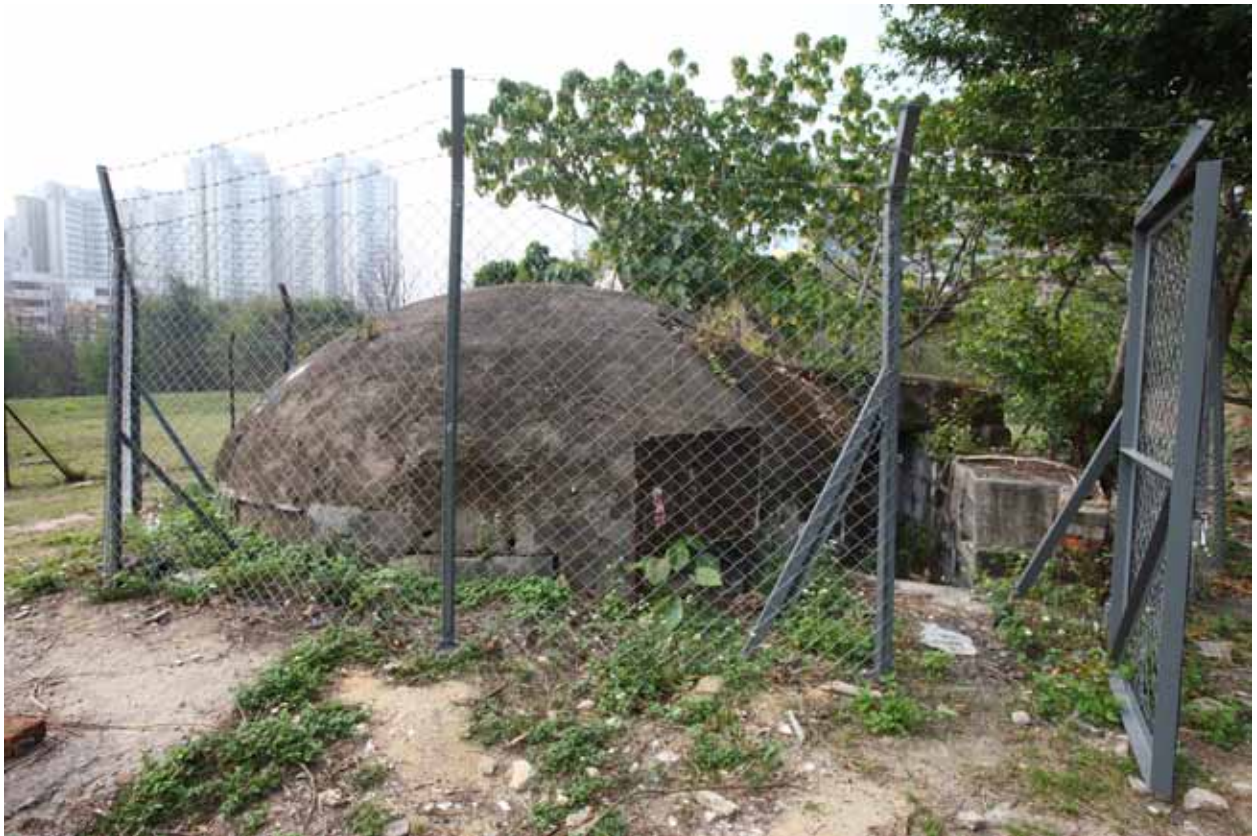
Photo # 9

Elevation of the pillbox.

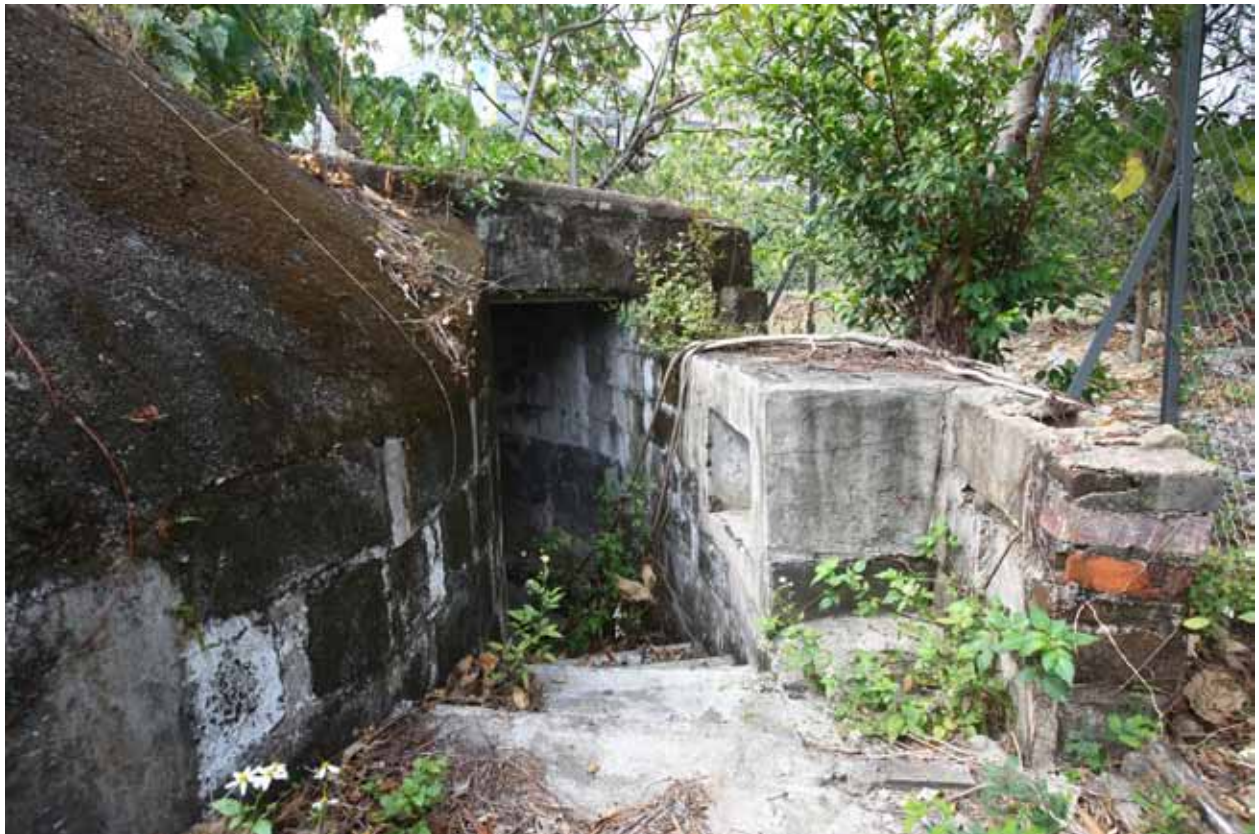
Photo # 10

View of the entrance. A spiral staircase leads to the semi-underground pillbox.

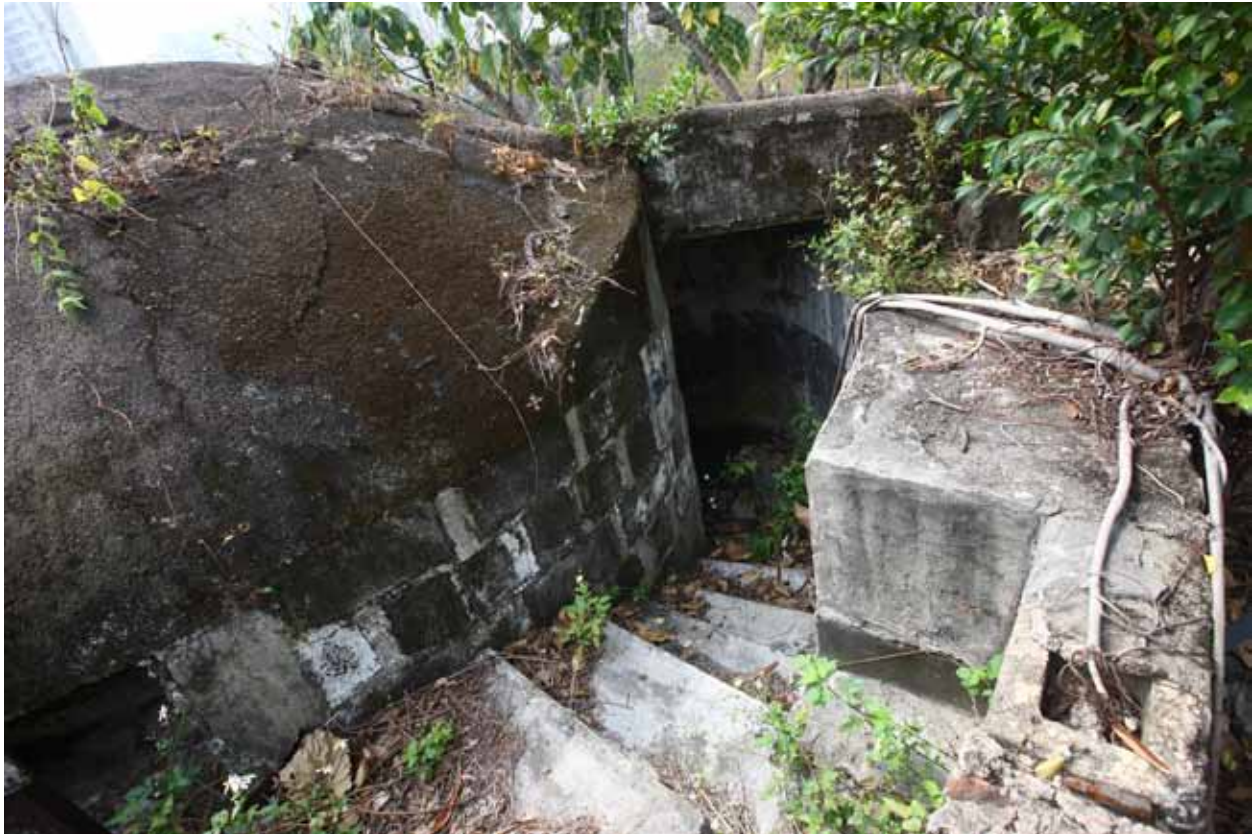
Photo # 11

View of the entrance.

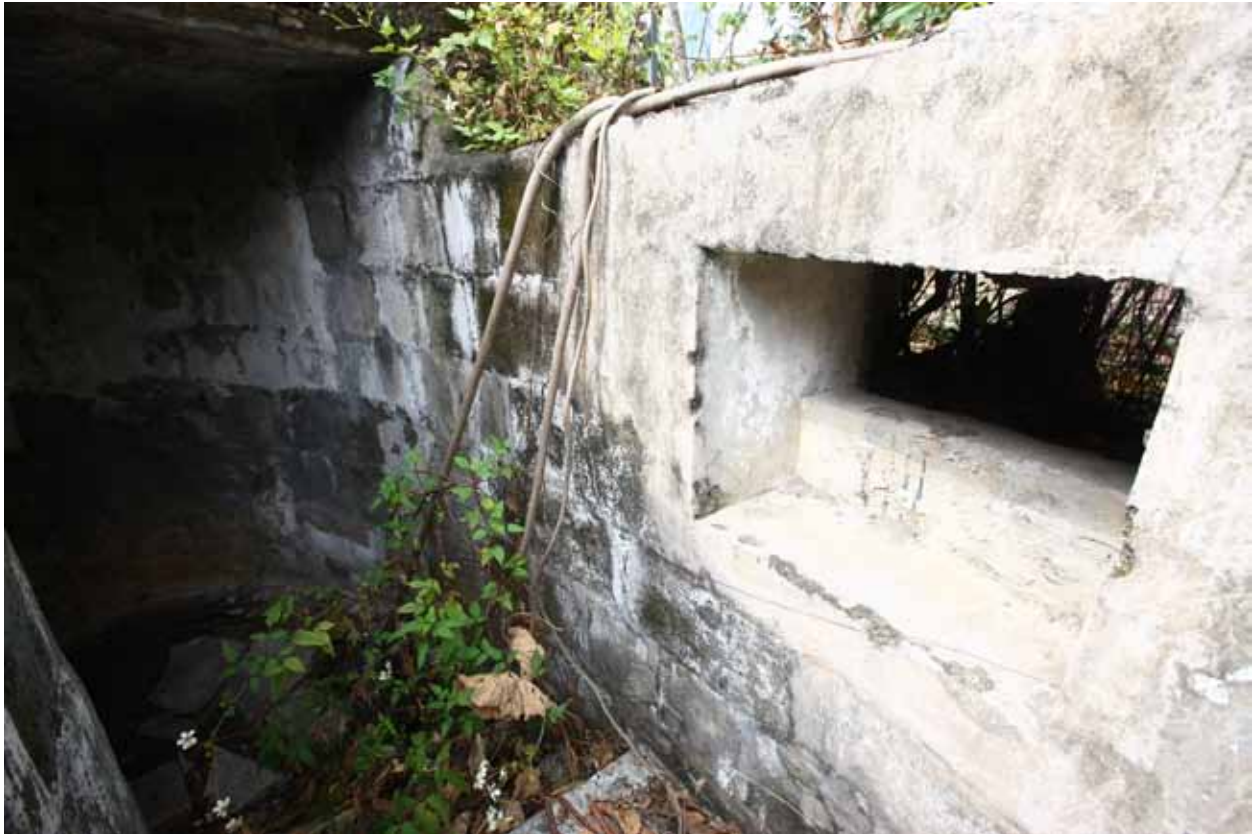
Photo # 12

View of the loopholed blast wall with narrow mounting.

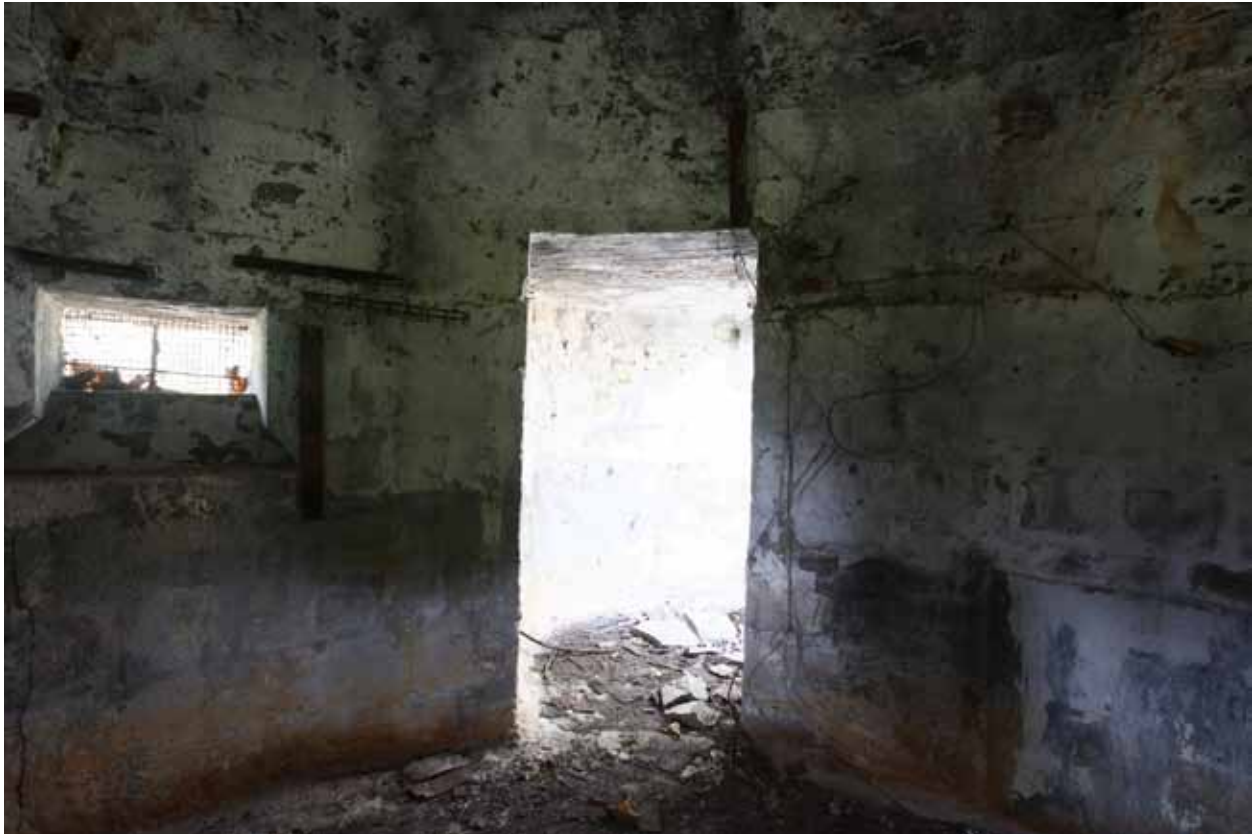
Photo # 13

An inside view of the entrance.

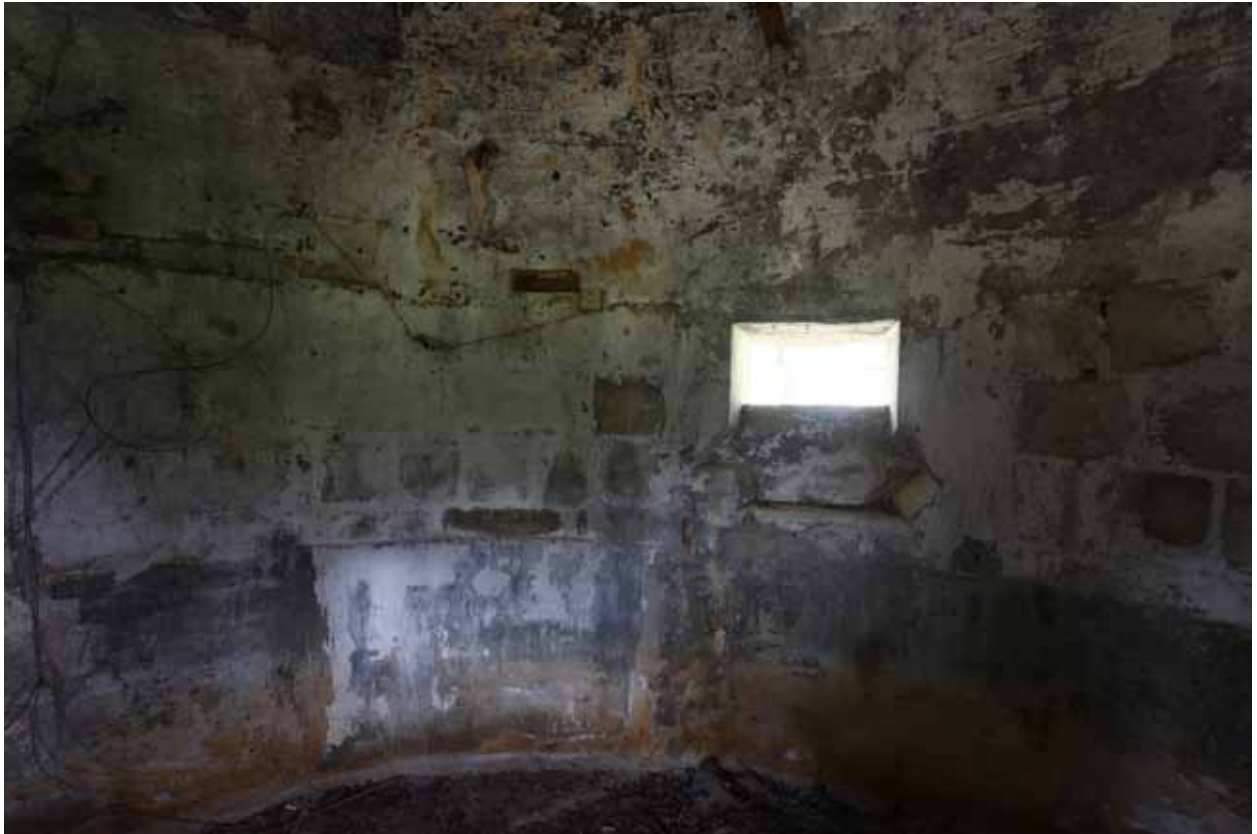
Photo # 14

View of the embrasure.

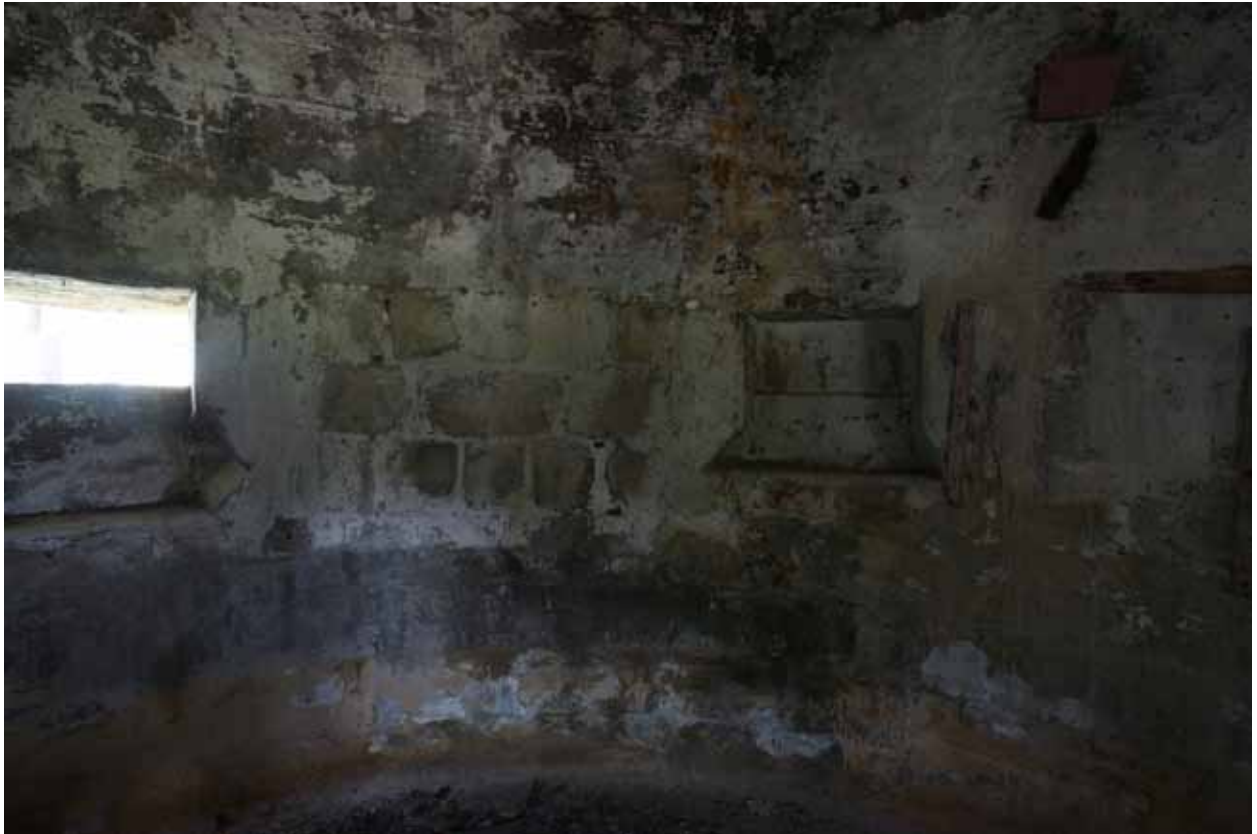
Photo # 15

View of the embrasure.

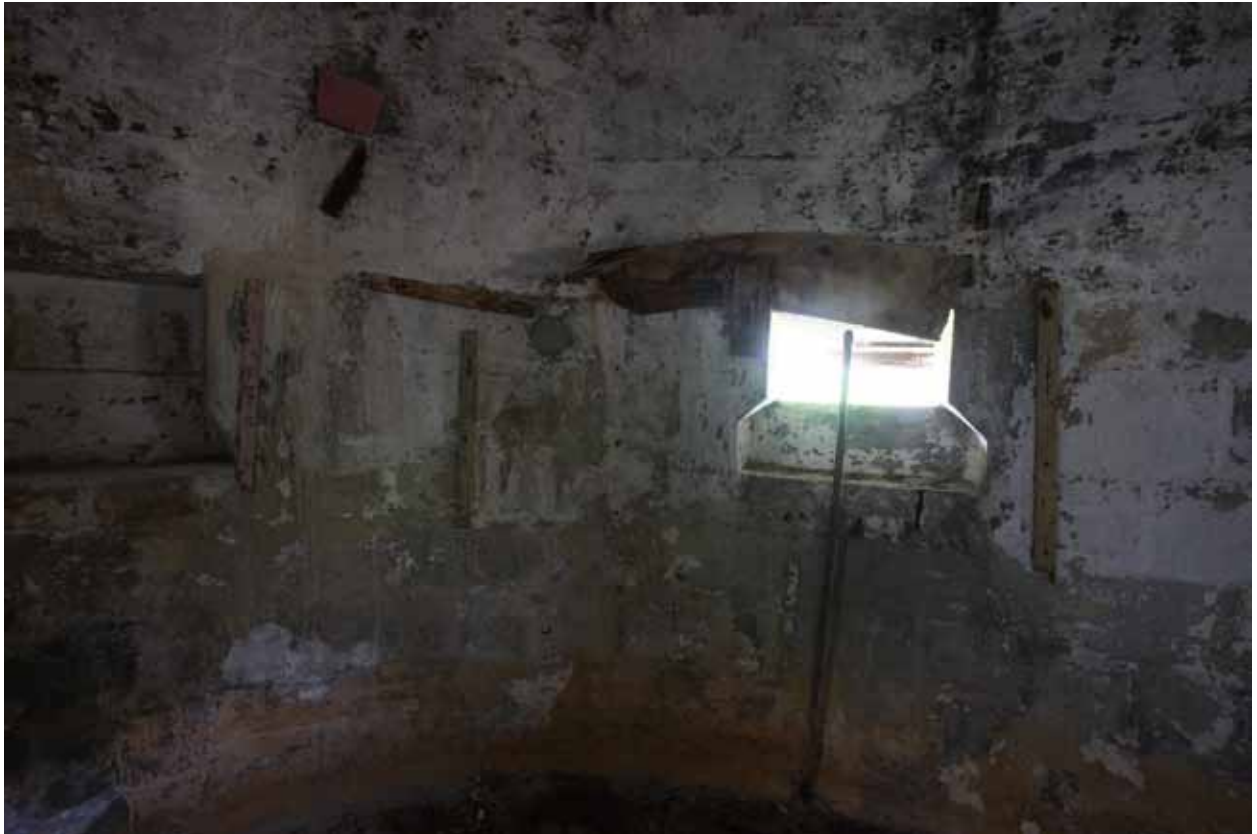
Photo # 16

View of the embrasure.

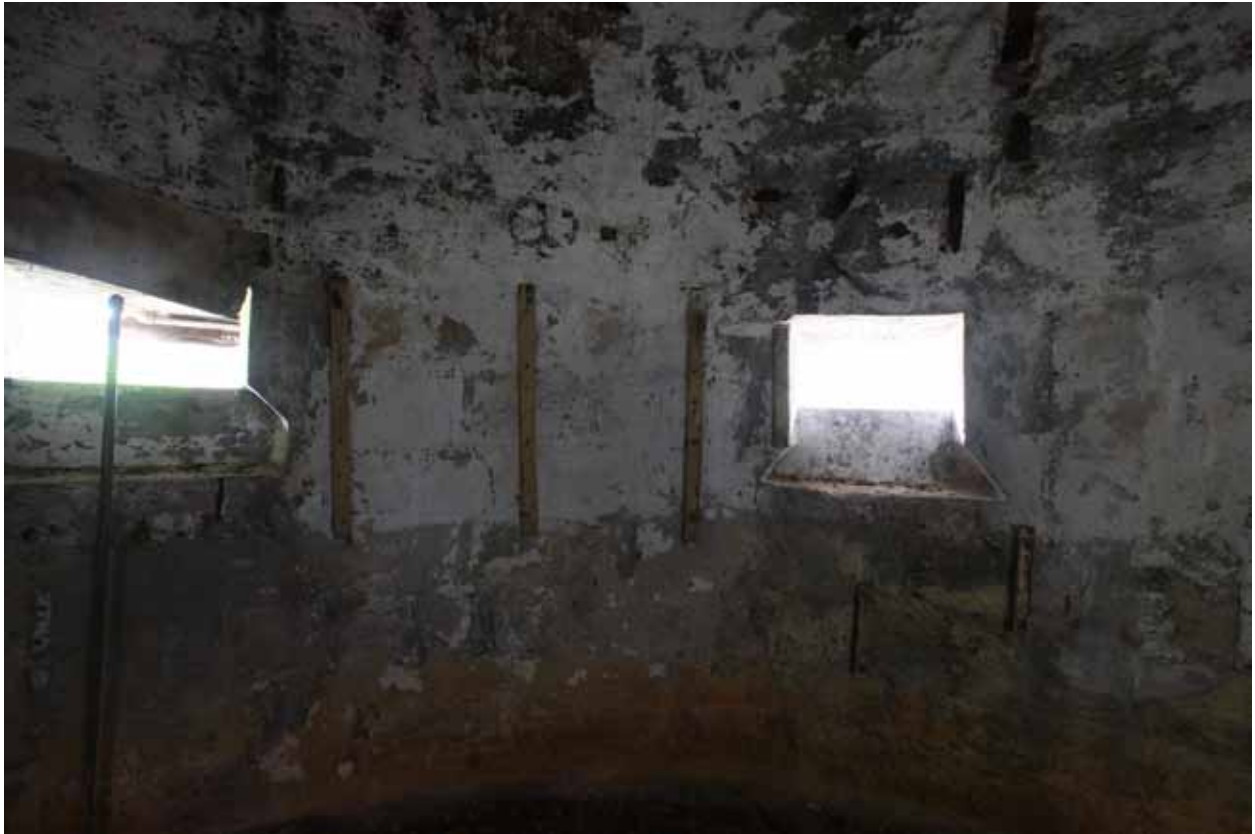
Photo # 17

View of the embrasure.
