**Shatin to Central Link –  
Tai Wai to Hung Hom Section**

Conservation Plan  
for the Old Pillbox  
at the former Tai Hom Village site

# Shatin to Central Link Consultancy Agreement No. C1103 Detailed Design for Diamond Hill Station and Stabling Sidings

Further Structural Survey for the Old Pillbox

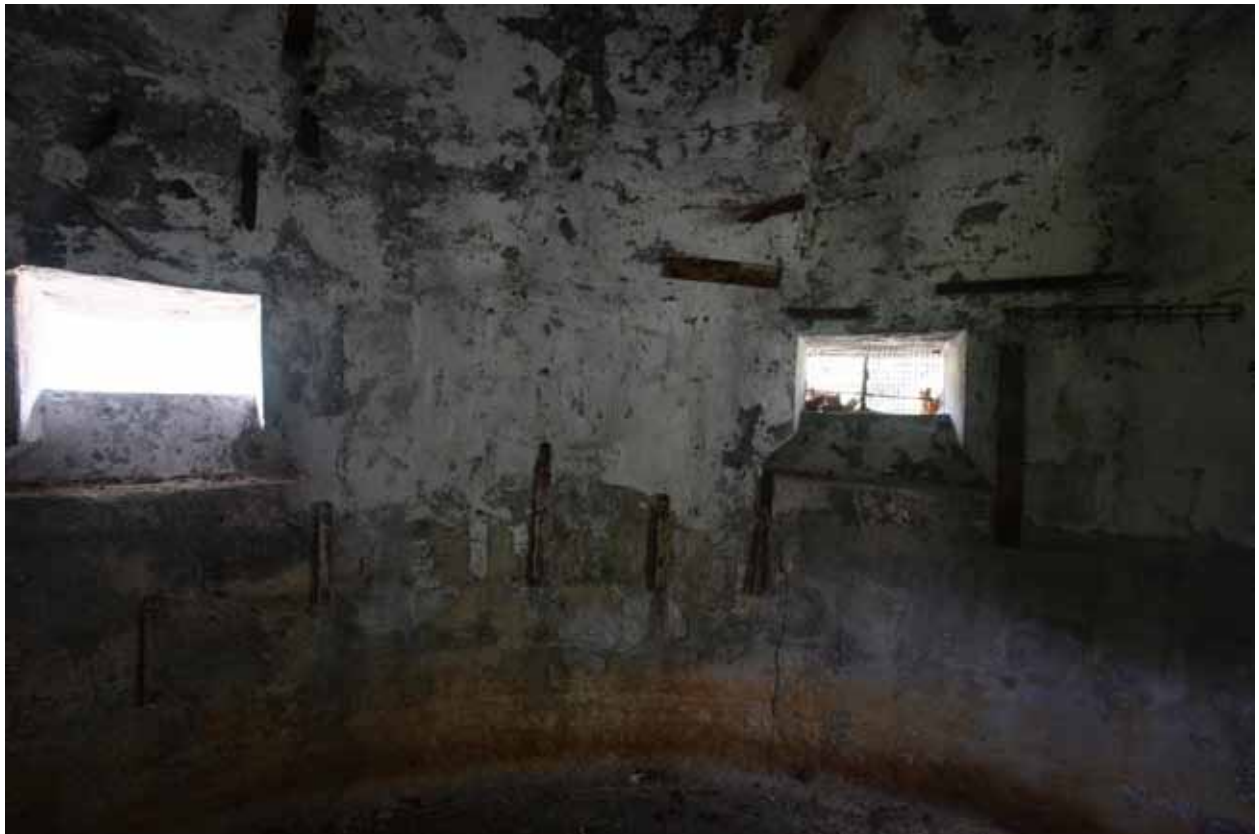
Photo # 18

View of the embrasure.

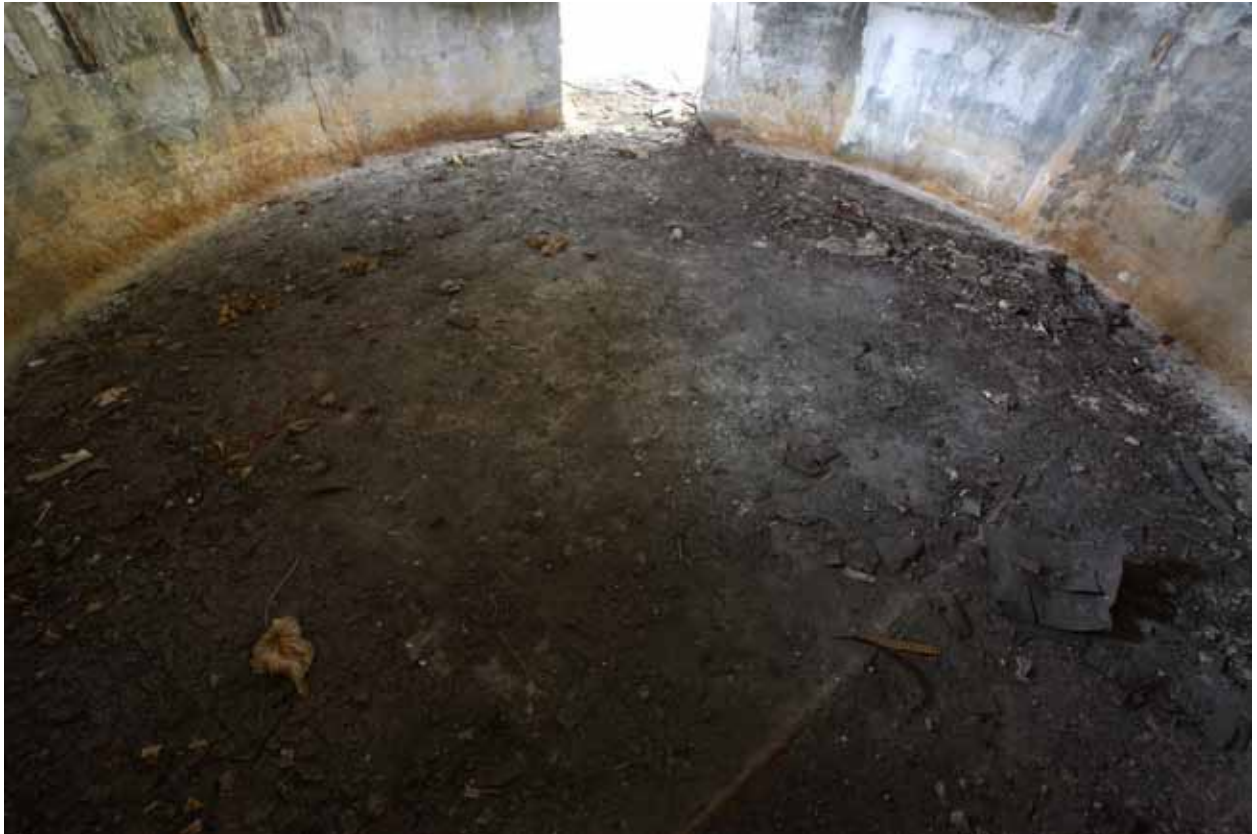
Photo # 19

The floor of the pillbox.

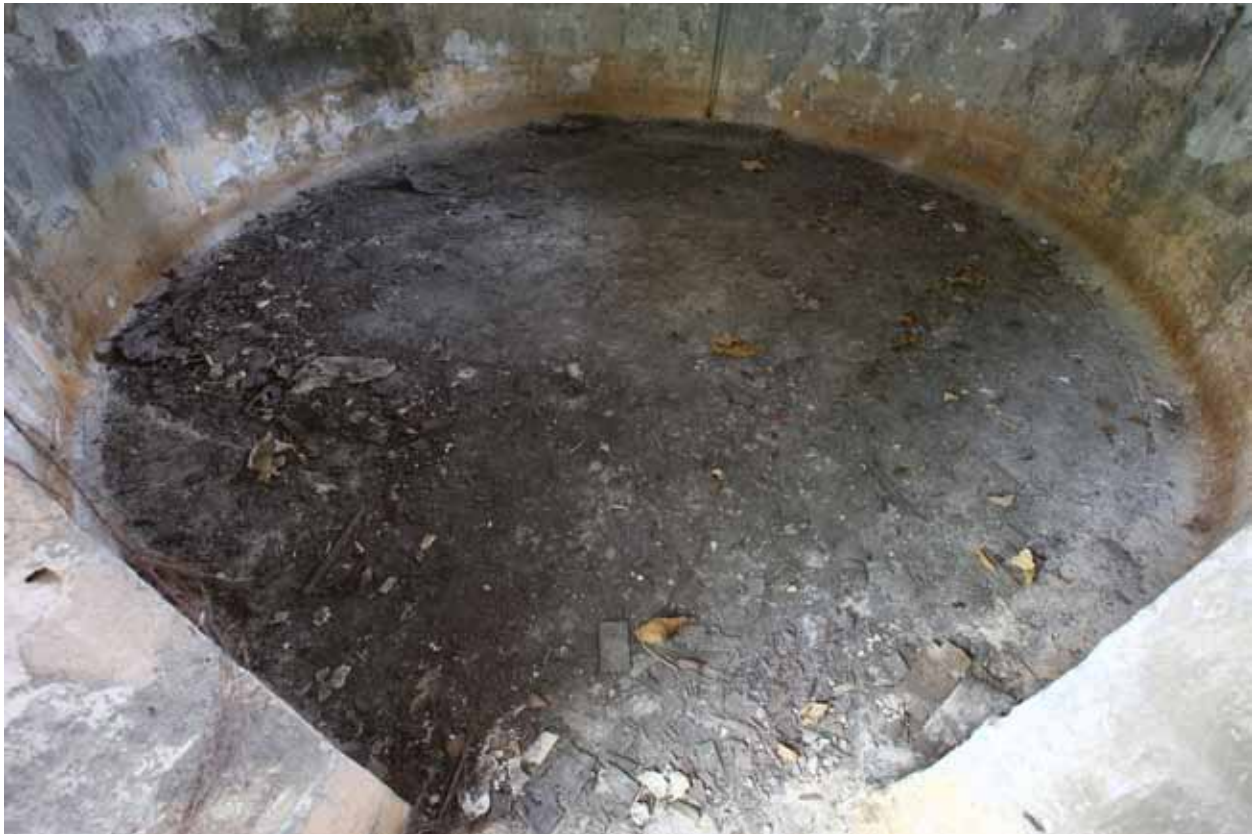
Photo # 20

The floor of the pillbox.

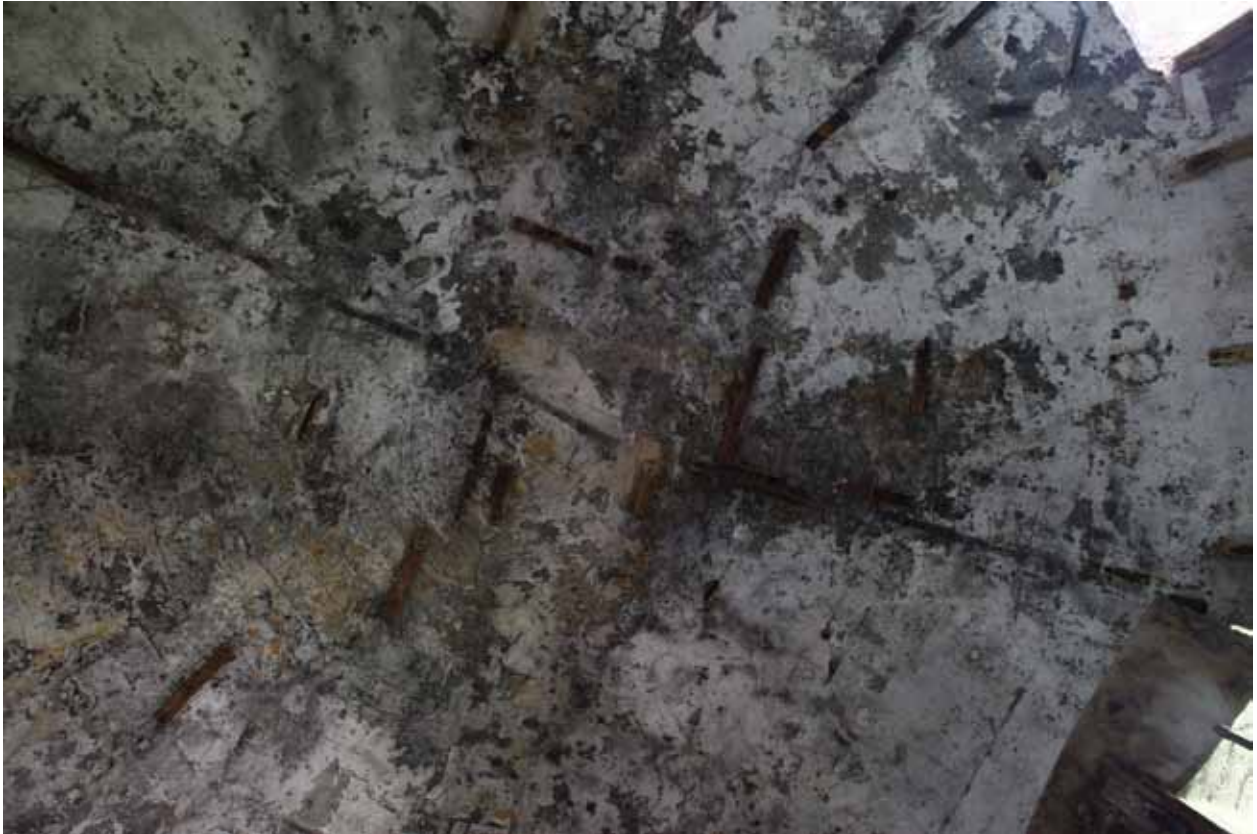
Photo # 21

The ceiling of the pillbox. Exposed steel bars can be seen.

3. Please check if statements in Section 3.3 have been repeated. Please also explain the reason for no provision of photo for the overview of the ceiling of the Pillbox in Section 3.3.	Noted. The repeated statement due to typo was deleted.  For interior, full overview of the ceiling is not available because of the low ceiling height that limits the view angle. The best practicable photos have been provided in Photo nos. 21 and 22. Such limitations are also stated in Section 3.3 of the report.

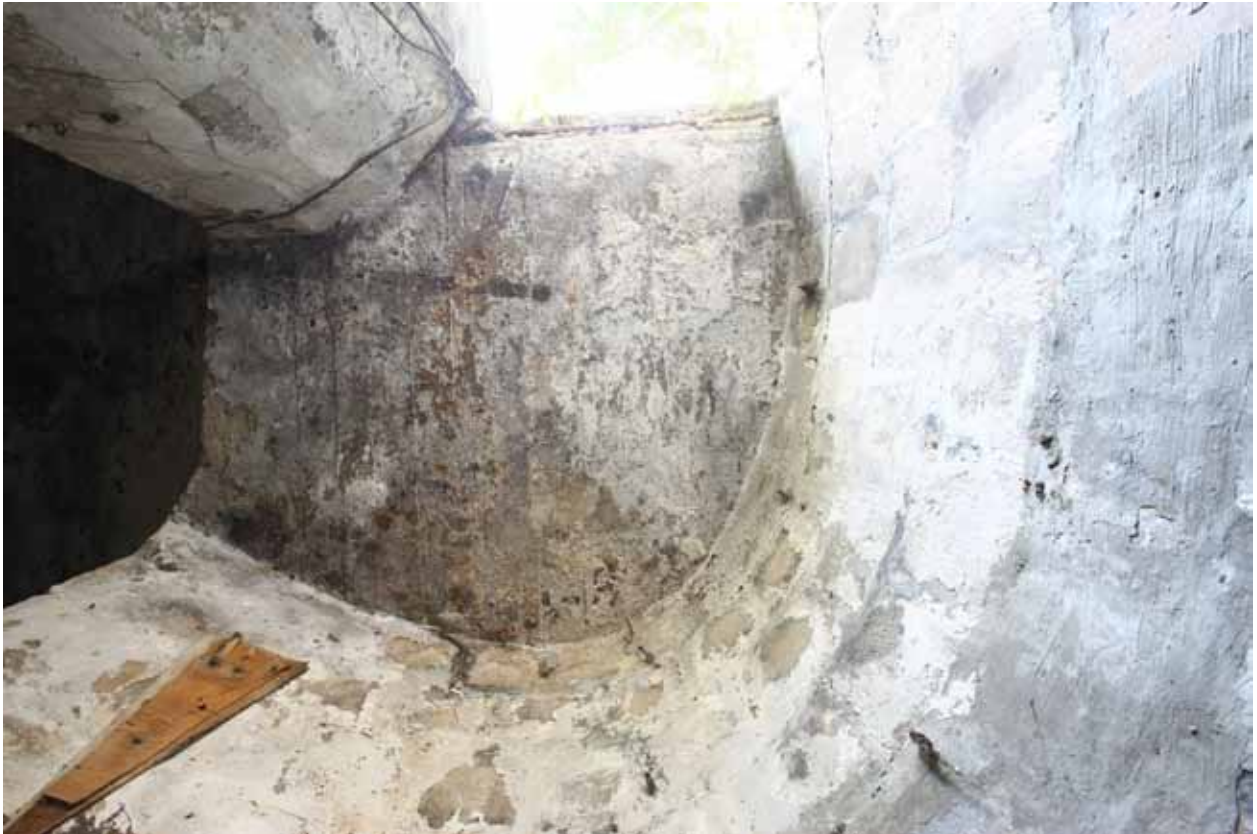
Photo # 22

The ceiling at the pillbox entrance.

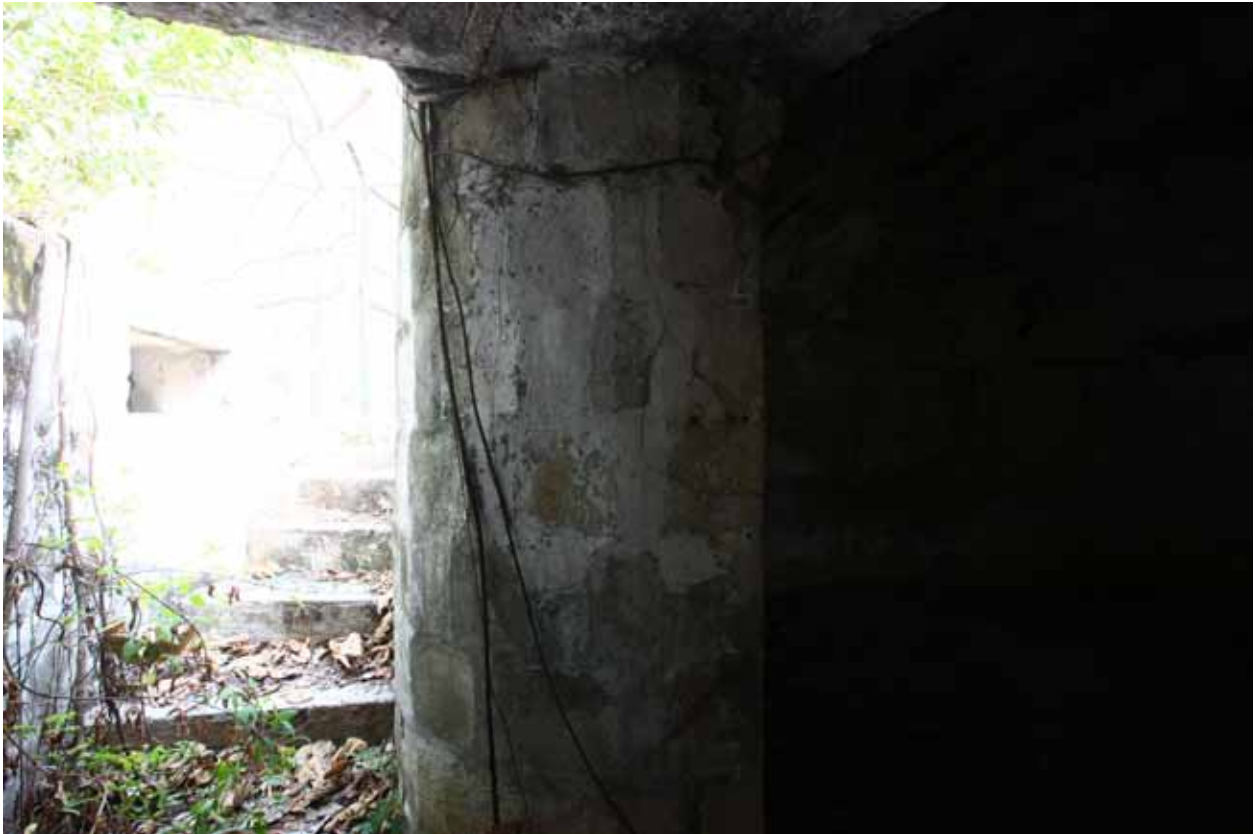
Photo # 23

An inside-looking out view of the entrance.

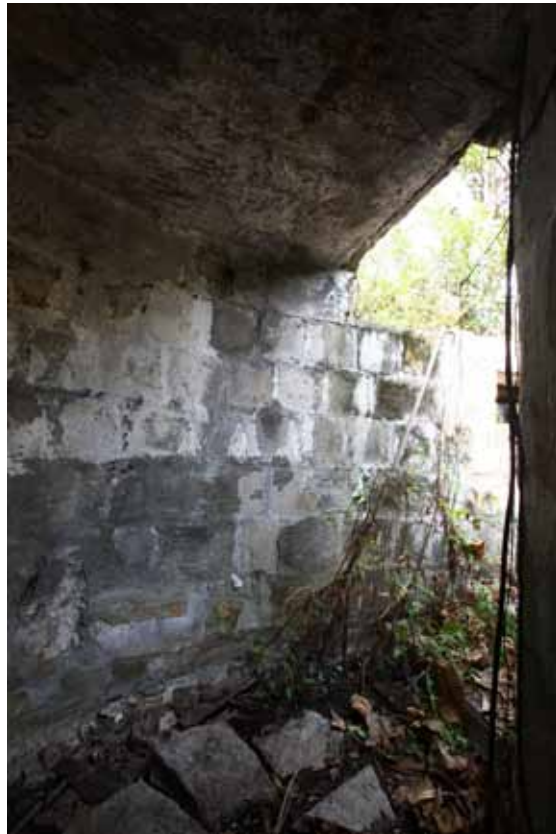
Photo # 24

View of the blast wall.

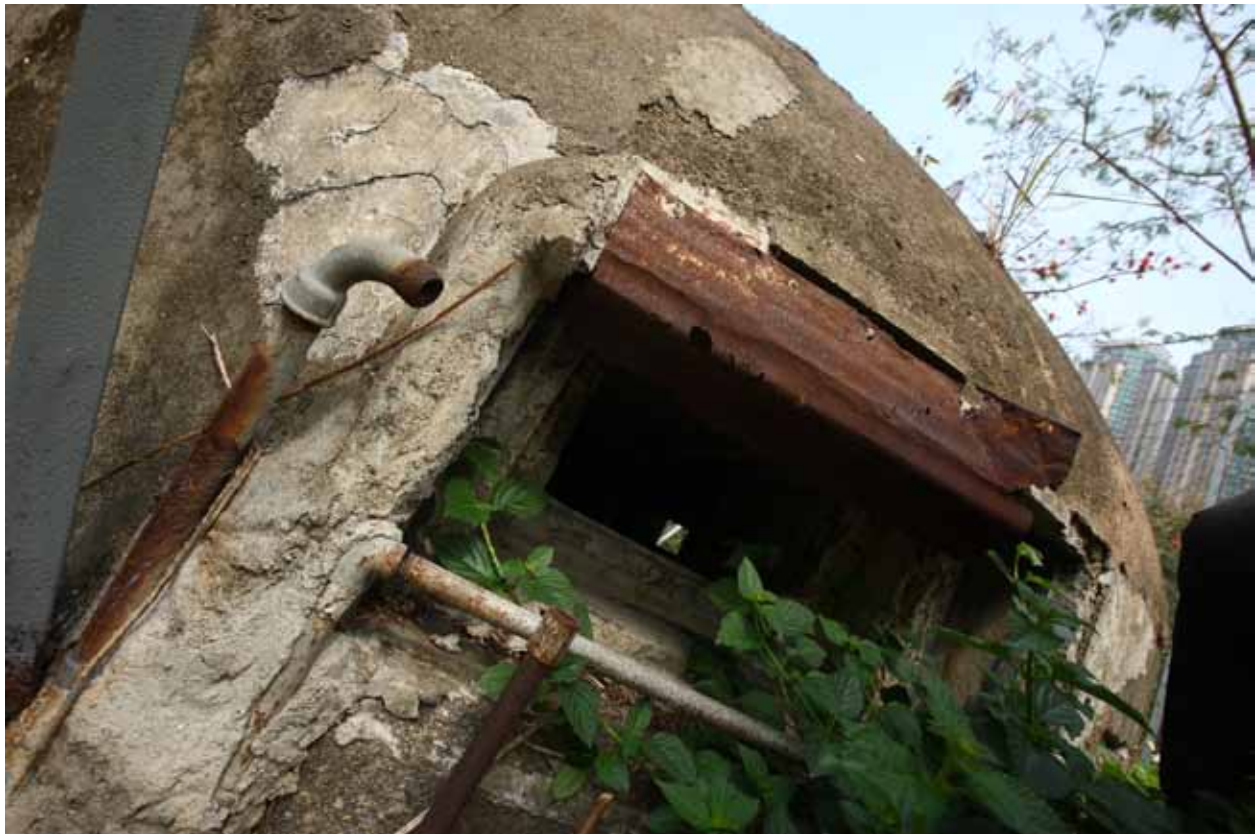
Photo # 25

The embrasure - detail.

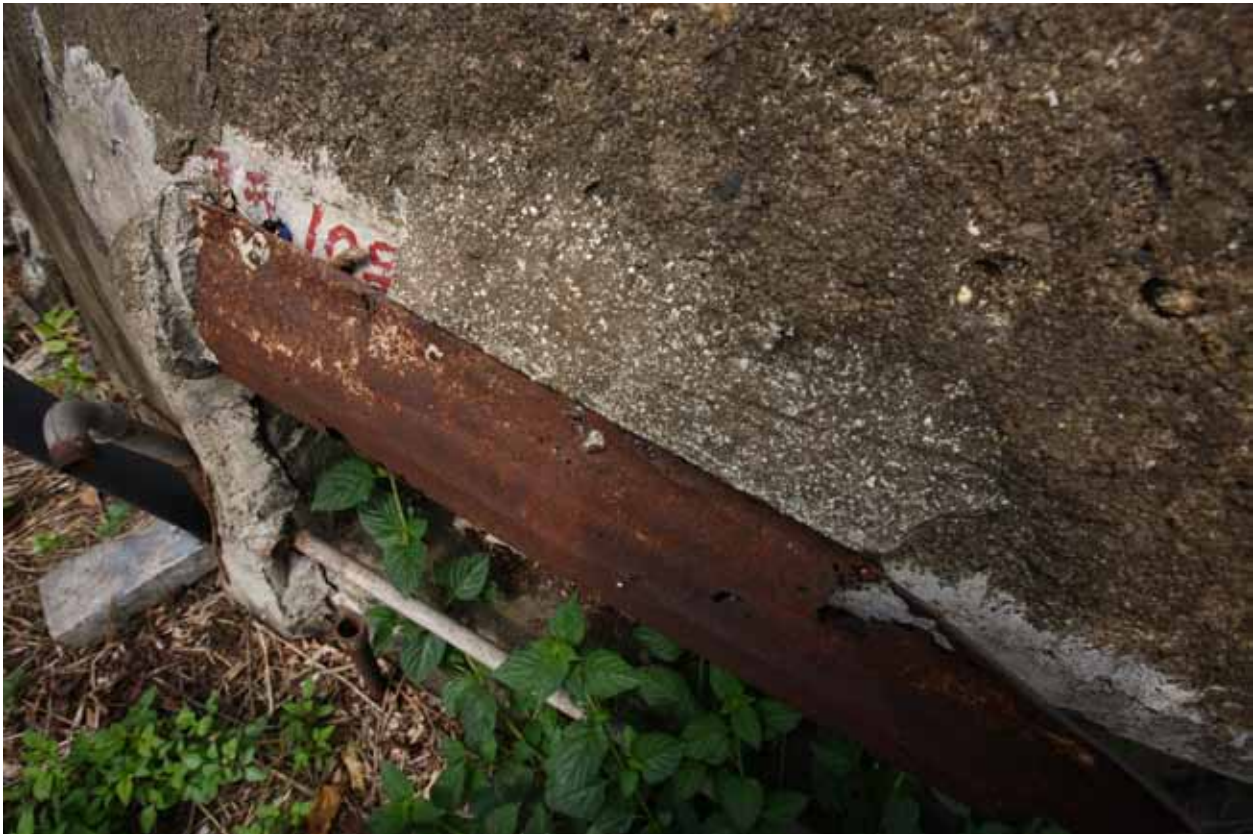
Photo # 26

The embrasure -detail.

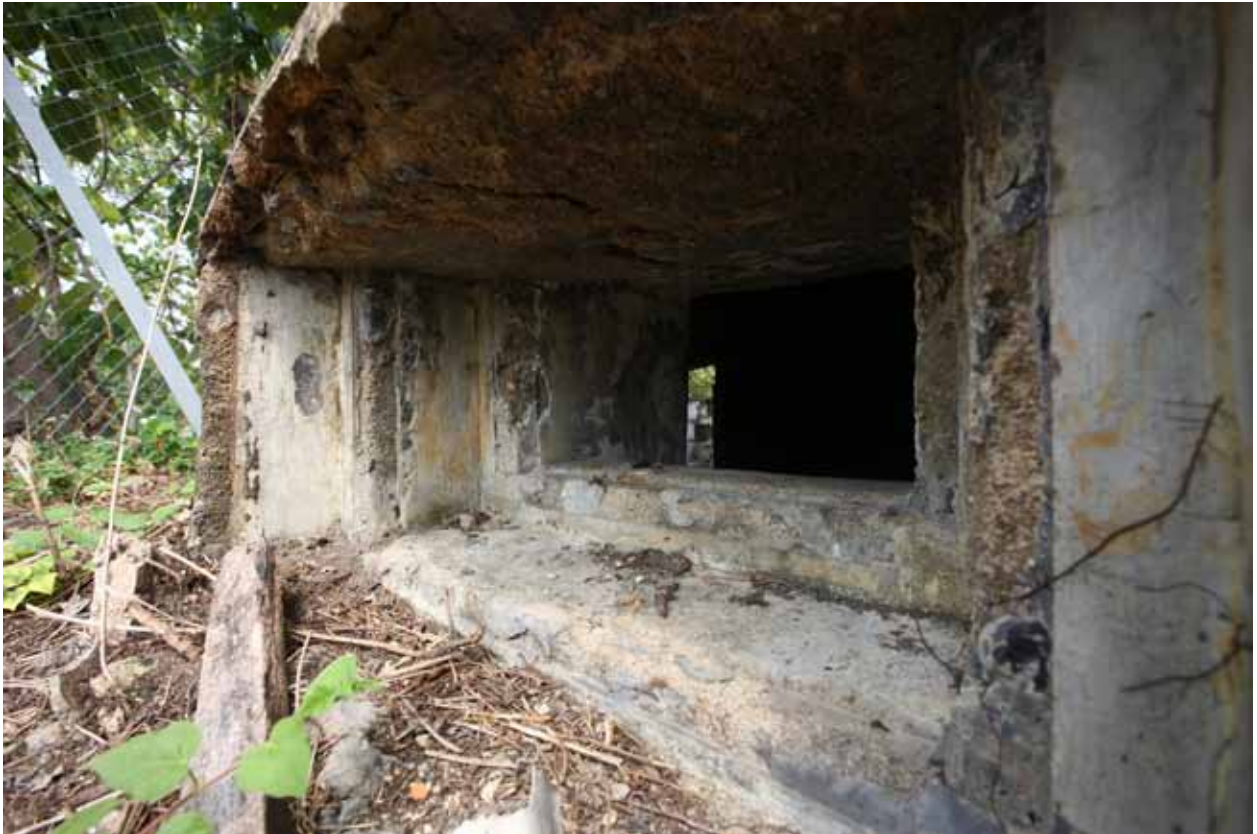
Photo # 27

The splayed embrasure -detail.

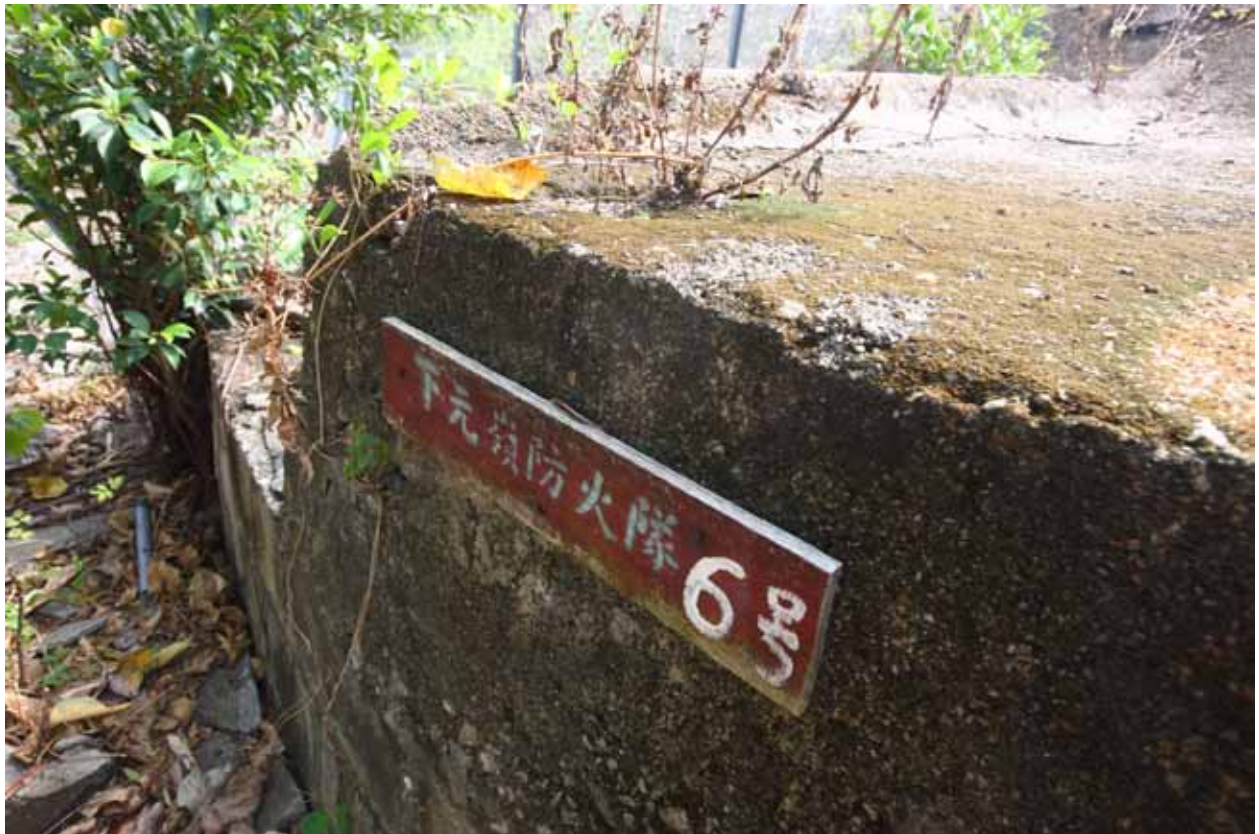
Photo # 28

A sign, "Ha Yuen Ling Fire Brigade no. 6", attached on the external wall.
