TUEN MUN - CHEK LAP KOK LINK
CONTRACT NO. HY/2013/12 –
NORTHERN CONNECTION TOLL PLAZA AND
ASSOCIATED WORKS

13TH MONTHLY ENVIRONMENTAL MONITORING AND
AUDIT (EM&A) REPORT – NOVEMBER 2015

PREPARED FOR
CRBC AND KADEN JOINT VENTURE

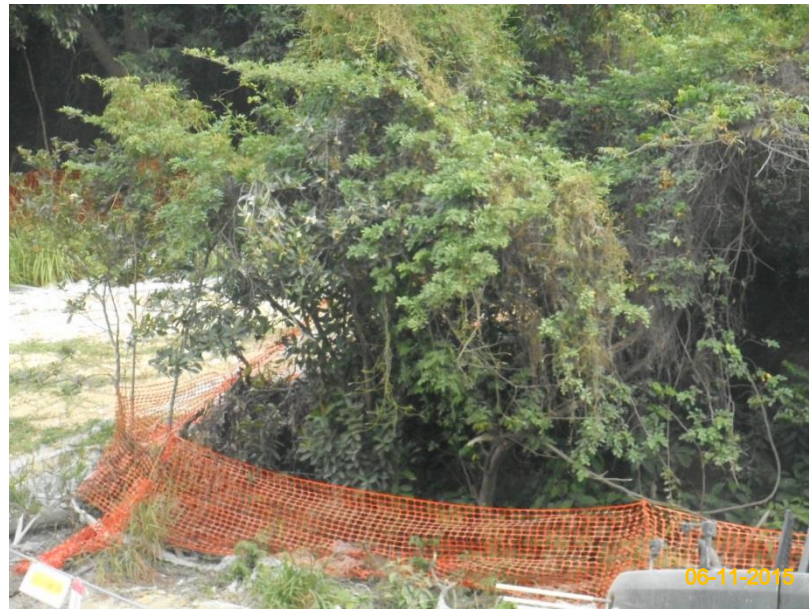
Item 1. Existing trees on boundary of the Project Area have been protected carefully during construction.

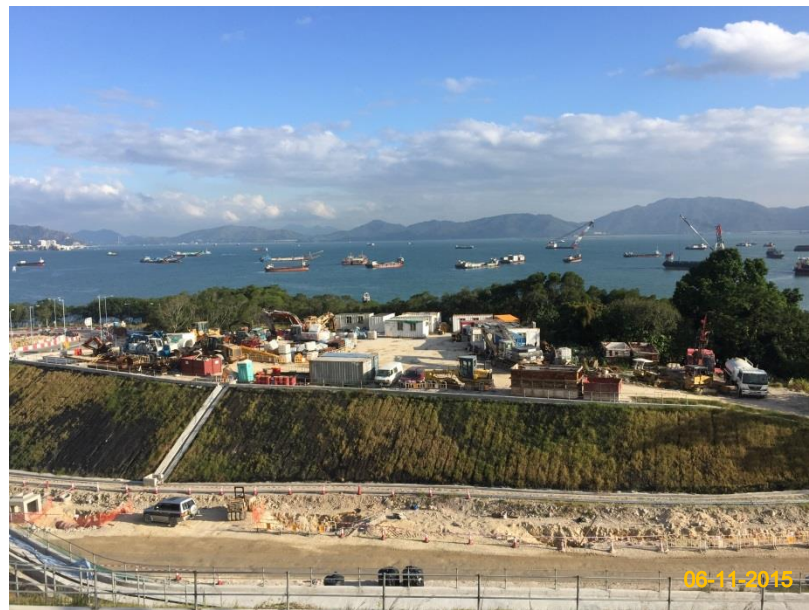
Item 4. Hydro-seeding or sheeting provided at stockpile.

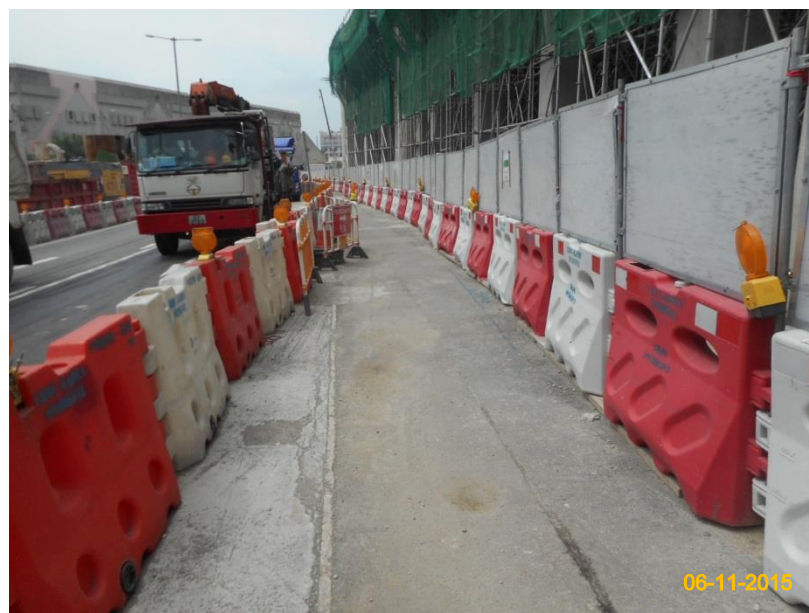
Item 5. Hoarding with panel around works area & Item 6. Temporary traffic management lighting.

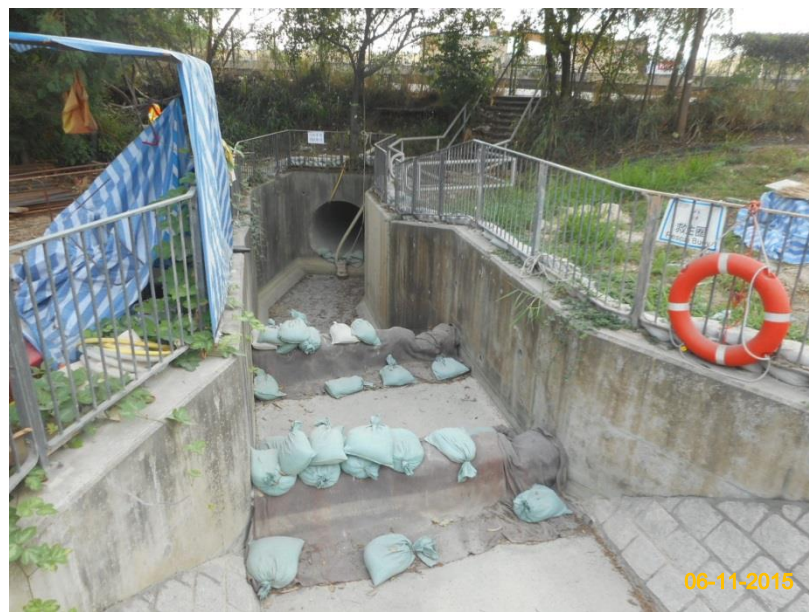
Item 7. Ensure no run-off into water body.

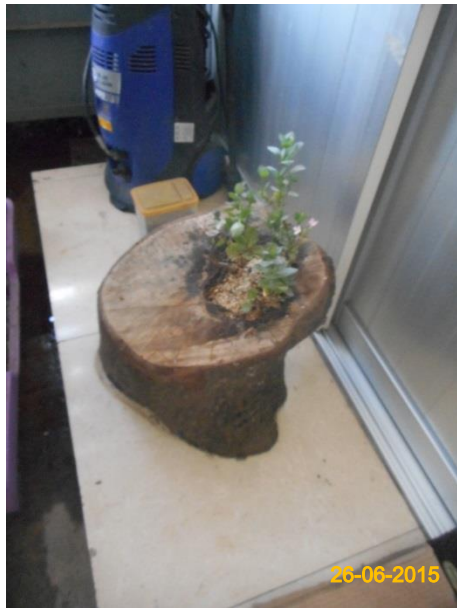
Item 9. Recycle of felled trees as facilities to reuse.

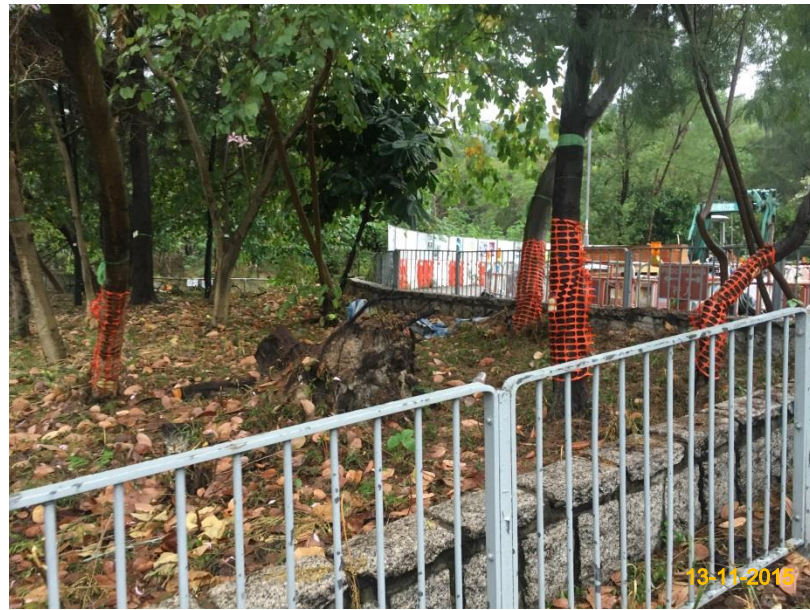
Item 1. Existing trees on boundary of the Project Area have been protected carefully during construction.

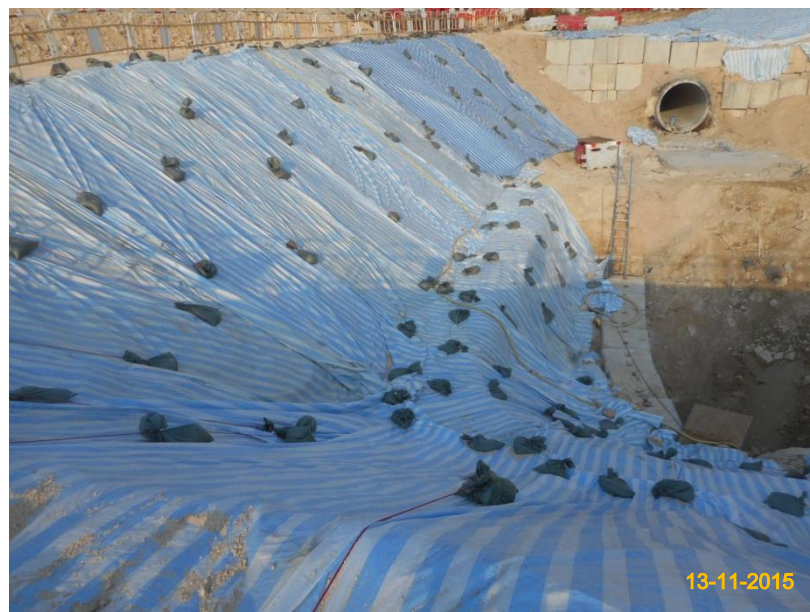
Item 4. Hydro-seeding or sheeting provided at stockpile.

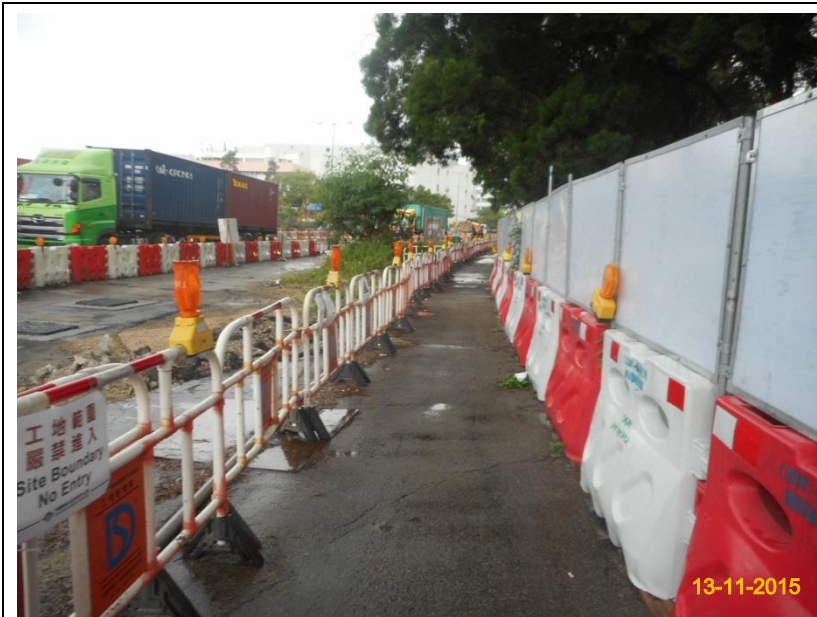
Item 5. Hoarding with panel around works area & Item 6. Temporary traffic management lighting.

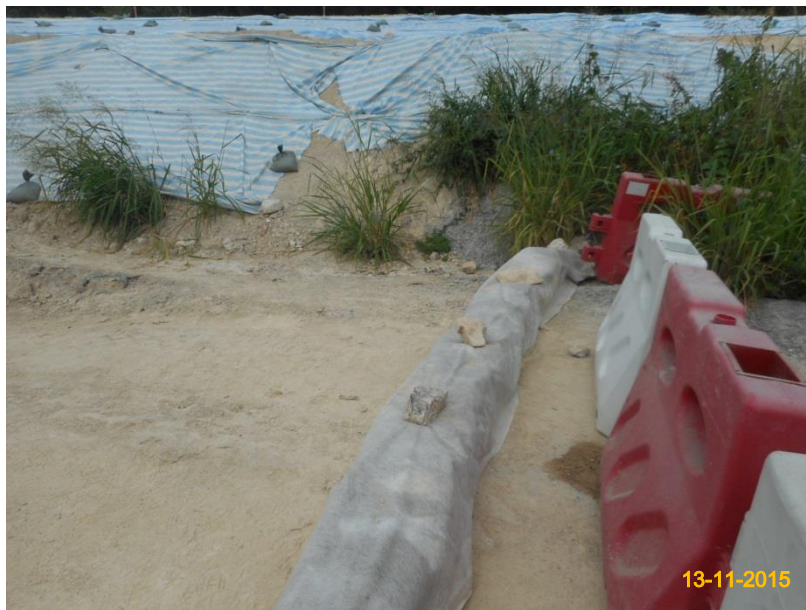
Item 7. Ensure no run-off into water body.

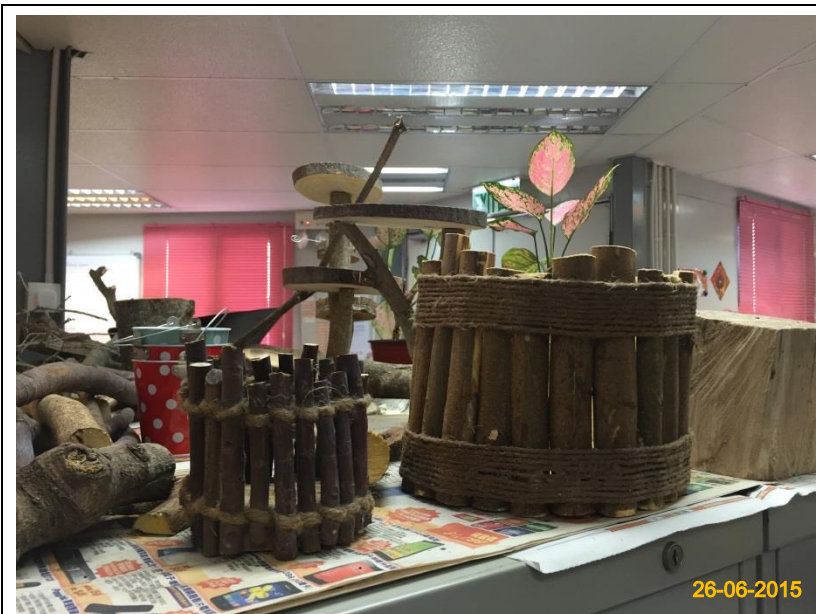
Item 9. Recycle of felled trees as facilities to reuse.

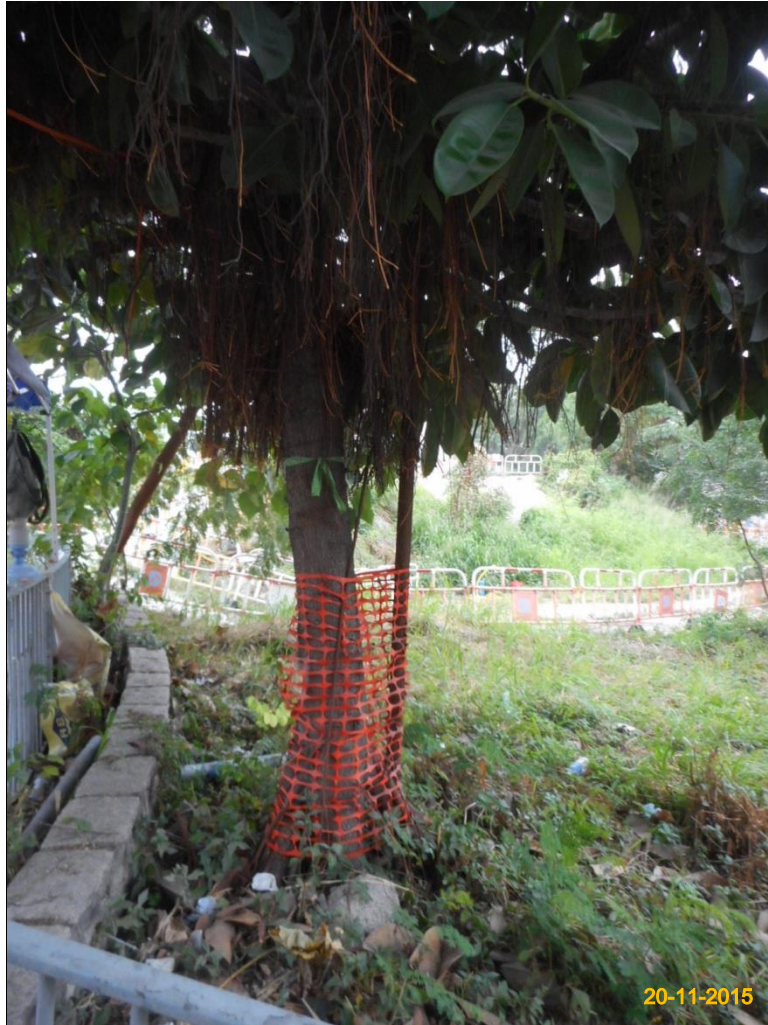
Item 1. Existing trees on boundary of the Project Area have been protected carefully during construction.

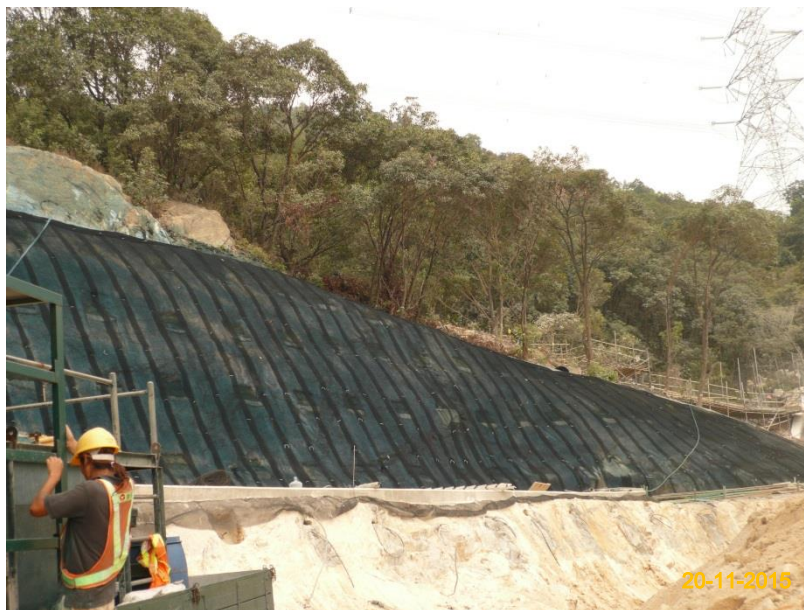
Item 4. Hydro-seeding or sheeting provided at stockpile.

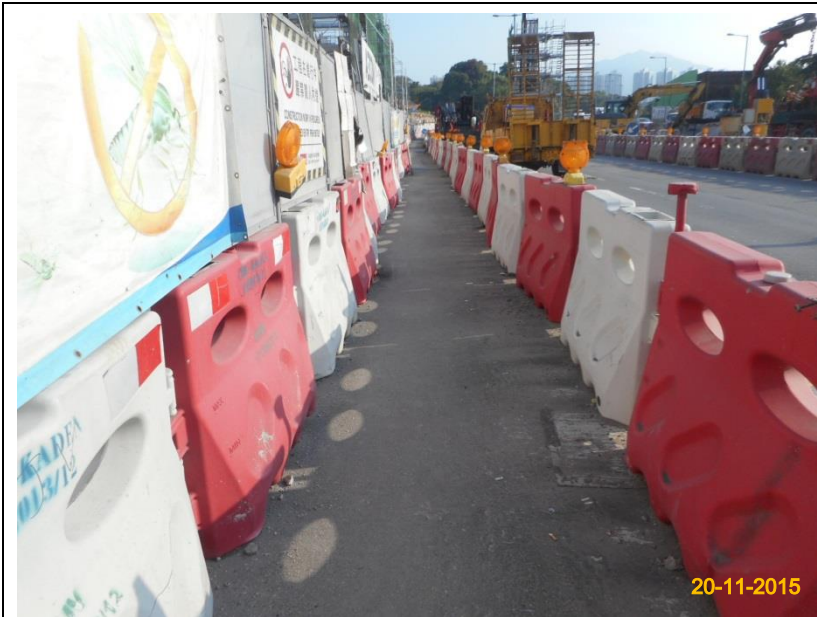
Item 5. Hoarding with panel around works area & Item 6. Temporary traffic management lighting.

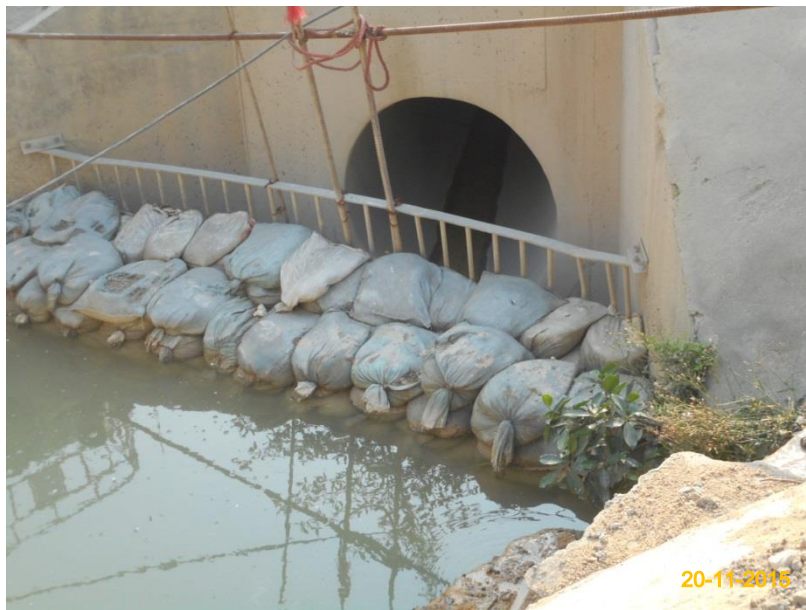
Item 7. Ensure no run-off into water body.

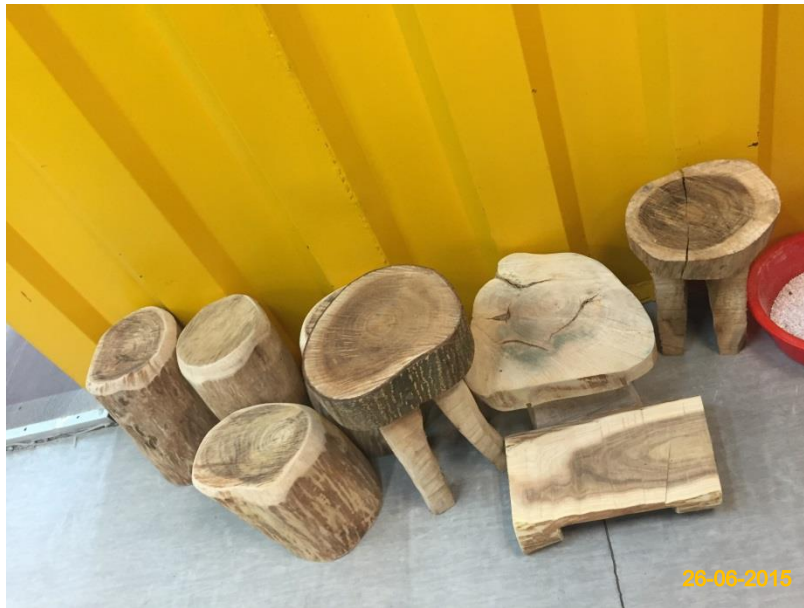
Item 9. Recycle of felled trees as facilities to reuse.

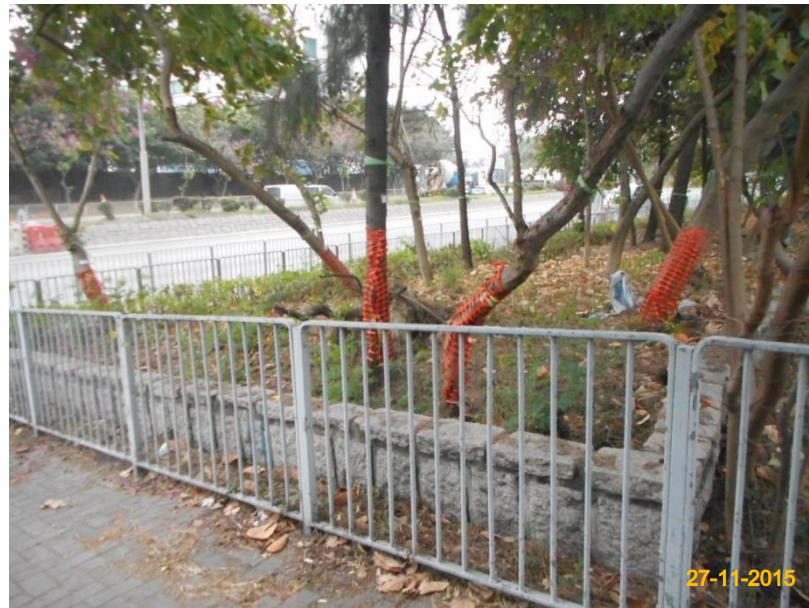
Item 1. Existing trees on boundary of the Project Area have been protected carefully during construction.

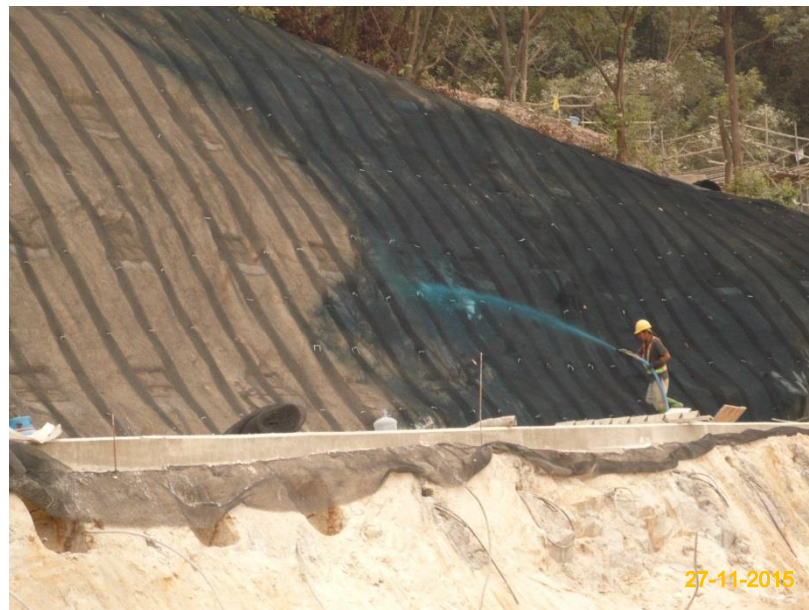
Item 4. Hydro-seeding or sheeting provided at stockpile.

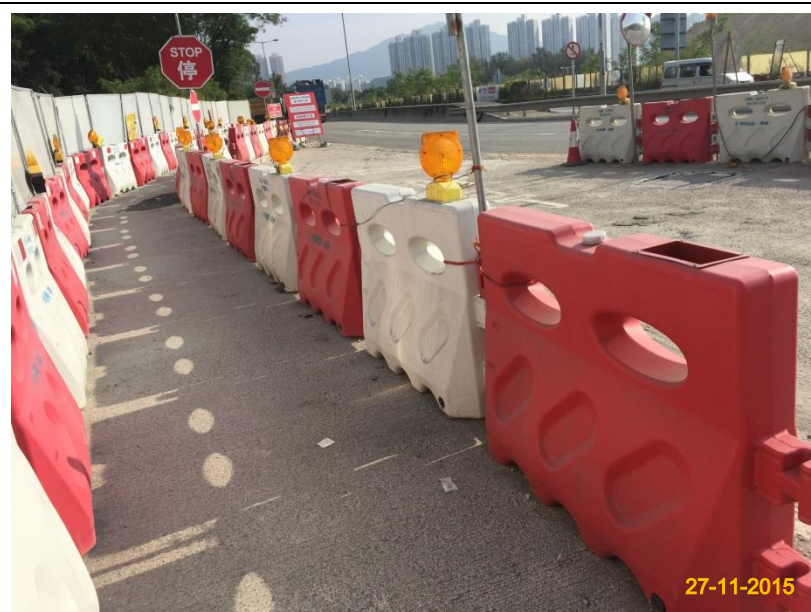
Item 5. Hoarding with panel around works area & Item 6. Temporary traffic management lighting.

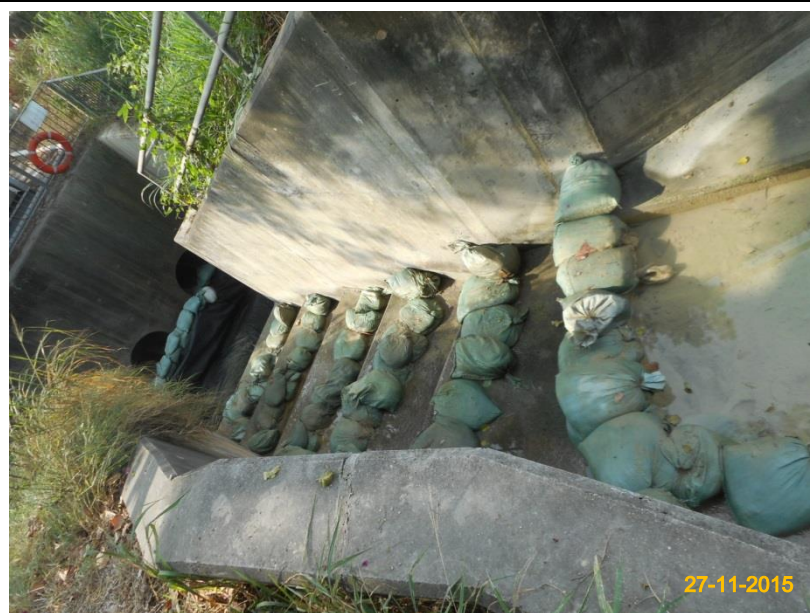
Item 7. Ensure no run-off into water body.

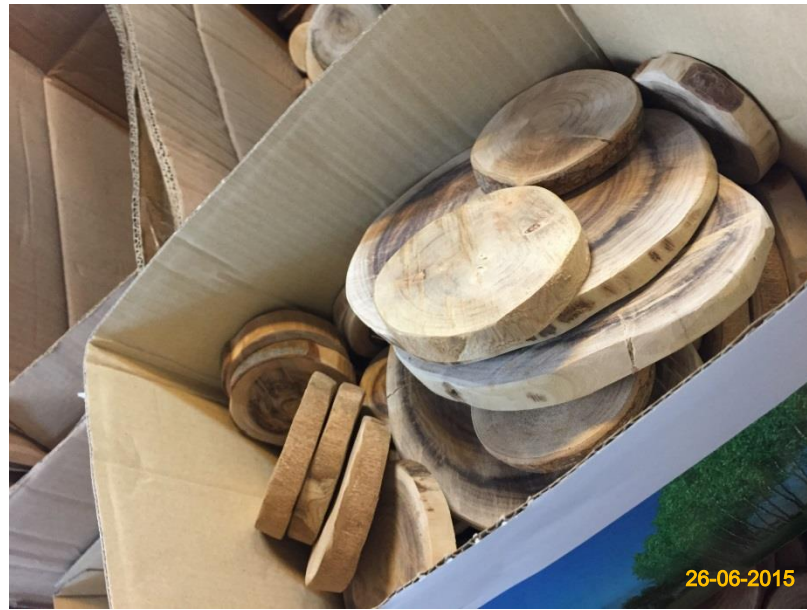
Item 9. Recycle of felled trees as facilities to reuse.

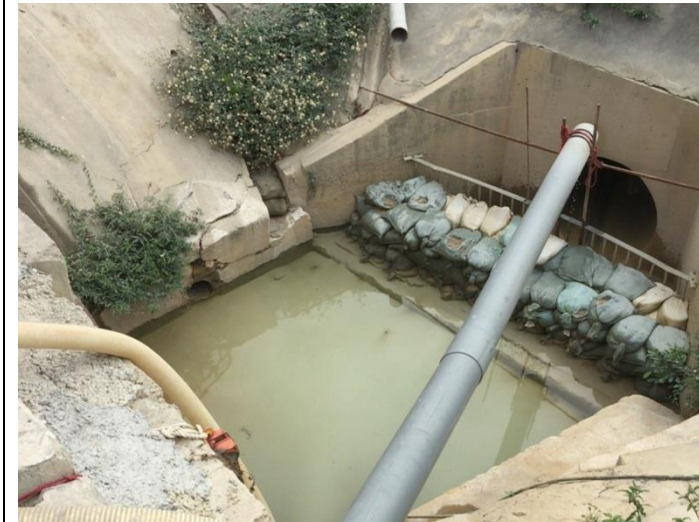
Stream A Outfall: pumped muddy water and discharged after treatment.

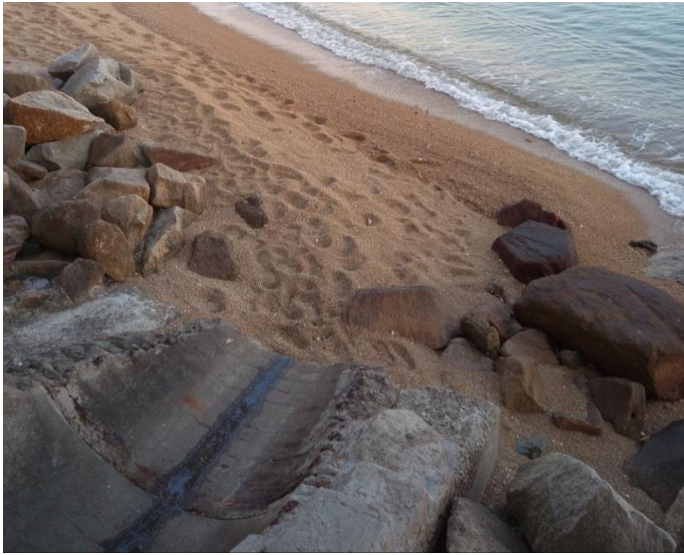
Outfall 1: No water is discharging.

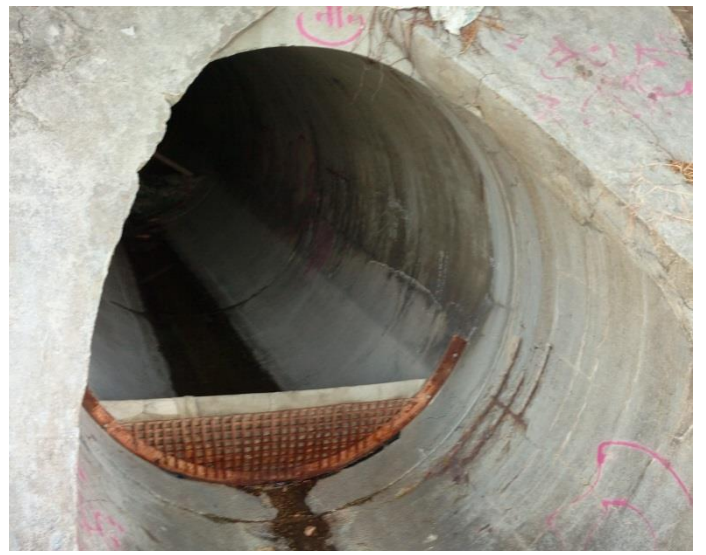
Outfall 1: No water is discharging.

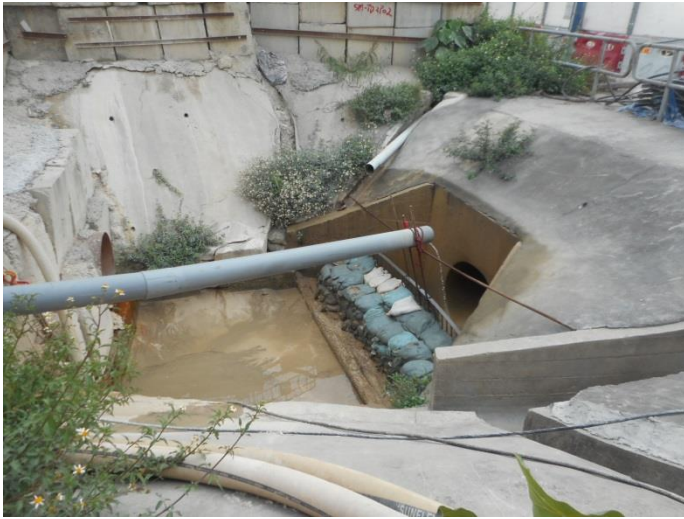
Stream A Outfall: pumped muddy water and discharged after treatment.

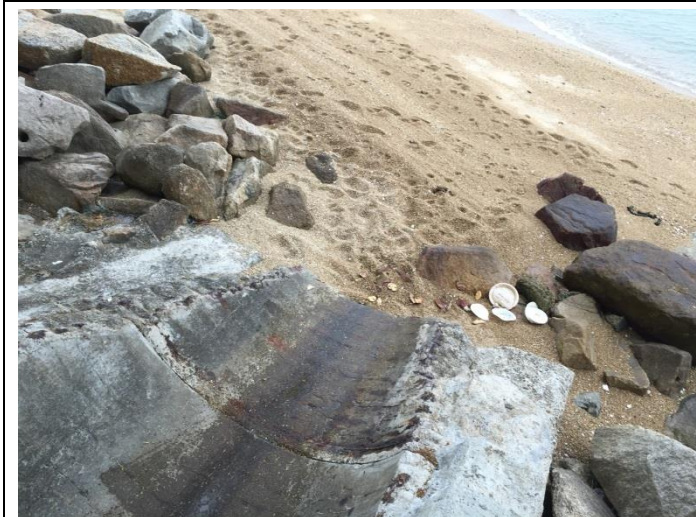
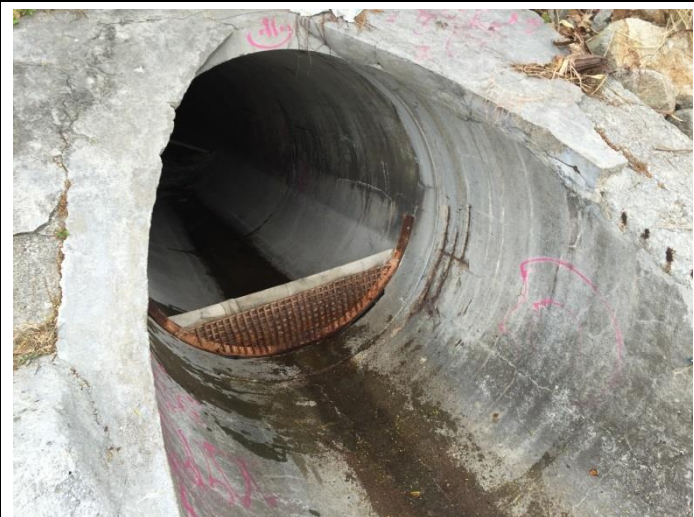
Outfall 1: No water is discharging.

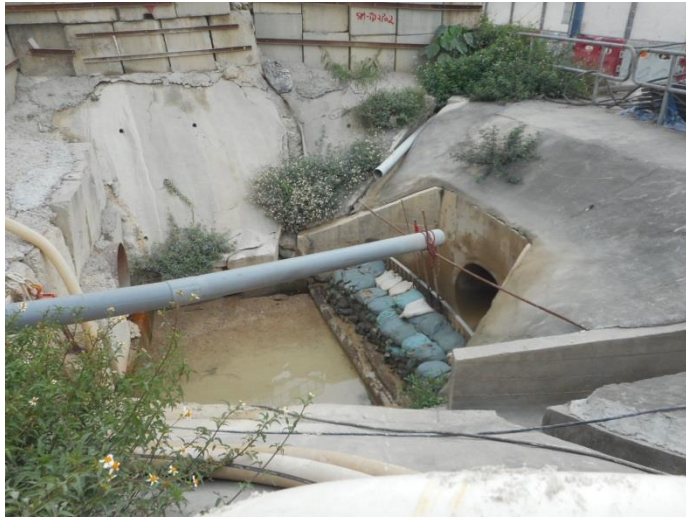
Stream A Outfall: pumped muddy water and discharged after treatment.

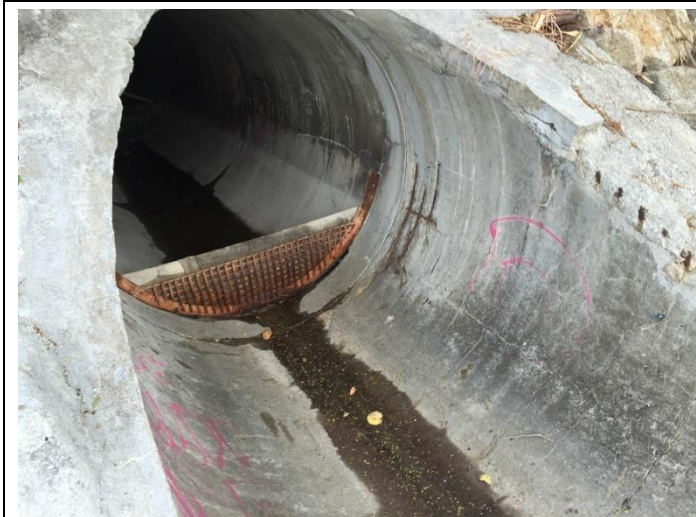
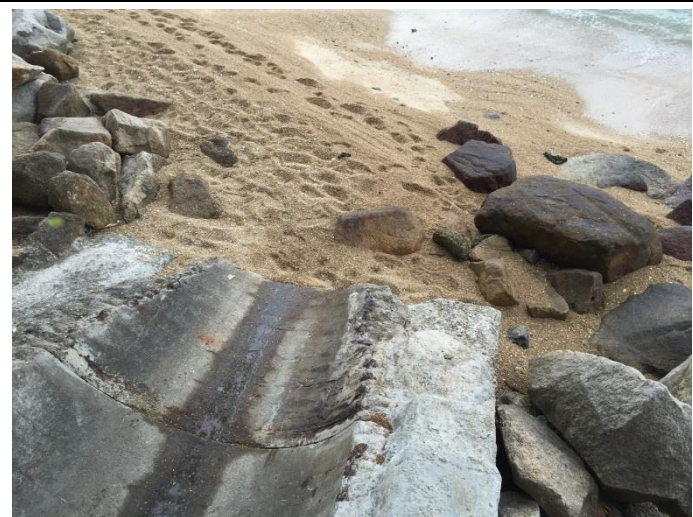
Outfall 1: No water is discharging.

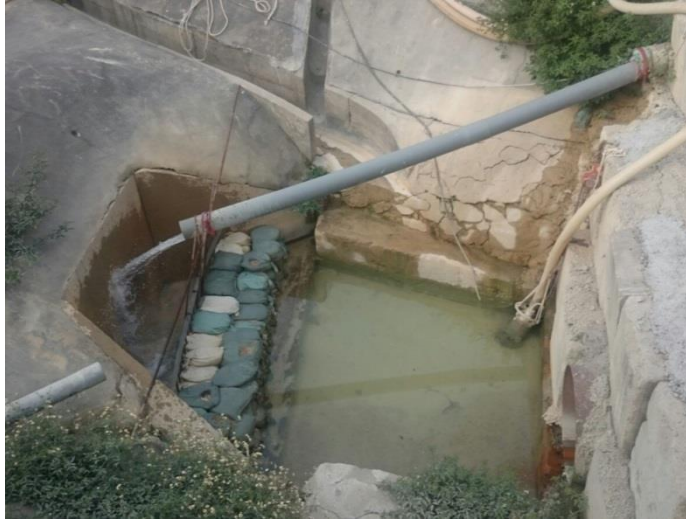
Stream A Outfall: pumped muddy water and discharged after treatment.

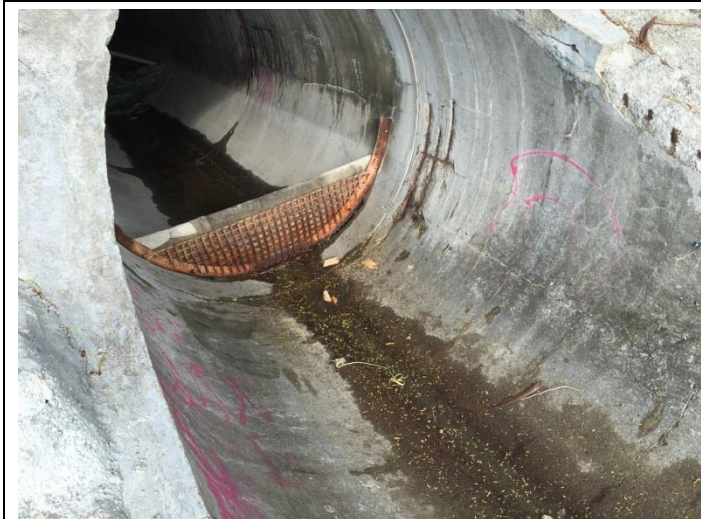
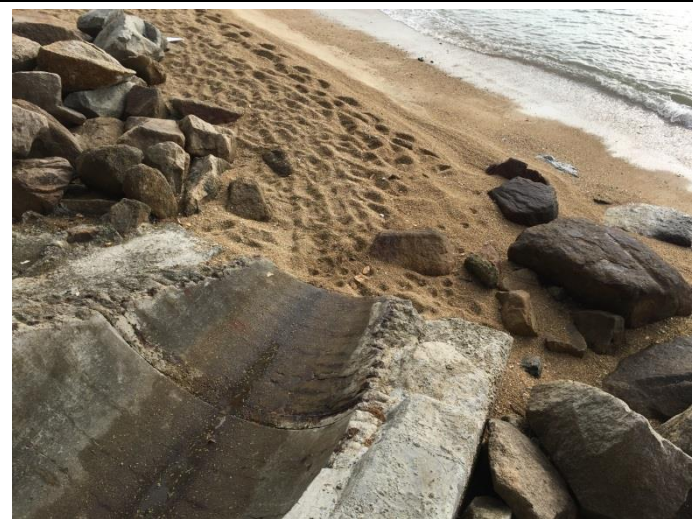
Outfall 1: No water is discharging.

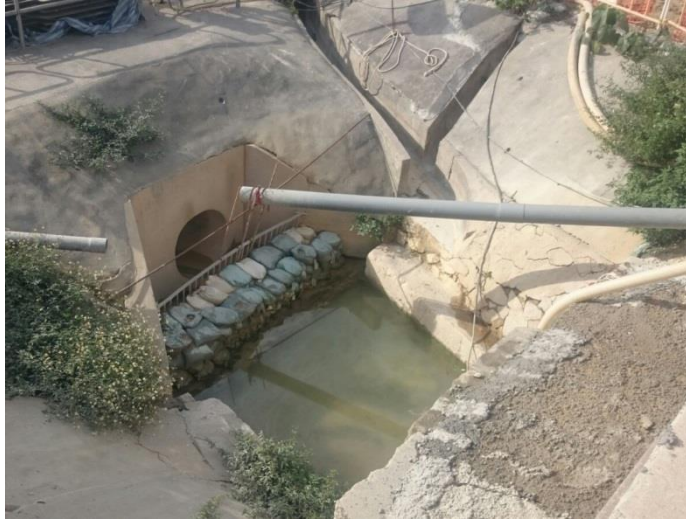
Stream A Outfall: pumped muddy water and discharged after treatment.

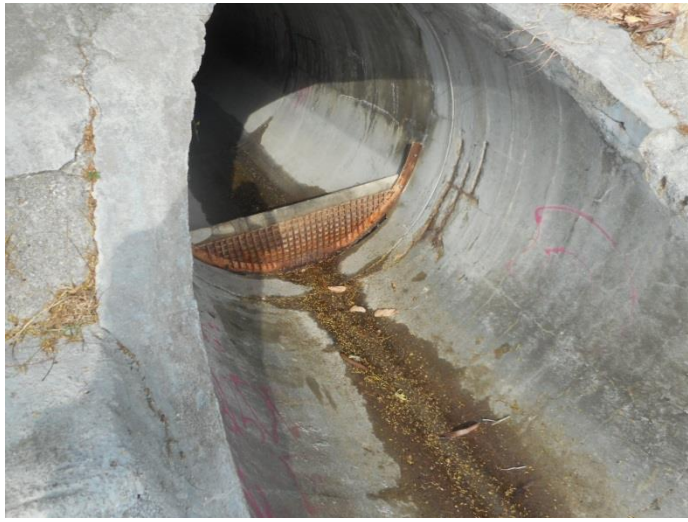
Outfall 1: No water is discharging.

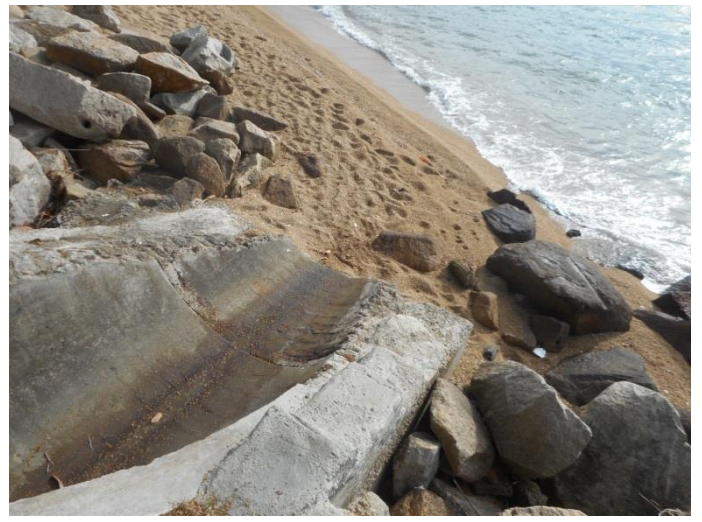
Outfall 1: No water is discharging.

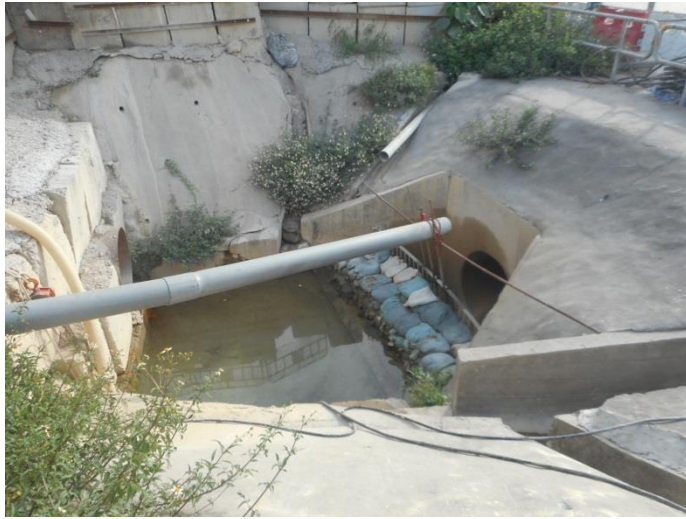
Stream A Outfall: pumped muddy water and discharged after treatment.

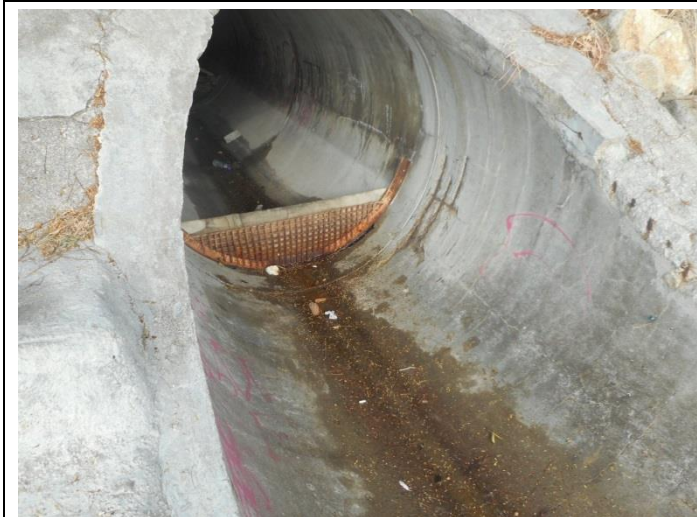
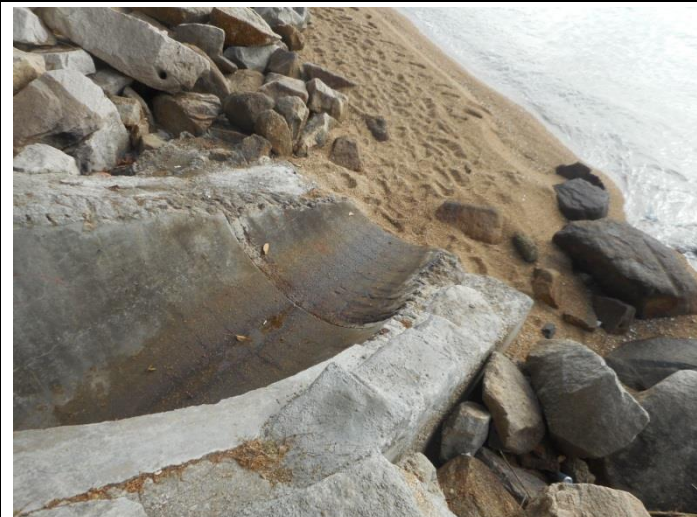
Outfall 1: No water is discharging.

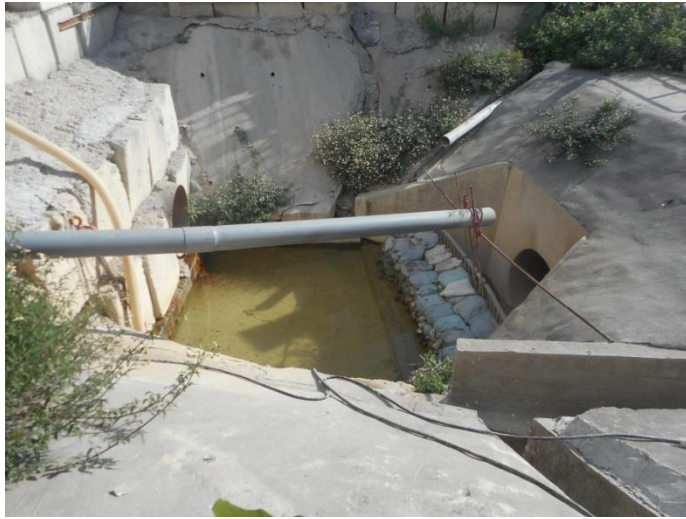
Stream A Outfall: pumped muddy water and discharged after treatment.

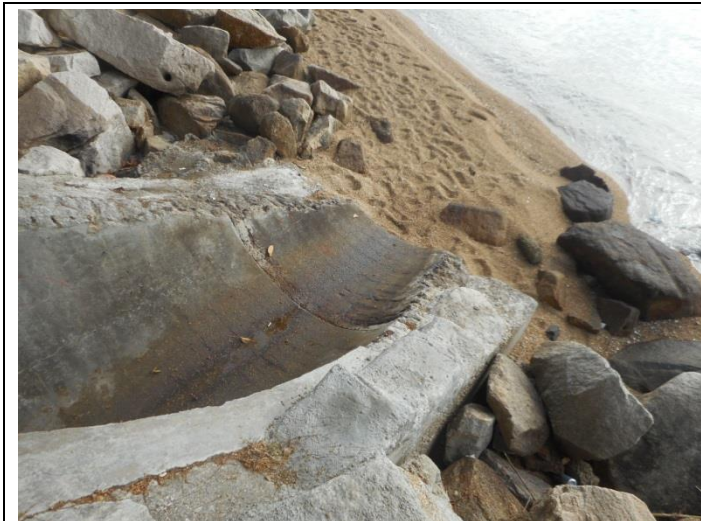
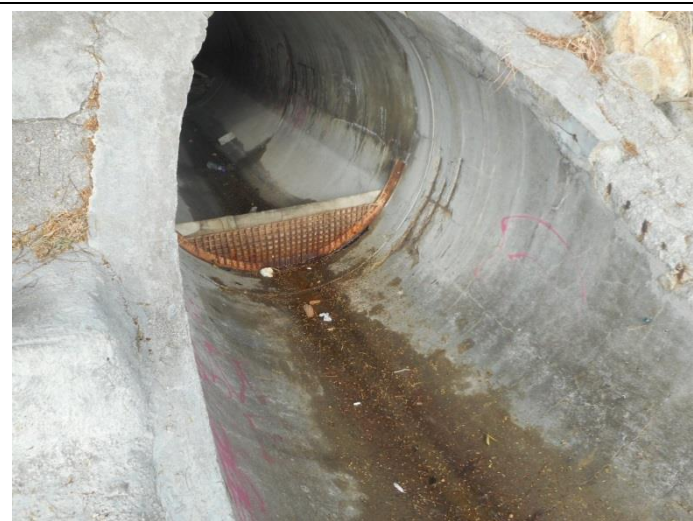
Outfall 1: No water is discharging.

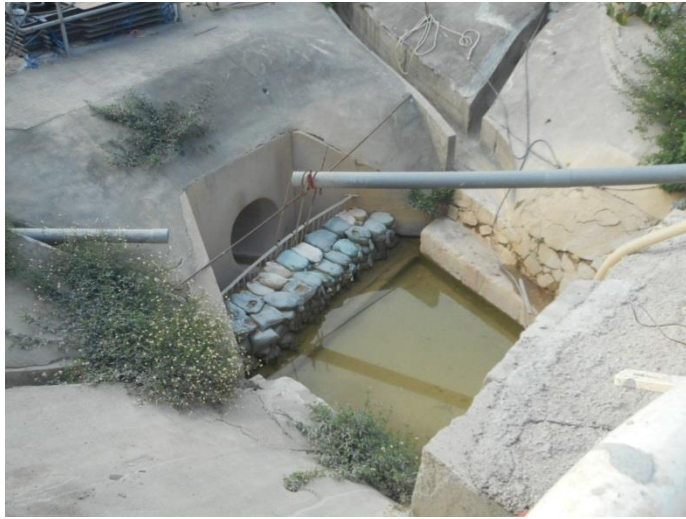
Stream A Outfall: No water is discharging.

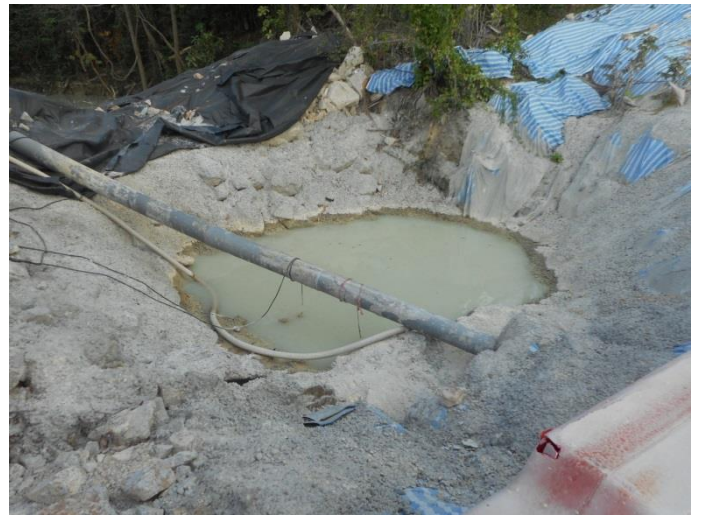
Stream B Pit 1: Treated water was directly discharged to downstream bypass.

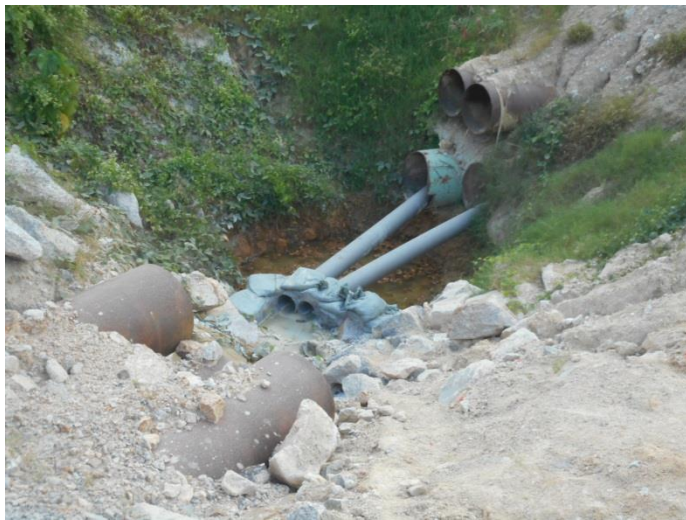
Stream B Pit 2: Treated water was directly discharged to downstream bypass.

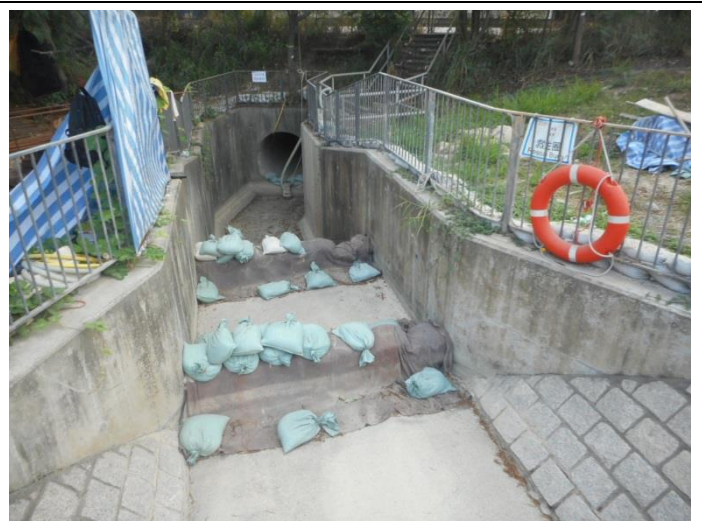
East Portal Cascade: No water is discharged.

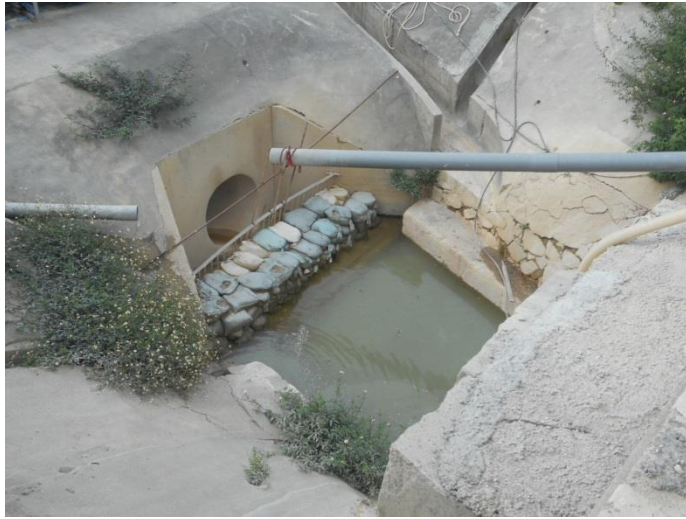
Stream A Outfall: No water is discharging.

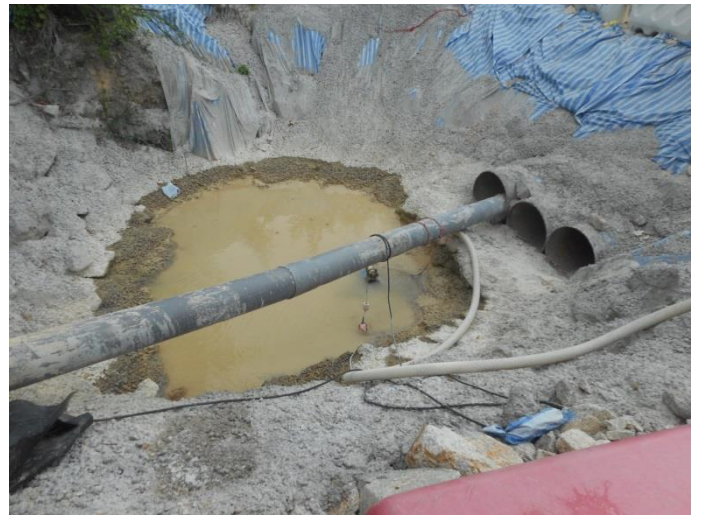
Stream B Pit 1: Treated water was directly discharged to downstream bypass.

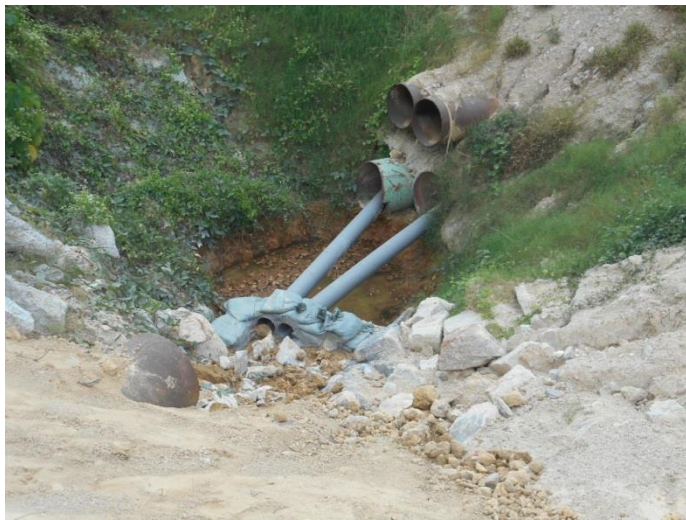
Stream B Pit 2: Treated water was directly discharged to downstream bypass.

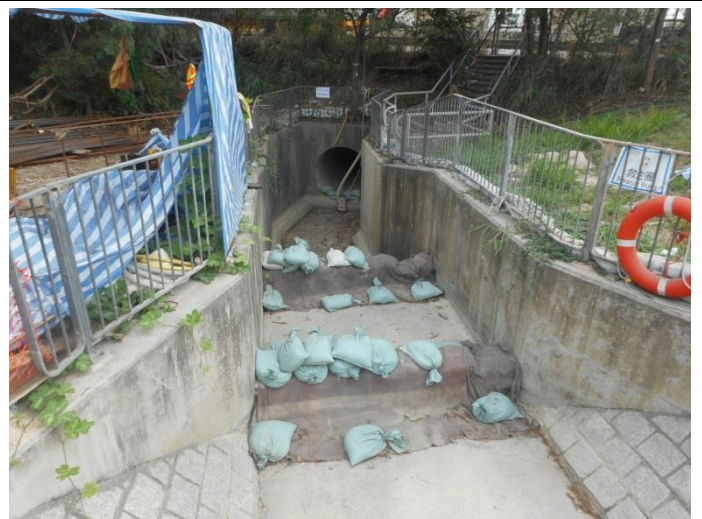
East Portal Cascade: No water is discharged.

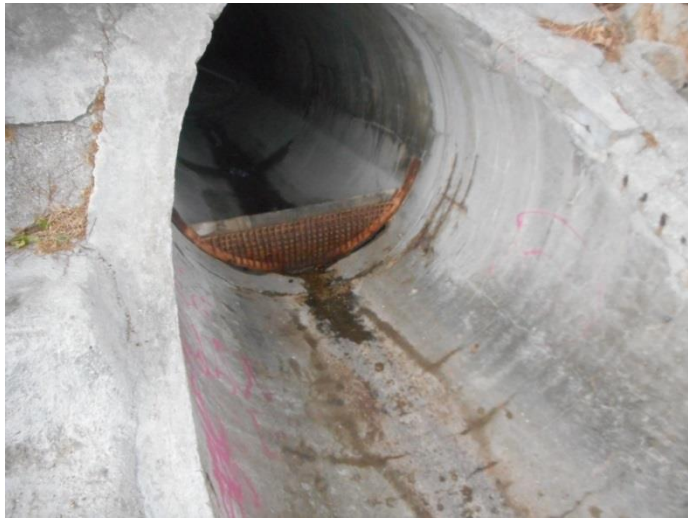
Outfall 1: No water is discharging.

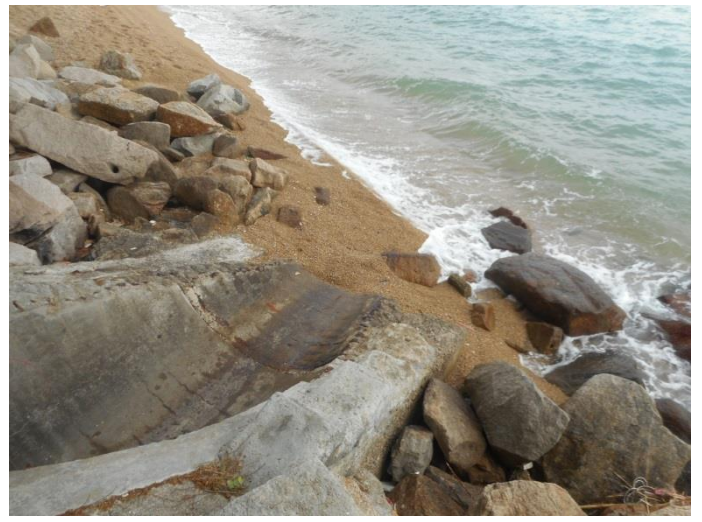
Outfall 1: No water is discharging.

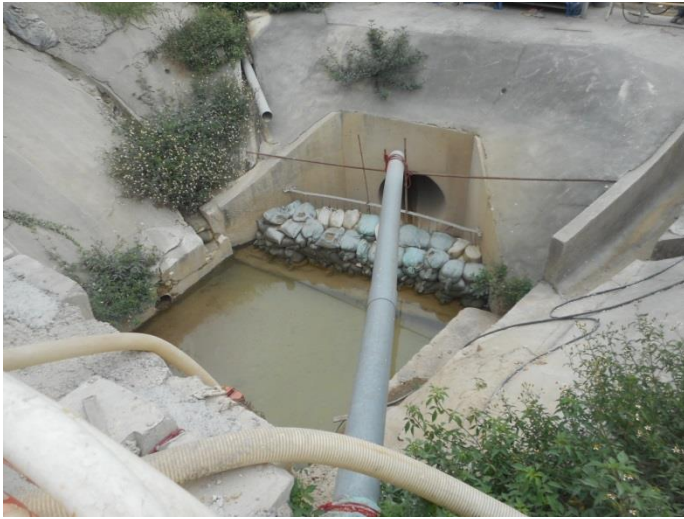
Stream A Outfall: No water is discharging.

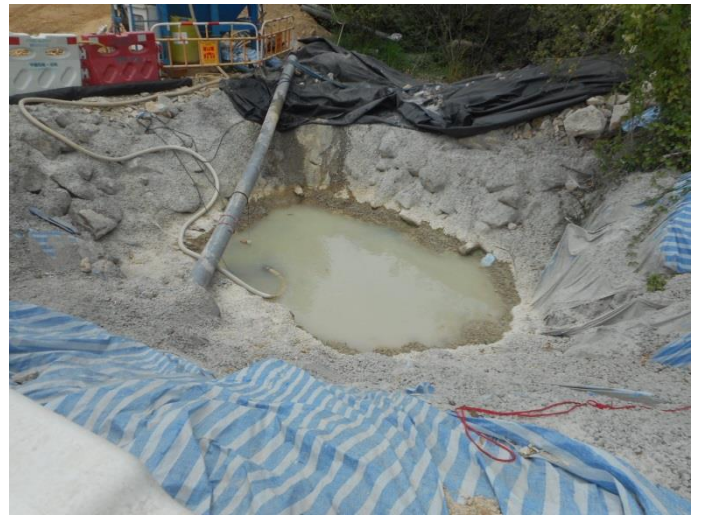
Stream B Pit 1: Treated water was directly discharged to downstream bypass.

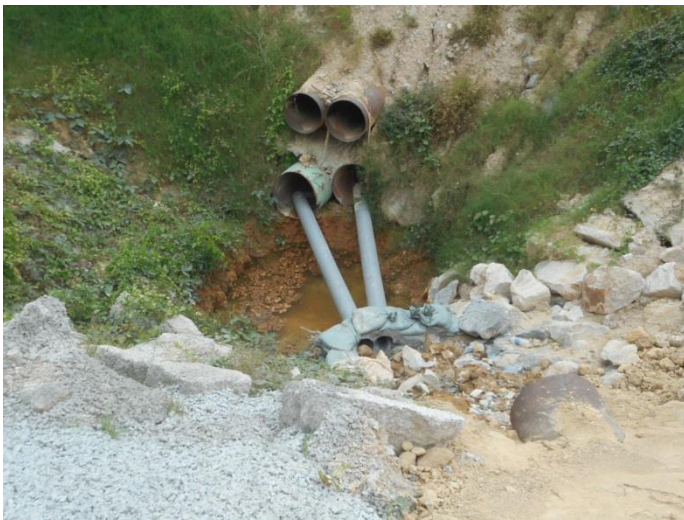
Stream B Pit 2: Treated water was directly discharged to downstream bypass.
