TUEN MUN - CHEK LAP KOK LINK
CONTRACT NO. HY/2013/12 –
NORTHERN CONNECTION TOLL PLAZA AND
ASSOCIATED WORKS

13TH MONTHLY ENVIRONMENTAL MONITORING AND
AUDIT (EM&A) REPORT – NOVEMBER 2015

PREPARED FOR
CRBC AND KADEN JOINT VENTURE

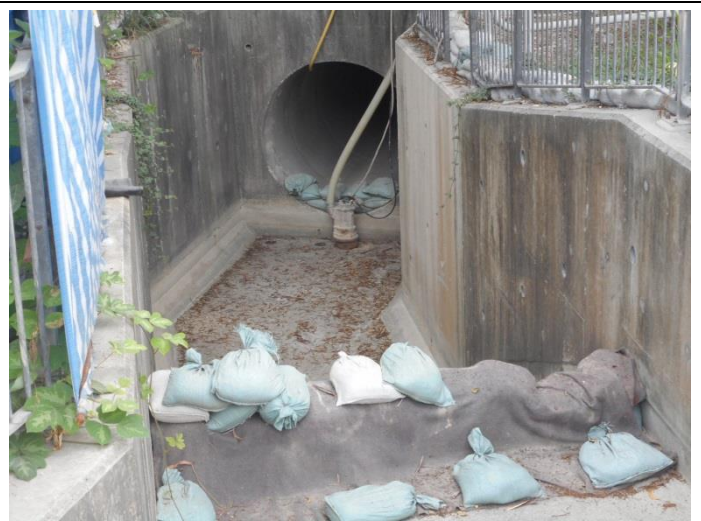
East Portal Cascade: No water is discharged.

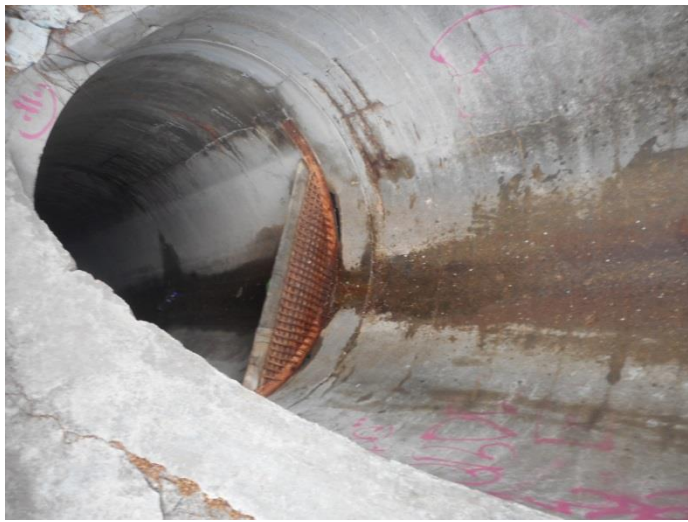
Outfall 1: No water is discharging.

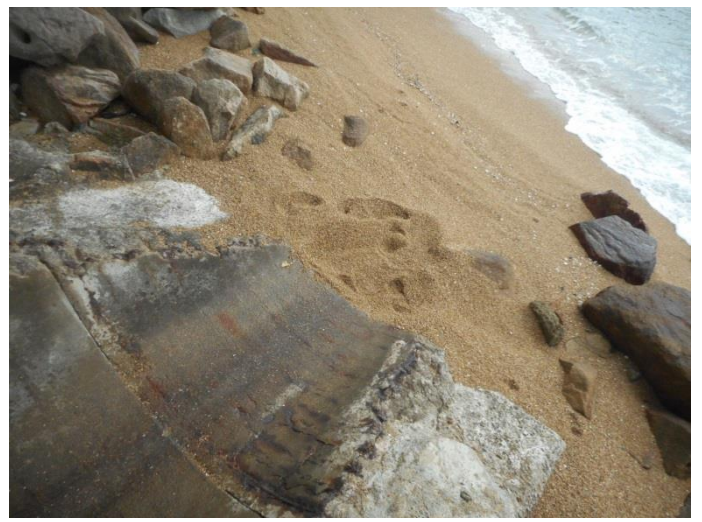
Outfall 1: No water is discharging.

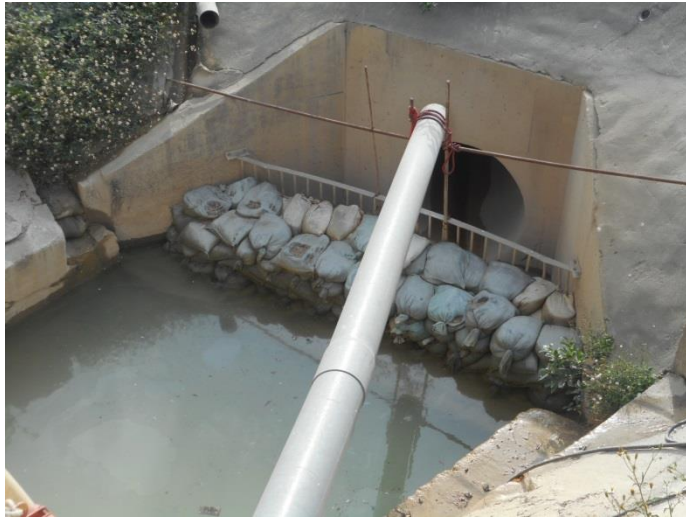
Stream A Outfall: No water is discharging.

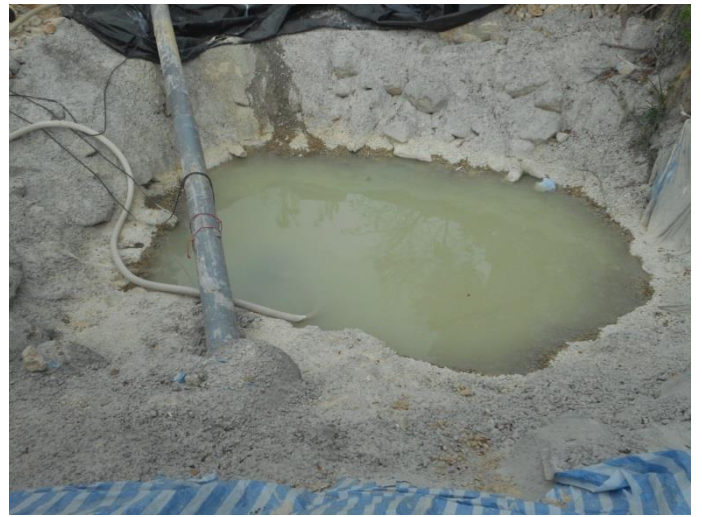
Stream B Pit 1: Treated water was directly discharged to downstream bypass.

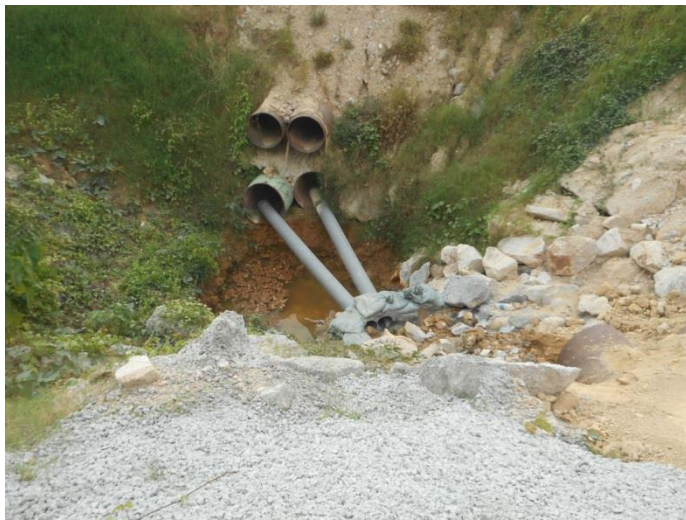
Stream B Pit 2: Treated water was directly discharged to downstream bypass.

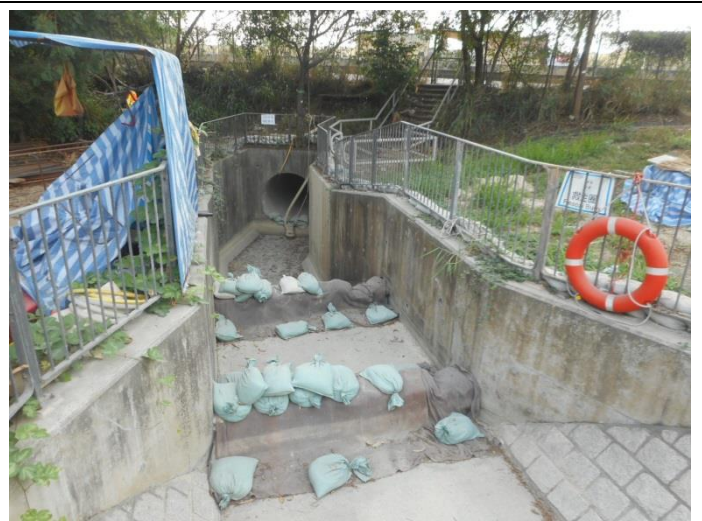
East Portal Cascade: No water is discharged.

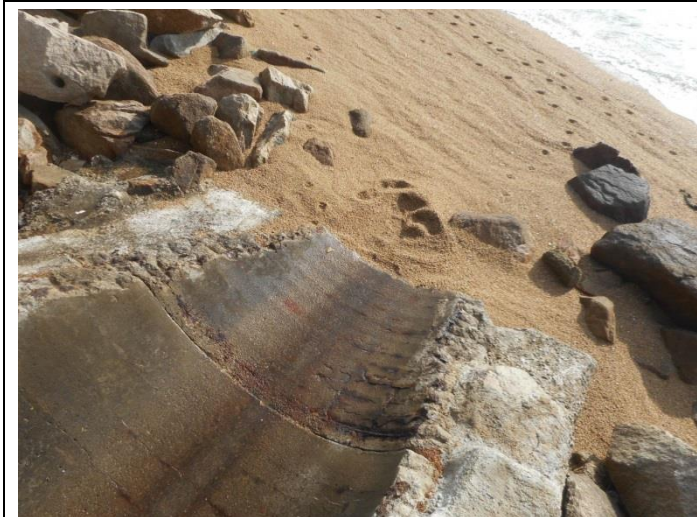
Outfall 1: No water is discharging.

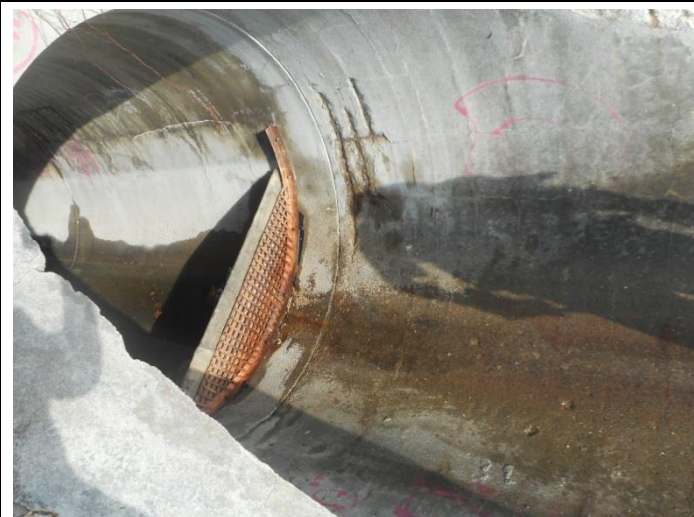
Outfall 1: No water is discharging.

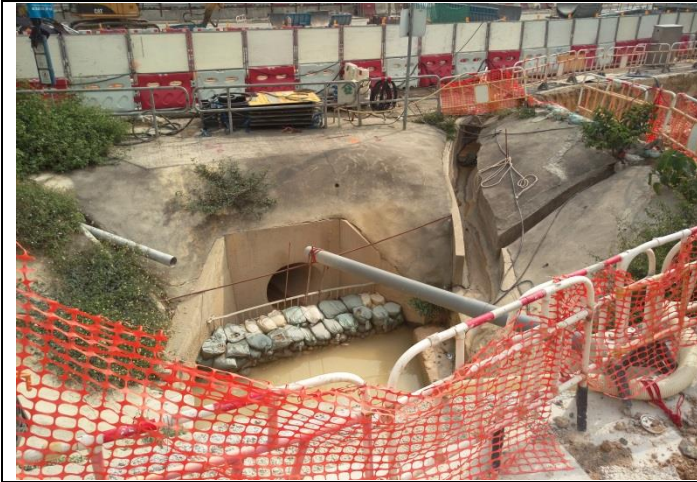
Stream A Outfall: No water is discharging.

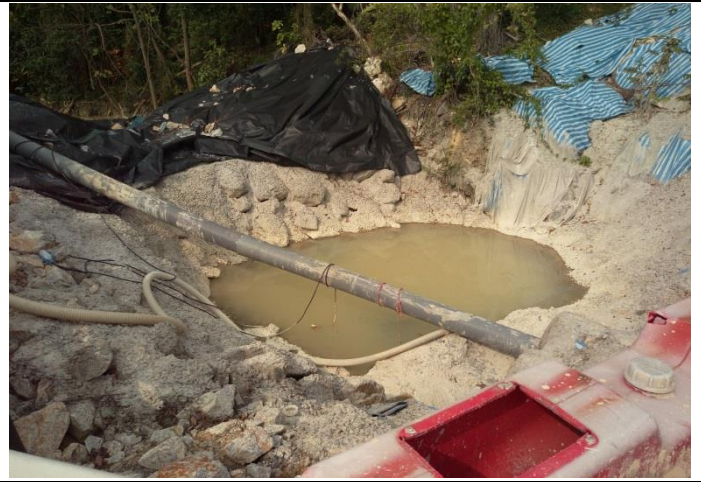
Stream B Pit 1: Treated water was directly discharged to downstream bypass.

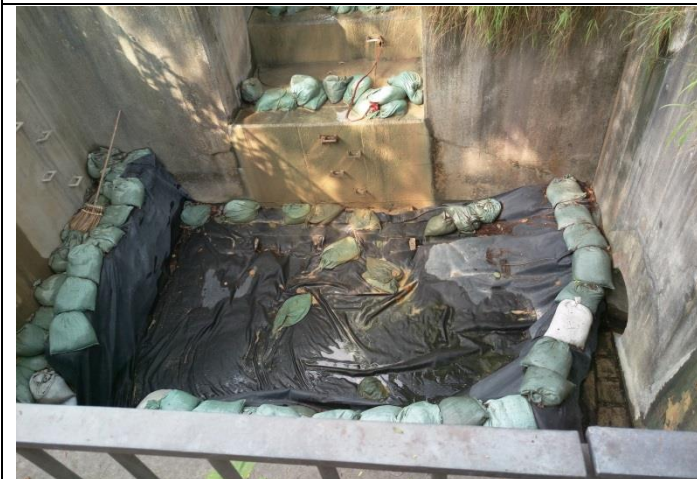
Stream B Outfall: No water is discharged.

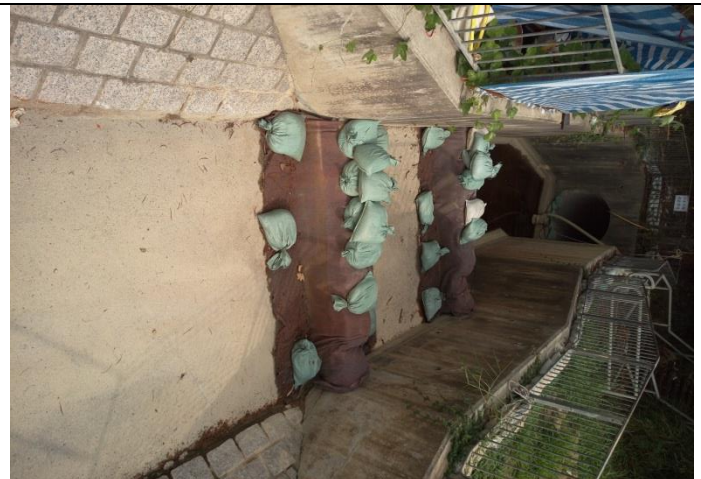
East Portal Cascade: No water is discharged.

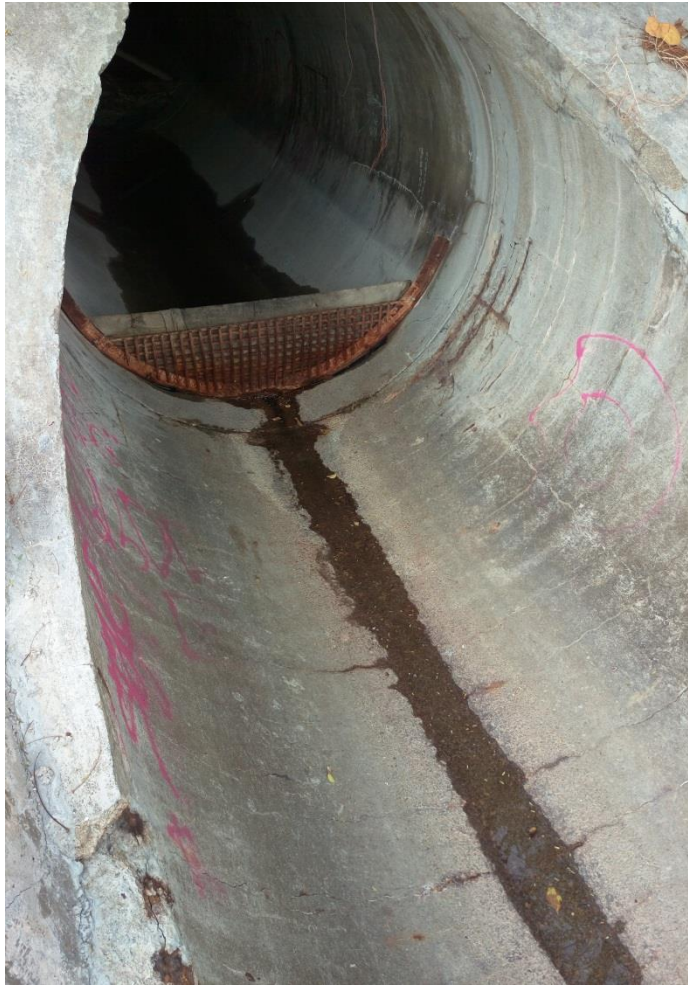
Outfall 1: No water is discharging.

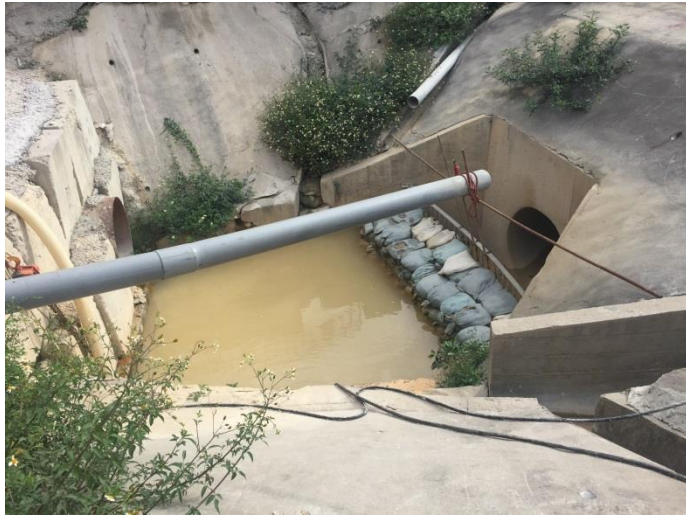
Stream A Outfall: No water is discharging.

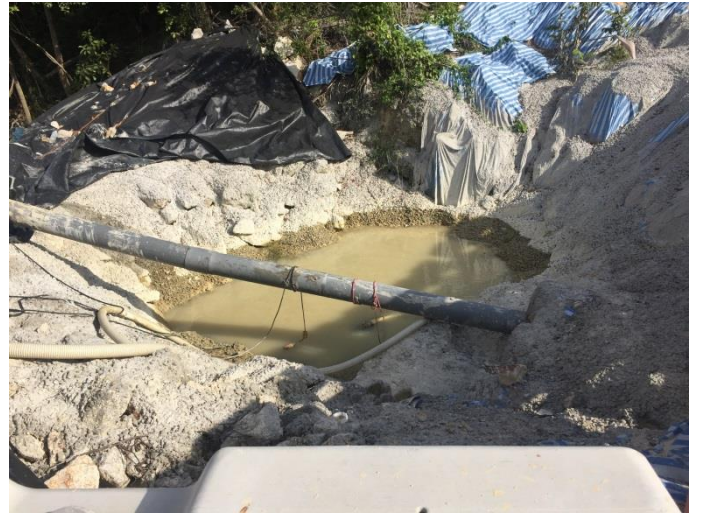
Stream B Pit 1: Treated water was directly discharged to downstream bypass.

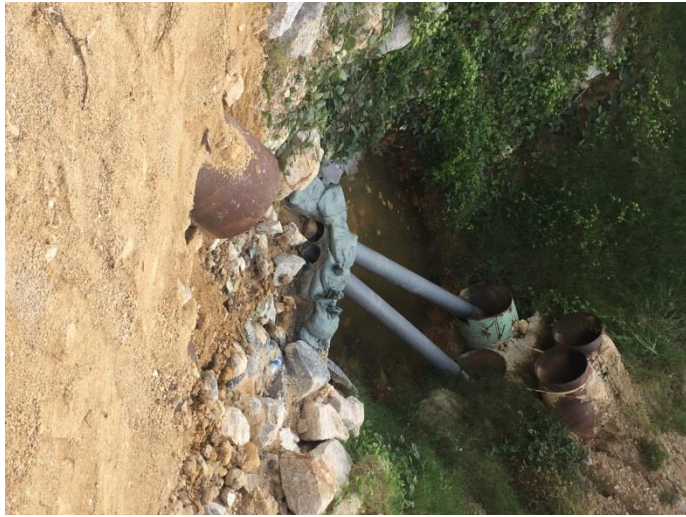
Stream B Pit 2: Treated water was directly discharged to downstream bypass.

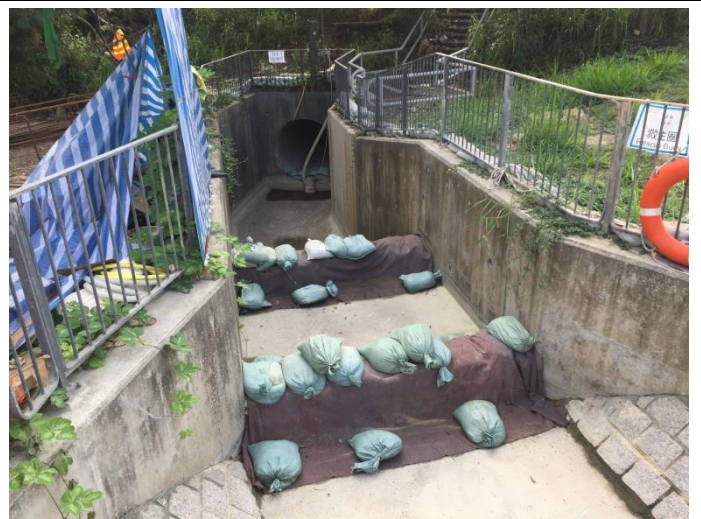
East Portal Cascade: No water is discharged.

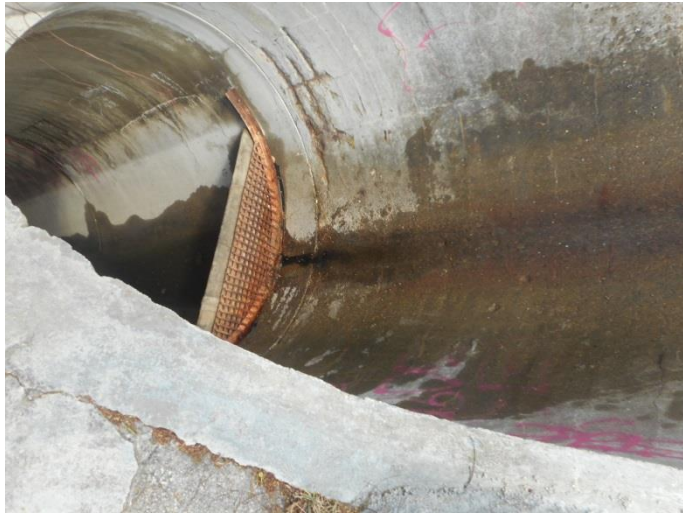
Outfall 1: No water is discharging.

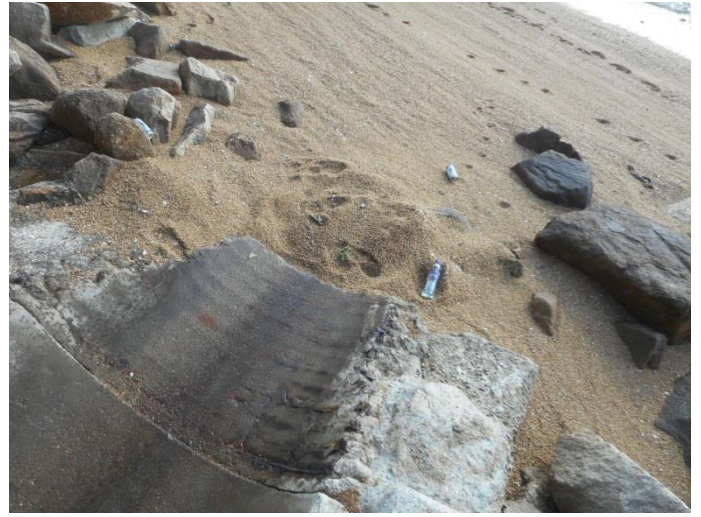
Outfall 1: No water is discharging.

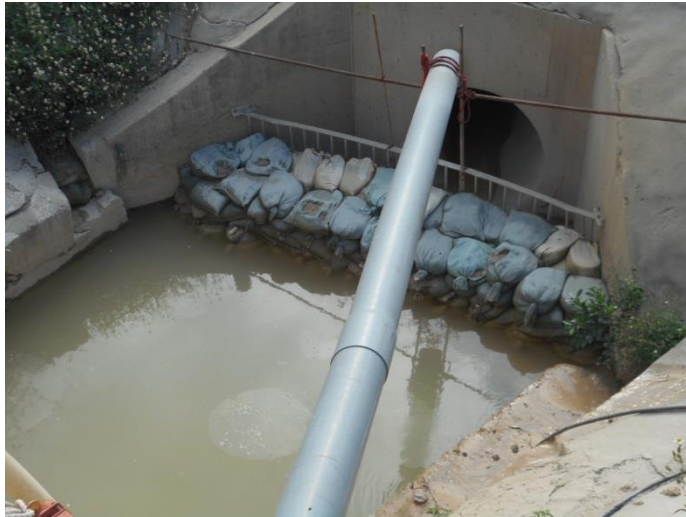
Stream A Outfall: No water is discharging.

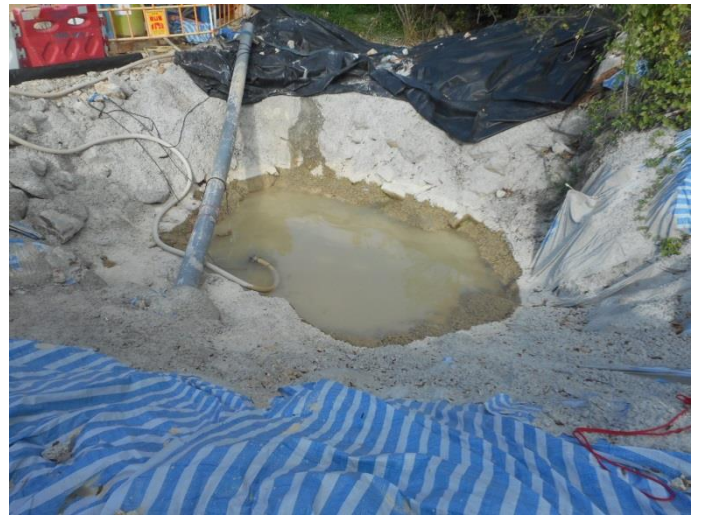
Stream B Pit 1: Treated water was directly discharged to downstream bypass.

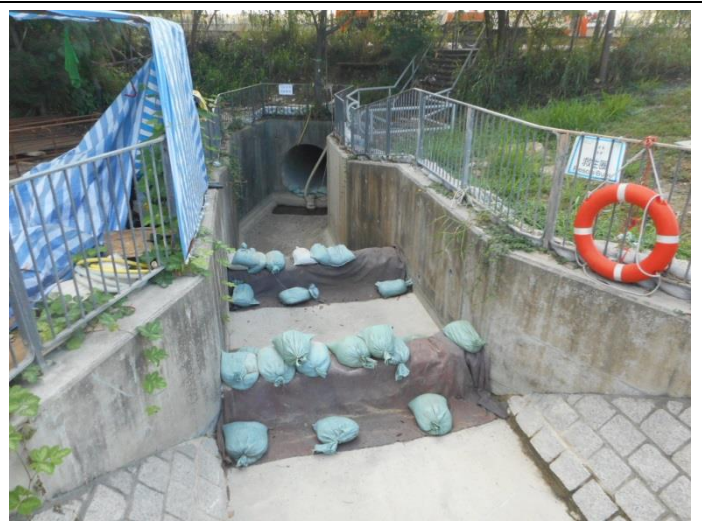
East Portal Cascade: No water is discharged.

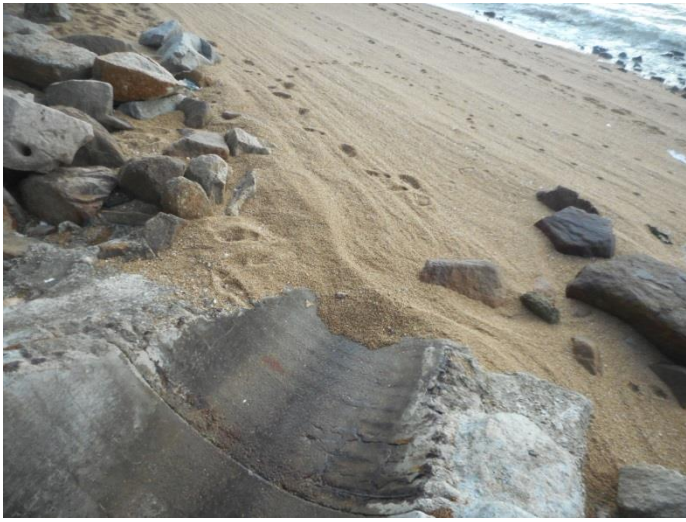
Outfall 1: No water is discharging.

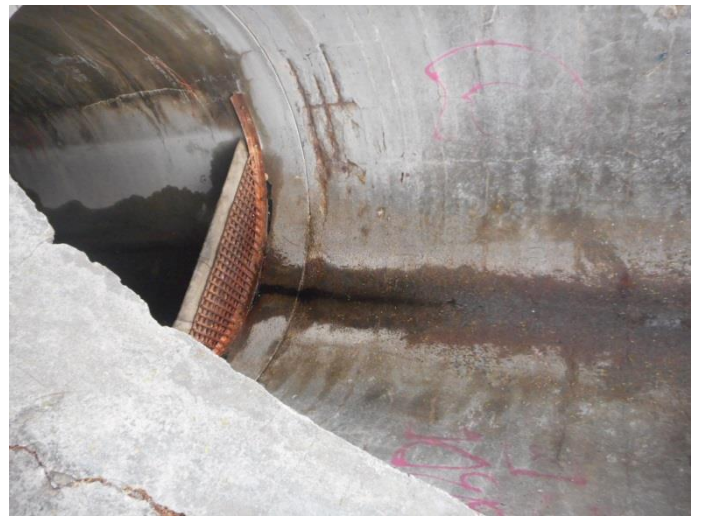
Outfall 1: No water is discharging.

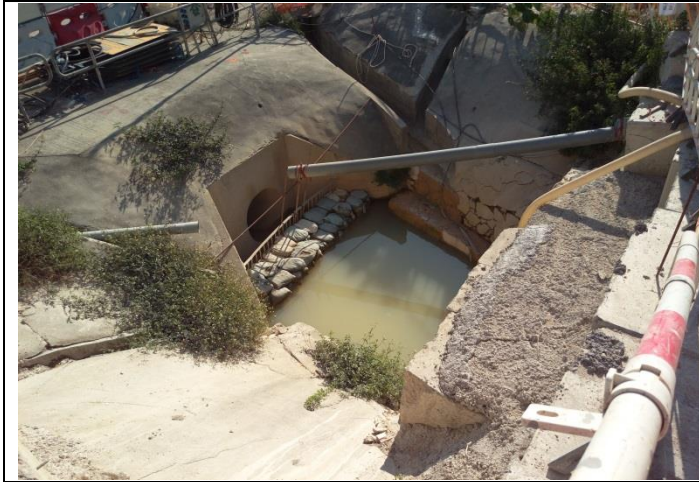
Stream A Outfall: No water is discharging.

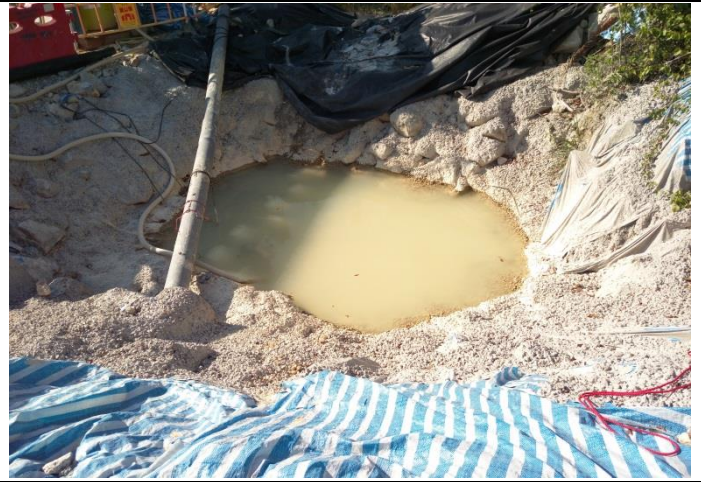
Stream B Pit 1: Treated water was directly discharged to downstream bypass.

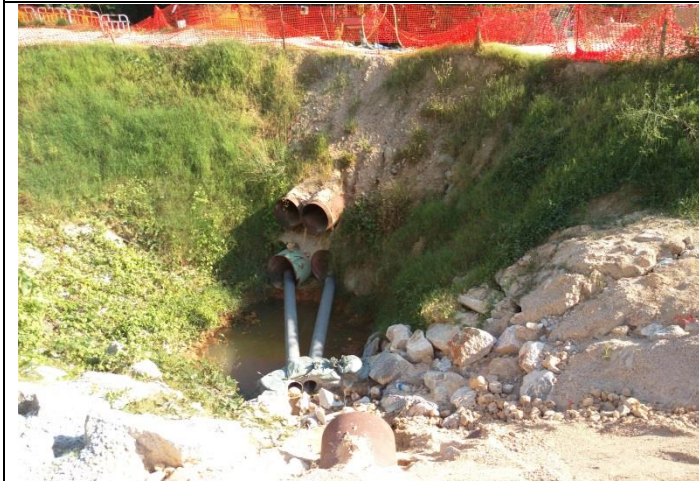
Stream B Pit 2: Treated water was directly discharged to downstream bypass.

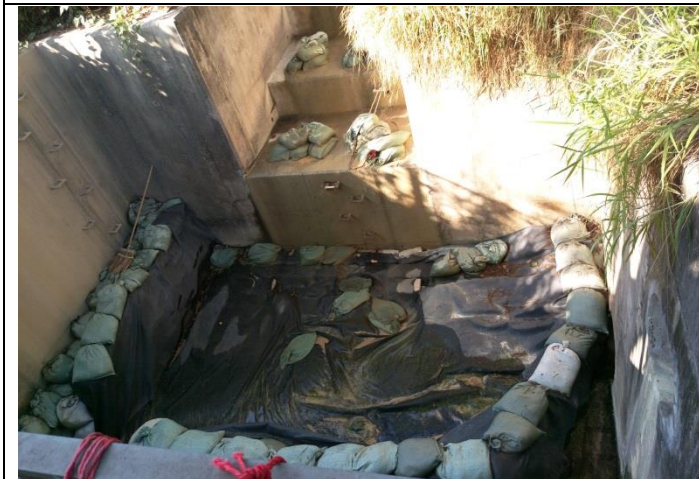
Stream B Outfall: No water is discharged.

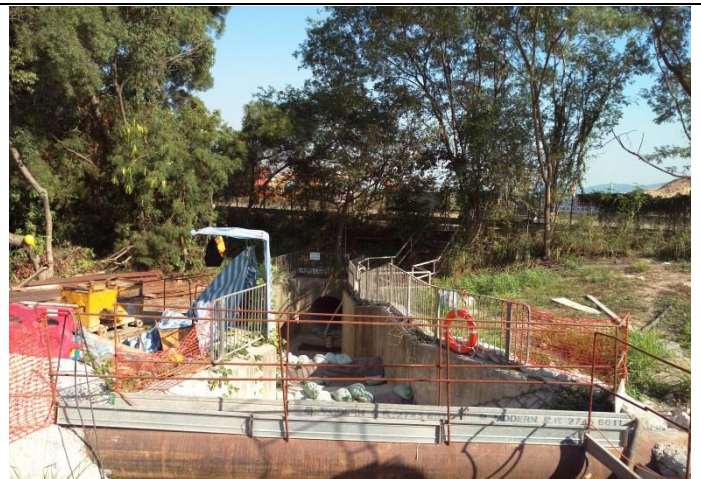
East Portal Cascade: No water is discharged.

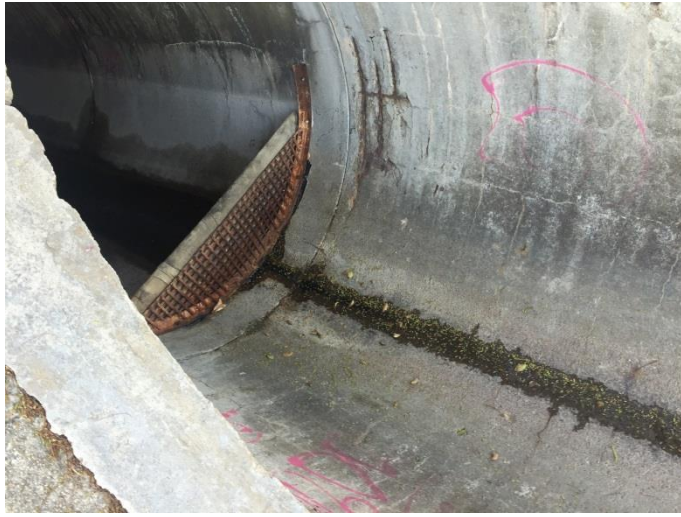
Outfall 1: No water is discharging.

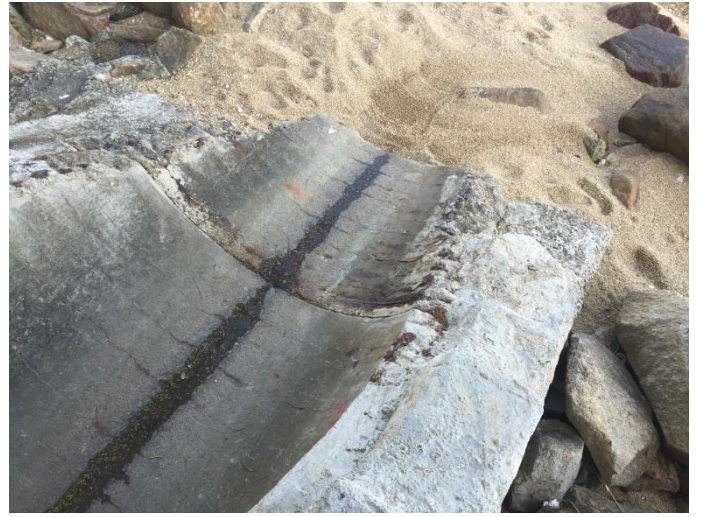
Outfall 1: No water is discharging.

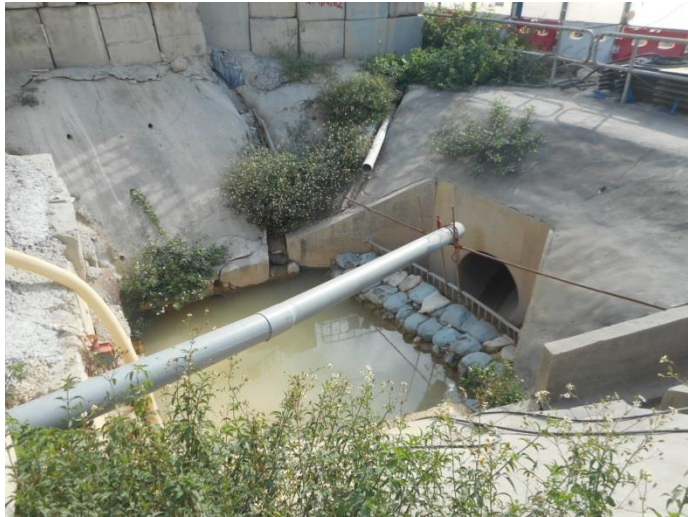
Stream A Outfall: No water is discharging.

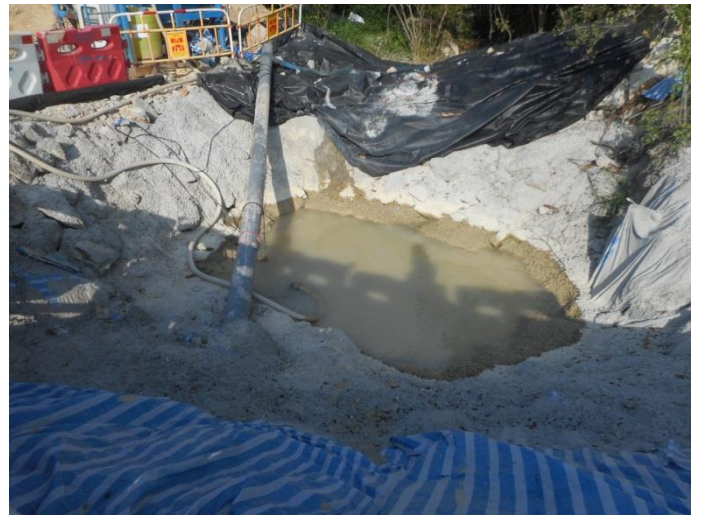
Stream B Pit 1: Treated water was directly discharged to downstream bypass.

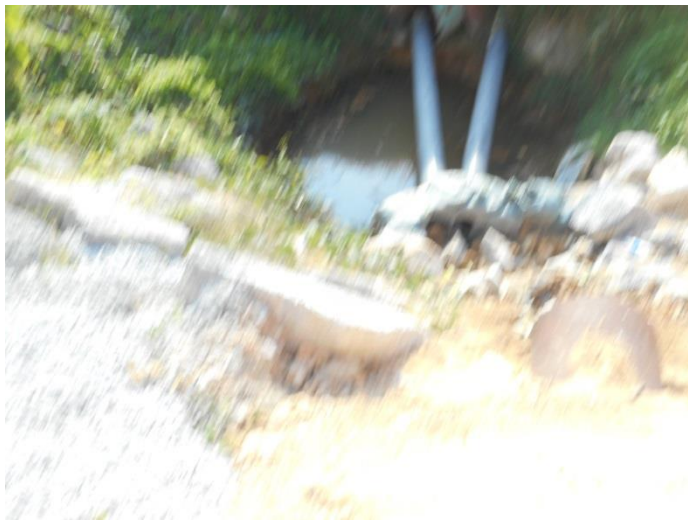
Stream B Pit 2: Treated water was directly discharged to downstream bypass.

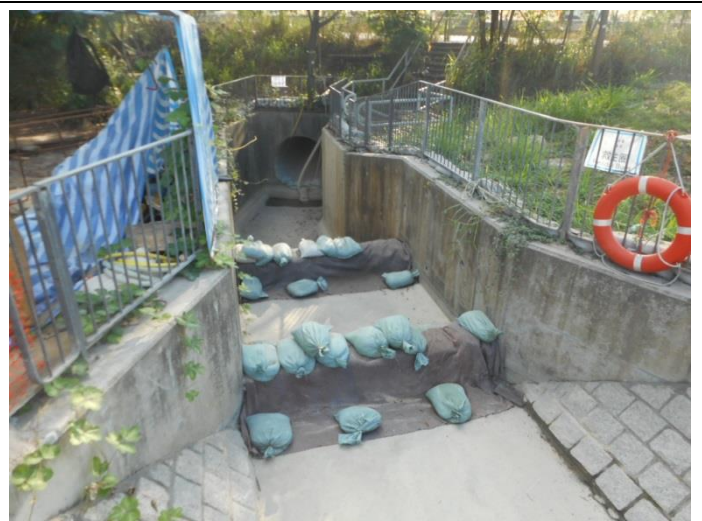
East Portal Cascade: No water is discharged.

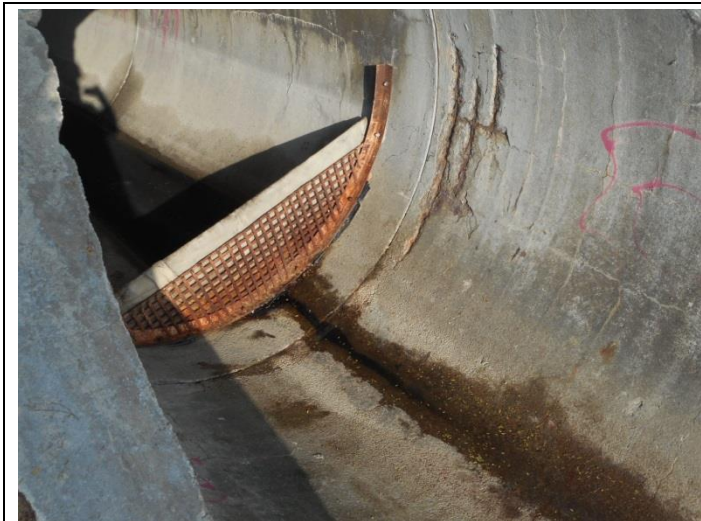
Outfall 1: No water is discharging.

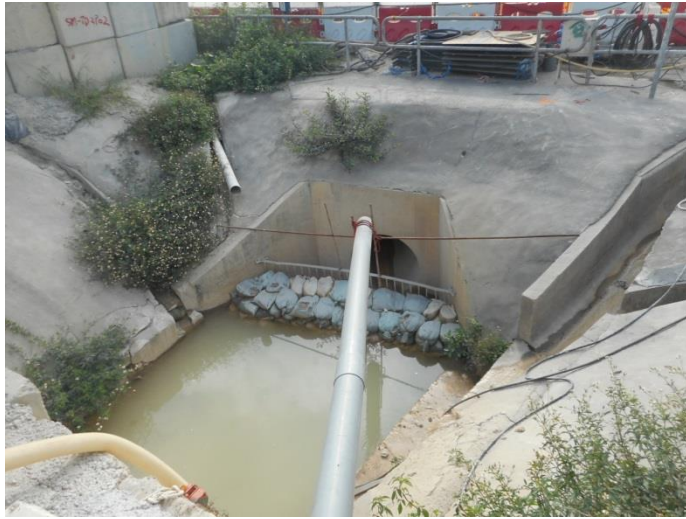
Stream A Outfall: No water is discharging.

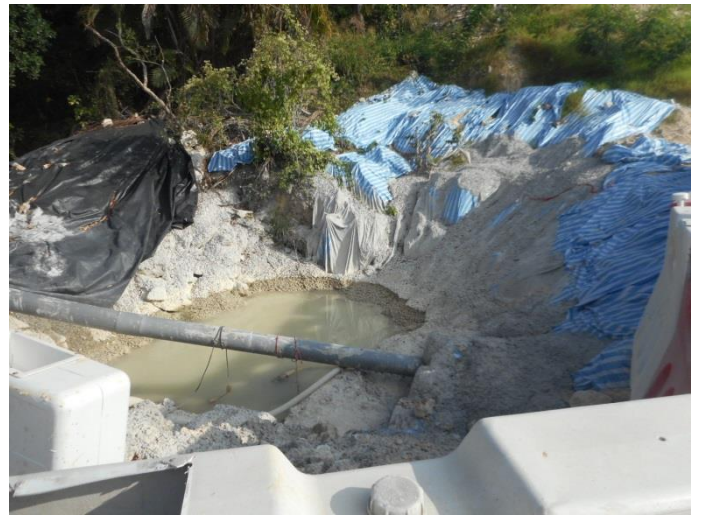
Stream B Pit 1: Treated water was directly discharged to downstream bypass.

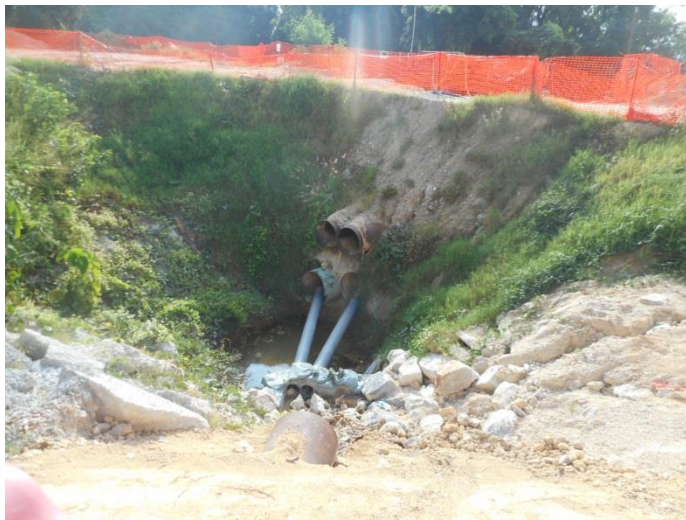
Stream B Pit 2: Treated water was directly discharged to downstream bypass.

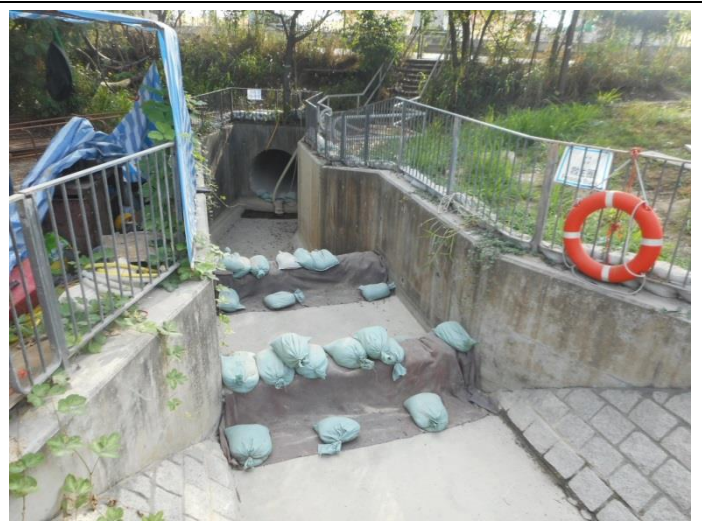
East Portal Cascade: No water is discharged.

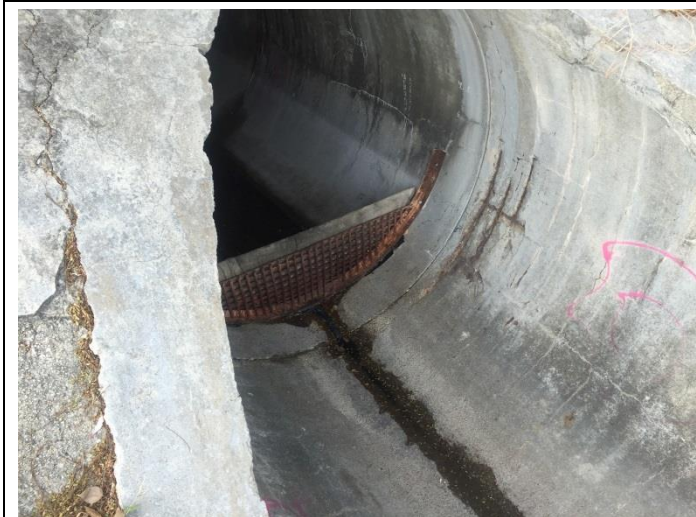
Outfall 1: No water is discharging.

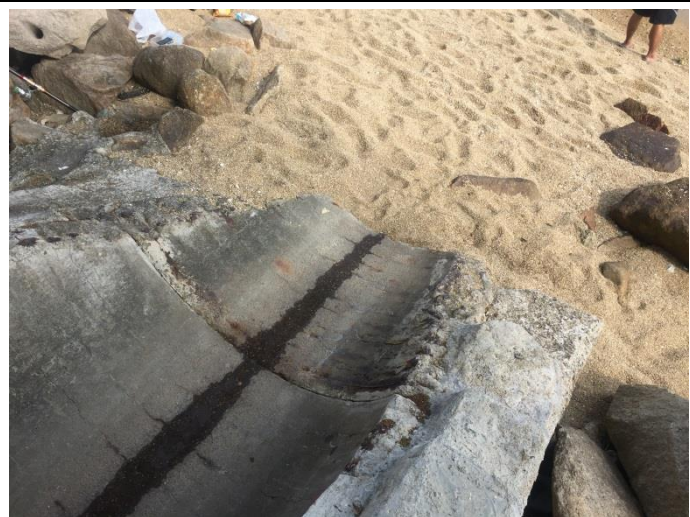
Outfall 1: No water is discharging.

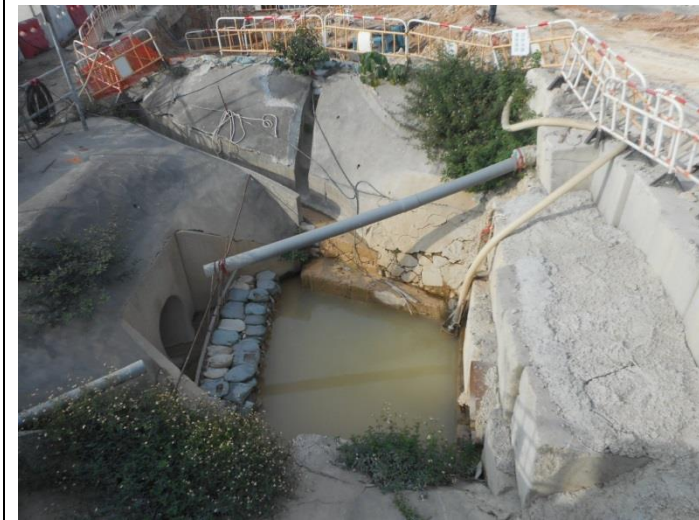
Stream A Outfall: No water is discharging.

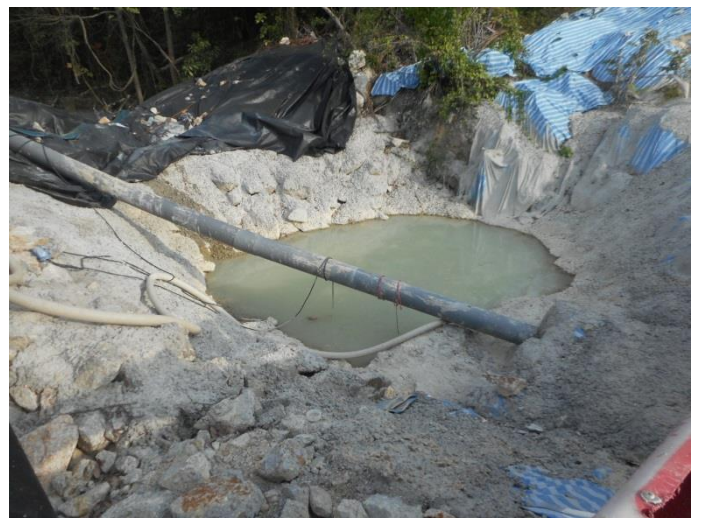
Stream B Pit 1: Treated water was directly discharged to downstream bypass.

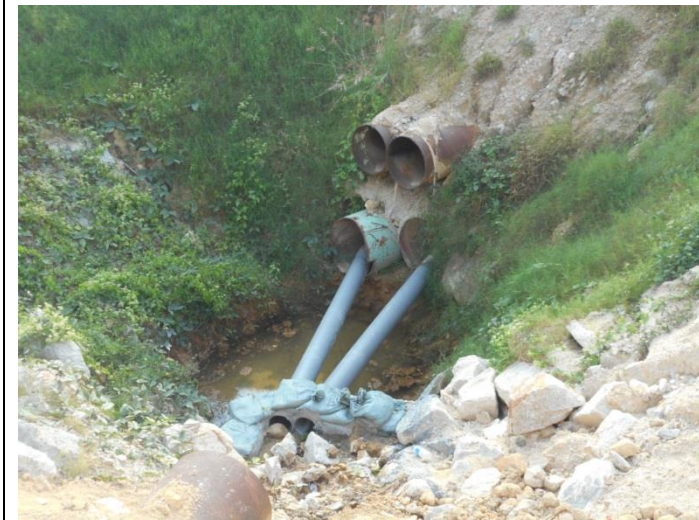
Stream B Pit 2: Treated water was directly discharged to downstream bypass.

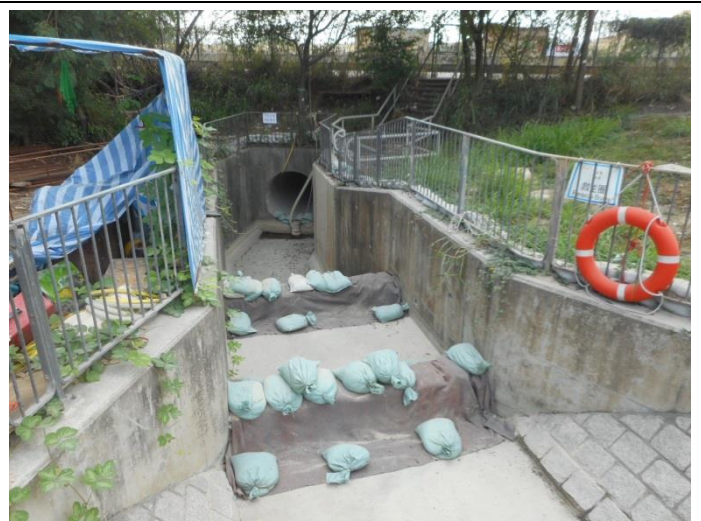
East Portal Cascade: No water is discharged.

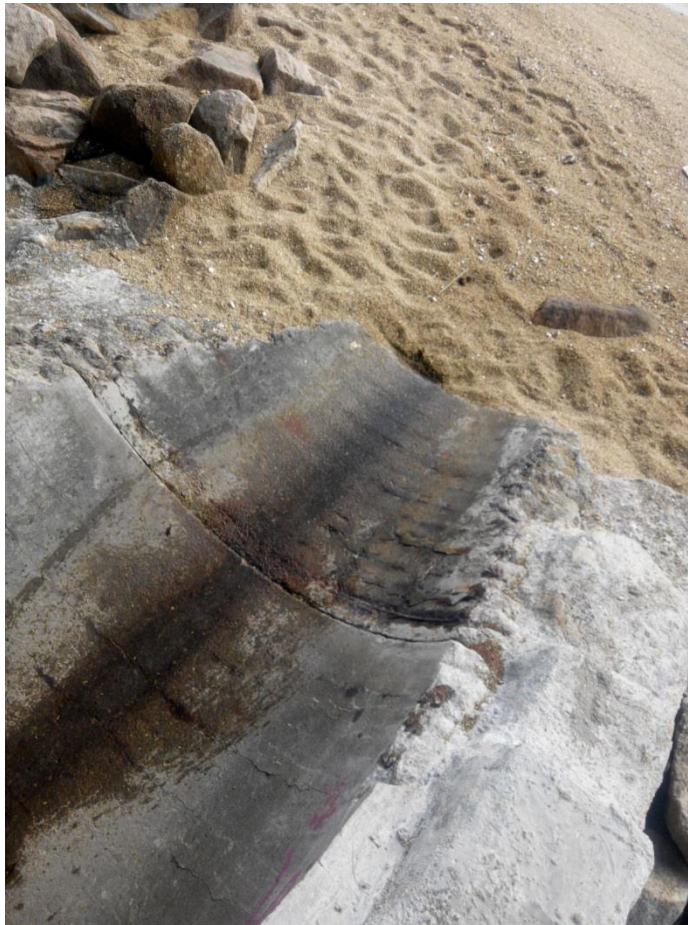
Outfall 1: No water is discharging.

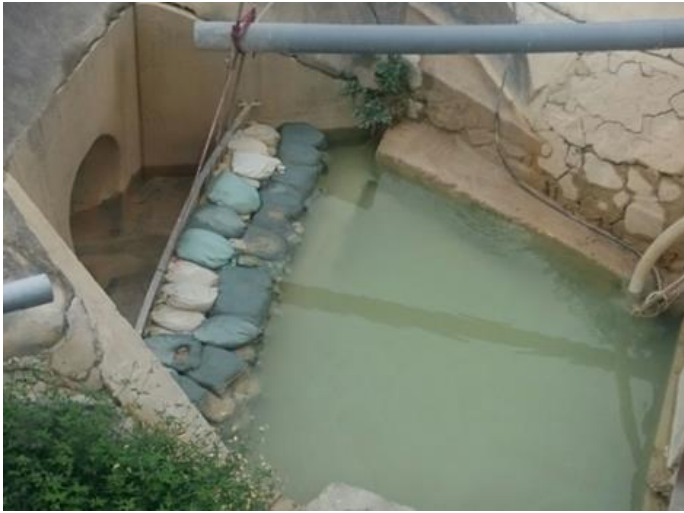
Stream A Outfall: No water is discharging.

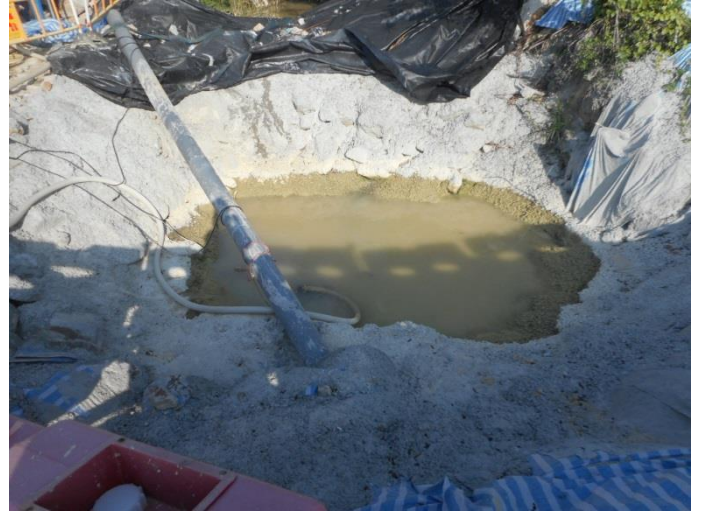
Stream B Pit 1: Treated water was directly discharged to downstream bypass.

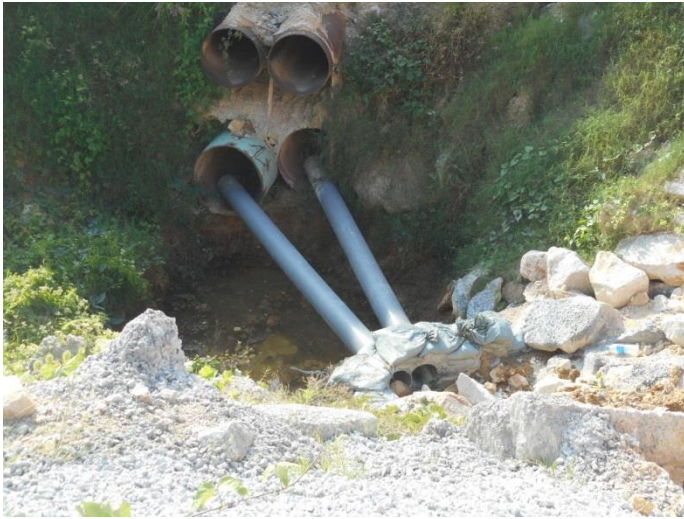
Stream B Pit 2: Treated water was directly discharged to downstream bypass.

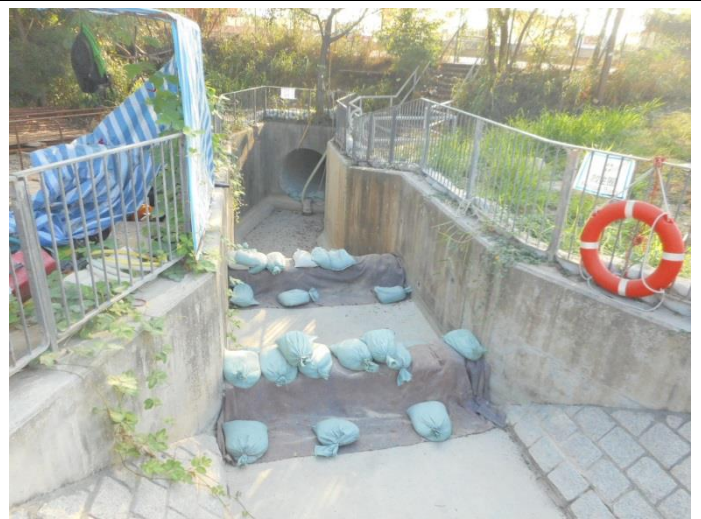
East Portal Cascade: No water is discharged.

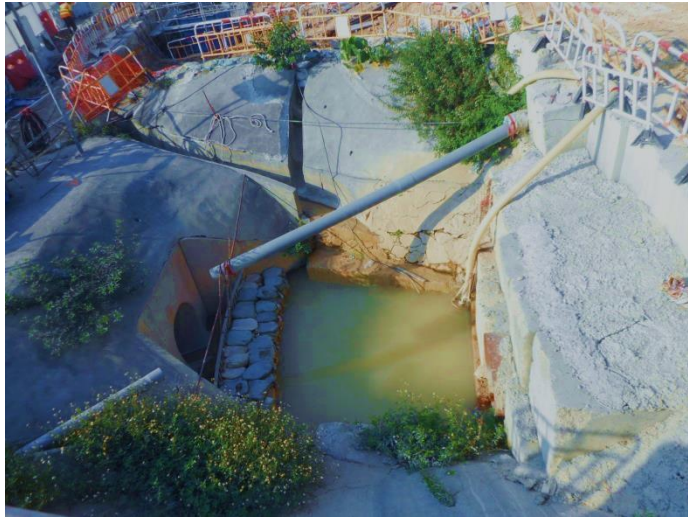
Stream A Outfall: No water is discharging.

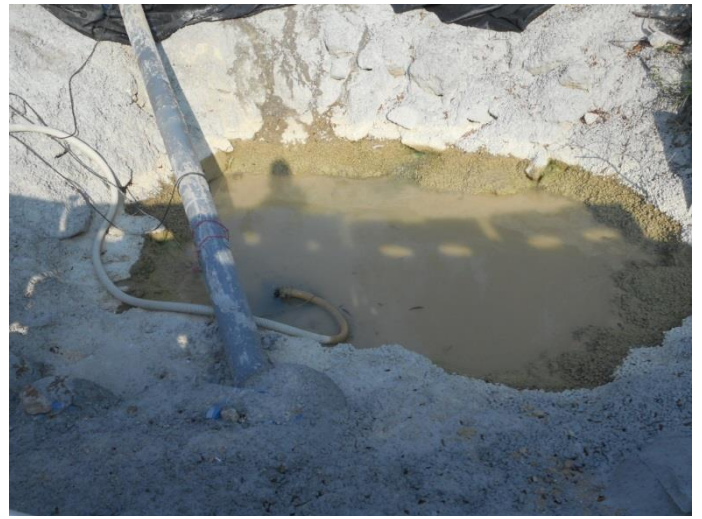
Stream B Pit 1: Treated water was directly discharged to downstream bypass.

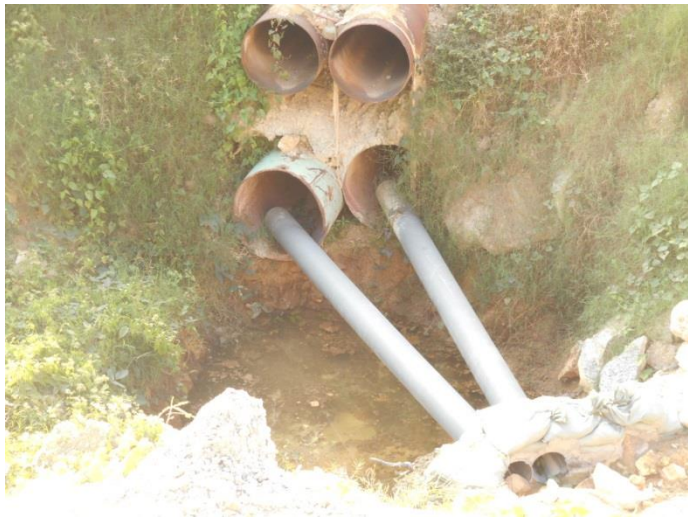
Stream B Pit 2: Treated water was directly discharged to downstream bypass.

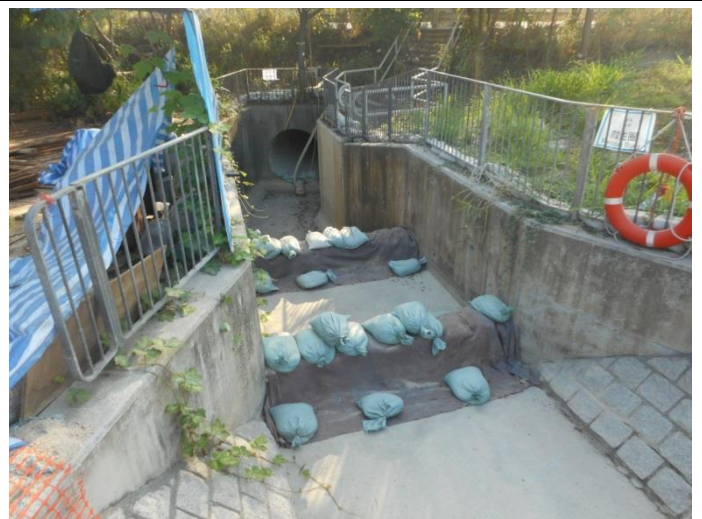
East Portal Cascade: No water is discharged.

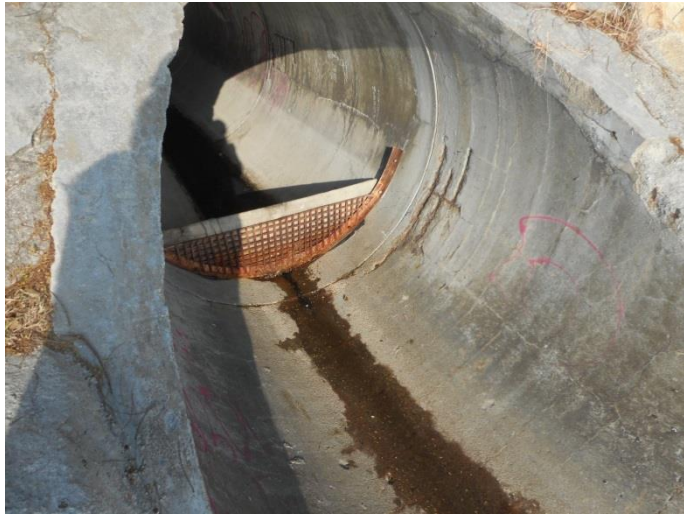
Outfall 1: No water is discharging.

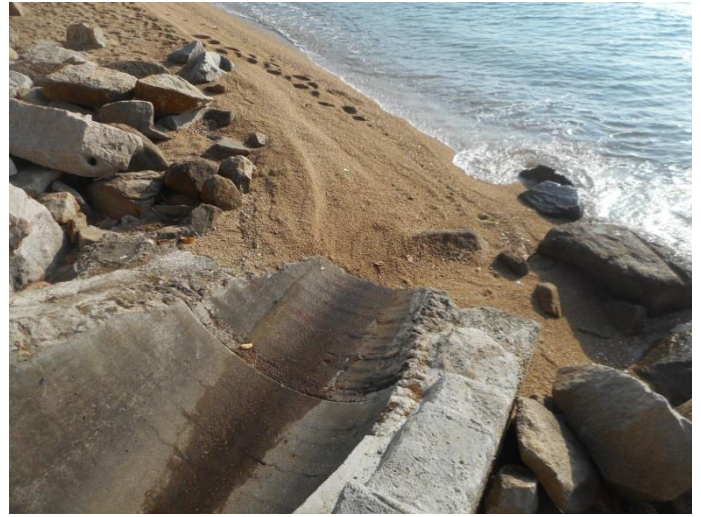
Outfall 1: No water is discharging.

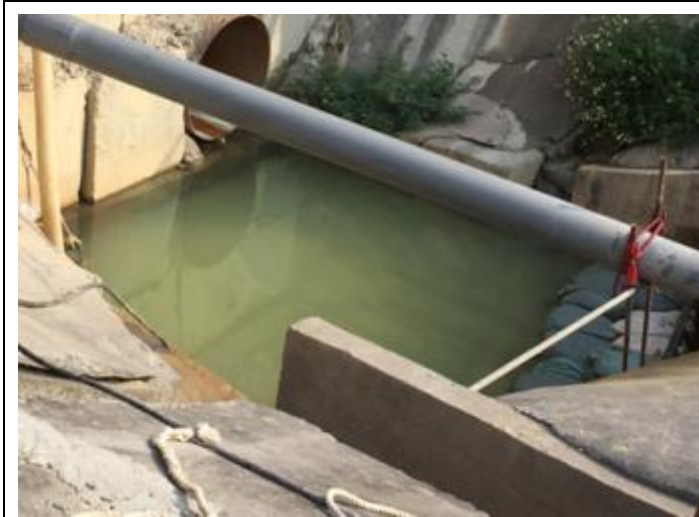
Stream A Outfall: No water is discharging.

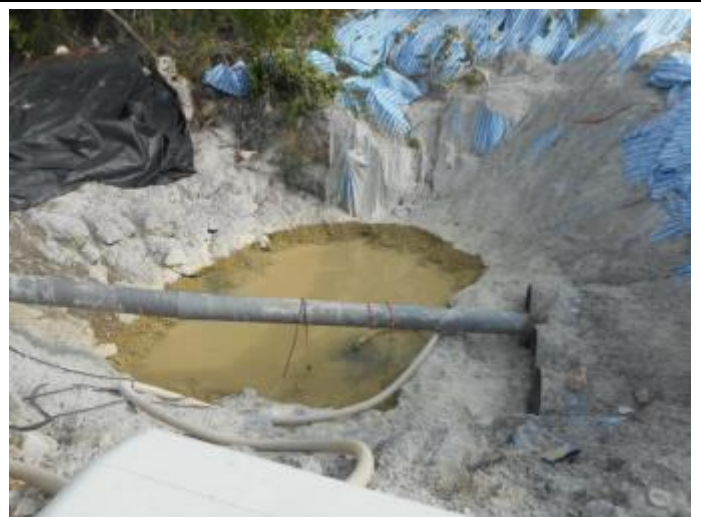
Stream B Pit 1: Treated water was directly discharged to downstream bypass.

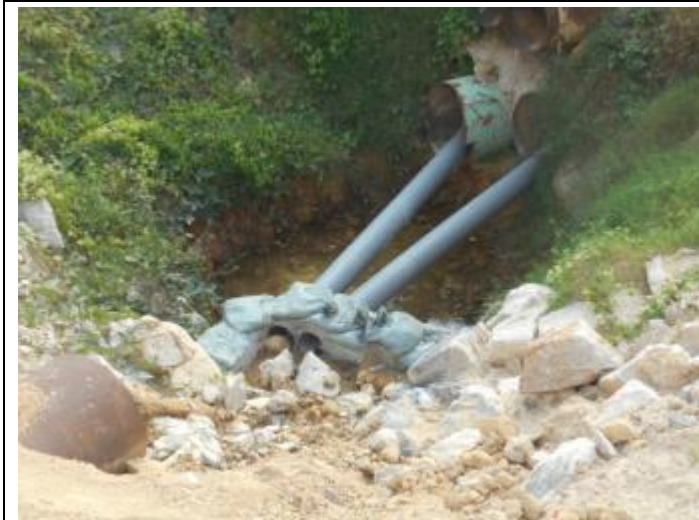
Stream B Pit 2: Treated water was directly discharged to downstream bypass.
