TUEN MUN - CHEK LAP KOK LINK
CONTRACT NO. HY/2013/12 –
NORTHERN CONNECTION TOLL PLAZA AND
ASSOCIATED WORKS

13TH MONTHLY ENVIRONMENTAL MONITORING AND
AUDIT (EM&A) REPORT – NOVEMBER 2015

PREPARED FOR
CRBC AND KADEN JOINT VENTURE

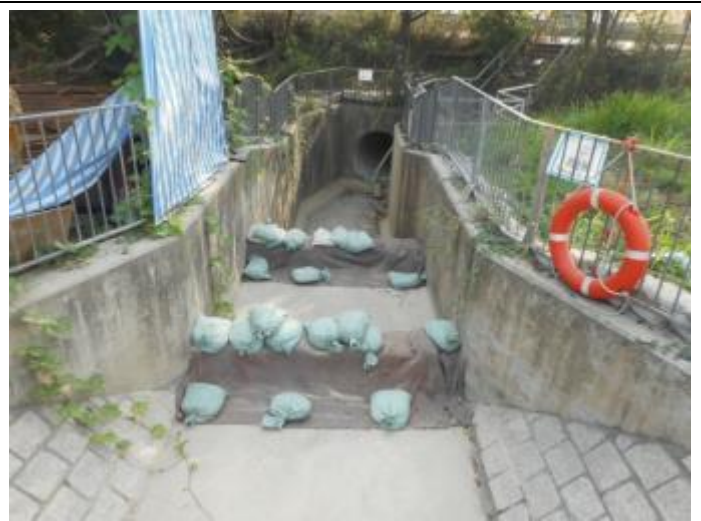
East Portal Cascade: No water is discharged.

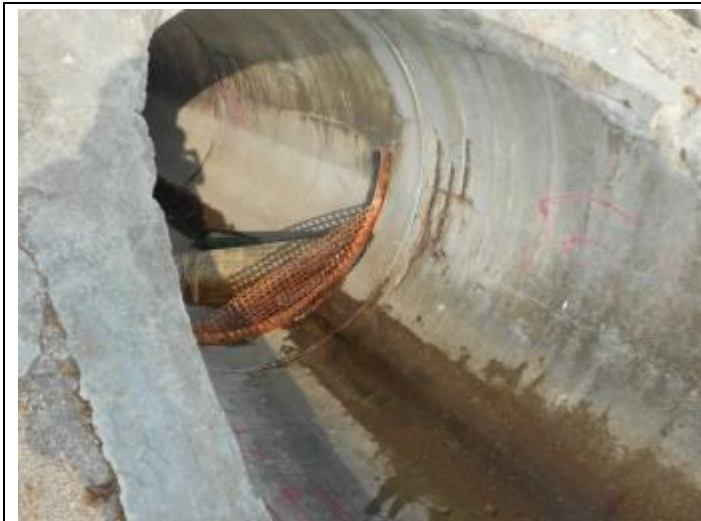
Outfall 1: No water is discharging.

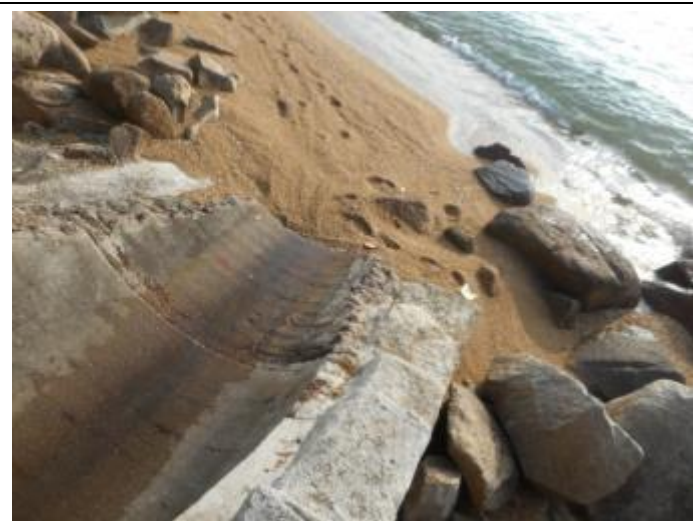
Outfall 1: No water is discharging.

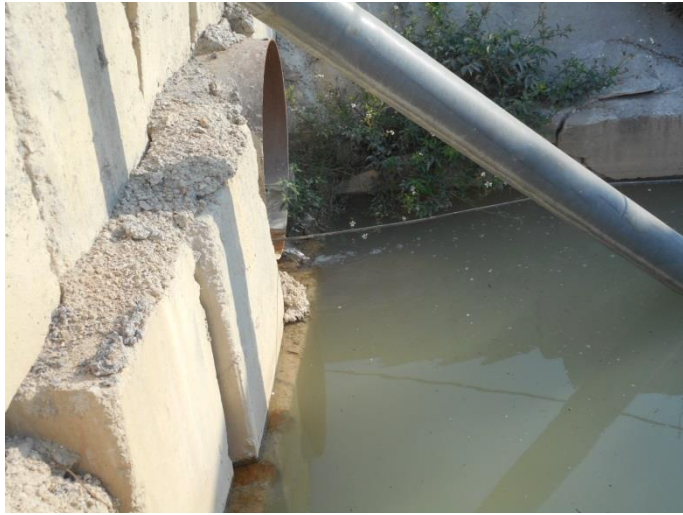
Stream A Outfall: No water is discharging.

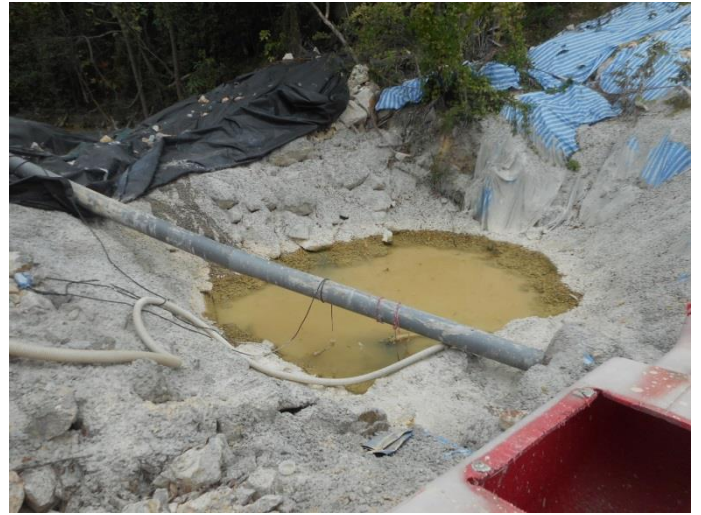
Stream B Pit 1: Treated water was directly discharged to downstream bypass.

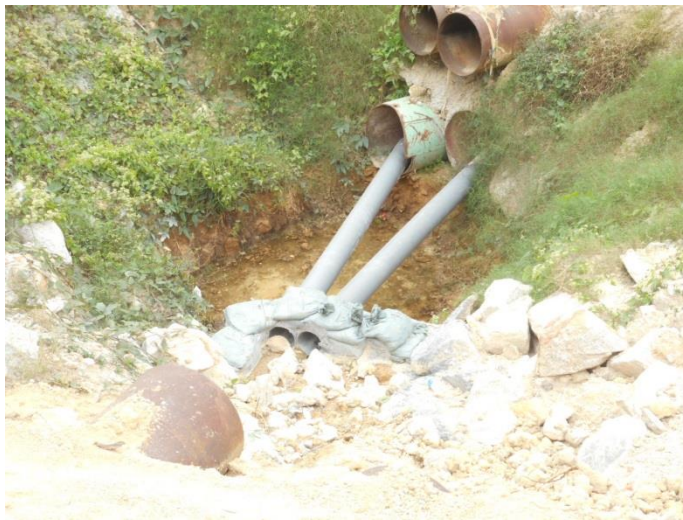
Stream B Pit 2: Treated water was directly discharged to downstream bypass.

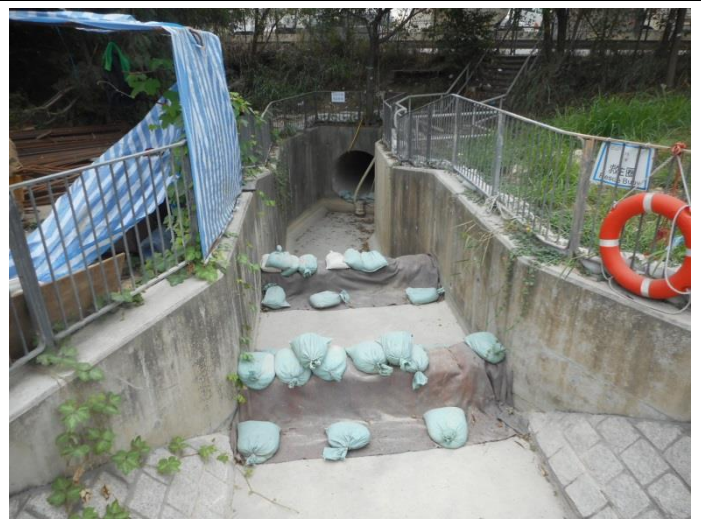
East Portal Cascade: No water is discharged.

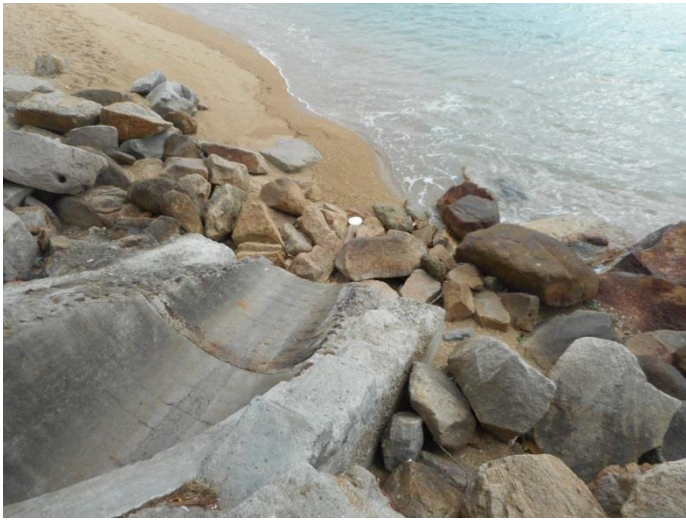
Outfall 1: No water is discharging.

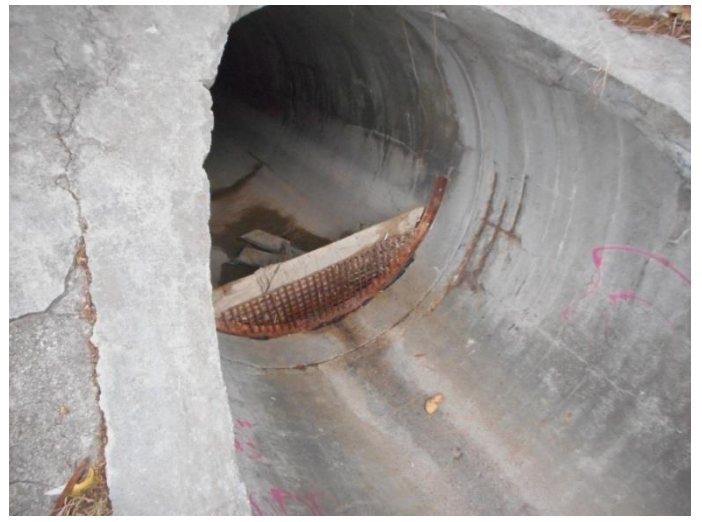
Outfall 1: No water is discharging.

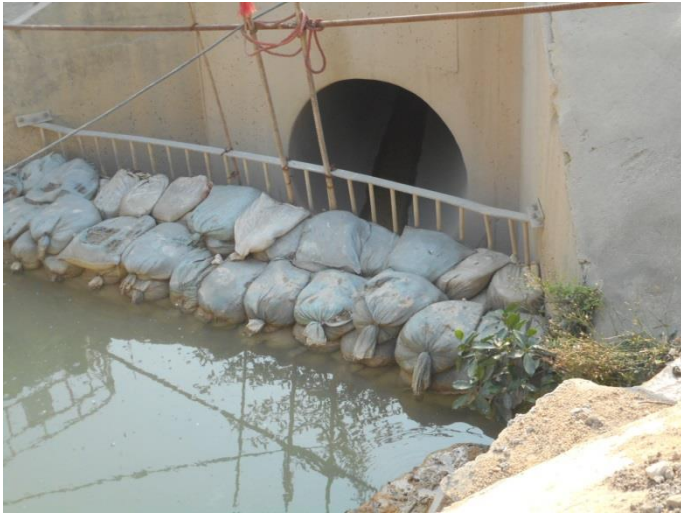
Stream A Outfall: No water is discharging.

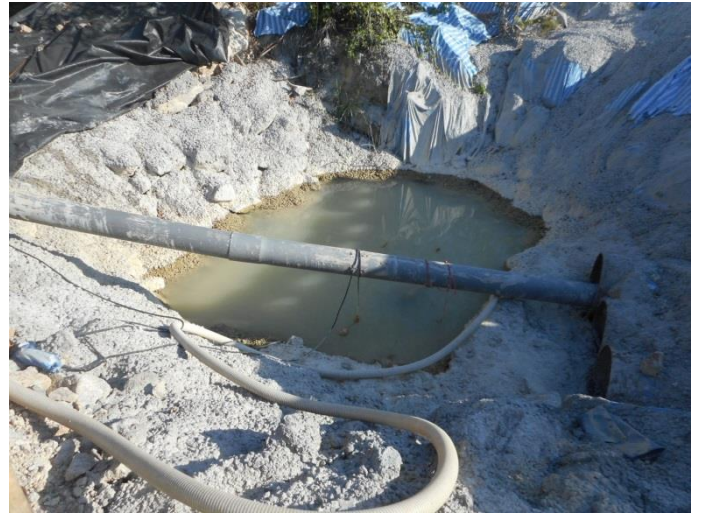
Stream B Pit 1: Treated water was directly discharged to downstream bypass.

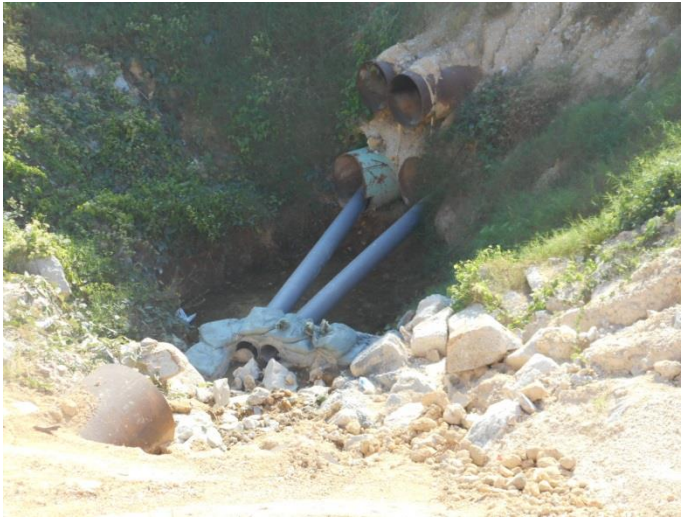
Stream B Pit 2: Treated water was directly discharged to downstream bypass.

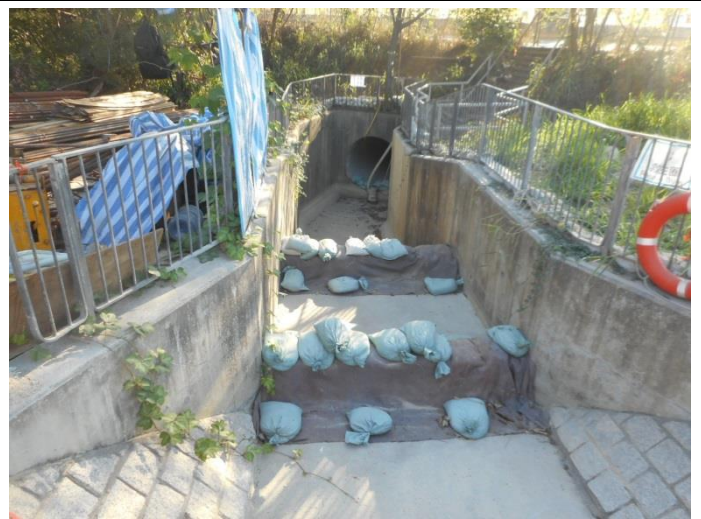
East Portal Cascade: No water is discharged.

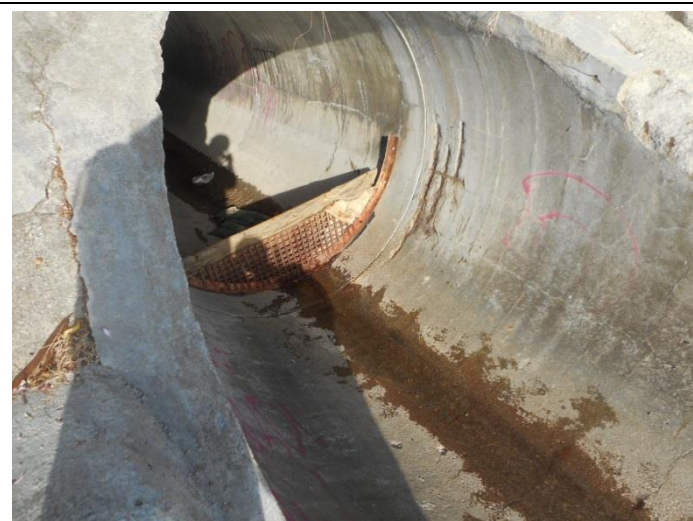
Outfall 1: No water is discharging.

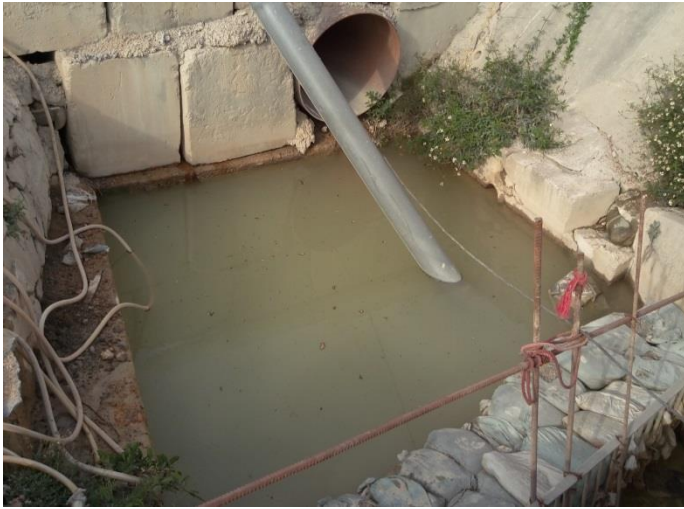
Stream A Outfall: No water is discharging.

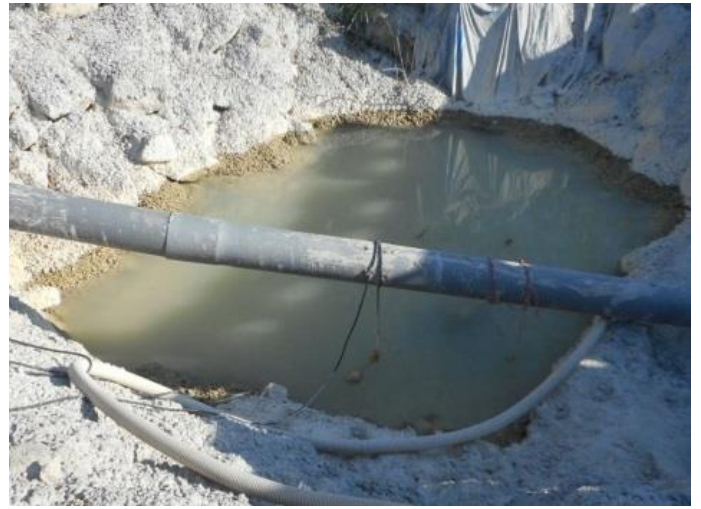
Stream B Pit 1: Treated water was directly discharged to downstream bypass.

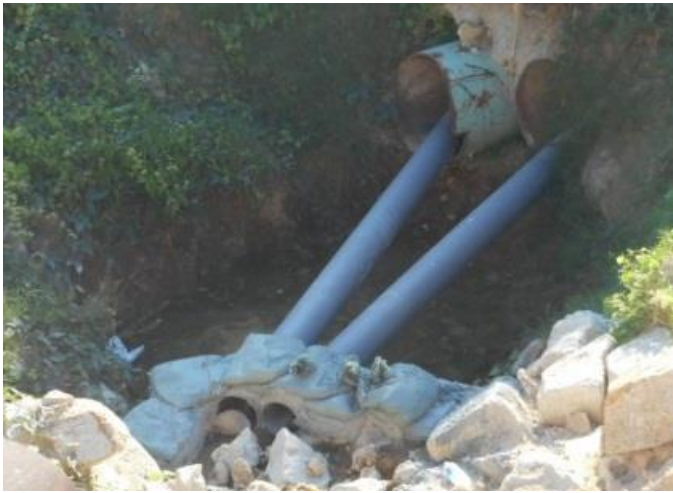
Stream B Pit 2: Treated water was directly discharged to downstream bypass.

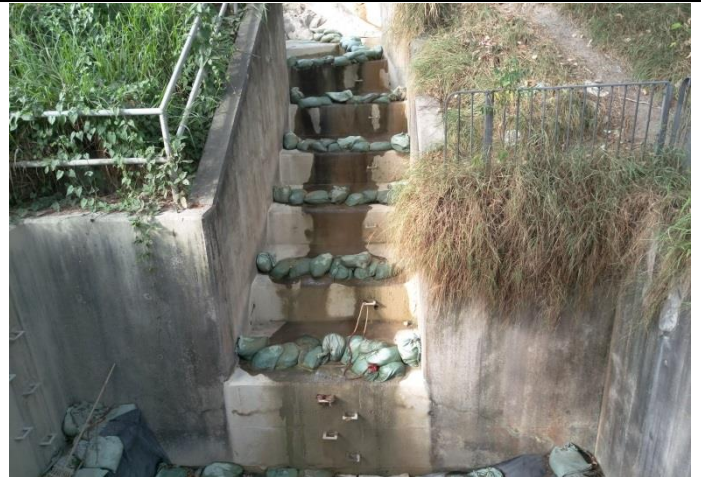
Stream B Outfall: Cascade step channel condition

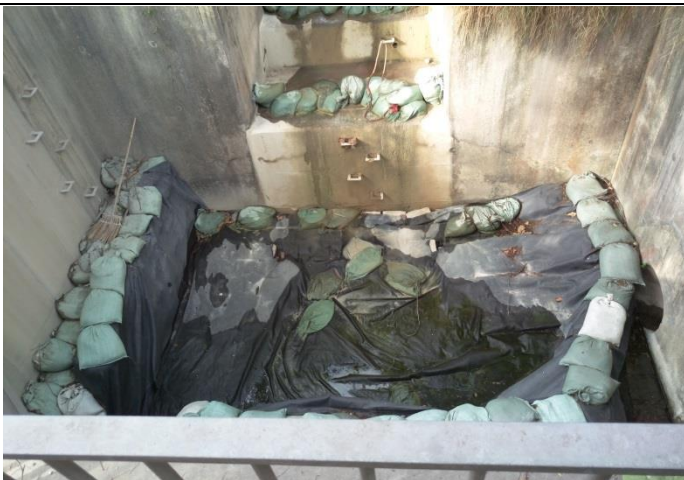
Stream B Outfall: No water is discharged.

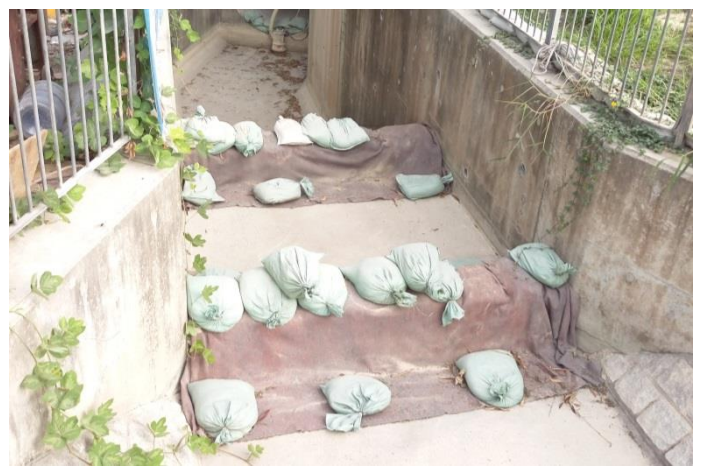
East Portal Cascade: No water is discharged.

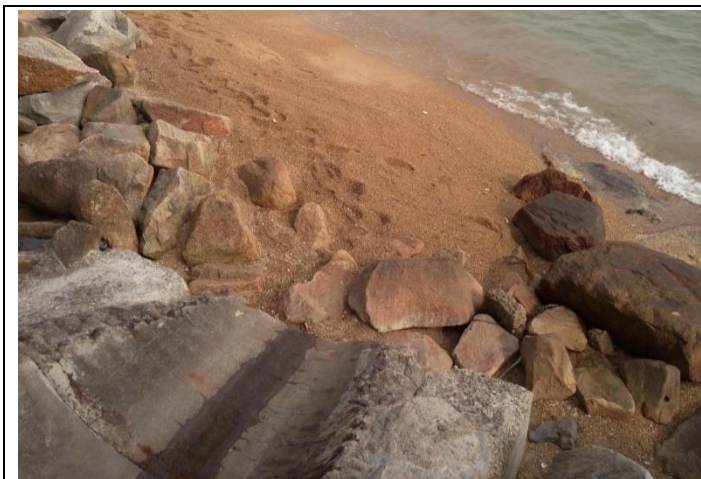
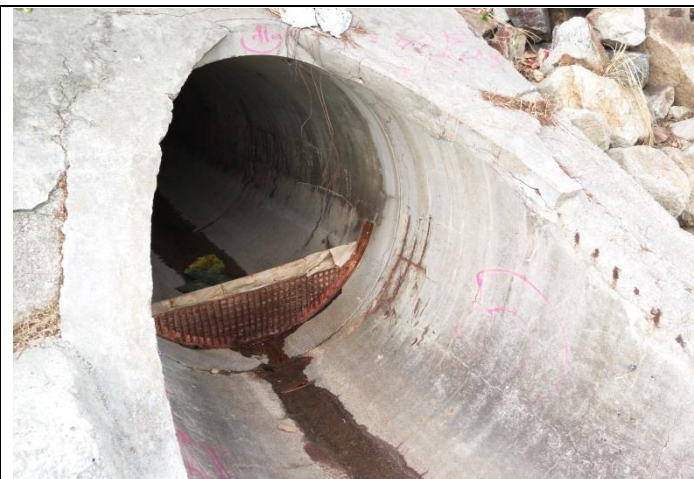
Outfall 1: No water is discharging.

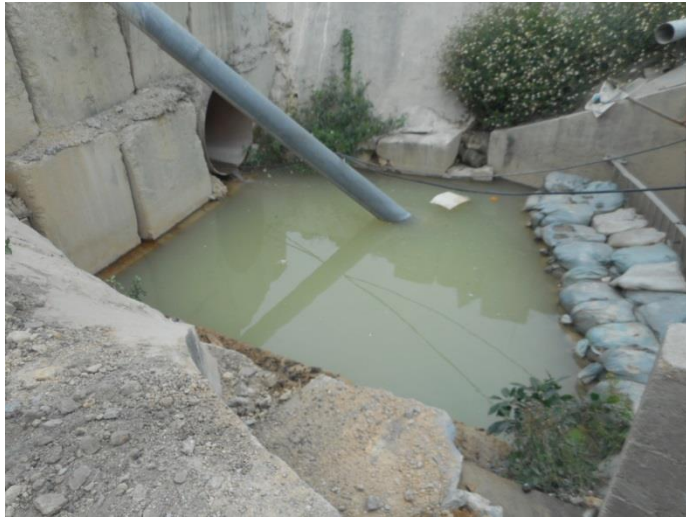
Stream A Outfall: No water is discharging.

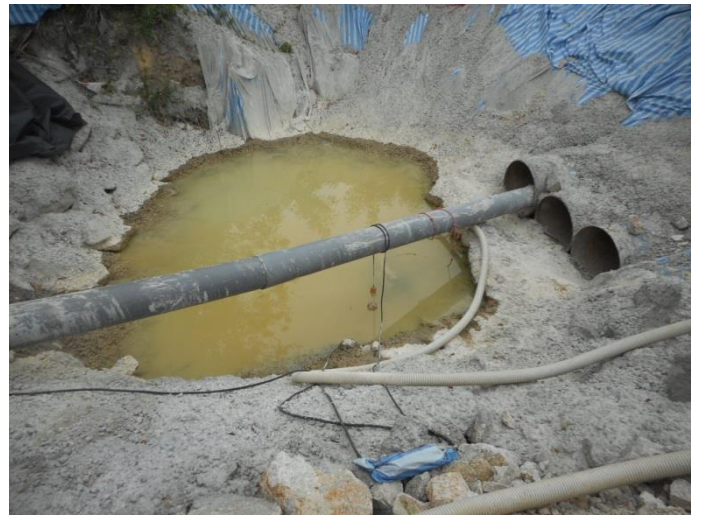
Stream B Pit 1: Treated water was directly discharged to downstream bypass.

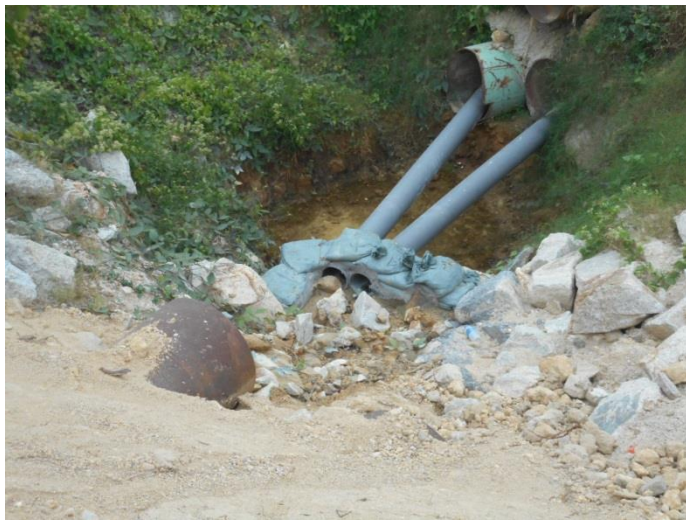
Stream B Pit 2: Treated water was directly discharged to downstream bypass.

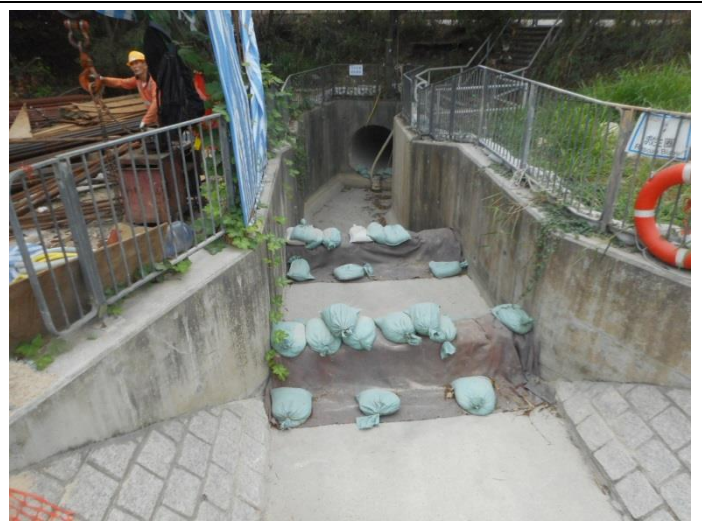
East Portal Cascade: No water is discharged.

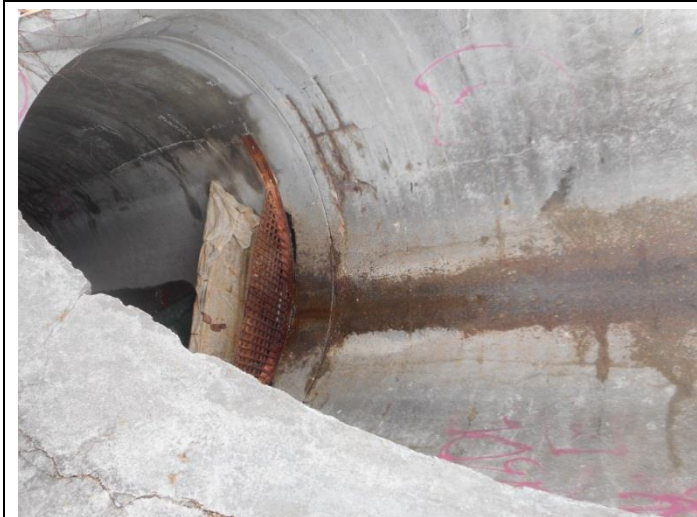
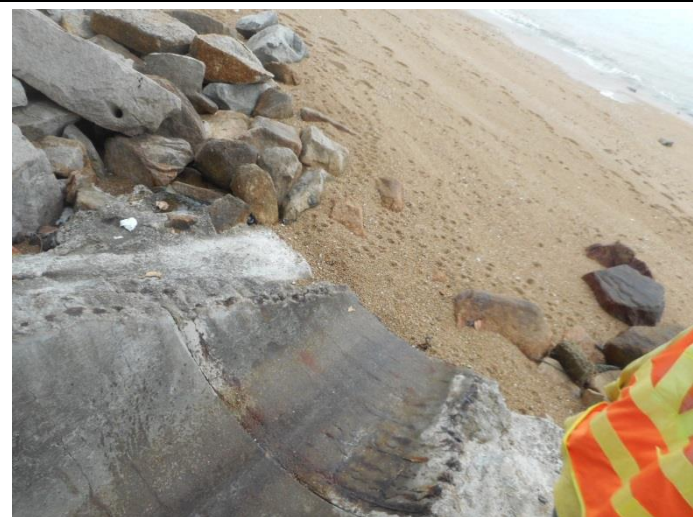
Outfall 1: No water is discharging.
