The Jockey Club CPS Limited

Central Police Station Conservation
and Revitalisation Project:
73rd Monthly EM&A Report
(1 November to 30 November 2017)

Environmental Resources Management

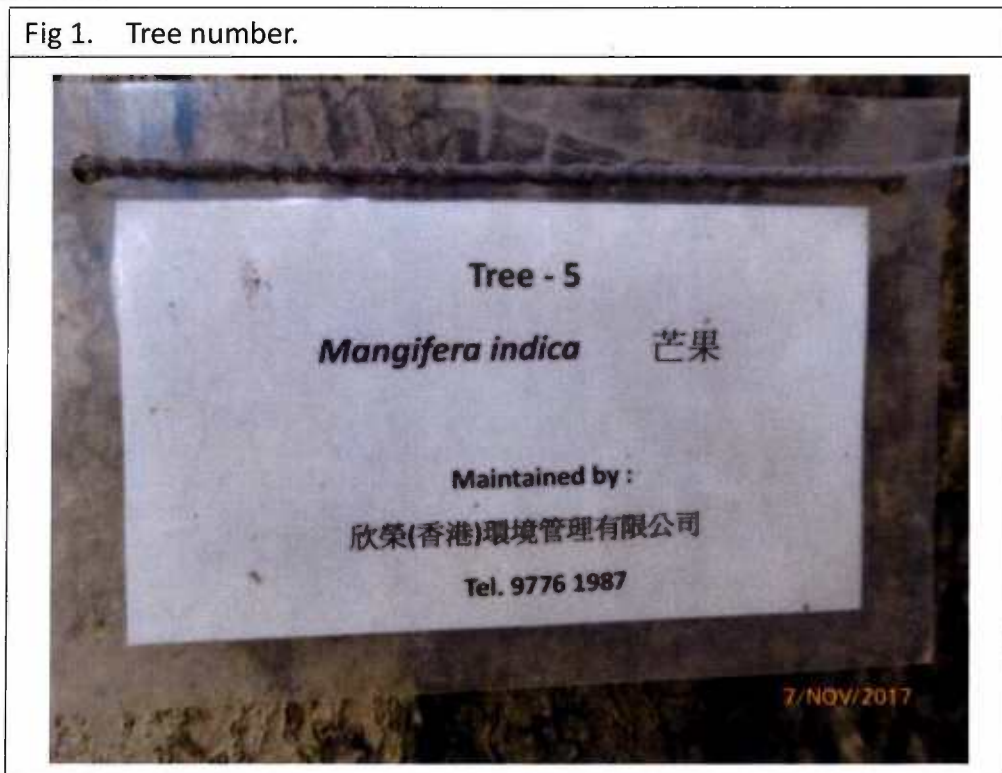
Fig 2. The root collar is normal. The planter is covered with small pieces of pine bark.

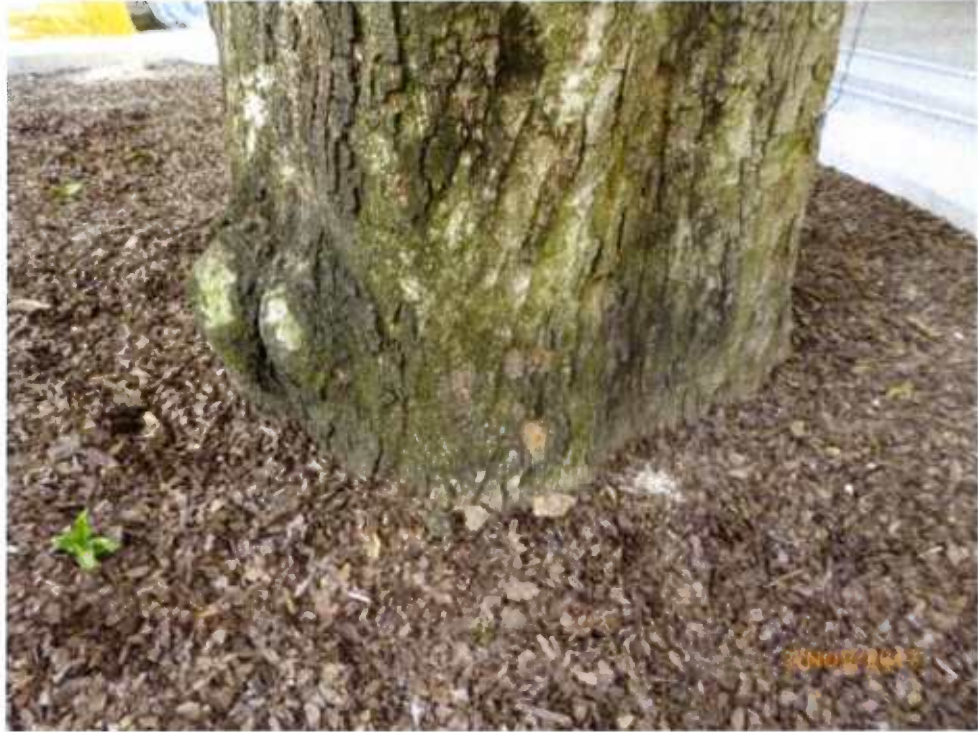
Fig. 3 Health condition of the lower trunk is fair.

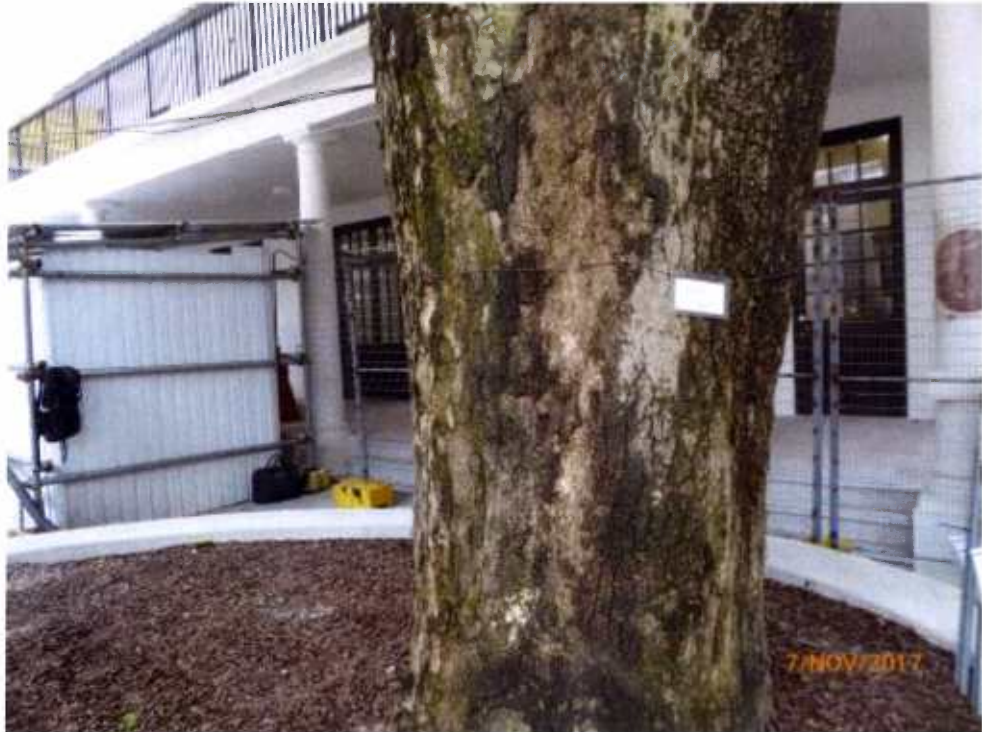
Fig. 4 Health condition of the mid trunk is fair.

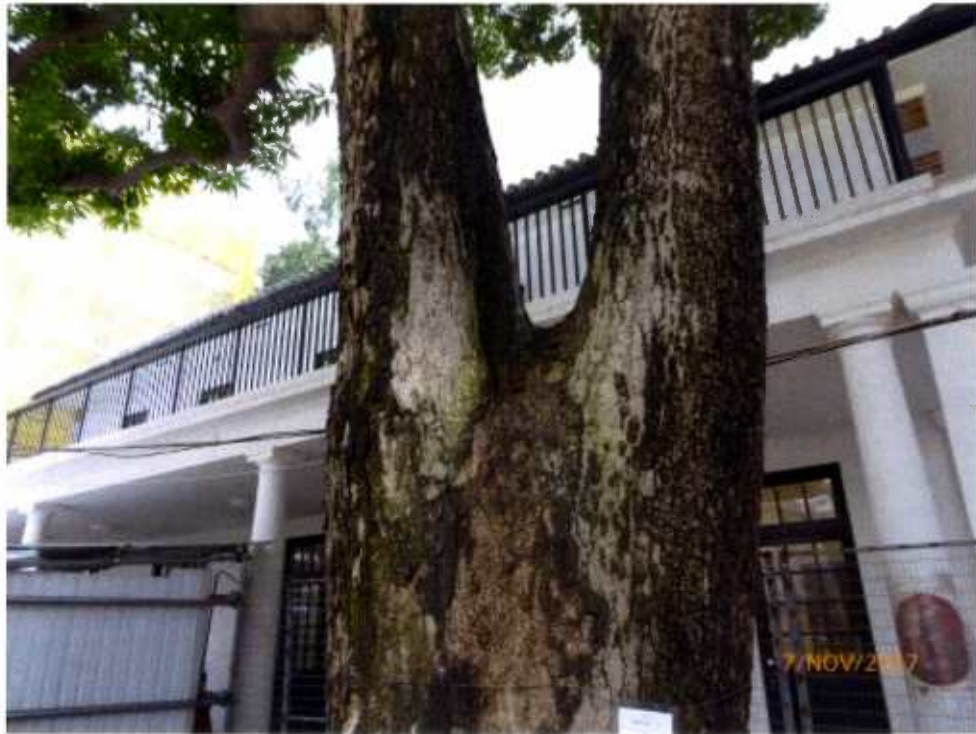
Fig. 5 Health condition of the upper trunk also is fair.

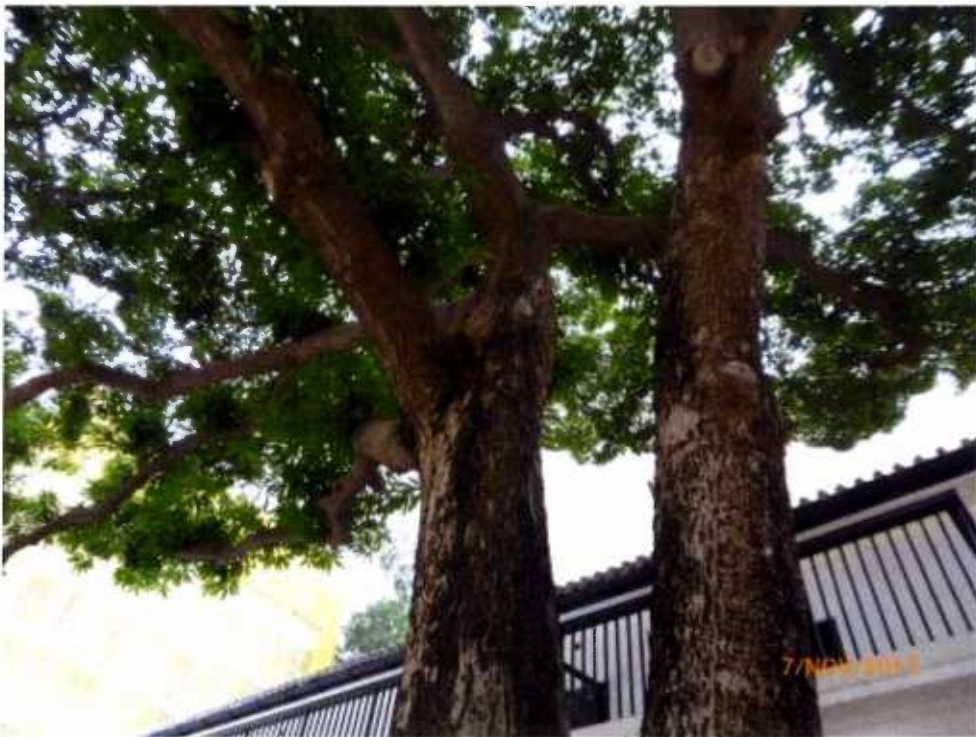
Fig. 6 The crown is full of vigorous and green leaves.

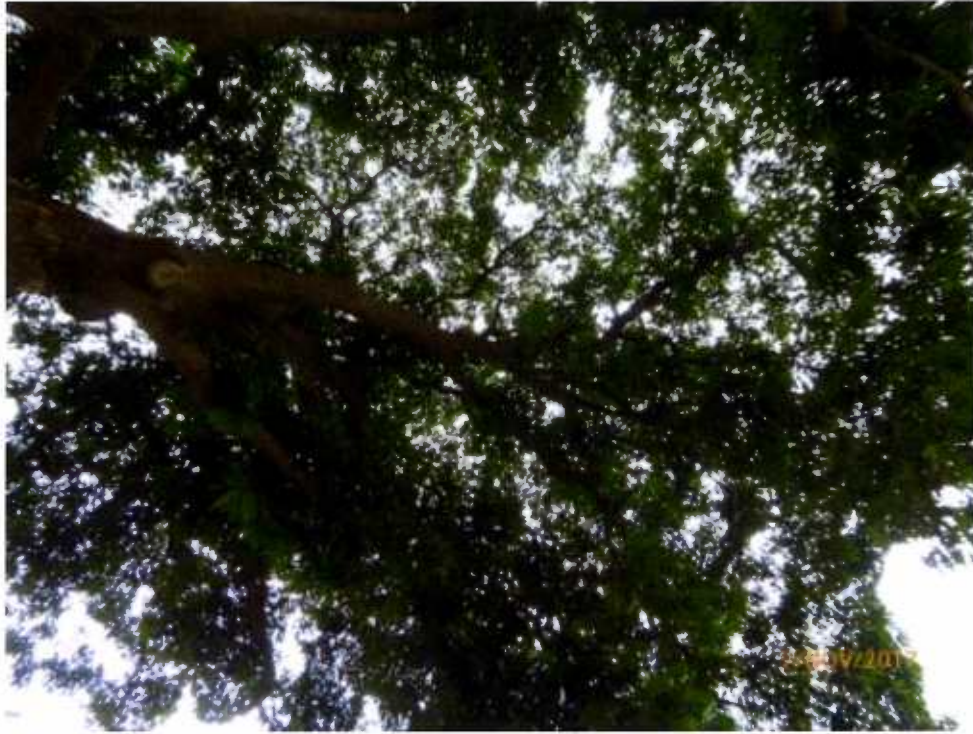
Fig. 7 Vigorous and green leaves also are growing on the lower branches.

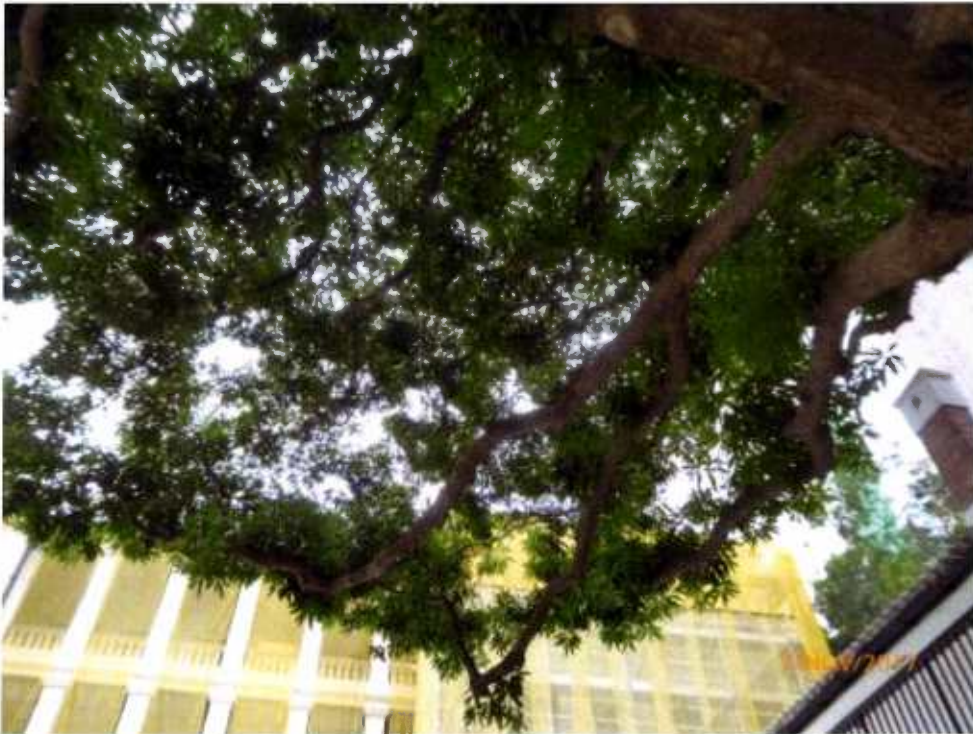
Fig. 8 Many young and green leaves appear on the tree.

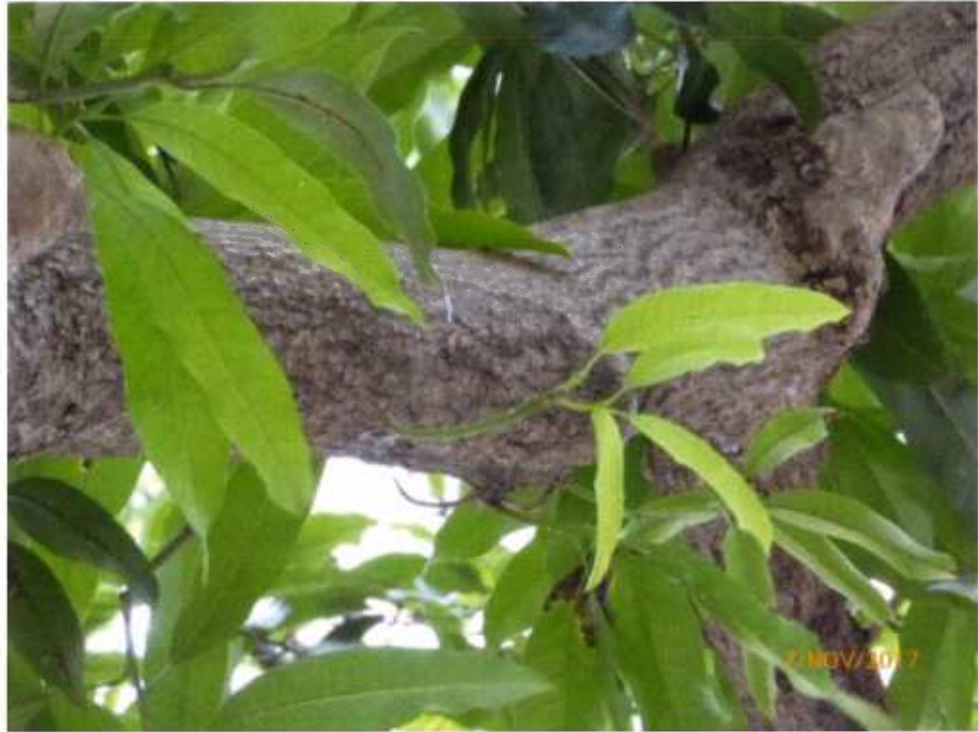
Fig. 9 Signs of Pest (Mealy Bugs 粉狀介殼蟲) are rarely found on the tree due to Pest Control Operation on 26th September 2017.

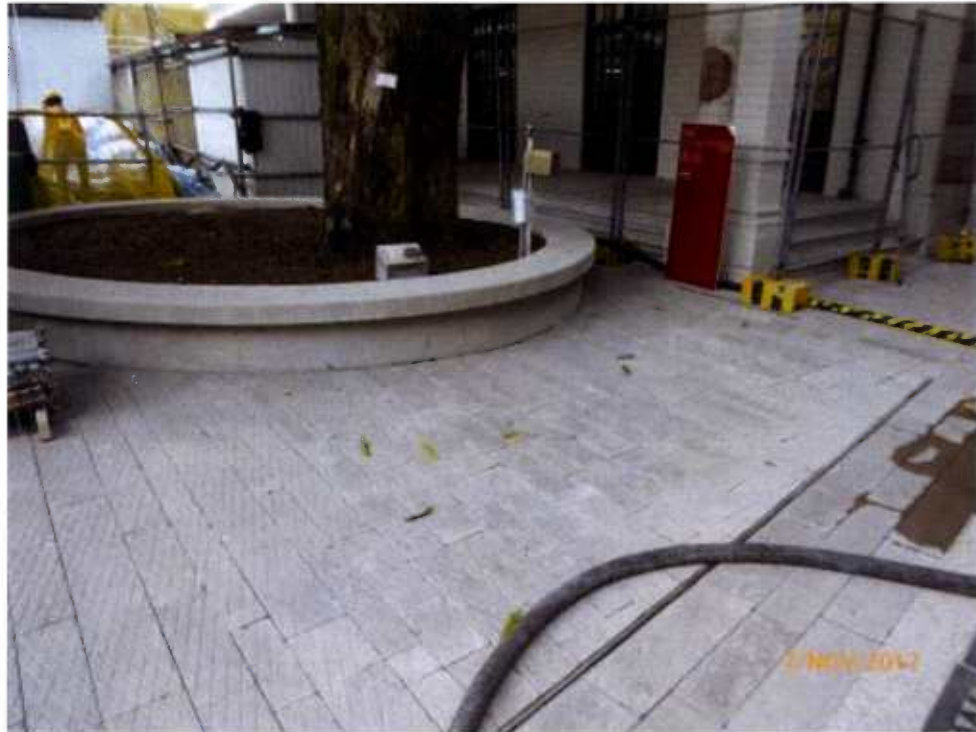
Fig. 11 The access near Tree-5 also is clean and tidy.

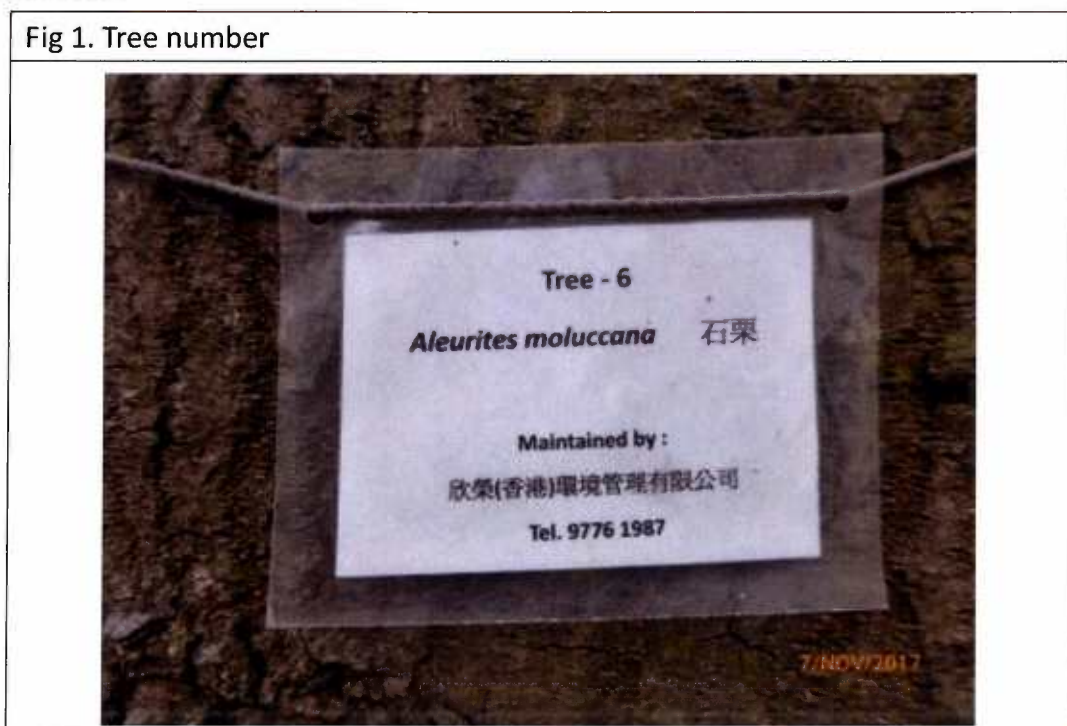
Fig 2. Root collar is normal. The planter is covered with too many dry leaves.

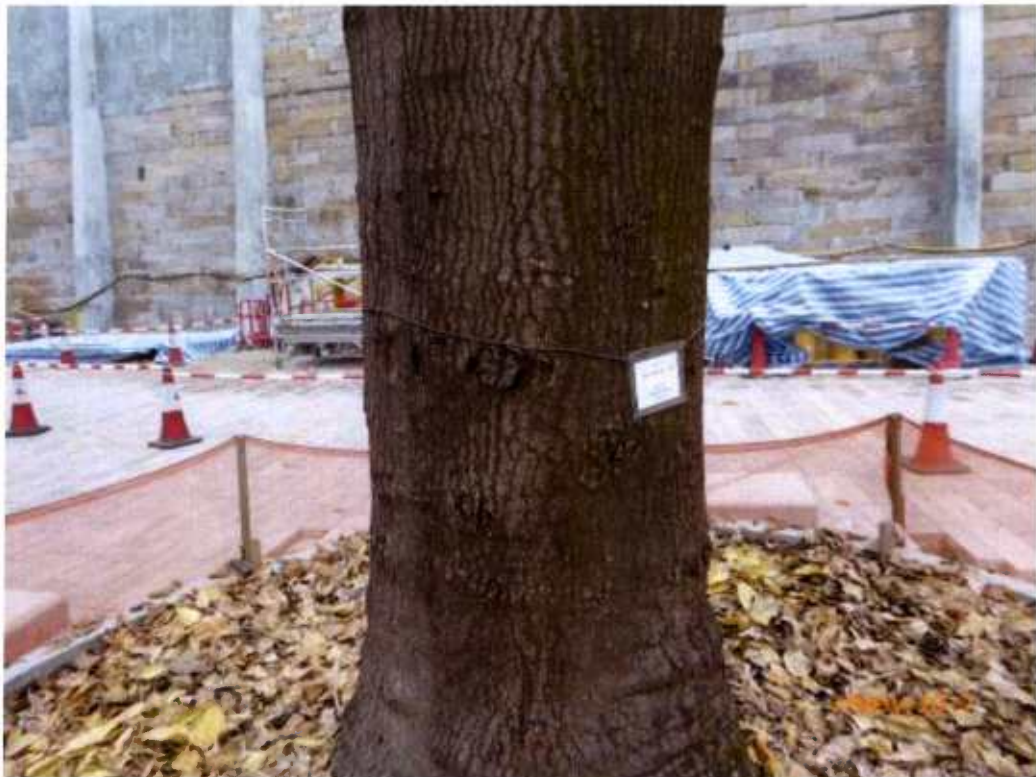
Fig. 4 Health condition of the mid trunk is fair.

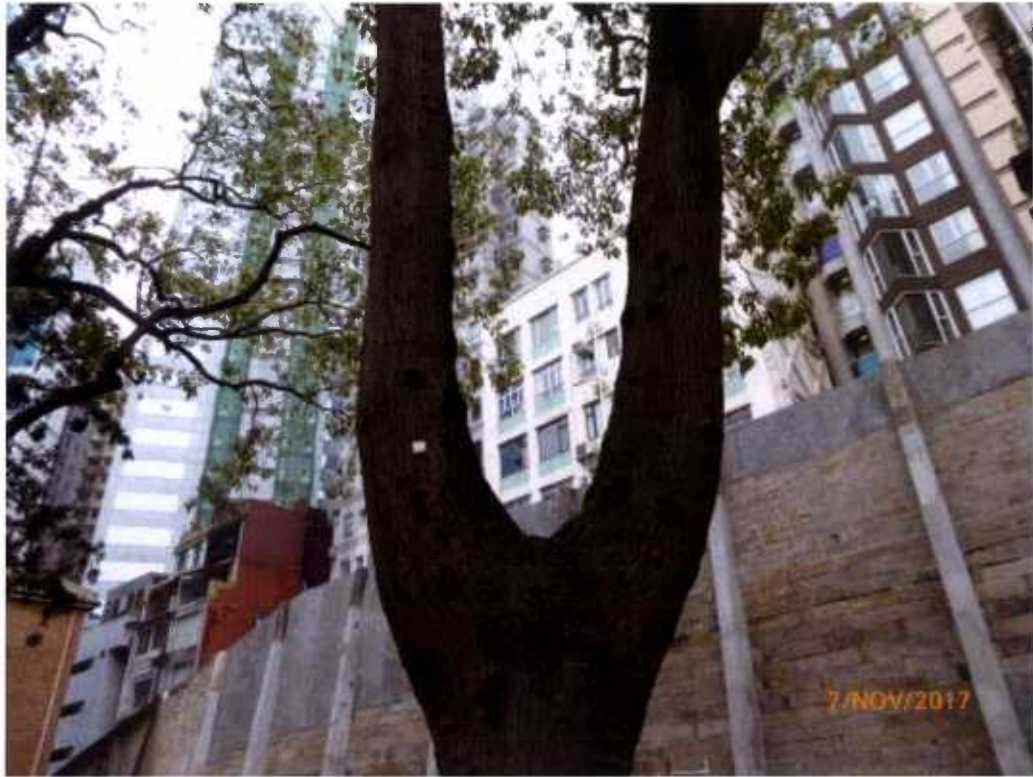
Fig. 5 Health condition of the upper trunk also is fair.

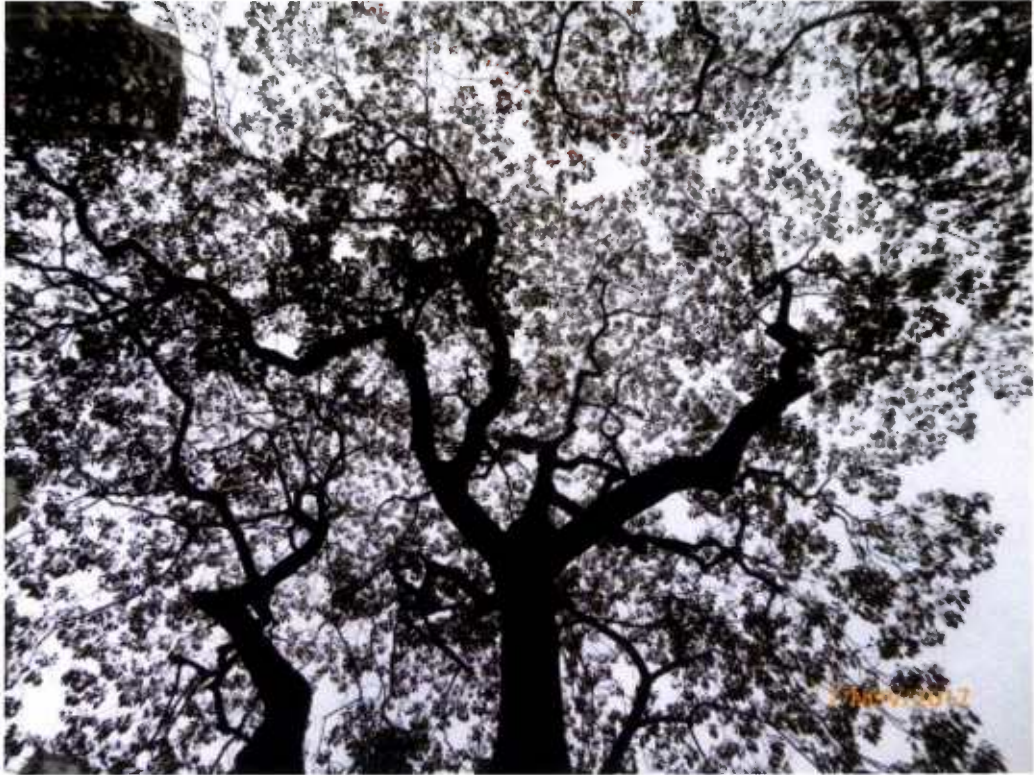
Fig. 7 Leaves on the lower branches are normal.

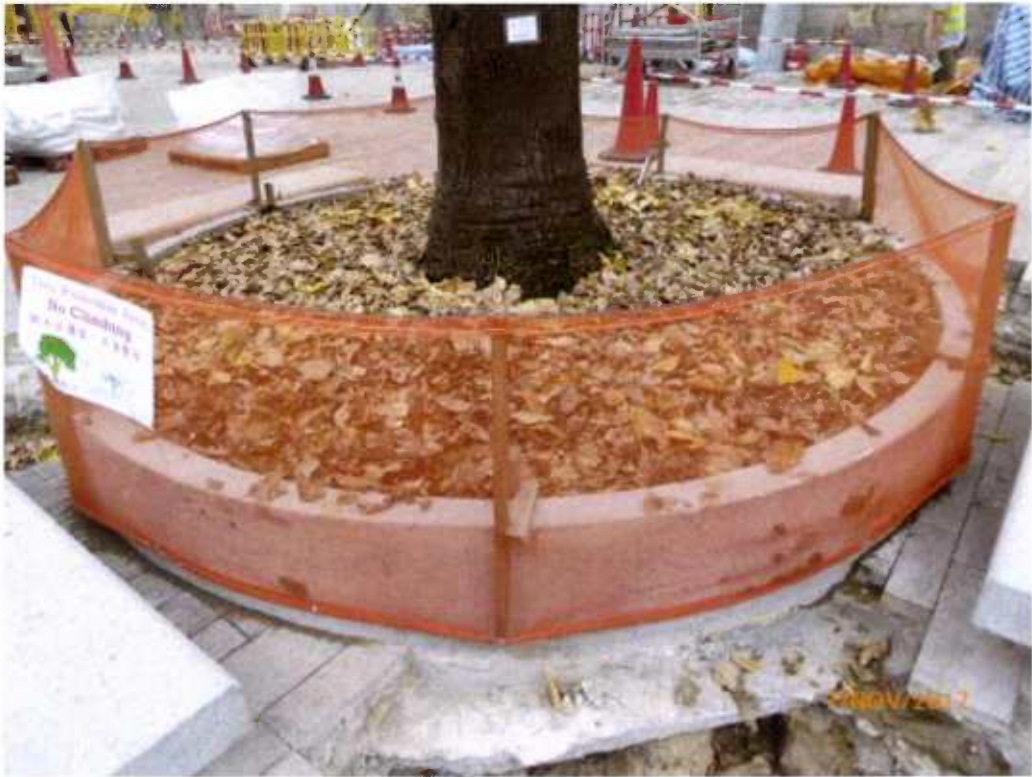
Fig. 11 Four large pits have been excavated close to the planter.

1. Cover the bare roots with hessian clothes as soon as possible.
2. Keep close monitoring on the growth of the tree.

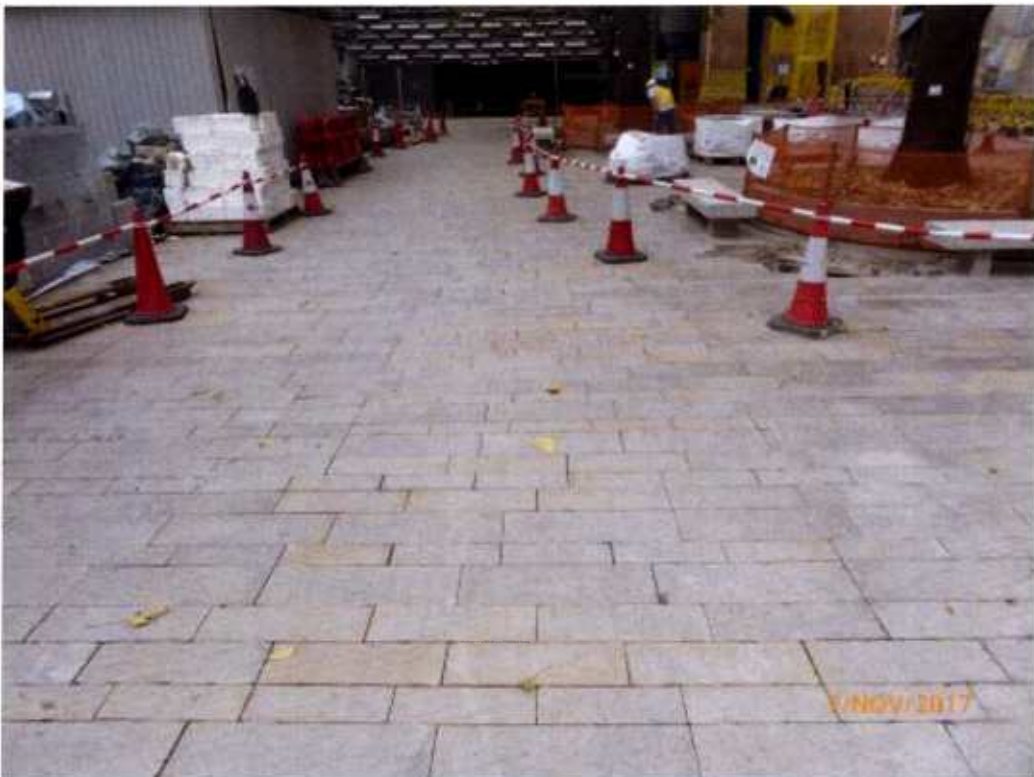
Fig. 14 Overall view of Tree-6 during inspection on 7th November 2017.

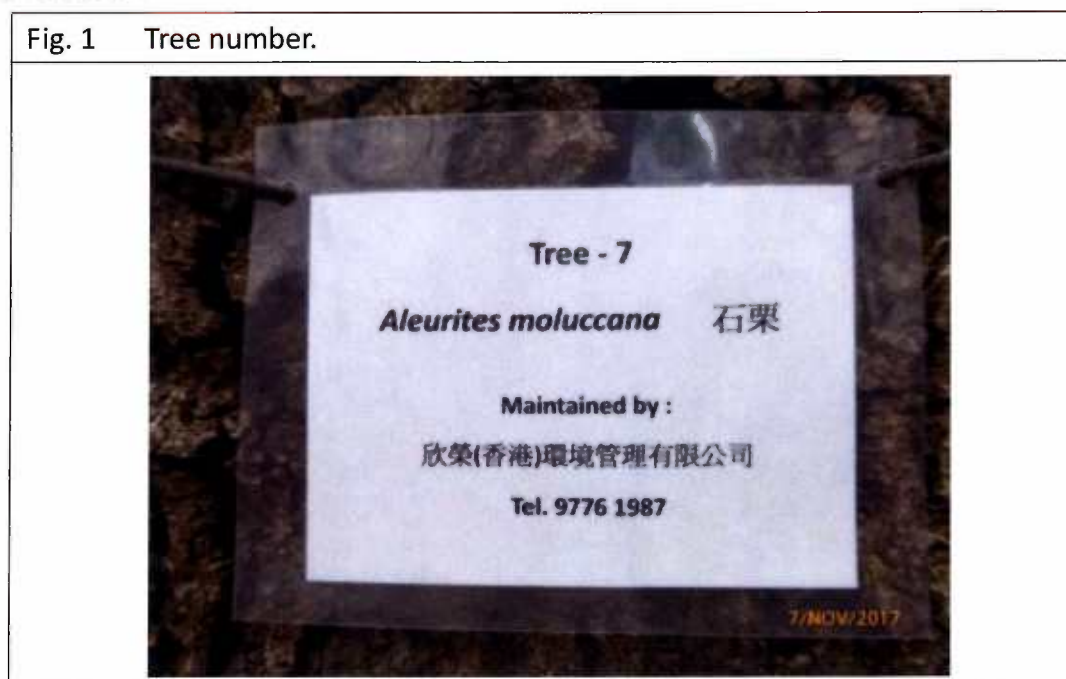
Fig. 2 Root collar is normal. The planter is covered with too many dry leaves.

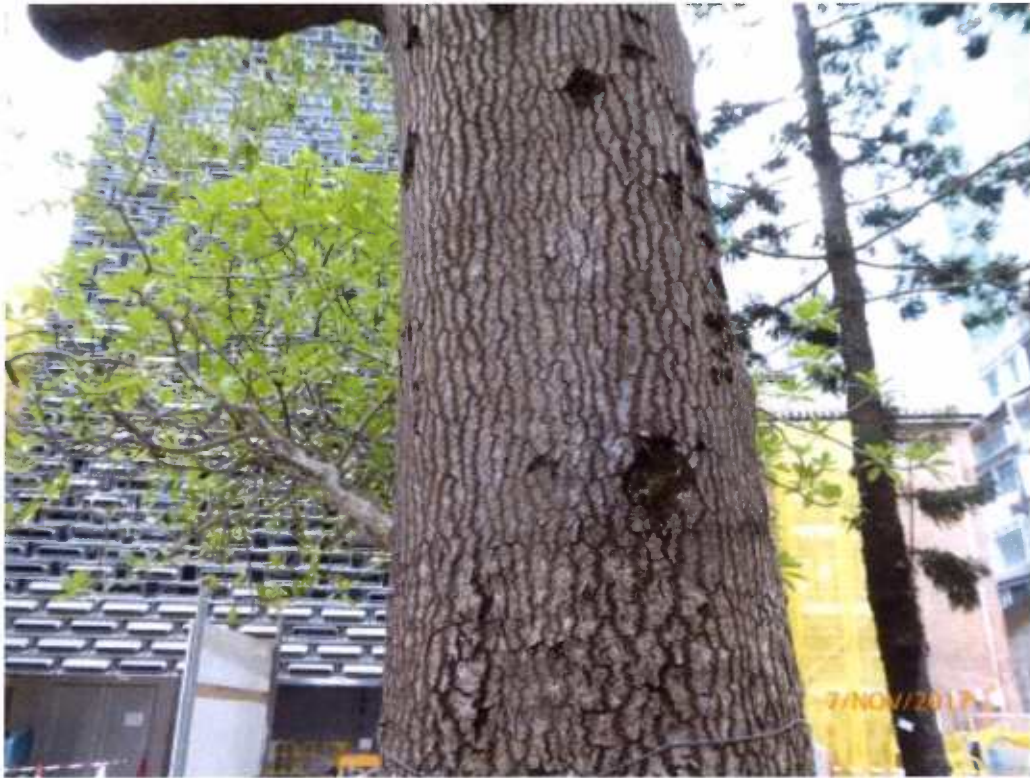
Fig. 5 Health condition of the upper trunk also is fair.

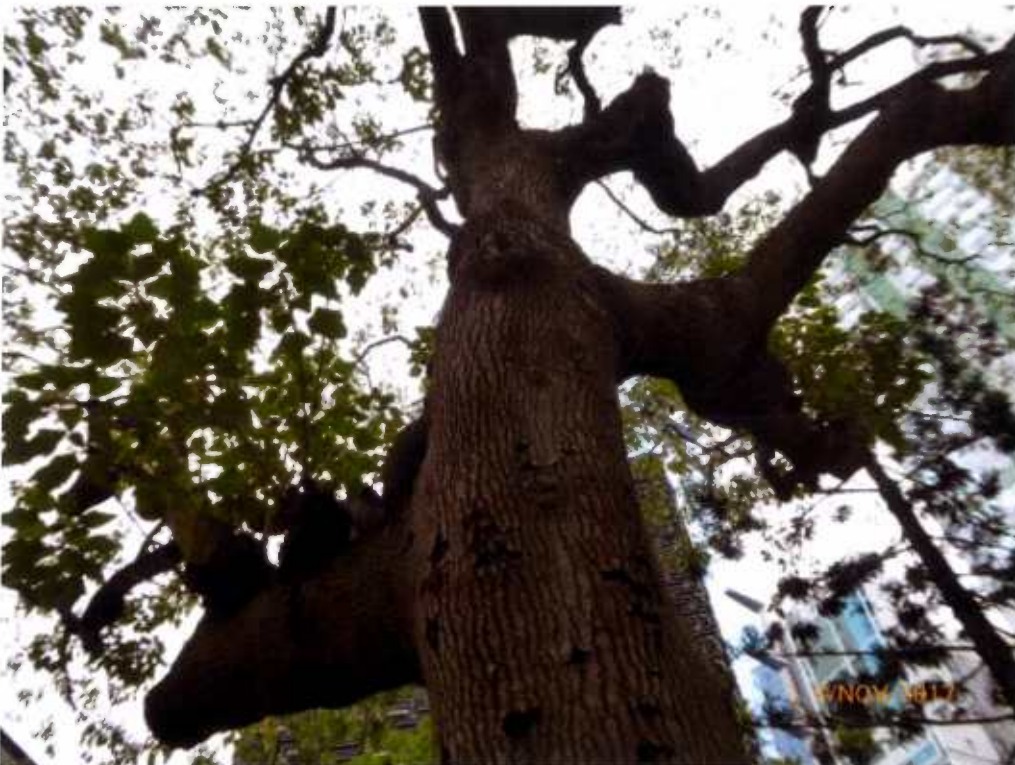
Fig. 6 Leaves on the crown are rather sparse.

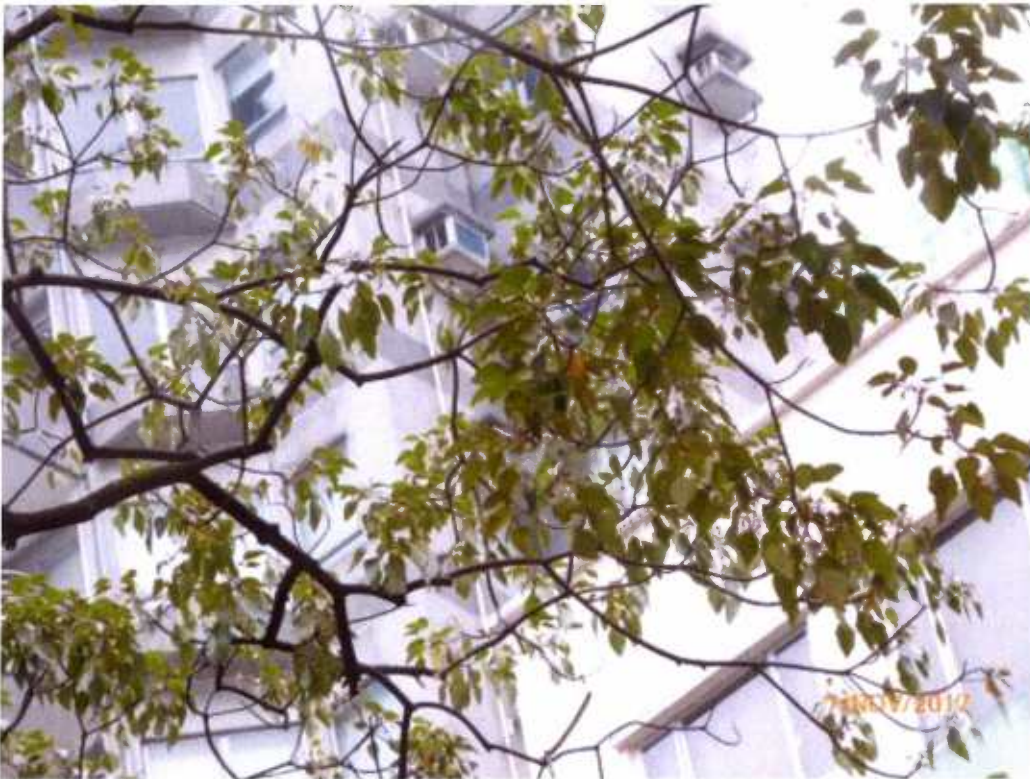
Fig. 8 Some young and green leaves appear on the lower branches.

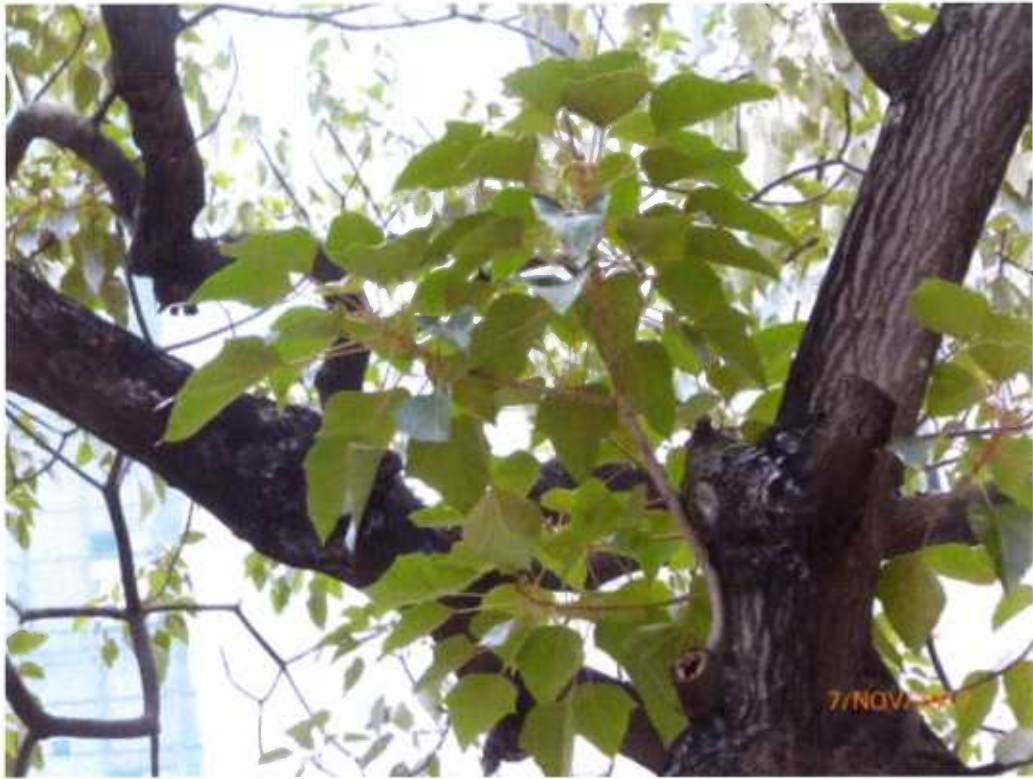
Fig. 9 Signs of Pest “白粉蝨 (*Trialeurodes vaporariorum*)” have apparently reduced due to Pest Control Operation on 3rd & 4th Aug. 2017.

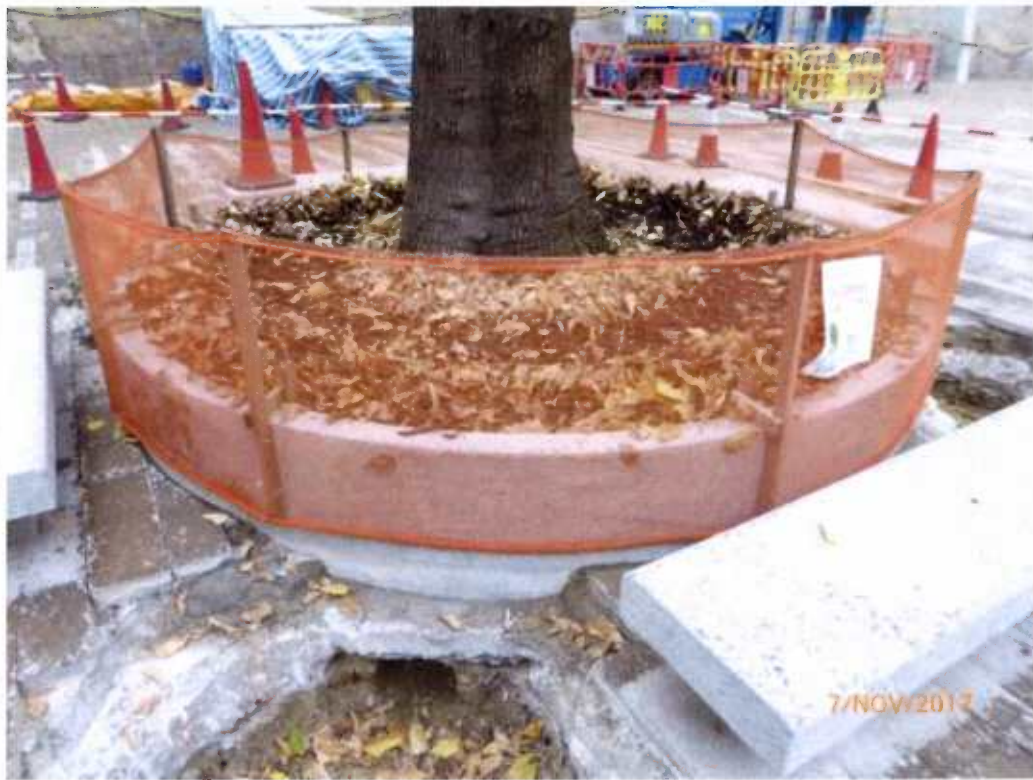
Fig. 13 The site near Tree-7 is clean and tidy.

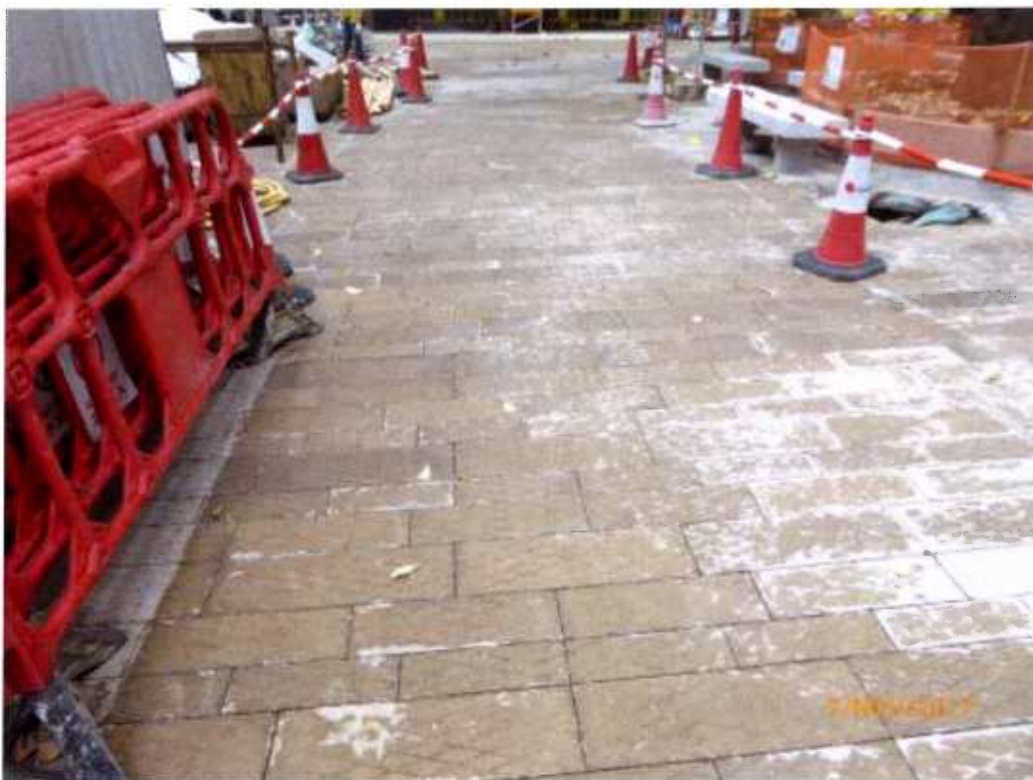
Fig.14 Overall view of Tree-7 during inspection on 7th November 2017.

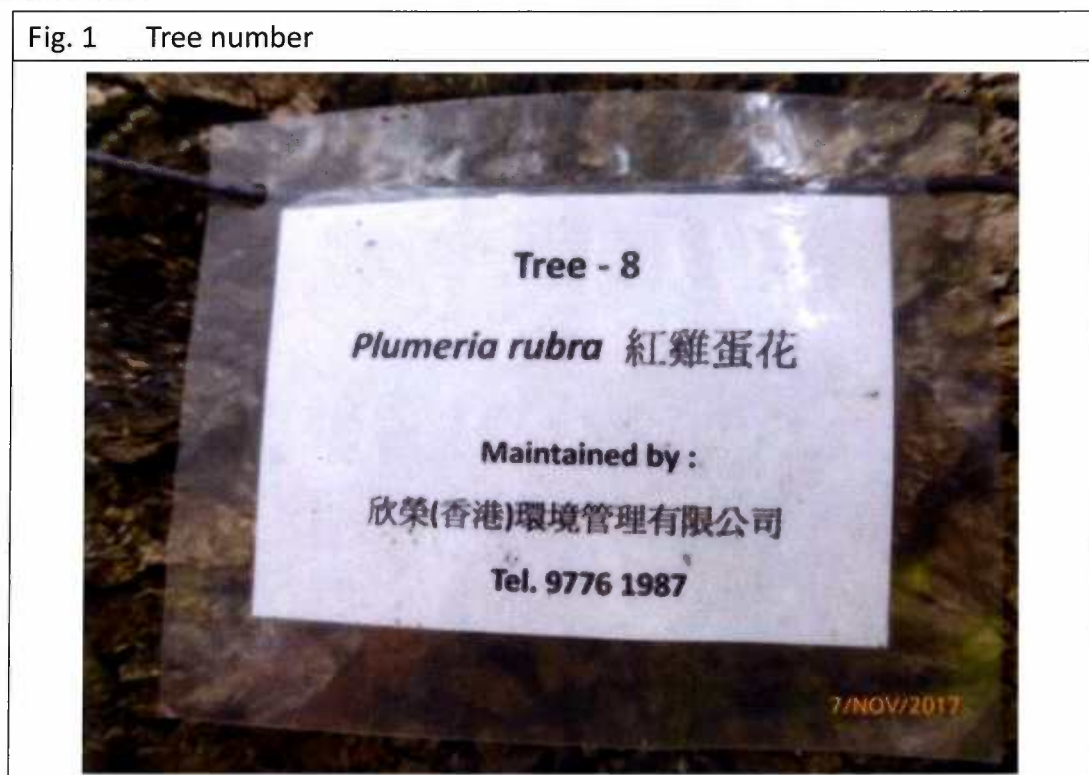
Fig. 2 Root collar is normal. The planter is covered with too many dry leaves.

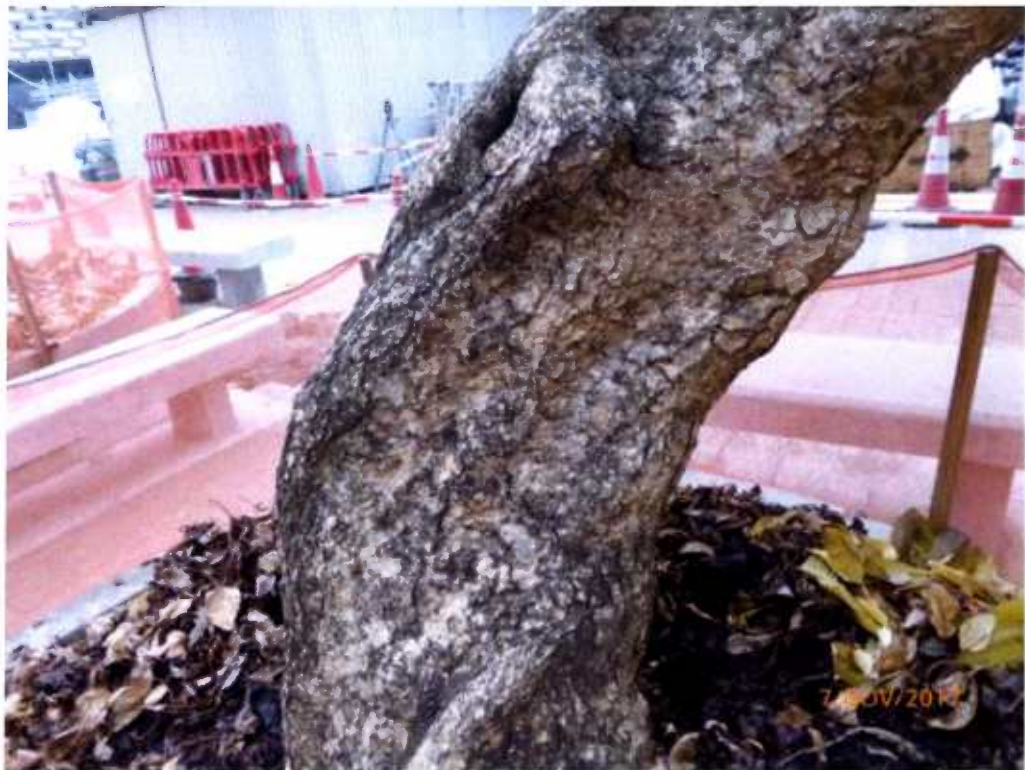
Fig. 4 Health condition of the mid trunk is fair.

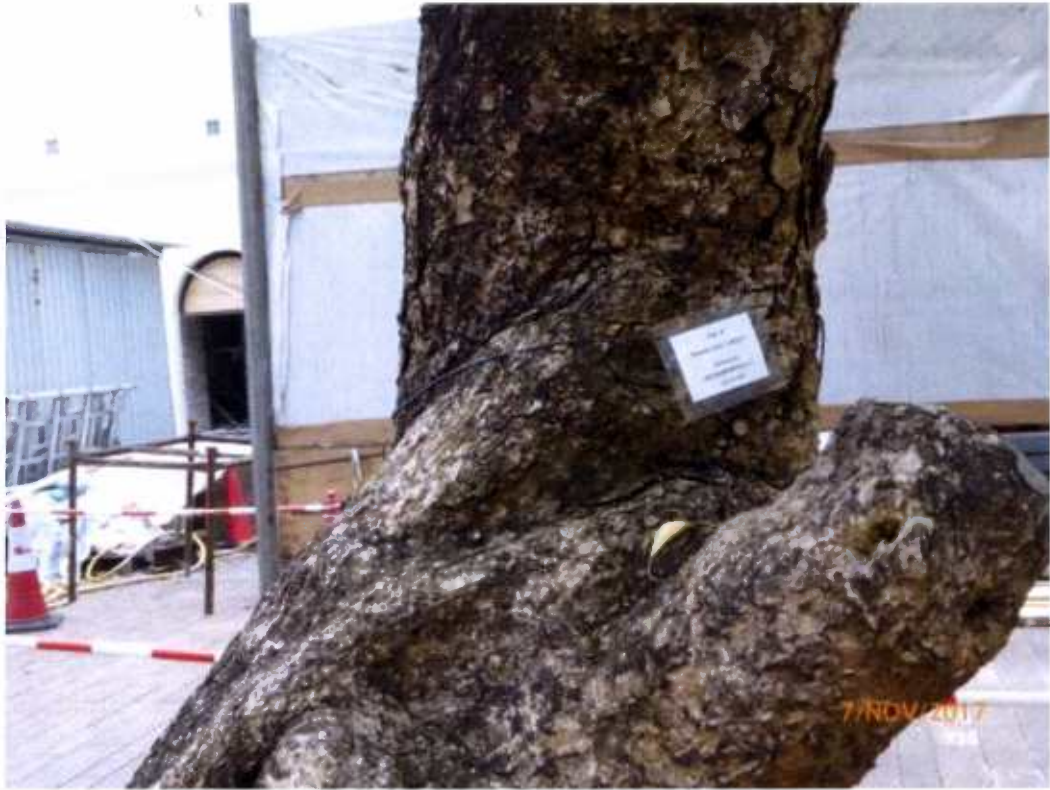
Fig. 5 Health condition of the upper trunk also is fair.

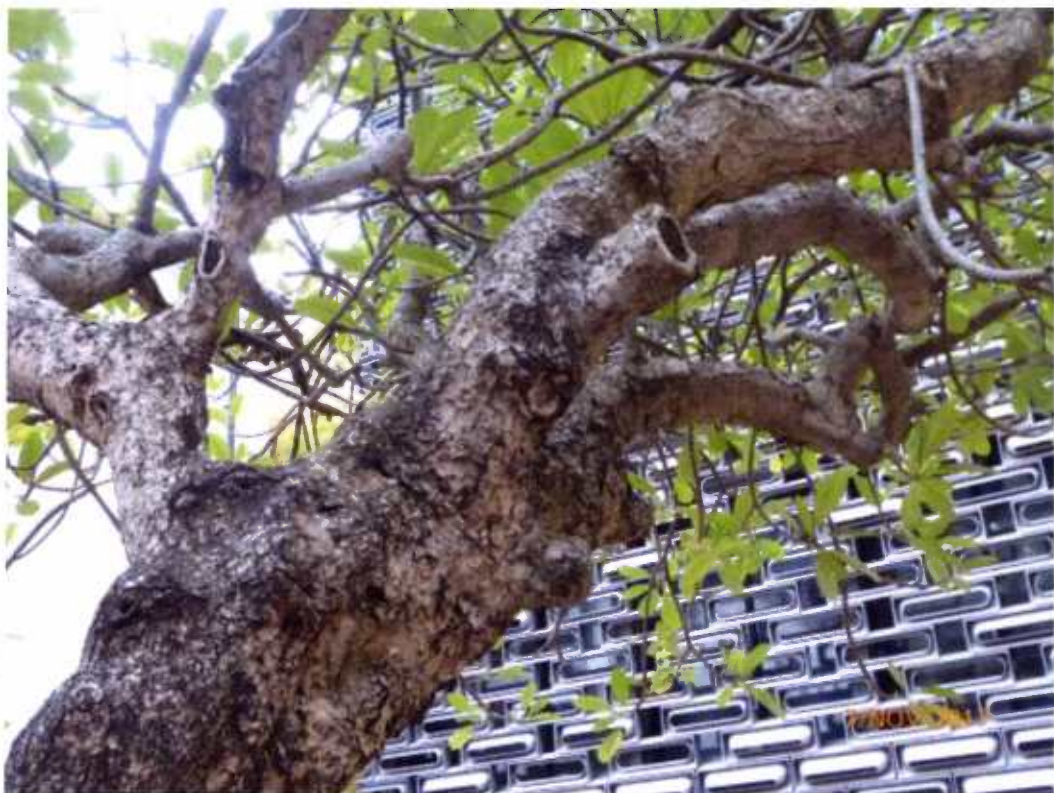
Fig. 6 The crown is full of vigorous and green leaves.

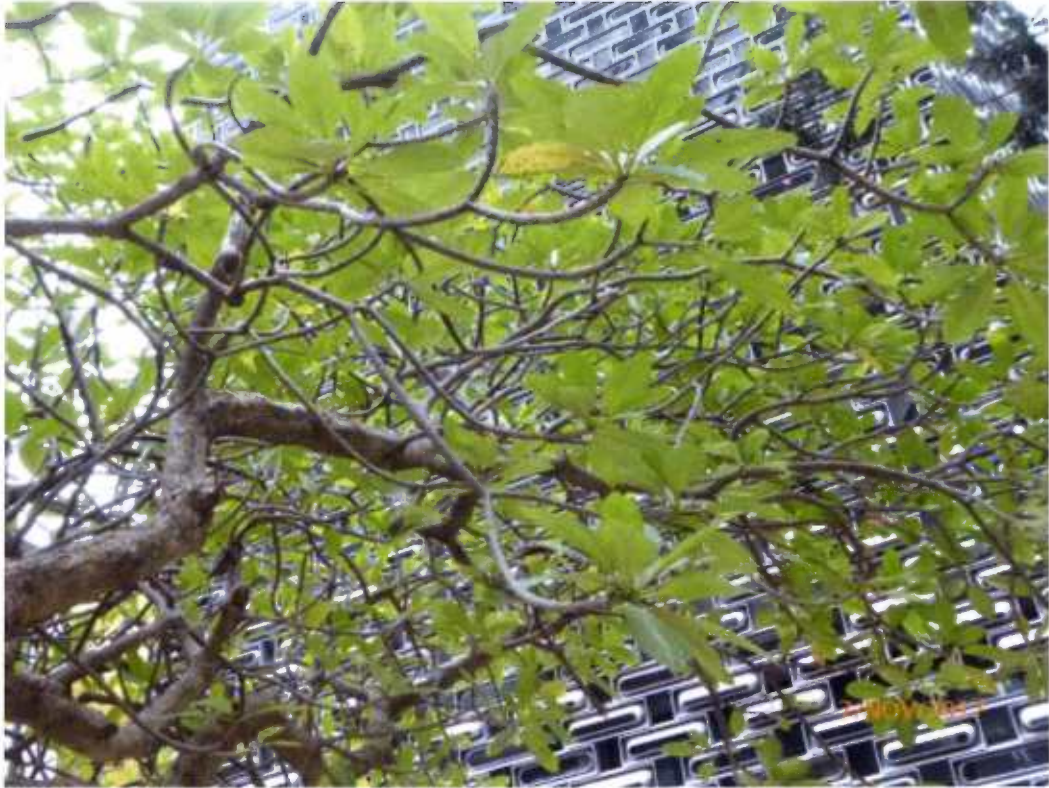
Fig. 7 Vigorous and green leaves also are growing on the lower branches.

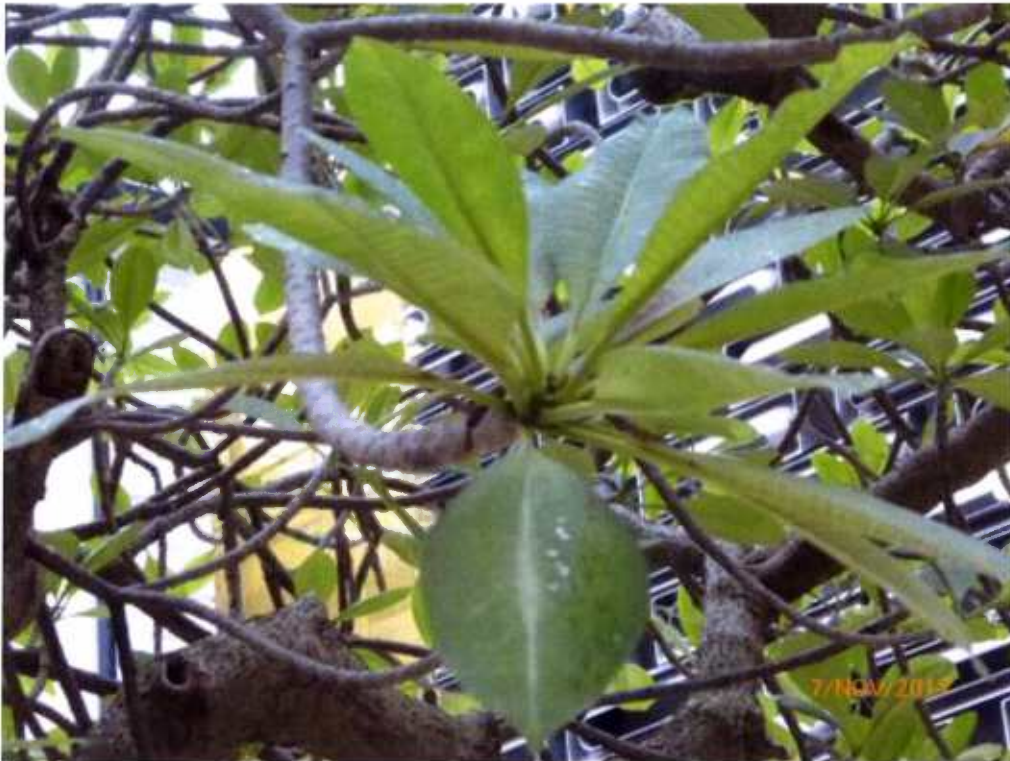
Fig. 8 Flowers still appear on the tree.

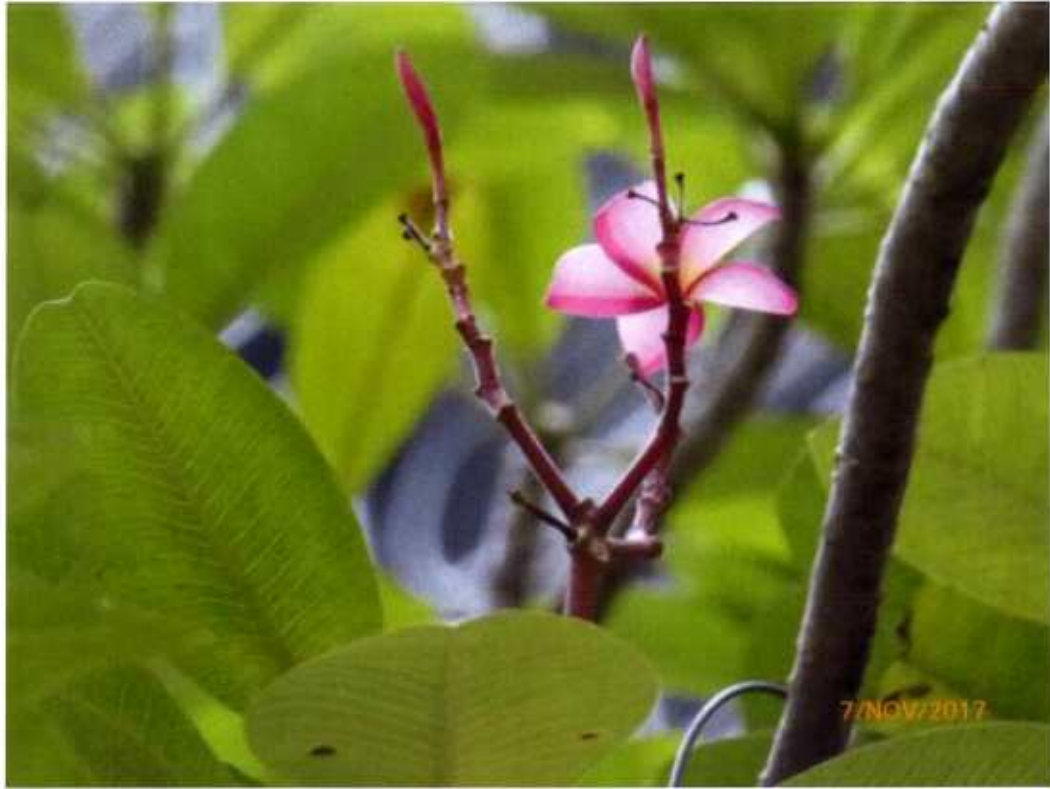
Fig. 9 The tree protection zone is in good order.
