The Jockey Club CPS Limited

Central Police Station Conservation
and Revitalisation Project:
73rd Monthly EM&A Report
(1 November to 30 November 2017)

Environmental Resources Management

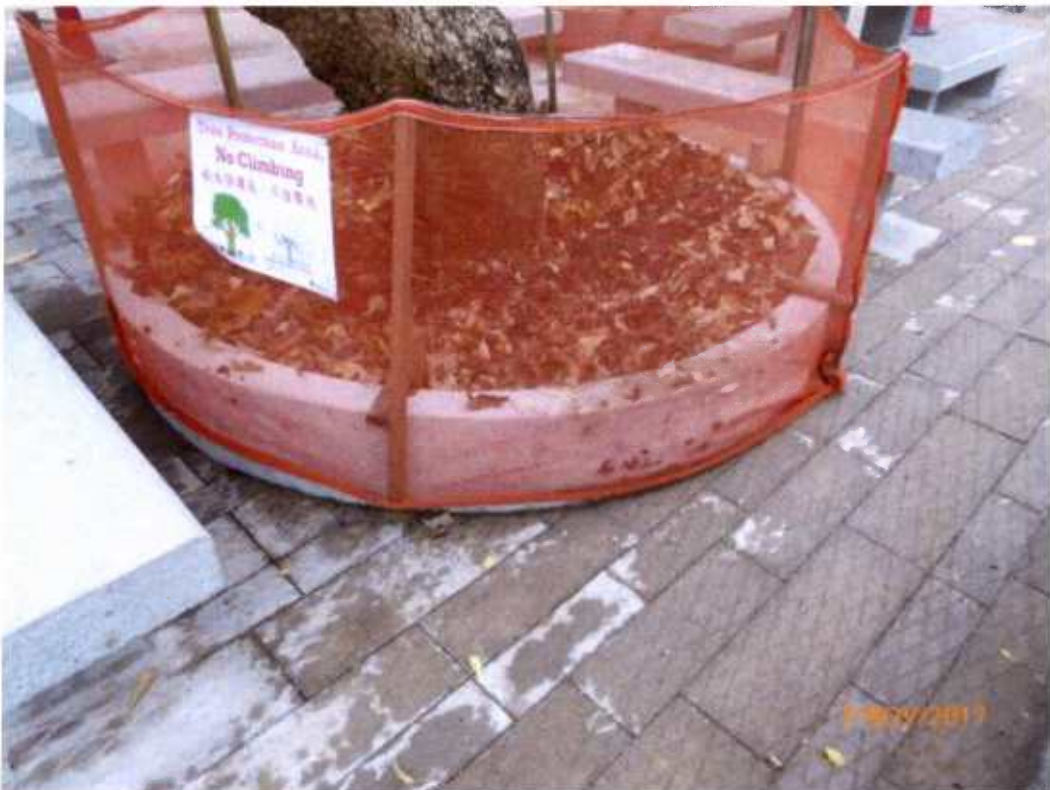
Fig. 10 The site near the planter is clean and tidy.

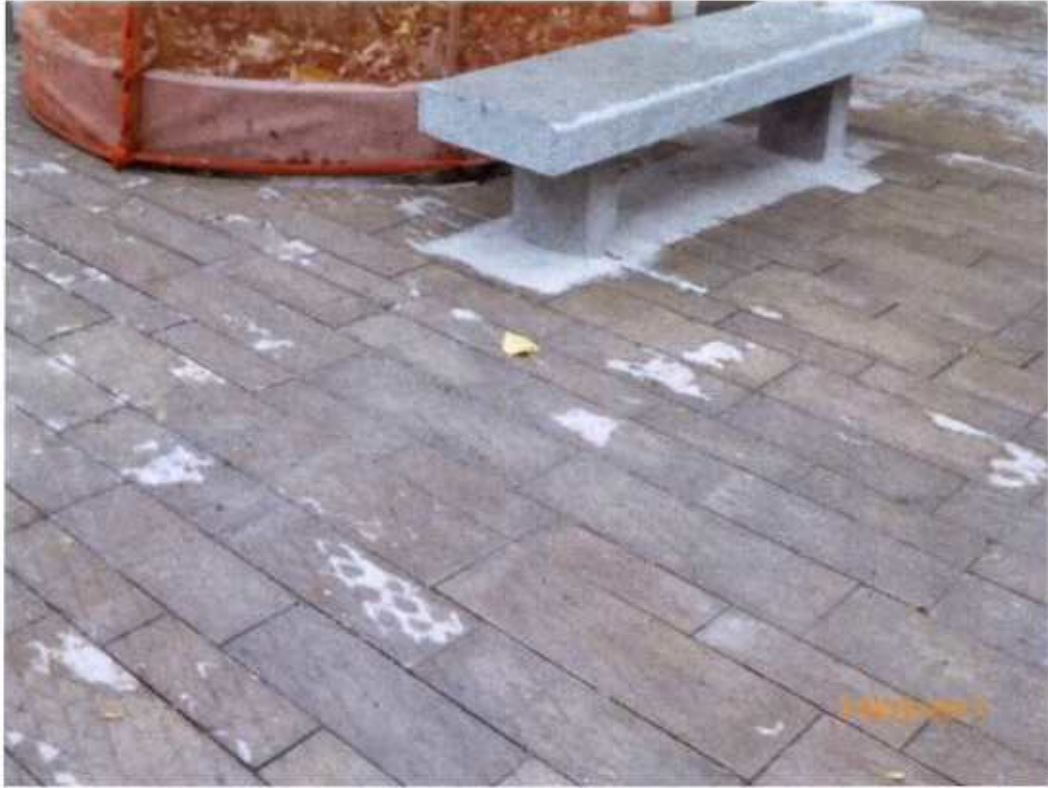
Fig. 11 The access near Tree-8 also is clean and tidy.

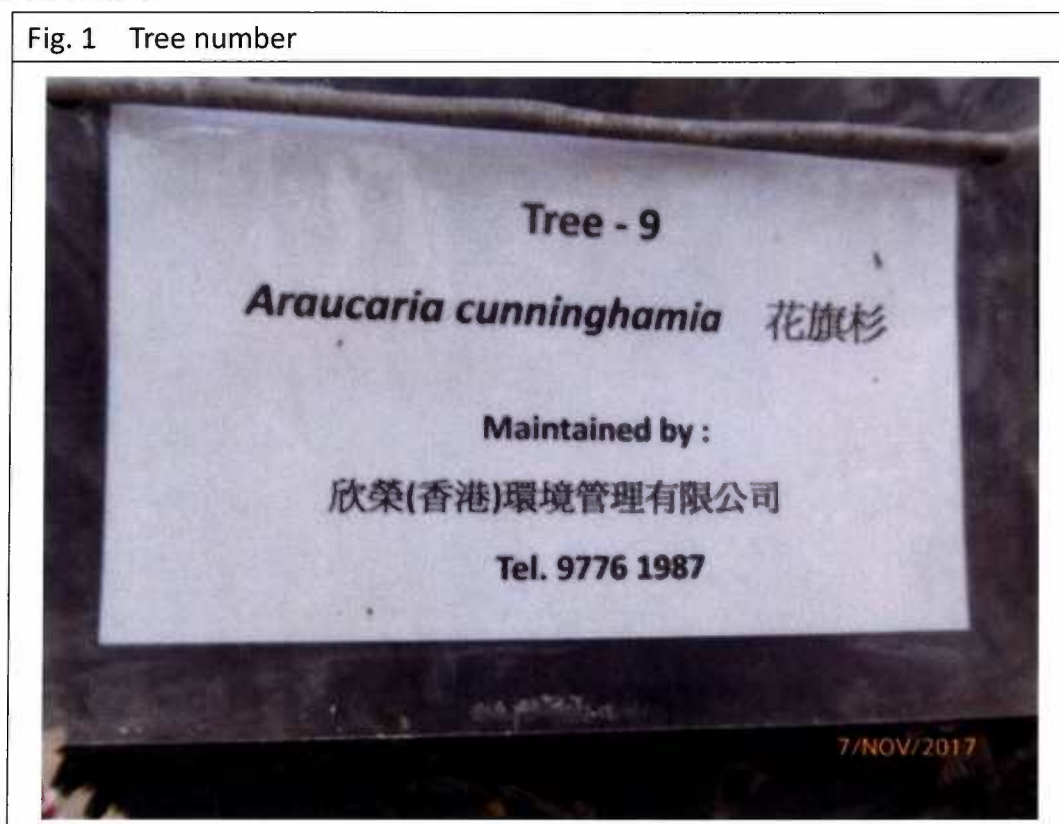
Fig. 2 Root collar is normal. The planter is covered with too many dry leaves.

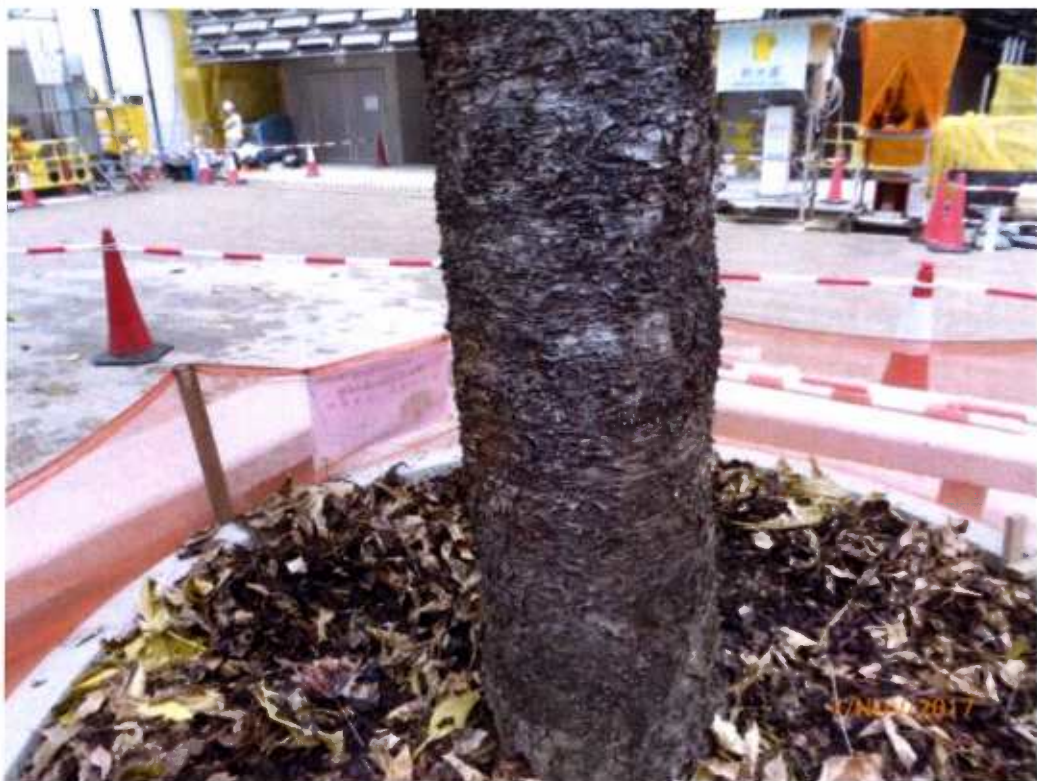
Fig. 4 Health condition of the mid trunk is fair.

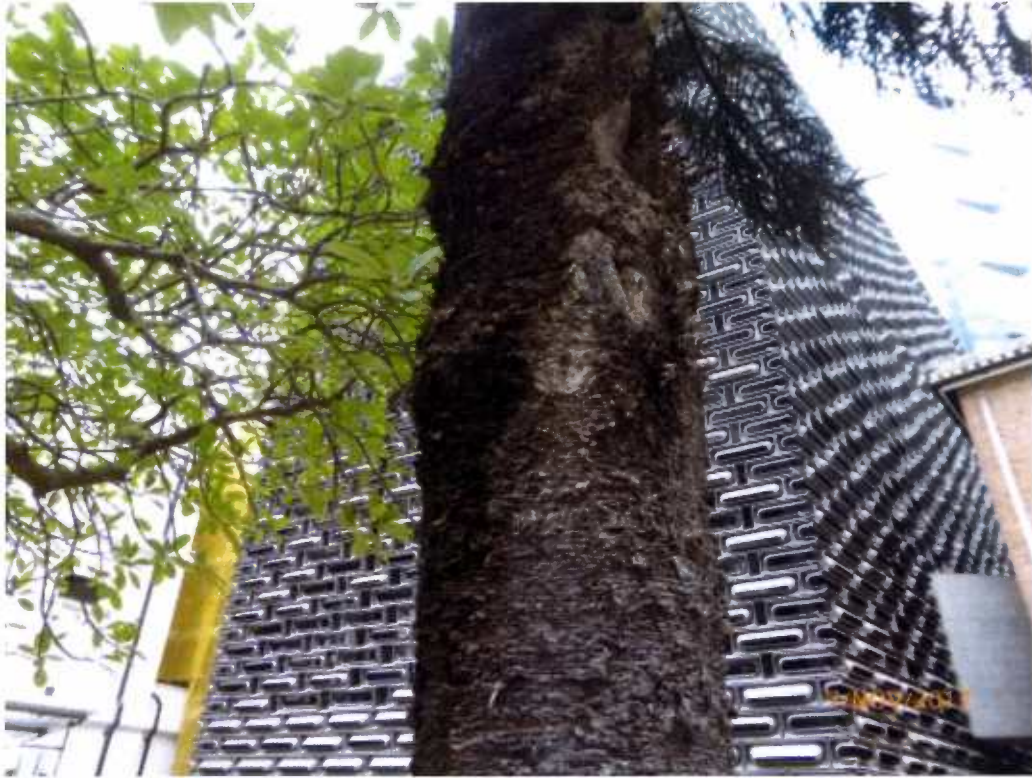
Fig. 5 Health condition of the upper trunk also is fair.

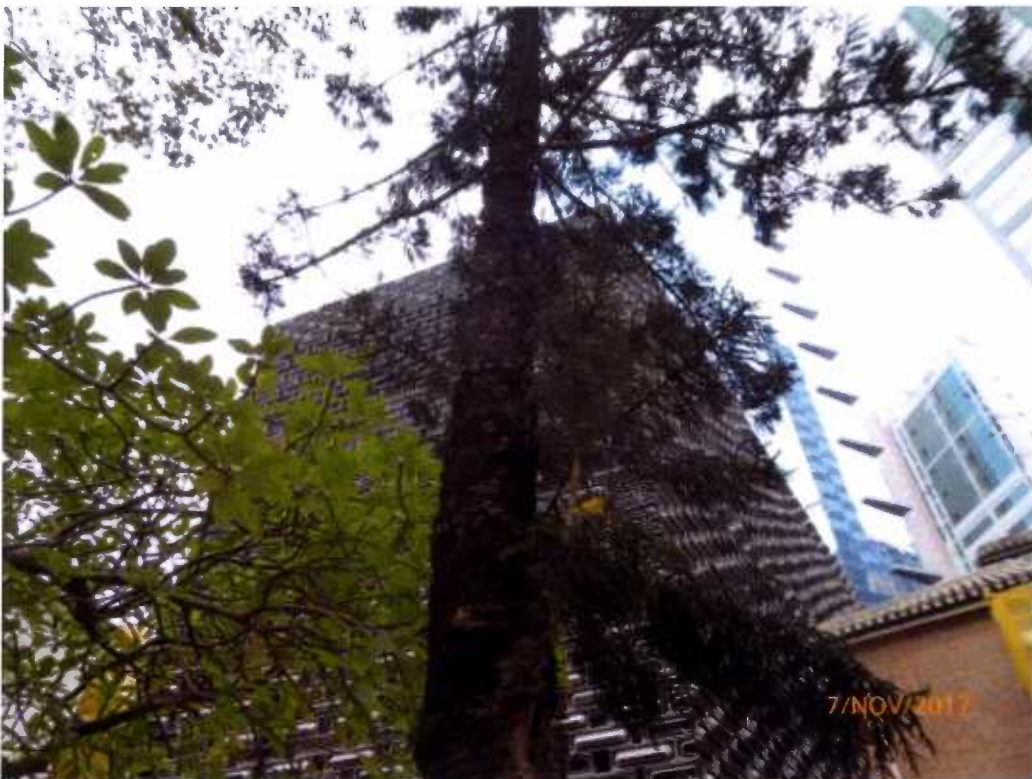
Fig. 6 The crown is full of vigorous and green leaves.

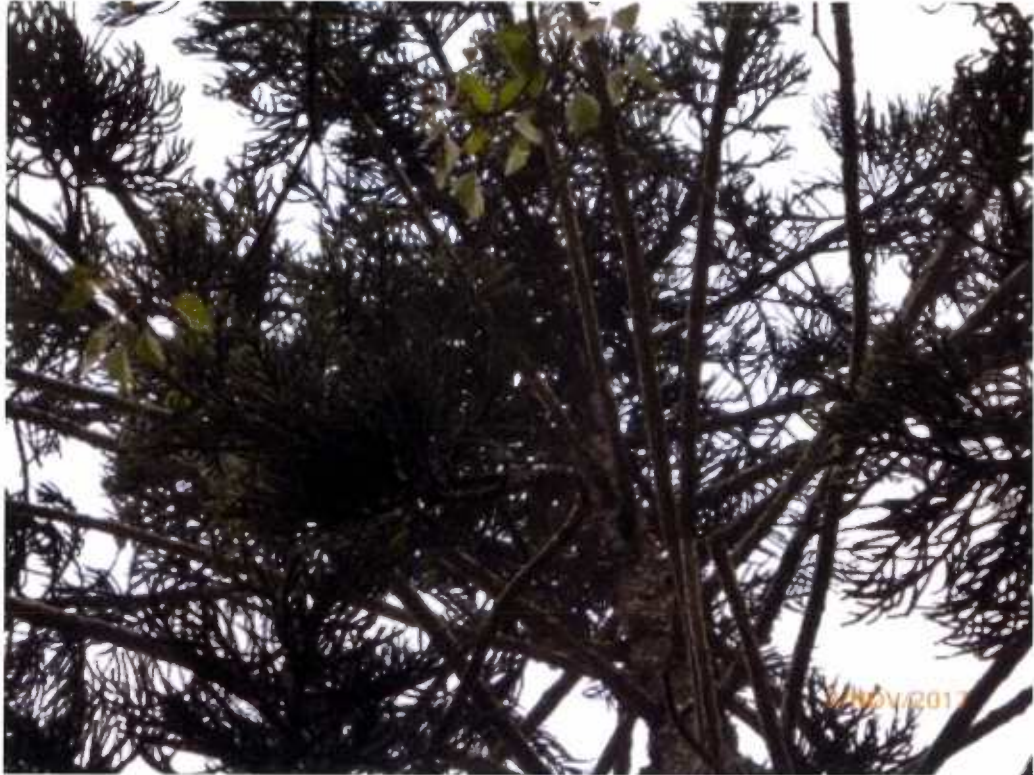
Fig. 7 Vigorous and green leaves also are growing on the lower branches.

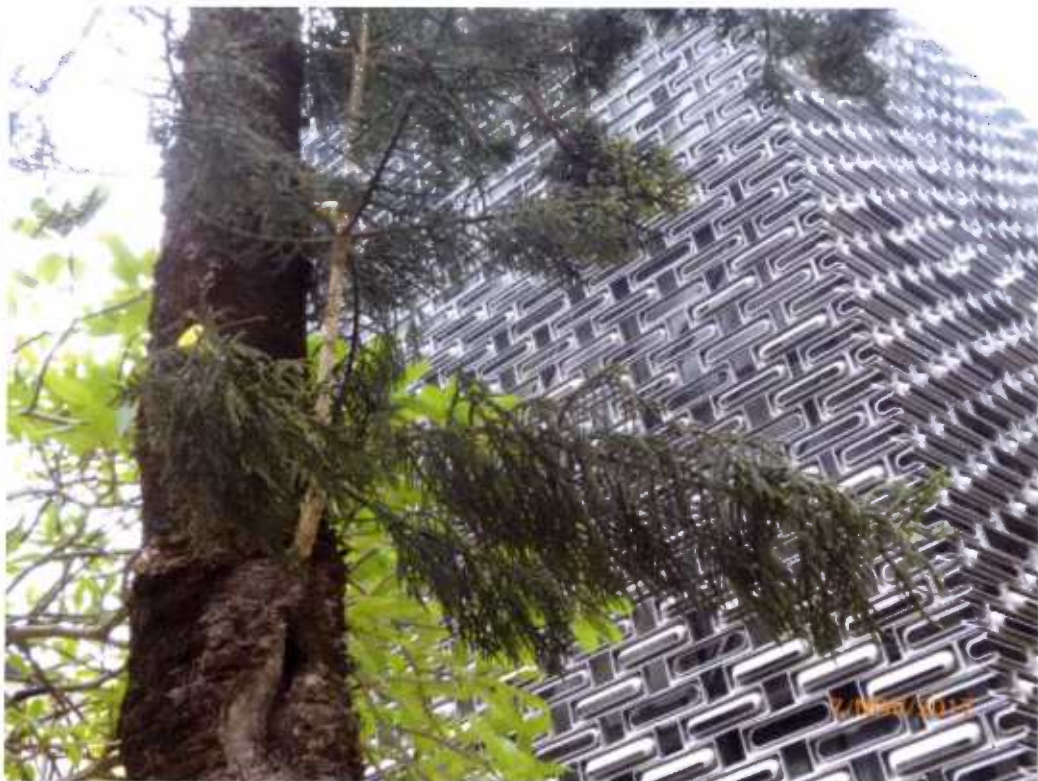
Fig. 8 Some young and green leaves appear on the mid trunk.

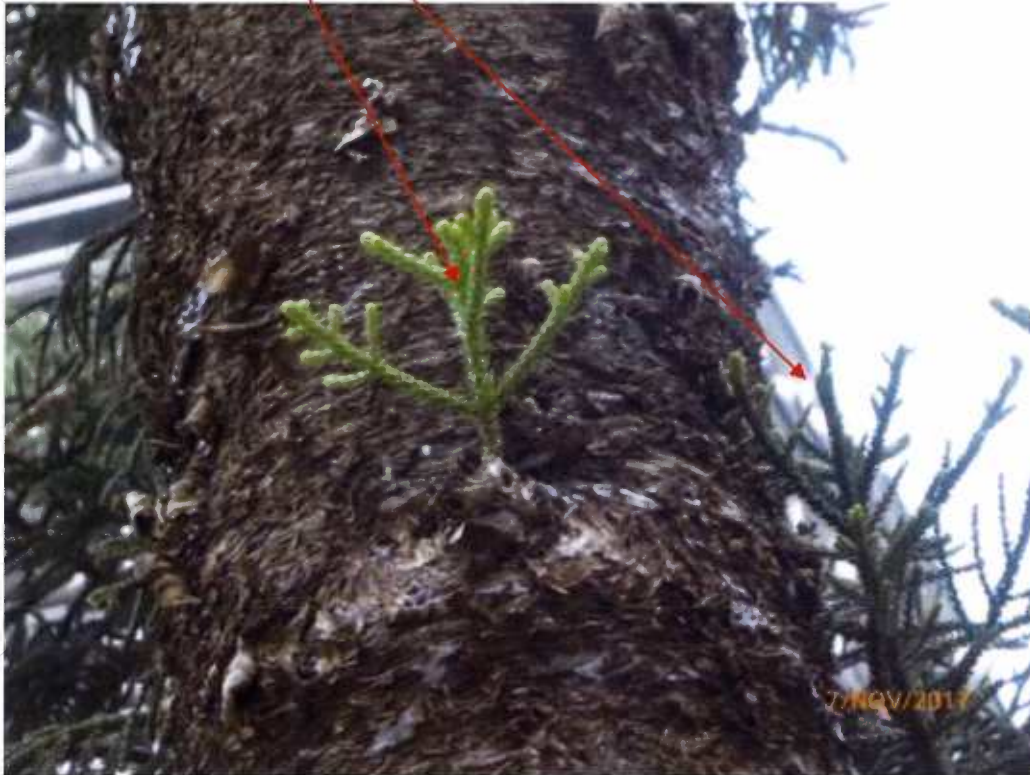
Fig. 9 The tree protection zone is in good order.

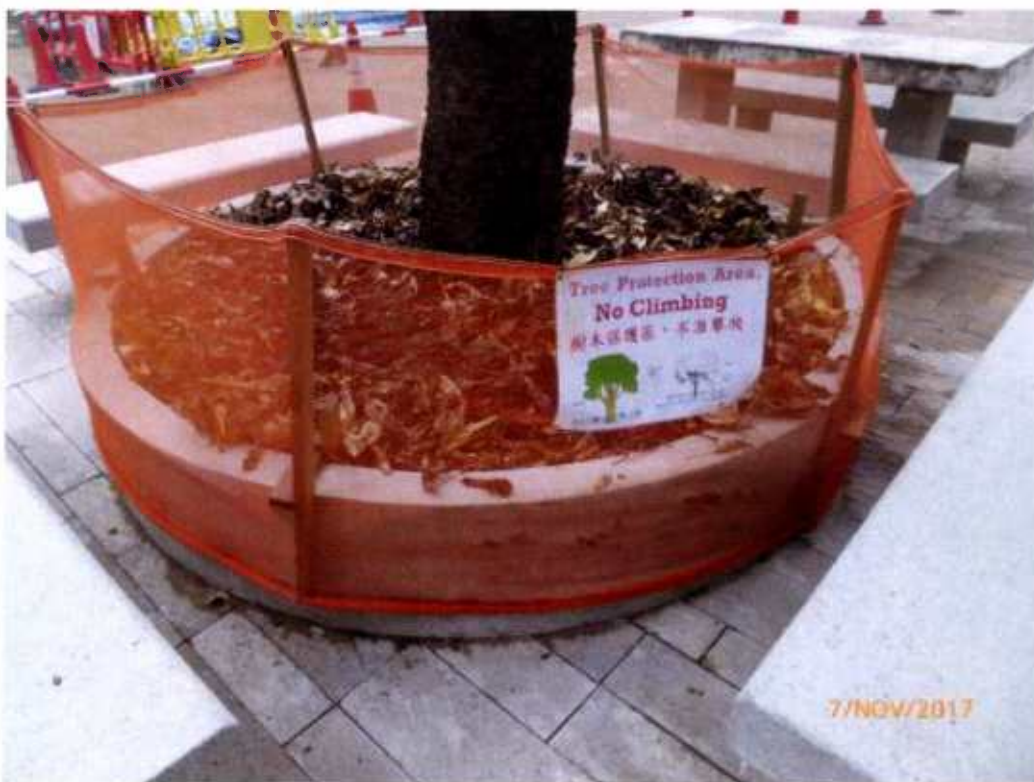
Fig. 10 The site near the planter is clean and tidy.

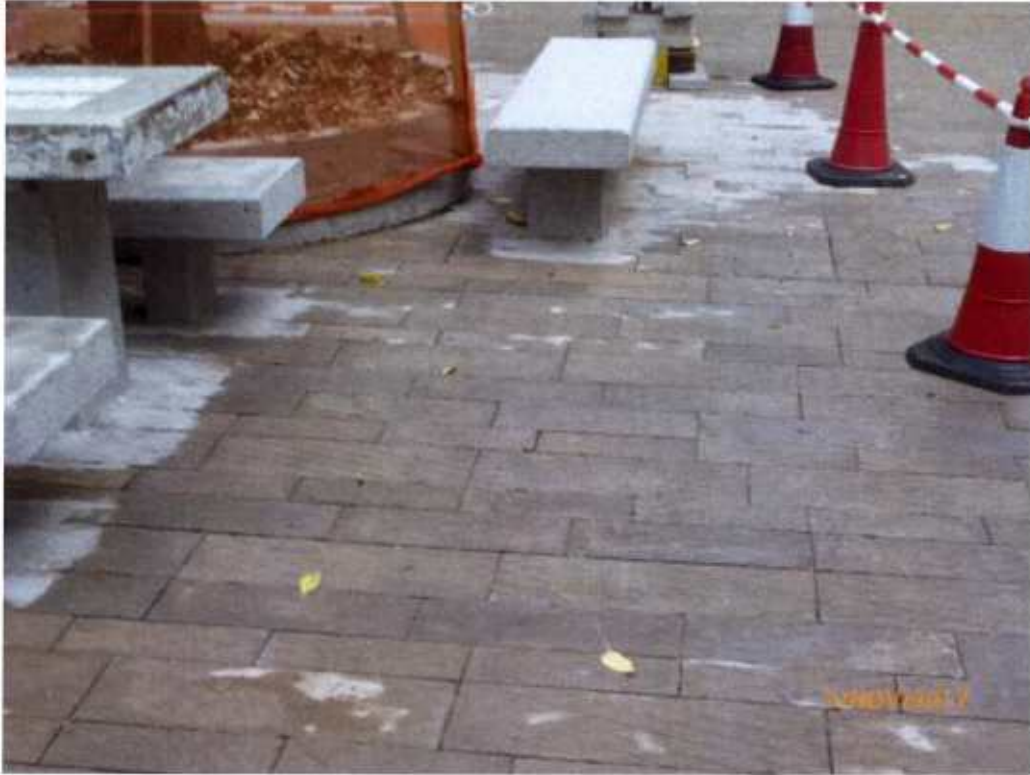
Fig. 11 The access near Tree-9 also is clean and tidy.

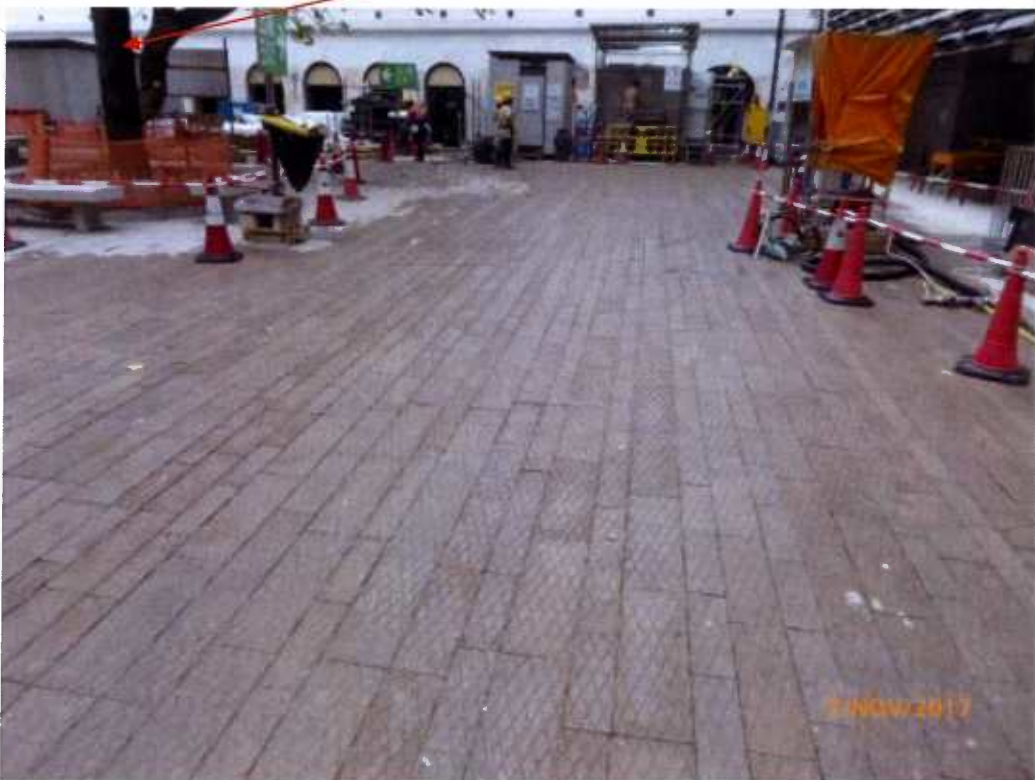
Fig. 12 Overall view of Tree-9 during inspection on 7th November 2017.

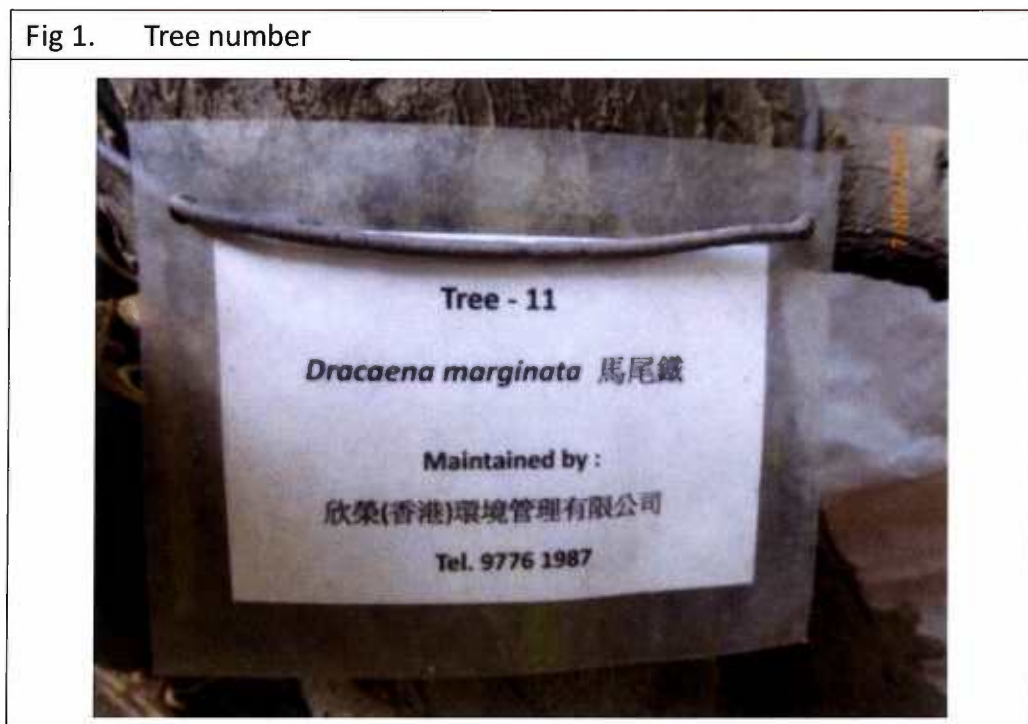
Fig. 2 Root collar is normal. The planter is covered with mulch.

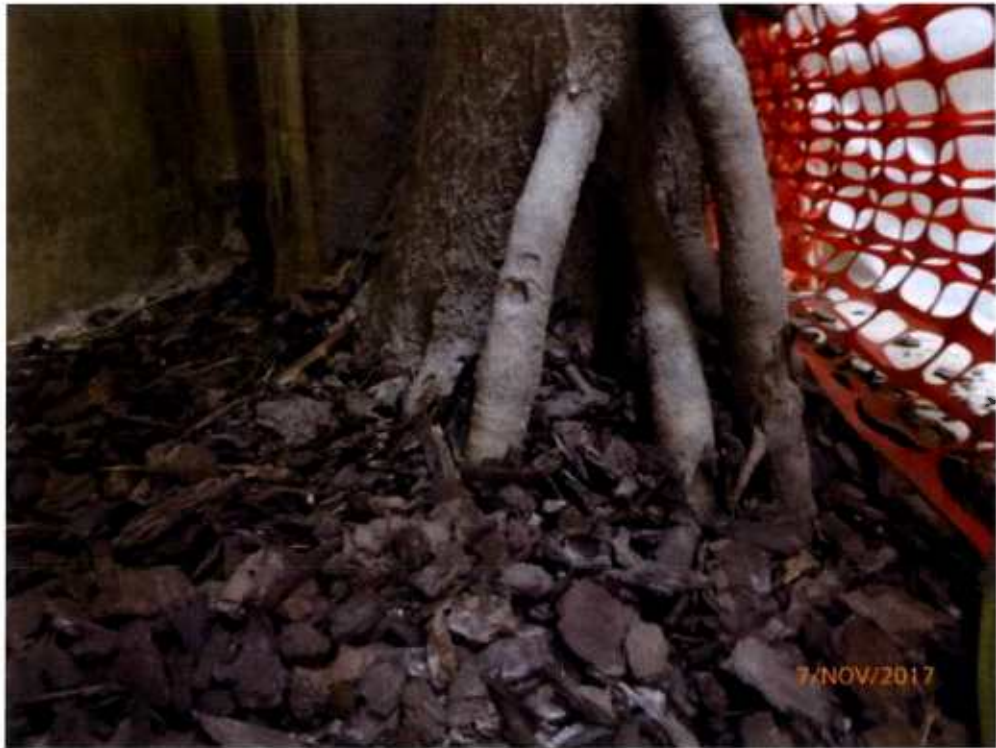
Fig. 3 Health condition of the lower trunk is fair.

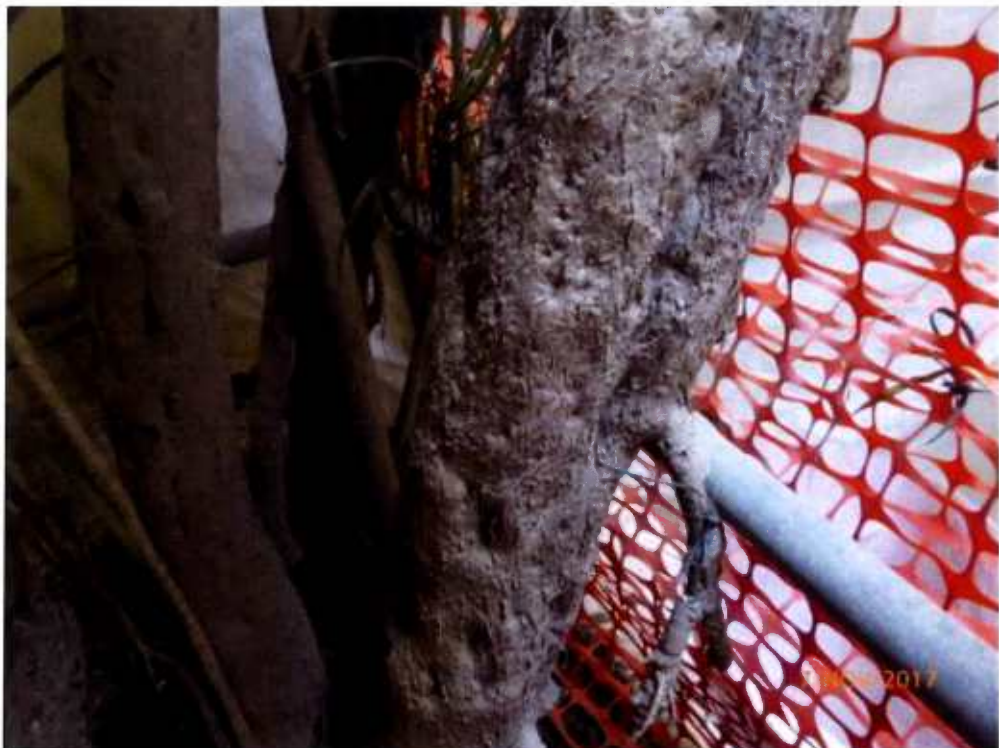
Fig. 4 Health condition of the mid trunk is fair.

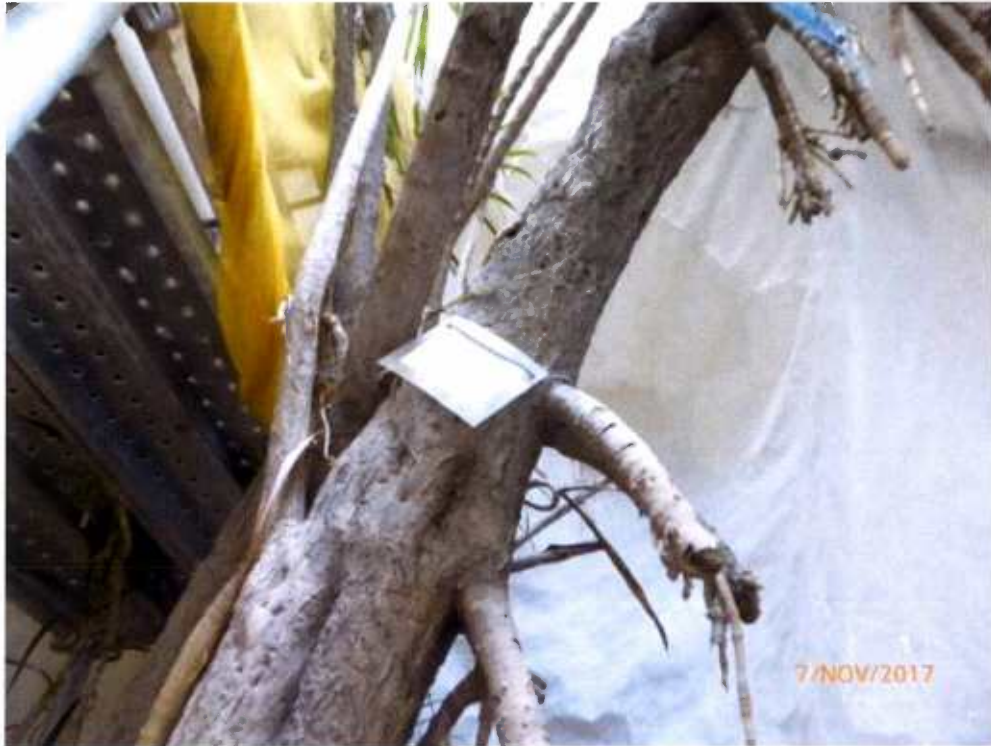
Fig. 5 Health condition of the upper trunk also is fair.

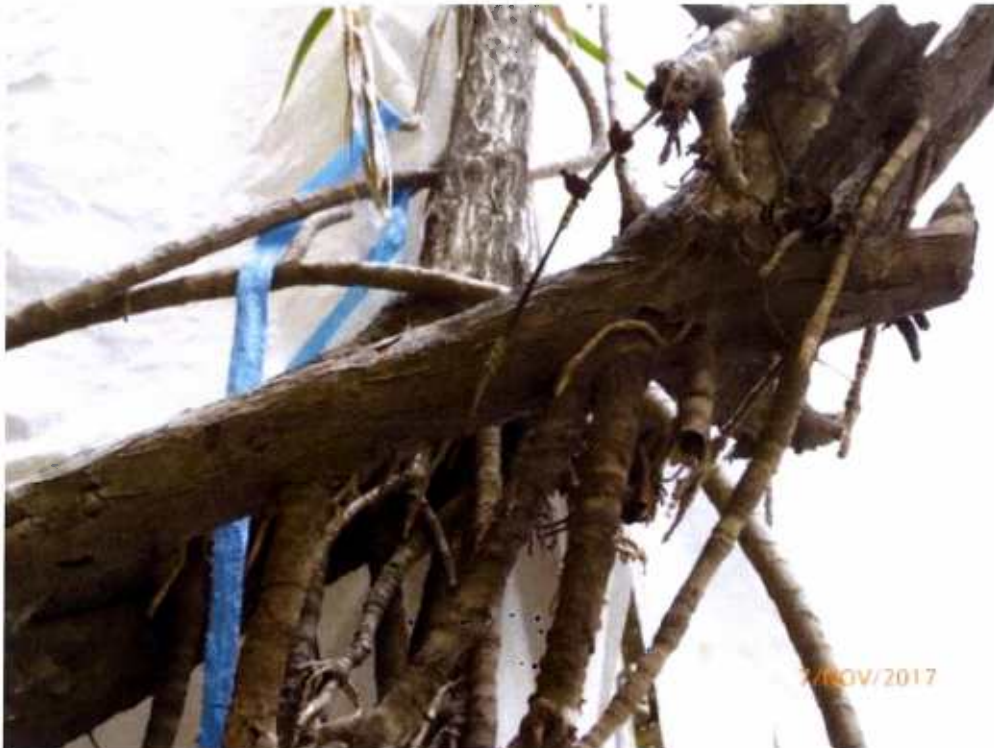
Fig. 6 Withered leaves still appear on the tree.

1. Keep close monitoring on the growth of the tree especially during the nearby renovation works are in progress.

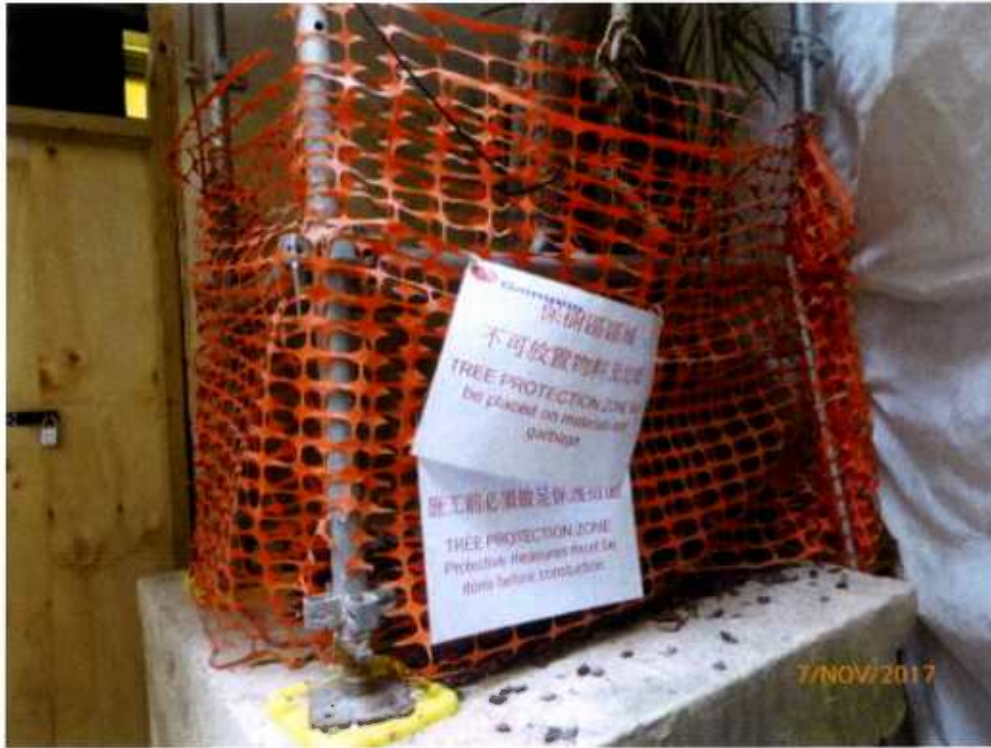
Fig. 9 A large shelter has been erected at site to protect the tree.
