The Jockey Club CPS Limited

Central Police Station Conservation
and Revitalisation Project:
76th Monthly EM&A Report
(1 February to 28 February 2018)

Issue Date: March 2018

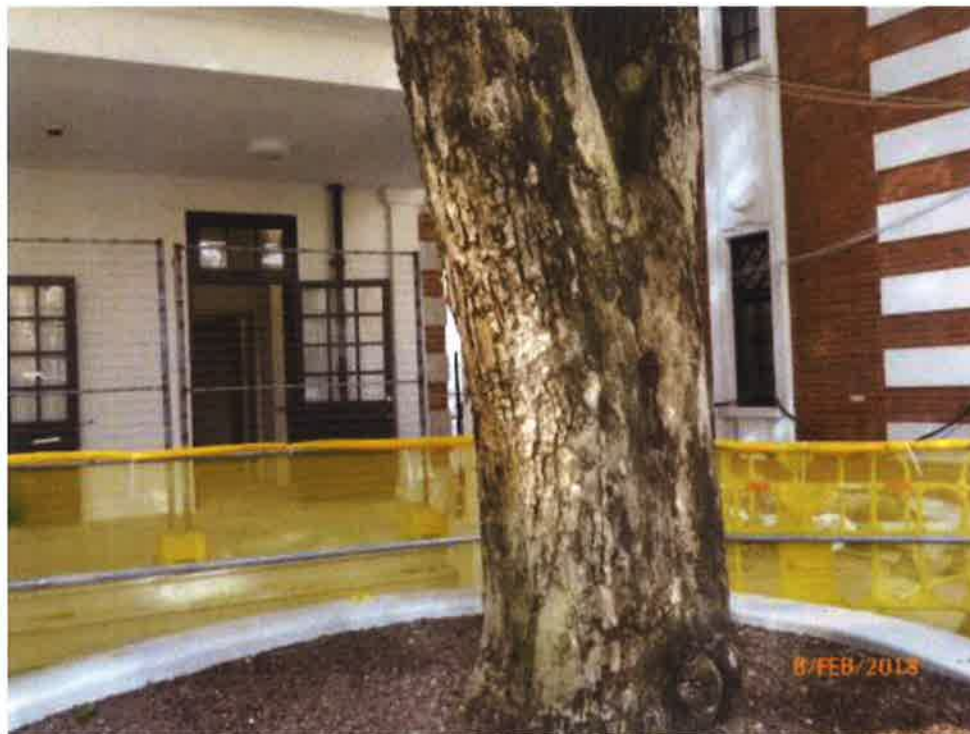
Fig. 3 Health condition of the lower trunk is fair.

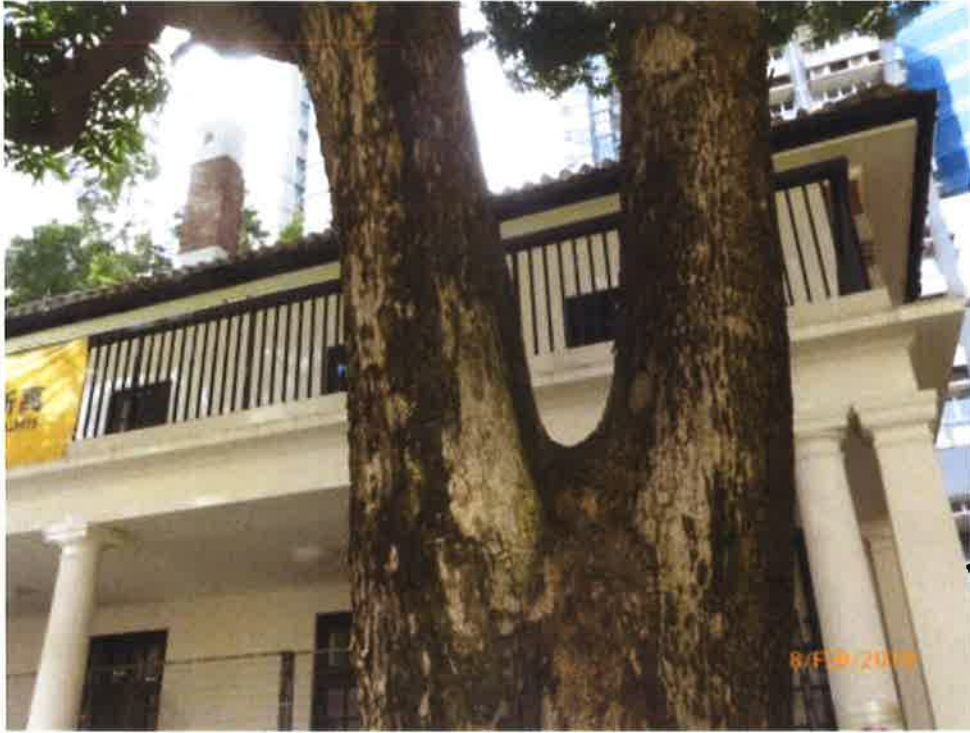
Fig. 4 Health condition of the mid trunk is fair.

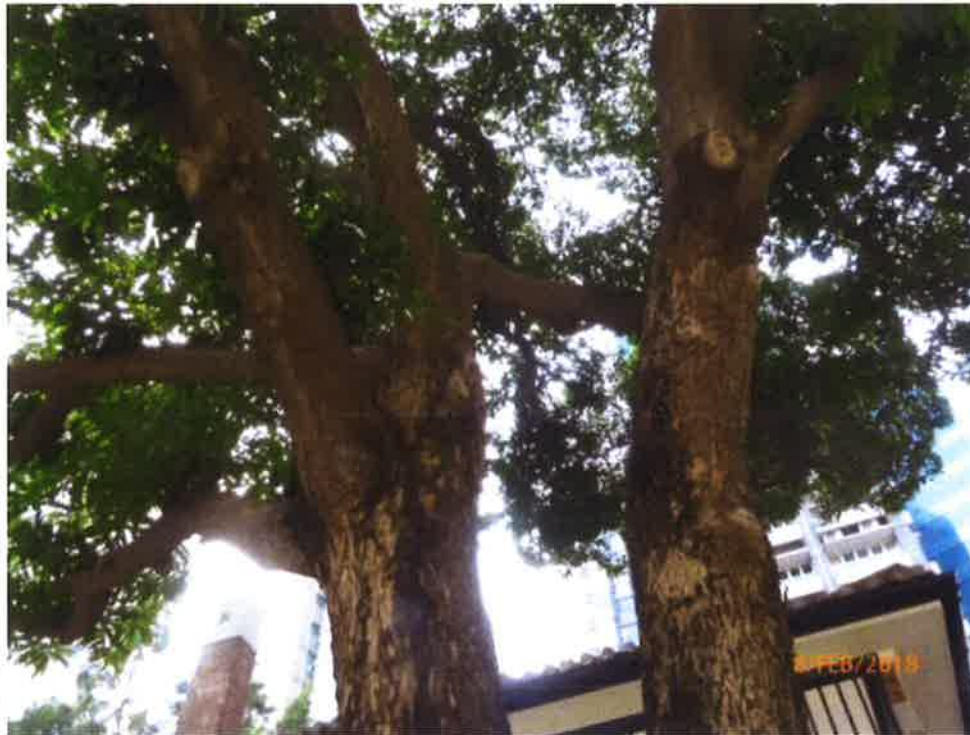
Fig. 5 Health condition of the upper trunk also is fair.

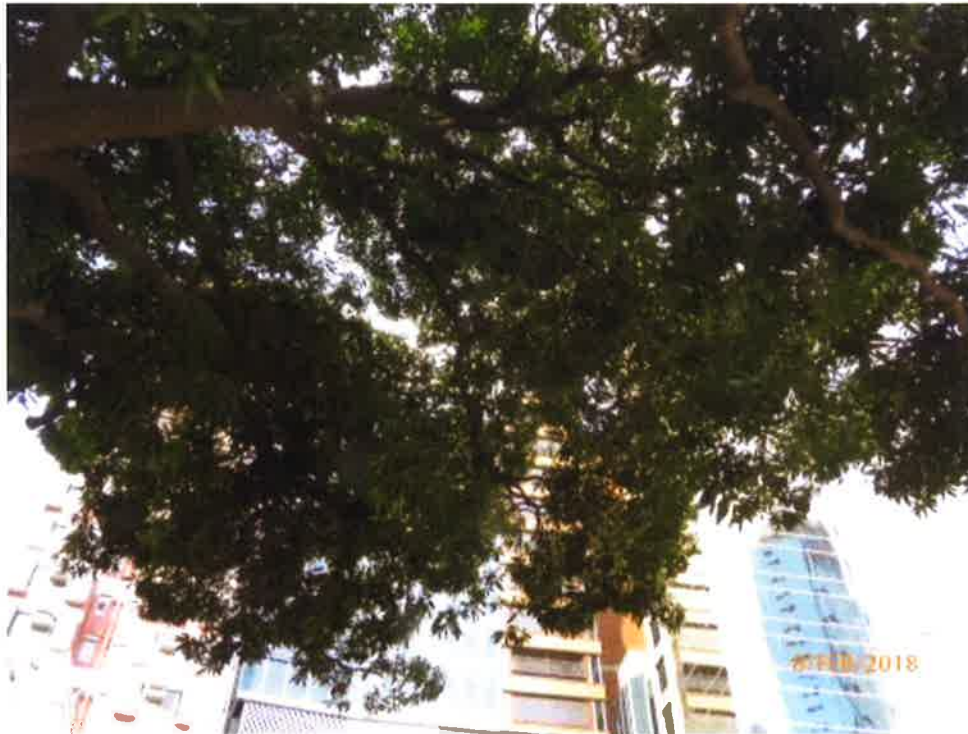
Fig. 7 Vigorous and green leaves also are growing on the lower branches.

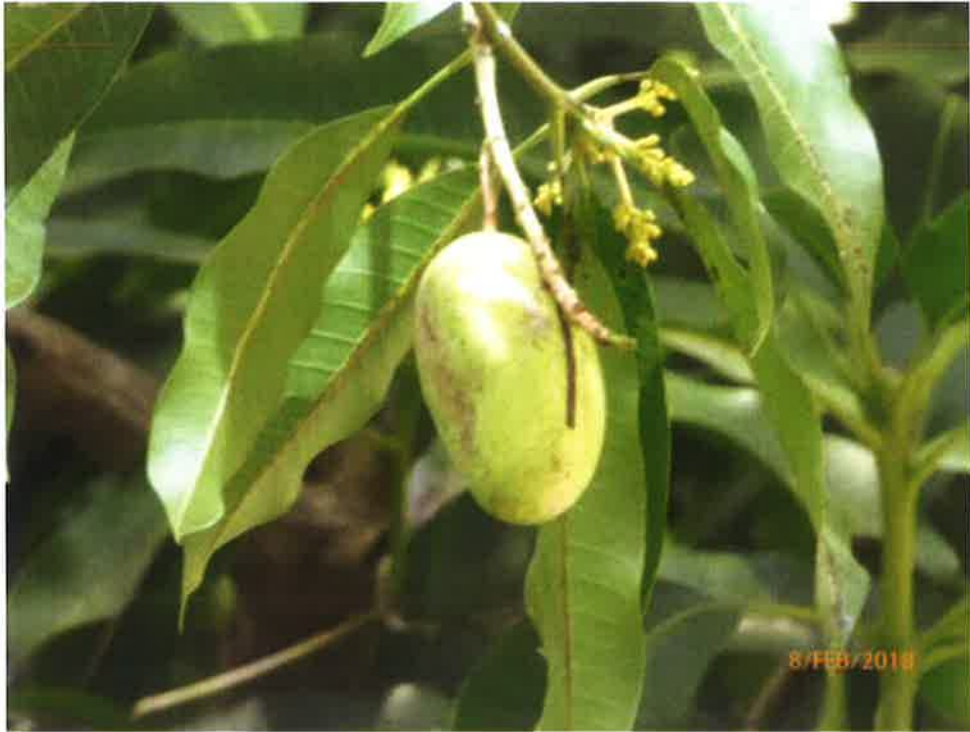
Fig. 10 A mango fruit still remains on the tree.

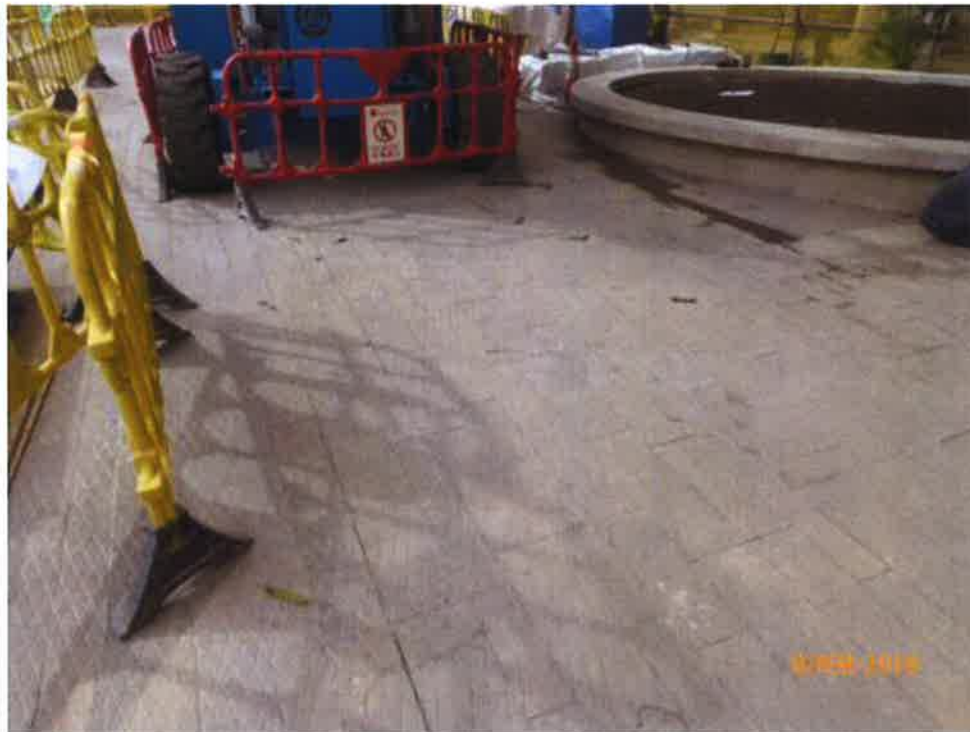
Fig. 11 The site near the planter is clean and tidy.

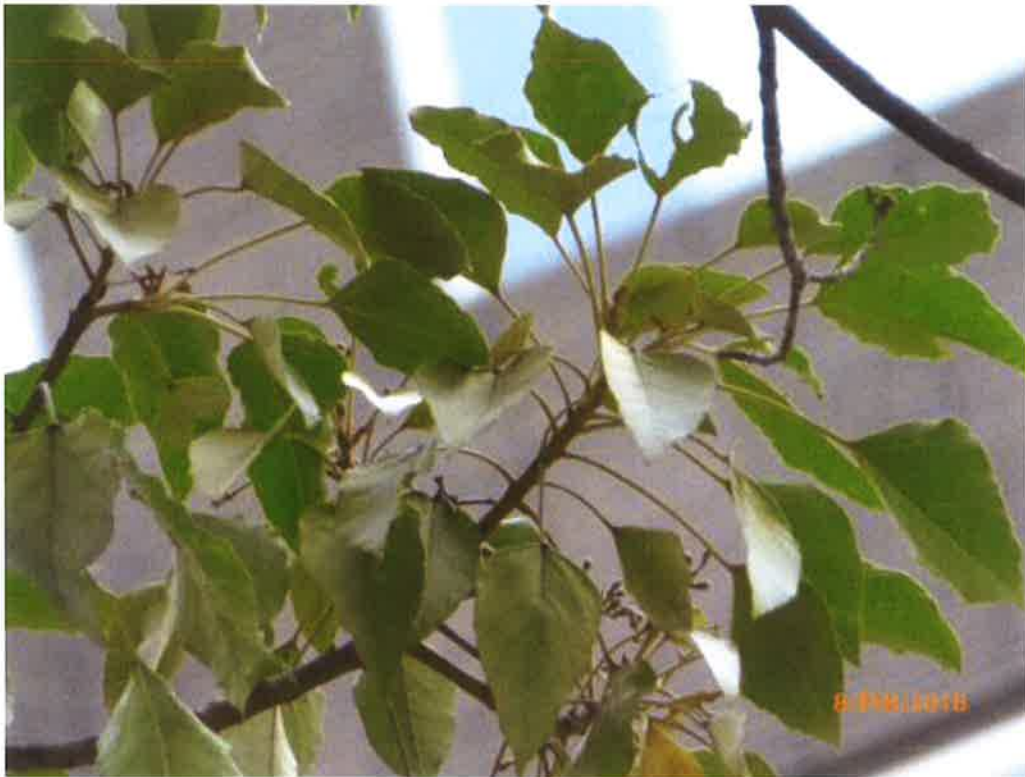
Fig. 9 As dry season has come, some leaves on the tree become faded.

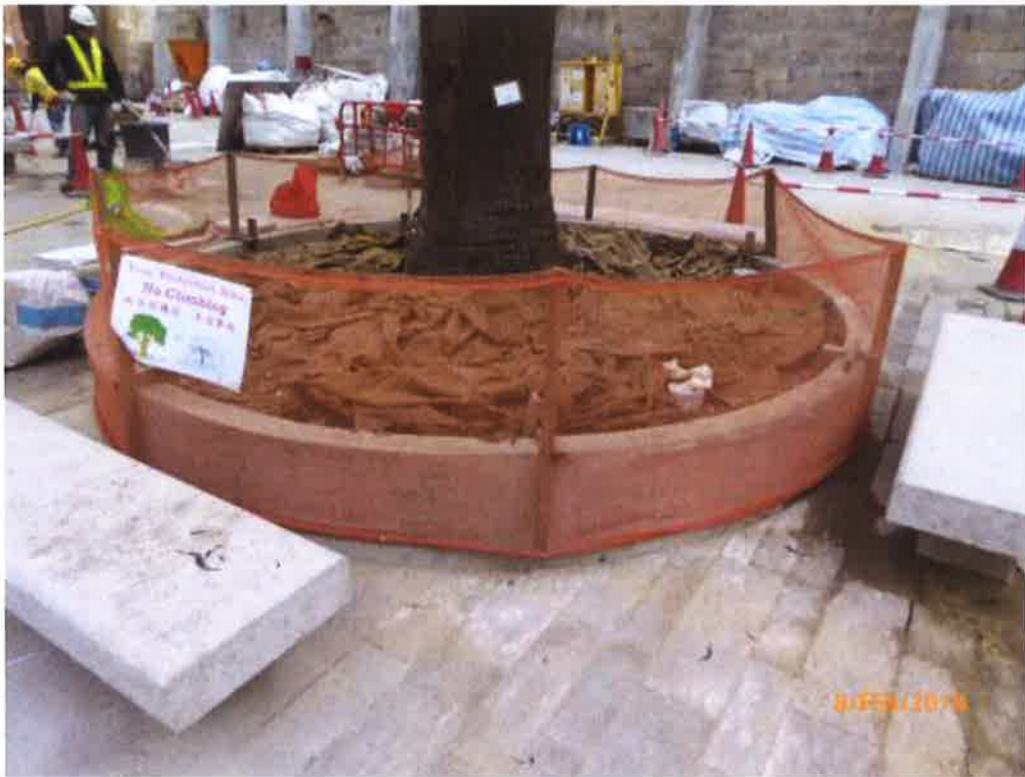
Fig. 11 Renovation works are in progress near the tree.

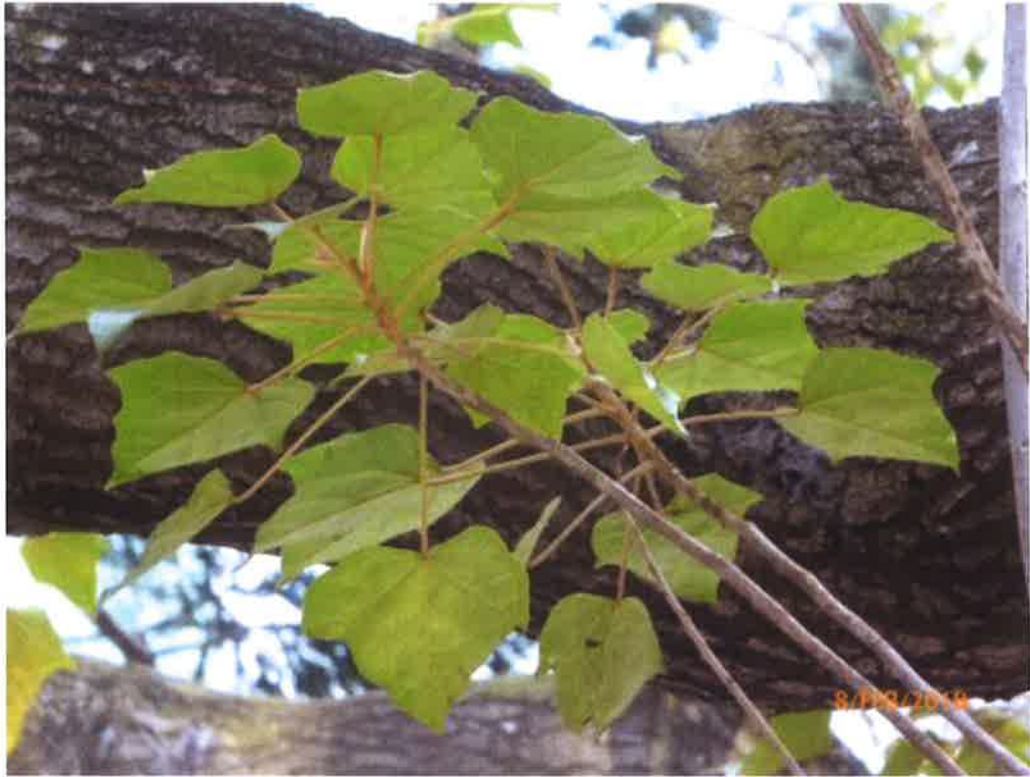
Fig. 9 As dry season has come, some leaves on the tree become faded.

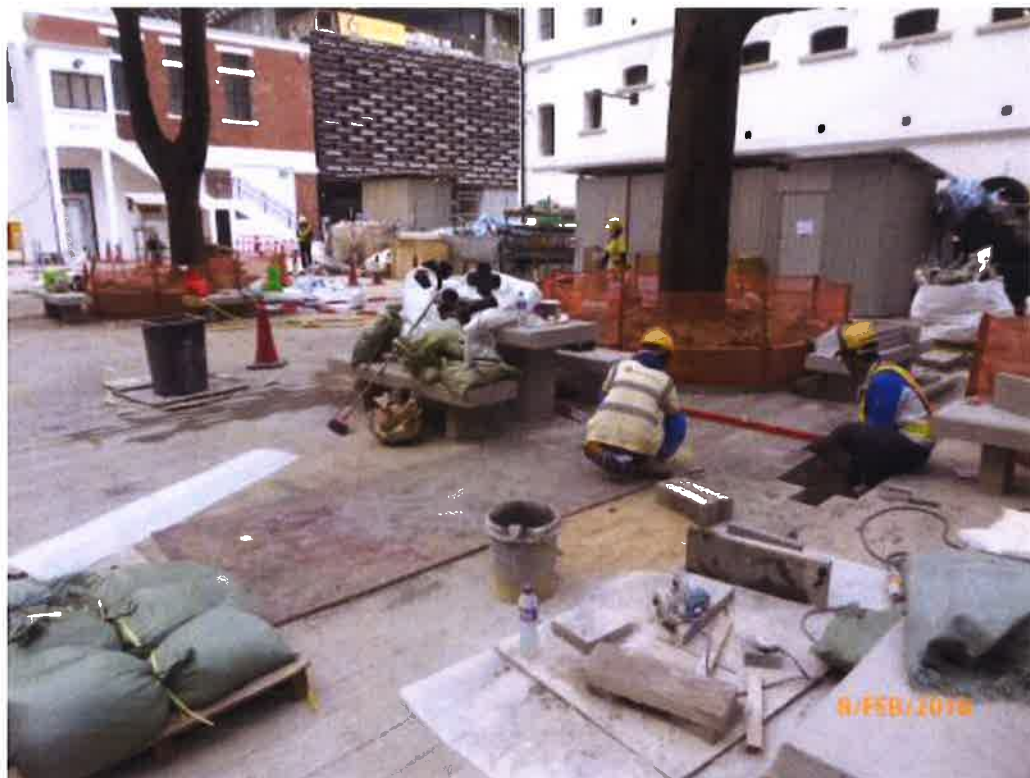
Fig. 12 Overall view of Tree-7 during inspection on 8th February 2018.

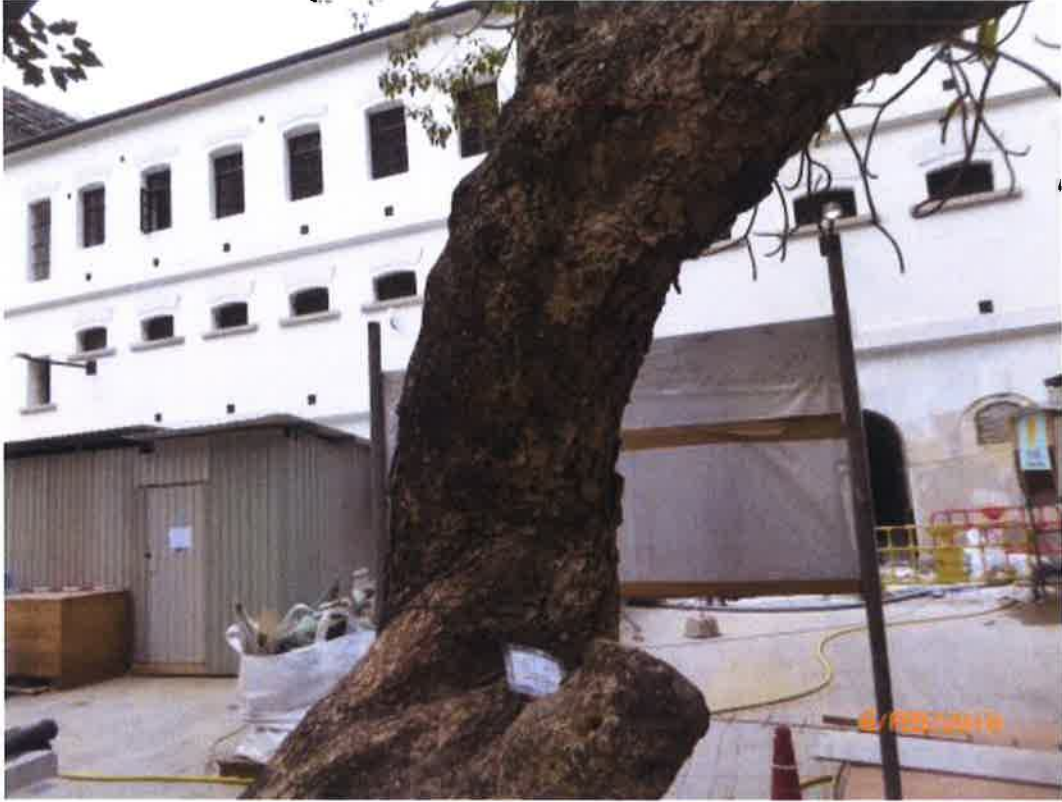
Fig. 5 Health condition of the upper trunk also is fair.

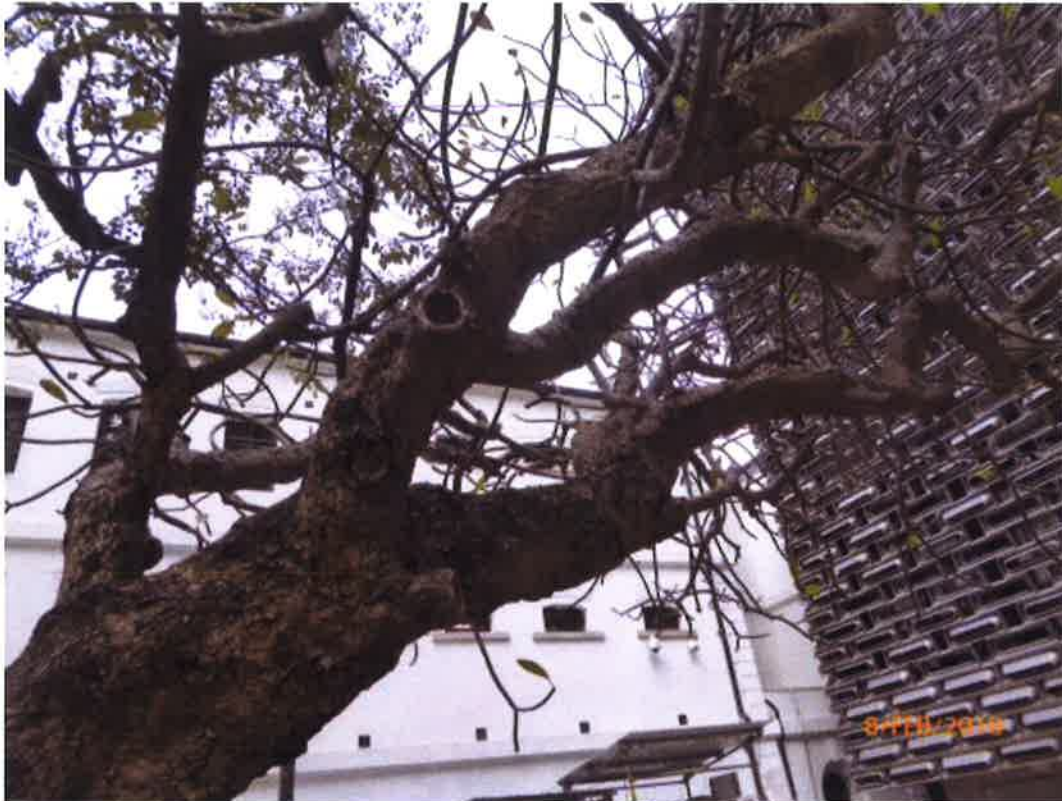
Fig. 6 As dry season has come, leaves are sparse on the tree.

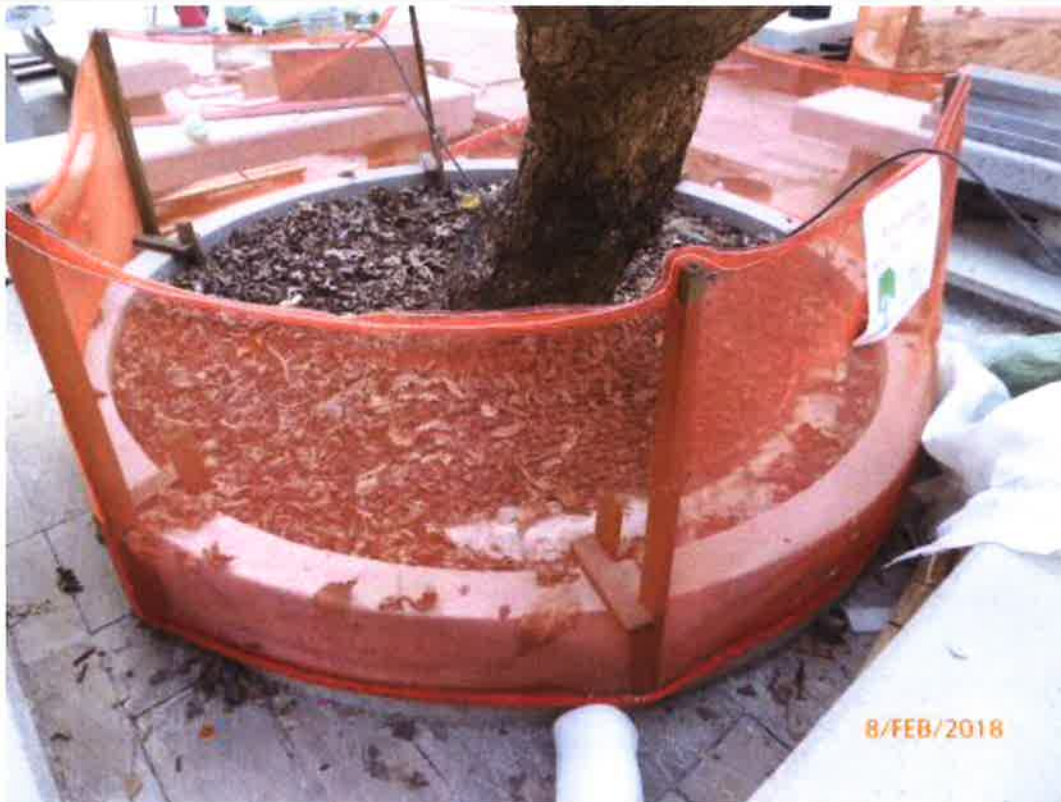
Fig. 10 Renovation works are in progress near Tree-8.

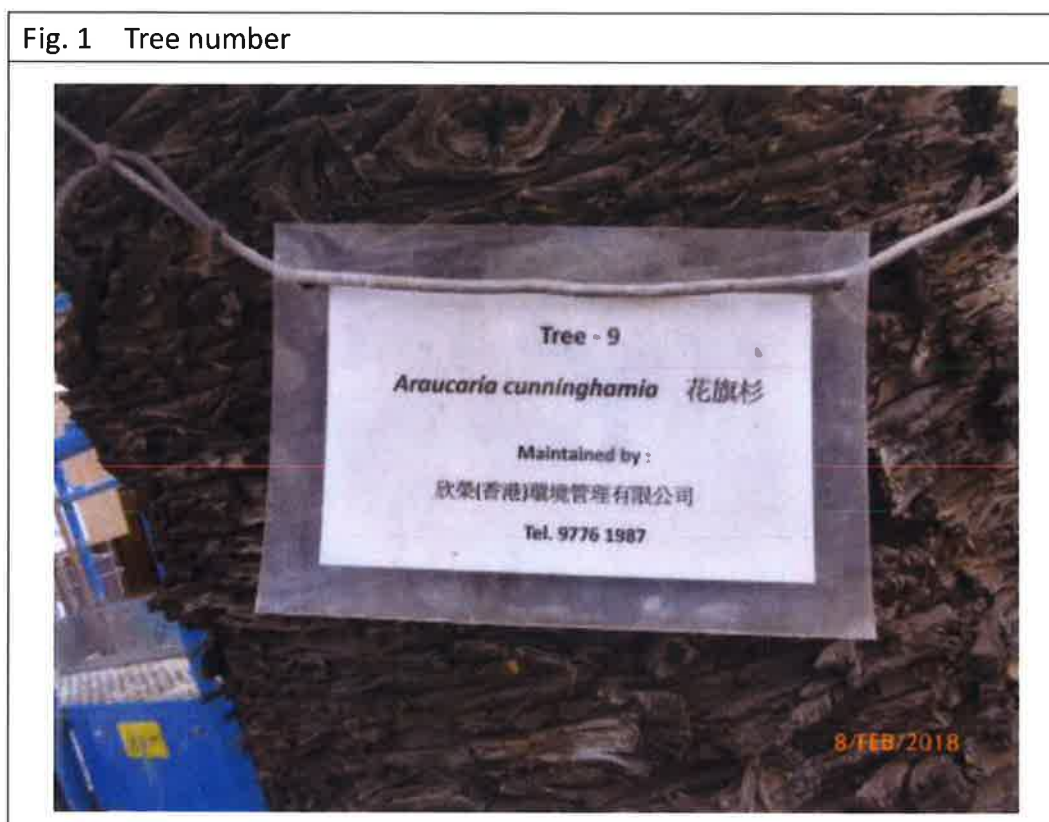
Fig. 2 Root collar is normal. The planter is covered with mulch and dry leaves.

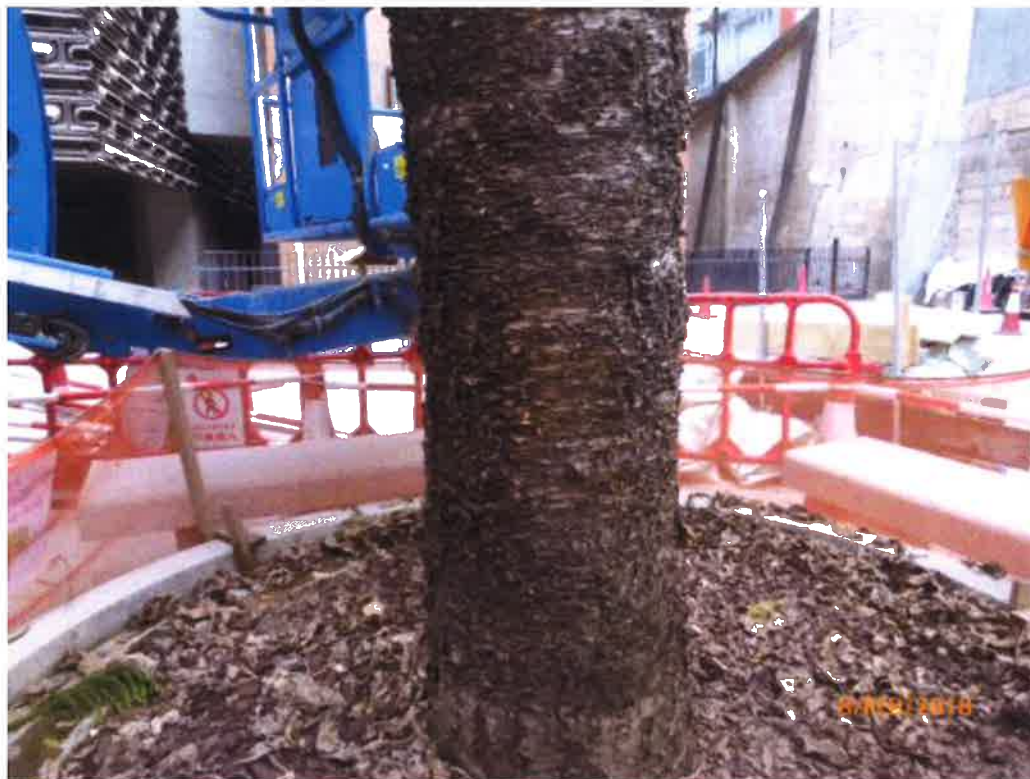
Fig. 4 Health condition of the mid trunk is fair.

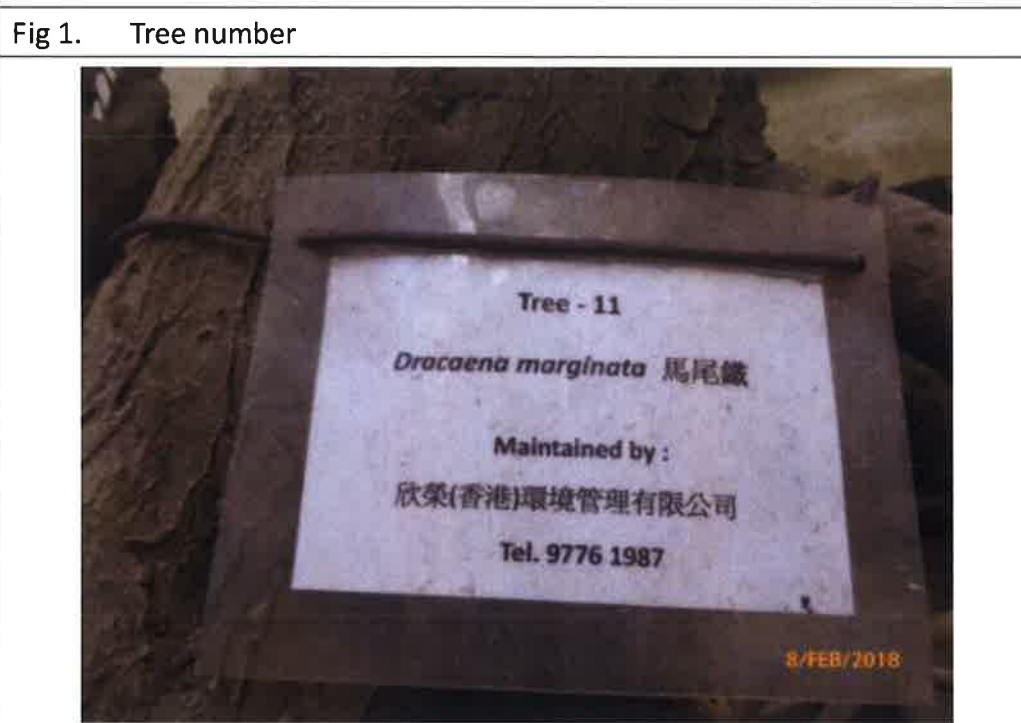
Fig. 2 Root collar is normal.

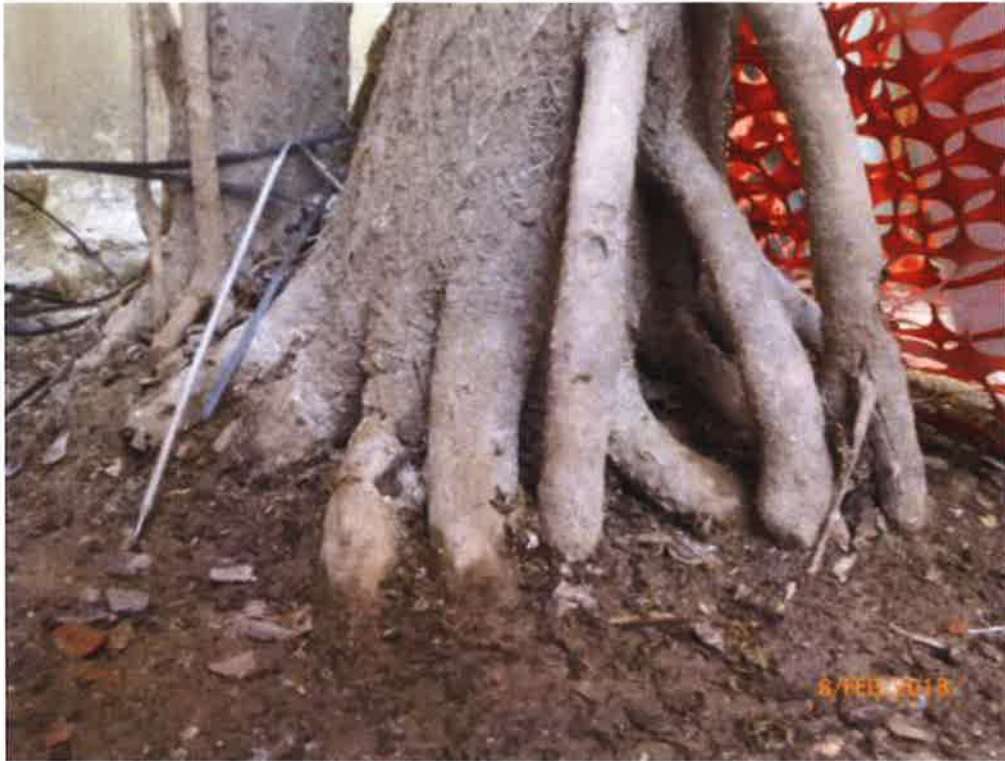
1. Health condition of the tree is fair.
2. Withered leaves still appear on the tree.
3. A few construction debris remained at the planter.
4. The site near the tree is clean and tidy.

Fig. 3 A few construction debris remained at the planter.

1. Remove the construction debris away from the planter.
2. Keep close monitoring on the growth of the tree especially during the nearby renovation works are in progress.

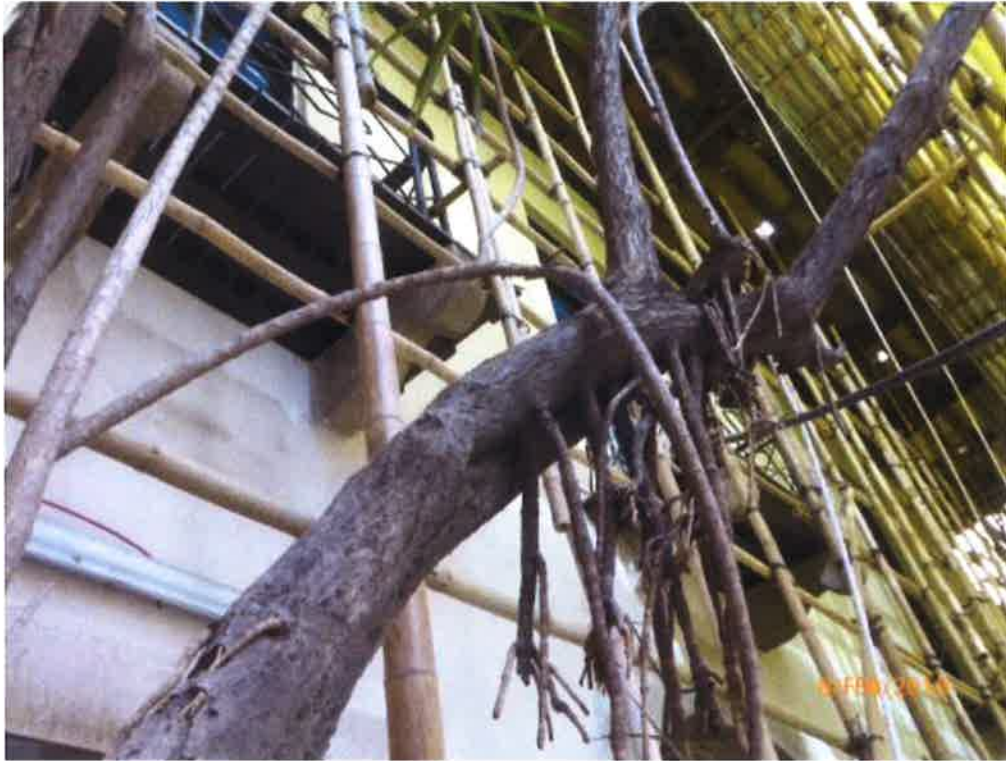
Fig. 7 Withered leaves still appear on the upper branches of Tree-11.

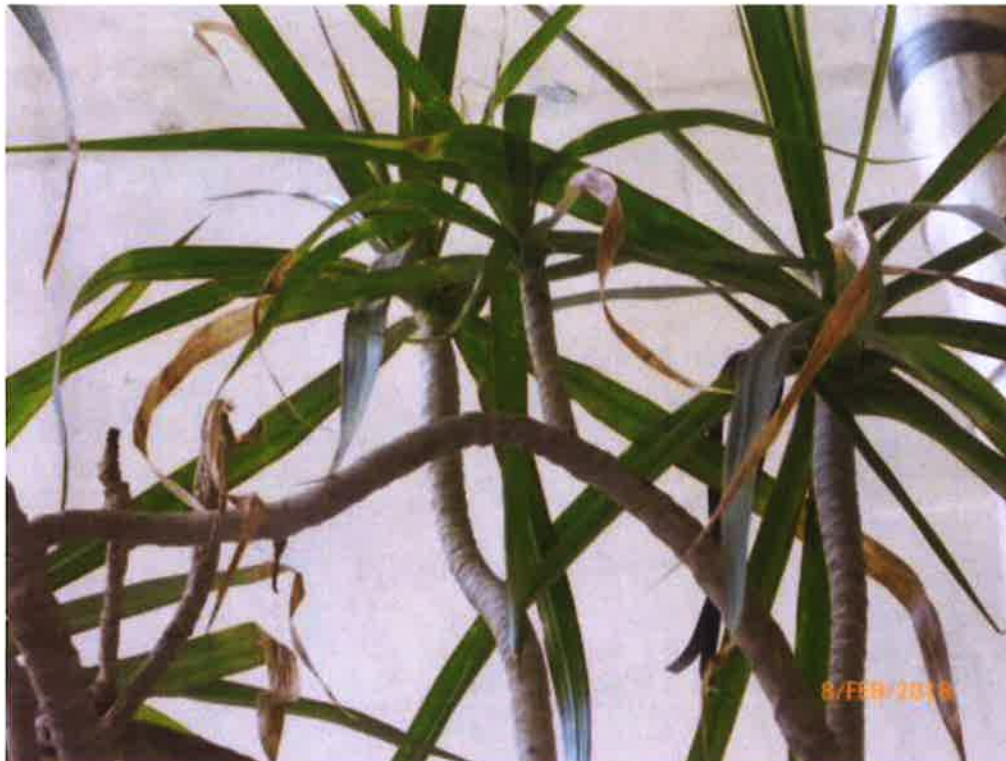
Fig. 8 Withered leaves also appear on the lower branches of Tree-11.

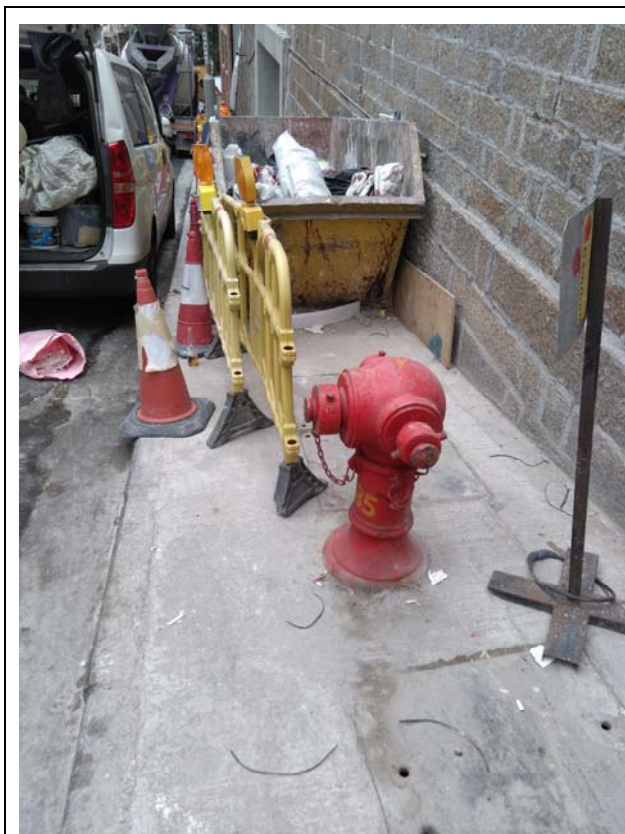
1. As advised by Gammon Construction Limited (the Contractor), one waste skip belonging to the CPS Site is located near the main entrance gate (blue gate) on the sidewalk of Old Bailey Street. The waste skip is located within the barricaded area on the east sidewalk of Old Bailey Street which is part of the approved road works area for CPS. The waste skip would not cause obstruction to road or pedestrians. A photo of the waste skip is shown in *Photo 1* and its location is shown in *Figure 1*. Construction waste generated from the CPS Site would be temporarily deposited in the waste skip, which will be cleared at the end of each working day. There is no illegal dumping of construction waste from the CPS Site. It should be noted that this waste skip has been in the same location for at least the past 1-2 years.

Photo 1: Construction Waste Skip (CPS Site)

All construction works are carried out strictly following the necessary requirements specified in EIA, EM&A Manual, EMP, Method Statements, General and Particular Specifications of this Project. The Contractor has been reminded to maintain tidiness of the construction waste skip and its surroundings. Construction waste should only be stored inside the waste skip and should be cleared on a daily basis to prevent accumulation. With regard to the temporary storage area at the junction of Old Bailey Street and Hollywood Road, the Contractor was also reminded to keep the temporary storage area tidy and clear of litter.

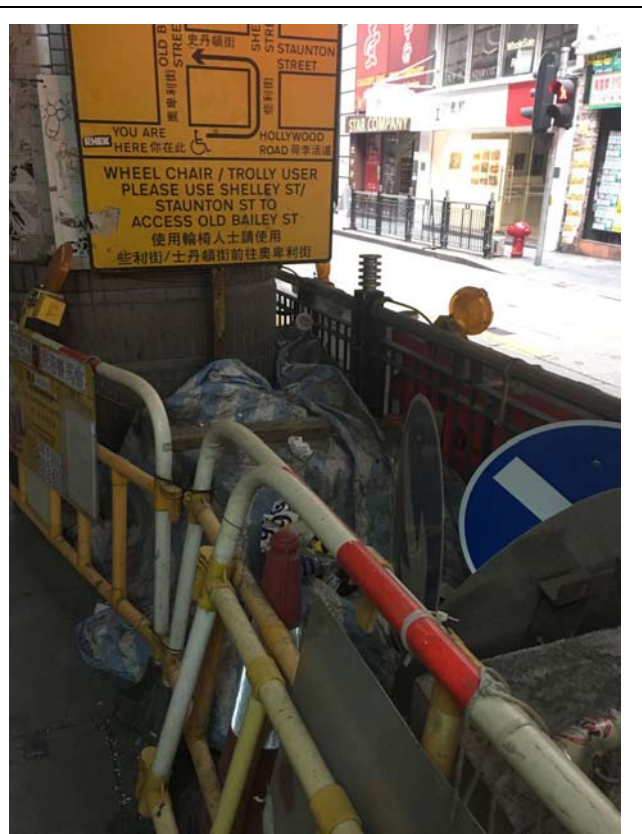
2. A small area at the junction of Old Bailey Street and Hollywood was barricaded for temporary storage of materials for the ongoing footbridge construction. A photo of the temporary storage area is shown in *Photo 2* and its location is shown in *Figure 1*. No construction waste is placed in the temporary storage area. The temporary storage area, which is included in the approved works area for the footbridge construction, only occupies part of the sidewalk of Hollywood Road and is considered not causing significant obstruction to the pedestrians. The temporary storage area would be in place until June 2018 which is the expected completion month of the footbridge construction.

Photo 2: Temporary Storage Area (CPS Site)
