The Jockey Club CPS Limited

Central Police Station Conservation  
and Revitalisation Project:  
*79<sup>th</sup> Monthly EM&A Report*  
*(1 May to 25 May 2018)*

Issue Date: June 2018

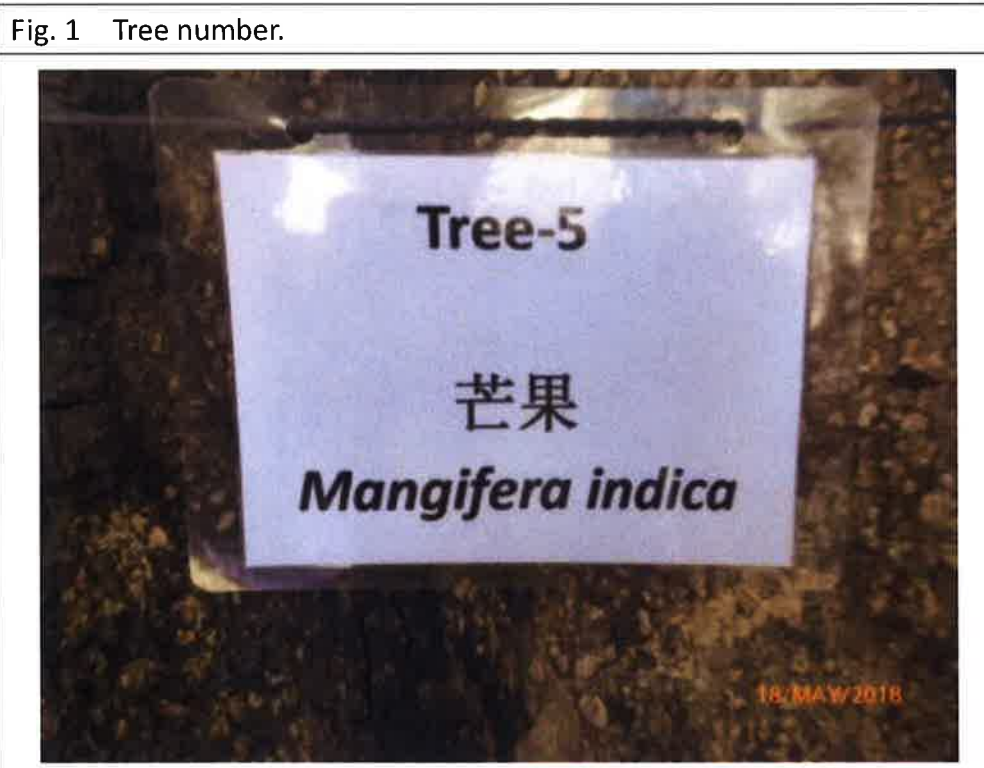
Fig. 2 The root collar is normal.

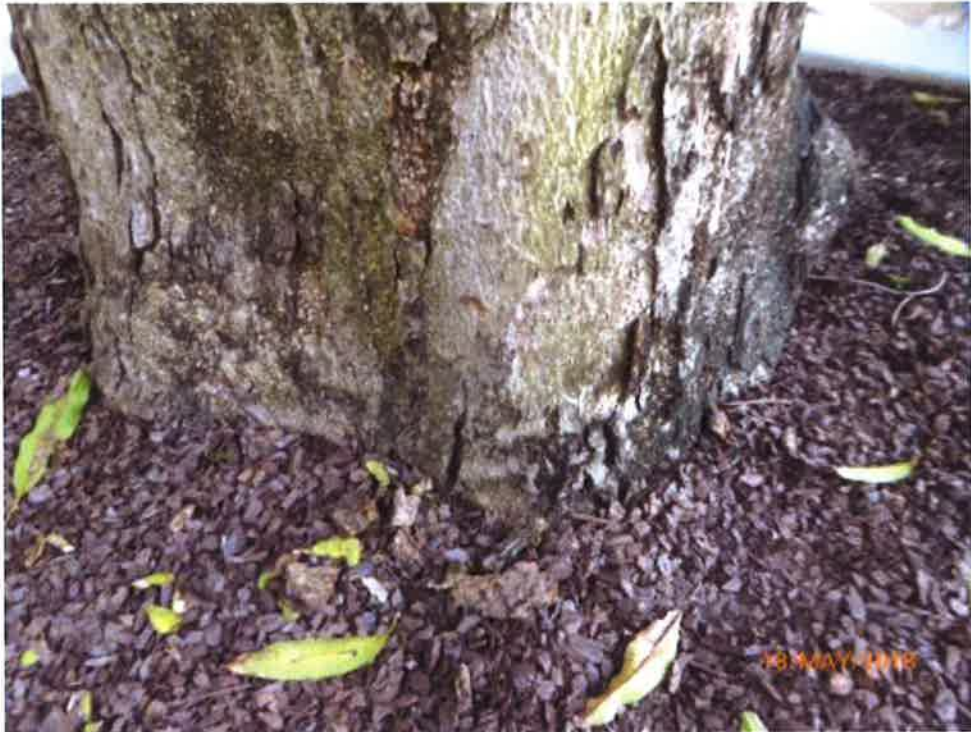
Fig. 3 The planter is covered with small pieces of mulch.

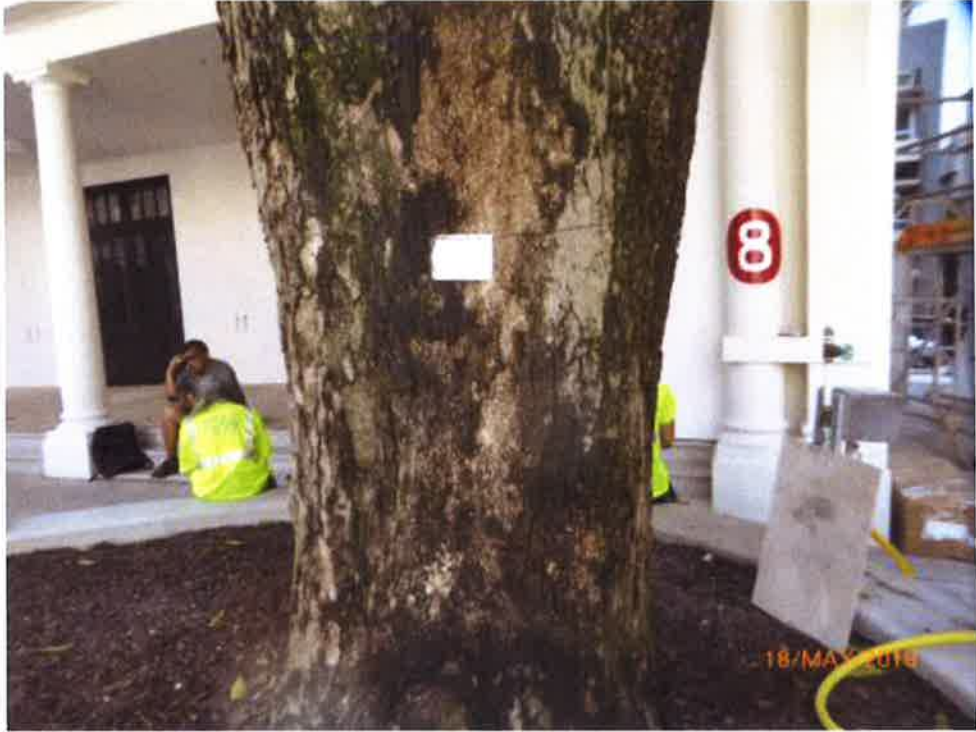
Fig. 5 Health condition of the mid trunk is fair.

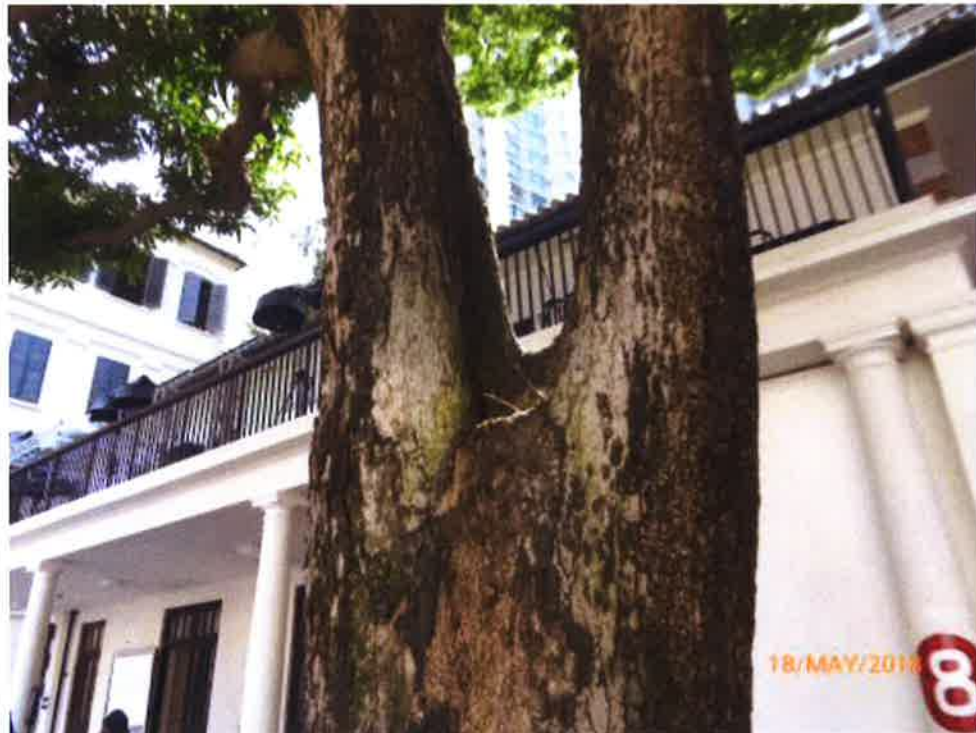
Fig. 6 Health condition of the upper trunk also is fair.

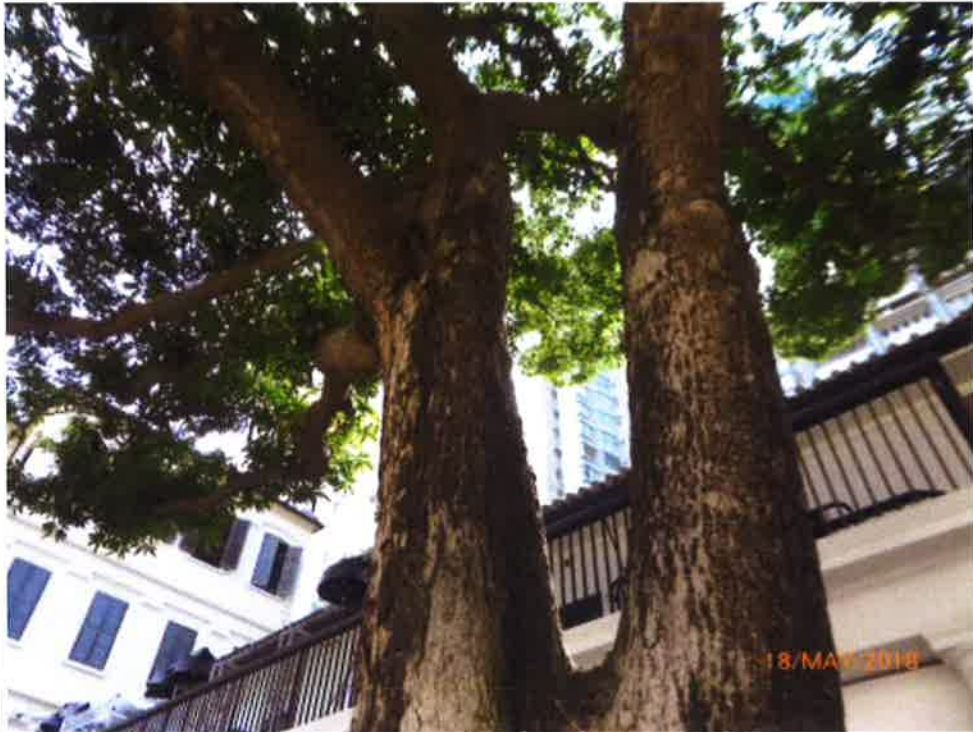
Fig. 7 The crown is full of vigorous and green leaves.

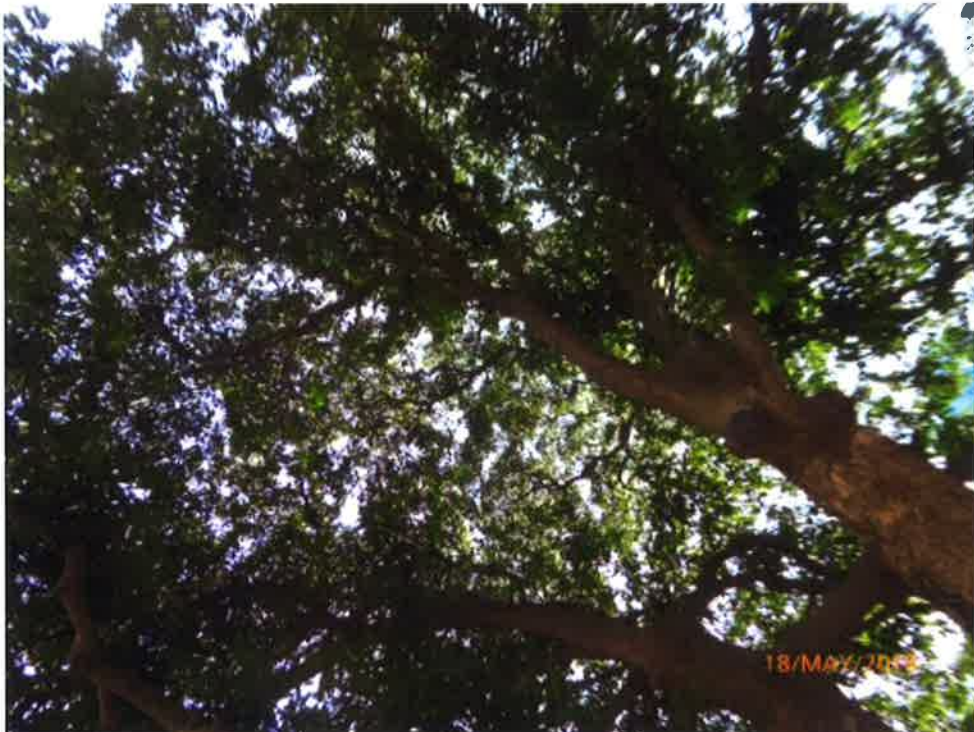
Fig. 8 Vigorous and green leaves also are growing on the lower branches.

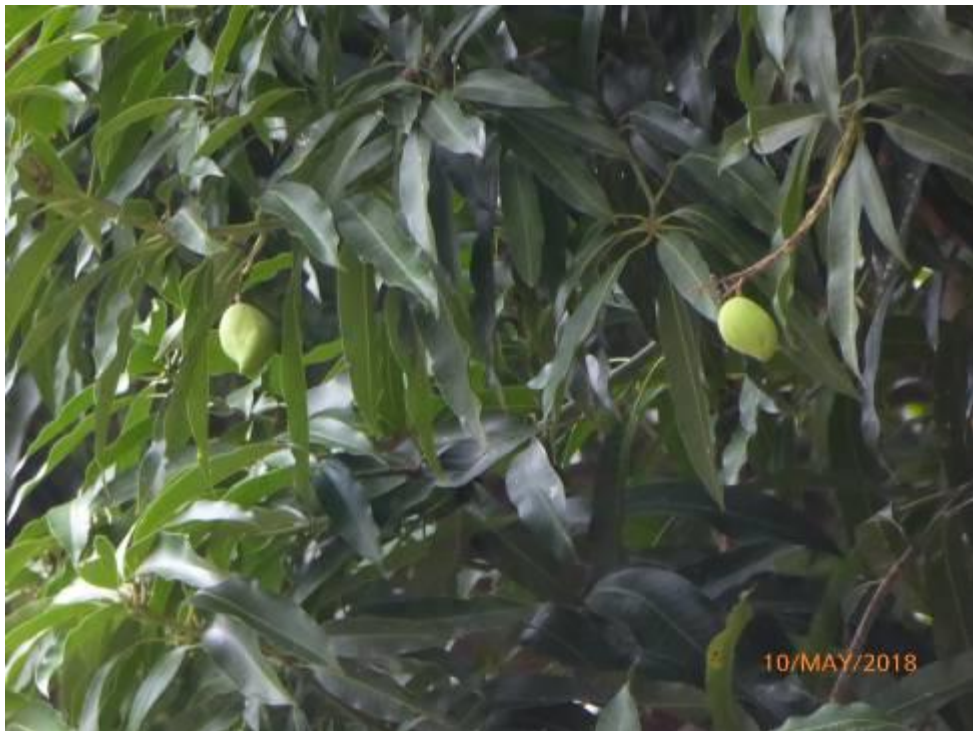
Fig. 10 A few dead twigs remain on the lower branches.

1. Remove the dead twigs as soon as possible.

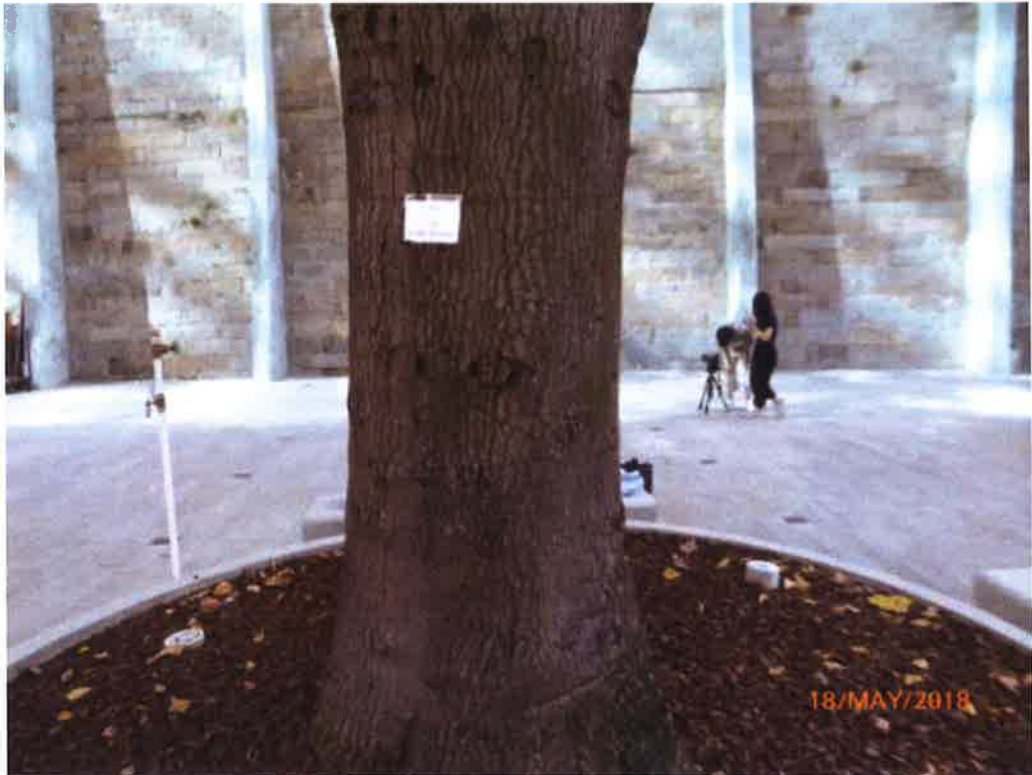
Fig. 5 Health condition of the mid trunk is fair.

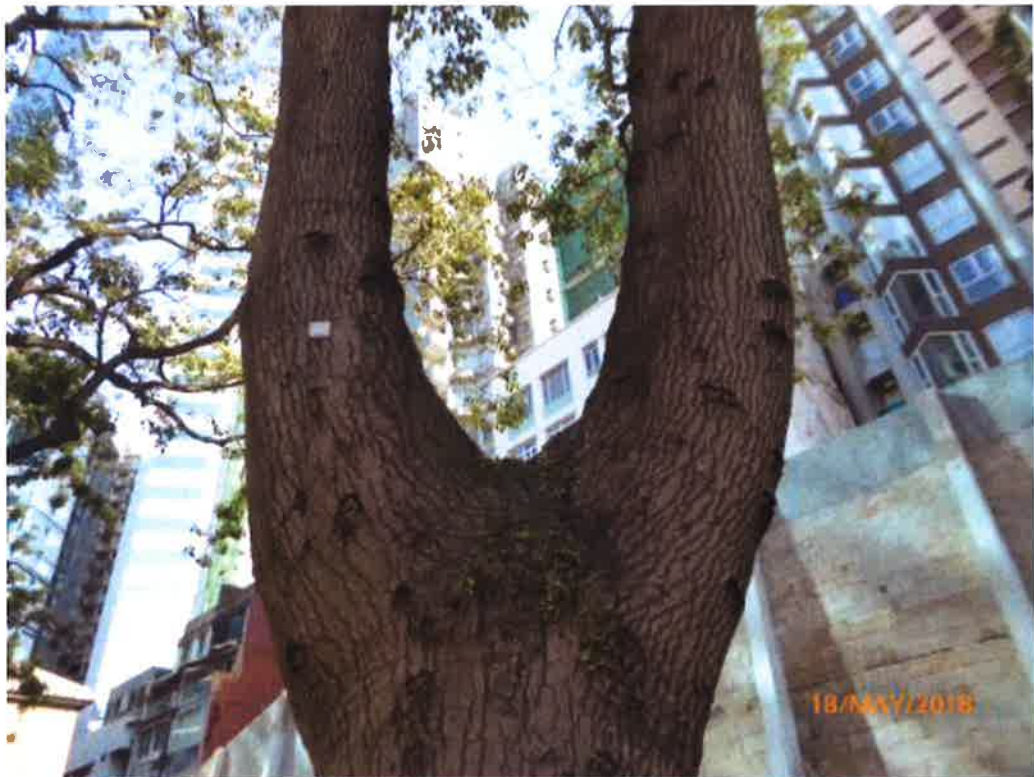
Fig. 6 Health condition of the upper trunk also is fair.

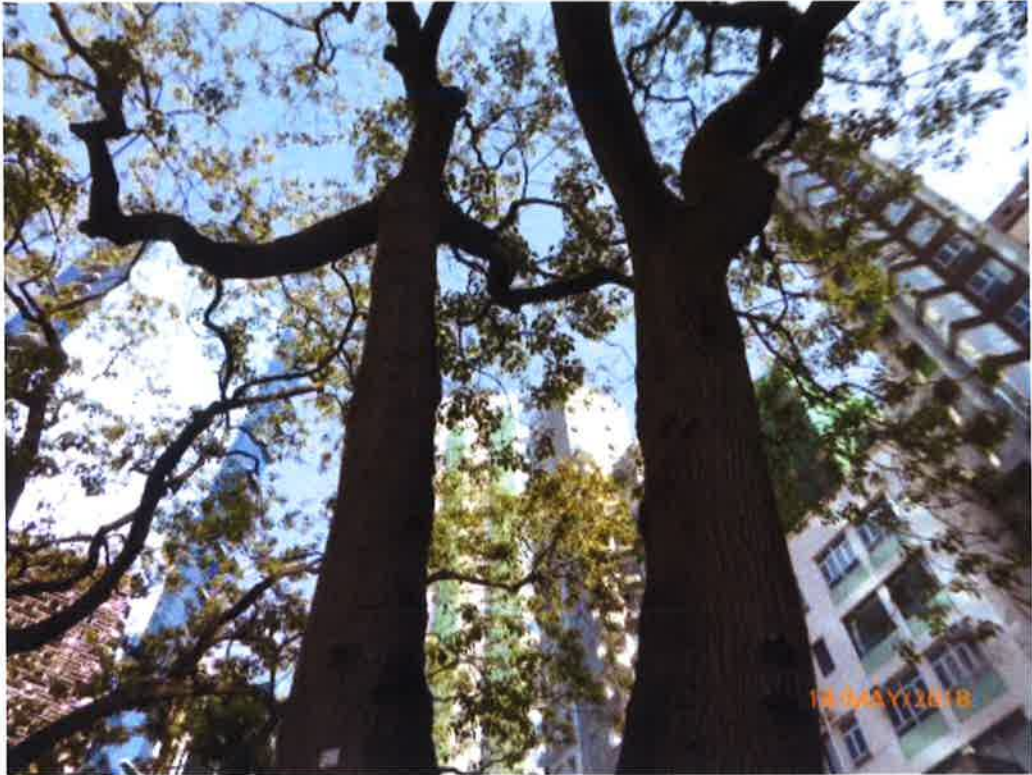
Fig. 7 Leaves on the crown are rather sparse.

1. Remove the dead twigs away from the tree as soon as possible.
2. Keep close monitoring on the growth of Tree-6. If dead twigs continuously appear on the tree, the site beneath the drop-line of Tree-6 should be cordoned to protect the visitors.

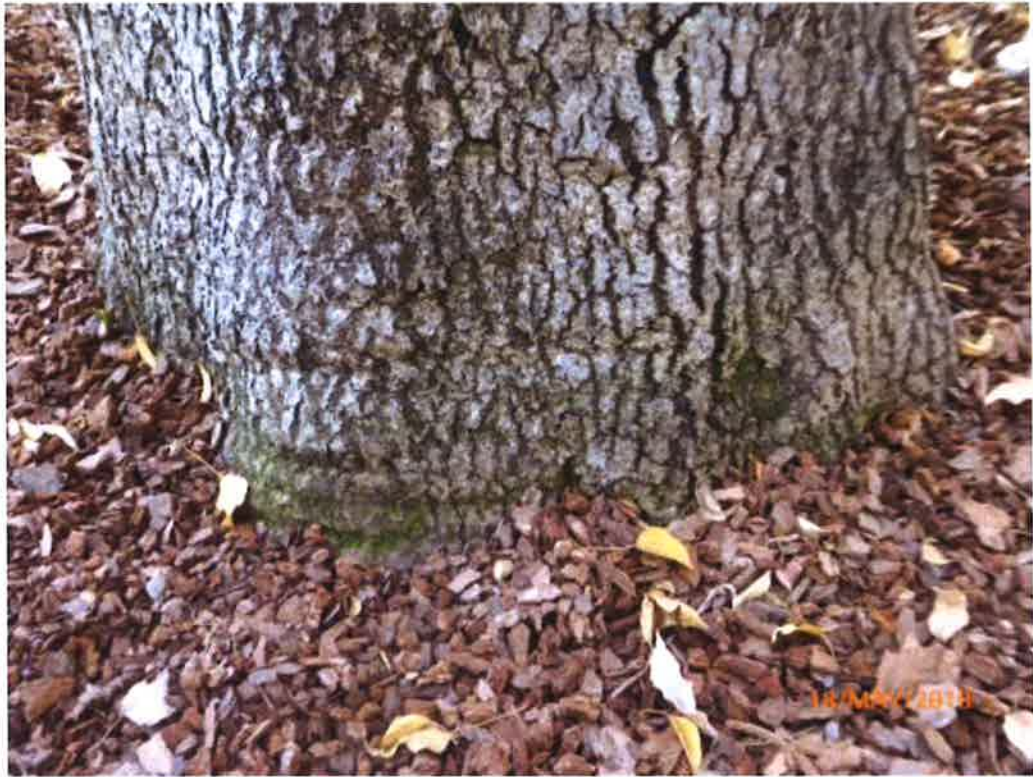
Fig. 3 The planter is covered with wet small pieces of mulch.

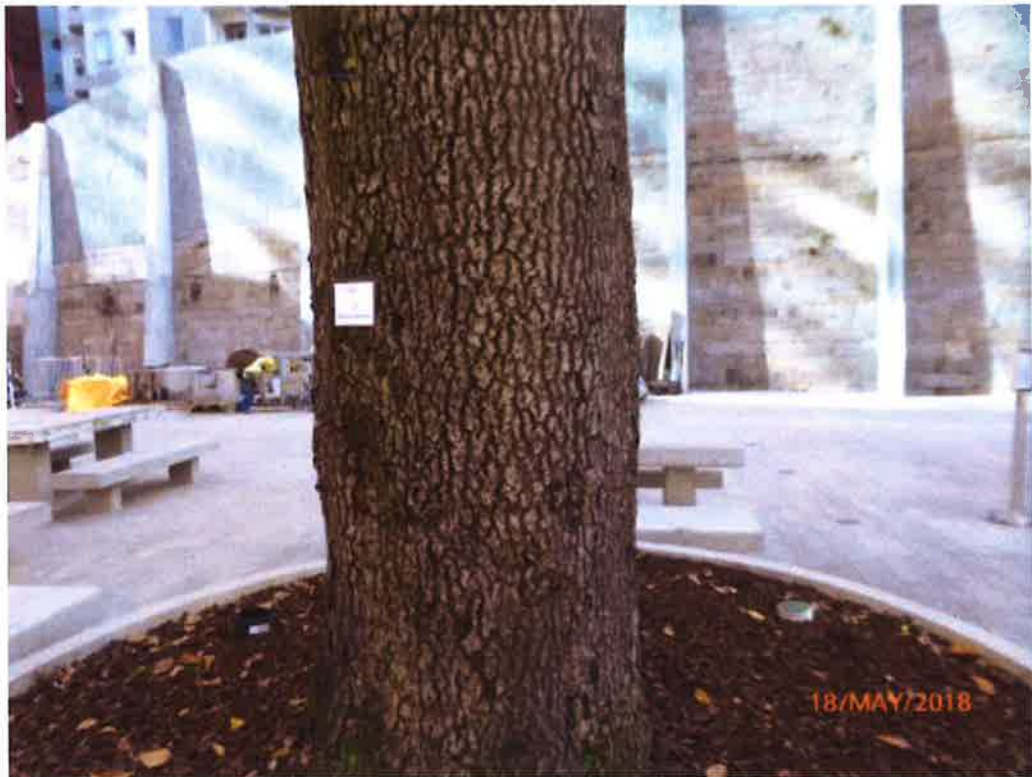
Fig. 5 Health condition of the mid trunk is fair.

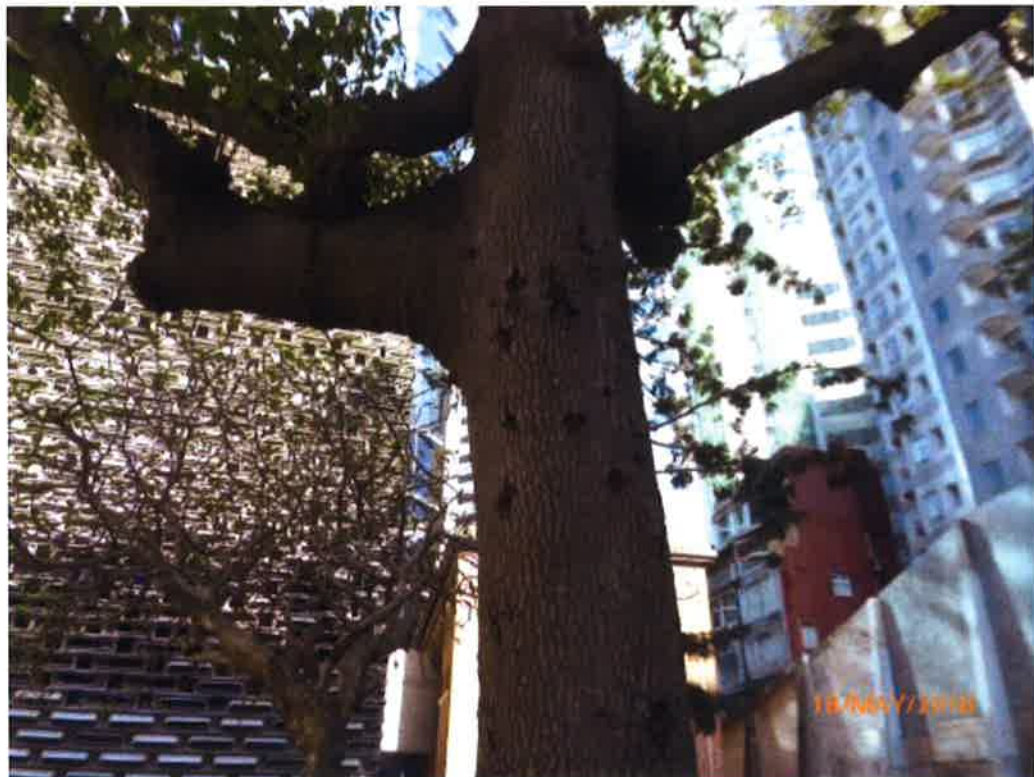
Fig. 6 Health condition of the upper trunk also is fair.

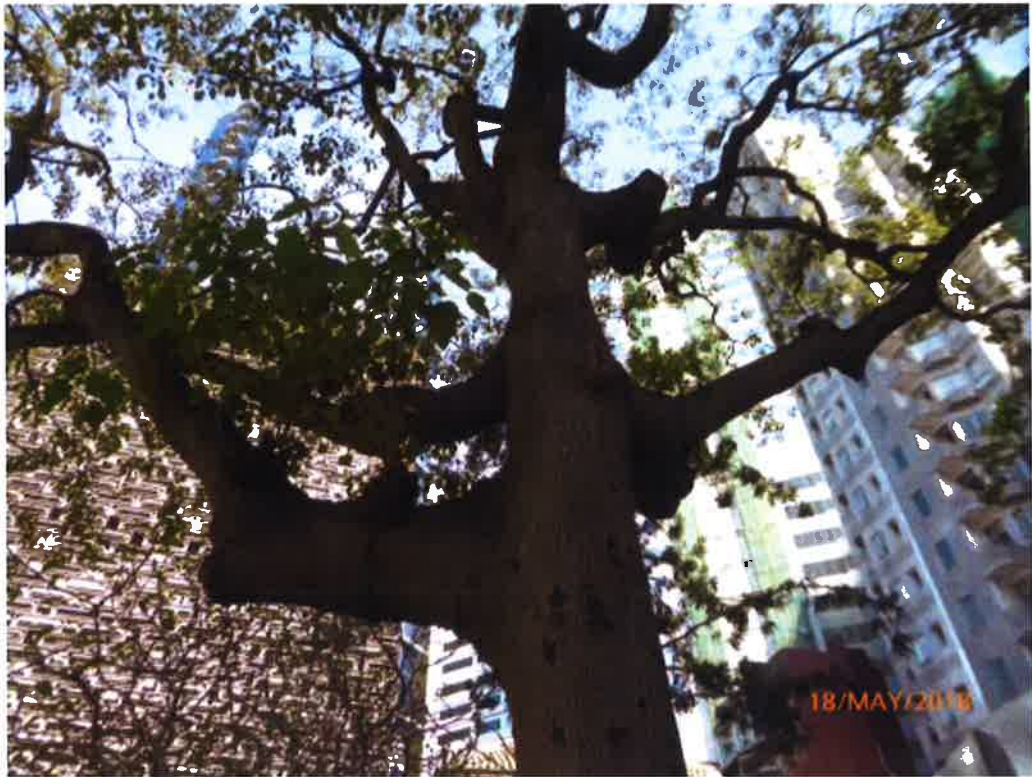
Fig. 7 Leaves on the crown are rather sparse.

1. **Remove the dead twigs away from the tree as soon as possible.**
2. **Keep close monitoring on the growth of Tree-7. If dead twigs continuously appear on the tree, the site beneath the drop-line of Tree-7 should be cordoned to protect the visitors.**

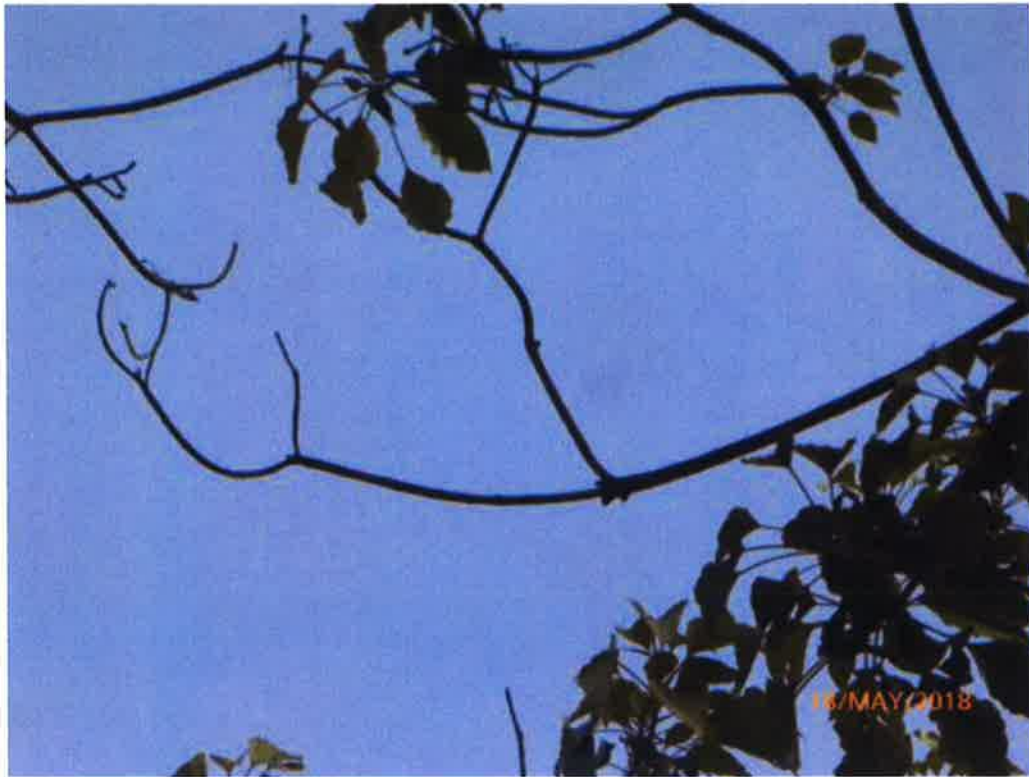
Fig. 9 Some young and green leaves are growing on the lower branches.

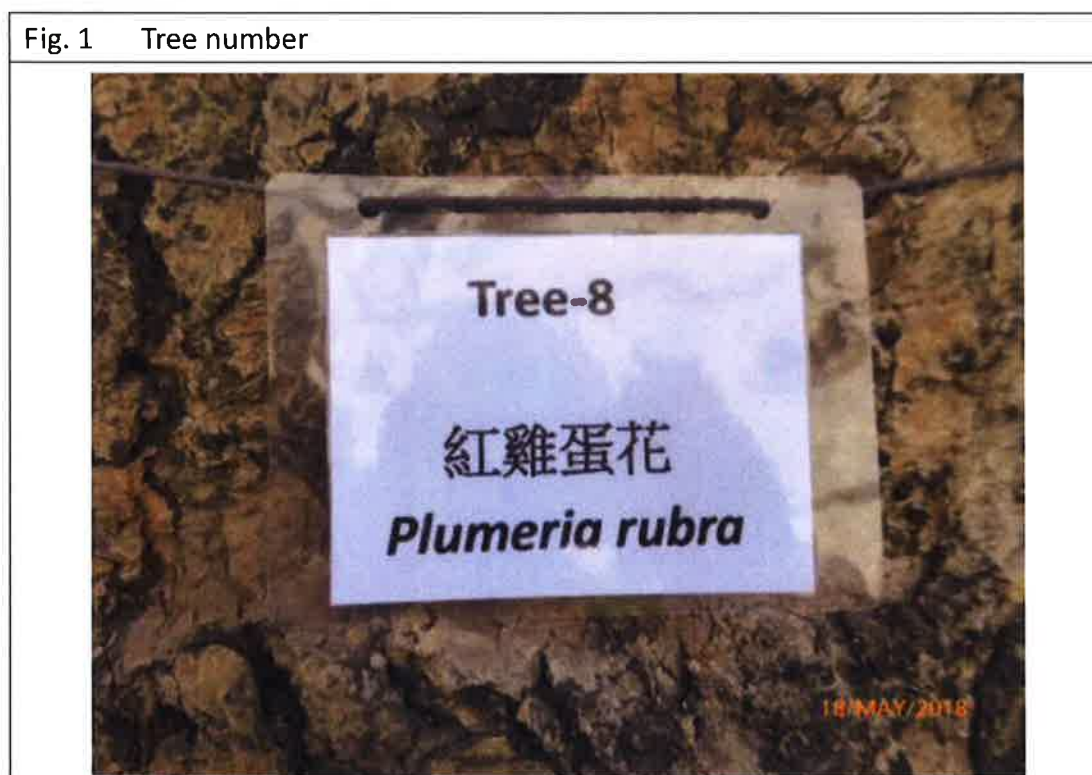
Fig. 2 Root collar is normal.

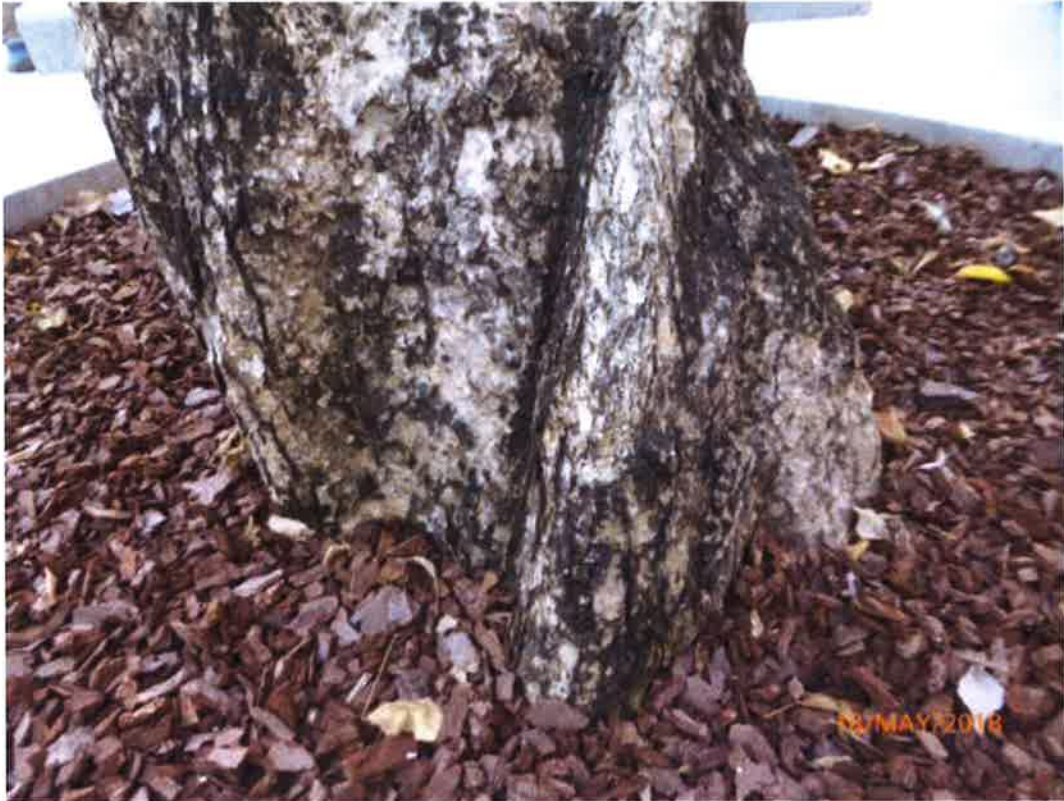
Fig. 3 The planter is covered with mulch and dry leaves.

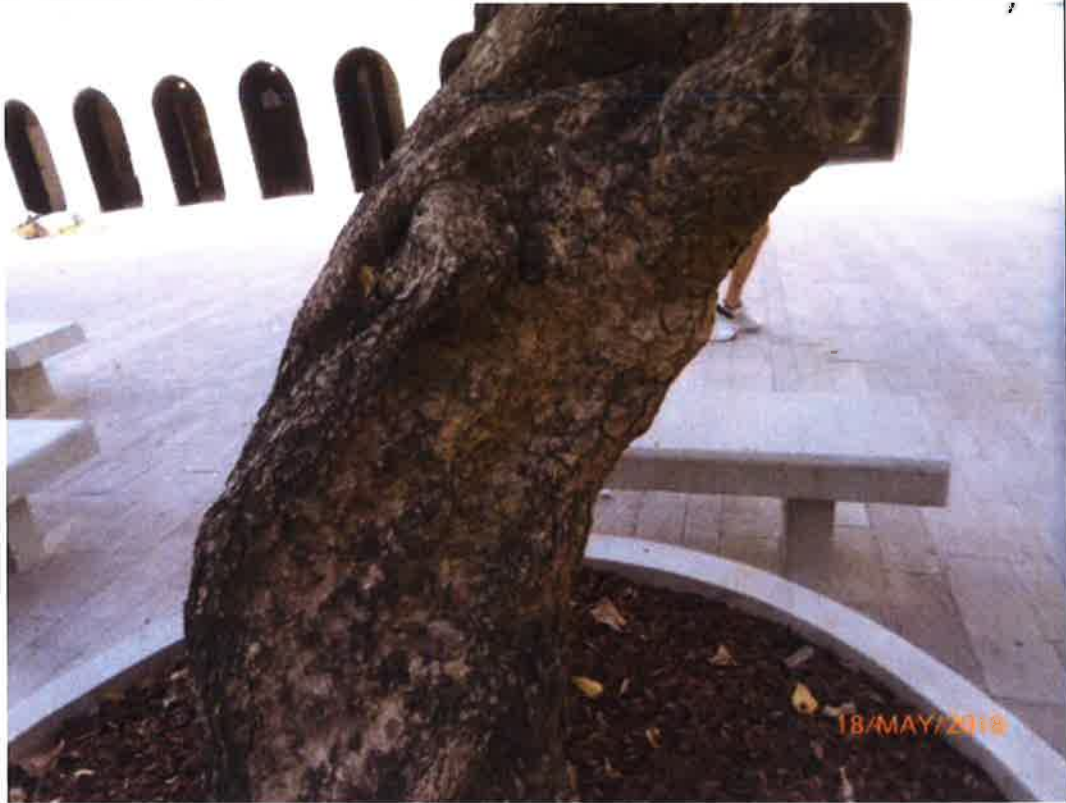
Fig. 5 Health condition of the mid trunk is fair.

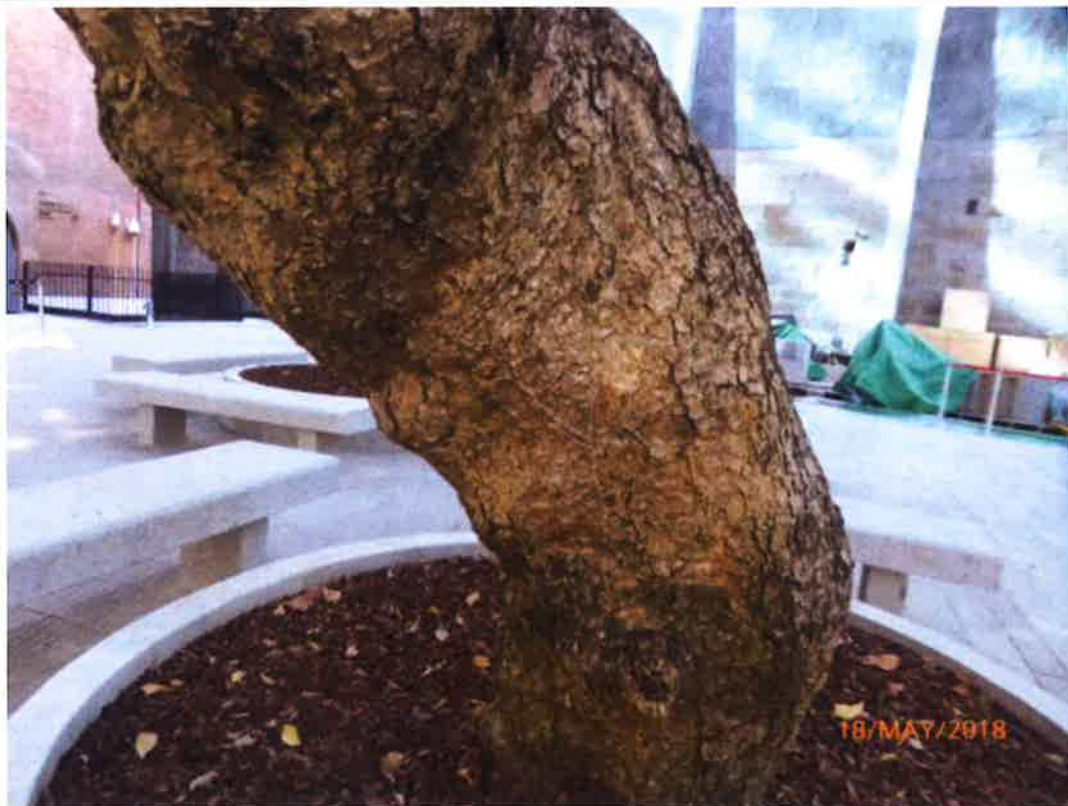
Fig. 6 Health condition of the upper trunk also is fair.

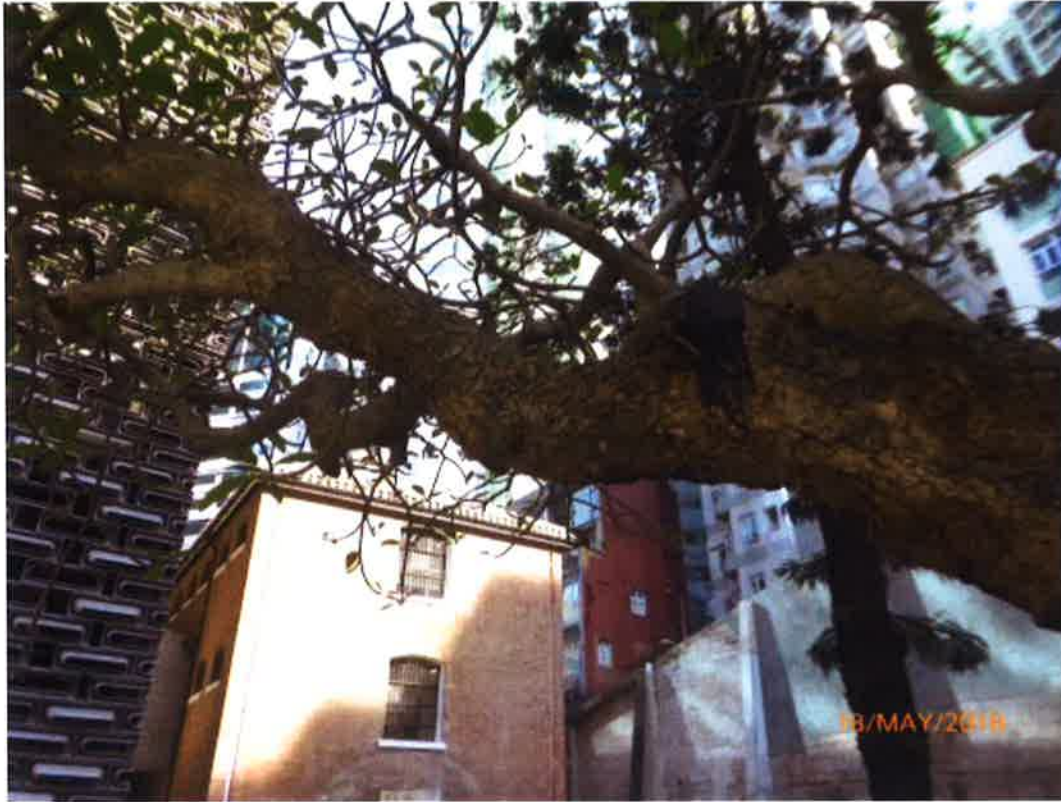
Fig. 7 The crown is full of vigorous and green leaves.

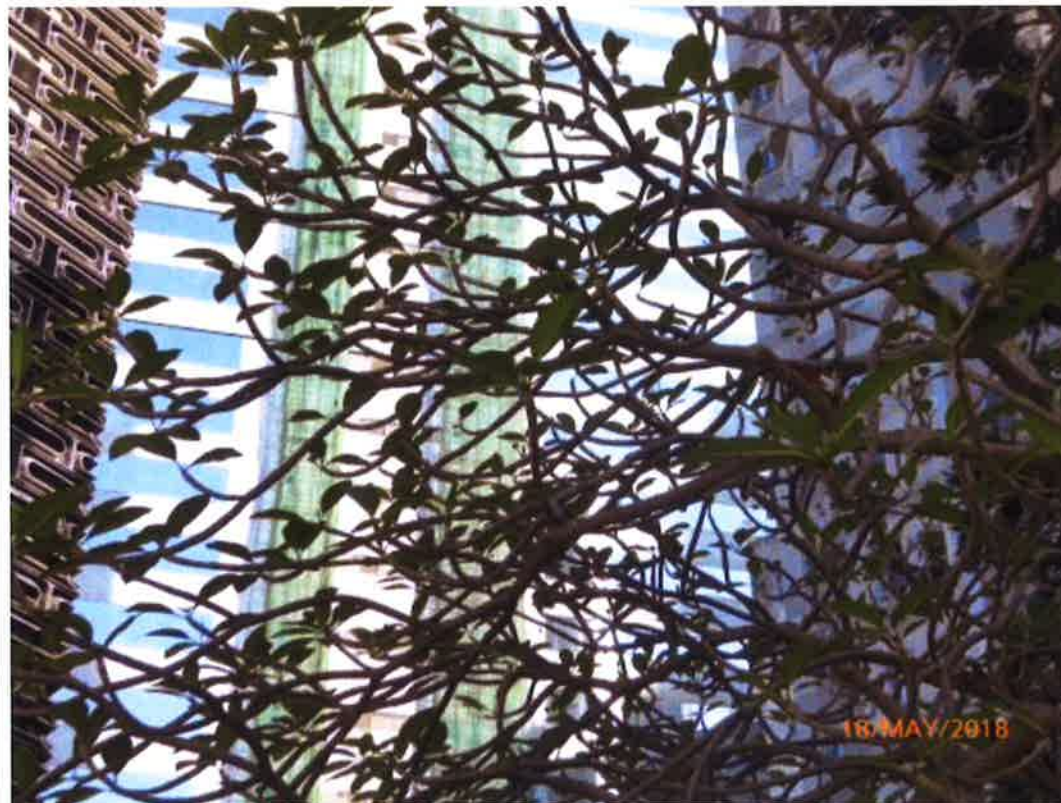
Fig. 8 Vigorous and green leaves also are growing on the lower branches.

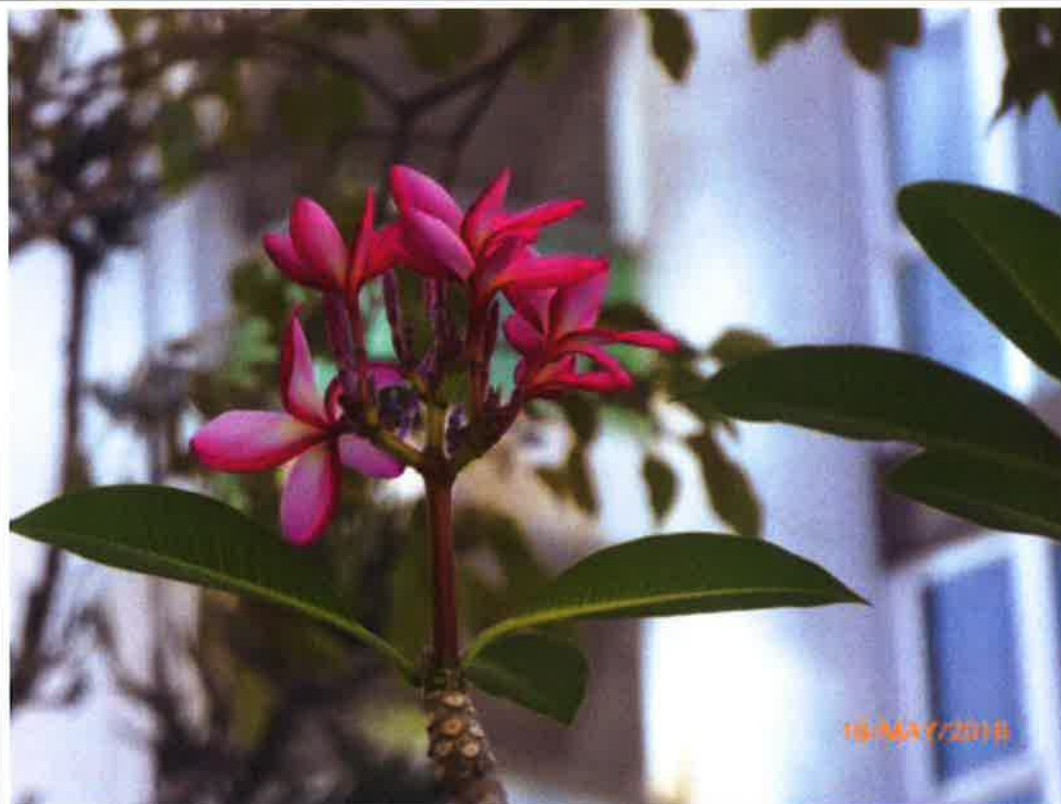
Fig. 10 Some young and green leaves also appear on the upper branches.

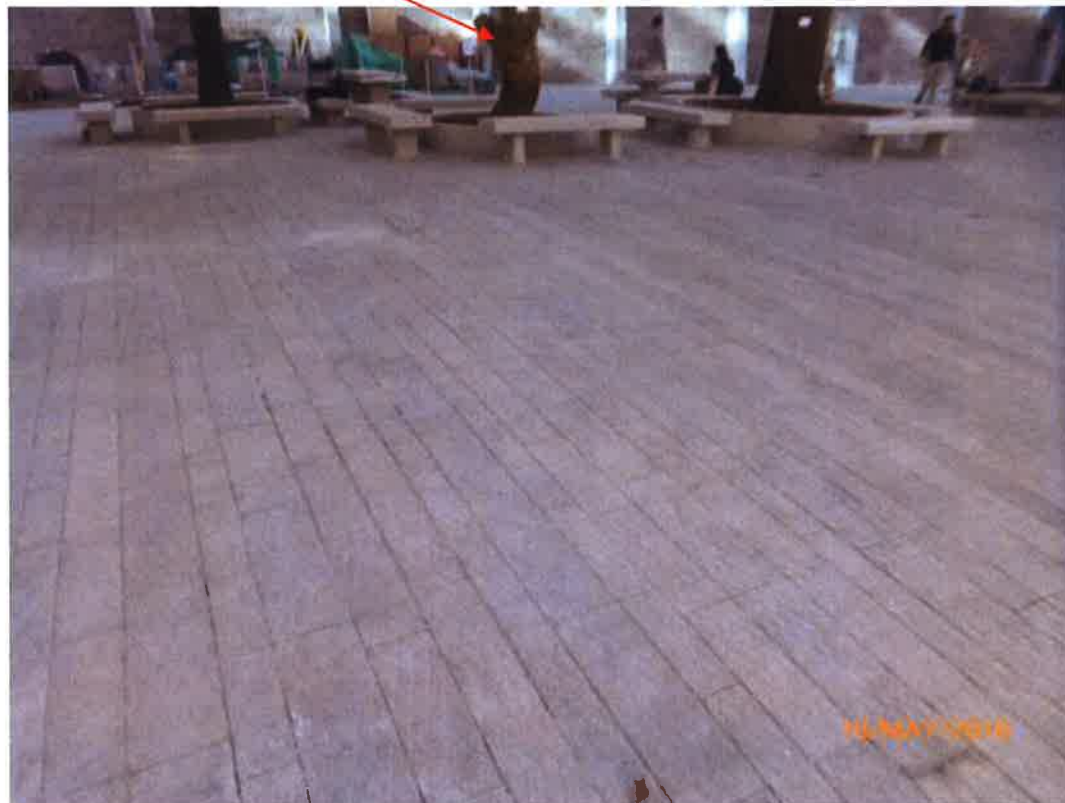
Fig. 12 Overall view of Tree-8 during inspection on 18<sup>th</sup> May 2018.

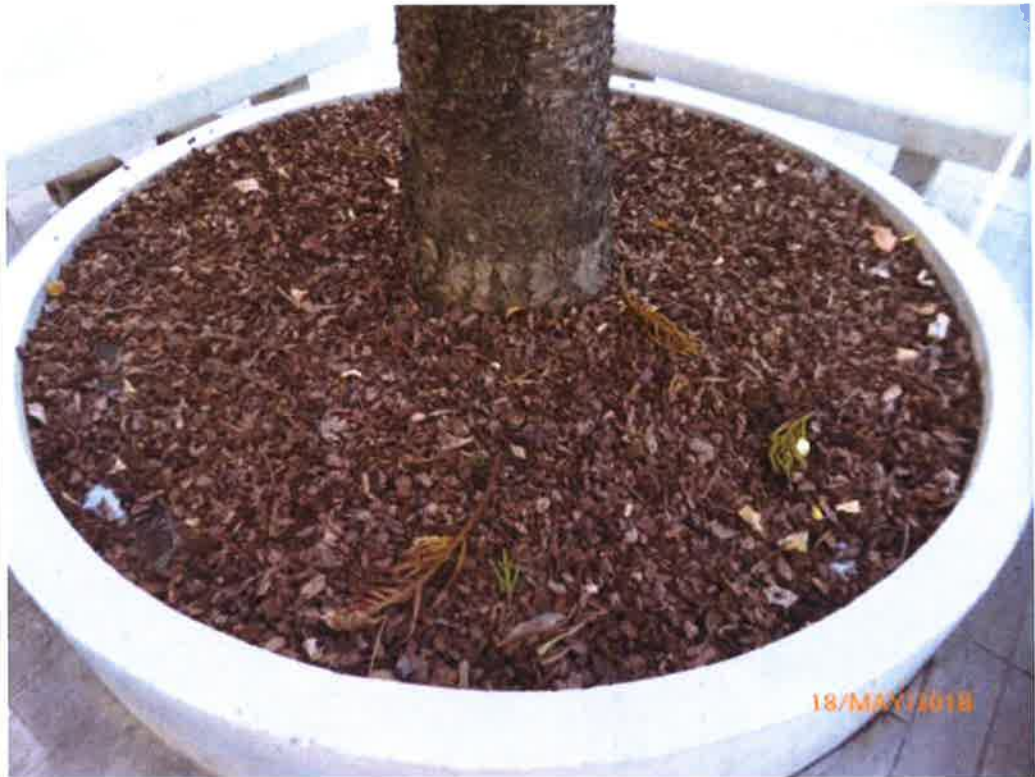
Fig. 3 The planter is covered with mulch and some dry leaves.

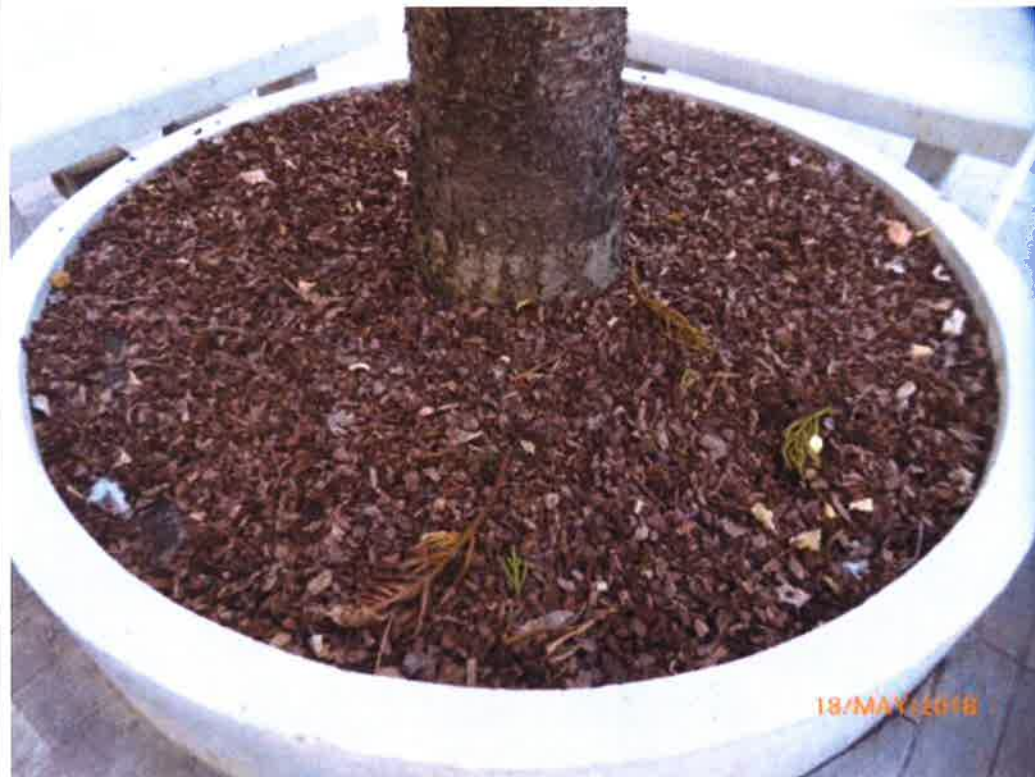
Fig. 4 Health condition of the lower trunk is fair.

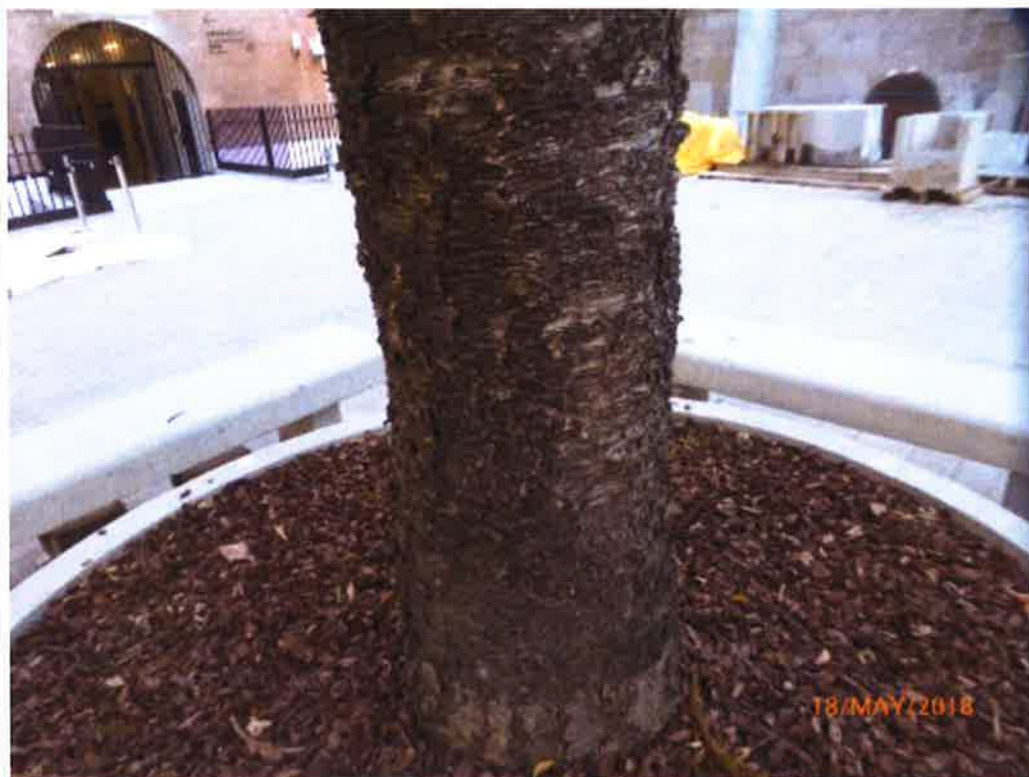
Fig. 5 Health condition of the mid trunk is fair.

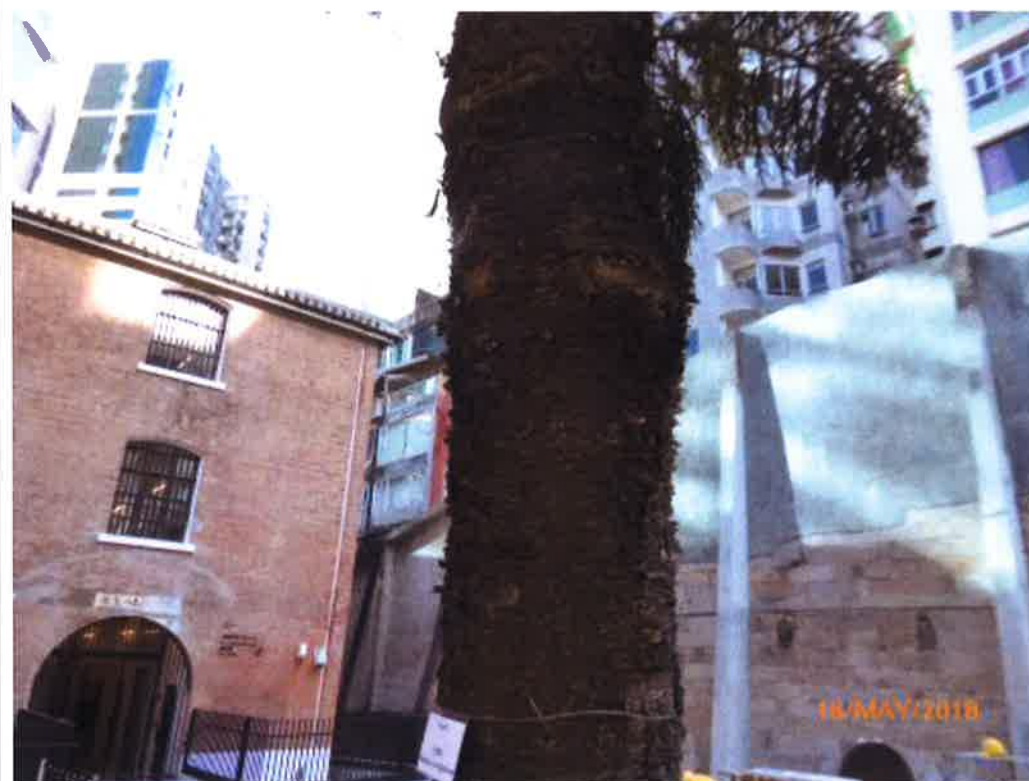
Fig. 6 Health condition of the upper trunk also is fair.

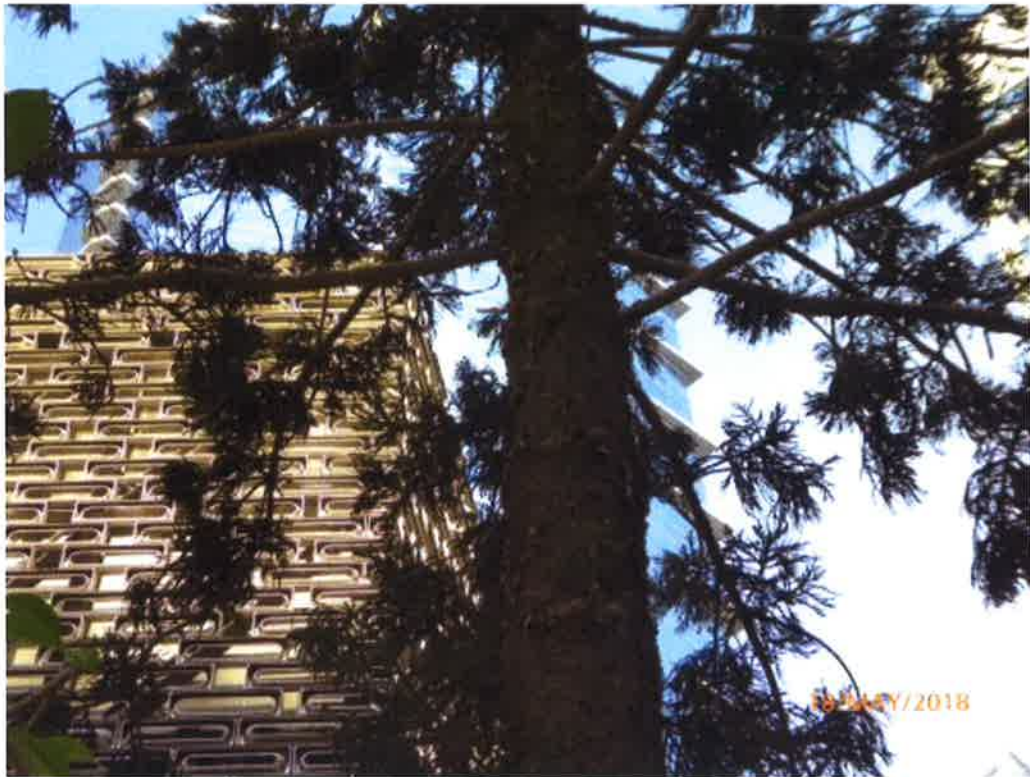
Fig. 7 The crown is full of vigorous and green leaves.
