The Jockey Club CPS Limited

Central Police Station Conservation  
and Revitalisation Project:  
*79<sup>th</sup> Monthly EM&A Report*  
*(1 May to 25 May 2018)*

Issue Date: June 2018

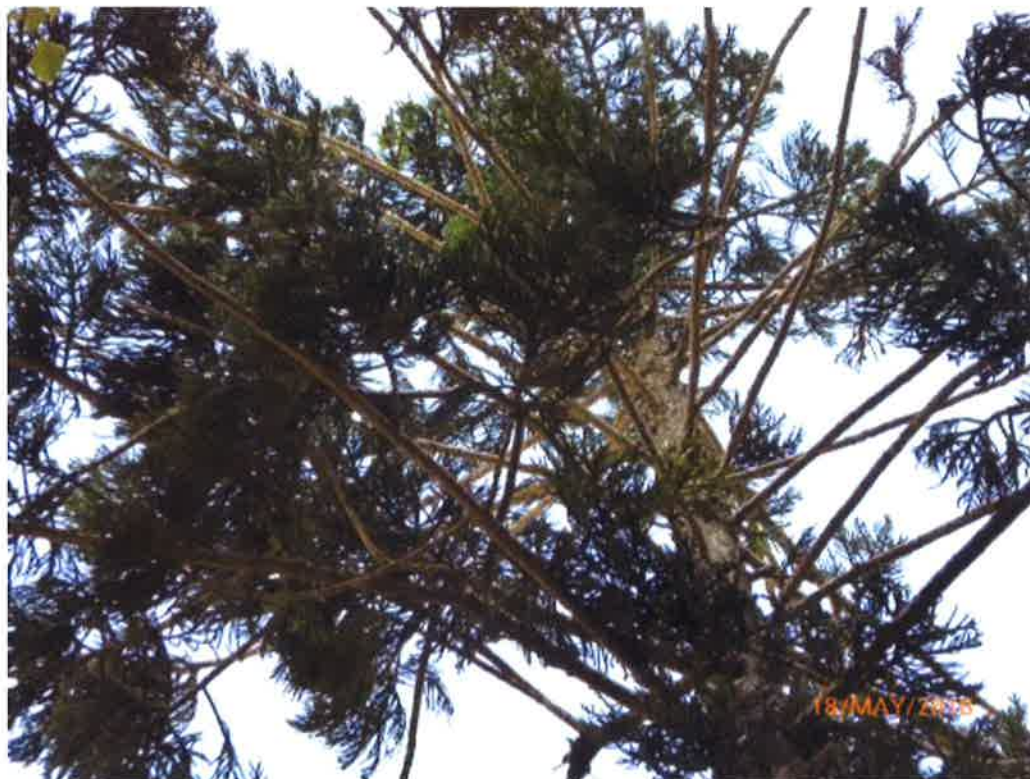
Fig. 8 Vigorous and green leaves also are growing on the lower branches.

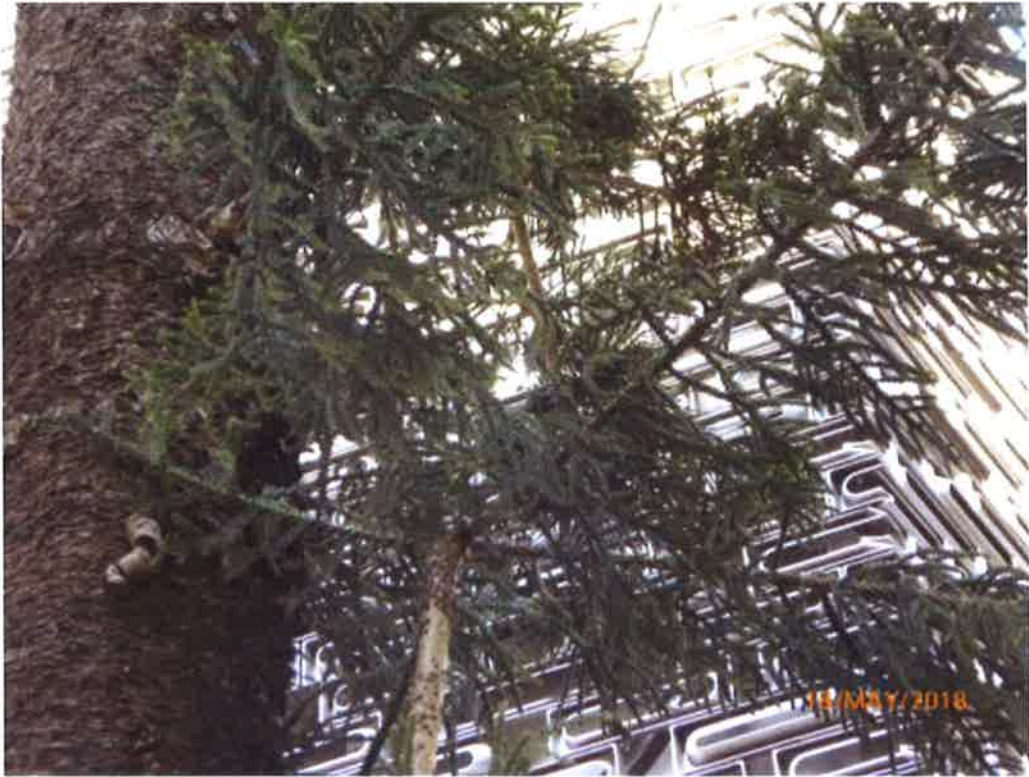
Fig. 9 Some young and green leaves appear on the upper trunk.

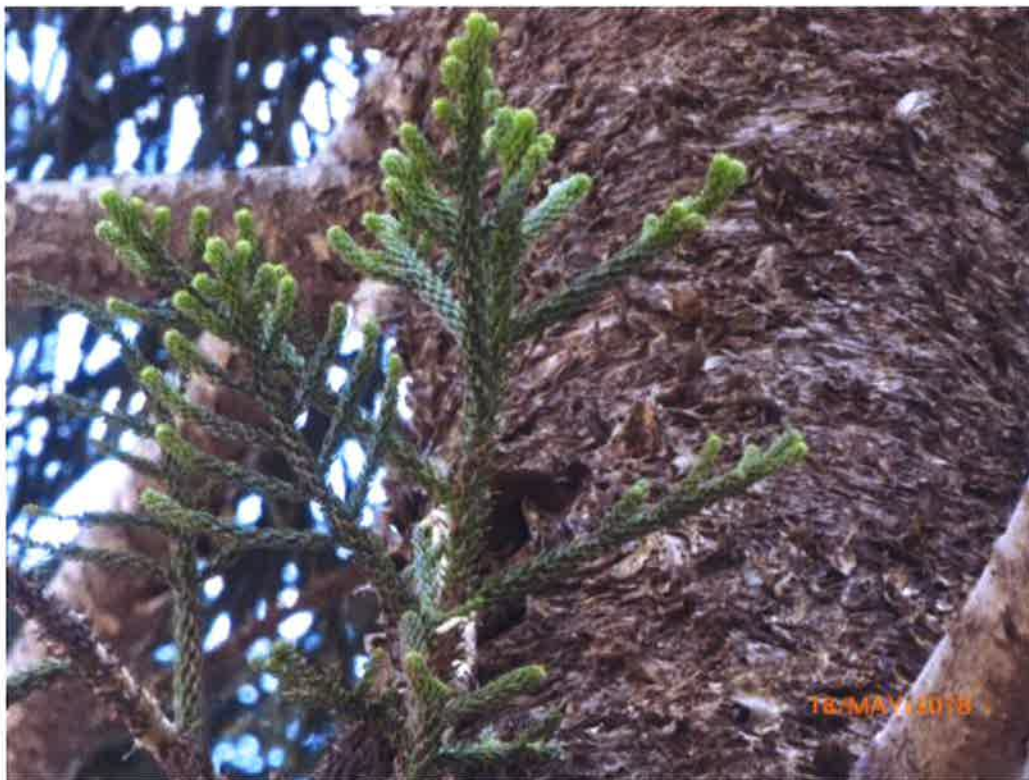
Fig. 10 Young and green leaves also are growing on the mid trunk.

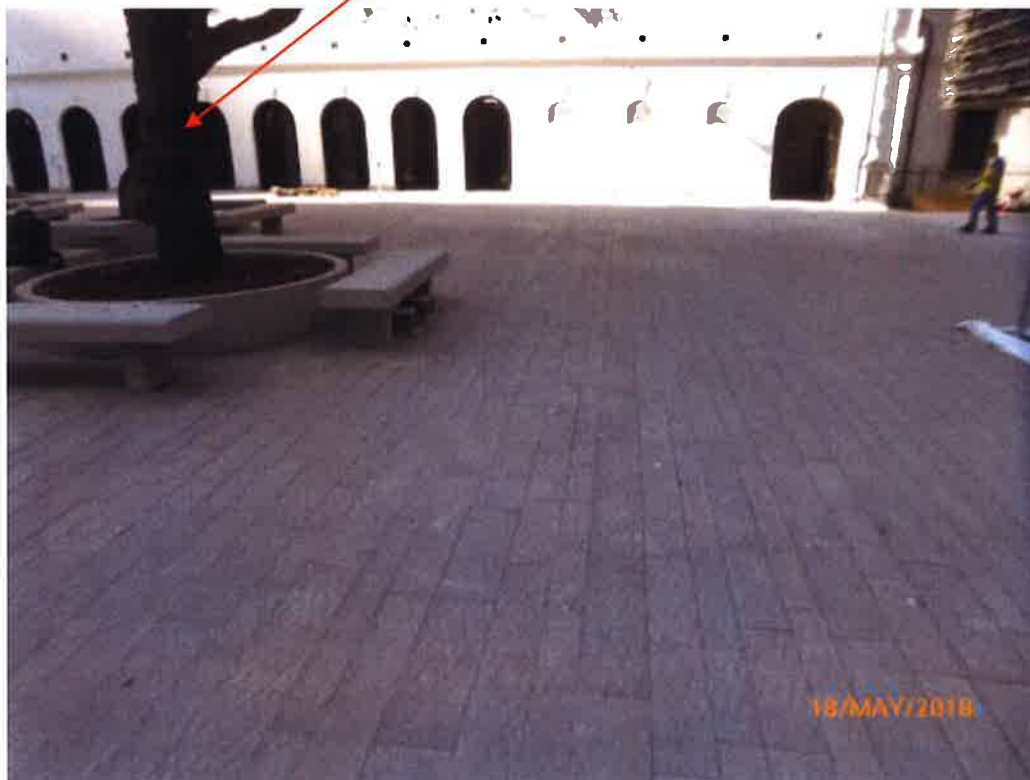
Fig. 12 Overall view of Tree-9 during inspection on 18<sup>th</sup> May 2018.

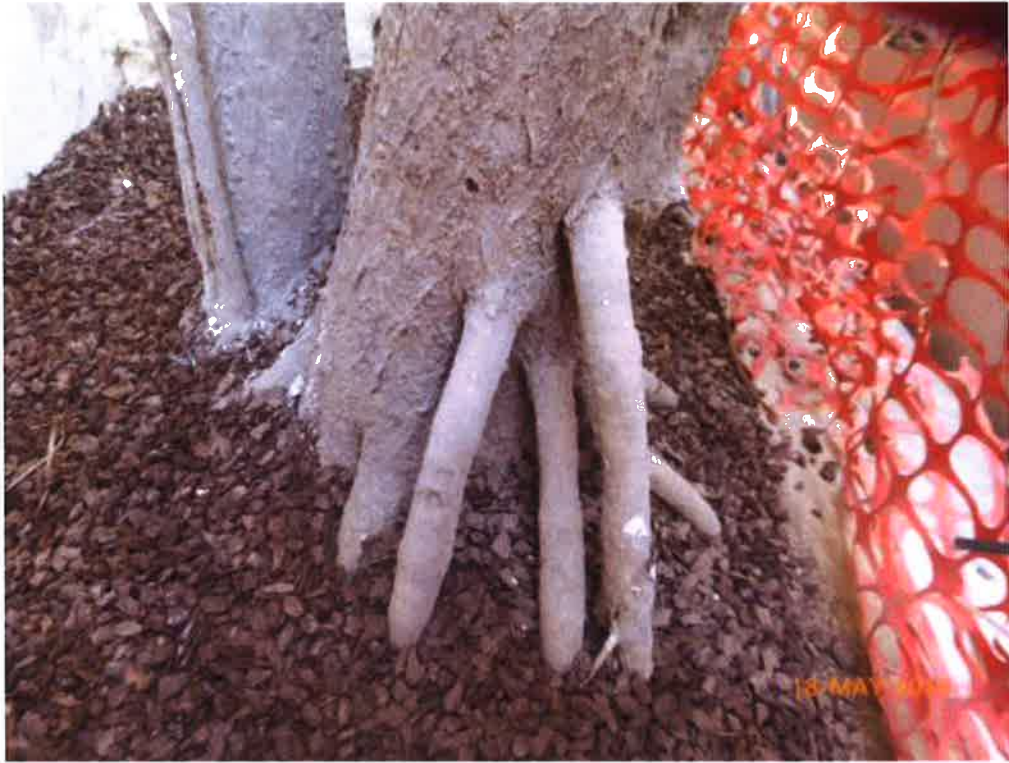
Fig. 3 Health condition of the lower trunk is fair.

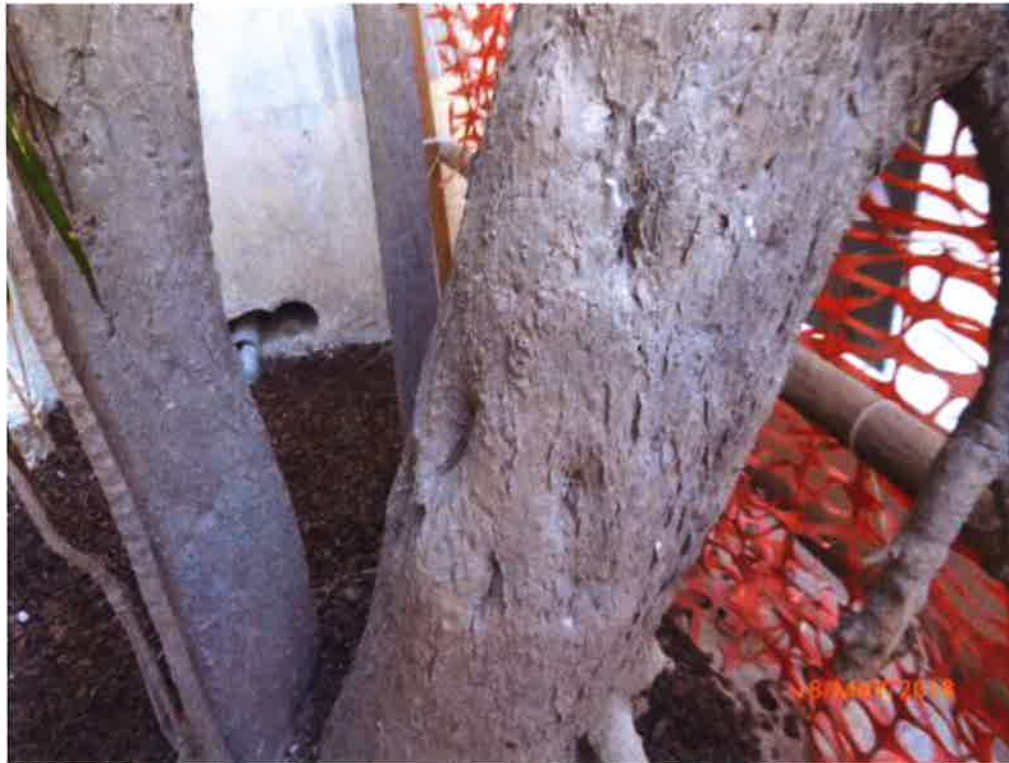
Fig. 4 Health condition of the mid trunk is fair.

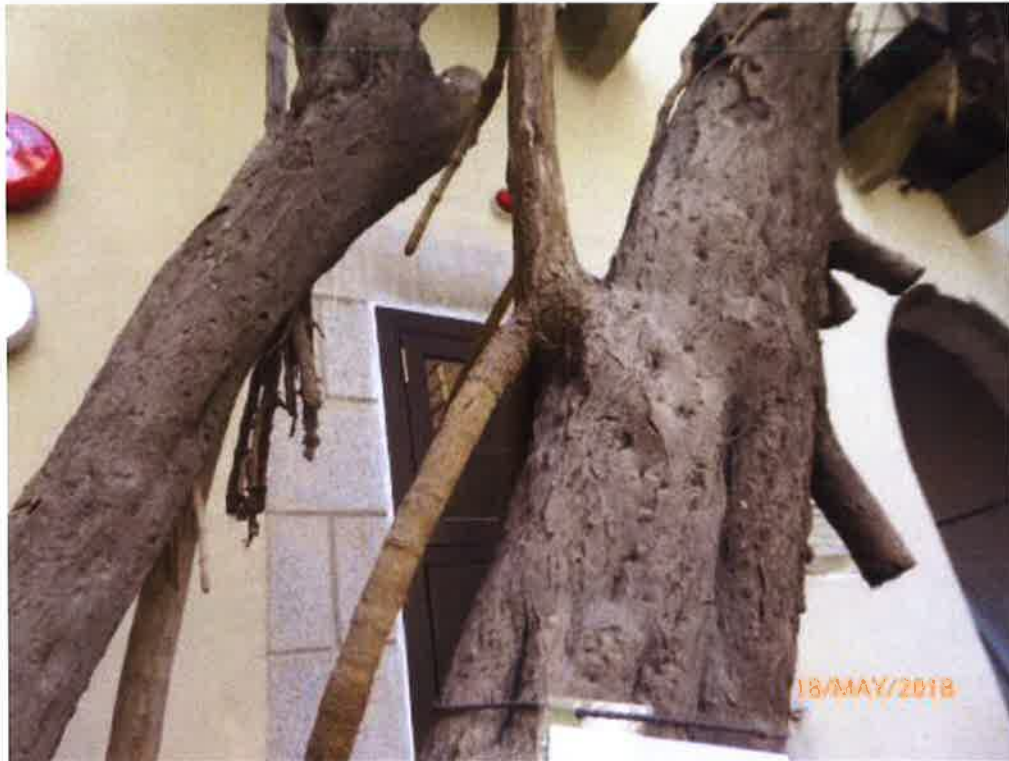
Fig. 5 Health condition of the upper trunk also is fair.

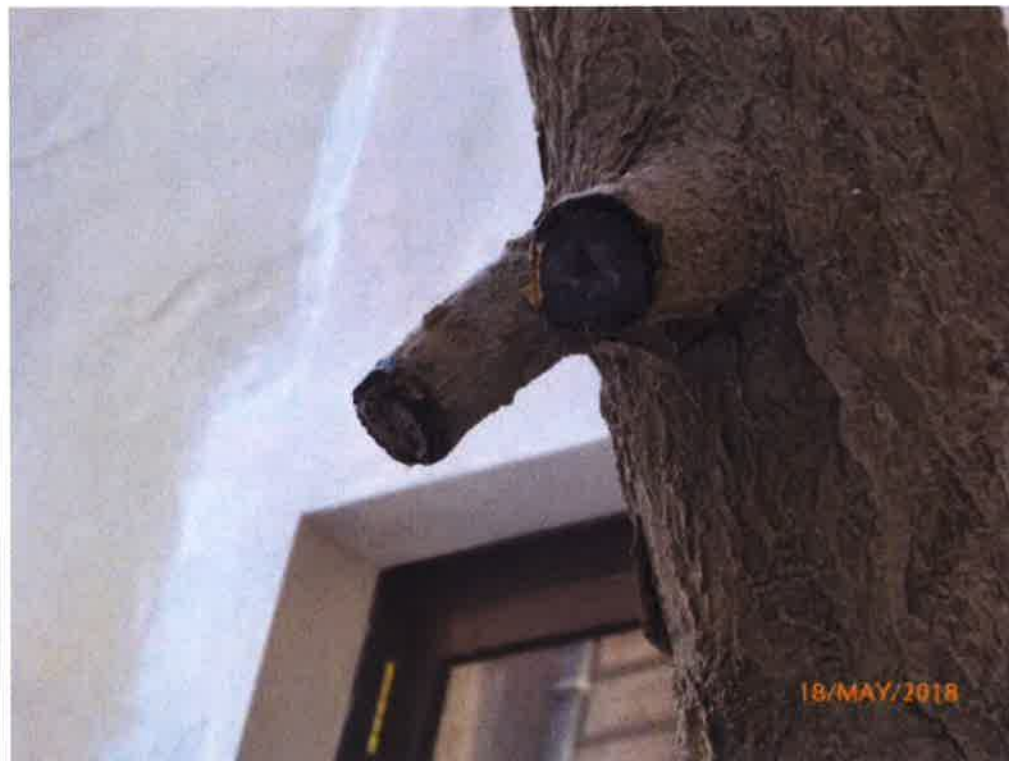
Fig. 8 Some young and green leaves appear on the mid trunk.

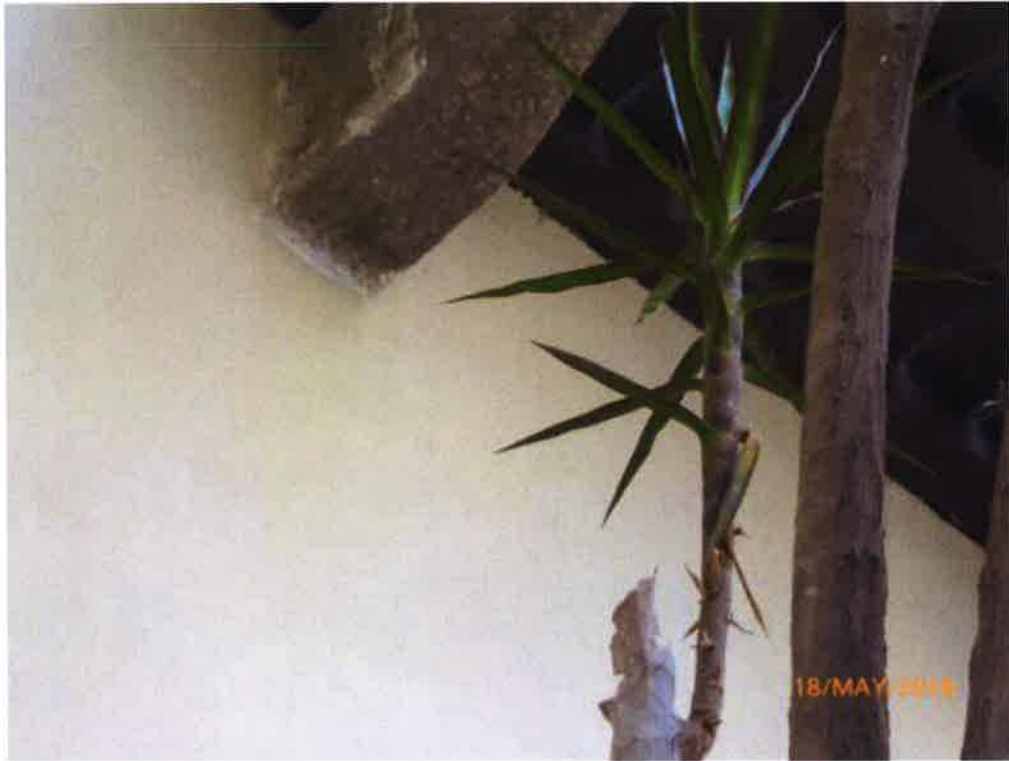
Fig. 9 Some young and green leaves also appear on the lower trunk.
